The Study on the Rehabilitation and Conservation Program of Bridges in The Republic of Chile

Final Report (Summary)

March 1993

Japan International Cooperation Agency

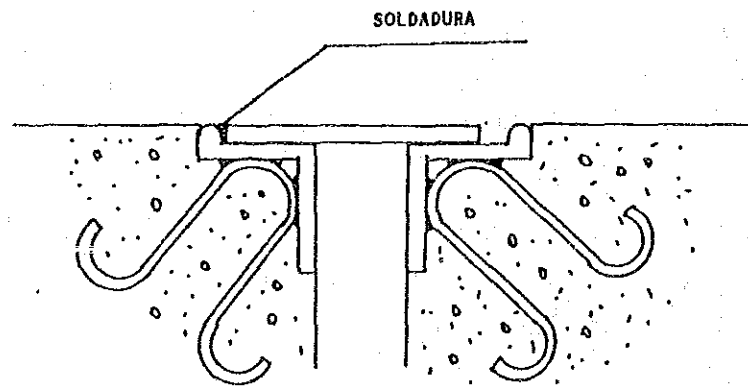
Figure 2-11 Expansion Joint

Cover plate expansion joints are used for most road bridges in Chile. The cover plate is welded at the construction site and its reliability is suspect. The joint's durability is questionable because most bridge joints were judged by the survey teams to have been damaged after only two years of use. As well, operation accuracy is poor and this has had an adverse affect on the main body of the bridge by creating abnormal sounds and increasing impact effect. (Refer to Figure 2-11)

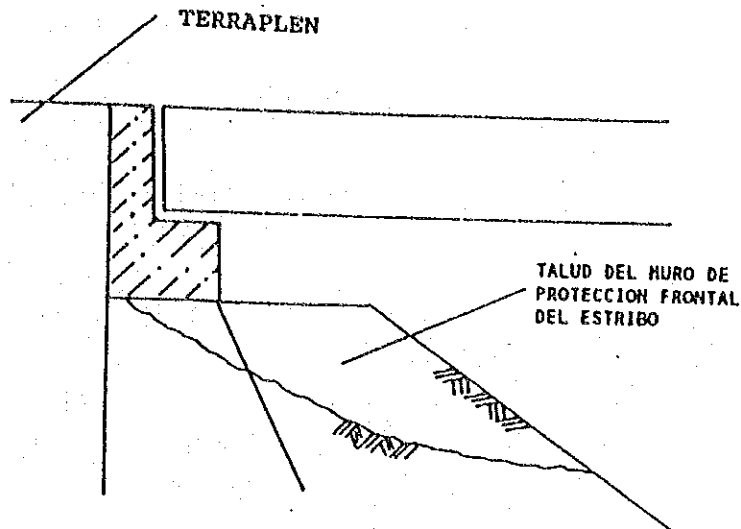
Figure 2-12 Filling

The protection of fill is extremely poor in the areas where fill touches the bridge. In order to reduce fill pressure, pier-abutment and pier-type abutment bridge bases have often been used. There is however is a high possibility that the fill on the backside of the abutment (approach) will sink as a result of poor compaction and lack of protection of the fill at the front. It is necessary to discuss protection methods for filling. (Refer to Figure 2-12)

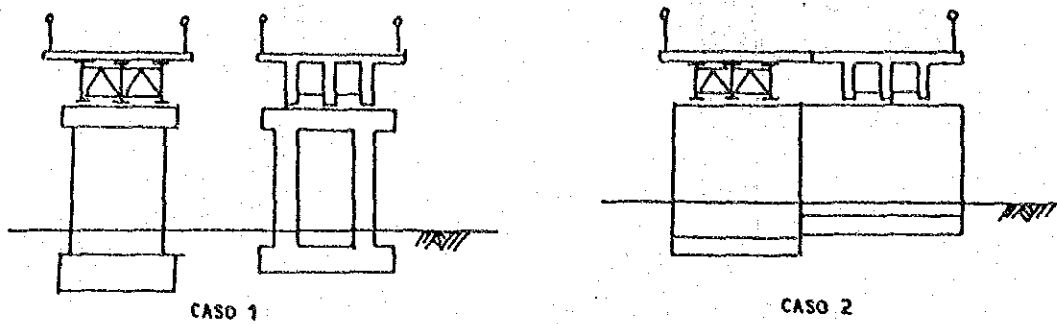
Figure 2-13 Bridge Widening Methods

An increase in traffic volume has resulted in a shortage of bridge width in Chile. There are two possibilities for expanding bridges from two lanes to four lanes. One possibility includes using the two old lanes exclusively for oncoming or ongoing traffic, while two lanes are added by constructing a totally separate bridge; the second possibility includes width expansion by creating a vertical joint to make the bridge seem as one. In both situations, the old and new bridge are always different. In the first situation, both bridges are constructed individually and there are few maintenance and control problems as long as the composition of the spans are the same. In the second situation, it is necessary to consider the influence of the new structure on the old structure, control of the expansion joint, and deformation of the vertical joint. (Refer to Figure 2-13)

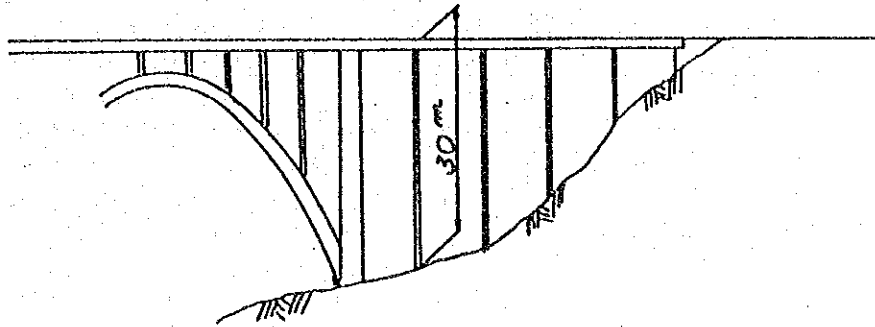
Figure 2-15 Pillars for Arched Bridges

The pillars used for arched bridges are too thin. Rigidity of the pillars is questionable as they are 30 meters in length and only 70 centimeters in thickness, furthermore, there are no middle crossbeams. Pillar elastic deformation does not seem to have been considered and significant bridge damage as a result of pillar thinness was observed in the southern part of the country. (Refer to Figure 2-15)

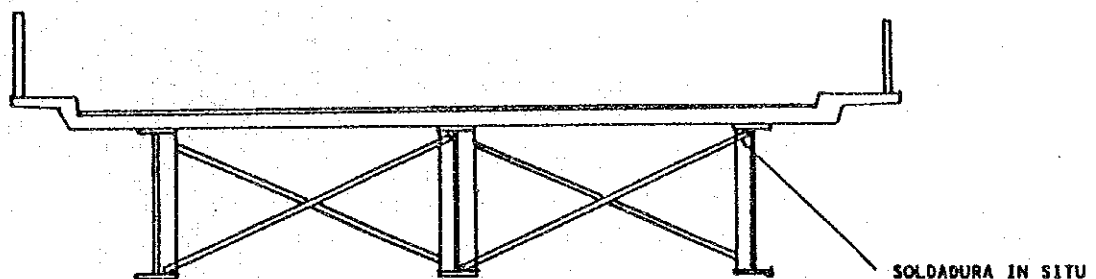
Figure 2-16 Crossbeam Structure

Floor framing was composed of the floor beam only and in rare case, both crossbeams and the floor beam are used. Connection with the main girders was done by on-site welding and was not carefully done. Breaks in the welding and repairs were seen at no less than 10 bridges. (Refer to Figure 2-16)
