THE STUDY  
ON  
THE MAINTENANCE AND REHABILITATION  
OF  
BRIDGES  
IN  
MALAYSIA

FINAL REPORT

VOLUME IV  
DRAWINGS

DECEMBER 1992

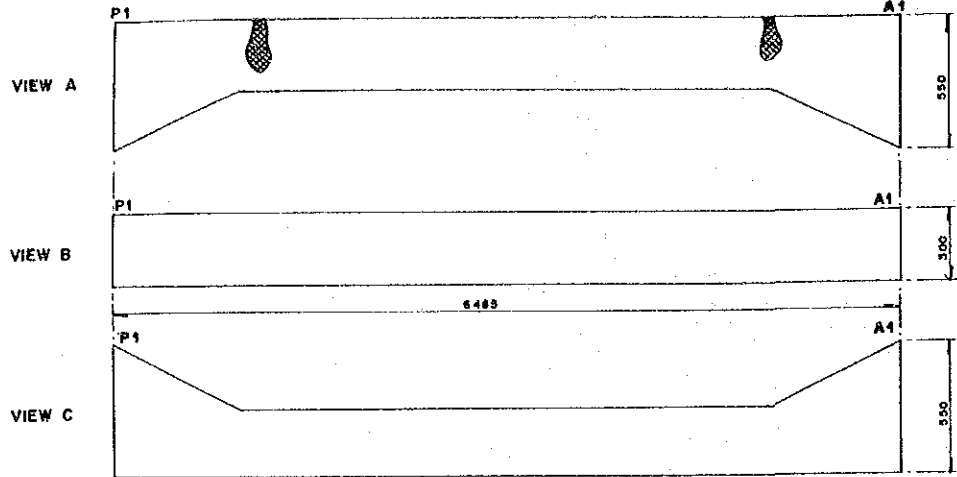
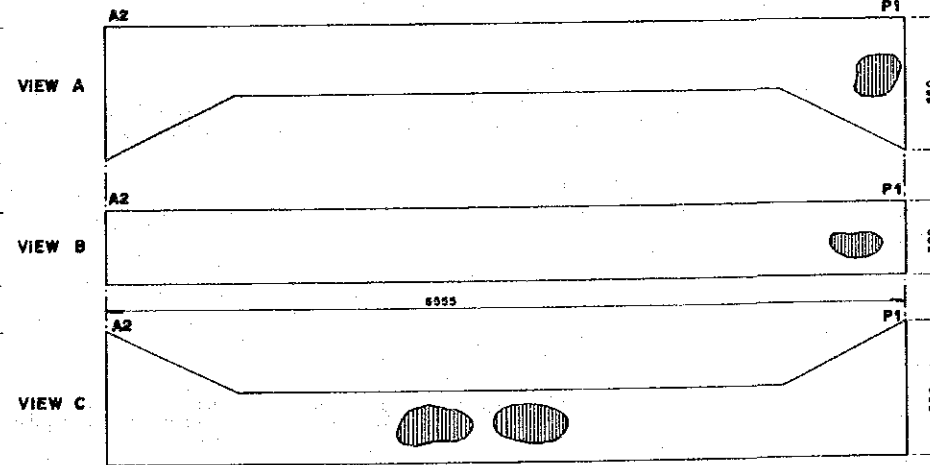
**CRACK DIAGRAM OF GIRDERS**

- BOTH DECK SLABS I.E. SPAN 1 & 2 ARE IN GOOD CONDITION.
- BOTH ABUTMENTS ARE IN GOOD CONDITION.
- SPAN 2 - GIRDER 2 NOT SHOWN IS STILL IN GOOD CONDITION.

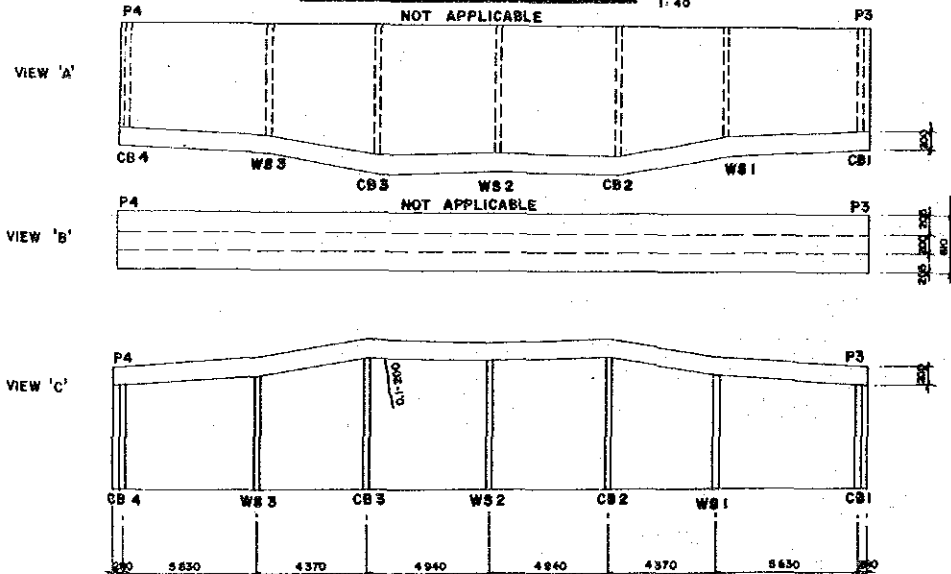
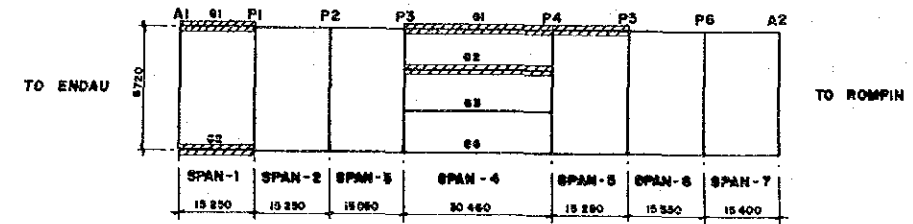
**CRACK DIAGRAM OF GIRDERS**

- ALL DECK SLABS ARE IN GOOD CONDITION.
- ALL CROSS-BEAMS IN SPAN 1, 2, 3, 4, 5, 6 & 7 ARE IN GOOD CONDITION.
- ALL CROSS-BEAMS ARE 200mm THK. UNLESS OTHERWISE SHOWN.
- 1140mm x CB1 & CB7  
1240mm x CB2, CB3 & WS2  
1450mm x WS1 & WS3.
- CORROSION DIAGRAM FOR SPAN 2, 3, 6 & 7 REPRESENTED BY SPAN 5.
- SPAN 4 - GIRDER 3 & GIRDER 4 CANNOT BE INSPECTED DUE TO ELECTRICITY CABLE.
- SPAN 5 - GIRDER 2 CANNOT BE INSPECTED DUE TO ELECTRICITY CABLE.
- CB - CROSS BEAM  
WS - WEAR STIFFENER

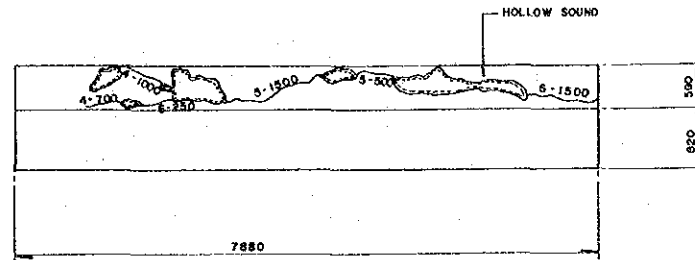
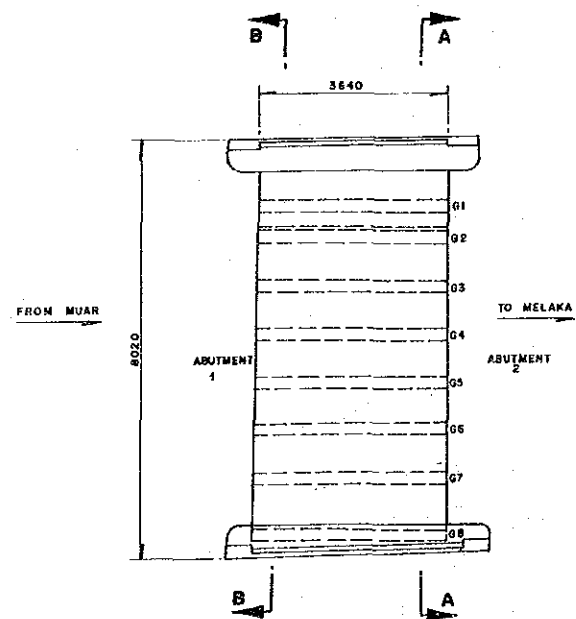
**CRACK DIAGRAM OF ABUTMENT**

**NOTES:-**  
1) BOTH ABUTMENTS ARE MASONRY WITH CEMENT MORTAR PLASTERING.  
2) CRACK AND FLACKING ARE ON THE PLASTERING SURFACE ONLY.

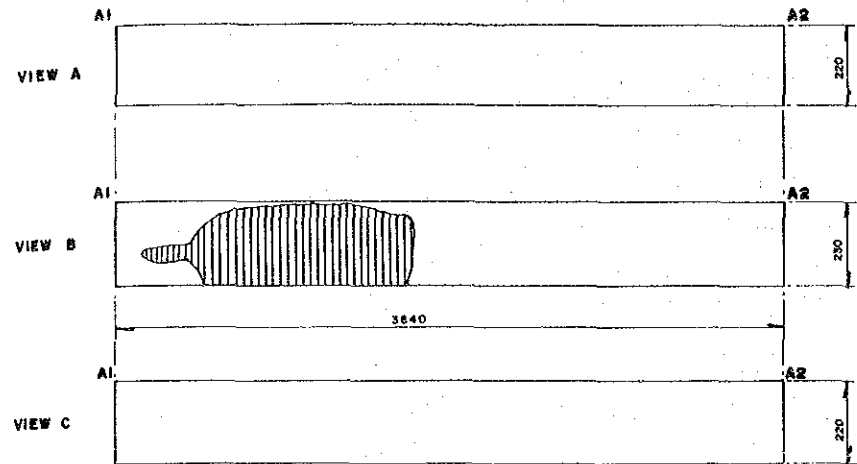
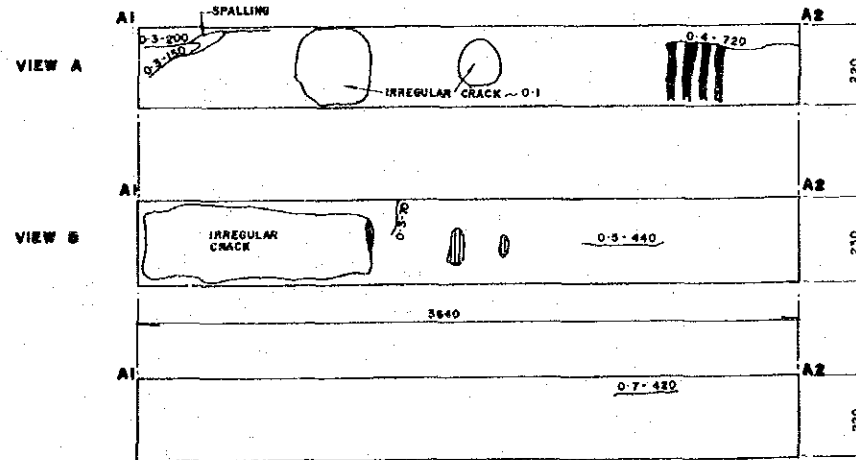
**CRACK DIAGRAM OF GIRDERS**

- GIRDER 1 & 4 ARE IN GOOD CONDITION.
- LOCATION OF CRACK DIAGRAM INDICATED BY 622 IS SHOWN ABOVE IN KEY MAP.
