添付資料－7 橋梁損傷調査結果の要約

橋梁損傷調査結果の要約

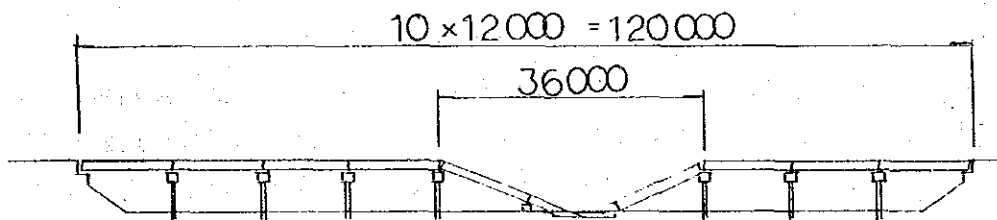
1) Prek Kheng橋

橋長120m、10径間の鉄筋コンクリートT桁橋で、下部工形式はすべてパイルベント形式である。P5、P6橋脚の爆破により第5径間から第7径間が落橋している。落橋している上部3径間は破壊がひどく、再使用は難しい。また吊り上げ可能なクレーンもないため再構築が必要である。脚柱はほとんど完全に杭との継ぎ目で破壊されており、再構築が必要である。

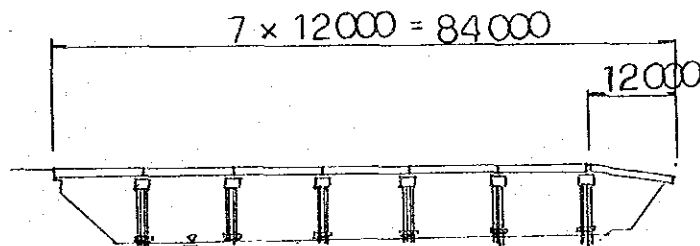
2) Kompong Prass 1st橋

橋長84m、7径間の鉄筋コンクリートT桁橋で、下部工形式はすべてパイルベント形式である。終点側の橋台が完全に爆破され、上部工1径間が落橋している。落橋している上部工および終点側橋台は再構築が必要である。

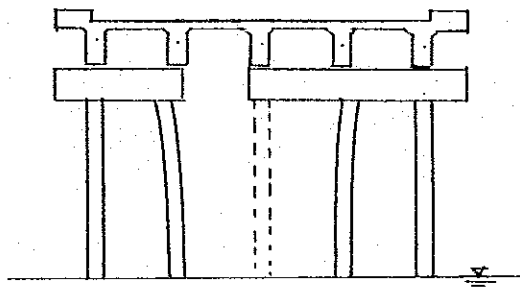
2) Prek Kra Poes橋

橋長120m、10径間の鉄筋コンクリートT桁橋で、下部工形式はパイルベント形式である。破損形態はPrek Bak橋と同様である。脚柱1基が完全に破壊され、両隣の脚柱が変形している。枕梁は約2.5mの長さでコンクリートが抜け落ちている。床版も同様に主桁と横桁に挟まれた部分が4箇所抜け落ちている。

補修対策としては、上部工2径間と橋脚破損部分の再構築が考えられる。

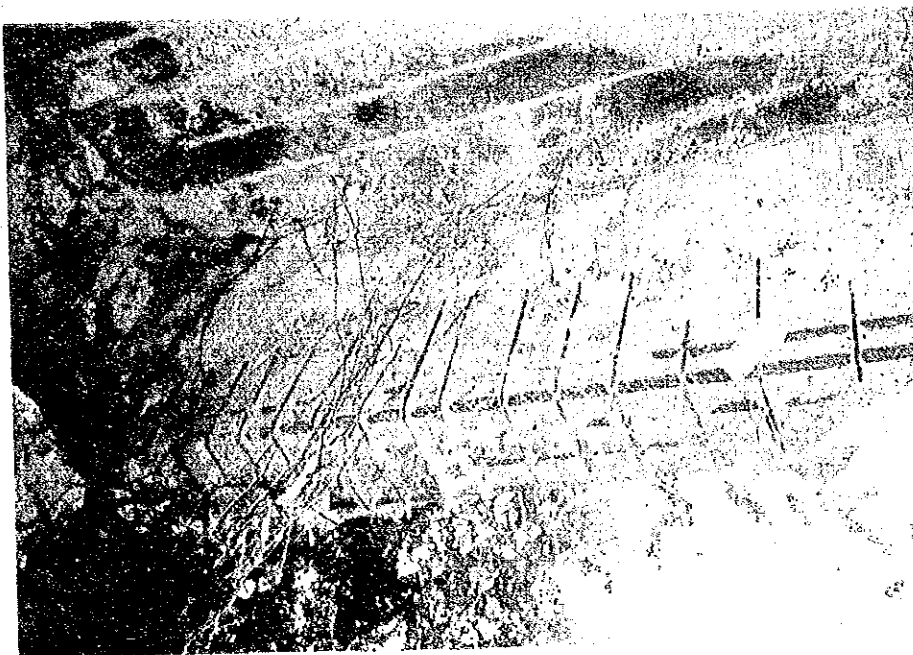
3) Prek Ta Sun橋

橋長24m、2径間の鉄筋コンクリートT桁橋で、下部工はパイルベント形式である。A1橋台部の両外桁付近の爆破により、上部工の桁と床版および橋台の一部が破壊されている。コンクリートは完全に抜け落ちておらず、剥離状態にある。ただし、ひび割れは内部に進行していると思われる。

補修対策としては、破壊している箇所の部分補修が考えられ、全面的な再構築は必要ないと考えられる。
