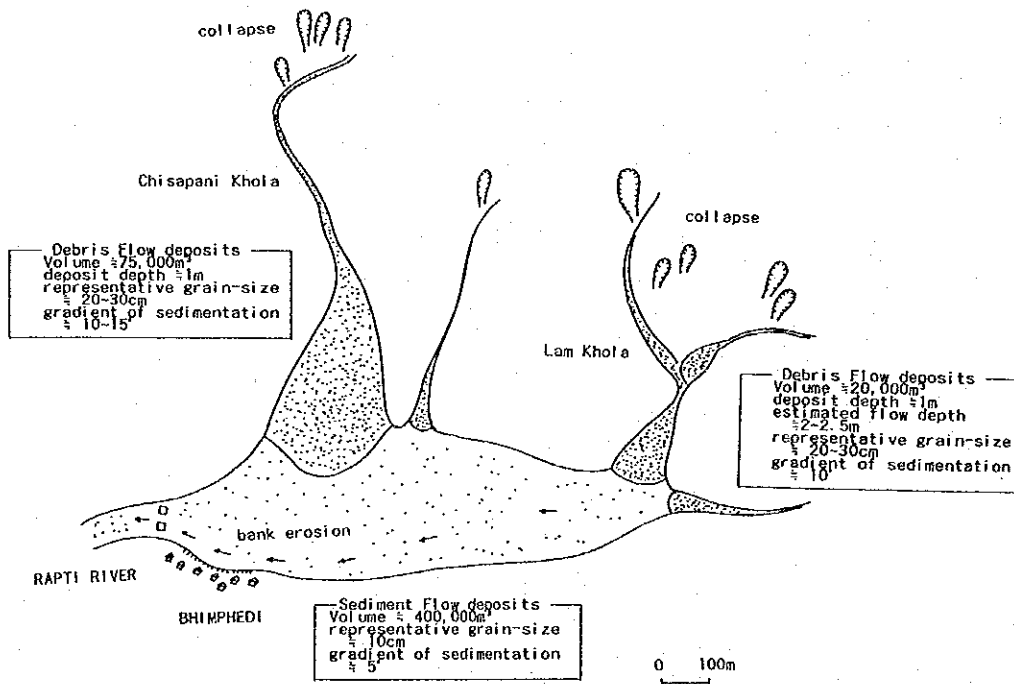
Fig. 6.2.2 Sediment discharge state in the upper reach of Rapti River (Bhimphedhedhi VDC)

#### 1) General situation of debris flows (Fig. 6.2.2)

In the upper most reaches of the Rapti River from Bhimphedi to Bhainse, a number of debris flows occurred in almost all tributaries as a combined effect of mountain slope collapses, river bank erosion and discharge of old deposits on the river bed in the upstreams.

Near the confluence between Bhimphedi River and Lam in the upstream of Bhimphedi VDC, an alluvial fan of the volume of approximately 20,000 m<sup>3</sup> was formed by debris flows. The depth of the debris flow is assumed to have been 2.0 m to 2.5 m judging from damages to trees. The gradient of sedimentation is about 10 degrees. The representative grain-size is relatively small (20-30 cm) and accordingly the mode of sediment transport is assumed to have been a mud-flow rather than a debris flow.

In Chisapani valley located in front of Bhimphedi an alluvial fan was formed as a result of a similar mode of sediment transport. The volume of the deposit is about 75,000 m<sup>3</sup> with the depth of 1 m and the surface gradient is 10 degrees. The revetment protecting Bhimphedi was damaged by a length of about 50 m due to the sediment flow from this valley.

In Bhimphedi, the terrace on which the town is located is composed of unstable river deposits. Therefore a revetment with a strong foundation should be constructed along the foot of the terrace in order to protect the terrace from scouring. Shifting the road from the terrace slope to the terrace surface might be a viable idea, which is free from any damage from the river.

Consolidation work is necessary at the downstream end of the wide portion, where the river becomes narrow and the increased tractive force may cause heavy erosion resulting in abrupt discharge of massive sediment and scouring of the foundation of the revetment. It will be necessary to excavate sediment deposited and reuse them for construction.

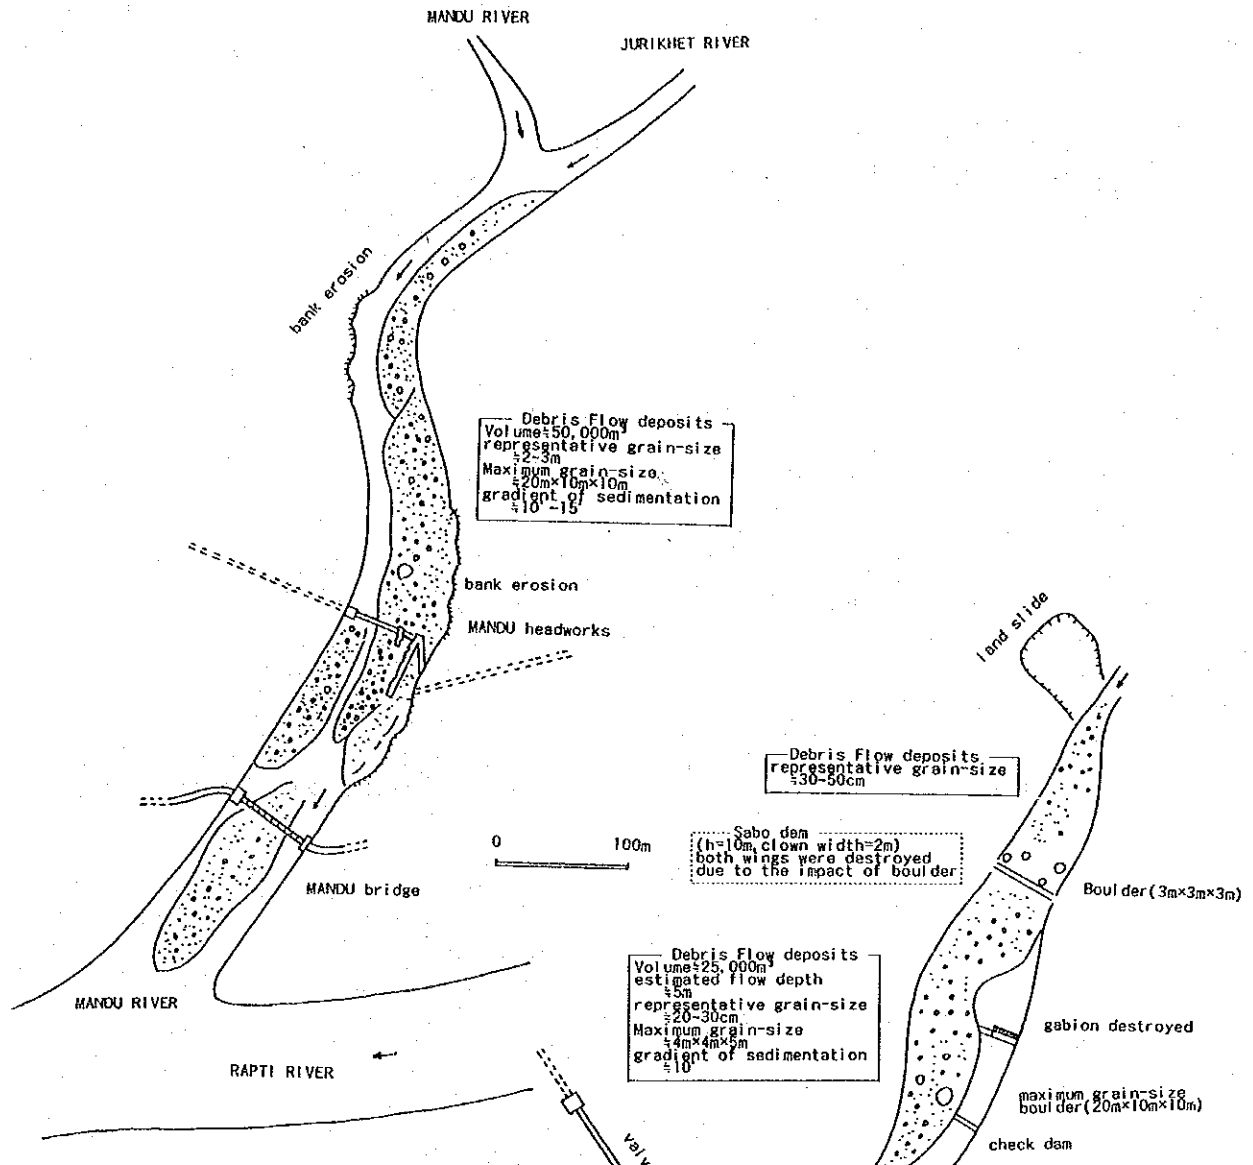
Fig. 6.2.3 Sediment discharge state in Mandu Khola basin

In these circumstances, it is recommended ① to carry out debris flow measures in the catchment of the Mandu Khola and ② to reconstruct the intake, not in the original place but in a place where the impact of debris flows will be less. One of places to be proposed for the new site of the intake is that on the left bank just upstream of the bridge. In order to minimize the effects on the Rapti River, it is important to construct a series of consolidation works to fix the river bed of the Mandu Khola so that the existing deposits may not be discharged downstream.

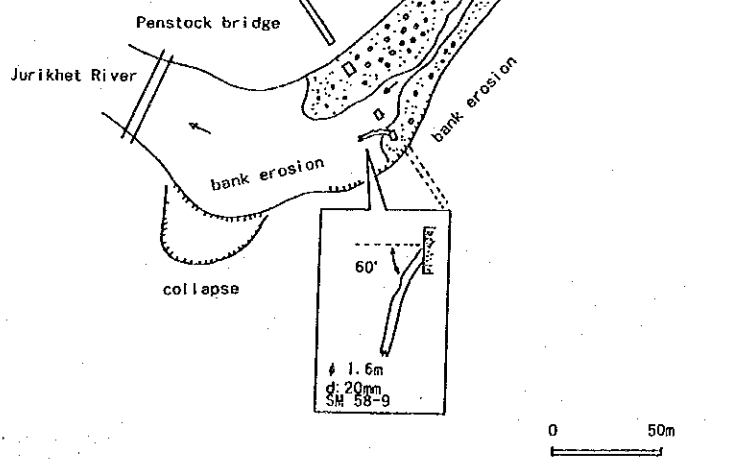
Fig. 6.2.4 Sediment discharge state in the down stream of Mandu Khola basin

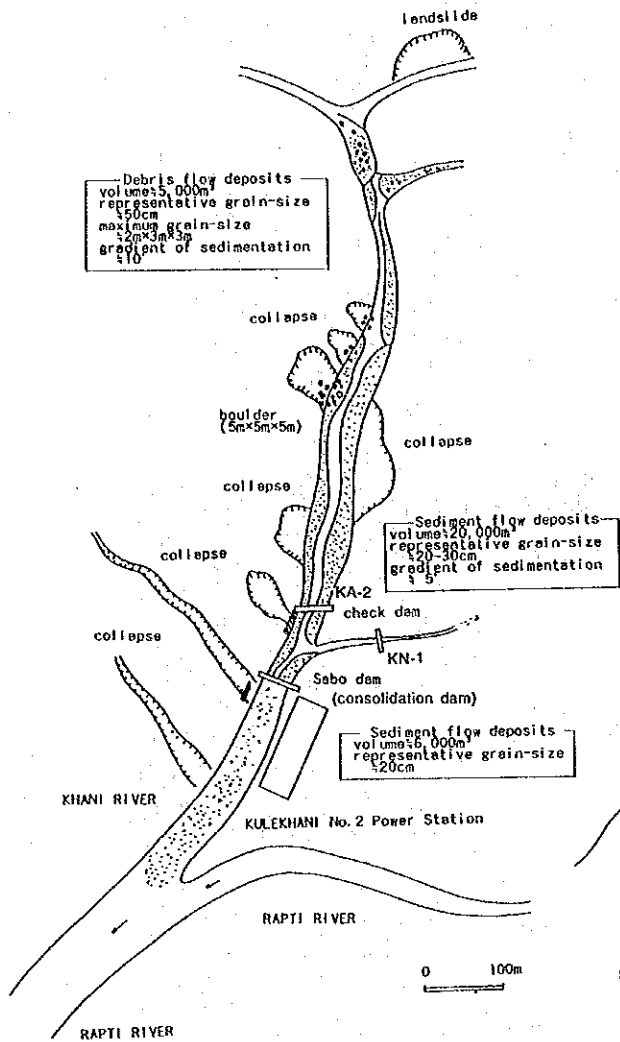
The dam axis of the upper check dam is not at a right angle to the direction of the mainstream of the Khani Khola, therefore, debris flows flowing down over the check dam may hit and damage the left wing of the check dam in the downstream. Construction of revetment to regulate the direction of the flow from the left to the center of the river course is recommended immediately in the downstream of the upper dam.

In the upstream of the confluence there is a heavy deposit due to the sediment discharge from the Khani Khola combined with the backwater effect of the Rapti river. Therefore measures should be taken not only along the Khani Khola but also in the Rapti River downstream of the confluence. It is recommended to dredge deposits around the confluence, as the emergency measure, and then to construct a separation levee at the confluence, as the future measure, which will be effective to augment the tractive force of the river flow and to lower the river bed.

**Fig. 6.2.5** Sediment discharge state in Khani Khola near the confluence with Rapti River

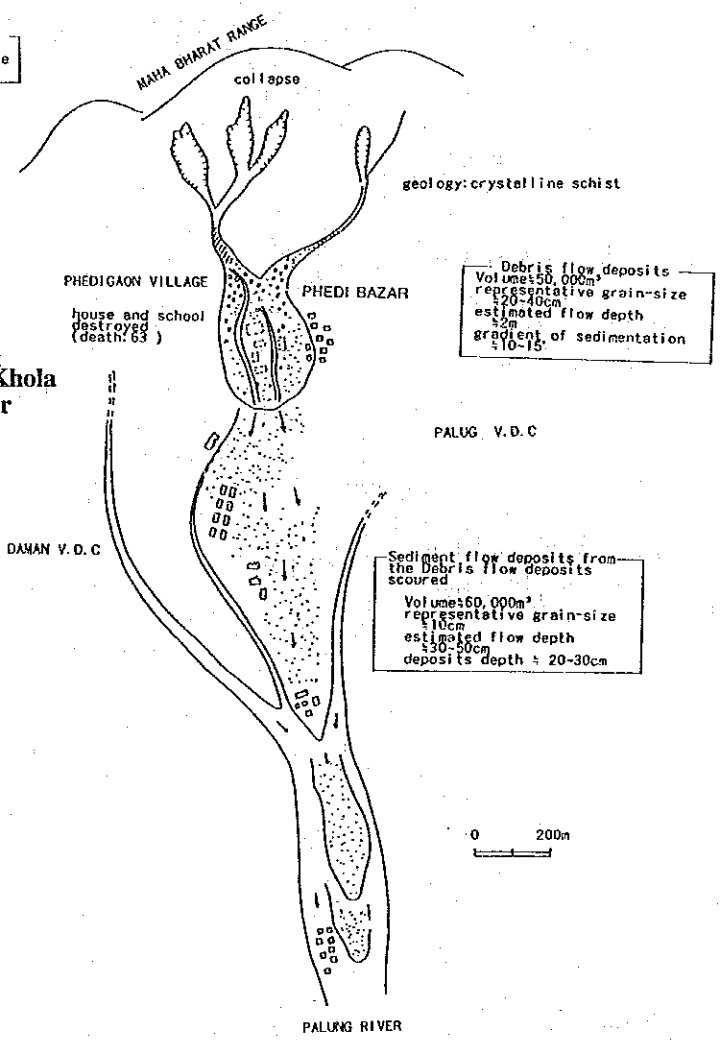
The Palung Khola is a tributary of the Kulelhani River with a catchment area of 31.4 km<sup>2</sup> at the confluence with the Kitini Khola. A mountain slope collapsed in the catchment (crystalline schist zone) caused the debris flows of the Palung Khola, which flowed directly into the top of the alluvial fan resulting in an extensive damage to the Palung VDC especially to the Phedigaon village. About 60 persons died.

**Fig. 6.2.6** Sediment discharge state in the upper stream of Palung Khola

It is further proposed that a straight channel should be constructed from the fan downwards to the confluence with the mainstream of the Palung Khola so that the water discharged through the deposit may flow down smoothly without causing any damage to river banks downstream.

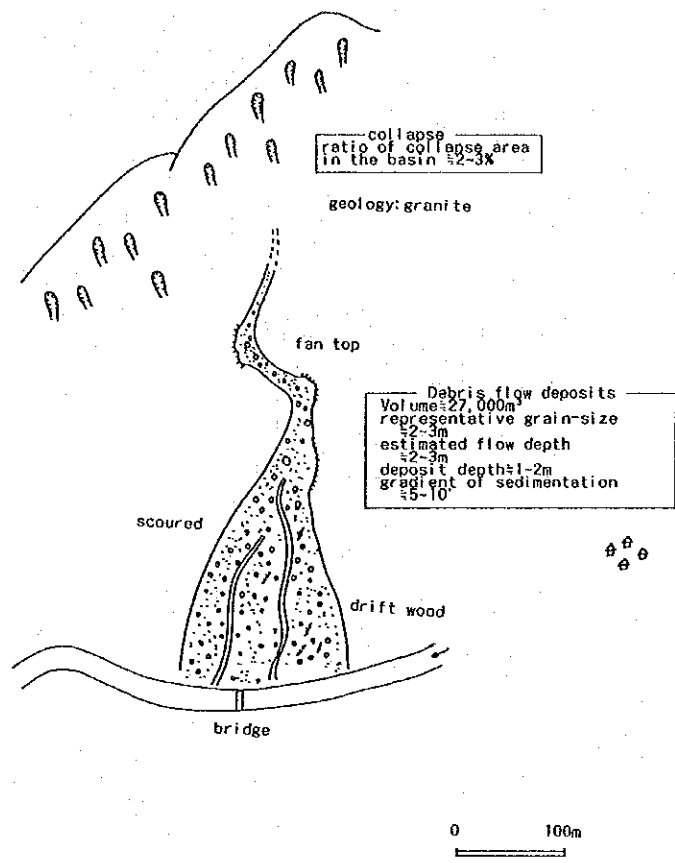
Remnants of old debris flows were observed here and there scattered widely, indicating that debris flows repeatedly occurred in the past in this area.

**Fig. 6.2.7** Sediment discharge state in the upper stream  
Kitini Khola

Hillside work will be necessary to reduce sediment production at a number of collapses in the catchment. Japan has a good experience of hillside work in granite zones (ex. Tanakami mountain) for more than a century. The techniques developed there might well be applied to Nepal in view of the similar meteorological conditions between the two countries.

On the alluvial fan, there are many houses along the left bank of Kitini Khola and dispersion of debris flows on the fan may endanger their safety. It is therefore recommended to construct a direct channel from the fan top to the confluence with the Palung Khola. In this case, it is important to construct a series of consolidations on the fan in order to reduce the sediment transport to the Palung Khola and also to prevent erosion due to overflow from the channel.

The channel should be so designed as to join the Palung Khola downstream of the Palung bridge so that the discharge from the channel may not affect the bridge. Due to the topographical condition at the site, however, the joining angle can not be small. Therefore, if the sediment load from the channel is great, it may accumulate in the Palung Khola without being flashed and the flow of the Palung Khola will be compelled to run along the left bank. Revetment to protect the left bank of Palung Khola from scouring will be required.

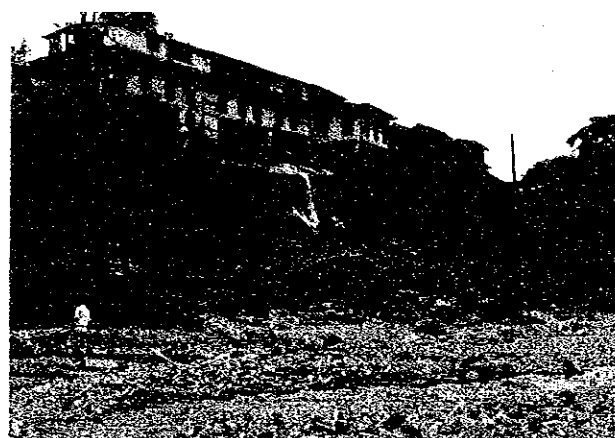
Therefore, the existing houses on this terrace can be damaged unless some measures are provided to protect the banks from subsequent erosion.

**Photo. 6.2.3 Bank erosion due to drift current of  
sediment flow at Bhimpedi village**

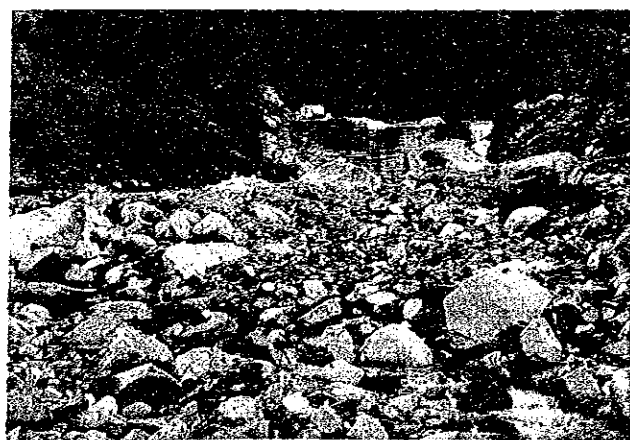
**Photo. 6.2.4 Check dam damaged by debris flow in  
Jurikhet Khola**

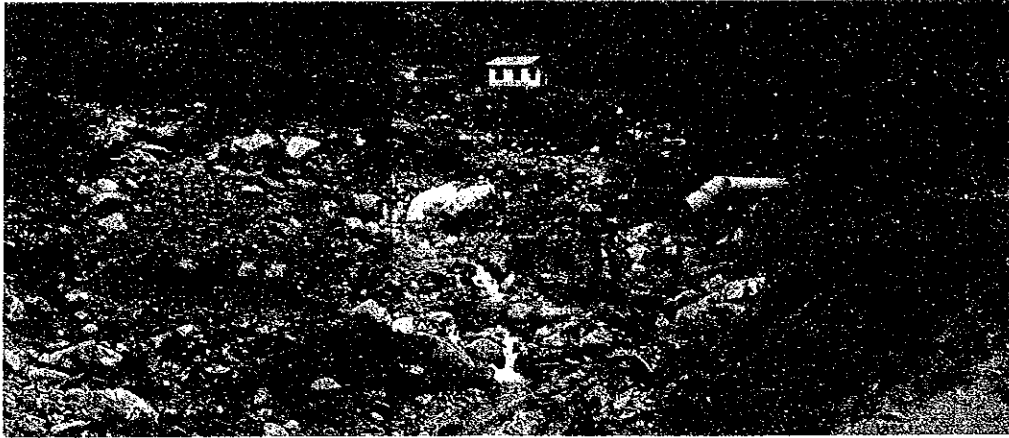
**Photo. 6.2.6 Penstock pipe destroyed by debris flow in Jurikhet Khola**

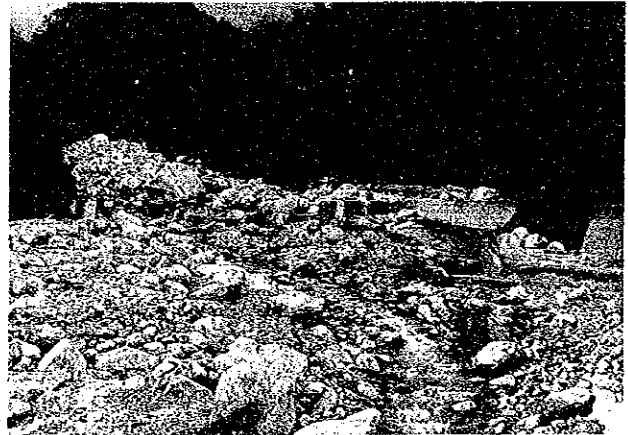
**Before the Debris flow occurrence**

**Photo. 6.2.7 Mandu Intake (head work) destroyed and overlain by debris**

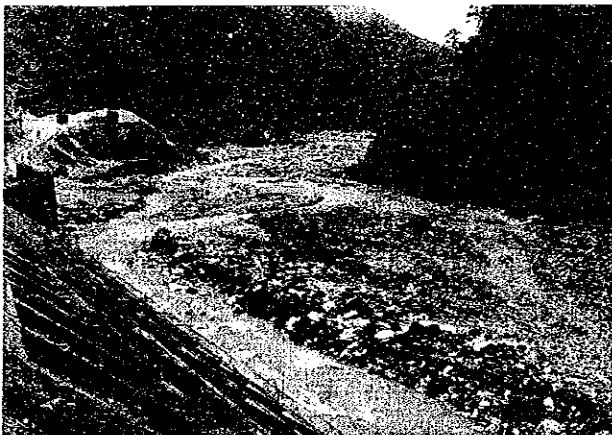
**Photo. 6.2.8 Aggradation of Khami Khola near the confluence with Rapti River**

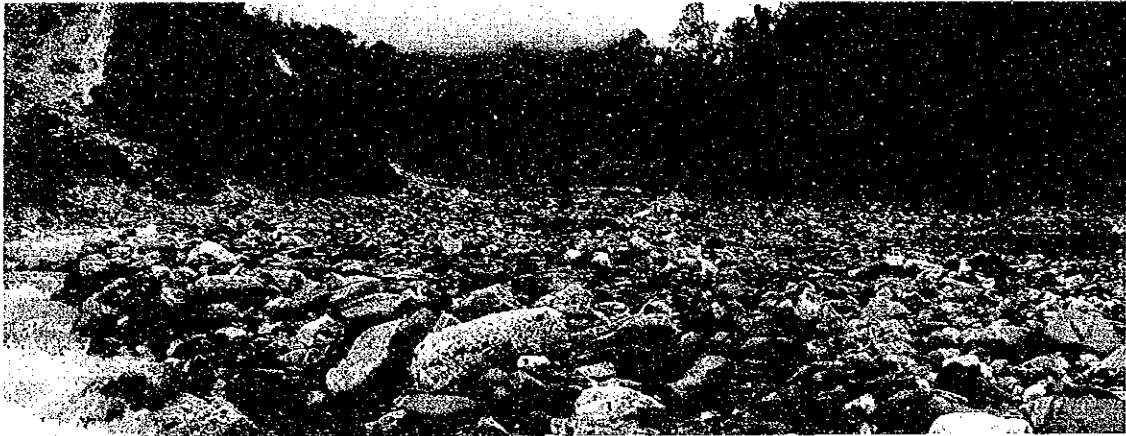
**Photo. 6.2.10** Sedimentation state in just upper stream of check dam shown in the photo. 6.2.9

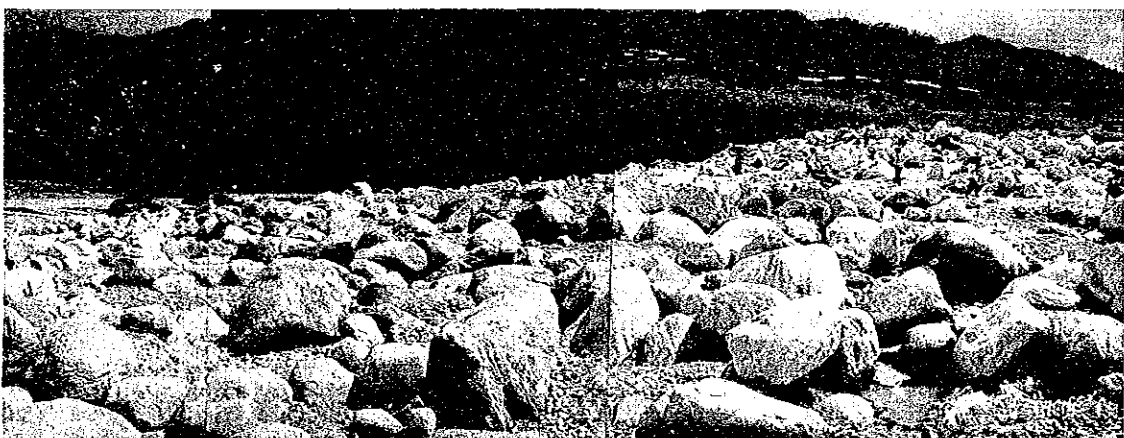
**Photo. 6.2.12** A number of collapses in the granite area triggered debris flows in Kitini Khole

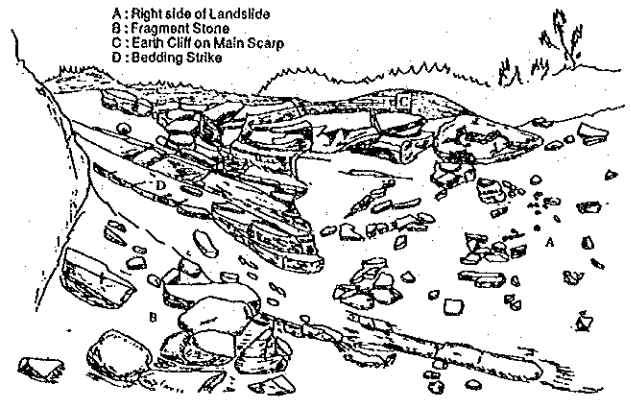
Fig. 6.3.1 Landscape Sketch of Upper Jurikhet Landslide (so called as Small Landslide)

continuously outcropped (Fig. 6.3.1, D). Especially geological formation in the landslide area is specialized as structure of dip gradient layer. Rockslide controlled by geological conditions defined as a dip gradient formation is a general form on this region. From the above mentioned reasons the expansion of landslide can not be anticipated in the future.

- 3) Sliding mass almost flowed down from the spot of beneath locating path as the moving forms of debris avalanche along the sharp gully channel is estimated at over about 6 m in width. Due to this sliding the beneath locating path for the maintenance purpose of Kulekhani dam reservoir is destroyed ranging over 6 m in length. Landslide in the future will be only small scale rock fall originated from the condition of jointed formation.

- 4) Although cause of this rockslide is directly heavy rain fall, primary causes are the particular geological formation, which is called as dip inclination and gully development due to the erosion of the Chisapani Khola extended to the landslide toe spot.

- ② Measures for new road to be constructed on Upper Jurikhet landslide are sufficient by construction of wet masonry wall based on the hard rock in order to prevent the further development of gully magnification and trimming work in order to remove the very small scale rock fall and the collapse of remaining earth material (Photo. 6.3.3). Slope protection works should be discussed on the outcropped slope after trimming, mortar spray work is effective to prevent the weathering process causing further rock fall.
- ③ As landslides form is controlled by the geological condition originated from the tectonic movement, the detailed investigation of geological structure should be planned. To assess the degree of danger of landslide prone area the investigation in regards with correlation between the landslide occurrence until the present day and gully development degree should also be planned.

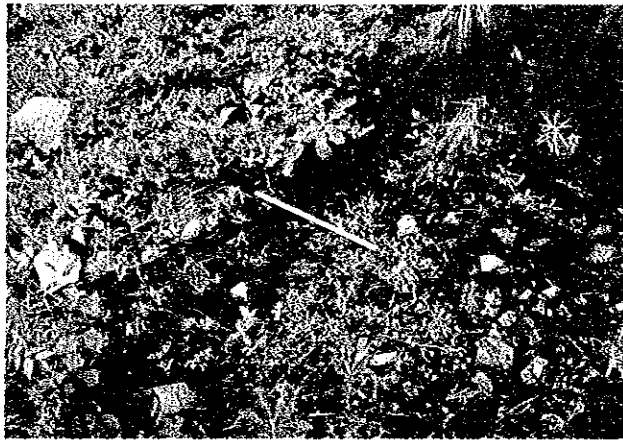
- 5) On the other hand, opening crack having 20 cm in maximum width, which is locating about 2 m above the slope side of road, continues parallel with the road running direction (Photo. 6.3.2). The continuous length of this crack extends over 100 m from the above mentioned rockslide toward Upper Jurikhet. The depth of this landslide (refers to lower landslide) is estimated to be a relatively shallow form judging from the dipped geological formation of its surrounding area and the only existence of opening crack without being accompanied by subsidence or uplift phenomena.

Photo. 6.3.2 Tension Crack of Landslide locating along road

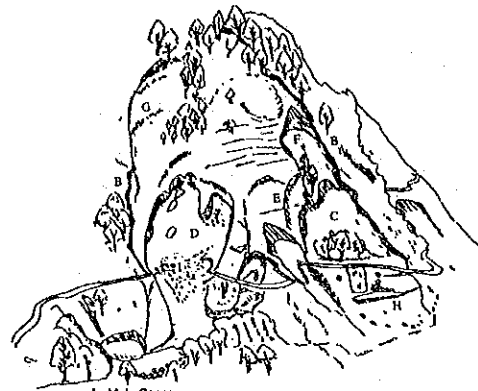
Fig. 6.3.3 Landslide Sketch of Jurikhet River Landslide

- 5) Many cracks and another small scale landslide are observed behind two landslides (Fig. 6.3.3, F, G). This characteristic is clearer in the lower region. From the point of view of a sliding form the slip surface configuration is estimated to be a planer form type. On the condition of planer slip surface another landslide easily occurs behind upper slope. As this landslide clearly indicates the same characteristic features, moving type of this landslide is surmised to be a typical retrogressive form.

- 6) Main cause of larger landslide is a sliding of these previously occurred landslides which locate on the both flanks and gorge bank slope attacked by river flow. Erosion of sliding material of lower part of landslides reaching to Jurikhet Khola is a main cause of behind larger landslide. The erosional protection of lower two landslides is important to check the further development of behind larger landslide.

- 8) Cutting action against two landslides locating at lower part of larger landslide for the rehabilitation of road is a cause of further sliding activity of larger landslide.

- ① Equipments of extensometer as warning system for the prediction of collapsing time should be urgently set up on main and sub-occurred crack so as to prevent the human damages until the completion of permanent measures.
- ② Erosion protection measures by using gabion work etc. should be taken so as to prevent scouring of toe of two landslides which may cause further development of larger landslide.
- ③ Drainage bore hole drilling is available as an effective measure for the first stage of permanent measure.

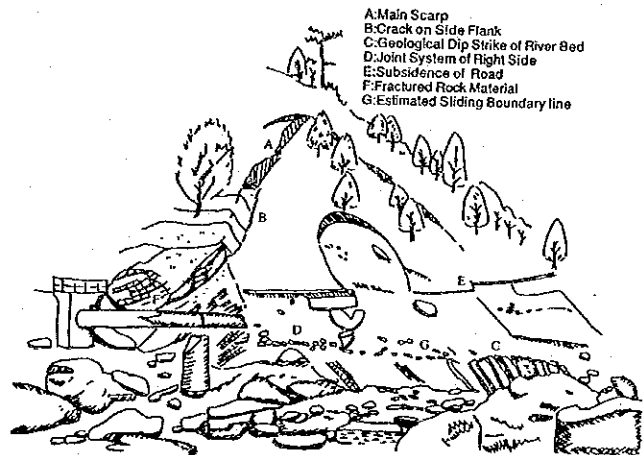
Fig. 6.3.4 Landslide Sketch of Penstock Landslide

- 2) Geology of surrounding landslide consists of sandy schist of meta sediment. Fundamental geological structure observed on river bed is a dip slope formation (Fig. 6.3.4, C). However, joint system crossing this dip strike exists on the right side of landslide toe area (Fig. 6.3.4, D).

- 3) By reason of triangular moving shape, sliding depth will be thicker according to the approaching degree to toe area. And from the existence of clear subsidence of right side and of base rock in spite of fractured material in high elevation compared with left side (Fig. 6.3.4, D), left side is inferred to be deeper in sliding depth. The subsidence of road for maintenance of penstock is less than 1 m in contrast to the large subsidence of scarp area (Fig. 6.3.4, E). From this fact, slip surface gradient under road place will be a flat condition.

- 4) Slip surface seems to be located at the F line in the Figure because remarkable boundary line between deposit material and rock material is observed.

- 5) The toe area is located at situation of a frontal attack by flood and debris flow of Jurikhet Khola due to meandering of river course. Thus the cause of this landslide is a removal action of toe material by scouring.

- ② Cutting work at the head area of the presently occurred two landslides should not be designed because such action possibly cause a large sliding of behind slope. Some actions for urgent rehabilitation of road are necessary to be carried out by observation and check of data obtained by the above mentioned equipments.

- ① Rocks partially distributed at toe area are not so hard and are fractured into fragment materials in the central area. Anti-scouring works are recommended so as to avoid the landslide cause. This plan should be considered under the erosion control project including a series of sabo dam in order to recover the function of penstock.
- ② Drainage bore hole drilling is an effective measure as the first stage of permanent measure.
- ③ As the presently occurred two landslides and behind landslide show the topological feature of triangular sliding, cutting work of great amount volume may not be effective to attain the high safety factor of landslide slope. Permanent measures including anchoring works should be discussed under the situations of behind landslide. Then landslide surveys for the purpose of clarification of mechanism and interaction should be planned.

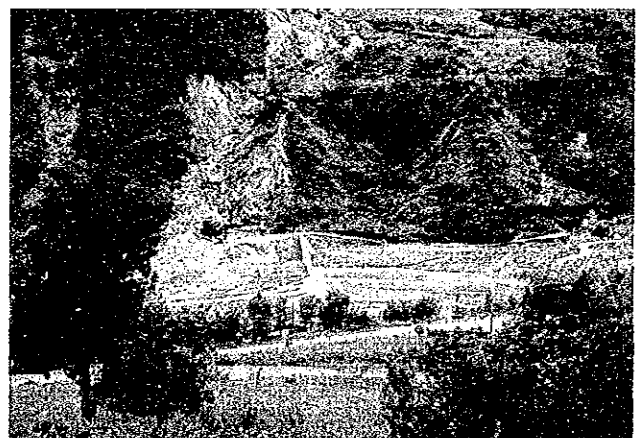
- 1) The slope locating at opposite river side of the 2nd power station at Bhainse is inferred to be a landslide landform (Photo. 6.3.8). Major sliding activity of this landslide is considered to have finished in the past time, because the fairly decayed main scarp resulting from the long term erosion is clearly observed. But, main sliding block still remains on the right side of the Khani khola.

Photo. 6.3.8 View of opposite slope of 2nd Power Station

- ① An abandonment of rock fragment and earth from limestone quarry on the top of main sliding block makes a cause of unstable condition. Abandonment of wasted material from the quarry should be prohibited to prevent the landslide movement.

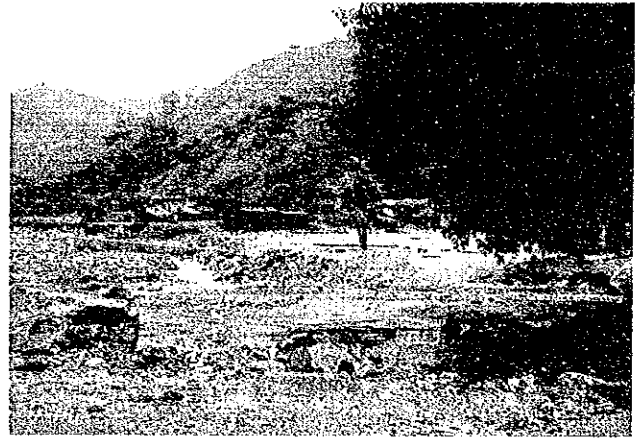
- 1) Debris flows of Rapti River caused many problems in Bhainse area. The Bhainse bridge was washed way, the river bank on both sides were heavily eroded (Photo. 6.3.10)
- 2) Some houses by the river were destroyed and many others were submerged. The rise of the river bed has caused not only the inundation of Bhainse village but also a serious problem to the tailrace of Kulekhani 2nd power station.

**Photo. 6.3.10** View of Erosive and Sedimentary Situation of Bhainse Bridge

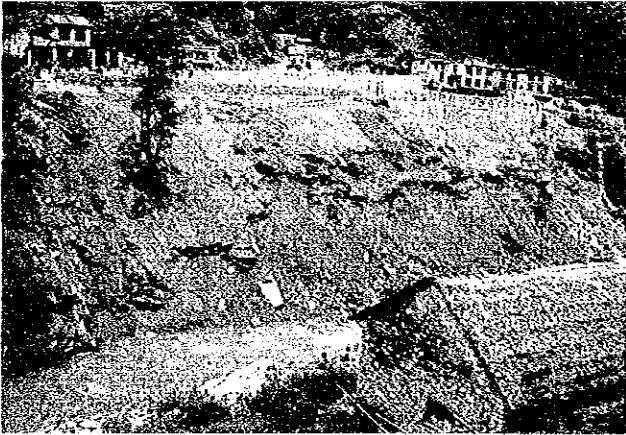
- 1) Landslide of a scale of about 80 m in width, 5 m in length, 10 m in height occurred with the moving direction toward river side (Photo. 6.4.1).
- 2) Retaining wall made by wet masonry supporting the road embankment was destroyed and tilted in ranging over 20 m. Degree of opening cracks scale and subsidence phenomena is greater and clear in proportion to central part of landslide (Fig. 6.4.1, A, B).

**Photo. 6.4.1** View of Naubise Landslide

- ① Gabion work should be urgently carried out at the landslide foot to prevent the removal of earth material as a function of counter weight caused by further scouring of river flow.
- ② Sheet covering for prevention of surface water infiltrating into the sliding ground should be urgently made on the opening crack. And packing using clayey soil into opening crack occurred at road surface should also be made.
- ③ Warning system by using extensometer should be set up as early as possible to prevent damages to transportation.

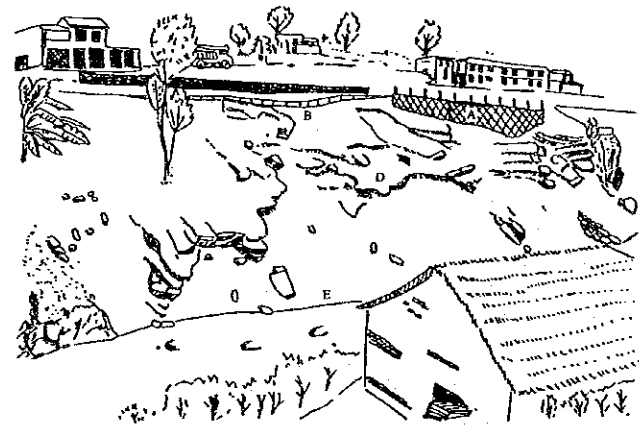
**Fig. 6.4.1** Landscape Sketch of Noubise Landslide

- 3) Geological structure consisted of sandy schist in the landslide area is observed as 45° tilted formation in contrast to the almost vertical bedding plane existing on river bet (Fig. 6.4.1, C). Outcropped rock layer observed on sliding ground surface forms a wave undulations (Fig. 6.4.1, D).

- 5) Main cause of toppling is a release of counter weight of foot area by scouring of river flow (Fig. 6.4.1, E).

- ① Generally speaking anchoring work is often used as direct preventive measures to toppling movement. However, as this toppling mass is mainly consisting of earth material, the lack of sufficient supporting force for anchoring plates is anticipated. Therefore banking work supported by retaining wall constructed on hard rock of river bed is recommended. If hard rock for support of retaining high wall is not expected, the shifting of river course should be considered for much more banking.
- ② On the river side of road, surface water channel work to prevent the infiltrating water into ground and the development of gully occurred on landslide ground surface should be made.
- ③ As banking volume depends on the toppling mechanism, the investigation of geological structure should be made.

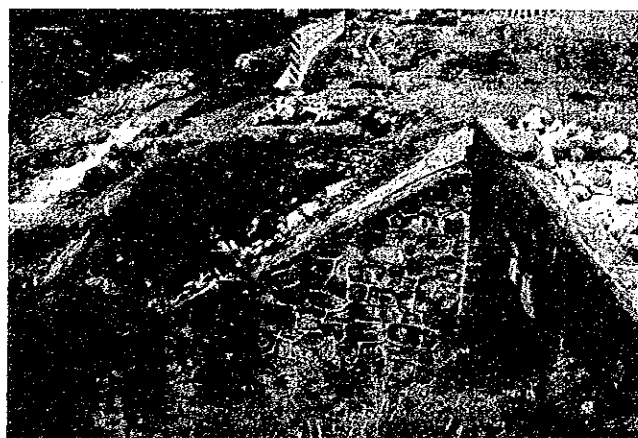
- 4) Landslide form is judged as a toppling by reasons of existence of obviously different bedding formation to river bed, wave structural formation and about 20 cm clear open cracks only at the road institution (Photo. 6.4.2).

**Photo. 6.4.2** Open Crack occurred on Retaining Wall of Naubise Landslide
