**REPORT OF JAPAN DISASTER RELIEF TEAM**  
**(EXPERT TEAM)**  
**ON THE EARTHQUAKE**  
**IN**  
**REPUBLIC OF INDONESIA**  
**OF**  
**DECEMBER 12, 1992**

**MARCH, 1993**

**JAPAN INTERNATIONAL COOPERATION AGENCY**  
**(JICA)**

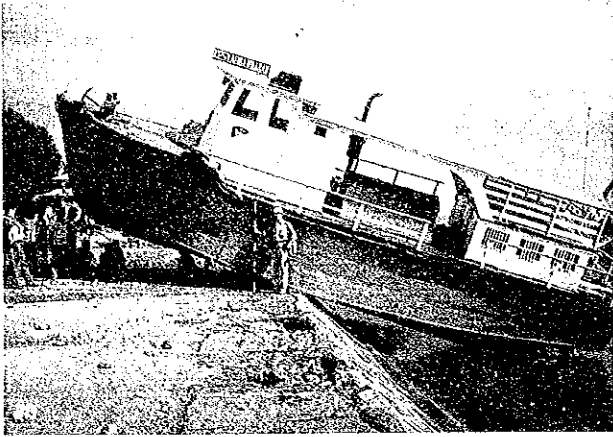
Port facilities were severely destroyed not only by tsunami but also the liquefaction damage of the ground associated with the earthquake. Photo 3.1 shows a ship raised over the quay in Maumere Port. The height of the quay wall at this time was about 1.5 m above the sea level. Taking account of the draft of this boat, tsunami wave height at this location is considered to be about 1 m over the present ground level. At a location east of this point, the quay was destroyed by both the earthquake and tsunami as shown in Photo 3.2, and a truck was carried away toward the tip of the pier by the returning current of tsunami. Photo 3.3 shows the inundation height left at the outside wall of the house. The height pointed out by the right hand shows the inundation level and maximum depth at the side wall was about 50 cm.

Photo 3.1 A Ship Raised Over the Quay in Maumere Port

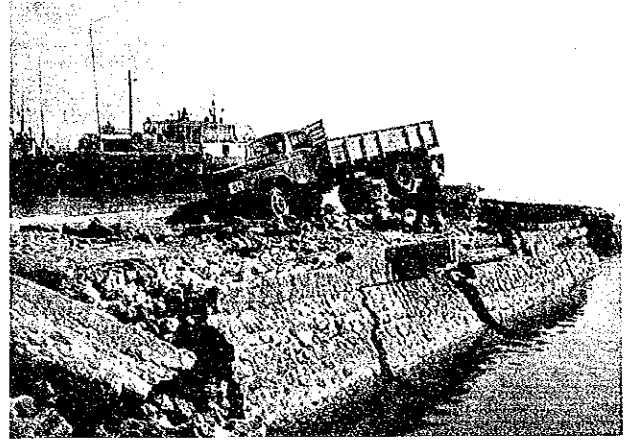
Photo 3.2 Damaged Pier of Maumere Port and a Truck Carried by Tsunami

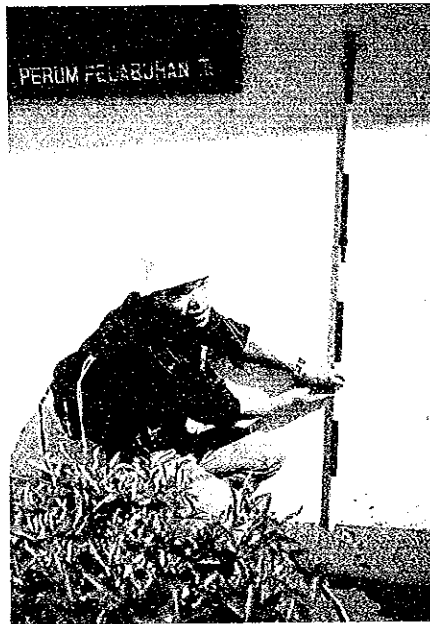
Photo 3.3 Inundation Height in Maumere Port

- (3) The forests formed by palm trees or other trees must be protected because they are useful for reducing tsunami energy.
- (4) In the locations where high tsunami run-up was observed such as in Maumere Port, some signs showing the inundation height (usually recorded on the outside wall of the houses) should be noticed to open public in order to inform people of the danger of the tsunami and not to forget the tsunami disaster.

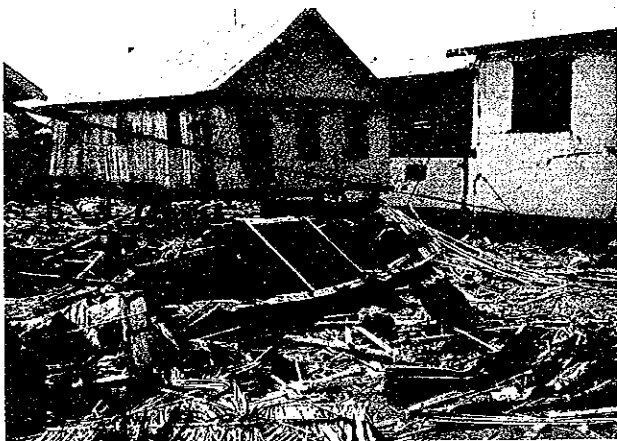
Wuring is located about 2 km northwest of Maumere Port. Tsunami can be characterized by the phenomena that vast amount of sea water invade land from the shoreline with keeping strong energy compared with the wave overtopping at a rough wave condition. This means that the damaged area due to tsunami is totally different from that by the flooding with gradual increase of water level. Everything including houses is destroyed and carried away in a mess. Furthermore near the fishery port fishing boats floating with tsunami often collide with the houses and thus enlarge the destruction of houses. Photo 3.4 shows the disastrous situation of Wuring area. It is seen from this picture that vast amount of debris were scattered and a fishing boat was also carried. Photo 3.5 shows the situation at a location further seaward from Photo 3.4. Here many houses of raised floor were destroyed and many boats were scattered on land. In Photo 3.4 some buildings were left since the position was located considerably landward from the shoreline, but the location shown in Photo 3.5 was destroyed to the further extent. At Wuring area many houses of raised floor had been built and almost all these houses were destroyed.

Photo 3.4 Tsunami Disaster at Wuring Area (Landward side from the center of the village)

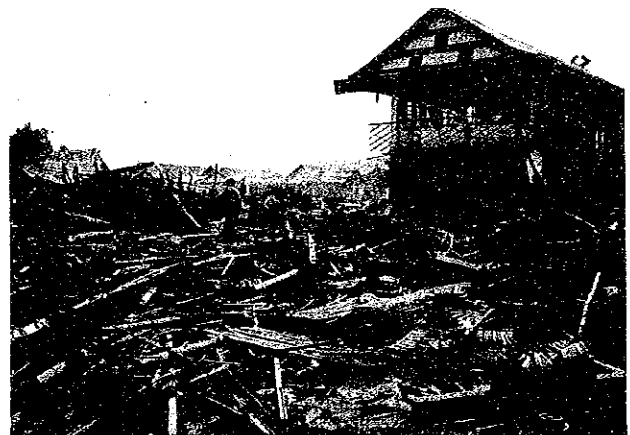
Photo 3.5 Tsunami Disaster at Wuring Area (Center of the village)

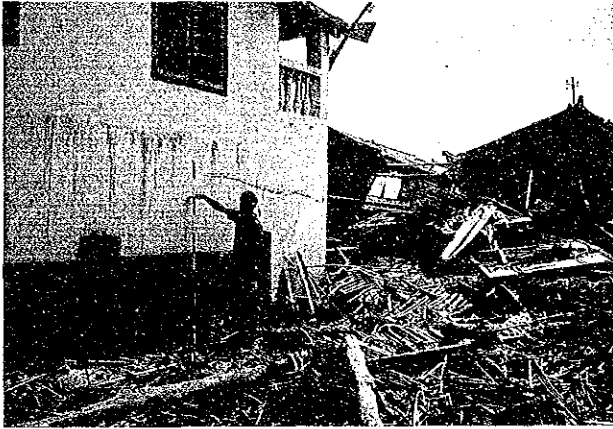
In Photo 3.6 the inundation height can be clearly read at the white wall of the building, of which ground level is about 1 m, and it is seen that the height between the mark and the present ground level is 1.6 m. This means that tsunami wave of the height of a man ran up in this area. In this area final death toll was 79. The causes of tsunami disaster at Wuring area can be summarized as follows:

Photo 3.6 Inundation Height at Wuring Area

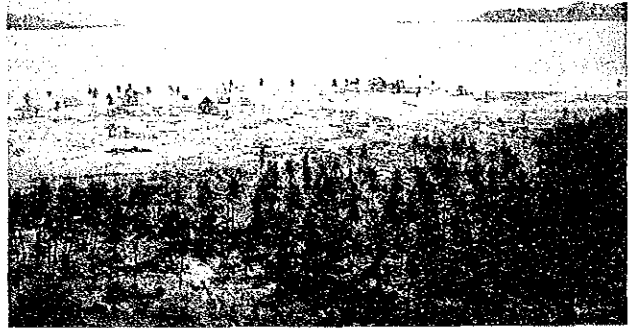
By this tsunami attack all buildings of this village were destroyed. Photo 3.7 shows the oblique picture of the village devastated by the tsunami taken in the southwest direction from the middle of the mountain. Since tsunami attacked the village from south, debris of houses were carried northward and scattered inside the palm trees. For instance, from Photo 3.8 showing the situation inside the palm trees, it is observed that vast amount of debris were scattered. The village located on the sandy beach was totally demolished. Photo 3.9 shows the concrete basement of the destroyed school building.

Photo 3.7 Ruin of the Village on South Cuspate Foreland of Babi Island

- (5) When people must live in the potentially dangerous area for tsunami as in the case of Babi island, it is recommended to build shore protection facilities such as the coastal dike along the shoreline.

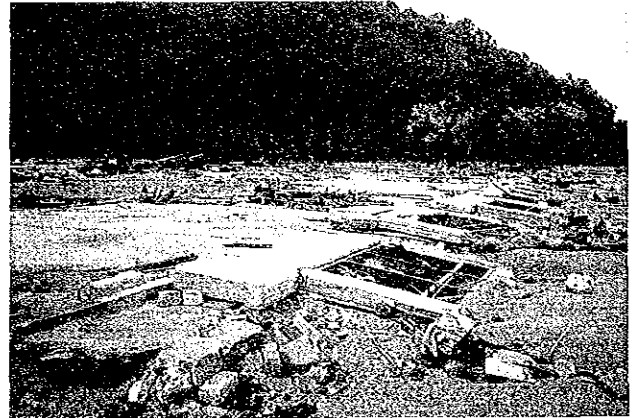
Photo 3.9 Damaged School Buildings

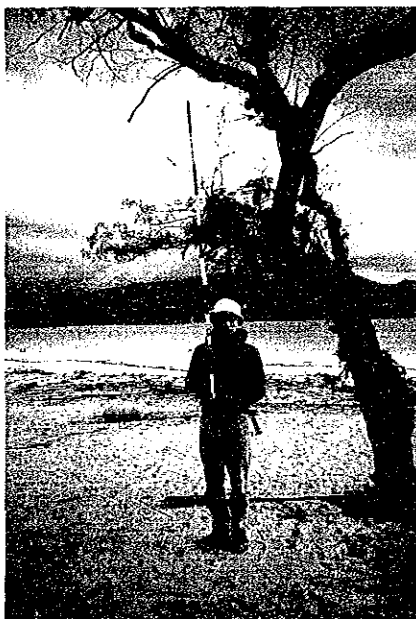
Photo 3.10 Inundation Height on Foreshore of Babi Island

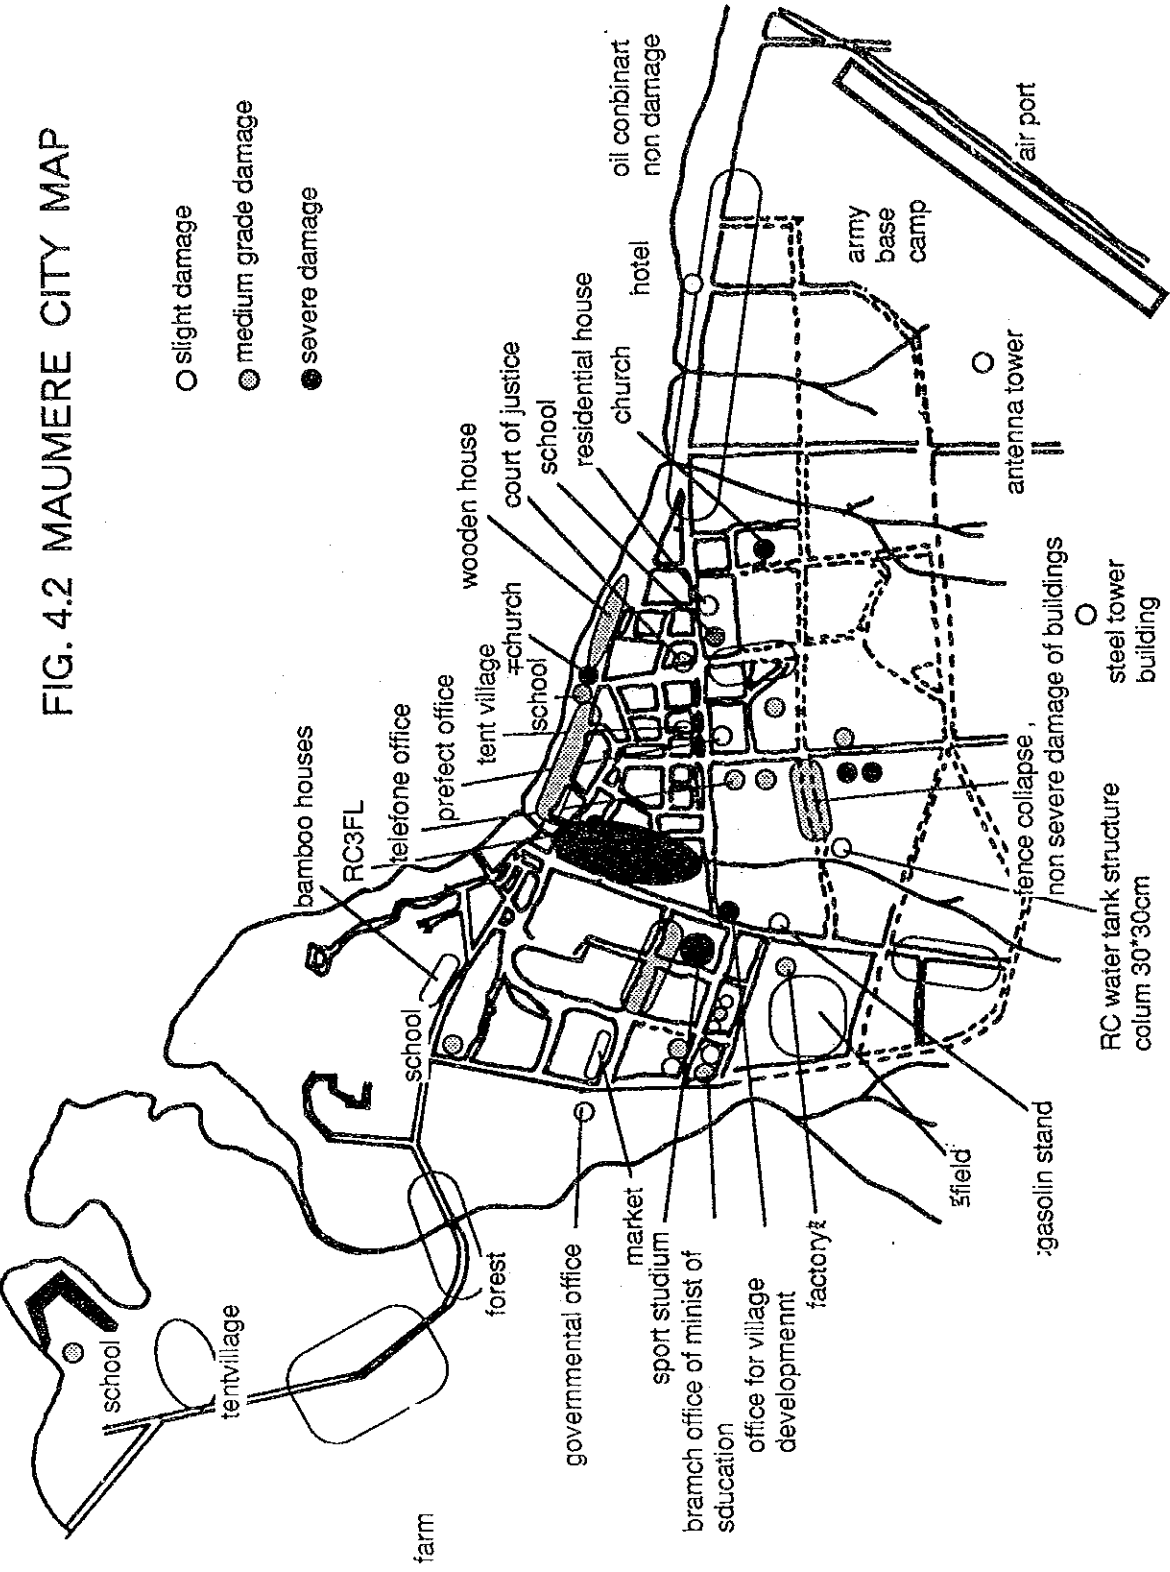
Fig. 4.2 Maumere City Map

As shown in Fig. 4.2, central area of this city was much damaged. Buildings along the coast area were tilted and settled due to liquefaction of foundation soil. In the central area, reinforced concrete water tank structure was found to be almost non-damaged. It's height is around fifteen meters. The section size of its four columns were 30 cm by 30 cm. Considering that this type of reinforced concrete water tank tower was not damaged so severely, input earthquake was estimated not to be so large; 0.1 g – 0.2 g. Typical masonry structural walls which are often observed in this city, were estimated the lateral load carrying capacity of more than 0.2 g base shear coefficient from very lough assumptions and calculation. However, the lateral load carrying capacity of masonry wall system in out-of-plane direction was much smaller than that of in-plane shear capacity of masonry wall as mentioned above.

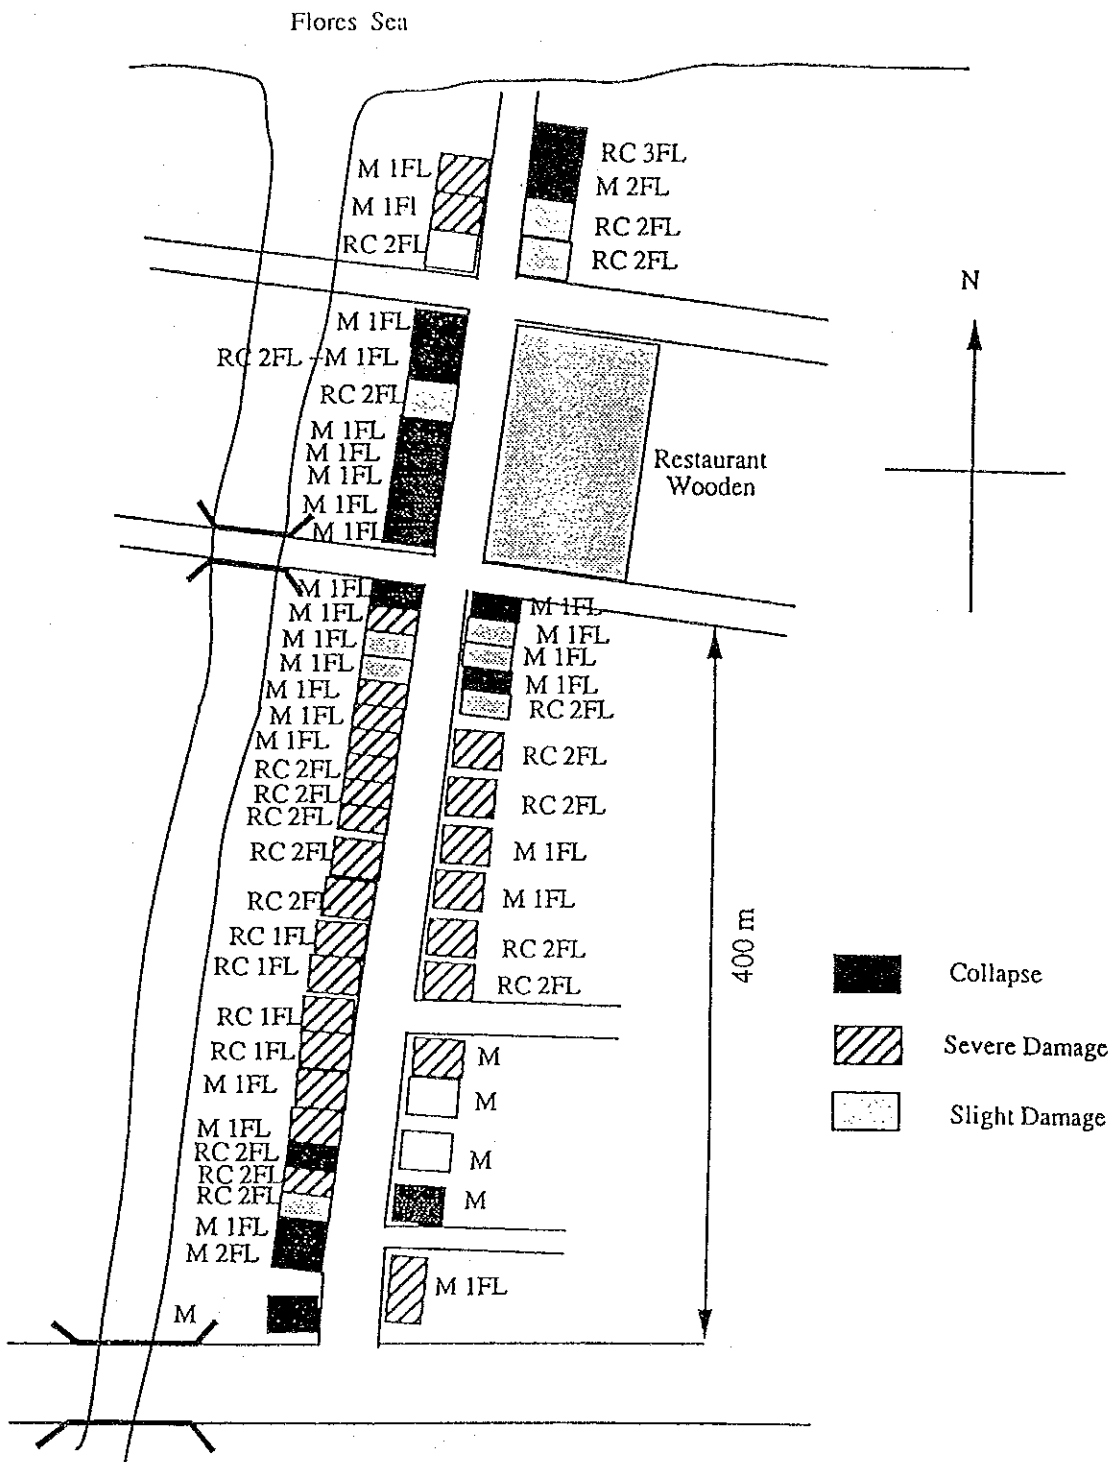
Fig. 4.3 Maumere City Commercial Area

Especially along the Radjacentis Street which is commercial main area in this city, more detailed damage survey was conducted. Such results are shown in Fig. 4.3. The classification of damage grade was defined by the outside observation of buildings.

Among thirty two brick masonry buildings (M), fifteen buildings were collapsed (47%). Two reinforced concrete framed masonry wall buildings (RC + M) were collapsed among twenty-two same types buildings (9%). Sixteen (RC + M) buildings were severely damaged (73%). Twenty-seven M structures were also severely damaged (84%).
