## 4.5 Recommendations

## 5. Damage of Lifeline Facilities

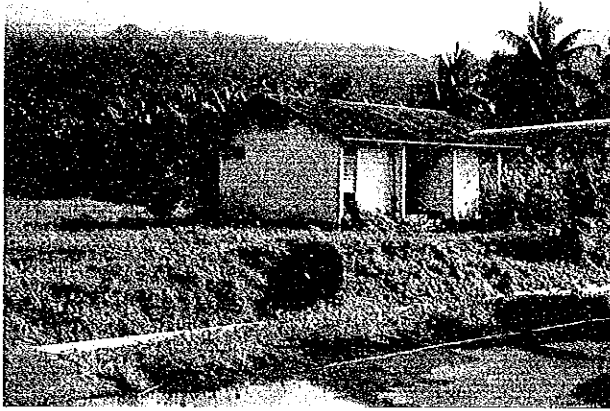
Photo 4.1 Masonry Building in Ende Airport, No Damage

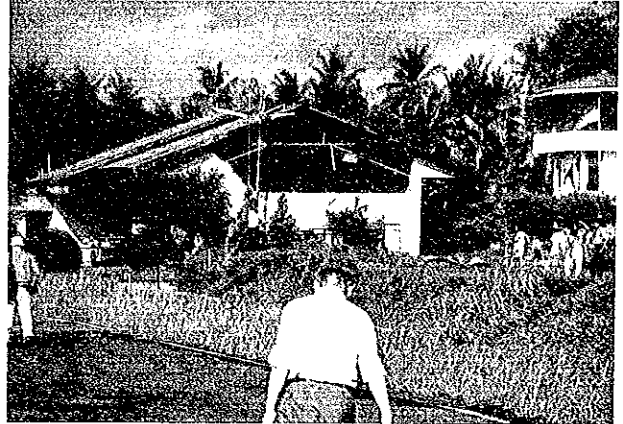
Photo 4.2 Masonry Building in Ende Airport, Falling Down of Side Upper Wall

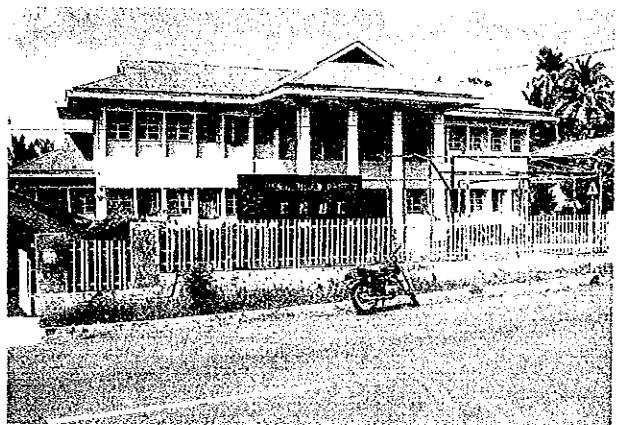
Photo 4.4 Ende City Office, Severe Damage, Remaining Story Drift 10 cm

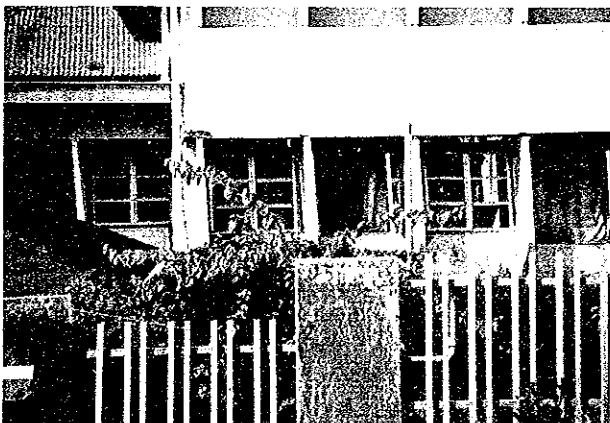
Photo 4.5 Ende City Office, Close Up

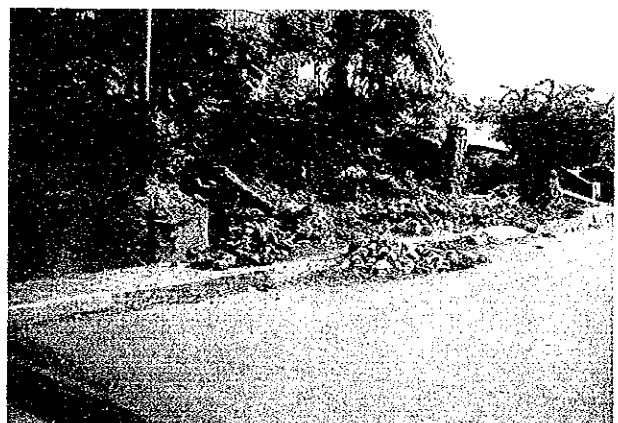
Photo 4.6 Collapse Example of Retaining Wall, Ende City

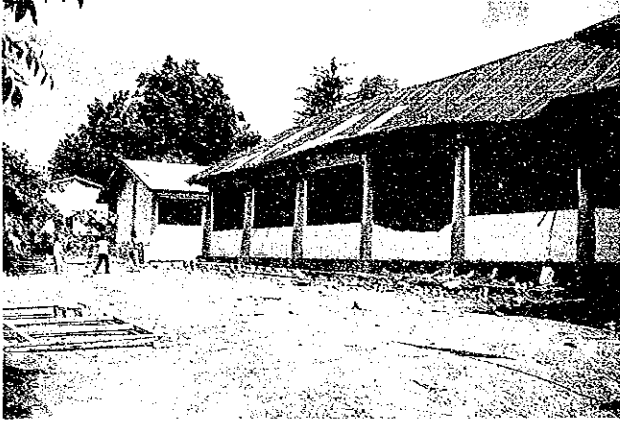
Photo 4.7 Severely Damaged Elementary School Building, Roof; Timber; Masonry, Column; Reinforce Concrete

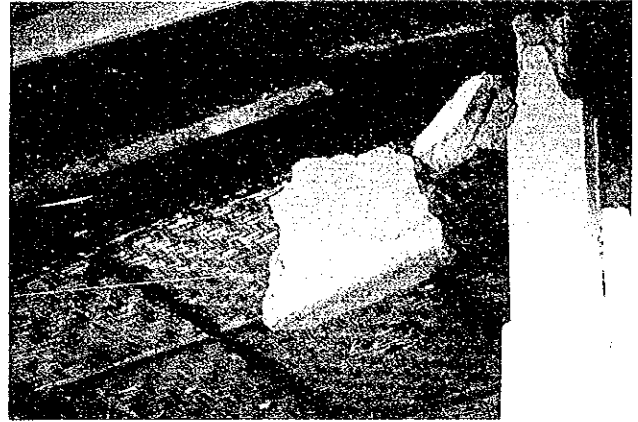
Photo 4.8 Close Up of This School Building; Column Top and Ceiling

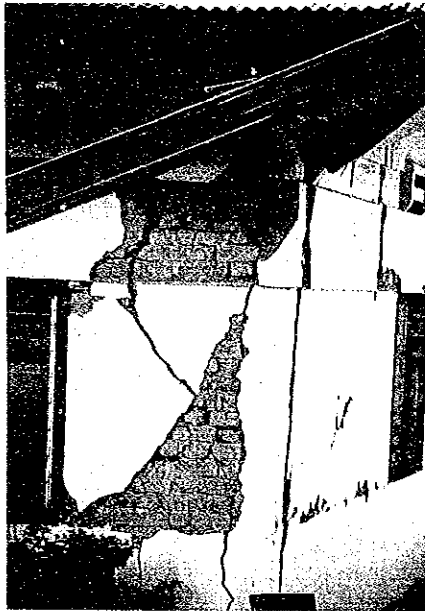
Photo 4.9 Adobe One Storey House, Severe Damage

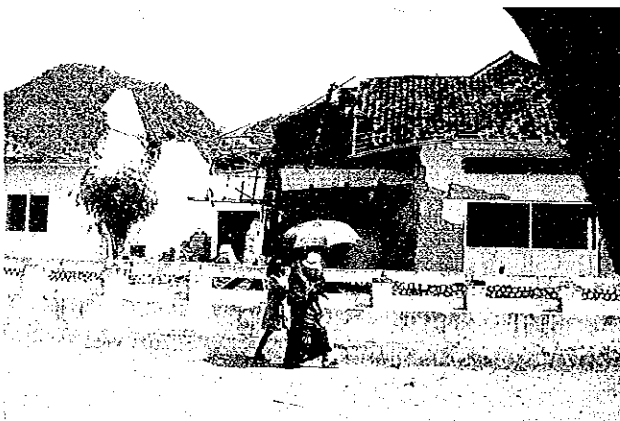
Photo 4.10 Branch Office of Ministry of Public Works, Partially Collapsed

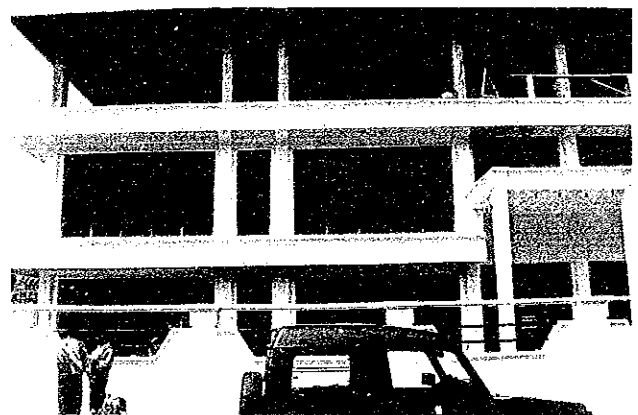
Photo 4.11 3-Storeyed Reinforced Concrete Building; Slight Damage, Under Construction

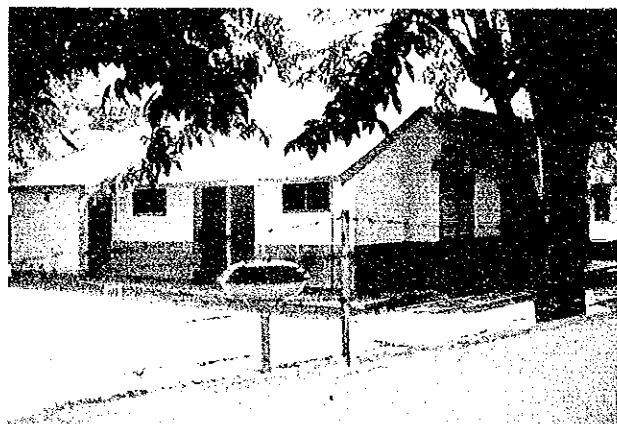
Photo 4.13 Example of Slight Damage of Masonry House

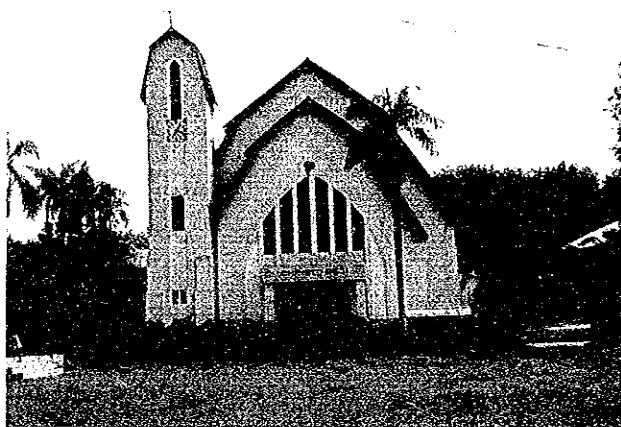
Photo 4.14 Medium Level Damage of Masonry Church

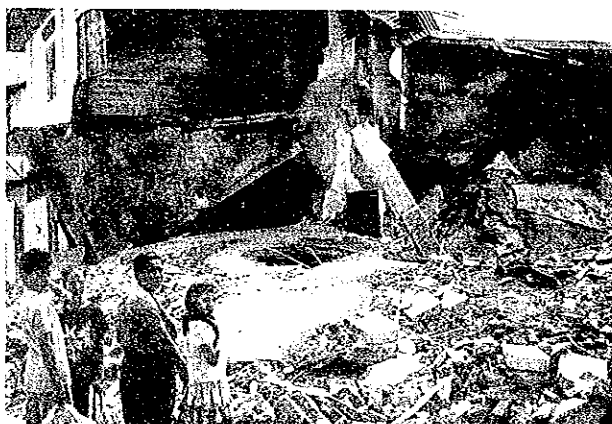
Photo 4.15 Collapse of Reinforced Concrete Building

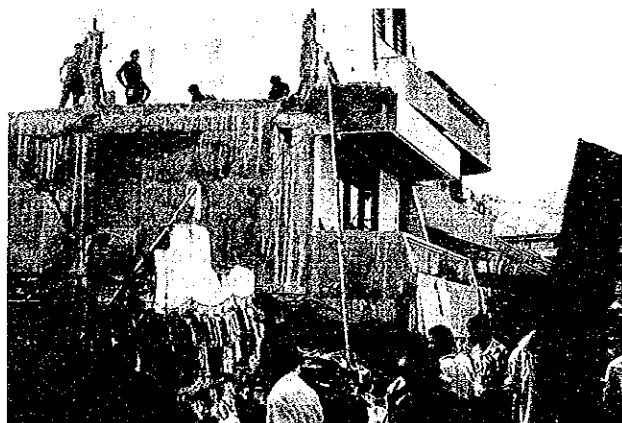
Photo 4.16 3-Storeyed Reinforced Concrete Frame + Masonry Wall Building; Collapsed

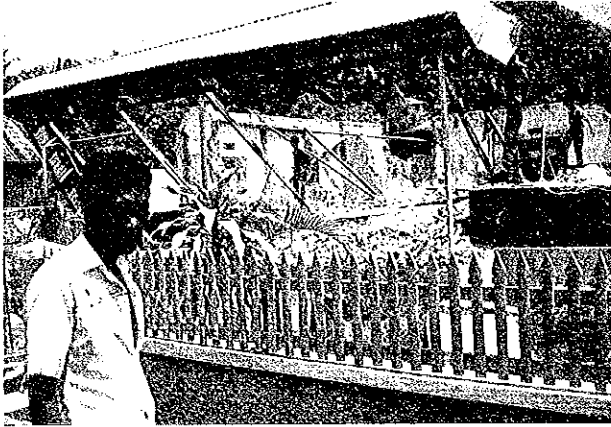
Photo 4.18 Typical Damage Pattern of Masonry Wall Building; Perfect Collapse

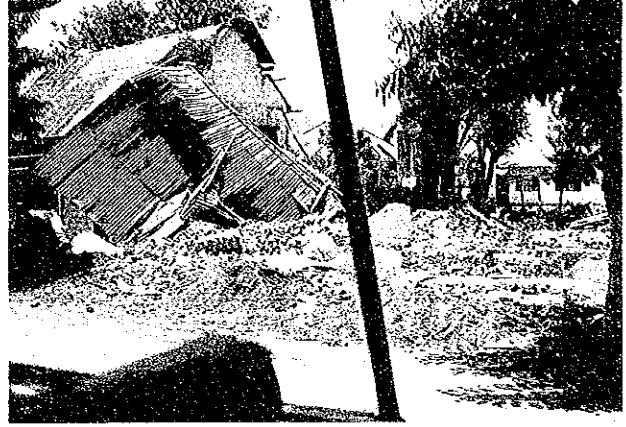
Photo 4.19 Typical Damage Pattern of Masonry Wall Building; Perfect Collapse

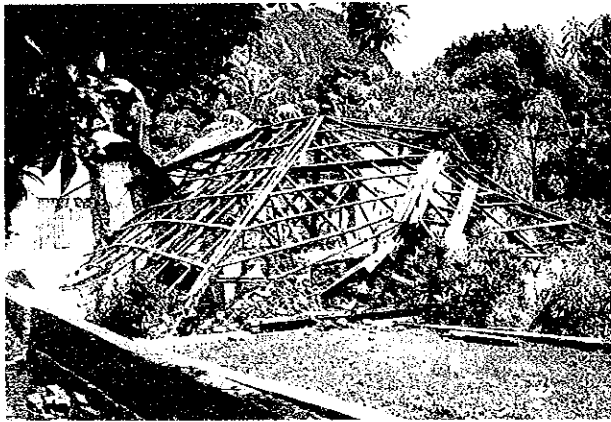
Photo 4.20 Collapse of Masonry House, Only Timber Roofing Frame Was Observed

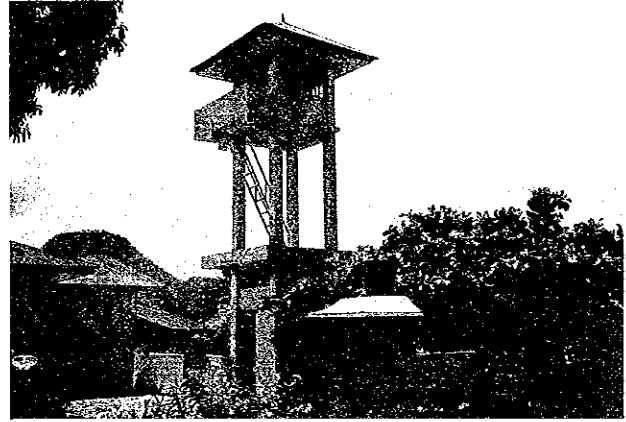
Photo 4.21 Reinforced Concrete Tower Building; Slight Damage

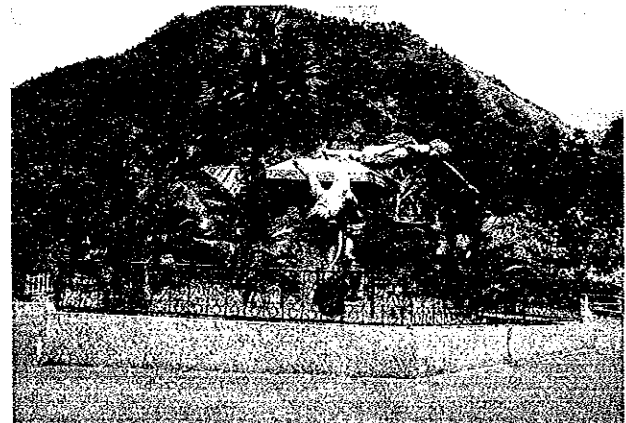
Photo 4.23 Reinforced (wire) Concrete Sculpture; Collapsed

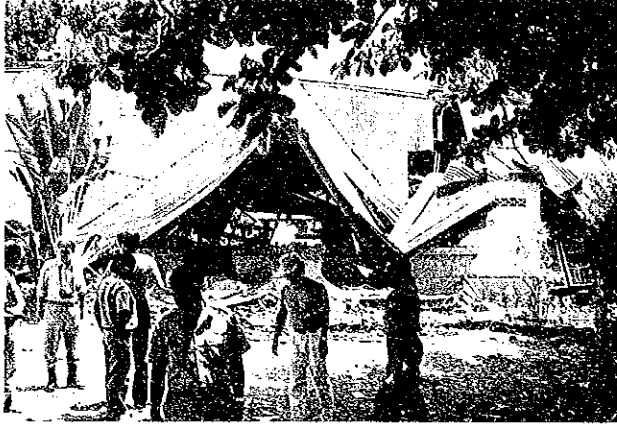
Photo 4.24 Religious House; Collapsed, Ende City

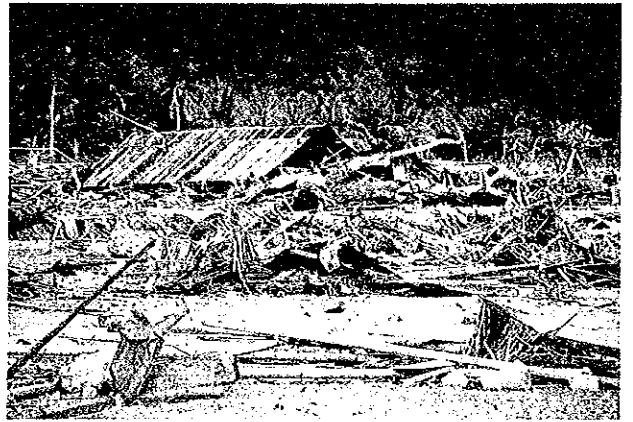
Photo 4.27 Collapsed House Due to Tsunami in Babi Island 30 km from Maumere City

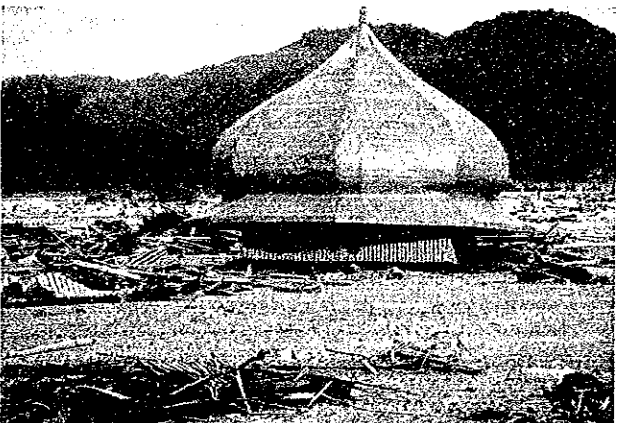
Photo 4.28 Only Roofing of Mosque was Remaining in Babi Island

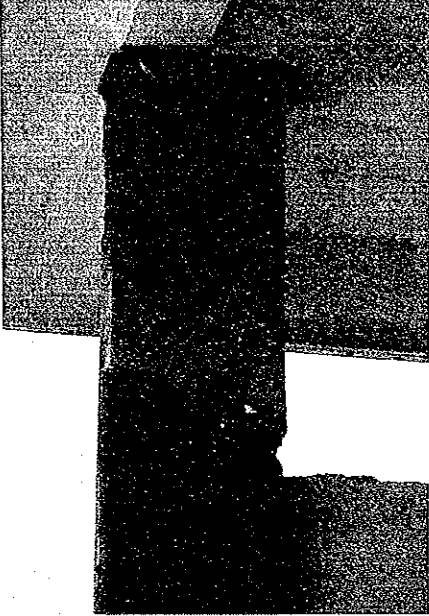
Photo 4.29 Airport Terminal Building (RC, one storey);  
Shear Failure Column Top

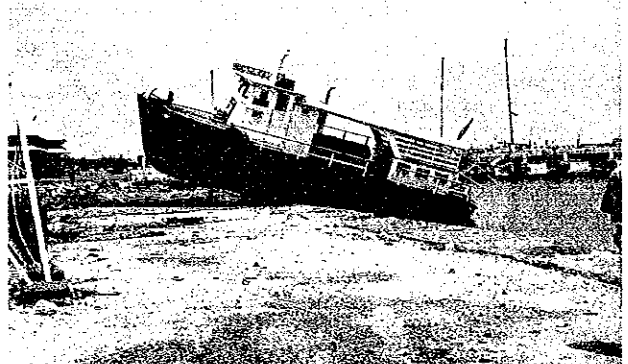
Photo 4.32 Damage of Maumere Port; Stranding of Steamer by Tsunami

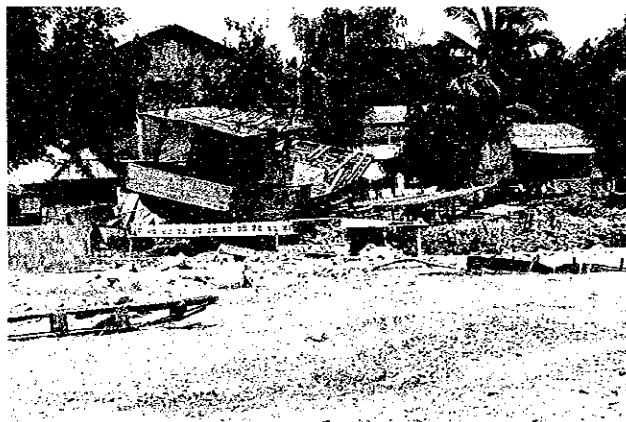
Photo 4.33 Damage of Maumere Seaport by Tsunami

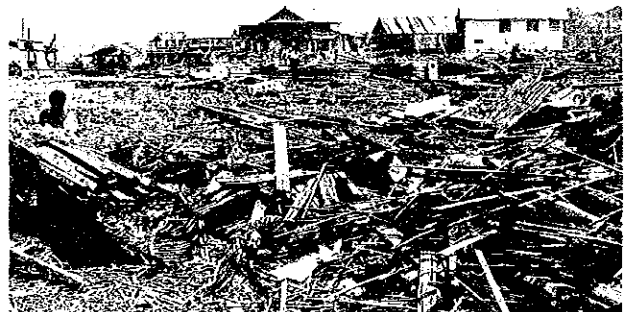
Photo 4.34 Perfect Collapse of Wulin Town by Tsunami 3 km West of Maumere

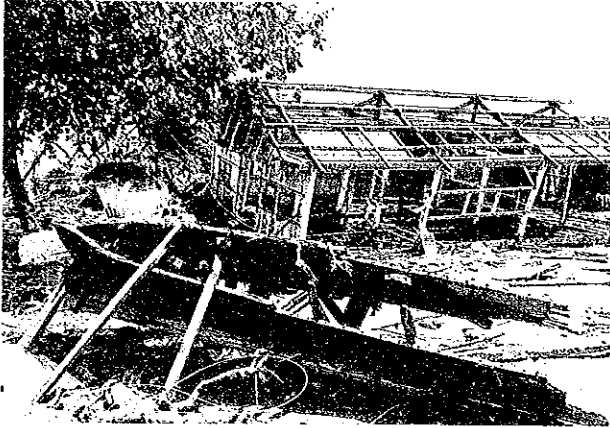
Photo 4.35 High Floored Timber Houses Were Collapsed in Wulin; People Came from South Sulawesi Fishermen Race "Bugise"

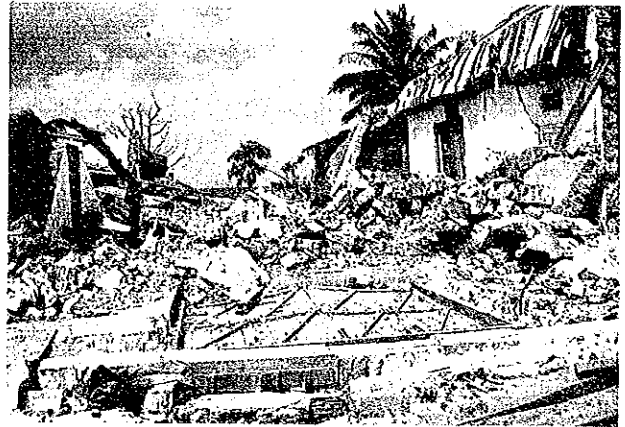
Photo 4.36 Collapsed Masonry House in Maumere City

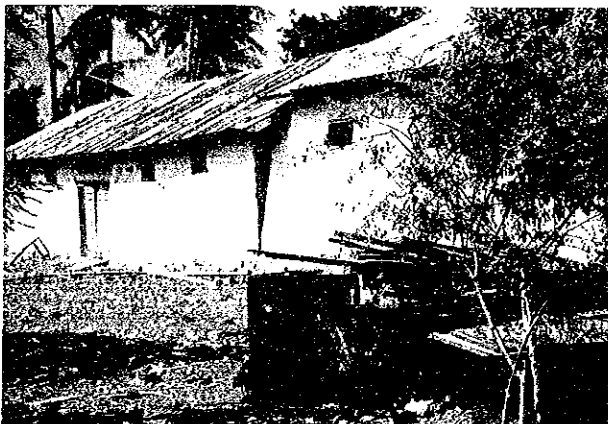
Photo 4.39 Severe Damage (out of plane break) of Wall System of Masonry Storage Building

For the countermeasure of safer masonry building due to earthquake, much more improved device is indispensable especially on the seismic strength against out-of-plane falling down of brick masonry wall system.

- a) to strengthen more the rotation resistance of foundation system.
- b) As long as masonry structure is low rise building, in-plane shear strength of masonry wall may be enough to such level of earthquake as occurred as this time. However the out-of-plane bending resistance is very small. It is required some reinforcement or prestressing using reinforcing bars, wires and bamboos, should be installed in masonry walls with enough encourage to concrete foundation systems. If we use bamboo as reinforcement, which is available in Sikka Prefecture, it's Young's modulus and tensile strength are respectively  $1.25 - 1.55 \times 10^5 \text{ kg/cm}^2$  and  $1700 - 2400 \text{ kg/cm}^2$ . So, bamboo can be much effective for strengthening wall system by intelligent device of construction. Such detailed construction manual for local people should be based on the test results which shall be planned and conducted in Research Institute of Human Settlements, Ministry of Public Works, Bandung.

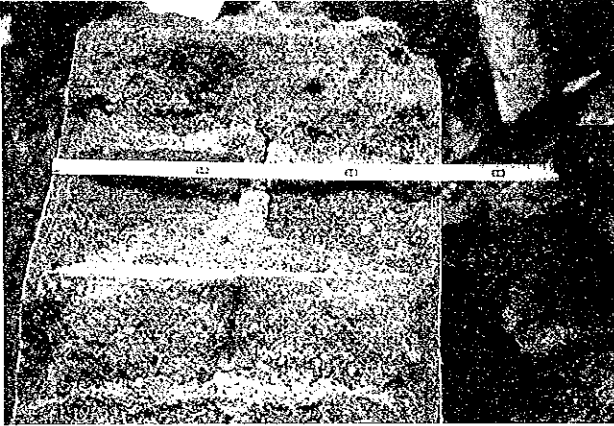
Photo 4.41 Cross Section of Masonry Wall from Collapsed Building

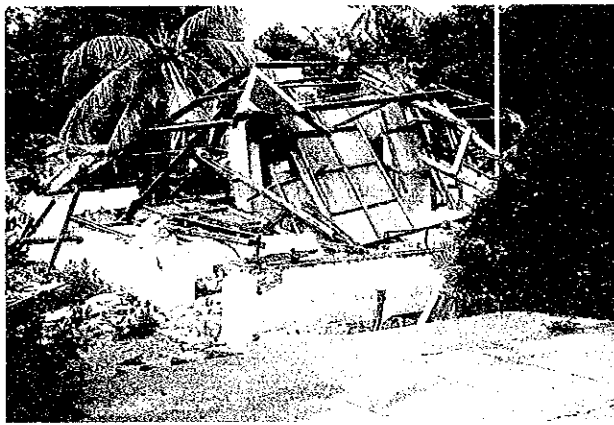
Photo 4.43 Typical Collapse Pattern of Masonry House; Many of Masonry Houses were Collapsed Like This Pattern in Maumere City

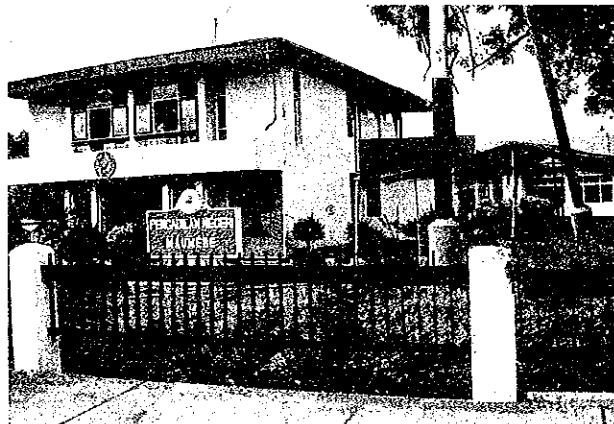
Photo 4.45 Two Storey Reinforced Concrete Masonry Building; Severe Damage, Business Work was Done in Temporary Facilitated Sheet Tent

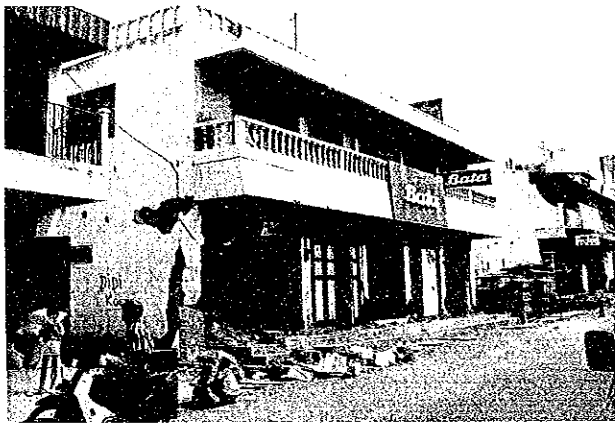
Photo 4.50-1 Severely Damaged Reinforced Concrete masonry Wall Building

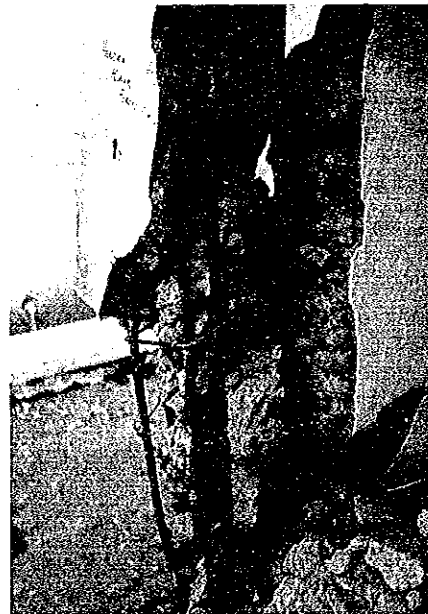
Photo 4.50-2 Small Column and Small Size Reinforcing Bars of Same Building

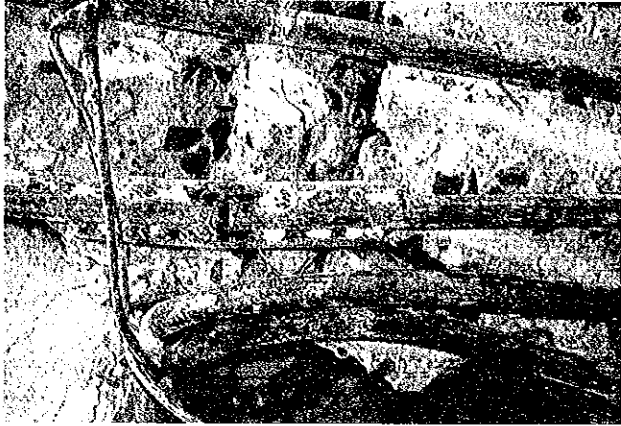
Photo 4.51-2 Close Up of This Building; Longitudinal Reinforcing Bars 29 mm Was Jointed by Welded Two 13 mm Bars

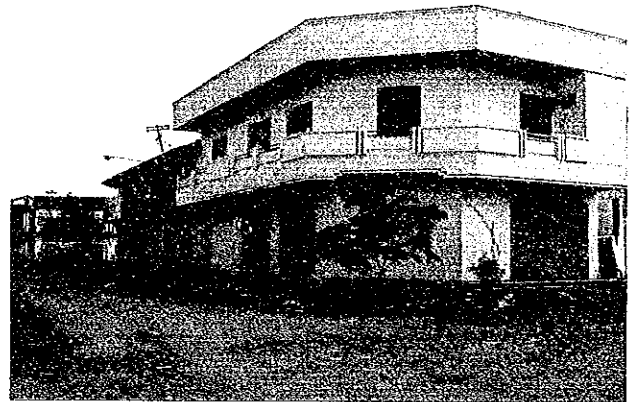
Photo 4.52 Reinforced Concrete Masonry Wall Building; Slight Damage Adjacent to the Building Photo No. 4.51

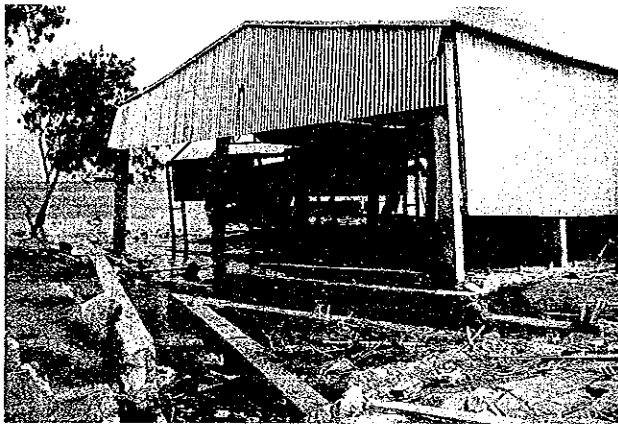
Photo 4.53 Freezing Factory of Fish Market; Damage of Settlement Due to Liquefaction

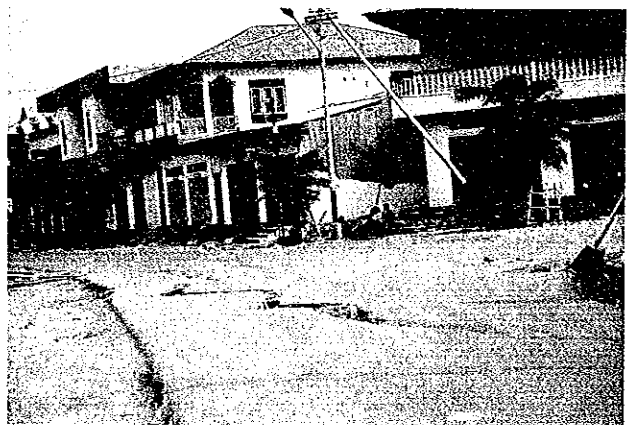
Photo 4.54-1 Damage of Road Observed in maumere City; Only This Area Was Damaged

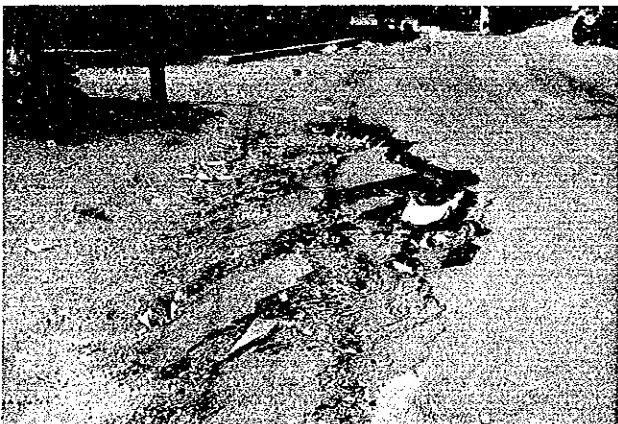
Photo 4.54-2 Same as 4.54-1

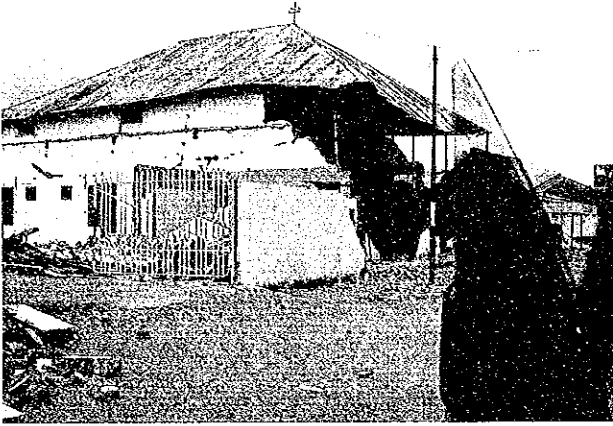
Photo 4.56 Out of Plane Collapse of Non Reinforcing Masonry Wall Structure

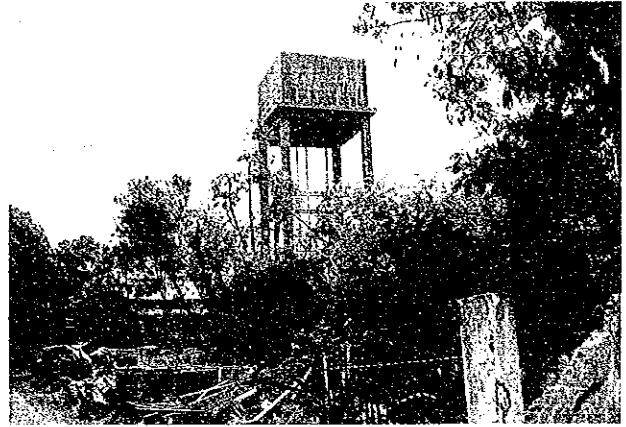
Photo 4.57-1 Reinforced Concrete Water Tank Structure; h=15 m; Slight Damage

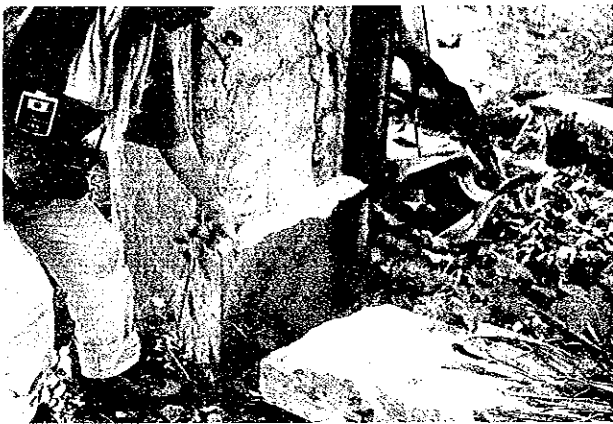
Photo 4.57-2 Span: About 3 m, Column: 50 cm, Covering Mortar: 10 cm

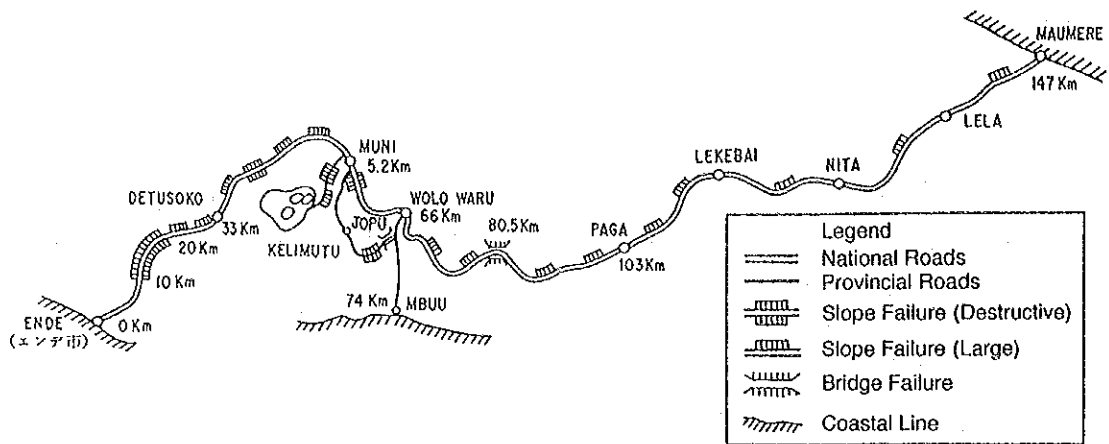
**Fig. 5.2 Major Damage on National Road from Ende to Maumere**

Figure 5.2 shows the major damage on the National Road from Ende to Maumere. Inspection was made for several kilometers from Ende and from Maumere to Lekebal. Although the damage was extensive at Ende side, it could not be inspected due to road damage. Because the road crosses the mountainous site, many slope failures were developed.

Because the surface at the site is deeply covered by soils, slope failure associated with soil mass was developed. Photo 5.1 shows a slope failure at road shoulder at the National Road several kilometers from Ende. The hill-side is of very steep rock. Photo 5.2 shows the slope failure on and under the Road. Photos 5.3 – 5.5 show the similar but more destructive slope failure. Rock fall was also observed, but it is not frequent between Maumere to Lekebal. They were weathered lime stone and sand stone.

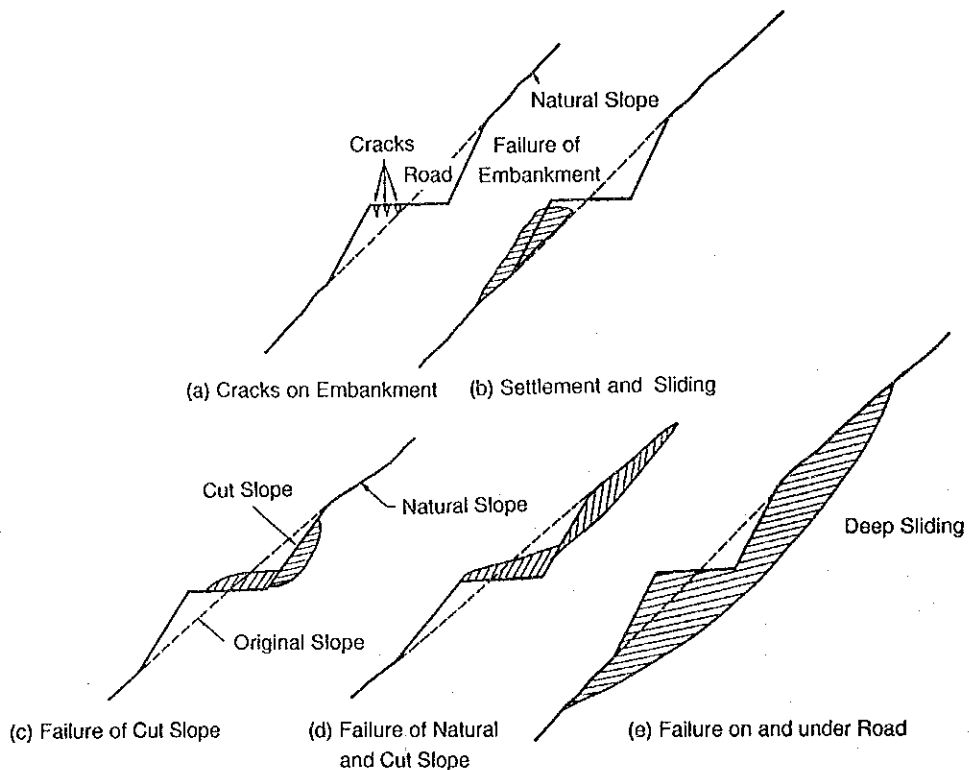
**Fig. 5.3 Types of Slope Failure**

Figure 5.3 classifies the type of failures inspected. At the site where one side was cut and the other side was embanked (cut and filled embankment), the filled embankment often settled and this caused extensive cracks on the pavement as shown in Fig. 5.3(a) and (b). Failure also occurred at cut slope as shown in Fig. 5.3(c) and natural slope as shown in Fig. 5.3(d). The soil from the slope often suspended the road. This type of failure could be seen frequently. Destructive failure in which not only the cut slope but the natural slope failed as shown in Fig. 5.3(e) were also widely observed.

The slope failure was significant because the soils are of soft and wet clayey materials (volcanic ash). At the sites where scoria was observed as shown in Photos 5.6 and 5.7, the failure was induced at this layer.

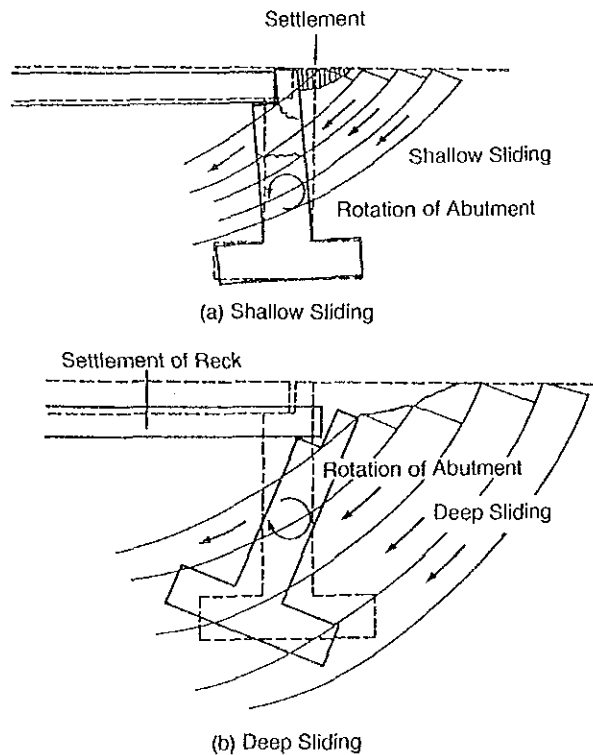
Fig. 5.4 Damage of Bridge Abutments due to Soil Instability

The most common type of failure was the settlement and tilting of abutments and back soils as shown in Photos 5.8 and 5.9. The settlement was as large as 1 m. It should be noted that such settlement and tilting of abutment were mostly caused by sliding of surrounding soils as shown in Fig. 5.4. Photo 5.10 shows large slidings developed near an abutment. Several sliding toward the center of a river was seen at this site. Photo 5.11 shows failure of soils in front of an abutment.

When only shallow soils slid, the abutments tend to tilt in the deck side, while when the sliding occurred deeply, the abutments tilted in back soil side. It is important to know that this is the damage caused by not vibration of the deck and abutment but the soil instability due to the earthquake. Therefore it is important to properly consider the large earth pressure due to such instability of surrounding subsoils into seismic design of bridges.
