5.9 Recommendations

6. Landslides and Soil Liquefaction

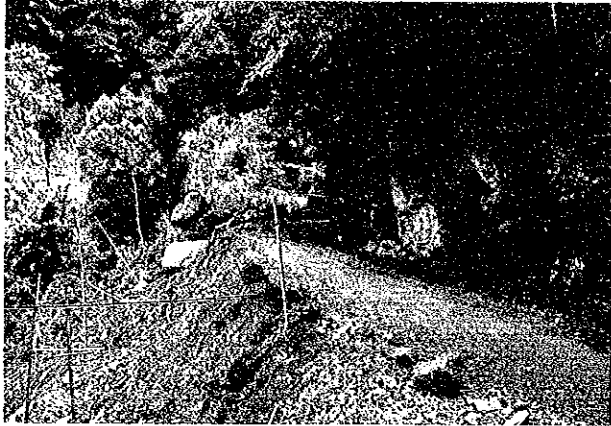
Photo 5.1 Slope Failure of Road Shoulder (National road, several kilometers from Ende)

- 3) It is difficult to prevent the failure of cut and natural slope along the road in mountainous area. It is recommended to investigate the possible measures against slope failure from cost and effective point of view. It is advised at this point to widen the road so that at least full two lanes of traffic be guaranteed. This may be effective to provide a space to store the falling soils and rocks from the above of the road during an earthquake. Covering the slope above the road by concrete mortar may be effective to prevent the weathering.

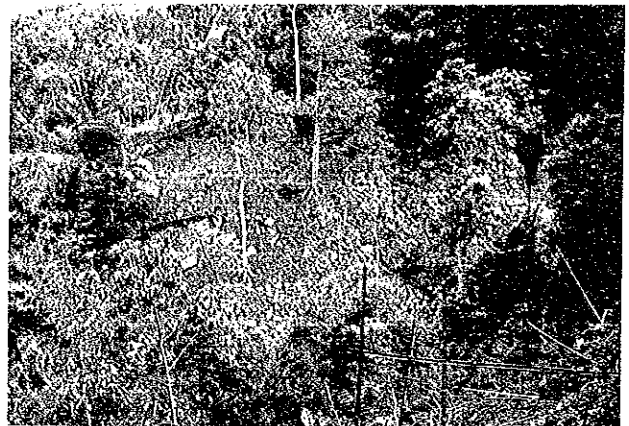
Photo 5.2 Large Slope Failure On and Below Road (National road, several kilometers from Ende)

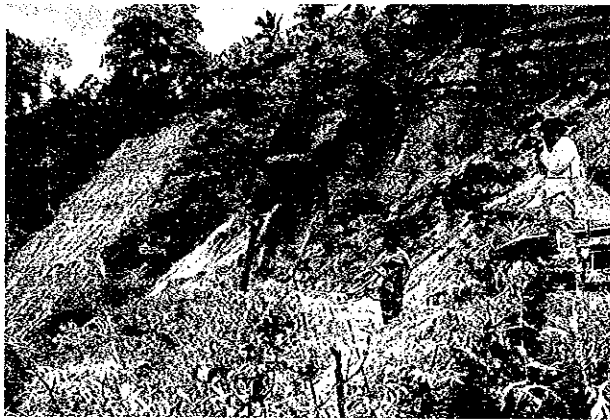
Photo 5.3 Destructive Slope Failure On and Below Road (National road, near Lekebai)

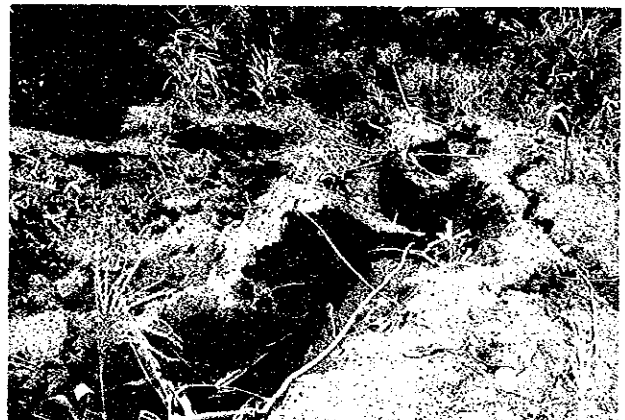
Photo 5.4 Slope Failure under Road Presented in Photo 5.3

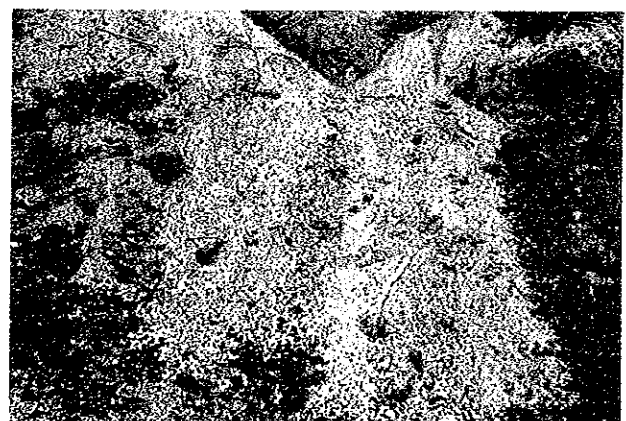
Photo 5.6 Slope Failure of Natural Slope

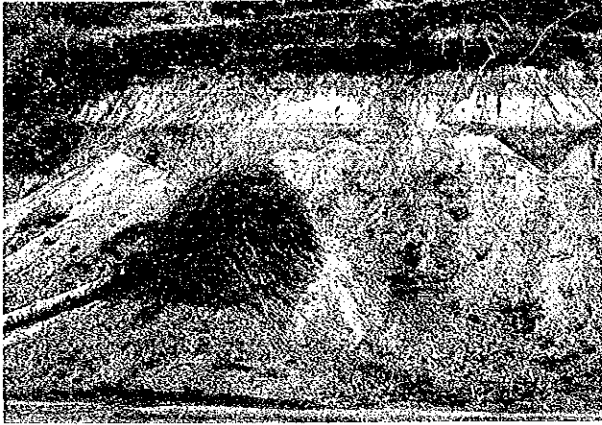
Photo 5.7 Scoria Layer at the Slope Presented in Photo 5.6

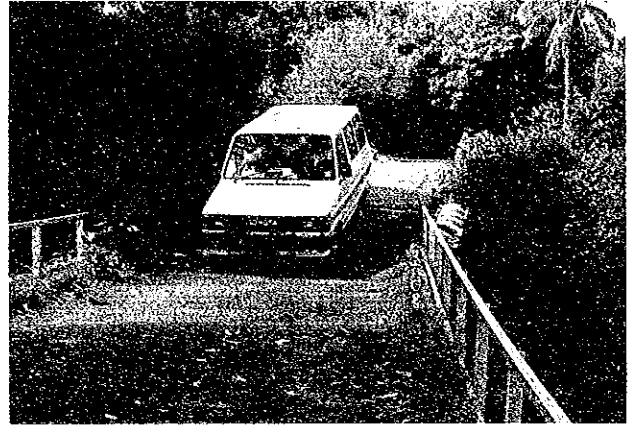
Photo 5.8 Settlement of Bridge Abutment and Back-Fill

- 1) It is recommended to carefully inspect the bridges in Flores Island with the major attention to the damage of substructures. For those bridges which suffered damage to the abutments in such a manner that the foundations slid to the deck side direction with the top of the abutment being tilted to the back fill side, it is recommended to fully replace the abutment to avoid the possible falling down of the girder. Because those bridges are very old with only one lane, evaluation needs to be made whether they should be repaired or replaced with new structures.

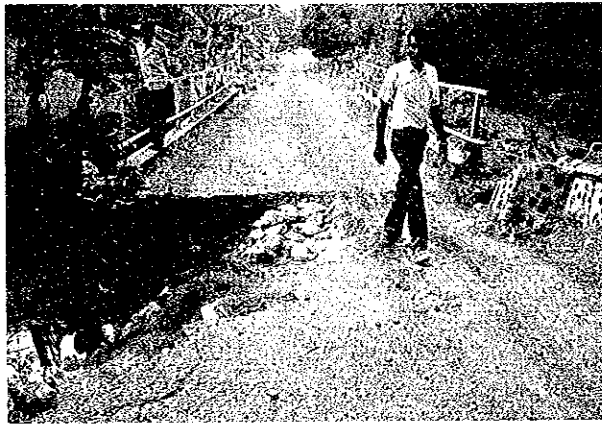
Photo 5.9 Failure of Parapet Wall and Back-Fill

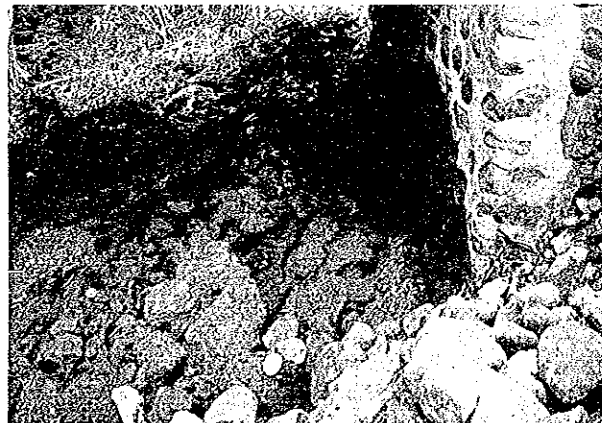
Photo 5.11 Soil Failure in Front of a Bridge Abutment

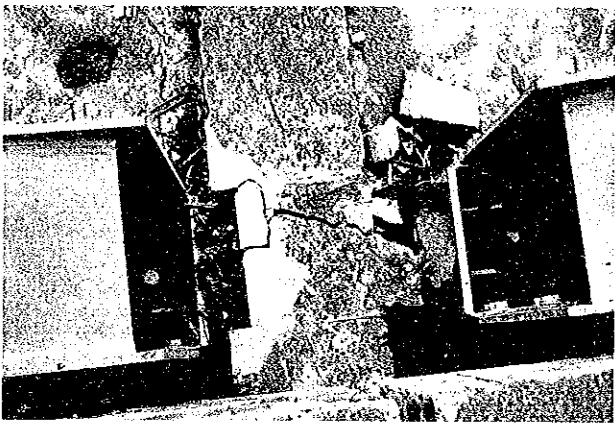
Photo 5.15 Failure of Concrete Block for Stopper

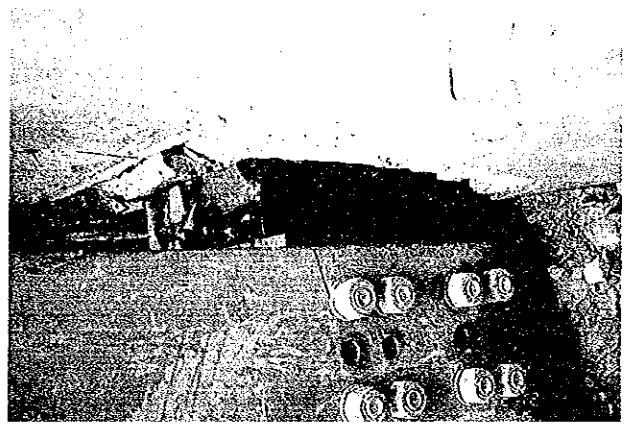
Photo 5.16 Failure of Abutment due to Collision with Deck

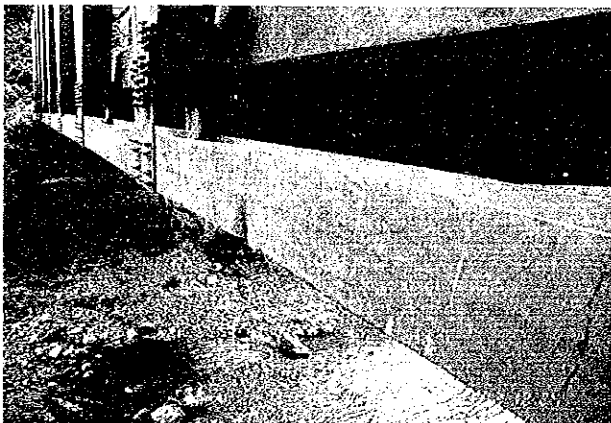
Photo 5.17 Buckle of Lower Cord of a Truss Bridge

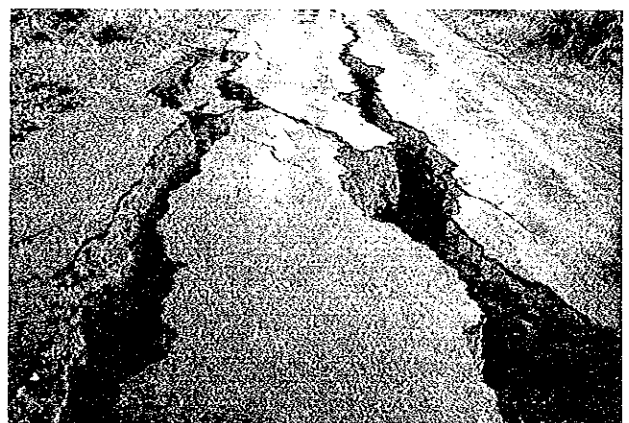
Photo 5.18 Cracks on Pavement

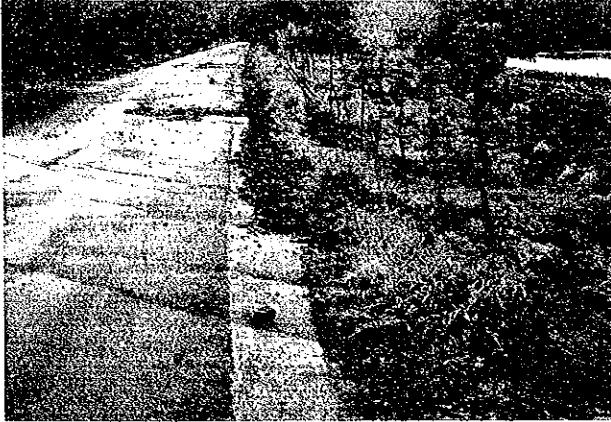
Photo 5.19 Cracks and Settlement of Pavement

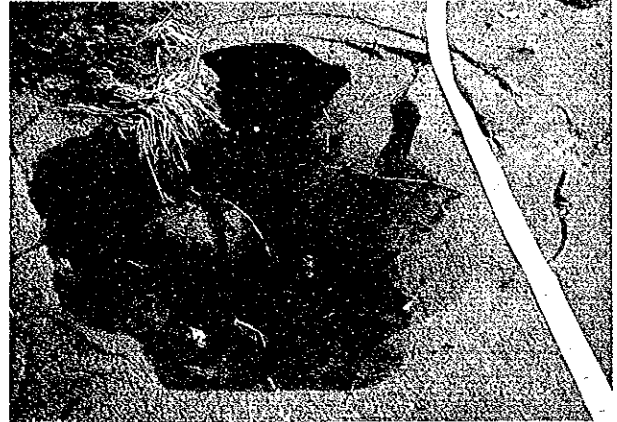
Photo 5.20 A Large Hole Caused by Soil Liquefaction

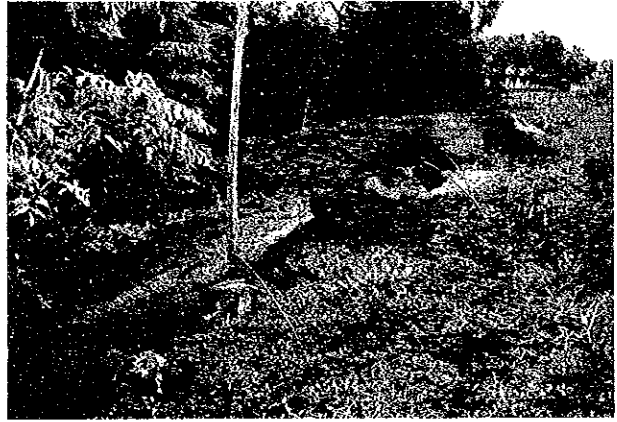
Photo 5.22 Large Sliding of Soils around the Bridge Presented in Photo 5.21

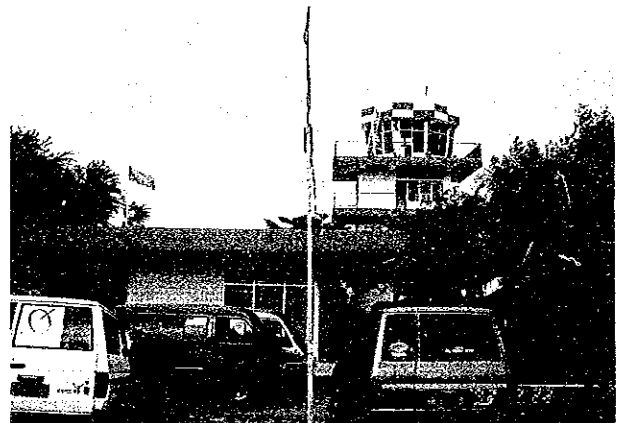
Photo 5.24 Damage of Control Tower at Maumere Airport

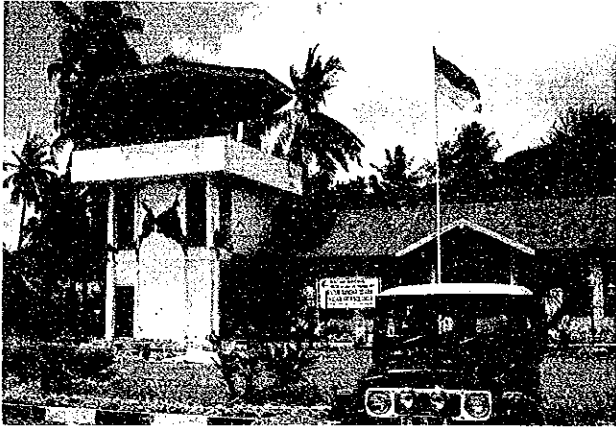
Photo 5.25 Damage of Control Tower at Ende Airport

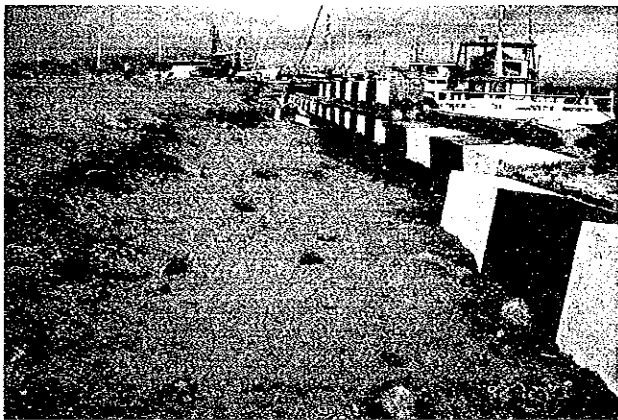
Photo 5.27 Tilting of Retaining Wall and Settlement of Back-Fill

- 5) For restoring the Maumere port, it is recommended to consider the soil liquefaction effects in design. Some treatment for preventing the failure of the retaining wall may be effective to reduce the damage of wall and apron. It is also recommended to consider the soil liquefaction effect for reconstruction of important buildings in the port.

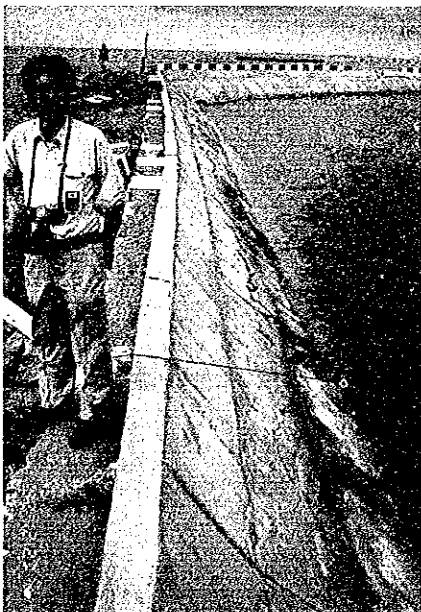
Photo 5.29 Cracks of Retaining Wall at New Port

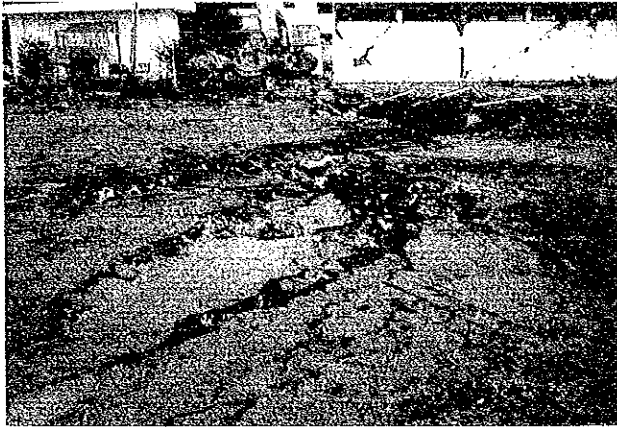
Photo 5.30 Settlement of Pavement due to Soil Liquefaction

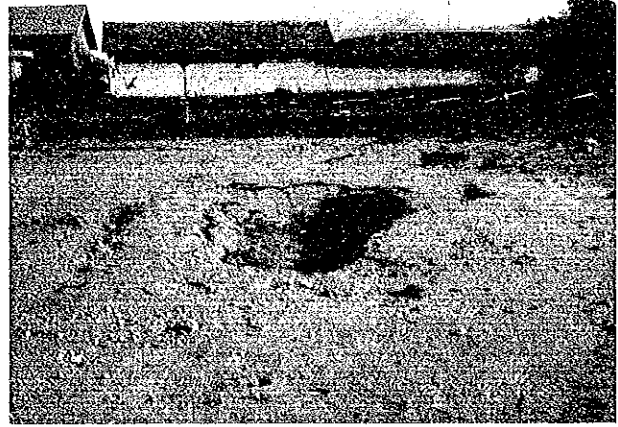
Photo 5.31 Cracks and Settlement of Pavement due to Soil Liquefaction

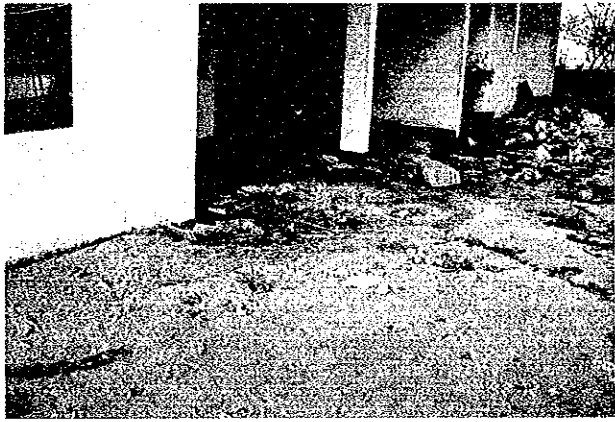
Photo 5.32 Settlement of Foundation of Building at Maumere Port

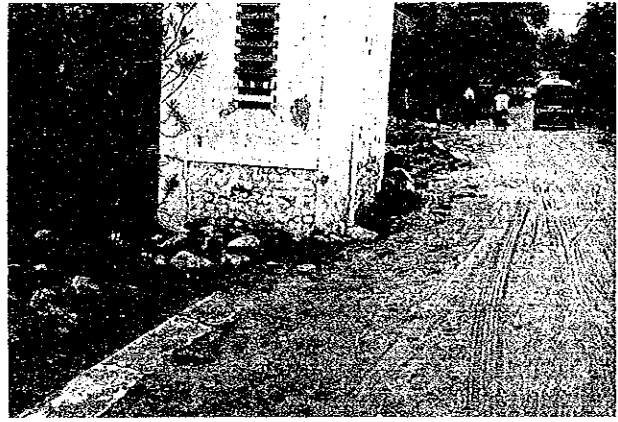
Photo 5.33 Settlement of Gate Building at Maumere Port

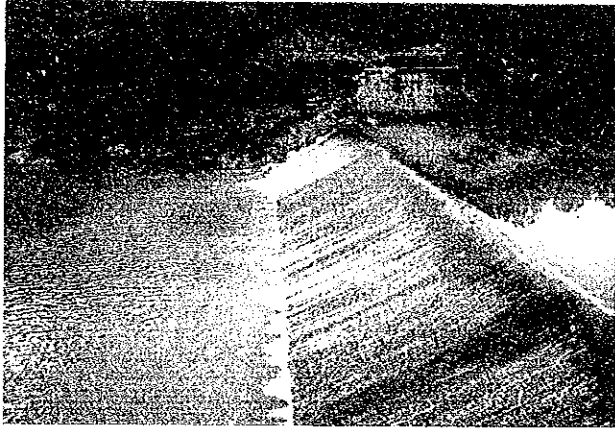
Photo 5.36 Damage of Concrete Block Cover along Water Barrier

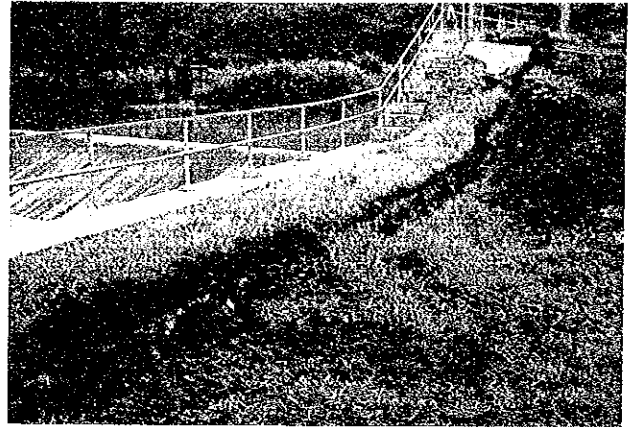
Photo 5.37 Tilting of Parapet Wall and Settlement of Back-fill

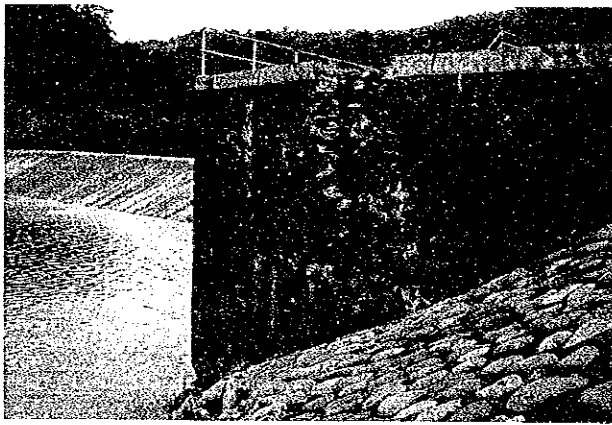
Photo 5.38 Cracks of Parapet Wall

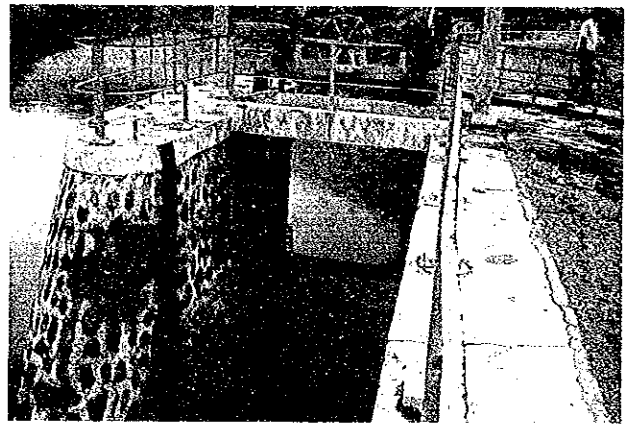
Photo 5.39 Cracks of Parapet Wall near Intake Tower for Irrigation

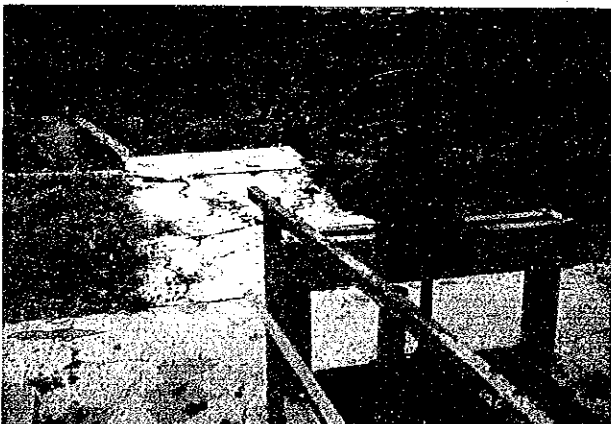
Photo 5.40 Cracks of Water Gate

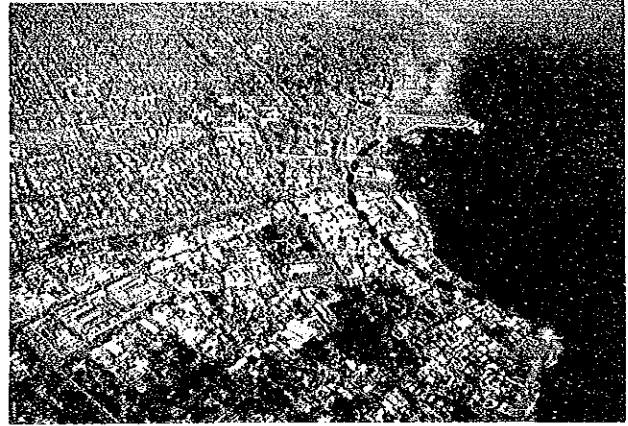
Special interest was large soil settlement and lateral soil movement developed widely along the coast of Maumere City as shown in Photo 5.43. At this site large settlement probably as deep as 1 – 2 m was developed along the coast. Photos 5.44 and 5.45 shows the settlement of storage yard. Several cracks on soils and road pavement were seen as shown in Photos 5.46 and 5.47 parallel to the coast. It is considered that the lateral spreading due to liquefaction caused such large settlement and lateral movement of top soils. It is known based on the Japanese experience⁴⁾ that the large lateral spreading of soils causes extensive damage to many structures.

Photo 5.43 Lateral Spreading and Settlement (Maumere City)

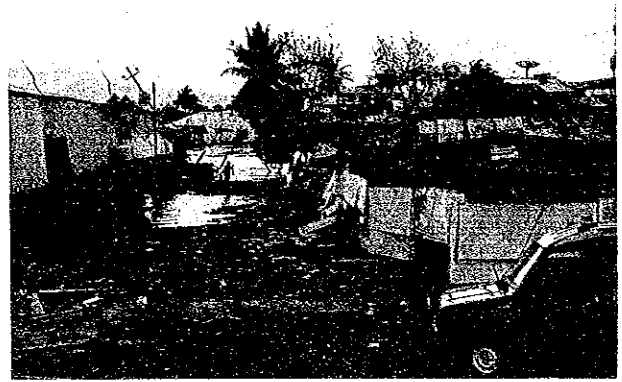
Photo 5.45 Settlement of Coast Line

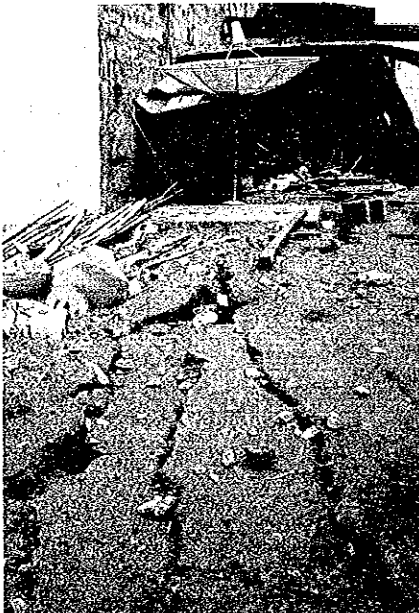
Photo 5.46 Cracks along the Coast (Maumere City)

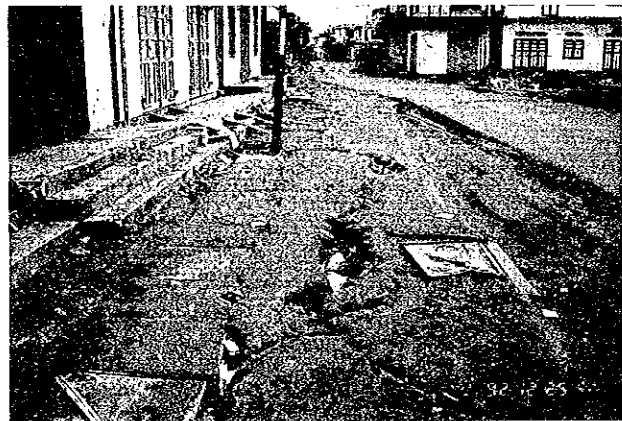
Photo 5.47 Cracks on Road Pavement along the Coast (Maumere City)

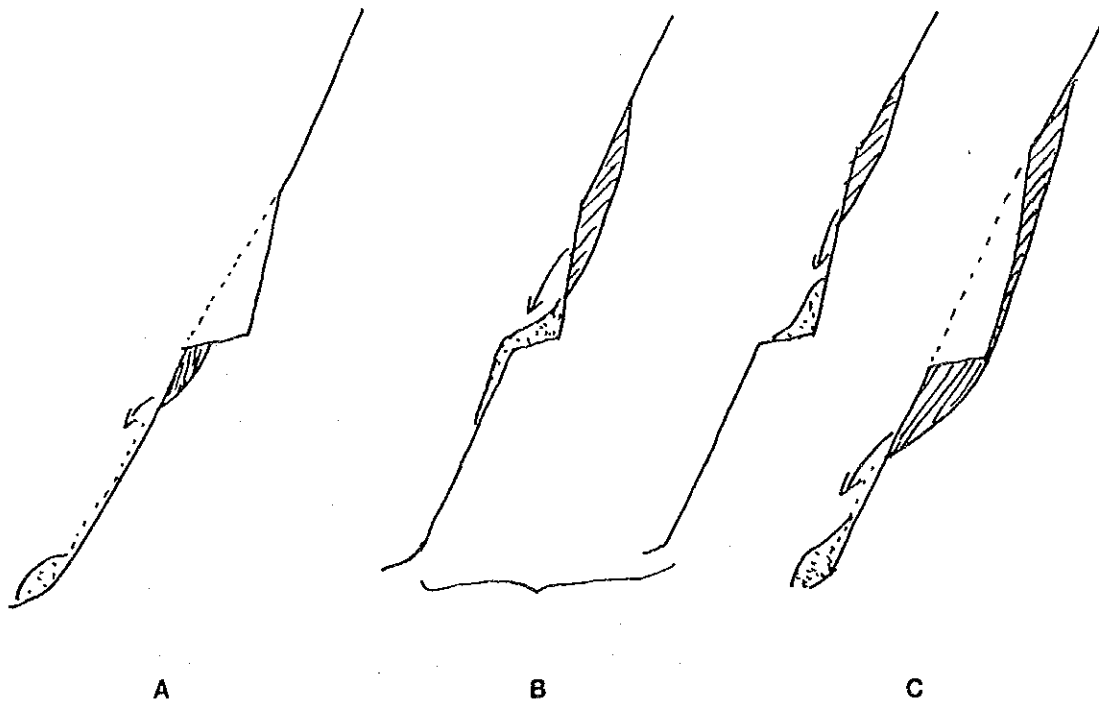
Fig. 6.4 Types of Road Side Slope Failures

- 1) Slope failures at mountain side of the road (Fig. 6.4B).
- 2) Slope failures including mountain side of the roadside slope and valley side through the roadbed, (Fig. 6.4C).
- 3) Slope failures at valley side of roadside slope. (Fig. 6.4A)
