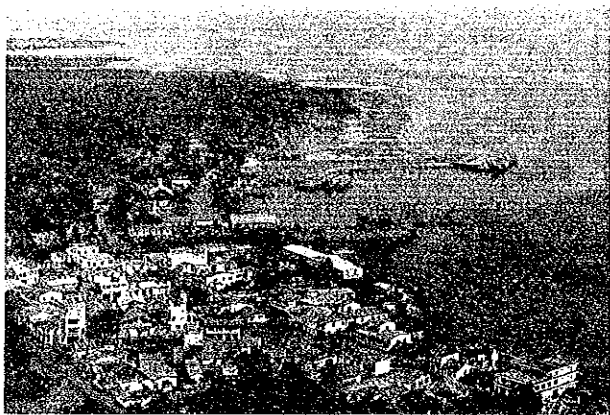
Photo 6.1 Soil Liquefaction Maumere Urban
The photo area includes damaged area by soil liquefaction along the coast line of the port.

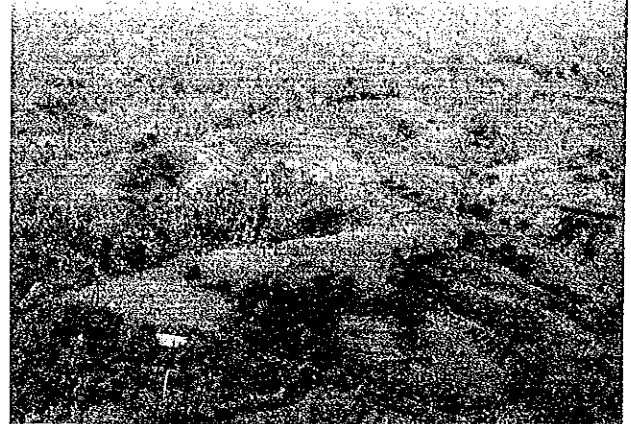
Photo 6.2 Soil Liquefaction Suburbs, Maumere
Area between maumere and mountainous area is undulating hilly area. The area is used as dry fields and palm forests.

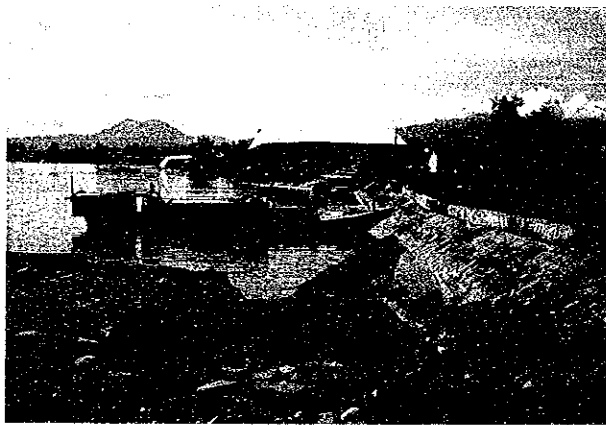
Photo 6.3 Soil Liquefaction Port Maumere
Wharf area was damaged by the tsunami and soil liquefaction
Photo shows damaged and tilted house (warehouse so on) is seen.
Wharf is also damaged.

- 16) For restoring the Maumere port, it is recommended to consider the soil liquefaction effects in design. Some treatment for preventing the failure of the retaining wall may be effective to reduce the damage of wall and apron. It is also recommended to consider the soil liquefaction effect for reconstruction of important buildings in the port.

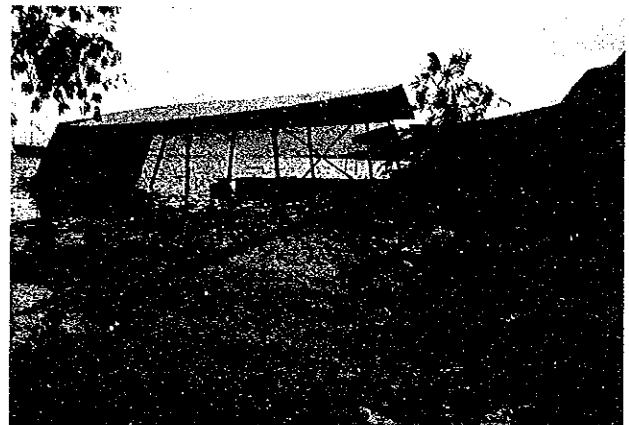
Photo 6.4 Soil Liquefaction Port Maumere
The coastal zone subsided by soil liquefaction. Damaged port facility drowned about one meter in water. The part was changed from paved wharf into drowned part.

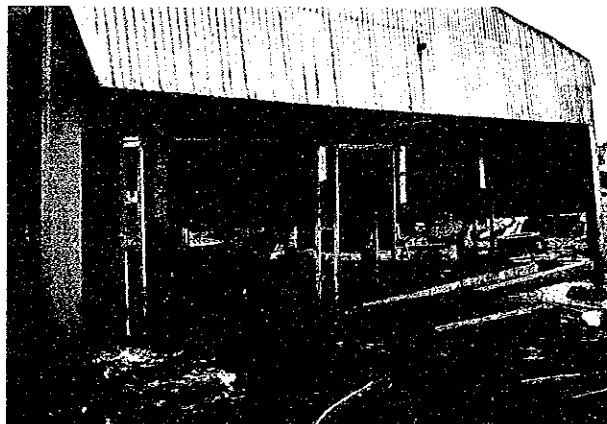
Photo 6.5 Soil Liquefaction Maumere Port
Port facility (fish market) was tilted and partly drowned vertical and horizontal displacement of soil layer (soil liquefaction).

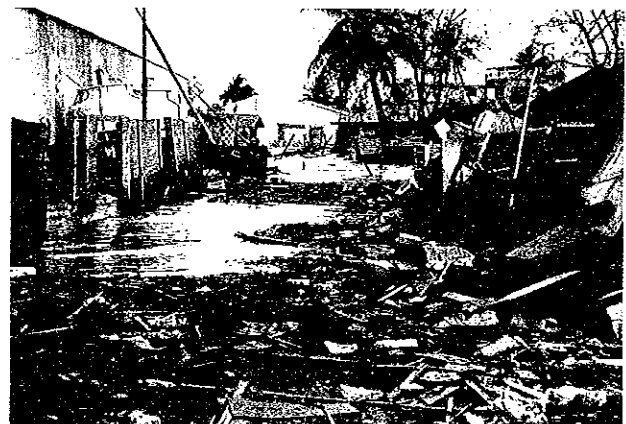
Photo 6.6 Soil Liquefaction Maumere Port
Road was drowned by land subsidence caused by soil liquefaction.

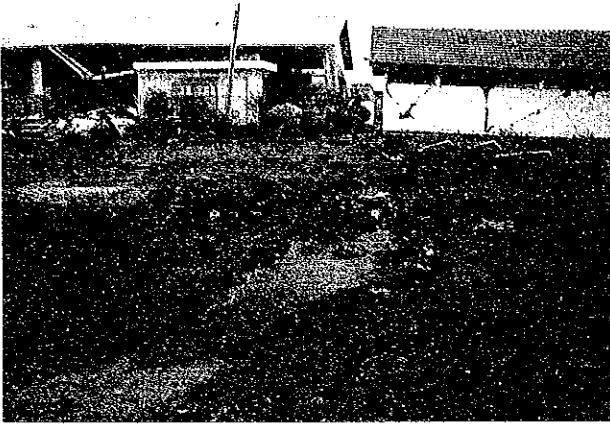
Photo 6.7 Soil Liquefaction Maumere Port
Port facility. Paved area was damaged. Cracks were caused in many sites.

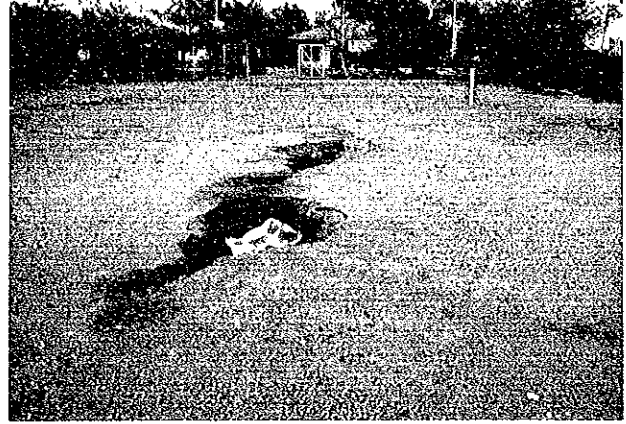
Photo 6.8 Soil Liquefaction Maumere Port
Port facility. Paved area was damaged. In this case, sand boils came out from cracks by soil liquefaction.

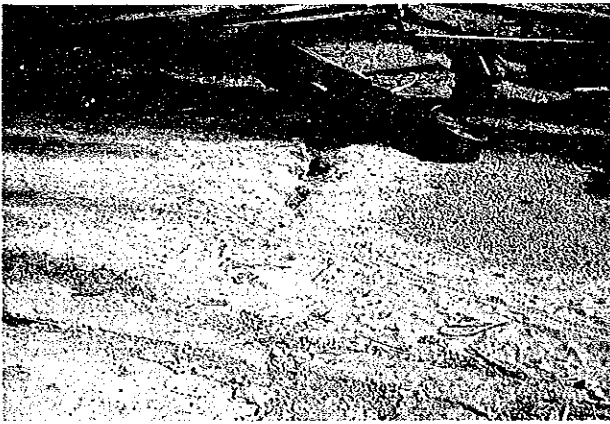
Photo 6.9 Soil Liquefaction Maumere Port
Beside an office, sand boil spouted out from cracks. Cracks are linear and straight. This site inundated by tsunami.

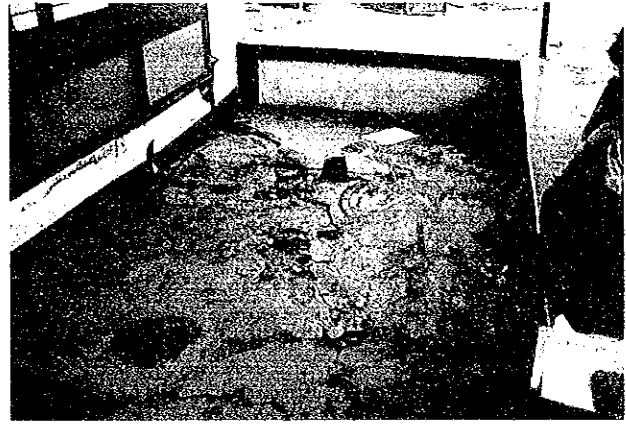
Photo 6.10 Soil Liquefaction Maumere City
In the residence area of Maumere, many houses were damaged by soil liquefaction. In the inside of the houses much sand with water spouted out from the floor. The house can not be used for daily life. Cracks were formed through the inside and outside.

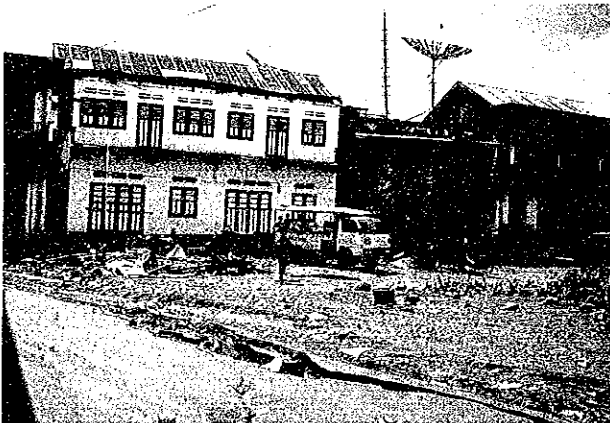
Photo 6.11 Cracks Maumere City
There are many long and wide cracks in Maumere City.

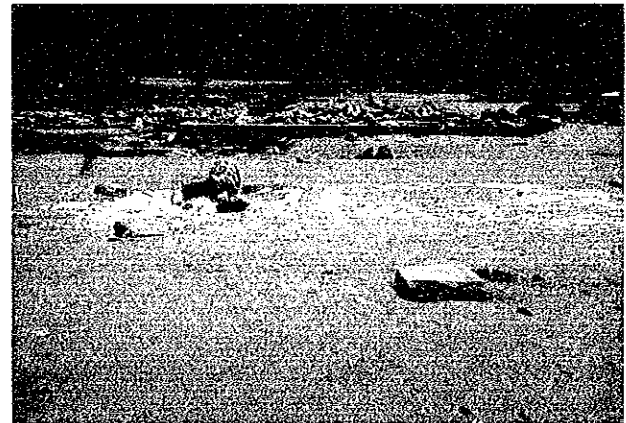
Photo 6.12 Soil Liquefaction Babi Island
Whitish part is the trace of sand boil. Sand was washed away by tsunami wave. In this case, sand boil was caused in the inside of the house. This type of traces can be seen in many sites of the Babi Island and in the coastal line of the main island of Flores.

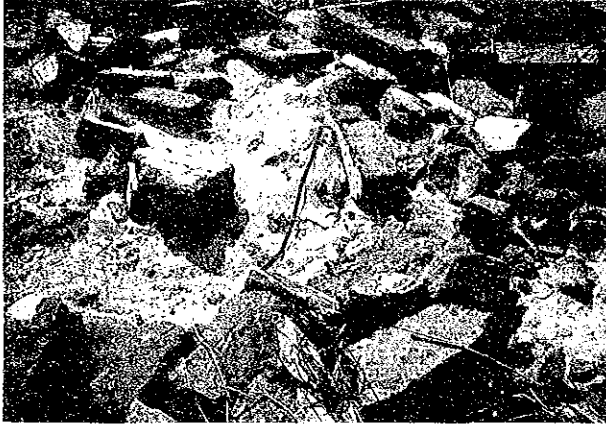
Photo 6.13 Soil Liquefaction Babi Island
 Example of traces of sand boils which was caused in the inside of the house. The house was washed away and only the part of the foundation and stone wall remained.

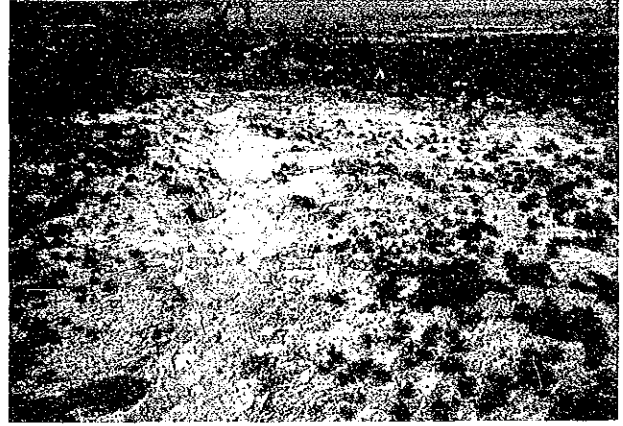
Photo 6.14 Soil Liquefaction Babi Island
 Long cracks were formed in many sites here. And sand boils spouted out from the cracks during and after tsunami wave. Most of spouted sand boils were washed away. Initial forms were pretty changed.

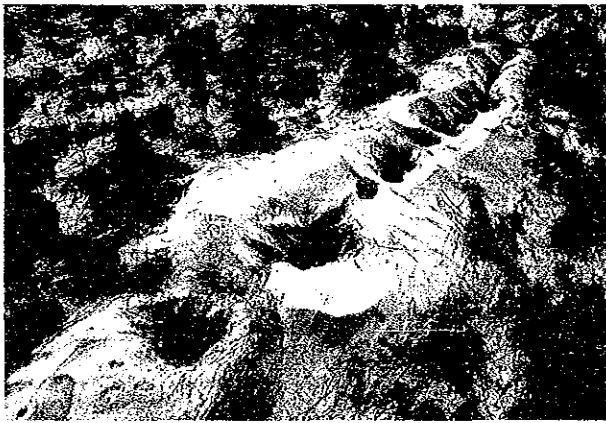
Photo 6.15 Soil Liquefaction Babi Island
 Some of sand boils were formed after tsunami wave. For the reason, initial forms of sand boils could be kept. Linear sand boils were formed on the linear cracks. But single one was formed in the inside of the houses.

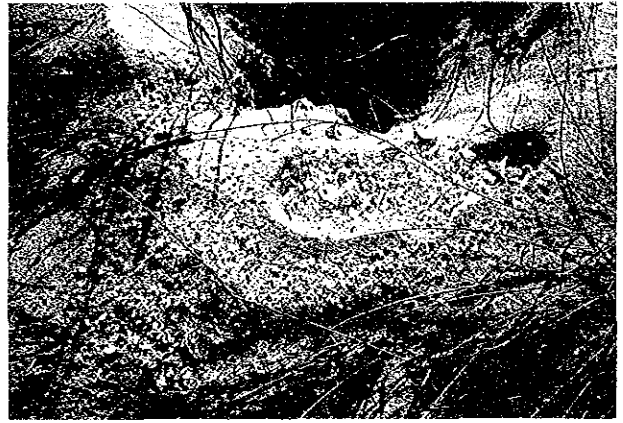
Photo 6.16 Soil Liquefaction Babi Island
 Here, sand boils consist of various kinds of sand bar material which are very small snails, coralltips and coral sand.

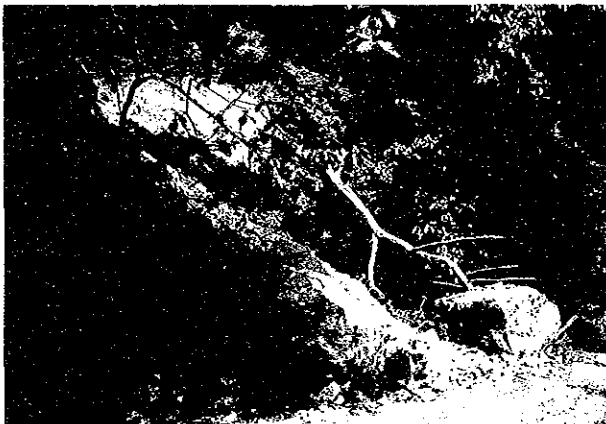
Photo 6.17 Road Side Slope Failure, Flores Island
 The site consists of weathered limestone. One side is a part of hill and another side is valley slope with a river floor. Probably this site was repeatedly collapsed. Cut and banked site was collapses.

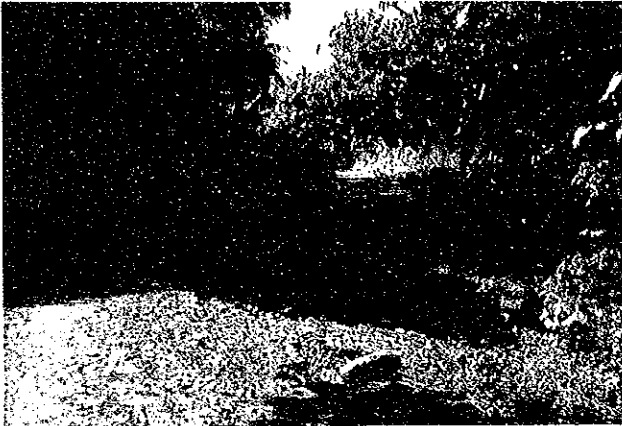
Photo 6.19 Road Side Slope Failure, Flores Island
 This site consists of volcanic material. Cut and bank site was damaged. Valley side road bed was collapsed. Relative height of crack was about 70 cm. Road was paved temporarily.

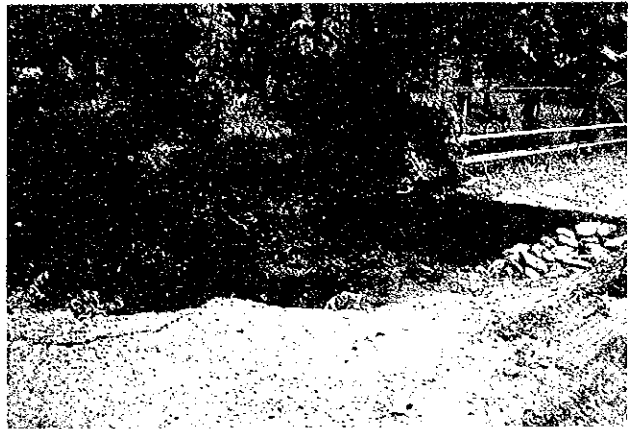
Photo 6.20 Road Damages, Maumere – Nebe
 There are many bridges in the route from Maumere to the east. Many bridges were damaged as shown in the Photo. Most of them were temporarily repaired.

- 12) It is recommended to carefully inspect the bridges in Flores Island with the major attention to the damage of substructures. For those bridges which suffered damage to the abutments in such a manner that the foundations slid to the deck side direction with the top of the abutment being tilted to the back fill side, it is recommended to fully replace the abutment to avoid the possible falling down of the girder. Because those bridges are very old with only one lane, evaluation needs to be made whether they should be repaired or replaced with new structures.

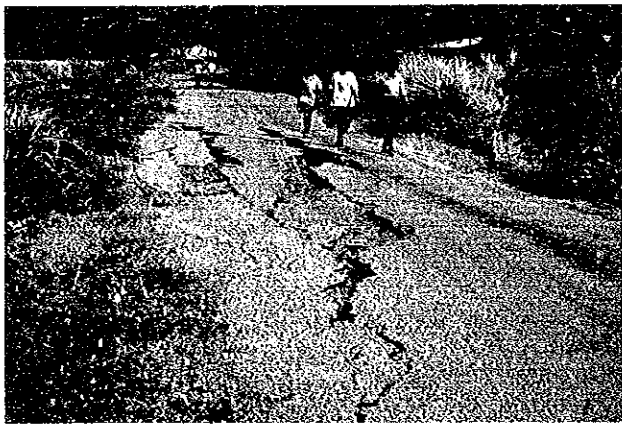
Photo 6.21 Road Damages
 In the route from Maumere to the east, there are many cracks on the road. Most of them are fine and long. Photo shows an example which is about 10 m long and 123 cm deep.

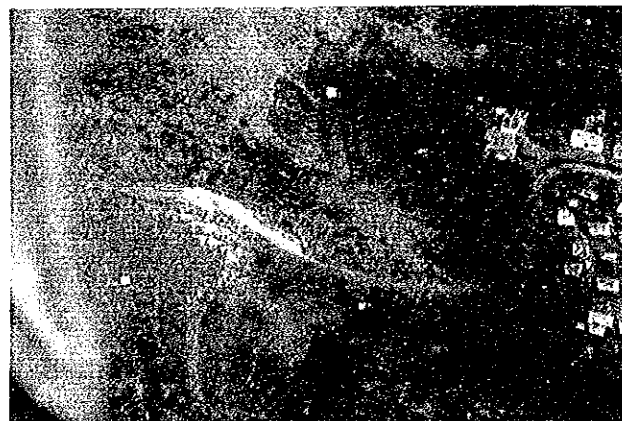
Photo 6.23 Landslides, Road Side Slope Failure, Maumere – Ende
 In hilly area, road side was collapsed. Only mountain side was collapsed.

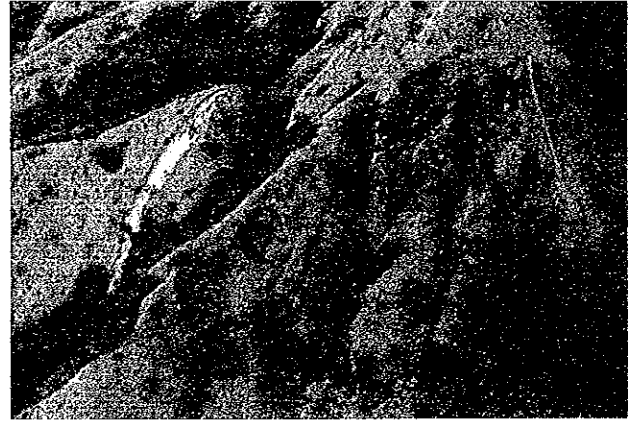
Photo 6.24 Landslides, Surface Side Slope Failure, Maumere – Ende
 Single collapse was caused in a dendritic drainage system area. The surface consists of weathered soil and deep layer consists of rock.

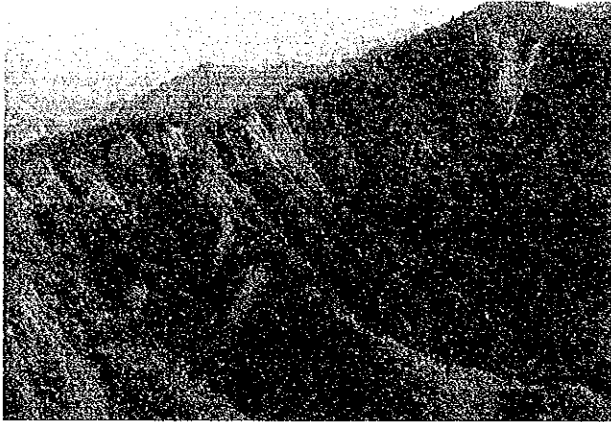
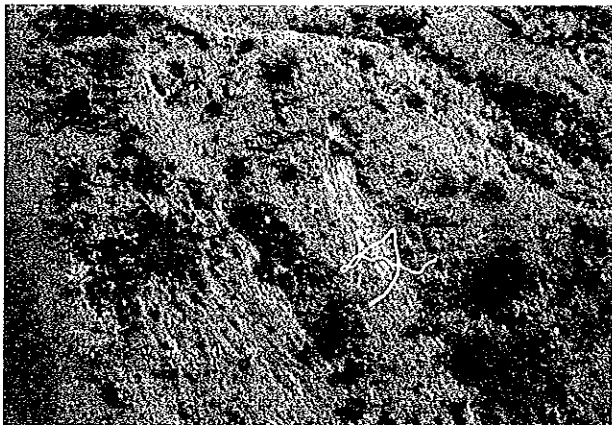
Photo 6.25 Top Landslides, Maumere – Ende Surface Collapses

Photo 6.26 Middle Landslides, Maumere – Ende Surface Collapses

Photo 6.27 Bottom Landslides, Maumere – Ende Surface Collapses

In the mountainous area, surface landslides were caused in many places. Top is a group of surface collapses. Middle is complex collapses. 6.25, 6.26 and 6.27 were caused just under break lines of ridges in steep slopes. Break line means a line which steep slopes change their gradients. Break lines can be interpreted using aerial photographs based on geomorphological method.

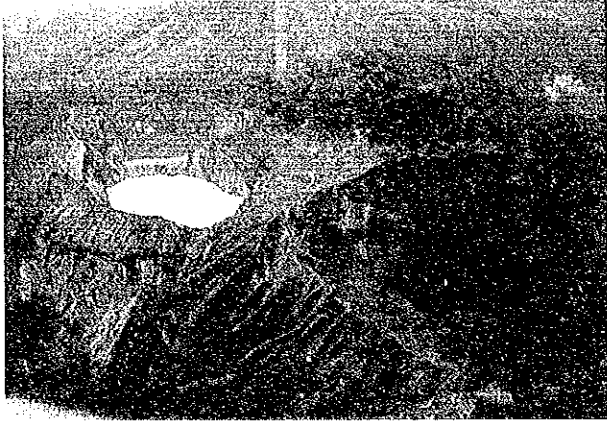
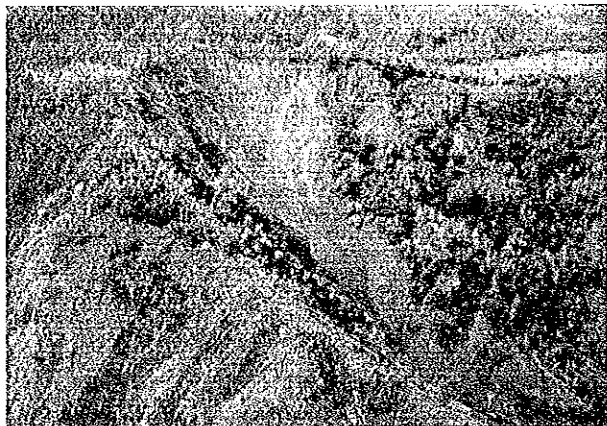
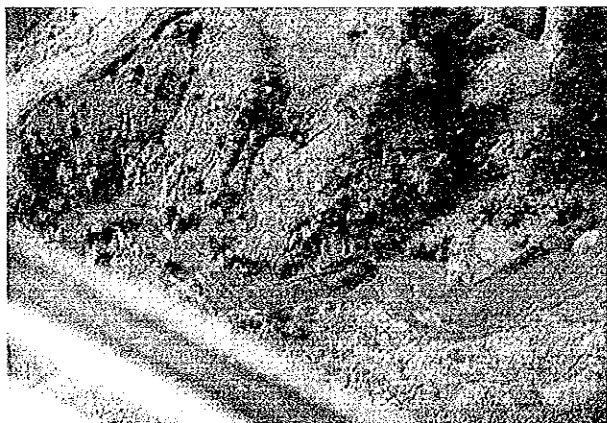
This active volcano has three crater lakes, Keli Bara, Radiation type of drainage system. Left bottom of the top photo, there is a deep collapse. And parallel valleys flow down in the volcano slope. Middle and bottom photos are the same deep and large collapse from ridge to valley floor. It has large and deep head and very long tail deposit. (transportation and depositional area).

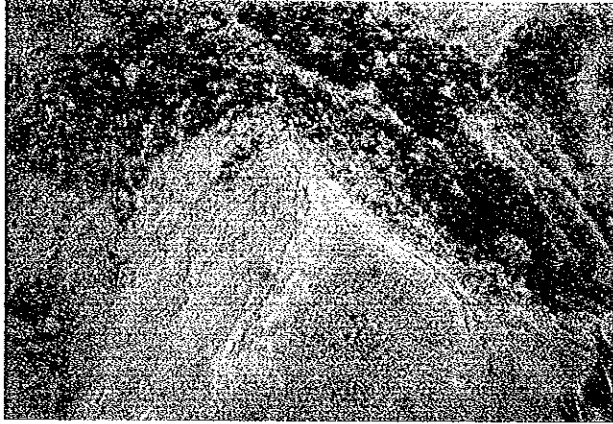
Photo 6.31 Landslide
 This landslide is surface land creep. There are cracks on the ridges. It is not clear whether it moved or not by this earthquake shock. Slope streak can be used available to monitor the behavior of landslide.

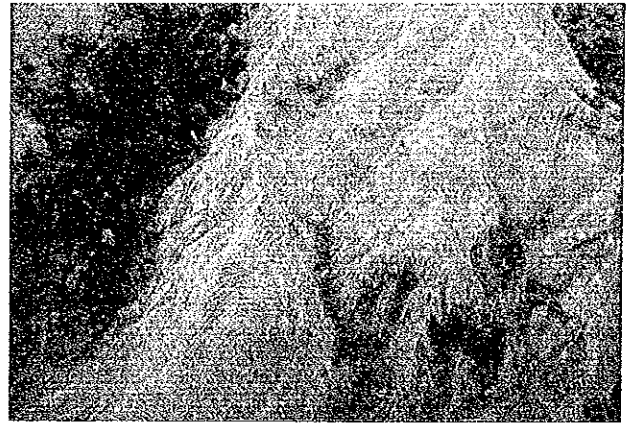
Photo 6.32 Landslide, Surface Collapses
 Slopes are controlled based on contour farming. Right bottom of the photo shows a group of collapses in the slopes and at the valley floors. This influences land use by farmers.

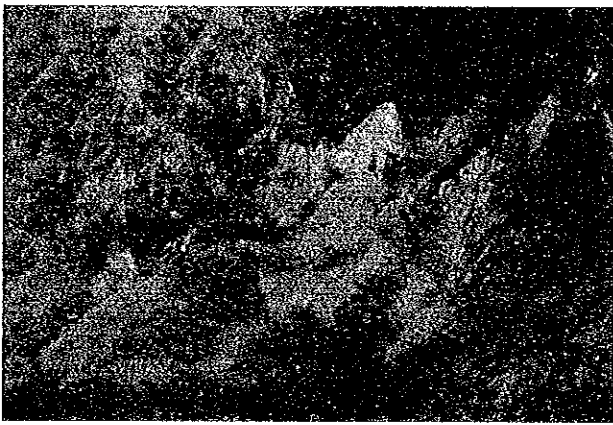
Photo 6.33 Landslide, Rock Wall Failures Mountainous Area
 This route was damaged by the rock wall failures and supplementary deposits. The site is one very bad geomorphological condition.

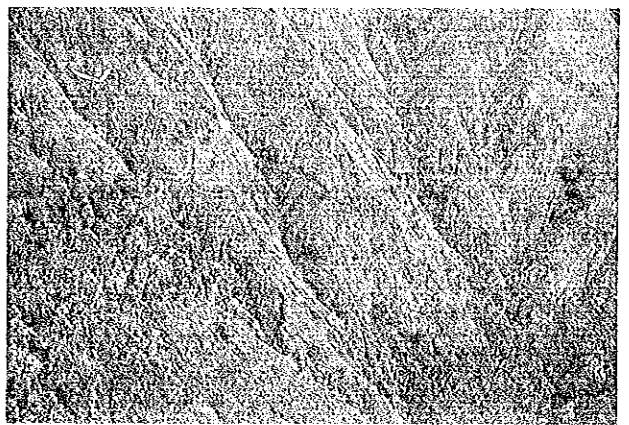
Photo 6.34 Landslide
 1) Road construction caused road side failures.
 2) Surface collapses were also caused in mountainous slopes.
 3) Geomorphologically landslides and collapses can be easily caused at the sites. And roads cross the sites and consequently roadbeds were damaged.

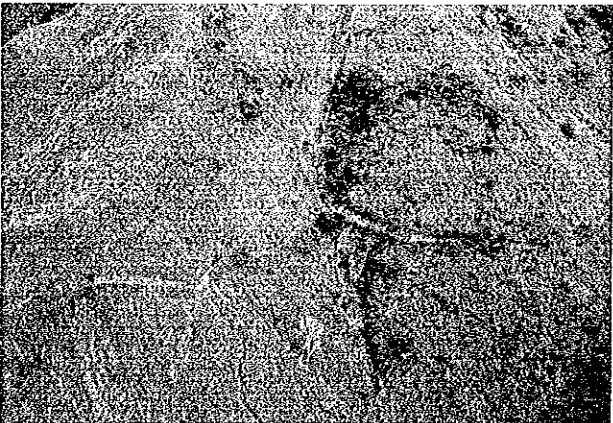
Photo 6.35 Landslide, Geomorphological Condition and Damages
 Geomorphologically, landslides were caused in specified sites and the tails cross the road.

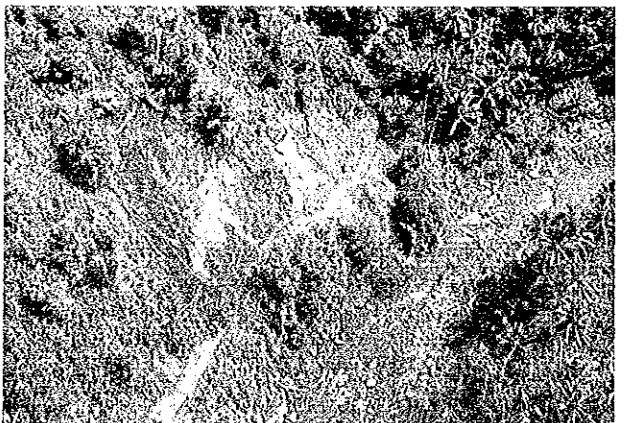
Photo 6.36 Landslide, Road Side Slope Failure, Near End
 Side slope was failed through the roadbed. But it was a kind of surface failure.

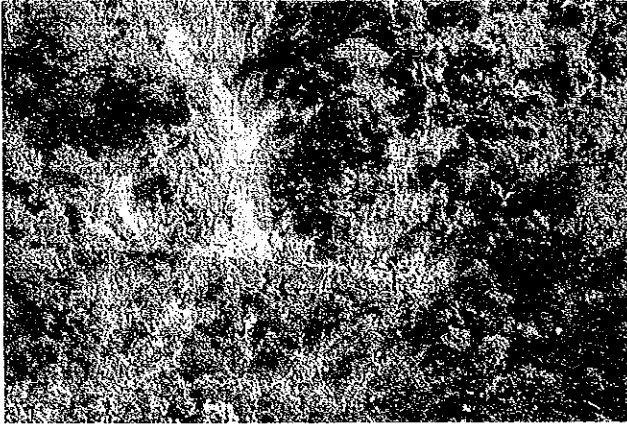
Photo 6.37 Landslide, Rock Boulder Flow
 Previously there is a 0-order valley. Earthquake shock supplied many rock boulders from mountain slopes to the downward through the 0-order valley and deposited on the road. A case that road is loated at very bad geomorphological conditions.

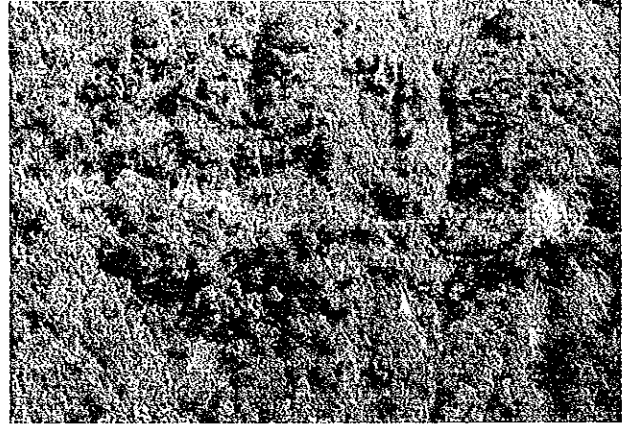
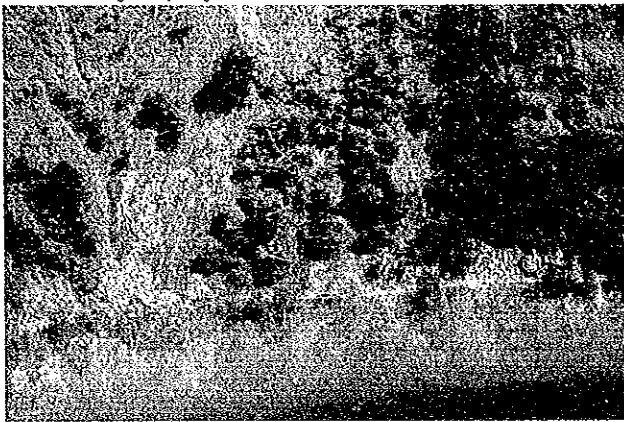
Photo 6.38 Landslide
 Photo shows the road through bad geomorphological condition area. On the road, there are a few buses.

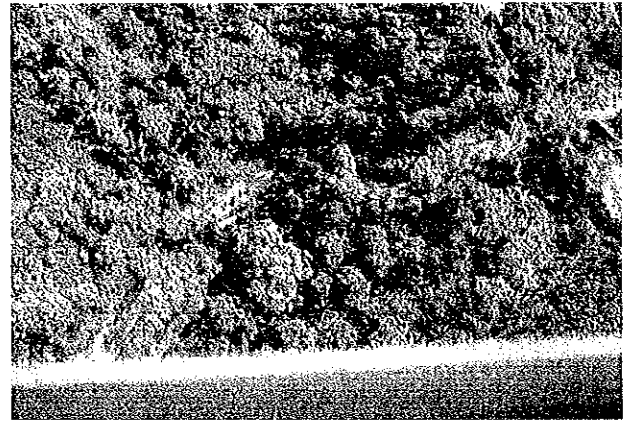
Photo 6.40 Landslide
 The site where the road recovery construction is in work from Ende side.

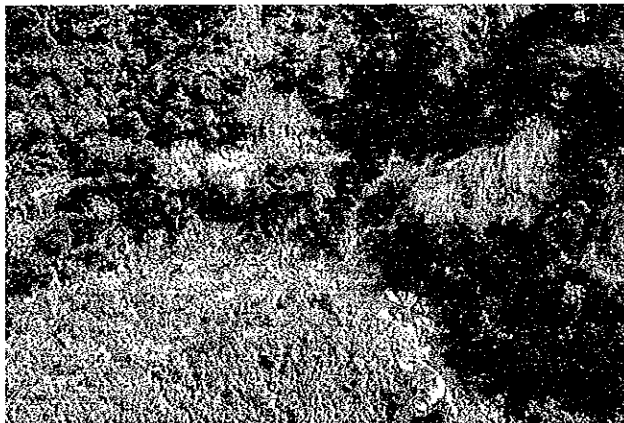
Photo 6.41 Landslide
 Side slope was collapsed.

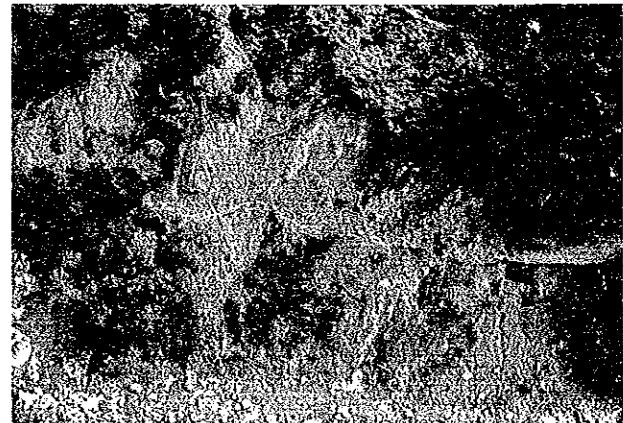
Photo 6.42
 Side slope was collapsed.

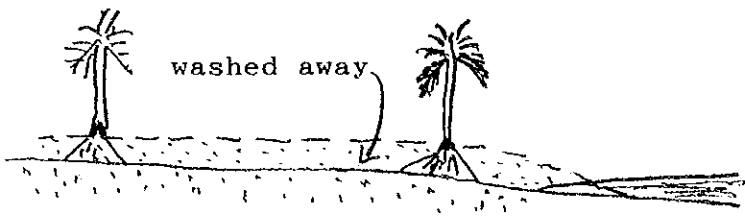
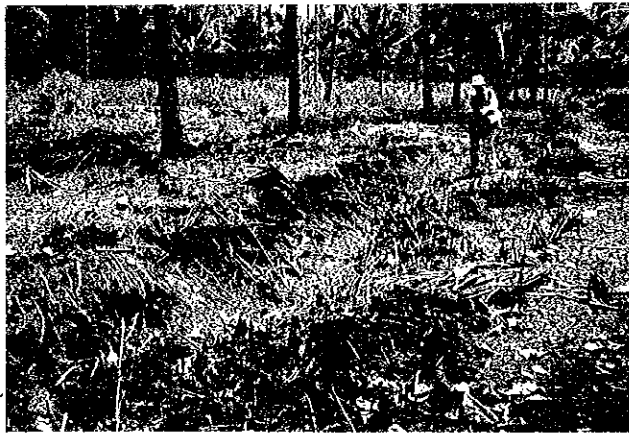
Photo 6.44 Cracks
Cracks were caused at the upper part of backshore of coastline 100 m long, 1 m wide, 1 m deep. From the man to the corner, a clear crack was caused.
Top of the photo is covered by green. Green part was not drowned by tsunami wave.
