**BASIC DESIGN STUDY REPORT
ON
THE PROJECT
FOR
EMERGENCY REHABILITATION PROGRAM
FOR
TYPHOON-DAMAGED WATER SUPPLY SYSTEM IN LEYTE
IN
THE REPUBLIC OF THE PHILIPPINES**

JUNE 1993

KYOWA ENGINEERING CONSULTANTS CO.,LTD.

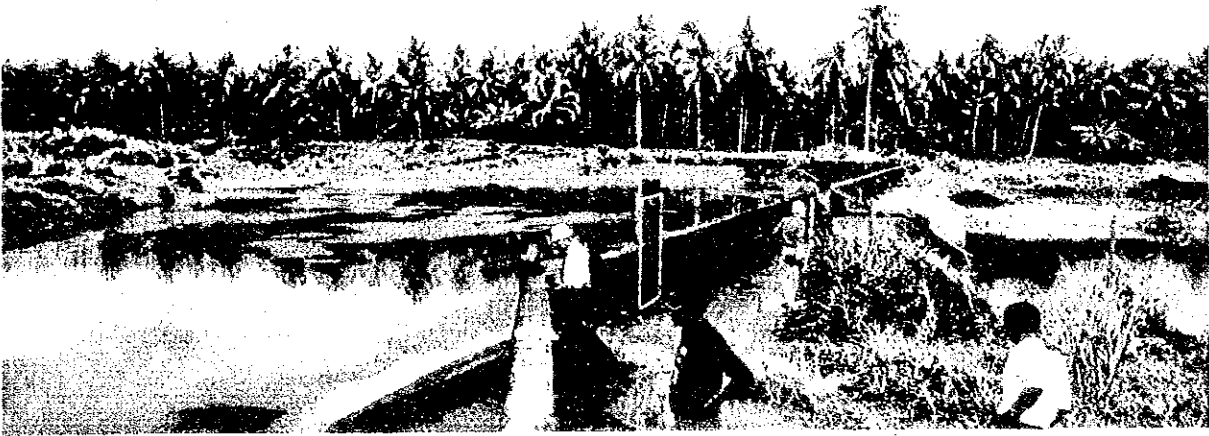
Entrance side of the existing filters of the Tingib treatment plant

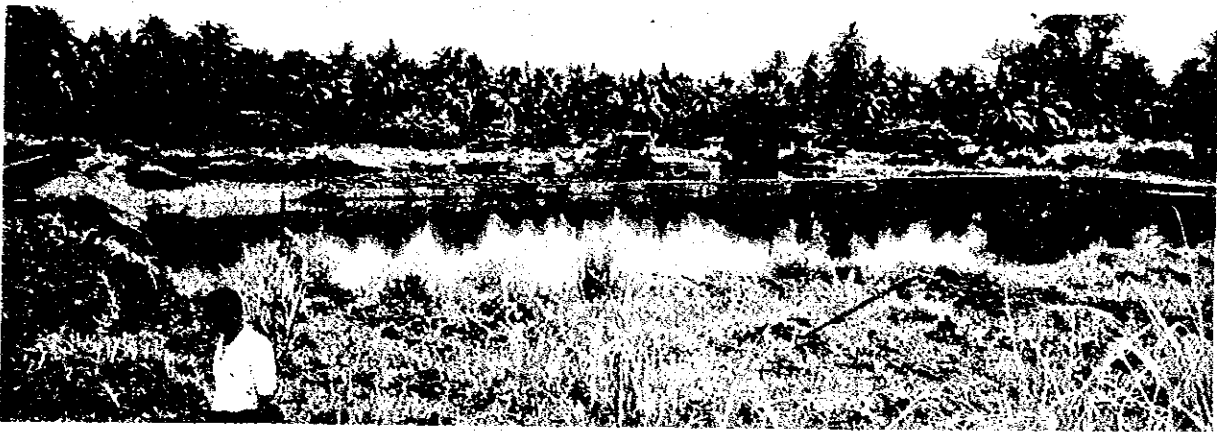
Existing slow sand filters of the Tingib treatment plant

- (2) Of the three filters, one is severely damaged and left without restoration up to now. To compensate for this filter, the thickness of the filter bed in the other two has been reduced and these filters are operated in an overloaded condition thus sacrificing the quality of treated water.

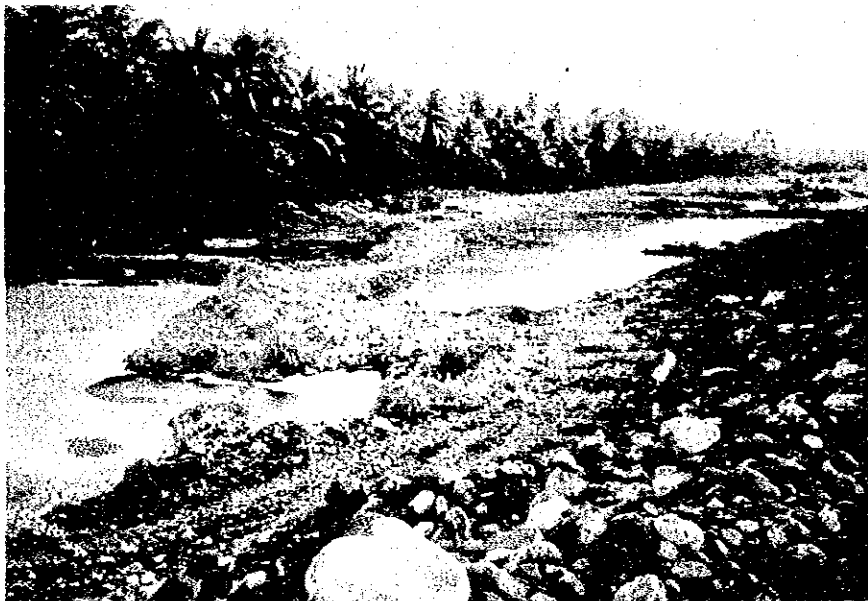
Manually dug settling ponds
constructed inside of the
earth dike of the Tingib
treatment plant

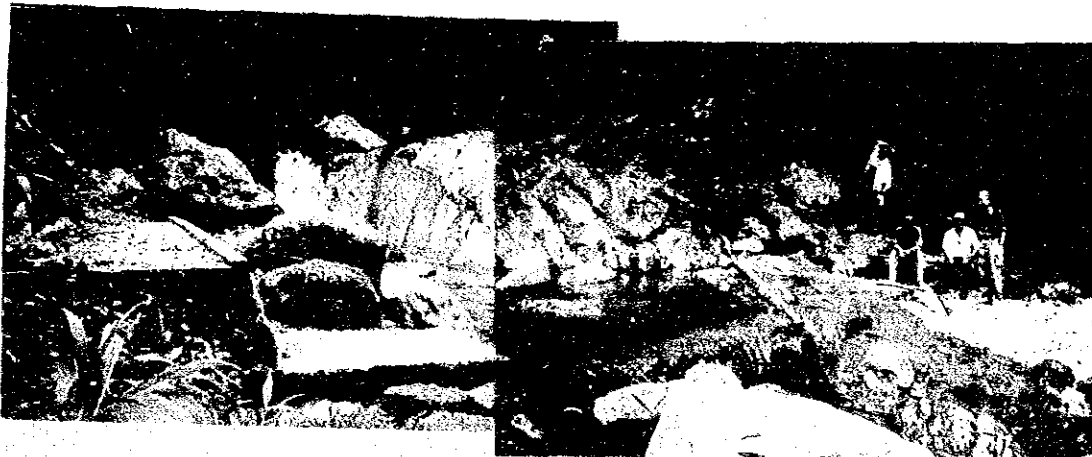
Hitognob dam (in the Dagami system)
Function was recovered as nearly same condition as before the Typhoon by
removal of rocks and woods flown into the dam during the Typhoon

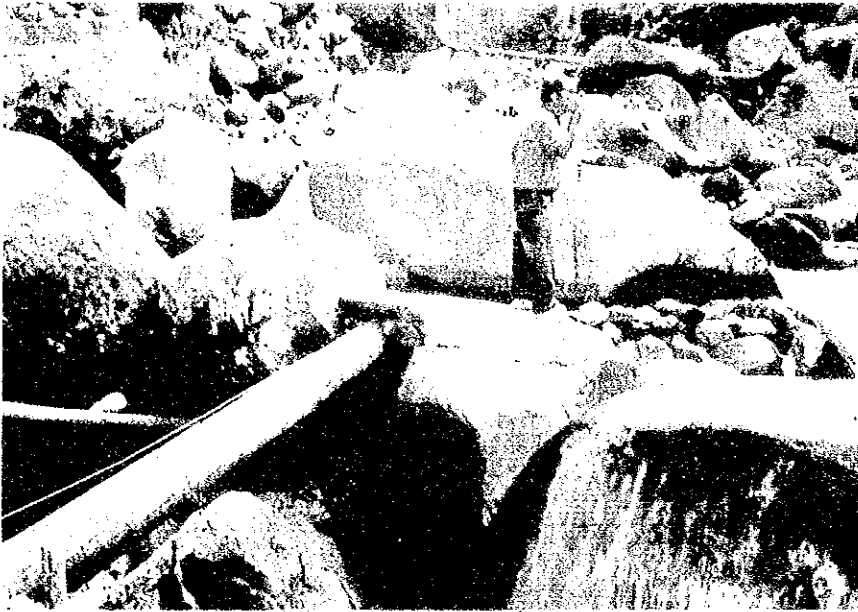
Intake installed in
the Hiabangan River
as a temporary measure

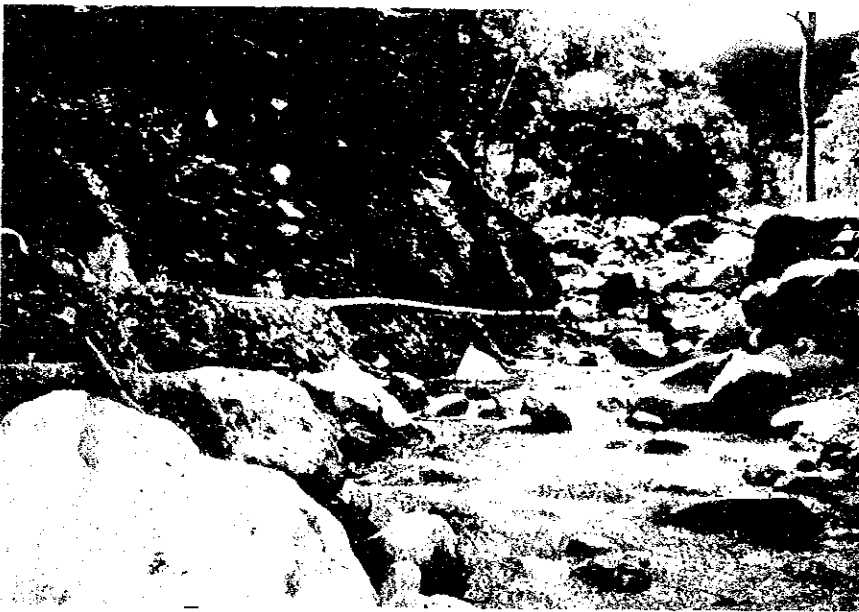
Rehabilitated raw water
conveyance pipeline
(PVC) of Hiabangan dam
as a temporary measure

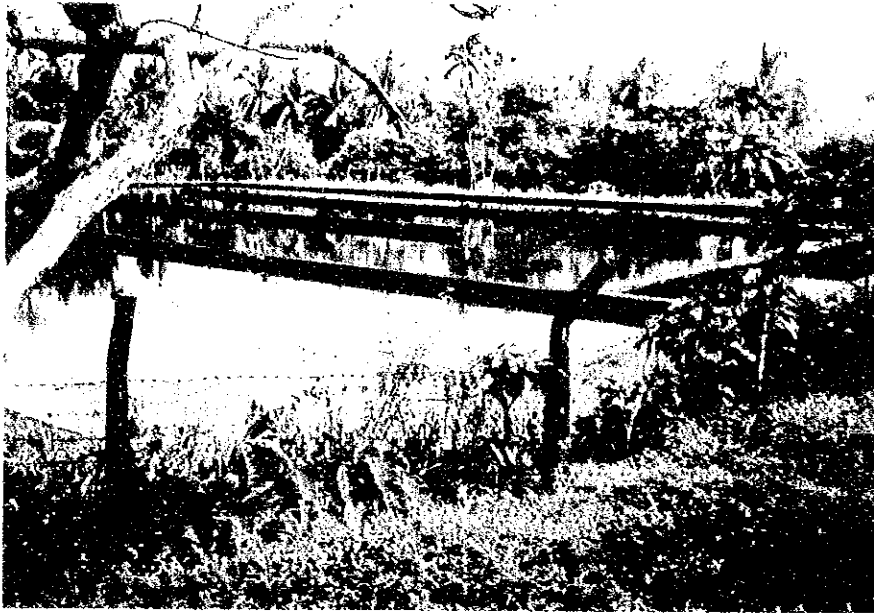
The sedimentation tank of Dagami treatment plant which was free from damage of the Typhoon Uring

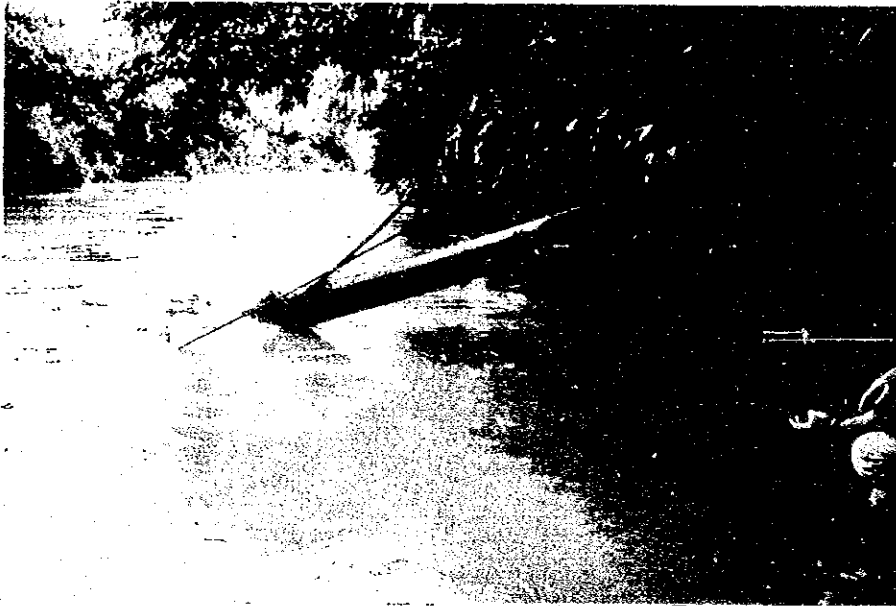
Aqueduct of the existing transmission pipeline in the Dagami system which was fallen into the Quilot River near Dagami town

The transmission pipeline which is laid with cast iron pipes is ϕ 300 mm from Dagami Treatment Plant to Dagami Town, and ϕ 250 mm from Dagami Town to Tacloban City through Palo. However, immediately after Dagami Town, an aqueduct has fallen and is left without repairs. Since the inside of the transmission pipeline is mortar lined, and as the mortar has peeled off with the fragments accumulated within the pipe as a result of the deformation of pipe caused by the falling of the aqueduct, it is assumed that the flow capacity of the pipeline is obstructed significantly.

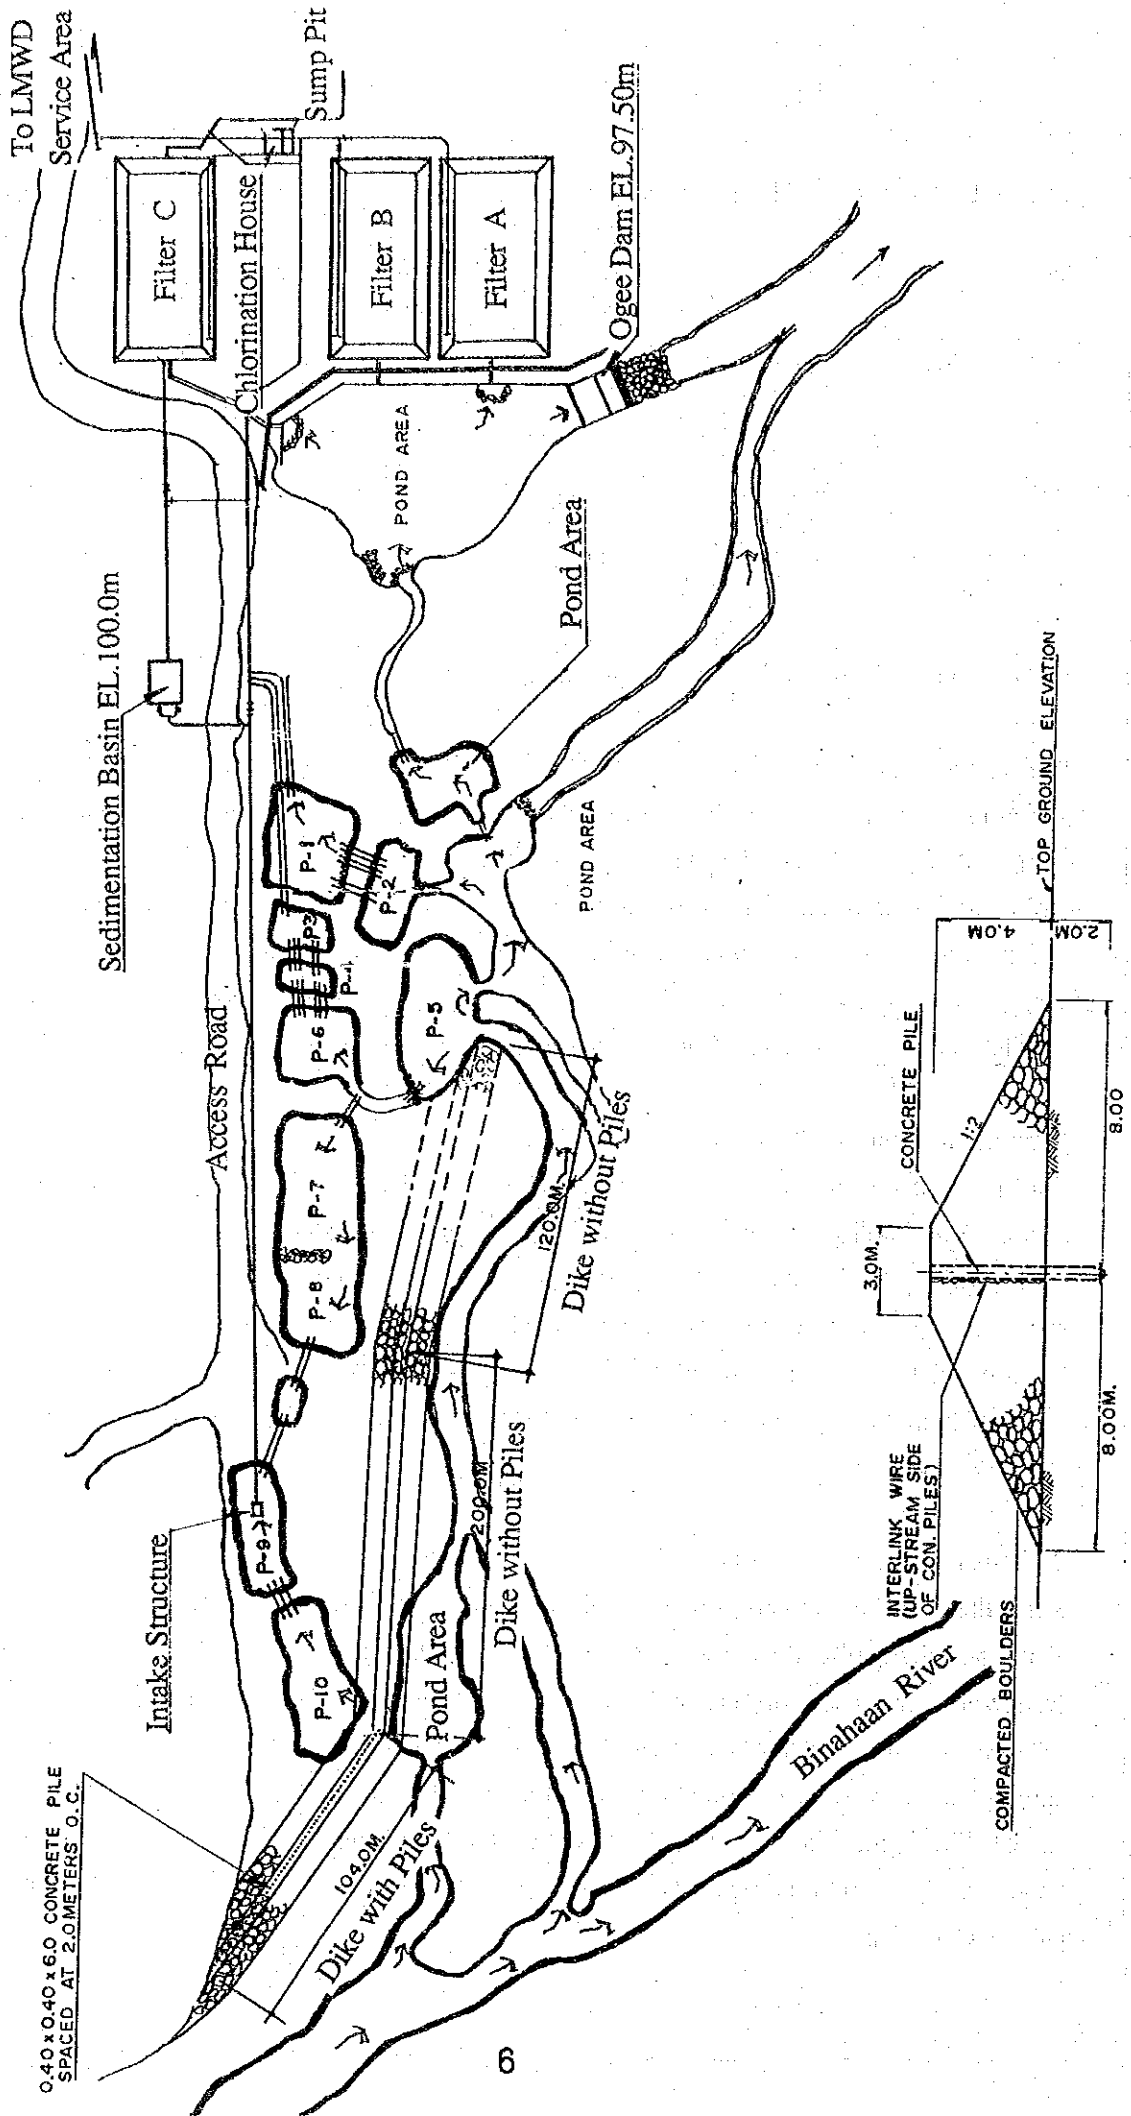
Fig. 2 Emergency Rehabilitation Plan for Tingib Treatment Plant

The silt deposited in the three filter basins has been removed. Out of the three filter basins two basins (A and C) have been rehabilitated by replacing the filter material after cleaning, whereas the remaining basin (B) is left as it is because it has been considered that its rehabilitation is impossible as the collecting pipes installed at the bottom of the basin are damaged severely. Even in the two basins restored, the filter bed is very thin and the filters are overburdened in the operation as emphasis is given to the quantity of water filtered by sacrificing its quality to some extent.

After the typhoon, construction of earth dike was commenced as the flow pattern of Binahaan River has changed and recurrence of flood was feared. Earth dike on the left bank, which has a trapezoidal cross section with a height of 4.0 m, a width of 3.0 m at the top and 16.0 m at the bottom, is reinforced over a stretch of 104 m from the upstream end with wires tied on to 8 m long 53 concrete piles driven at 2 m intervals along the dike. The adjacent downstream stretch of the dike, which is 250 m long, is constructed without piles and it protects the treatment plant. In the future, dike will be extended by another 70 m bringing the total length to 424 m.
