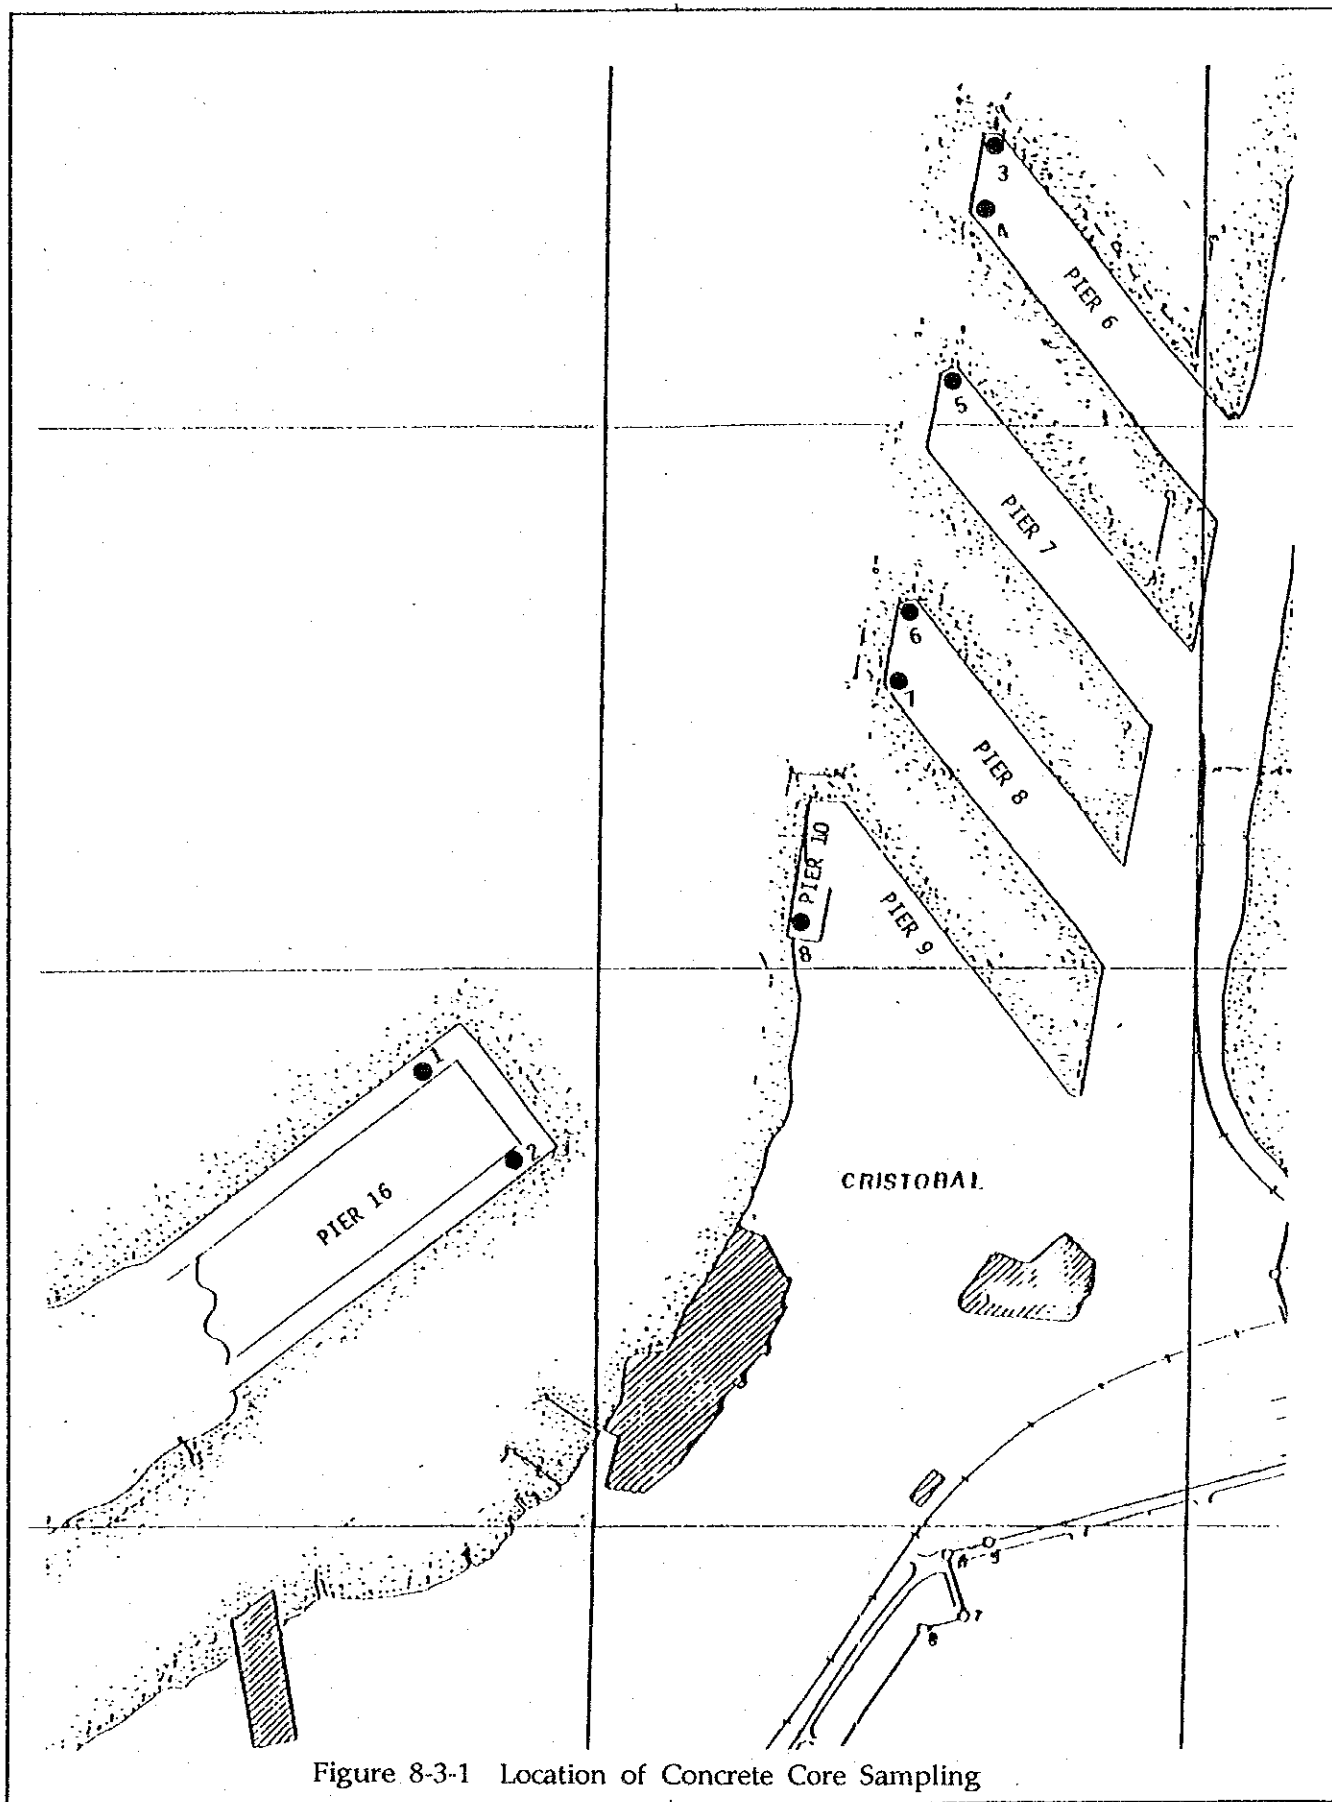
Figure 8-3-1 Location of Concrete Core Sampling

According to the visual inspection on the core samples taken, it is obvious that the concrete was casted and cured with a excellent quality control in 1910's. The quality of concrete generally decreases year by year due to chemical action from sea water, however, the result of compression test shows that very few chemical action affected the concrete quality of the Cristobal piers which sustained the concrete strength.

Regarding the concrete strength, although the figures varied by cores, it is assumed that the standard concrete strength of $f_c' = 350 - 400 \text{ kg/cm}^2$ was used in the original construction of the piers. In the structural analysis, it is recommended to apply a standard concrete strength of $f_c' = 240 \text{ kg/cm}^2$ to be on the safe side.

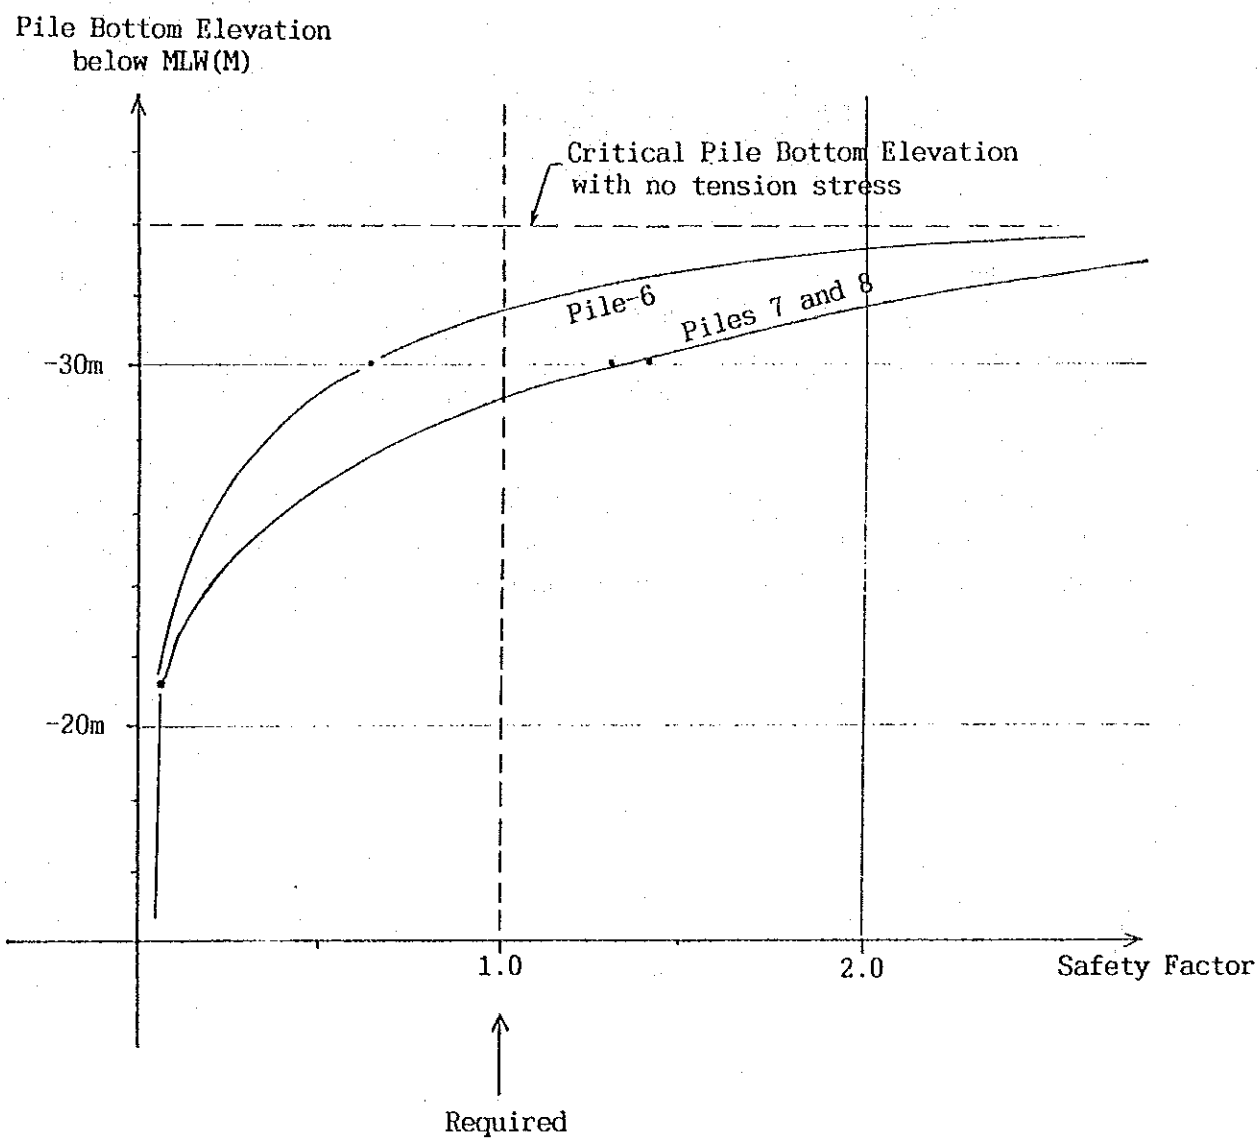
Figure 8-5-1 Critical Depth of Pile Bottom : Pier No.6
(at Seismic Condition of $K_h = 0.20$)

- (3) If the pile/Gatun connection is fix and the Gatun formation is shallow, bending moment at the piles' bottom appears to be so large that tensional stress might be generated and that might create cracks at the pile/Gatun connections. However, no pull-out force acts on any piles.
- (4) When cracks occurred at the pile bottom, the pile/Gatun connection turns to be pin connection from fix. And in the worse case, it becomes roller connection. In such cases, the bending moment at the pile top becomes larger than the fix-case, however the top of piles and beams have enough sectional areas and strength to resist against any possible forces.
- (5) From the above results, it has proved that the piers are stable against such external loads as berthing forces and seismic force ($K_h=0.20$) although the condition of pile/Gatun connection turns to be pin or roller from the fix condition.
