2-3 Port Facilities

Chapter 3 Evaluation Analysis of Present Deteriorating Condition

3-1-1 Present Deteriorating Condition at Channel and Basin

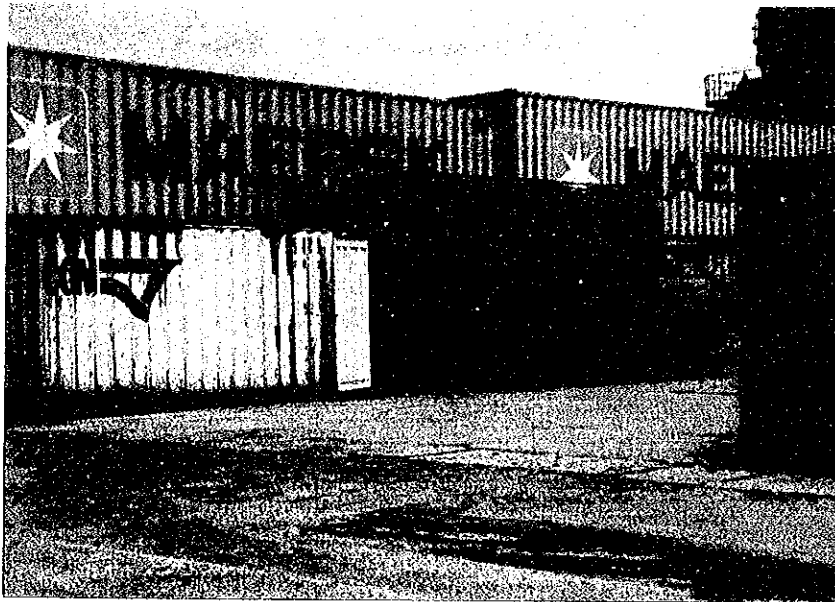
Main Port Area
Berth No. 1
CFS not provided.
Stuffing and unstuffing carried out at the container yard.

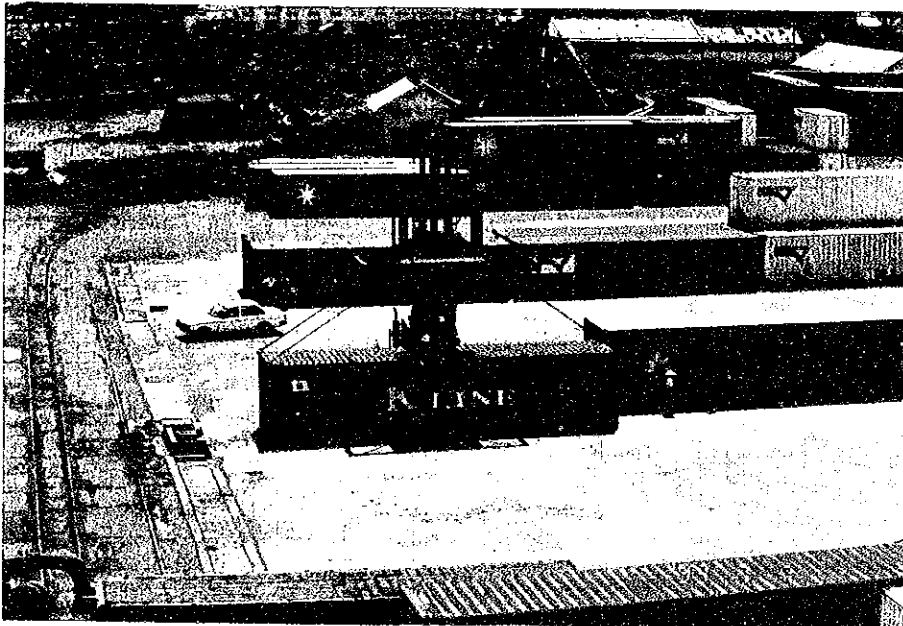
40' container shifted by using 20' spreader with wires.

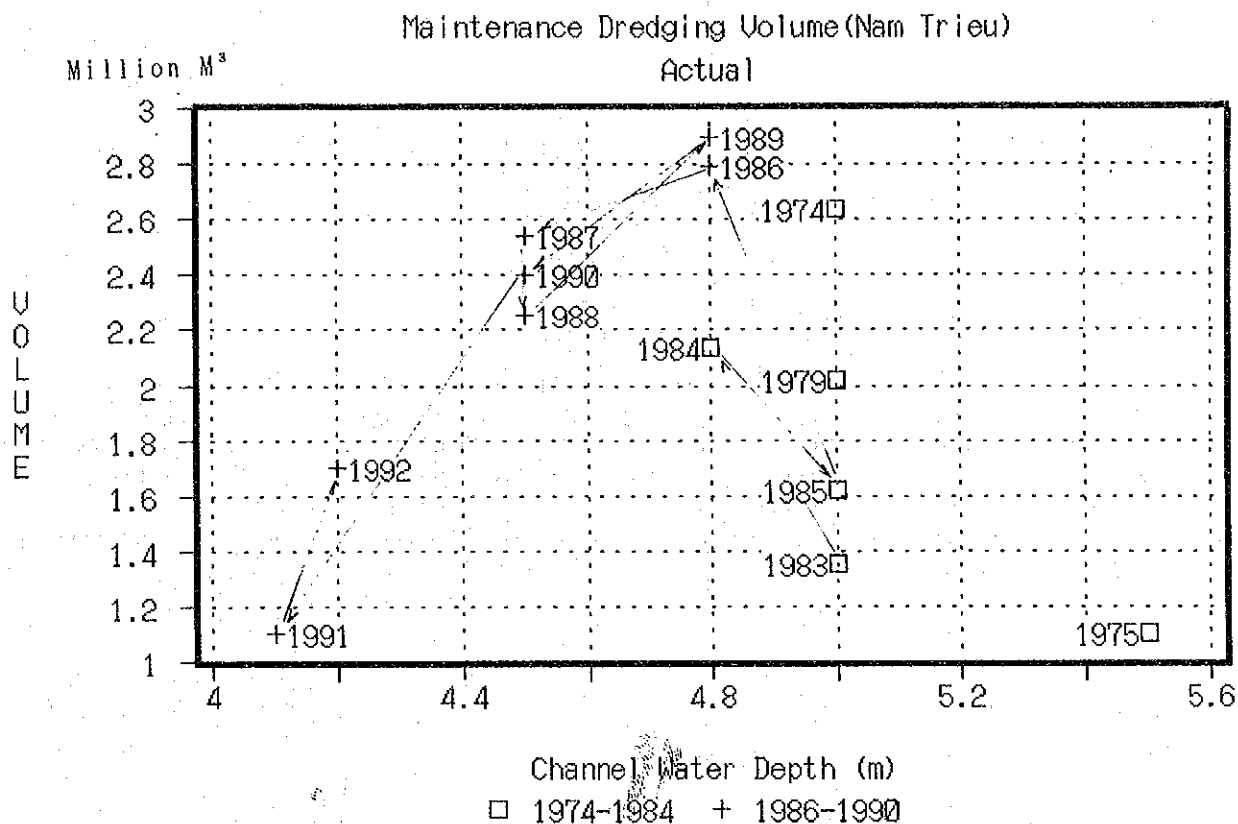
Figure 3-1-5 Maintenance Dredging Volume in Nam Trieu Channel

The completion of Dinh Vu Dam in 1982 significantly changed natural/environmental conditions of the Cua Cam River, the Bach Dang River, the Nam Trieu Channel and their estuaries, and as a result, the siltation volume increased. Also the volume of maintenance dredging has been increased accordingly.

Fig. 3-1-5 indicates the volumes of maintenance dredging and the maintained depths at the Nam Trieu Channel in the time series. After the completion of the Dam, the volumes to maintain the same channel depth have increased (1983-1986), and the maintained depth has become shallower as the volume of maintenance dredging has decreased in comparison.

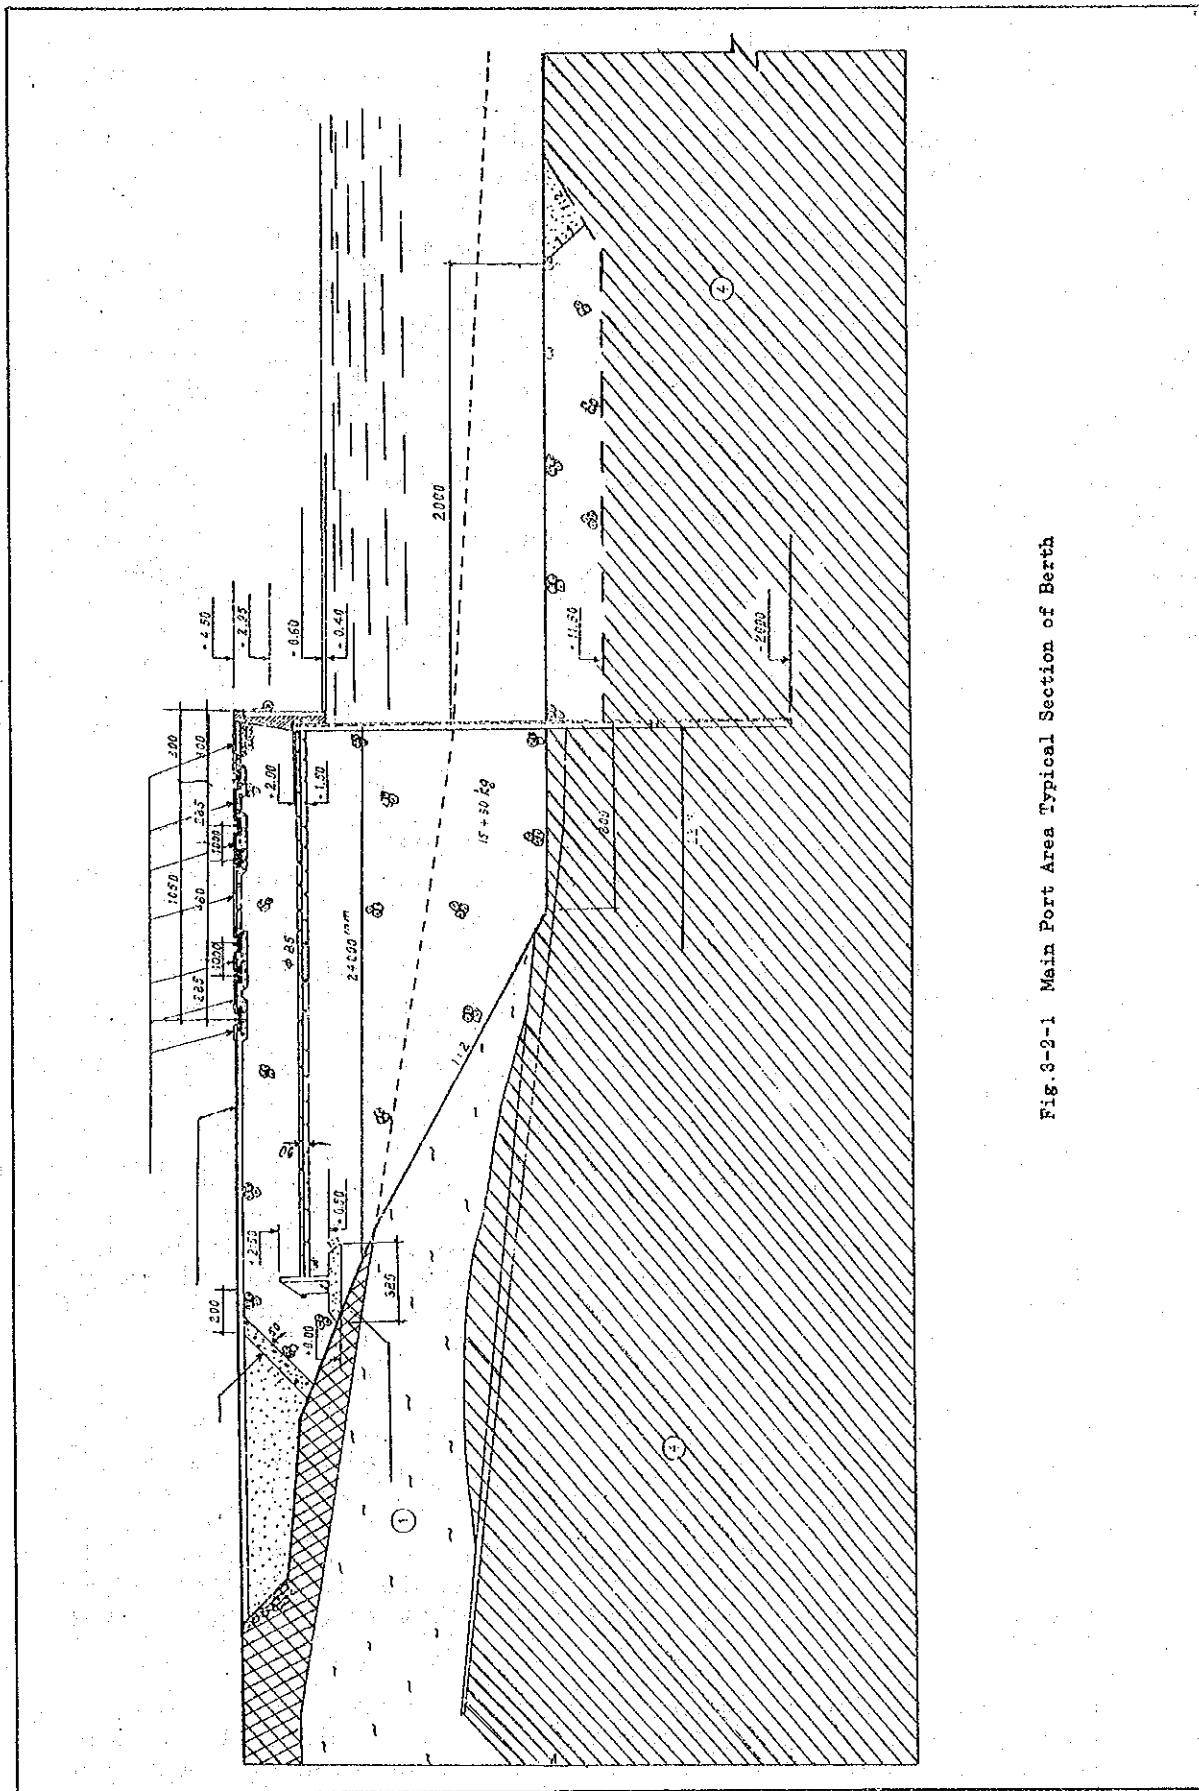
Fig. 3-2-1 Main Port Area Typical Section of Berth

This trial calculation indicates that this kind of combination loads, very rare in probability of occurrence should be interpreted as a short-time load. Otherwise the stability of the existing structure can not be assured. Furthermore, the steel-sheet piles have already experienced corrosion for more than 20 years, so that no definite conclusion can be reached yet without the actual data on steel corrosion of sheet piles. (During the period of our investigation, the lowest tidal level did not occur, so eye observation of the sheet pile surface could not clarify the extent of erosion.)

Applying full uniform loads mentioned above, it has been calculated that the sheet-pile structure could not withstand these loads in terms of allowable strength of steel materials. As such, it can be preliminarily concluded that the existing berths have no surplus in terms of structural capacity. When introducing heavy cranes such as container cranes at the births in future, more detailed and through study and investigation is mandatory. Nevertheless, it can be said now that the current berth usage, which does not entail such critical load condition as discussed above, would not pose any imminent risk to the existing berth stability.
