Form-1 : CUT SLOPE DAMAGE INSPECTION SHEET

Name of Province	BENGUET	
Road NO.	0221	Name of Road	KENNON ROAD	
Spot NO.	02	Location of Spot	24.00	
Classification of Road		<input checked="" type="checkbox"/> National Road	<input type="checkbox"/> Provincial Road	
NO. of Lanes & Roadway Width		(1) 1-Lane <input checked="" type="checkbox"/> 2-Lane (3) -Lane	Total Width: 7.10	
Surface Type & Pavement Width		(1) PCC <input checked="" type="checkbox"/> AC (3) Gravel (4) Earth	Pave. Width: 6.10	
Terrain		(1) Flat (2) Rolling	<input checked="" type="checkbox"/> Mountainous	
Evidence of Failure	1	Type of Slope	<input checked="" type="checkbox"/> Cut Slope (2) Natural Slope (3) ()	
	2	Kind of Failure	(1) Gully (2) Erosion (3) Land Slide <input checked="" type="checkbox"/> Rock/Debris Fall	
	3	Size of Failure	(1) Width: 300.0 m (2) Height: 8-20.0m (3) Number: 3	
	4	Date Occured	AUGUST / / 1992	
	5	Traffic Interruption	Magnitude	<input checked="" type="checkbox"/> Full Width (2) Half Width (3) Shoulder (4) No Influence

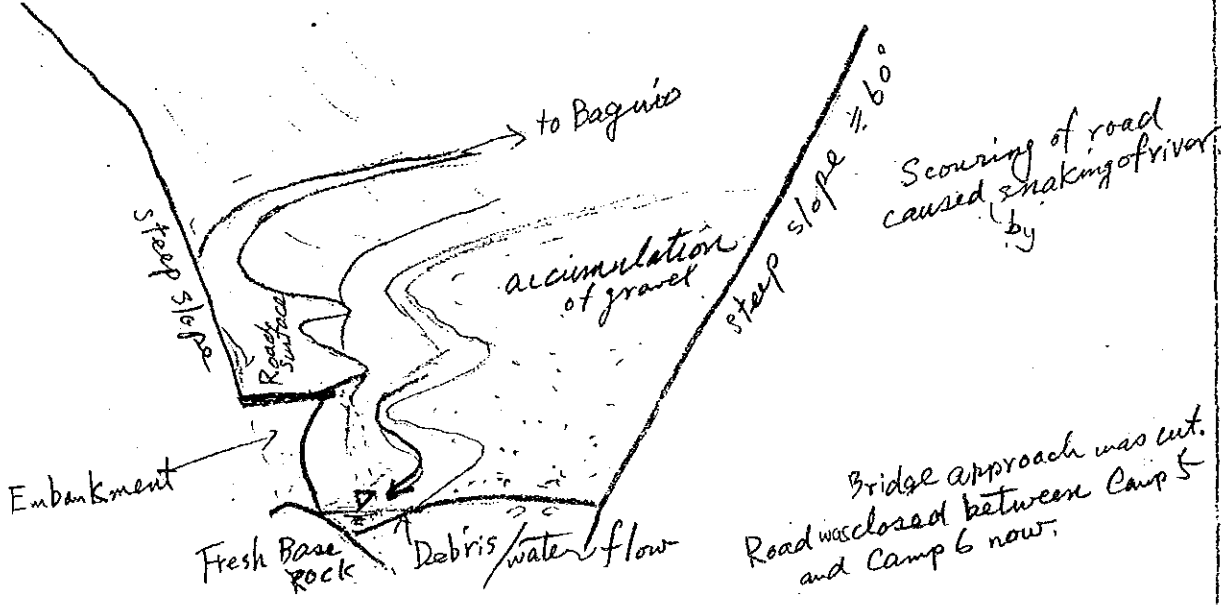
Sketch

5	Length of Damage	500.00 m		
	6	Date Occured	AUGUST / / 1992		
	7	Traffic Interruption	Magnitude	<input checked="" type="checkbox"/> Full Width (2) Half Width (3) Shoulder (4) No Influence	
			Duration	(1) 1 day < (2) 1~7 days <input checked="" type="checkbox"/> 7 days >	
8	Countermeasure	GROUTED RIPRAP (no more)			
Existing Drainage Condition	9	Drainage Facilities	(1) Existing <input checked="" type="checkbox"/> Nothing		
	10	Drainage Condition	NO INFLUENCE		
Engineering Judgement	11	Impact to Traffic	(1) Low (2) Medium <input checked="" type="checkbox"/> High		
	12	Cause of Damage	(1) Concentration of Surface Water <input checked="" type="checkbox"/> Snaking of River <input checked="" type="checkbox"/> Deposit of Riverbed (4) Flood (5) ()		
Judgement	13	Countermeasure	CONCRETE WALL		
	14	Detour Road	<input checked="" type="checkbox"/> None (2) Available

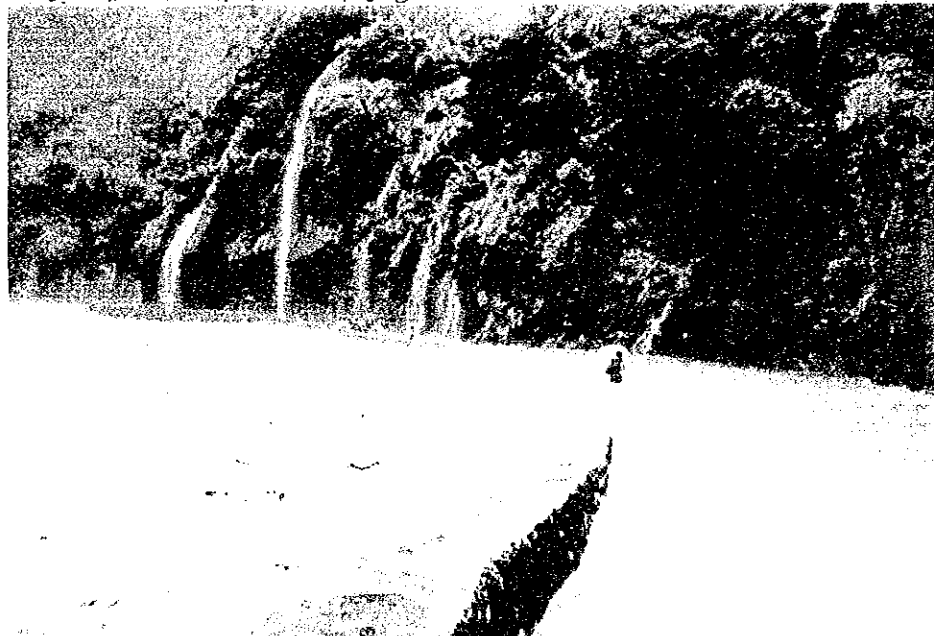
Sketch TO BE UPGRADED PORTION = 100.0 m

Evidence of Damage	4	Type of Damage	<input checked="" type="checkbox"/> Flooding Roadbed <input type="checkbox"/> (2) Deposit on Surface <input type="checkbox"/> (3) Scouring (4) Ground Subsidence <input type="checkbox"/> (5) (RIVER OVERFLOW)	
	5	Length of Damage	30.0 m HEIGHT = 1.0m	
	6	Date Occured	SEPT / 04 / 1992	
	7	Traffic Interruption	Magnitude	<input checked="" type="checkbox"/> Full Width <input type="checkbox"/> (2) Half Width <input type="checkbox"/> (3) Shoulder <input type="checkbox"/> (4) No Influence
			Duration	(1) 1 day < <input checked="" type="checkbox"/> 1~7 days <input type="checkbox"/> (3) 7 days >
8	Countermeasure	LOW RETAINING WALL		
Existing Drainage Condition	9	Drainage Facilities	(1) Existing <input type="checkbox"/> <input checked="" type="checkbox"/> (2) Nothing	
	10	Drainage Condition		
Engineering	11	Impact to Traffic	(1) Low <input type="checkbox"/> (2) Medium <input type="checkbox"/> <input checked="" type="checkbox"/> (3) High

12	Cause of Damage	(1) Concentration of Surface Water <input type="checkbox"/> (2) Snaking of River <input type="checkbox"/> (3) Deposit of Riverbed <input checked="" type="checkbox"/> (4) Flood <input type="checkbox"/> (5) (OVERFLOW)	
Judgement	13	Countermeasure	UPGRADE 2.0m HIGHER THAN THE ROAD & RETAINING WALL	
	14	Detour Road	<input checked="" type="checkbox"/> (1) None <input type="checkbox"/> (2) Available

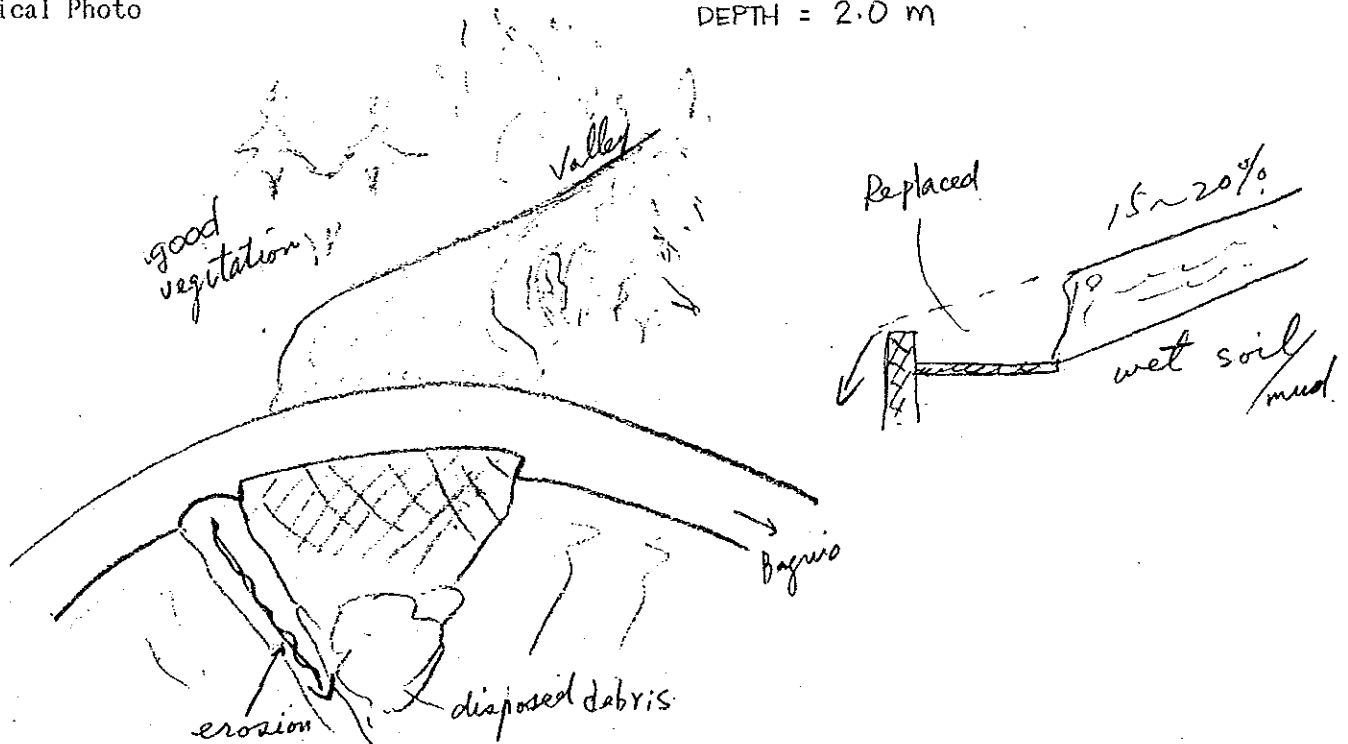
Typical Photo

Engineering Judgement	9	Impact to Traffic	(1) Low (2) Medium (3) High
	10	Cause of Damage	WATER CONCENTRATION / SOFT SOIL
	11	Countermeasure	IMPROVE DRAINAGE / WELL PIPE HORIZONTAL
	12	Detour Road	(1) None (2) Available

DEPTH = 2.0 m
