Preliminary Report

**Flores Island, Indonesia Earthquake
of December 12, 1992**

- Preliminary Investigation and Recommendations -

Japanese Expert Team

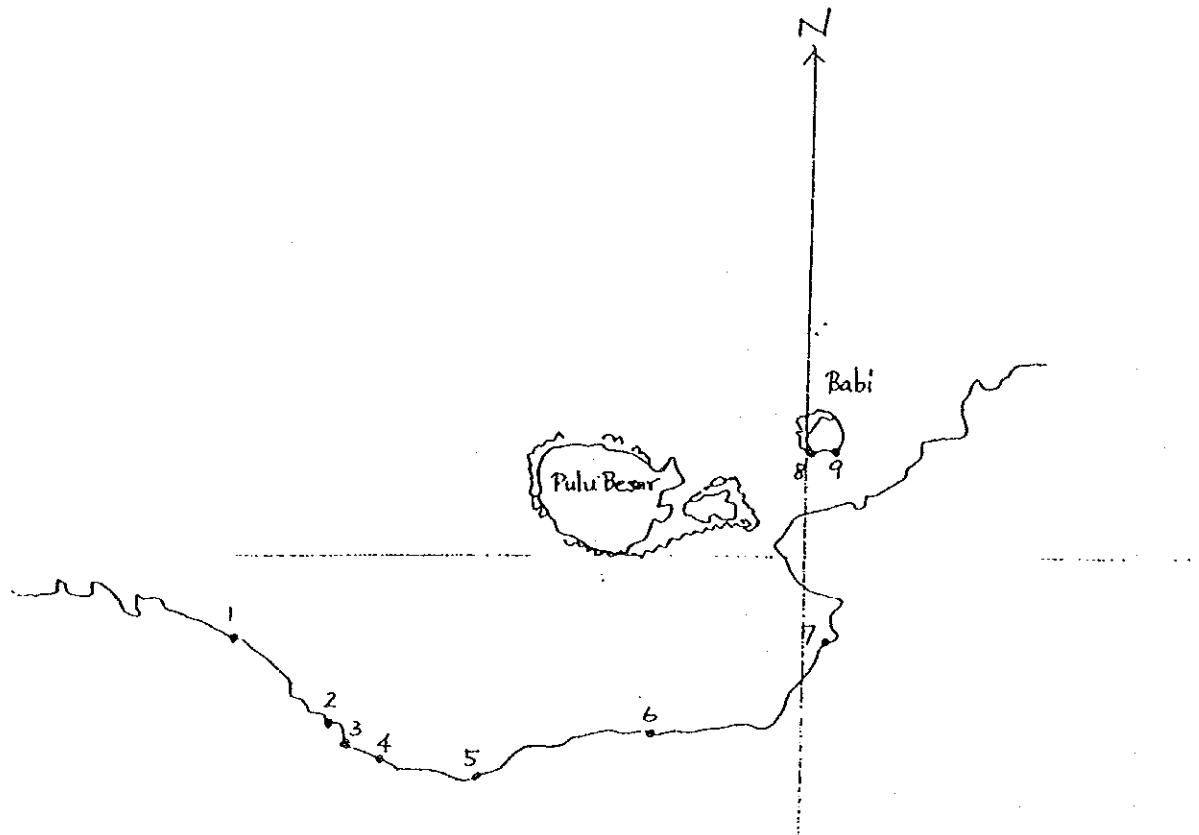
Figure 3-1 Location map and tsunami inundation height.

Field observation on tsunami inundation height was carried out between Dec.23 and Dec.25 along the coastline of Flores Island as well as the Babi Island. The inundation height was measured by a staff and a handlevel. Since the reference level of the ground is not known, vertical height of the inundation was measured with reference to the sea level at the measuring time. Therefore, measured inundation height is the relative value at the changing sea level condition.

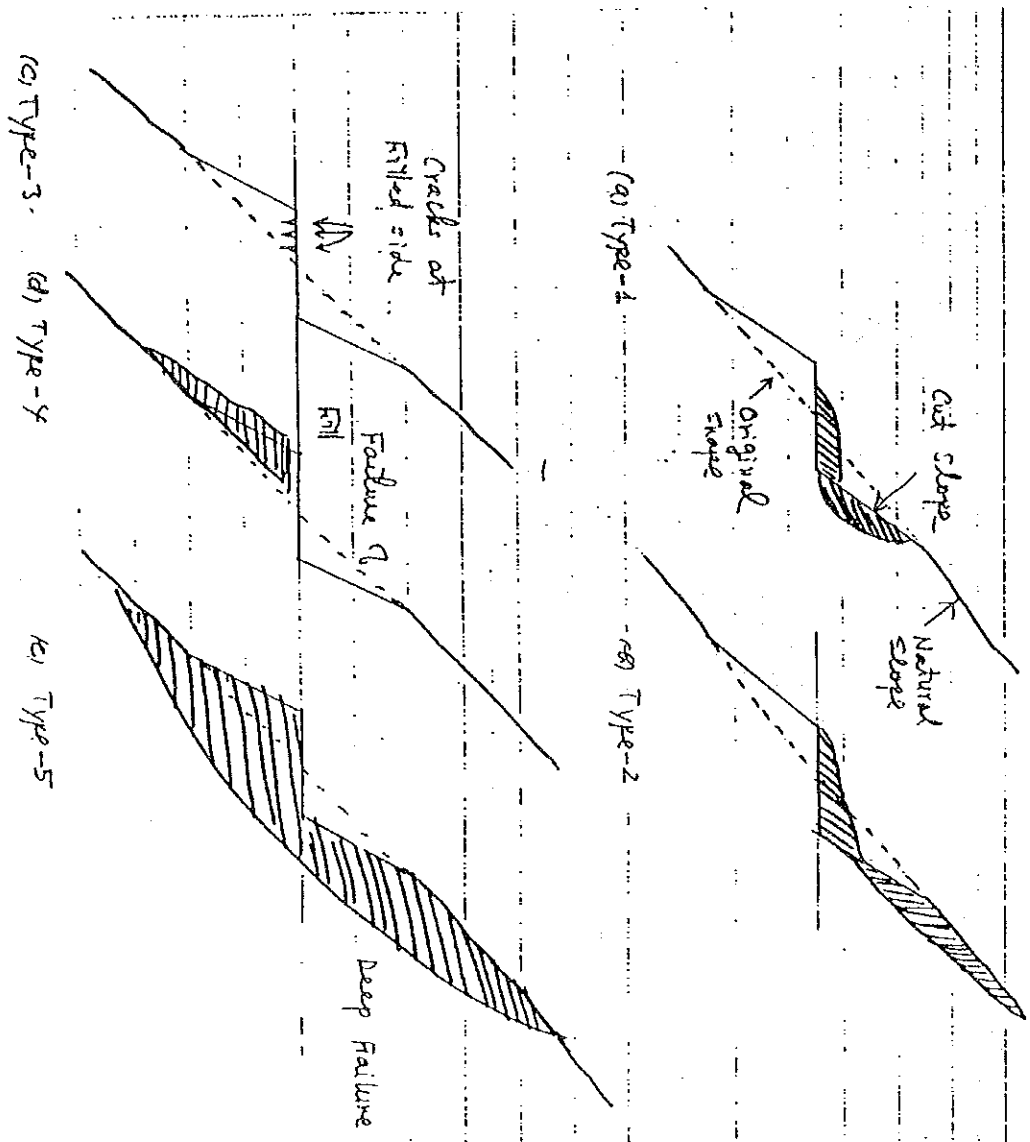
Fig. 5-1 Type of Slope Failure

Fig. 5-1 classifies the type of failures inspected. Four types of failure were observed. The Type 1 Failure in which the cut slope slid on to the road could be seen most frequently. The Type 2 Failure in which not only the cut slope but the natural slope failed were also widely observed. At the site where one side was cut and the other side was embanked, the pavement of the filled embankment side often settled and this caused cracks on the pavement (Type 3 and Type 4). The Type 5 Failure in which the slopes both on and under the road slid was also observed.

The damage became significant because the soils are of soft and wet clayey materials (volcanic ash). Scoria was observed at about 2 meter below the surface at a couple of sites. At those sites, the failure was induced at the scoria layer. Therefore, attention needs to be paid to survey the distribution of the scoria.

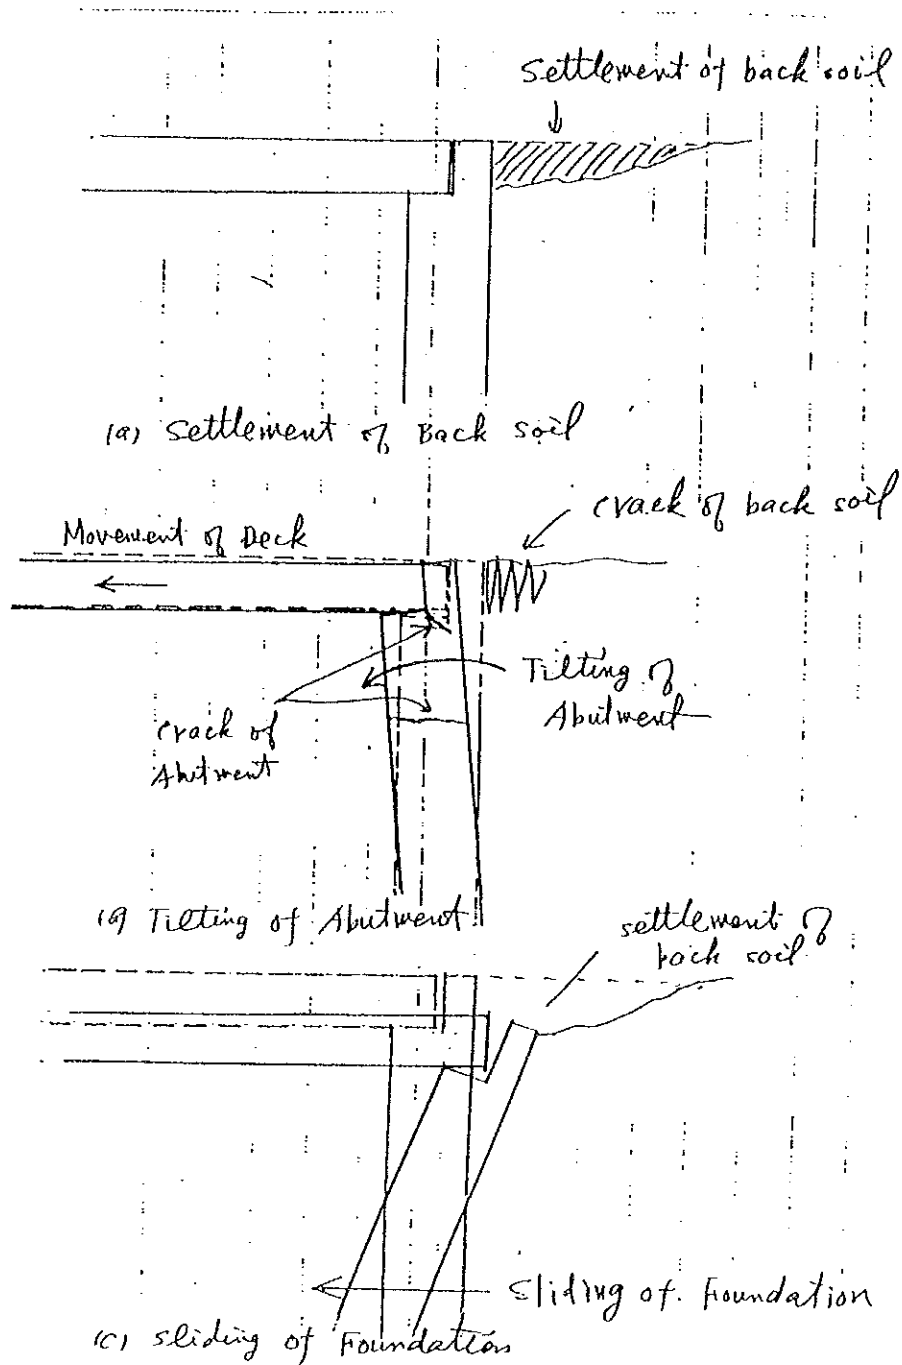
Fig. 5-2 Typical Damage of Abutment

Fig. 5-2 shows the typical damage of the bridge on this route. The most common type of failure was the settlement of back soils. However, this type of damage is nothing to do with the failure of the bridges, and can be easily repaired. The second type (Type 3) of the damage was developed due to tilting of the abutment in the deck side. Contact of the abutments with the deck caused cracks at the abutment, because the deck resisted as the lateral beam between the two abutments. Some of them were therefore extensively damaged and require full restoration. The third type (Type 3) of damage was the sliding of foundation to the deck side resulting the tilting of the abutment in the back fill side. A large settlement of the girder was also observed. This is the critical damage because the tilting of the abutment in this direction tends to result falling down of the girder. Therefore full restoration is advised to be made promptly for this type of failure.

- 1) It is recommended to carefully inspect the substructures of bridges with the major attention to the damage of substructures in Flores Island. For those bridges which suffered damage to the abutments in such a manner that the foundations slid to the deck side direction with the top of the abutment being tilted to the back fill side, it is recommended to fully replace the abutment as soon as possible to avoid the possible falling down on the girder. Because those bridges are very old with only one lane, evaluation needs to be made whether

they should be repaired or replaced with new structures.

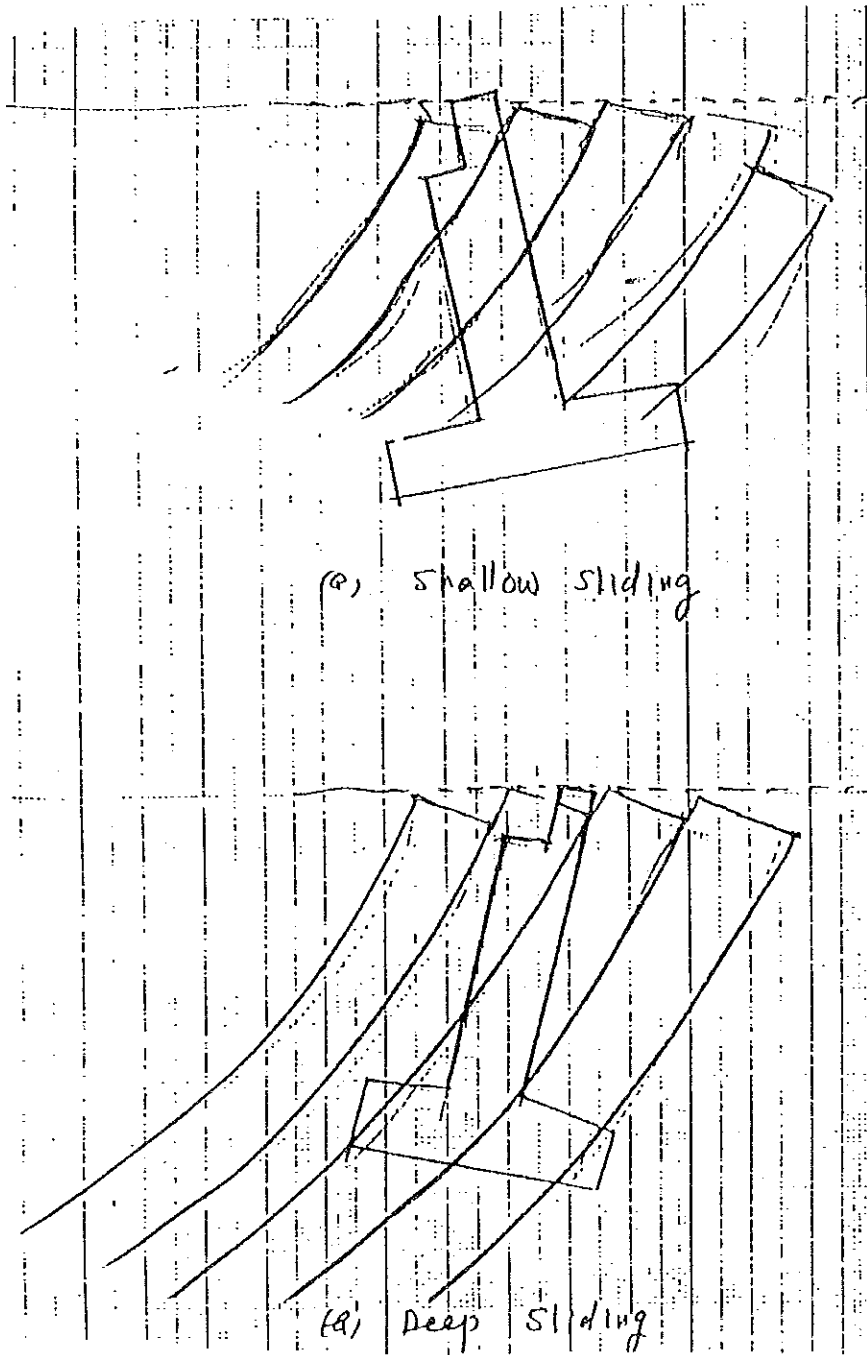
Fig. 5-3 Effect of soil sliding on
Damage of Abutment

It should be noted that such tilting and sliding of the abutment was mostly caused by sliding of surrounding soils as shown in Fig. 5-3. The difference of the Type 2 and Type 3 damage was attributed to the difference of depth of soil sliding. When only shallow soils slid, the abutments tend to tilt in the deck side, while when the sliding occurred deeply, the abutments tilted in back soil side. It is important to know that this is the damage caused by not vibration of the deck and abutment but the soil instability due to the earthquake. Therefore it is important to properly consider such instability of surrounding subsoils into

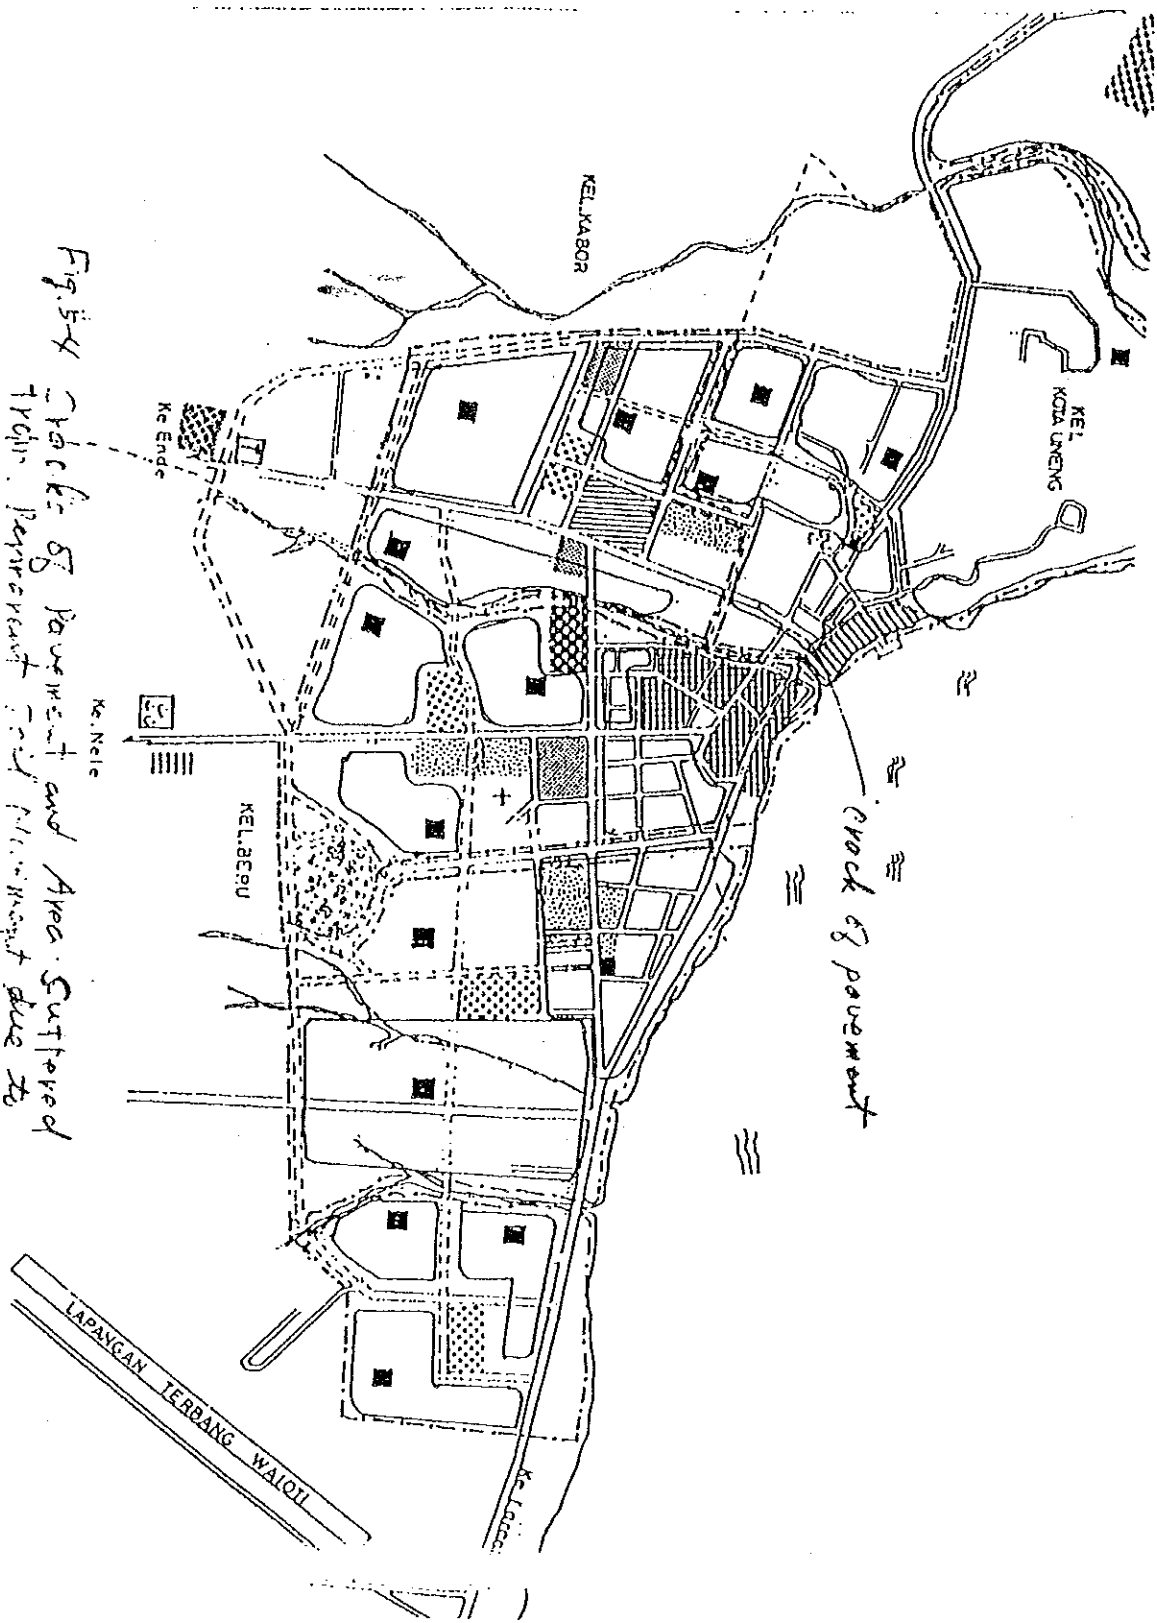
Fig. 54 Cracks of Pavement and Area Suffered
 from Repairment and Alignment due to
 soil liquefaction

Special interest was the cracks of pavement observed near Maumere Port. As shown in Fig. 5-4, the cracks were developed along the road parallel to the coast. Although there were several lines, they were essentially continuous. This clearly shows that a large sliding of top soils as well as the settlement as shown in Fig. 5-4 was developed along the coast.

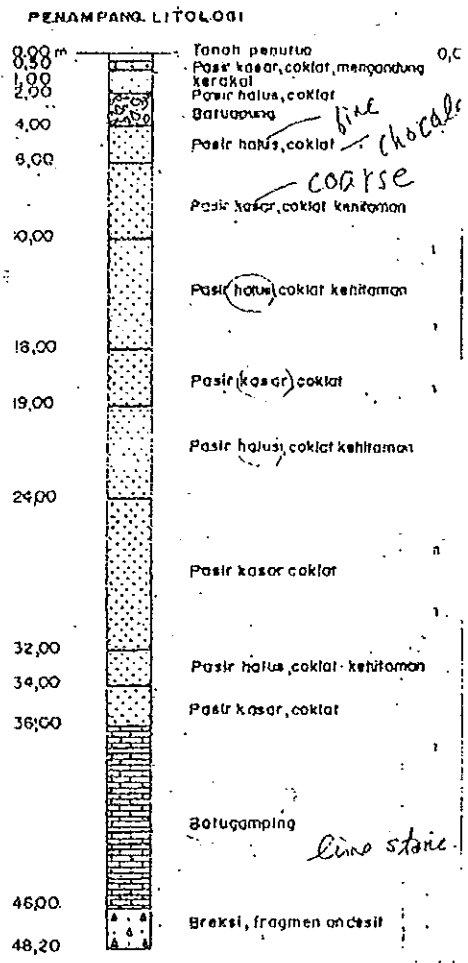
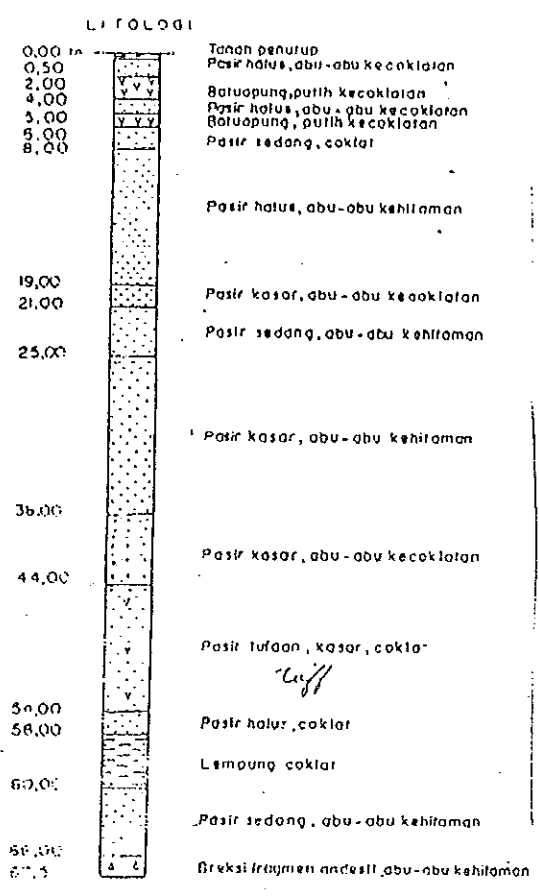
Fig. 5-6 Soil Profile at Maumere

Fig. 5-6 shows the soil profile at two sites near Maumere. The point 1 is located south west of Maumere and is about 1.5 km apart from the coast while the point 2 is located south east of Maumere and 1.8 km apart from the coast. The ground condition is similar at the two sites, and is of sandy soils with the thickness of about 30 m - 50 m overlaid by the top soil with the thickness of about 5 m. Although grain size curve needs to be precisely investigated, the sand obtained from the sand valves has the predominant grain size of 0.1 to 0.3 mm. Because water table is very high, it is considered that the sand near Maumere is quite vulnerable to liquefaction.
