REPORT OF JAPAN DISASTER RELIEF TEAM
(EXPERT TEAM)
ON THE EARTHQUAKE
IN
ARAB REPUBLIC OF EGYPT
OF
OCTOBER 12, 1992

MARCH, 1993

JAPAN INTERNATIONAL COOPERATION AGENCY
(JICA)

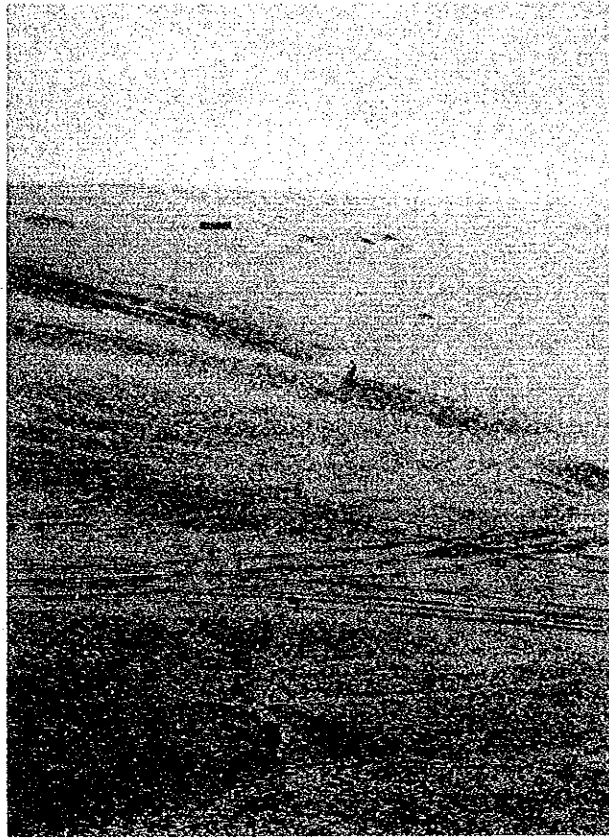
Some fresh ground cracks have been observed in the epicentral region by the scientists of the NRIAG and the EGSMA. These cracks show non-systematic orientation and no systematic displacement (Photo 3.4.1 and 3.4.2). Judging from these characteristics and field observations, these cracks may not be directly related to the fault which caused the October 12 earthquake. However, detailed geological and geophysical survey of the epicentral region is necessary for a better understanding of the October 12 earthquake and seismotectonics of the region.

Photo 3.4.1 Ground Cracks at Dahshur
No systematic trend observed

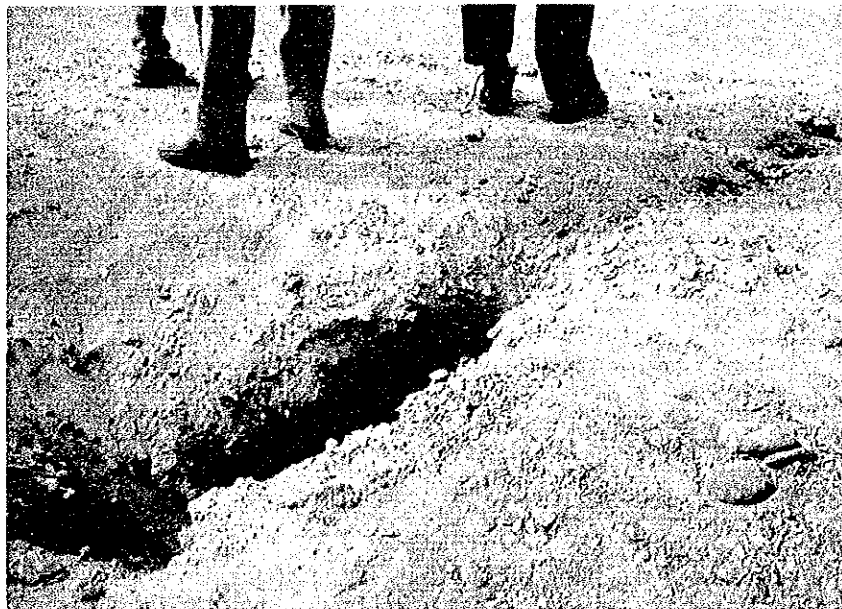
Photo 3.4.2 Ground Cracks at Dahshur
No displacement observed

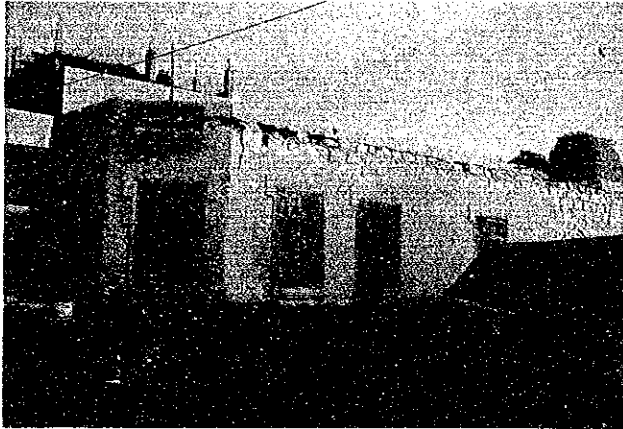
Photo 3.10.1 Damaged school (El Aiyat)

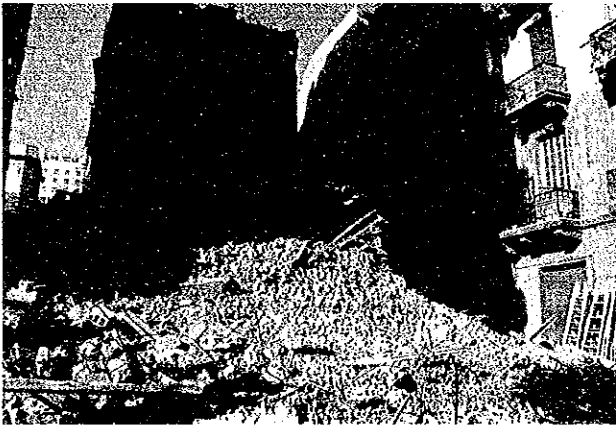
Many of these old, 3 to 5-story masonry buildings are concentrated in Old Cairo. These buildings are mainly used as residential buildings, the materials were extremely deteriorated and the level of damage is significant (see Photos 3.11.3 through 3.11.5).

Photo 3.11.3 5-story non-reinforced masonry residential building crushed to mud (building seen in the rear is the same type building)

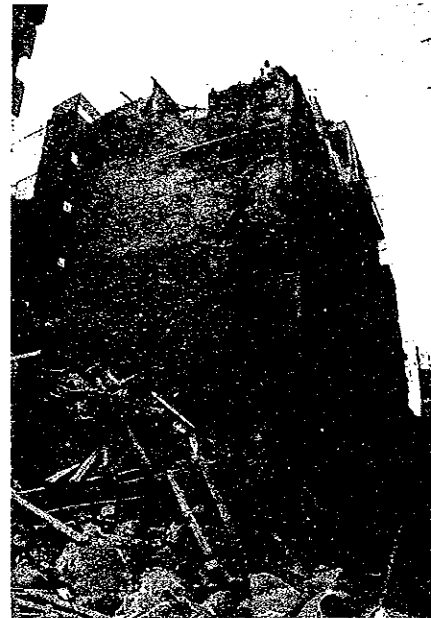
Photo 3.11.4 Closed up of the building in the rear side in Photo 3.11.3 (materials have deteriorated significantly and the building is ready to collapse at any time)

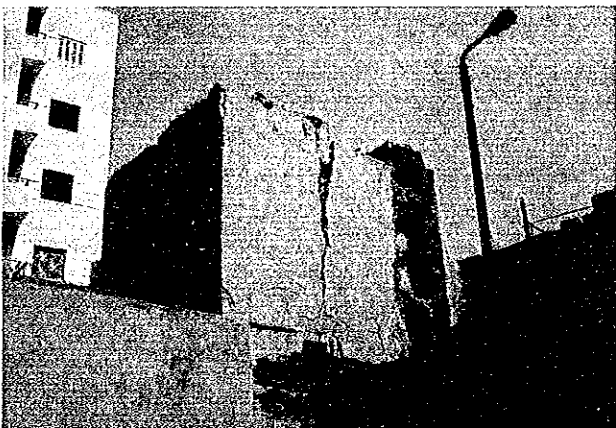
Photo 3.11.5 Non-reinforced masonry building (walls fell off out-of-plane)

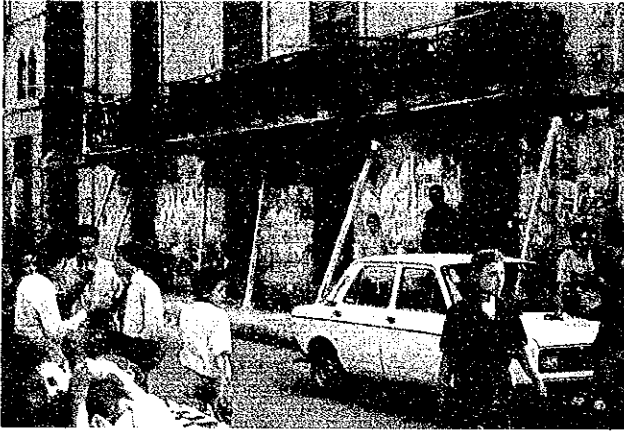
Photo 3.11.6 Temporary retrofit masonry buildings by wood supports

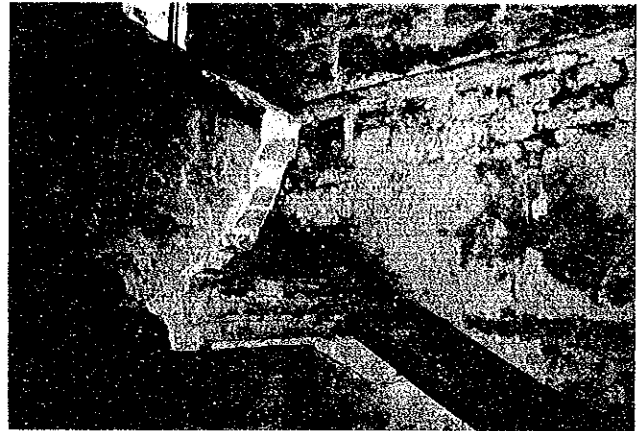
Photo 3.11.7 Damaged interior stone stairways of non-reinforced masonry building (1/2)

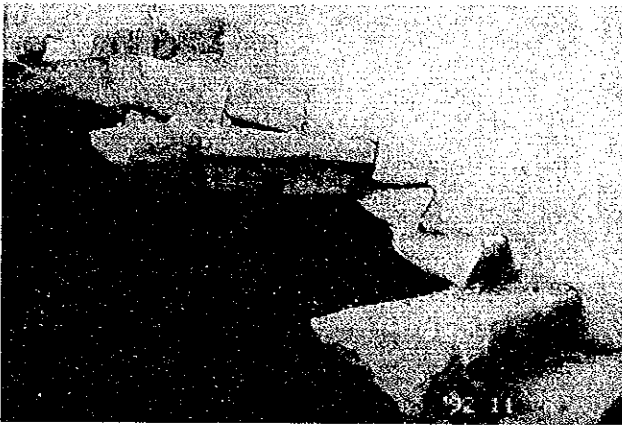
Photo 3.11.8 Damaged interior stone stairways of non-reinforced masonry building (2/2)

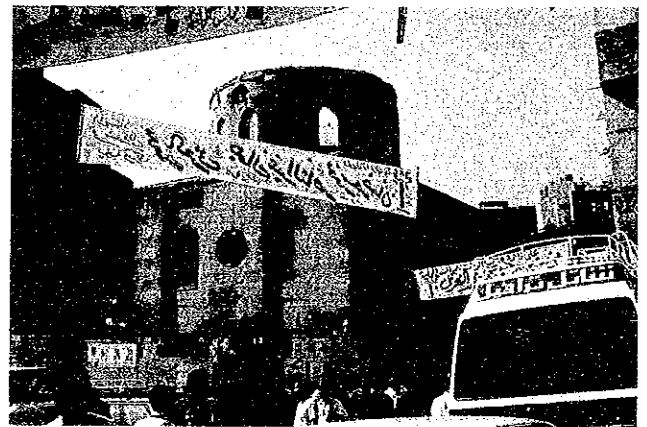
Photo 3.11.9 Old stone masonry mosque with its dome collapsed

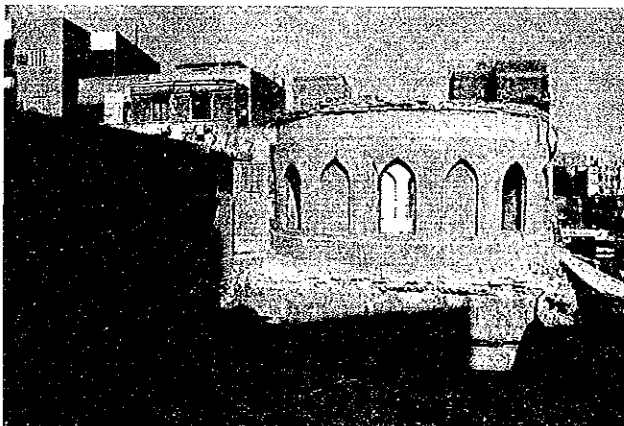
Photo 3.11.10 Structure of the mosque exposed after the dome collapsed and roof destroyed by dome

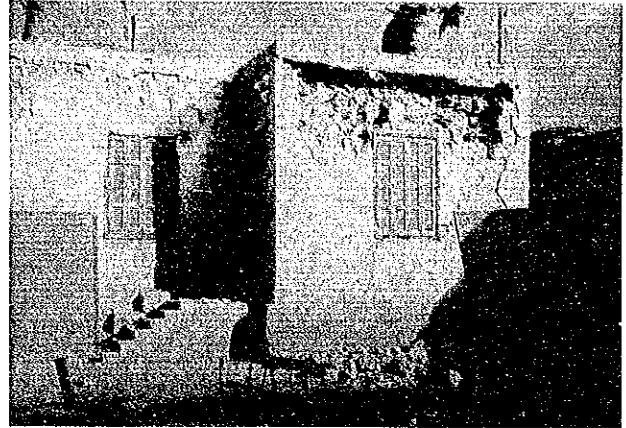
Photo 3.11.13 Damaged stone masonry school building

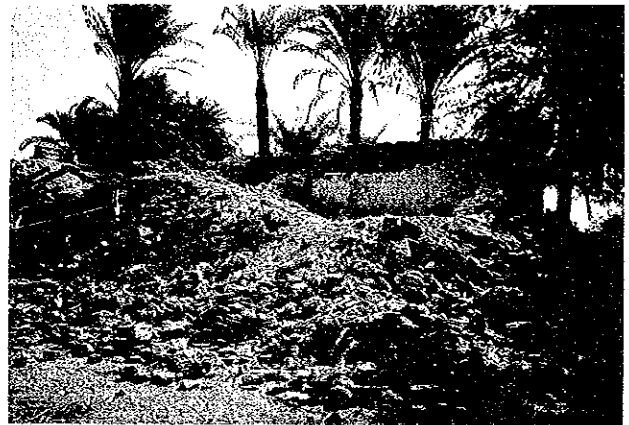
Photo 3.11.14 Totally collapsed stone masonry building

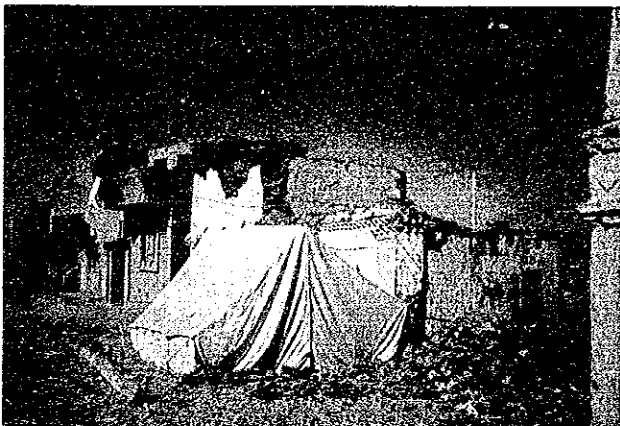
The reason the rural areas were severely damaged is mainly because the areas were close to the focus and heavily subjected to direct shocks of high intensity. In addition, the adobe structure and thick mud roofs further accelerated the damage.

Photo 3.11.15 Collapsed adobe building and the relief tent (Second story which supported roof is badly damaged in most cases)

Therefore, new structures should be constructed of materials other than adobe.

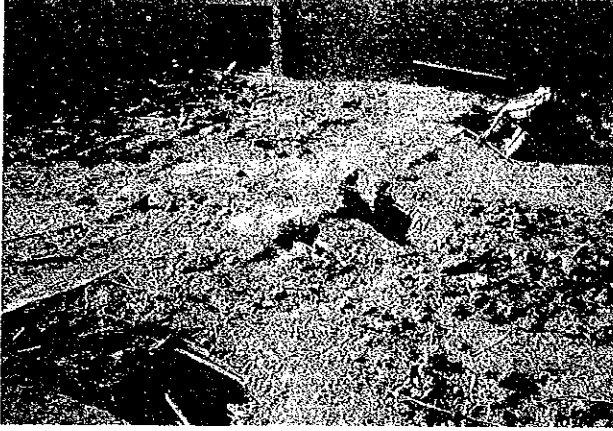
Photo 3.11.17 Roof collapsed almost

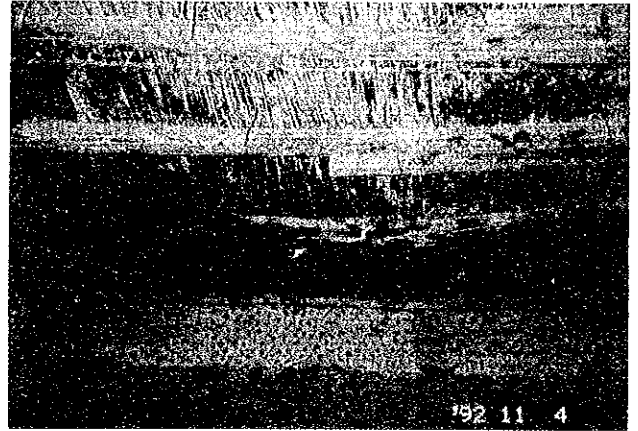
Photo 3.11.18 Cross beams are bent at the center due to vertical loads and about to fall down

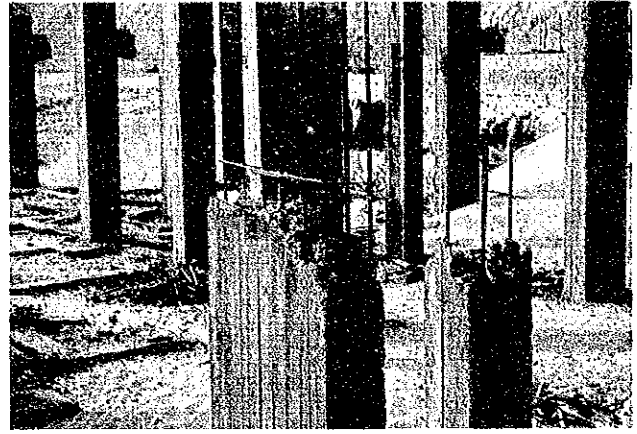
Photo 3.11.23 Poor construction joint in the column

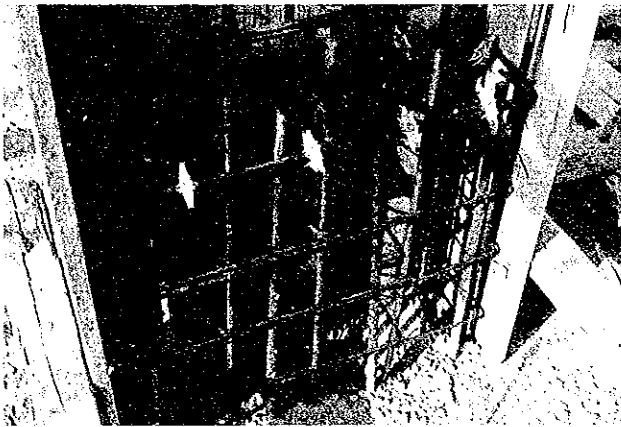
Photo 3.11.24 Reinforcement for the bottom of column (lapping splices without hook)

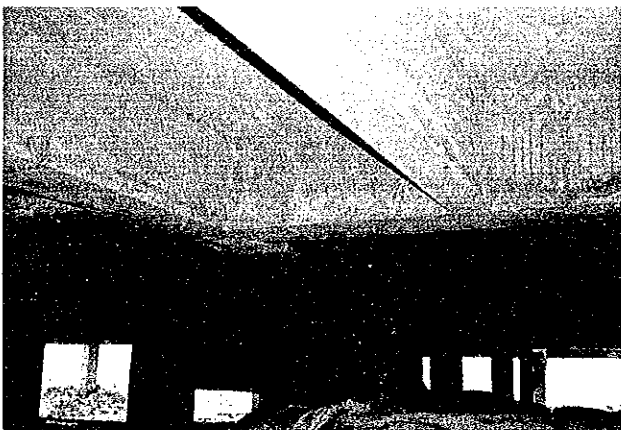
Photo 3.11.26 Girders and beams of residential building (columns are laid out offset)

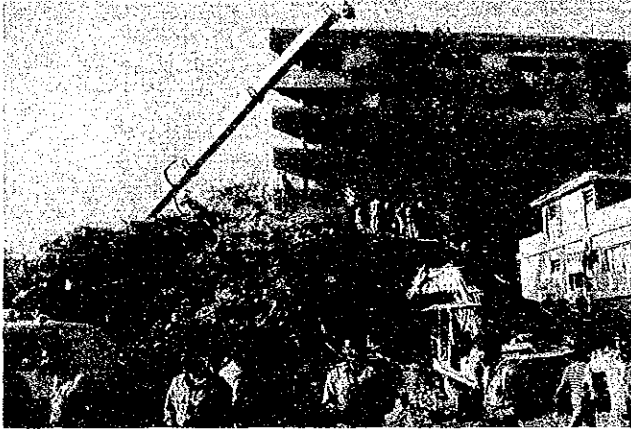
Photo 3.11.28 14-story residential building after collapsed (contributed by Mr. Furuichi, Kajima Corporation)

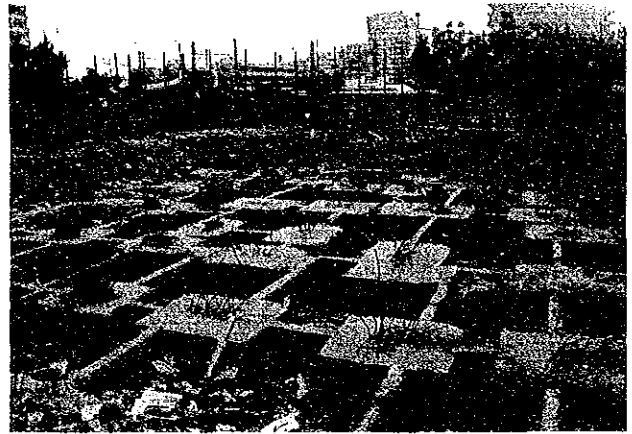
Photo 3.11.29 Foundations of 14-story residential building collapsed in Heliopolis

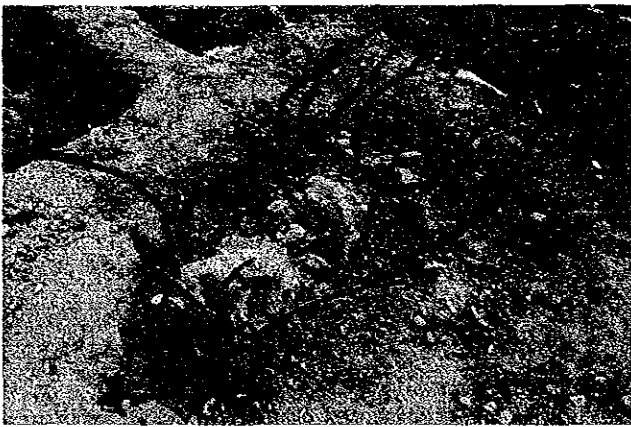
Photo 3.11.30 Damaged column and its reinforcement of 14-story residential building collapsed in Heliopolis (cross sectional dimension: approx. 130cm×30cm)

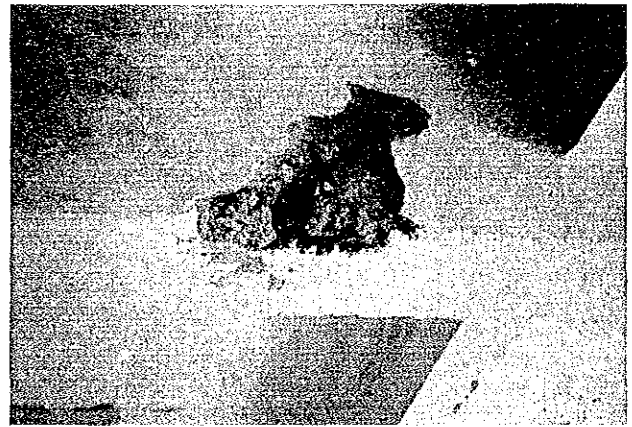
Photo 3.11.31 Concrete cover spalled and main re-bars exposed in beam (the splice of main bar is exposed and cover concrete around the hook dropped off.)

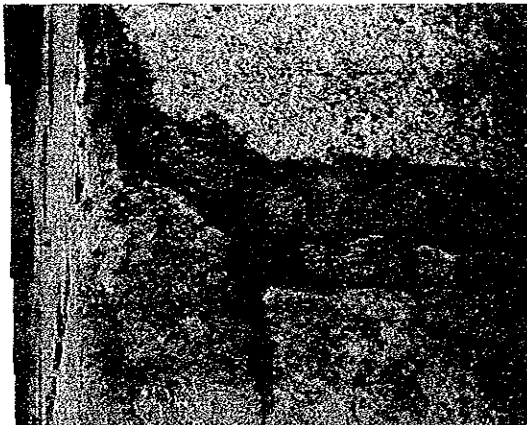
Photo 3.11.32 Shear failure occurred in the beam-column joint (this damage had occurred prior to the earthquake.)

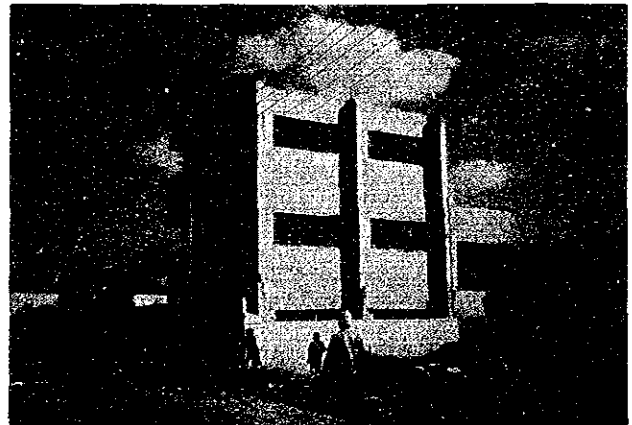
Photo 3.11.33 School building damaged by the collisions of buildings (1/2) (wide crack observed at expansion joint)

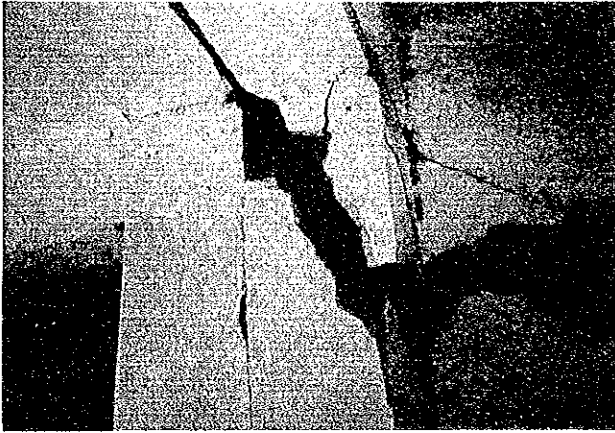
Photo 3.11.34 Shear failure of column facing expansion joint (lateral re-bars cannot be seen)

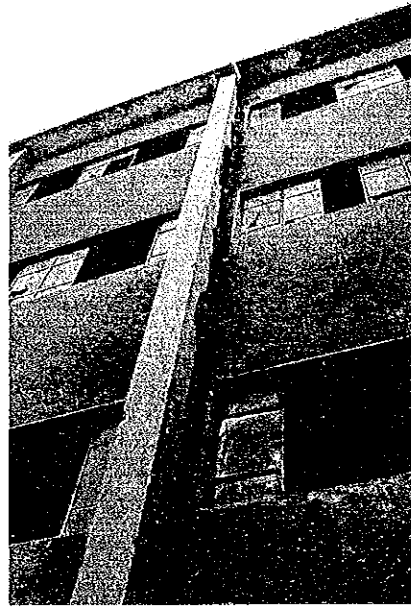
Photo 3.11.35 School building damaged by the collision of buildings (2/2)

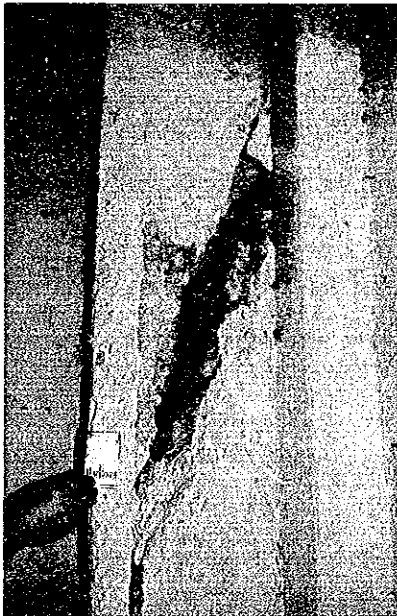
Photo 3.11.36 Shear failure occurred in column of the above building

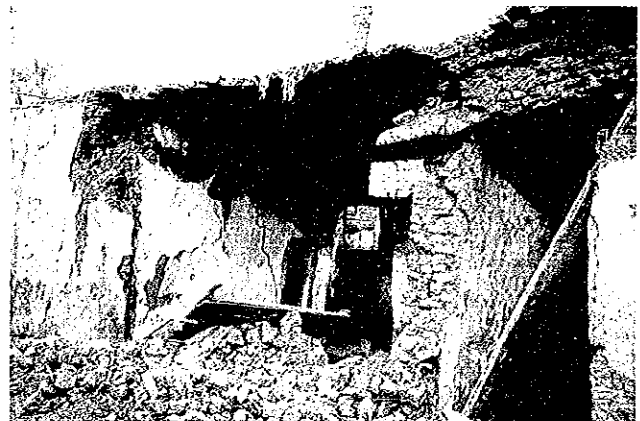
Photo 3.11.37 Damaged house in rural area (El Aiya)

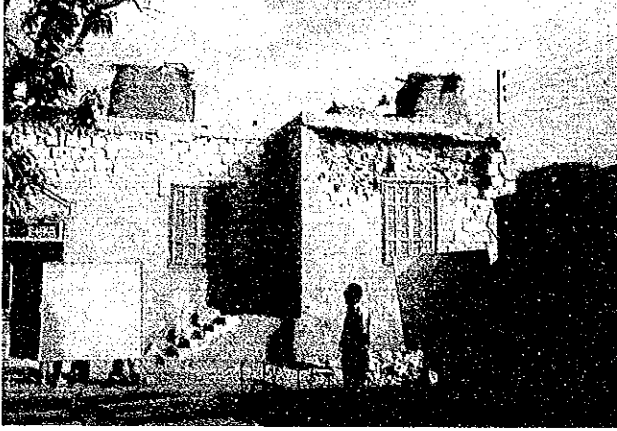
Photo 3.11.38 Damaged stone masonry elementary school building in Berwash
