**BASIC DESIGN STUDY REPORT
ON
THE PROJECT FOR REHABILITATION
OF
NATIONAL ROAD ROUTE 6A
IN
CAMBODIA**

APRIL 1993

PACIFIC CONSULTANTS INTERNATIONAL

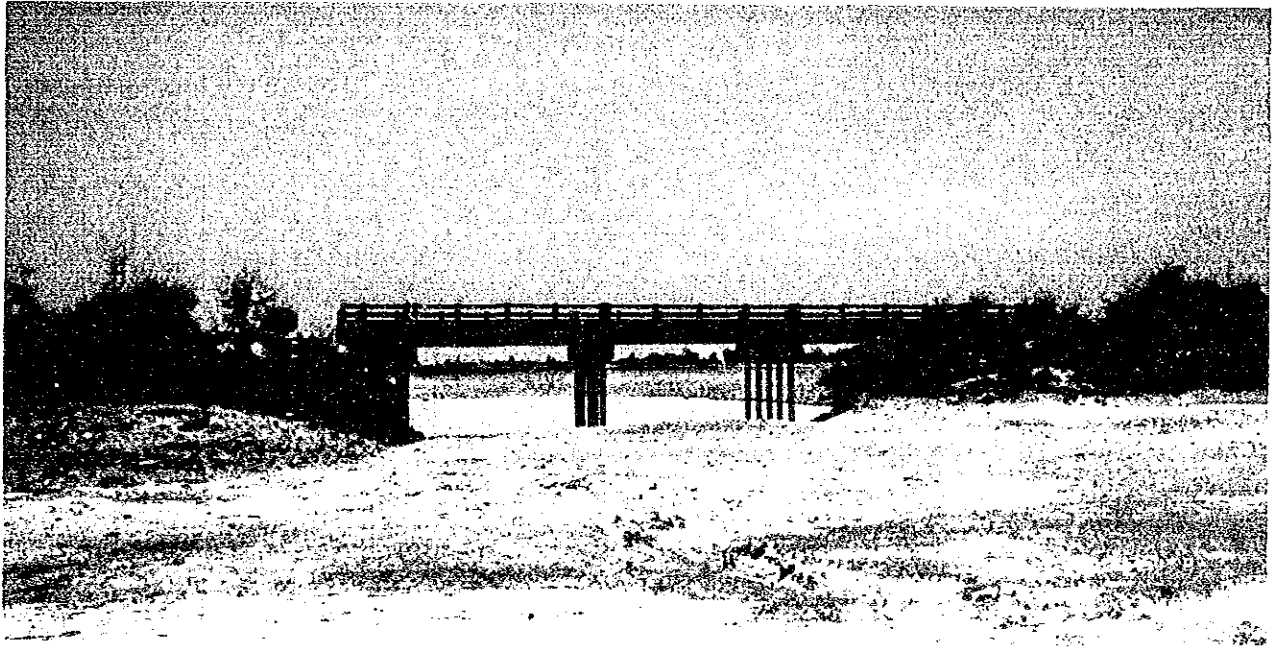
Damage of Bridge Approaches

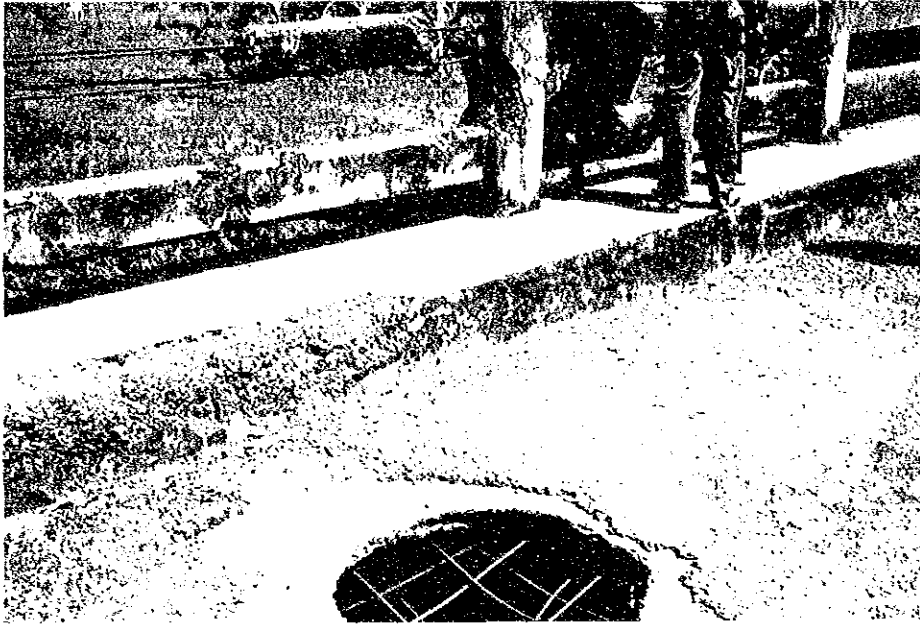
Damage of Bridge Deck and Railing

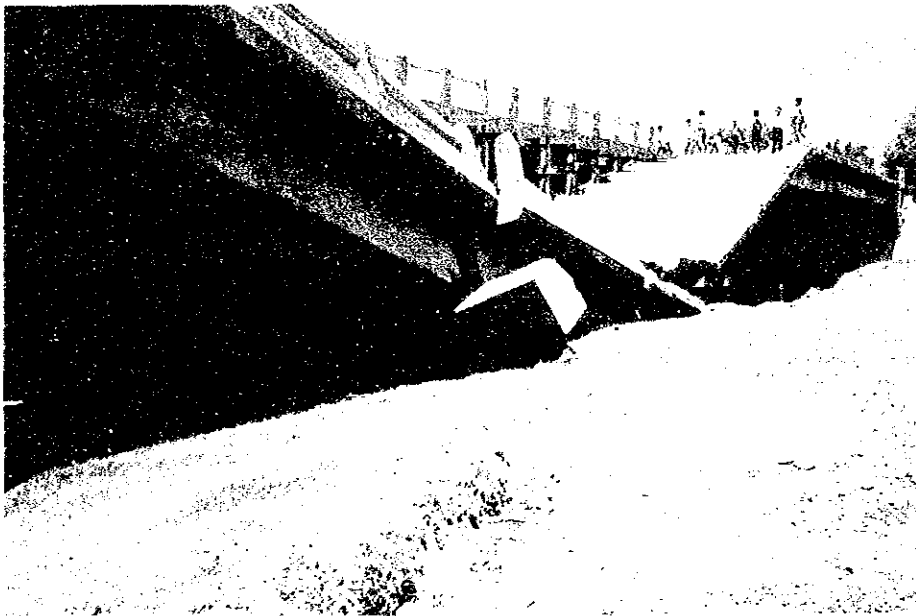
Fallen Bridge Spans

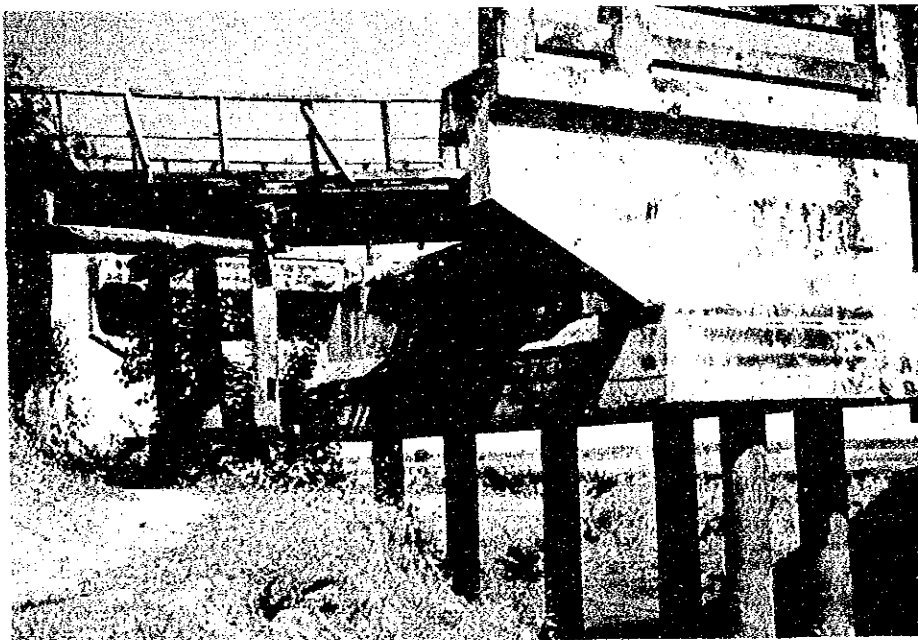
Washed Abutment Rear

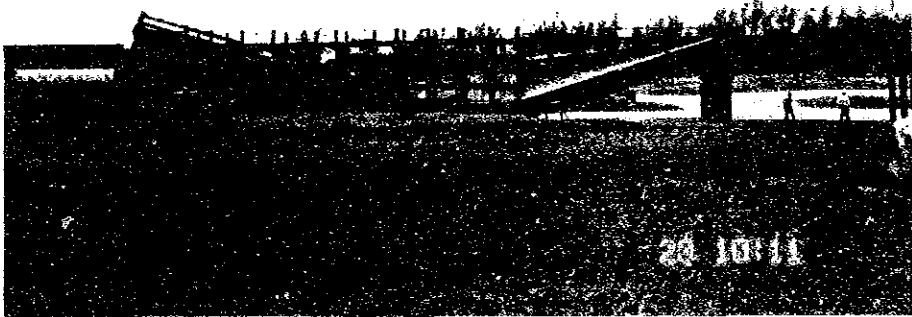
Figure 3.5 Present Status of Damaged Bridges (1)

Pattern 1: Collapse of Superstructure	
Existing Condition	<p>No. 14 Prek Kheng Bridge Three spans of superstructure are collapsed and two piers are destroyed. Wooden bridge is provided for collapsed spans.</p> <p>No. 24 Kompong Prass 1st Bridge One span of superstructure is collapsed and one abutment is destroyed. Wooden bridge is provided for a collapsed span.</p>
Photo

Cause of Damage	Superstructure is collapsed due to the destruction (by blasting) of abutment/pier(s).
Possible Counter-measure	<ol style="list-style-type: none"> 1. Removal of collapsed superstructure and destroyed substructure. 2. Reconstruction/repairing of superstructure and substructure.

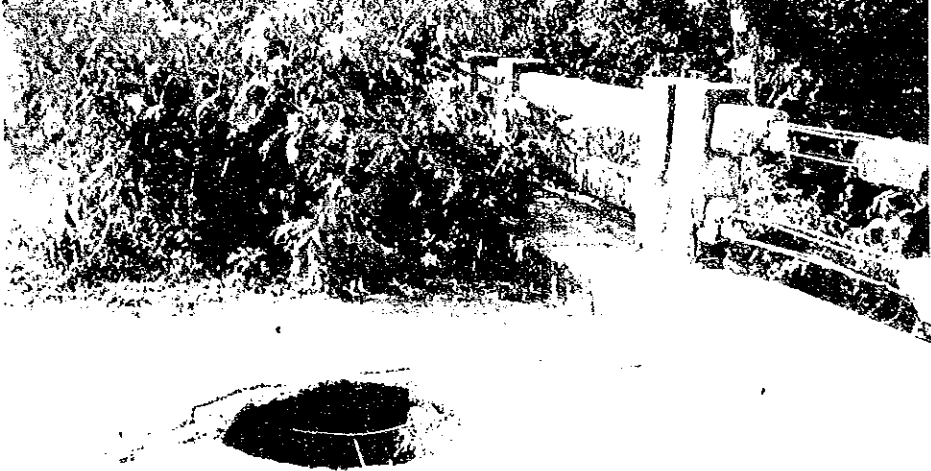
Figure 3.5 Present Status of Damaged Bridges (5)

Pattern 3: Holes/Damages in Deck Slab	
Existing Condition	No. 3 Khtor 2nd – One location No. 4 Prek Ta Sum – One location No. 6 Prek Vangsar – One location No. 8 Prek Suon Choeurn – Two locations No. 25 Kompong Pras 2nd – Three locations
Photo

Cause of Damage	Blasting/rocket bomb
Possible Counter-measure	Restoration by placing reinforcing steel and concrete

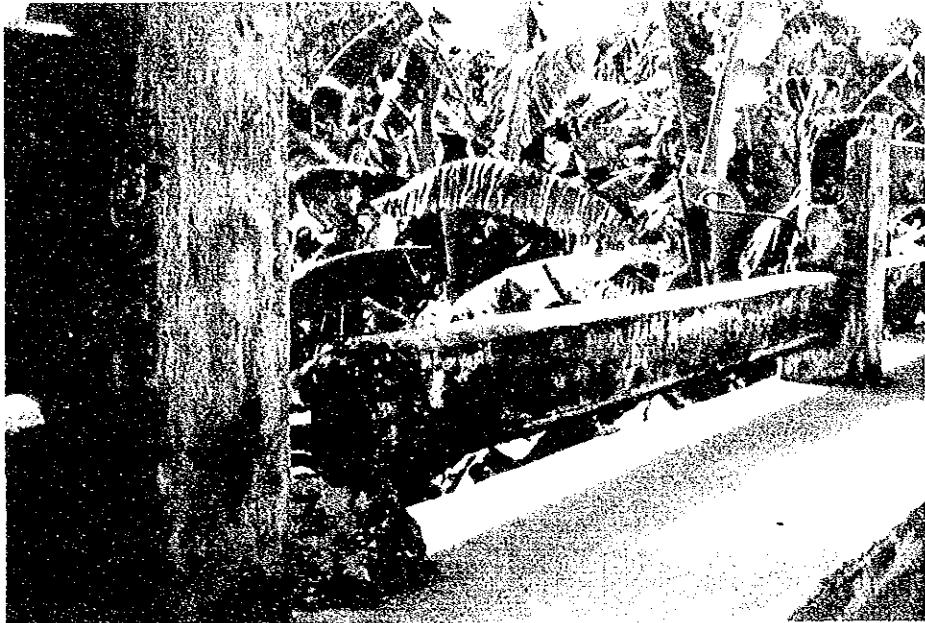
Figure 3.5 Present Status of Damaged Bridges (6)

Pattern 4: Damage of Bridge Railing	
Existing Condition	Fifteen bridges have major or minor damage. All bridge railing have been removed in case of Prek Kheng Bridge (No. 14, 10 spans).
Photo

Cause of Damage	Blasting/rocket bomb/removal
Possible Counter-measure	Restoration by using similar design of existing structure

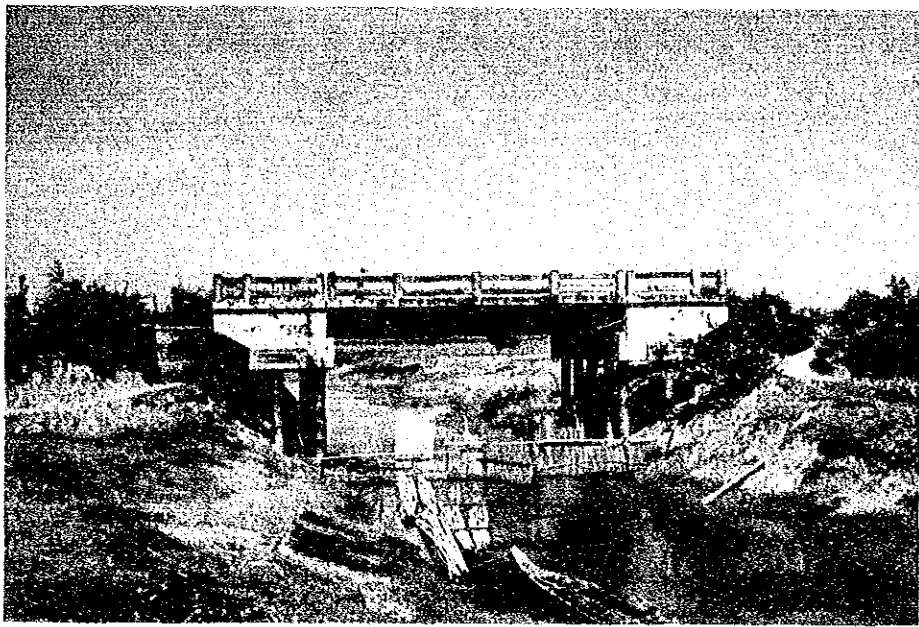
Figure 3.5 Present Status of Damaged Bridges (7)

Pattern 5.(1): Damage of Bridge Approaches (Washed Away)	
Existing Condition	<p>No. 7 Prek Chik Bridge Embankment behind abutment is washed away at both approaches (see photo).</p> <p>No. 26 Kompong Pras 3rd Bridge Embankment behind abutment is washed away at both approaches.</p>
Photo

Cause of Damage	Cause of initial failure is not clear but inundated water is adding damages by the water flow during high water seasons.
Possible Counter-measure	<ol style="list-style-type: none"> 1. Steel sheet piling around existing abutments. 2. Restoration of road embankment. 3. Construction of stone slope protection.

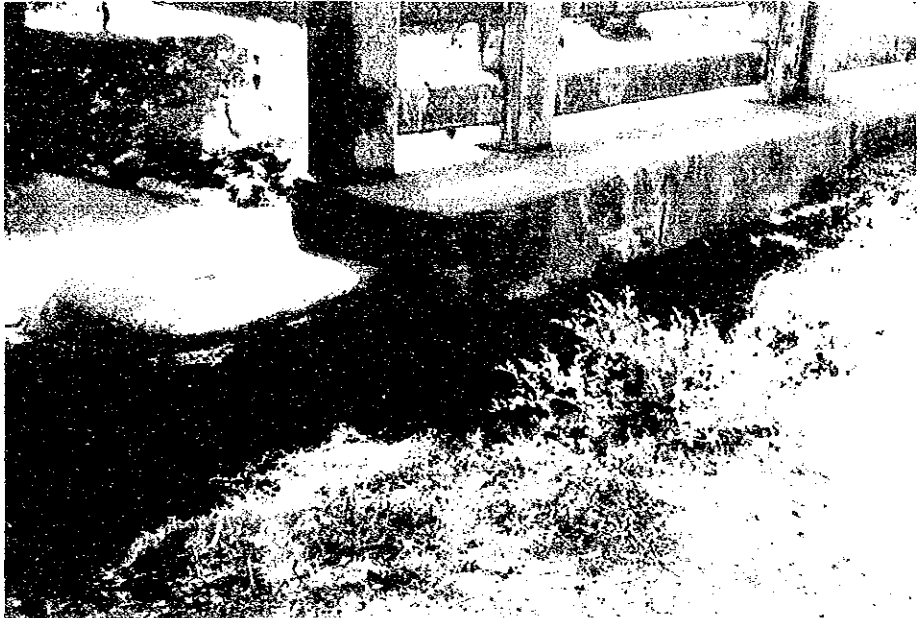
Figure 3.5 Present Status of Damaged Bridges (8)

Pattern 5.(2): Damage of Bridge Approaches (Settlement)	
Existing Condition	Bridge approaches are settled and the surface of road embankment slopes are eroded by water flow without exception.
Photo

Cause of Damage	Settlement of backfills of abutments and loss of materials by seepage/surface water.
Possible Counter-measure	<ol style="list-style-type: none"> 1. Placing and compaction of backfill material. 2. Installation of approach slabs. 3. Construction of stone slope protection.

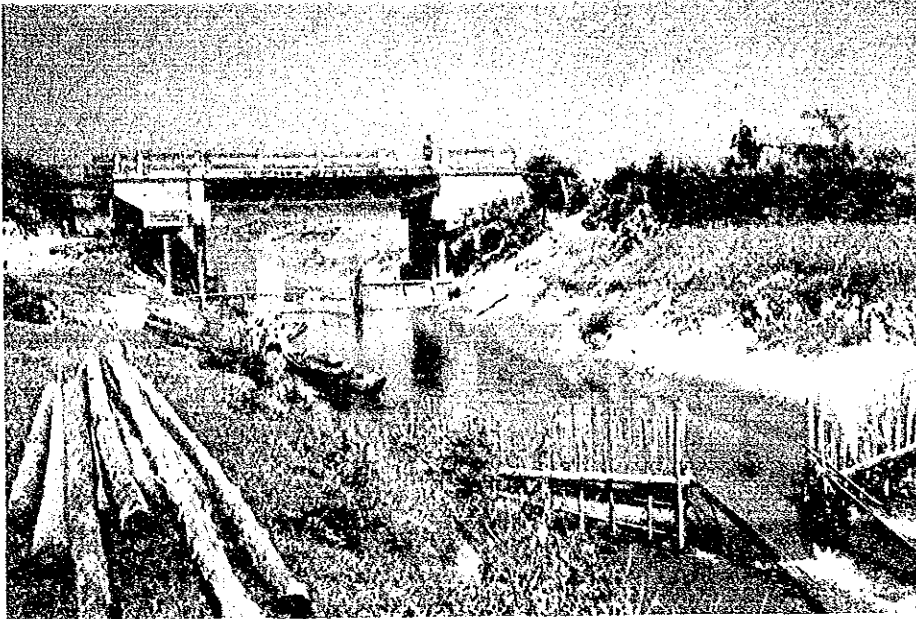
Photo 3.3
Damage of
Bridge
Approaches
(Washed Away)

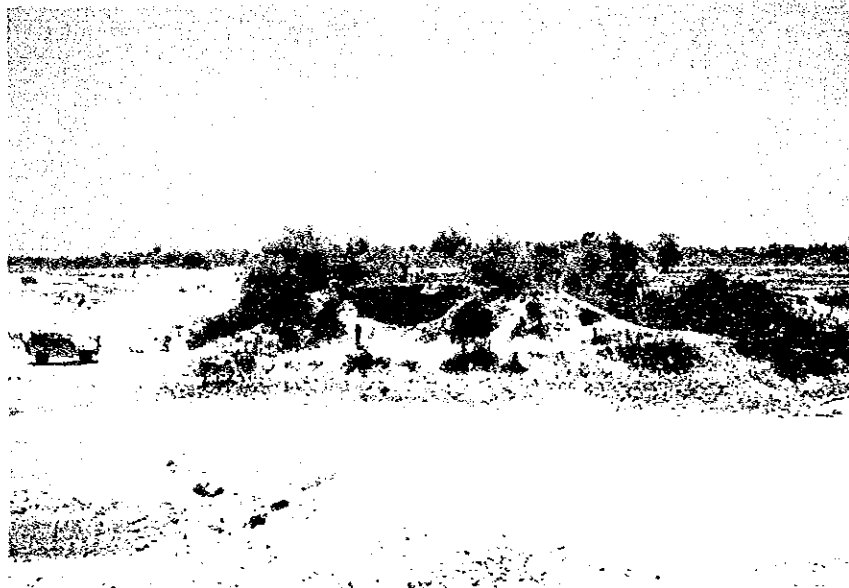
Photo 3.4
Severe
Embankment
Damage
(Washed Away)

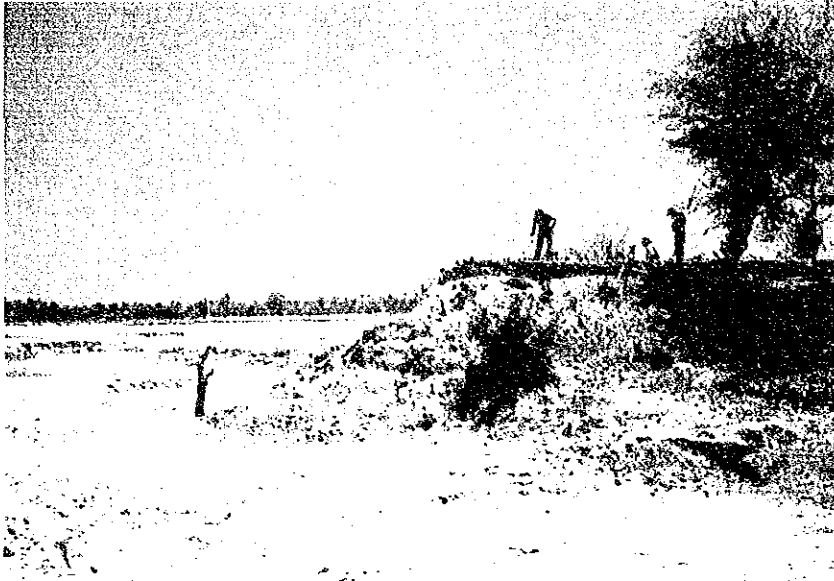
Photo 3.6
**Severe
Embankment
Damage
(Washed Away)**

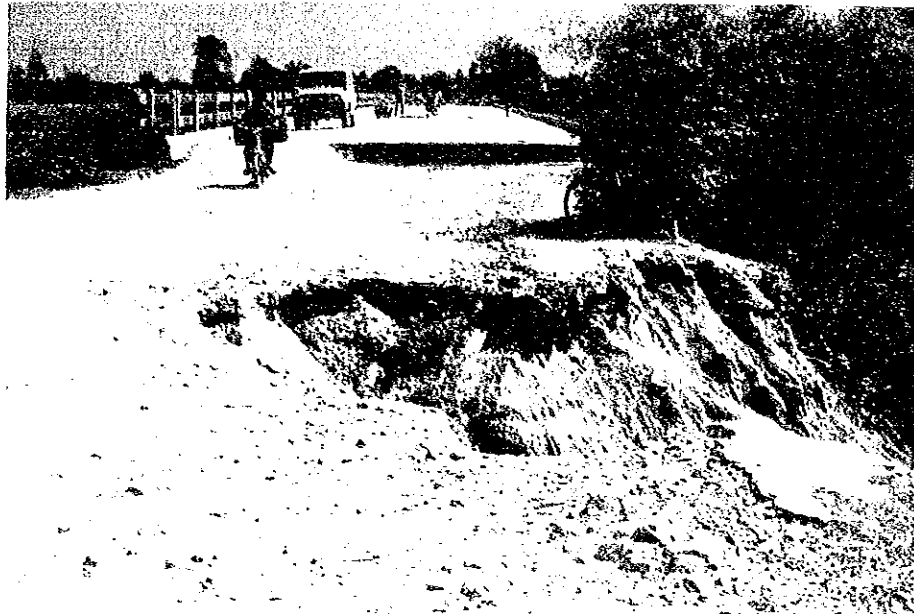
Photo 3.7
**Settlement of
Embankment**

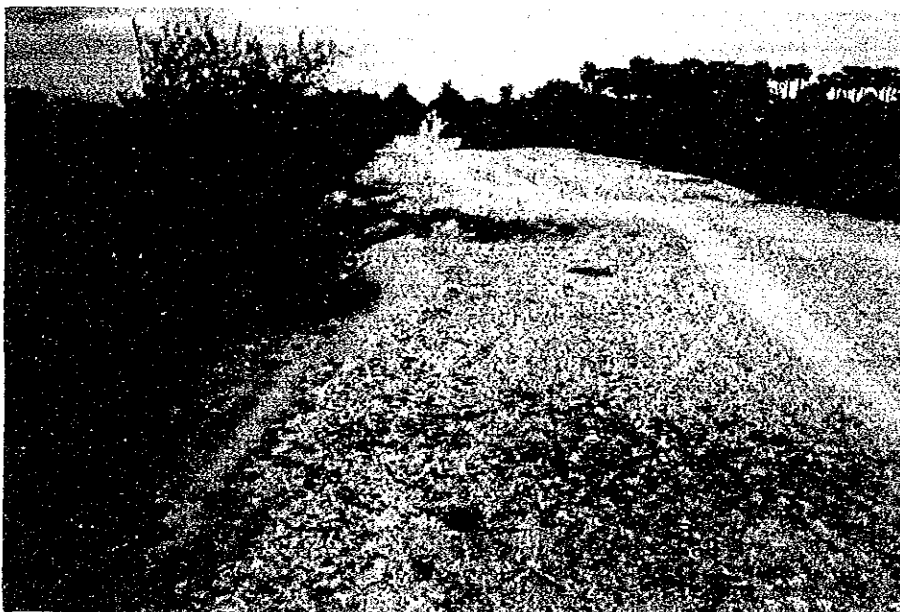
Photo 3.8
**Failure of
Embankment
Slope**

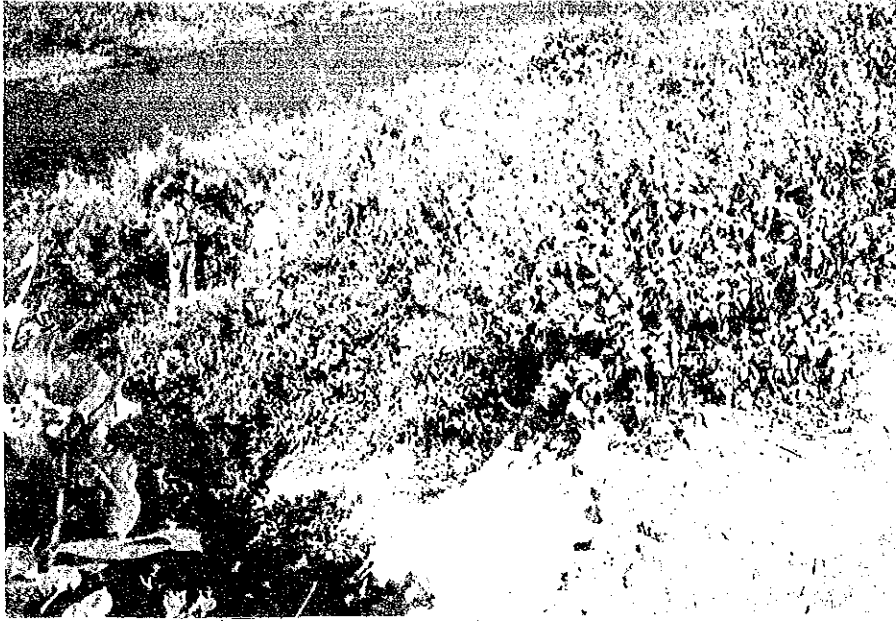
Photo 3.9
Failure of
Embankment
Slope

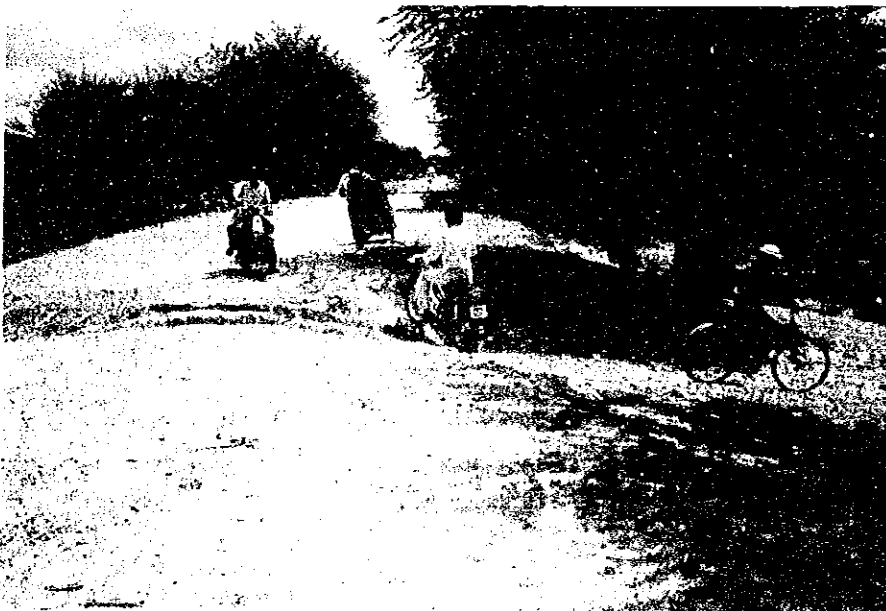
Photo 3.11
Damage of
Embankment
Slope by
Crossing Traffic

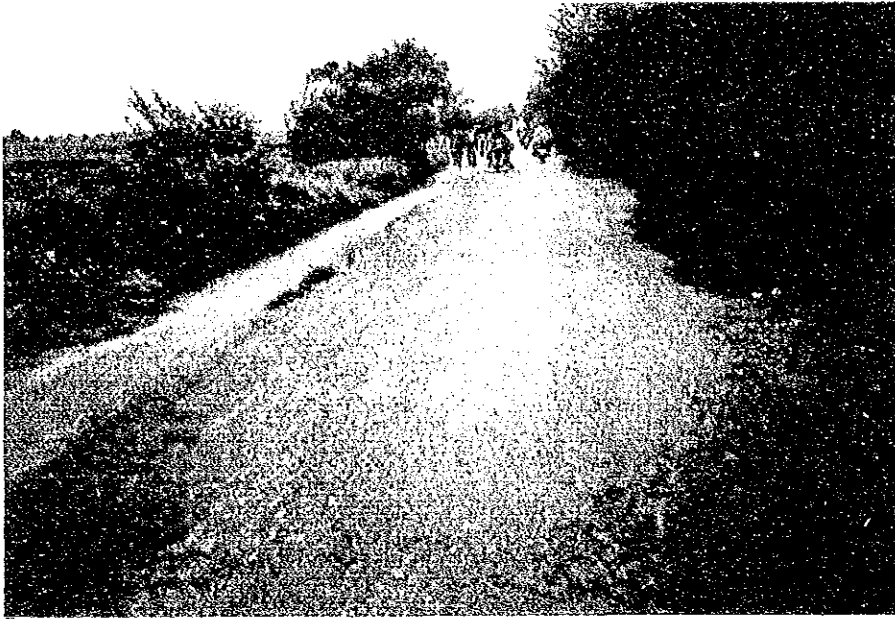
Photo 3.12

**Longitudinal
Cracks and
Deterioration
of Asphalt
Pavement**

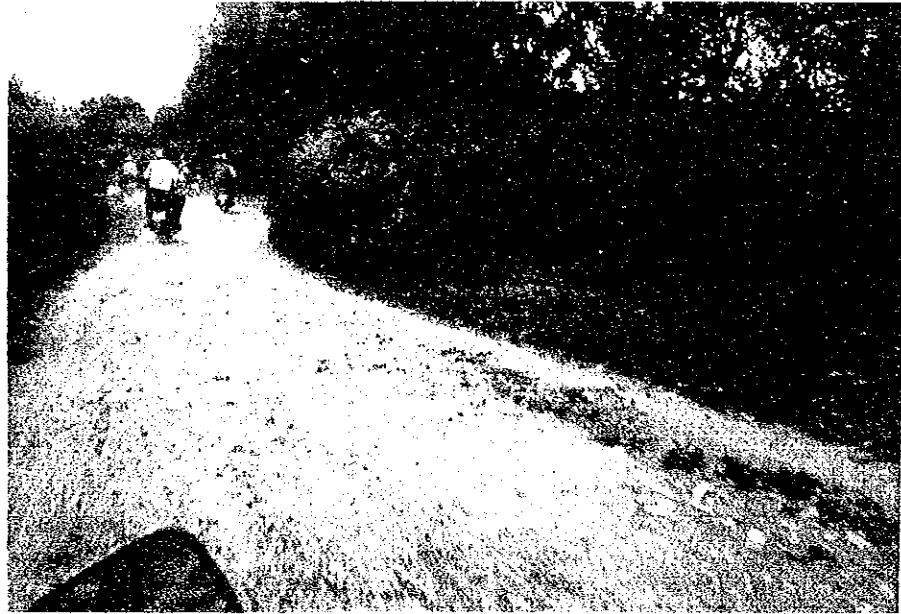
Photo 3.13

**Loss of Asphalt
Treated Surface**

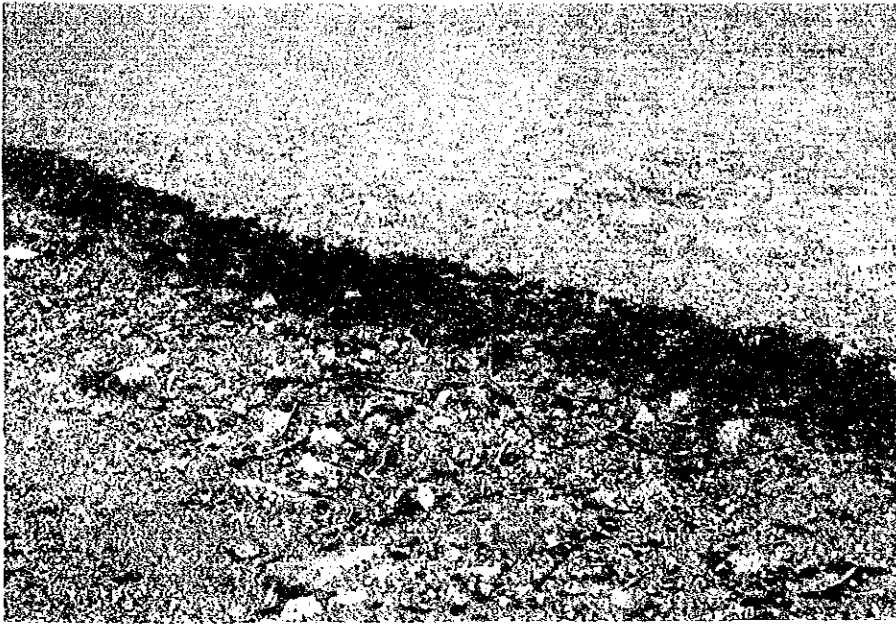
Photo 3.15
Damage of
Edge Strips of
Pavement
