THE ADDITIONAL STUDY ON
COASTAL PROTECTION AND PORT IMPROVEMENT
IN THE COOK ISLANDS

FINAL REPORT

SEPTEMBER 1994

PACIFIC CONSULTANTS INTERNATIONAL
THE OVERSEAS COASTAL AREA DEVELOPMENT INSTITUTE OF JAPAN

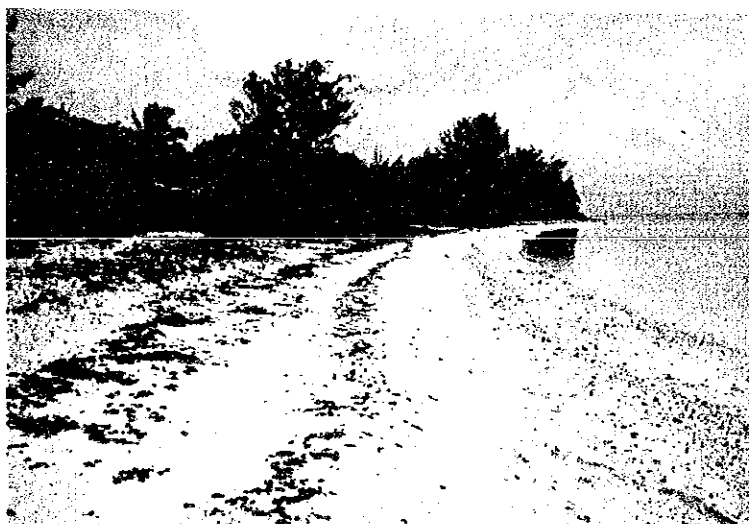
The beach is made of sandy gentle slope. There are houses broken and abandoned near the beach. Obviously, they were smashed by high waves. (See Photos 3-3, 3-4.)

Photo 3-3 Sand beach near the parliament building.

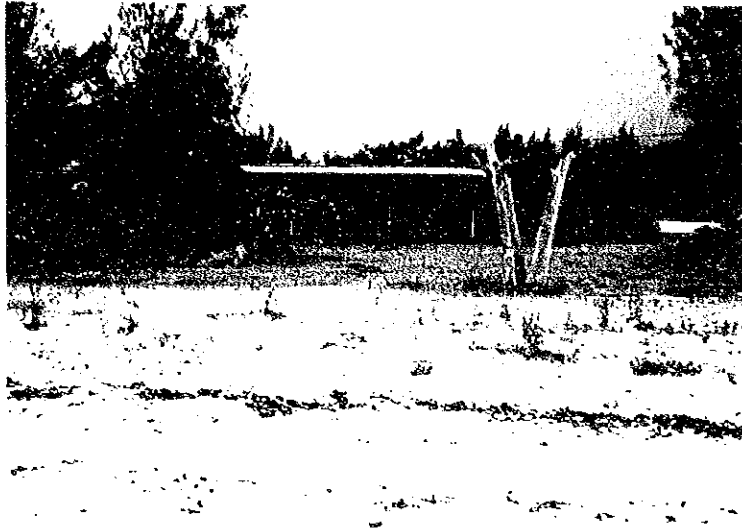
Photo 3-4 An abandoned house smashed by hurricane waves.

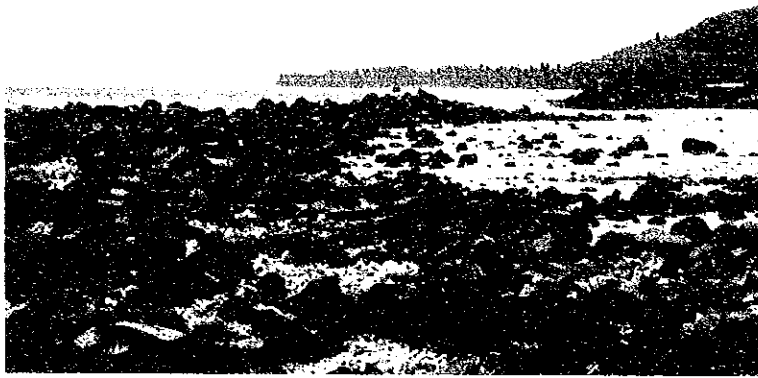
When Cyclone "Sally" attacked the northern coast, the east breakwater had almost been completed. The breakwater was not heavily damaged and is completed at present. Meanwhile, the west breakwater was under construction. Large amount of rocks were displaced by waves of Cyclone "Sally." Since then, smaller amount of rocks and core materials have been scattered leeward of the planned alignment of the west breakwater. (See Photo 3-7.)

Photo 3-7 The west breakwater of Avatiu Port, abandoned incomplete.

There are two breakwaters at Avatiu Harbour, that is, East Breakwater and West Breakwater. These were damaged by Cyclone Sally in 1987, especially the West Breakwater which was under construction when Cyclone Sally attacked Rarotonga Island have not yet been repaired.

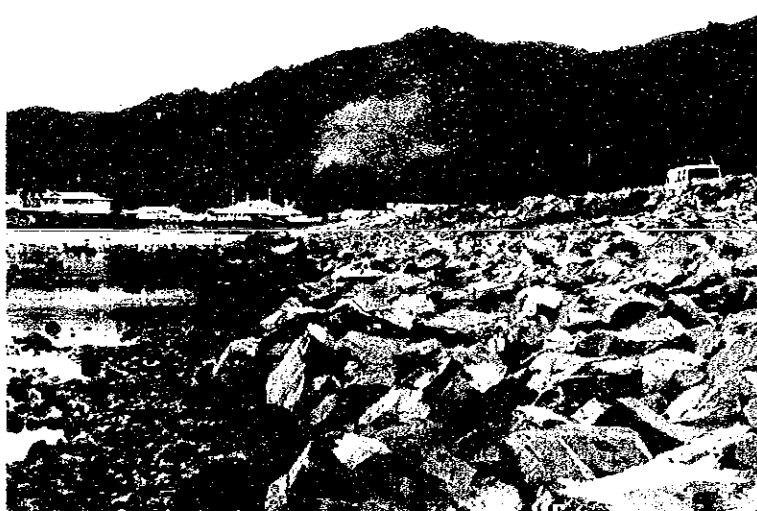
The rocks previously composing the breakwaters of Avarua Port were removed and temporarily placed on the slope of the coast road between Avarua and Avatiu. The slope is about 1 to 3. The rocks are of volcanic origin (basalt) and their surface partly became brown owing to corrosion of ferrous minerals they contain. The size of the rocks ranges from about 1 ton to 6 ton in weight. At several places, rubber sheets are placed between the rocks and the embankment to prevent erosion beneath the rocks. (See Photos 3-9, 3-10.)

Photo 3-9 The temporary coastal protection work between Avarua and Avatiu by use of armor rocks removed from the breakwaters of Avarua Port.

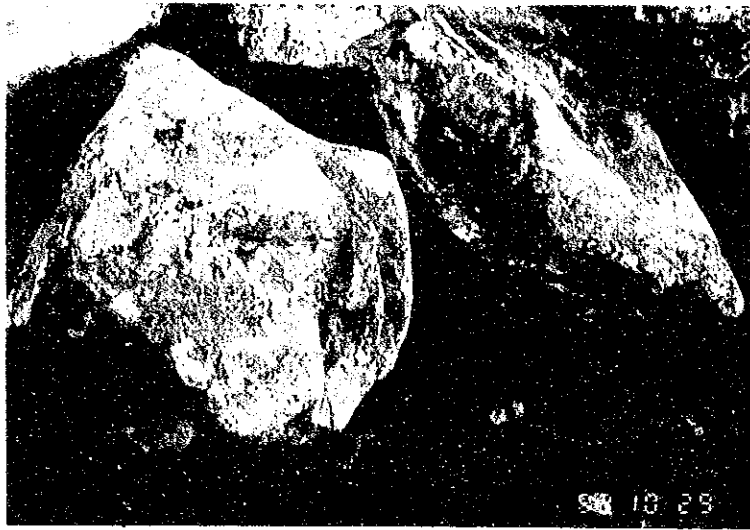
Photo 3-10 Details of the temporary coastal protection.
Armor rocks with rubber sheet for sand-loss prevention.

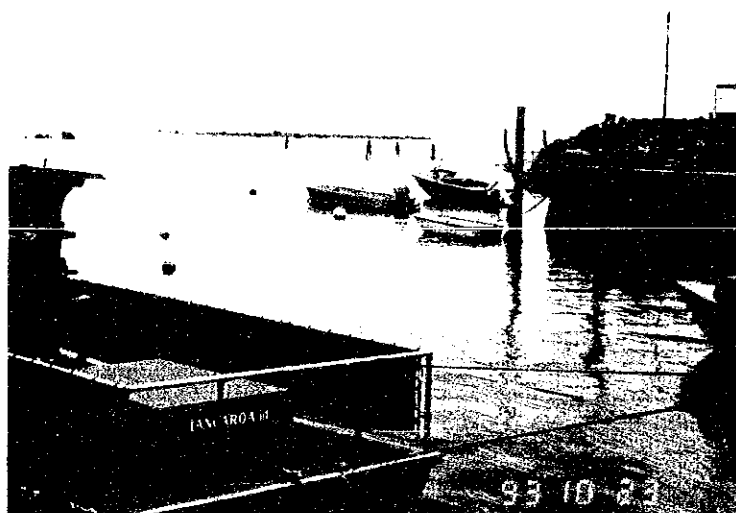
Under the calm sea conditions, the port is sheltered from the invading waves. However, the water area at the west side of the passage, the potential site for a small yacht basin, is rather rough owing to the waves reaching across the lagoon. For sheltering the small yacht basin, a breakwater aligned in parallel to the reef edge seems necessary. (See Photo 3-15.)

Photo 3-15 The potential water area for a small yacht basin in Avarua Port.

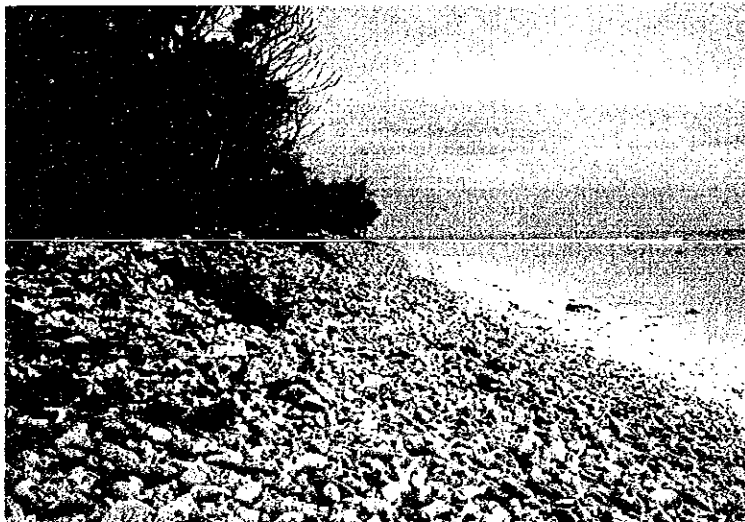
The lagoon is very narrow about 40 m to 70 m. The coast is made of coral boulders which diameter ranges from 5 cm to 20 cm. No coastal erosion is observed. The slope is steep about 1:2. The coast faces the north-east, in which direction winds are most prevailing. (See Photo 3-21.)

Photo 3-21 Coral boulders on the coast at Matavera.

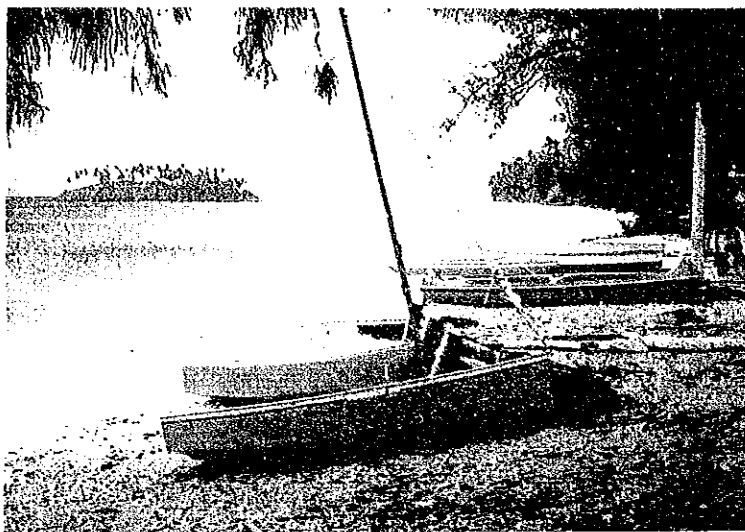
Beach erosion was reported in the previous JICA report. The erosion might be due to the dredging of the sands from the passage, which has been prohibited. Nowadays, the beach seems in a stable condition as the two photos taken at the same point in 1987 and this time show no significant changes. (See Photos 3-25, 3-26.)

Photo 3-25 Sand beach at Muri. The JICA photo taken in 1987.

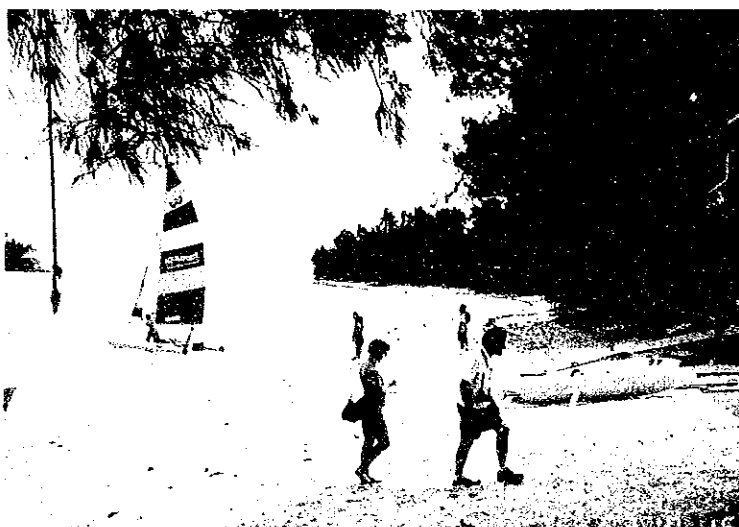
Photo 3-26 Sand beach at Muri. The same spot where the JICA photo was taken.

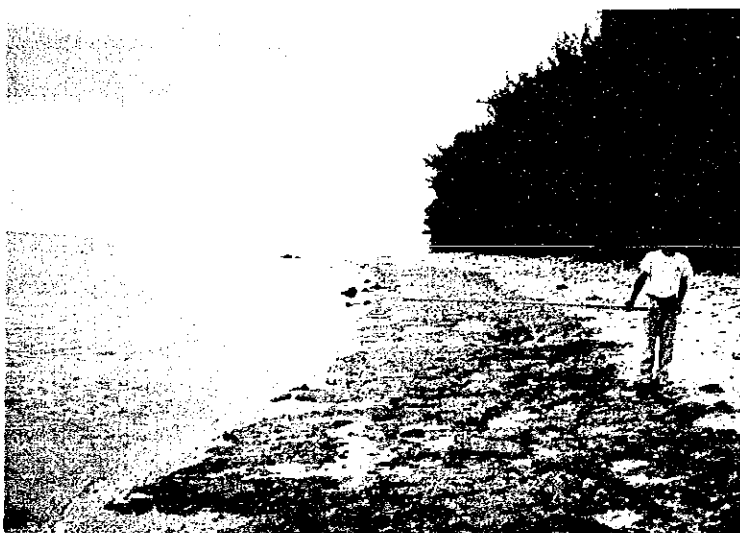
The southern coast has wide, about 550 m to 740 m, and deep lagoon. The beach is sandy but not so wide as it is on the western beach. Few boulders are found on the beach. Beach rock is exposed at several areas. At the river mouth, small black cobbles, which origin is basalt base rock of the island, are scattered. (See Photos 3-27, 3-28.)

Photo 3-27 Beach at Titikaveka with beach rock exposed.

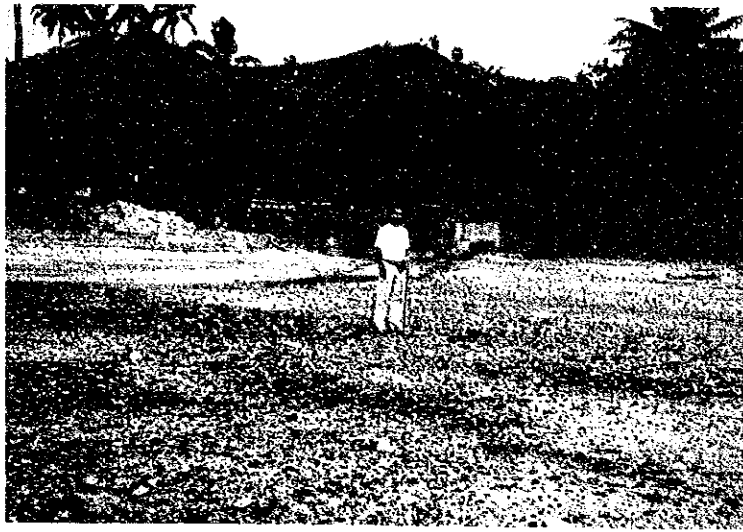
Photo 3-28 The river mouth with basalt cobbles at Titikaveka.

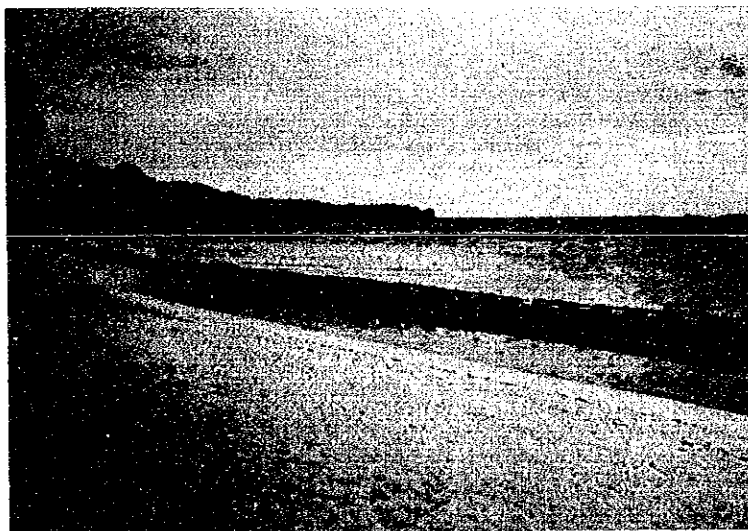
At the south-west corner of the island, the hotel resort is built. The beach had long suffered from erosion. Several measures were taken to protect the beach, e.g., groins, seawall. After all had failed, an invention was made by a coastal engineer. He invented Coastal Protection Units as shown on the photograph. The basic idea of this invention is to dissipate the wave energy, allow sand particles pass the units and settle behind them. This was made possible by dissipating the wave energy upward so that the water behind the units can be stabilized. (See Photos 3-3-, 3-31.)

Photo 3-30 Coastal Protection Units (CPU) from the front.

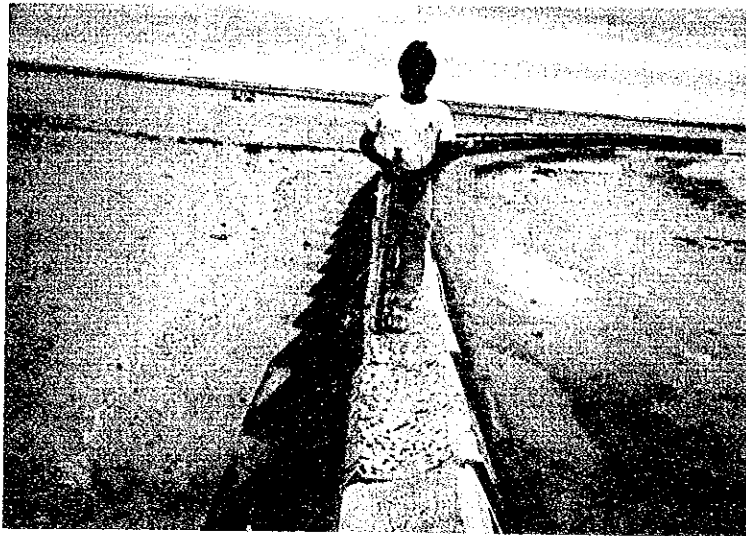
Photo 3-31 Coastal Protection Units (CPU) from the top.
