REPUBLIC OF PALAU

PRESENT CONDITION SURVEY OF THE

KOROR - BABELTHUAP BRIDGE

FEBRUARY, 1990

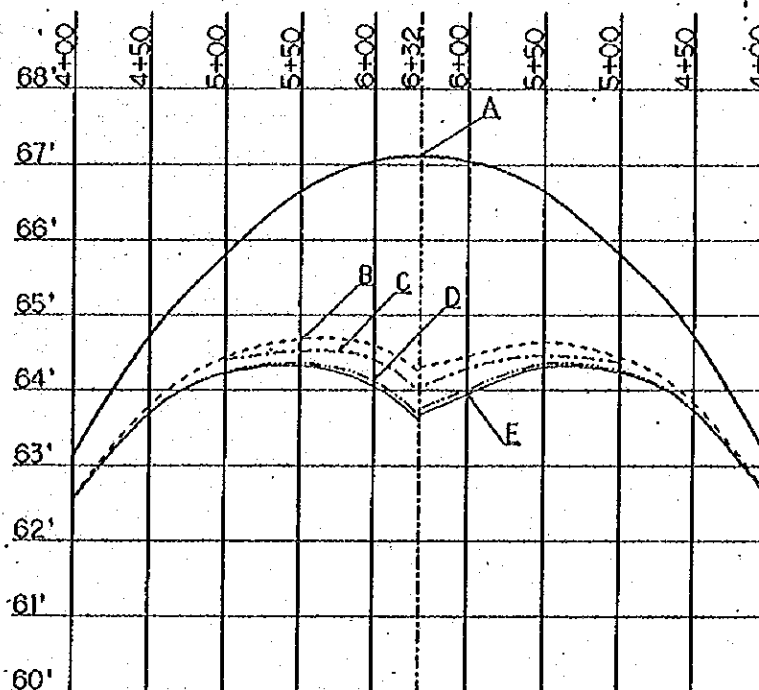
# BRIDGE ELEVATION

Date	Elevation	Difference
July, 1977 ( year of completion )	67.11 ft	
		> 2.84 ft ( 86 cm )
November, 1985	64.27 ft	
		> 0.25 ft ( 8 cm )
May, 1986	64.02 ft	
		> 0.30 ft ( 9 cm )
January, 1990	<u>63.72 ft</u>	
	Total	3.39 ft ( 103 cm )
January, 1990		
( weight of loading : 12.5 ton x 4 trucks ) III	63.64 ft	
January, 1990		> 0.10 ft
( after the removal of load )	IV 63.74 ft	( 3.0 cm )

The bridge has deflected 0.06 ~ 0.09 ft at the central hing.

The elevation survey of major girders shows that bridge deflection hasn't changed since completion of the bridge except the major girders at midspan. The bridge therefore has not sagged or subsided. This is supported by following three points :

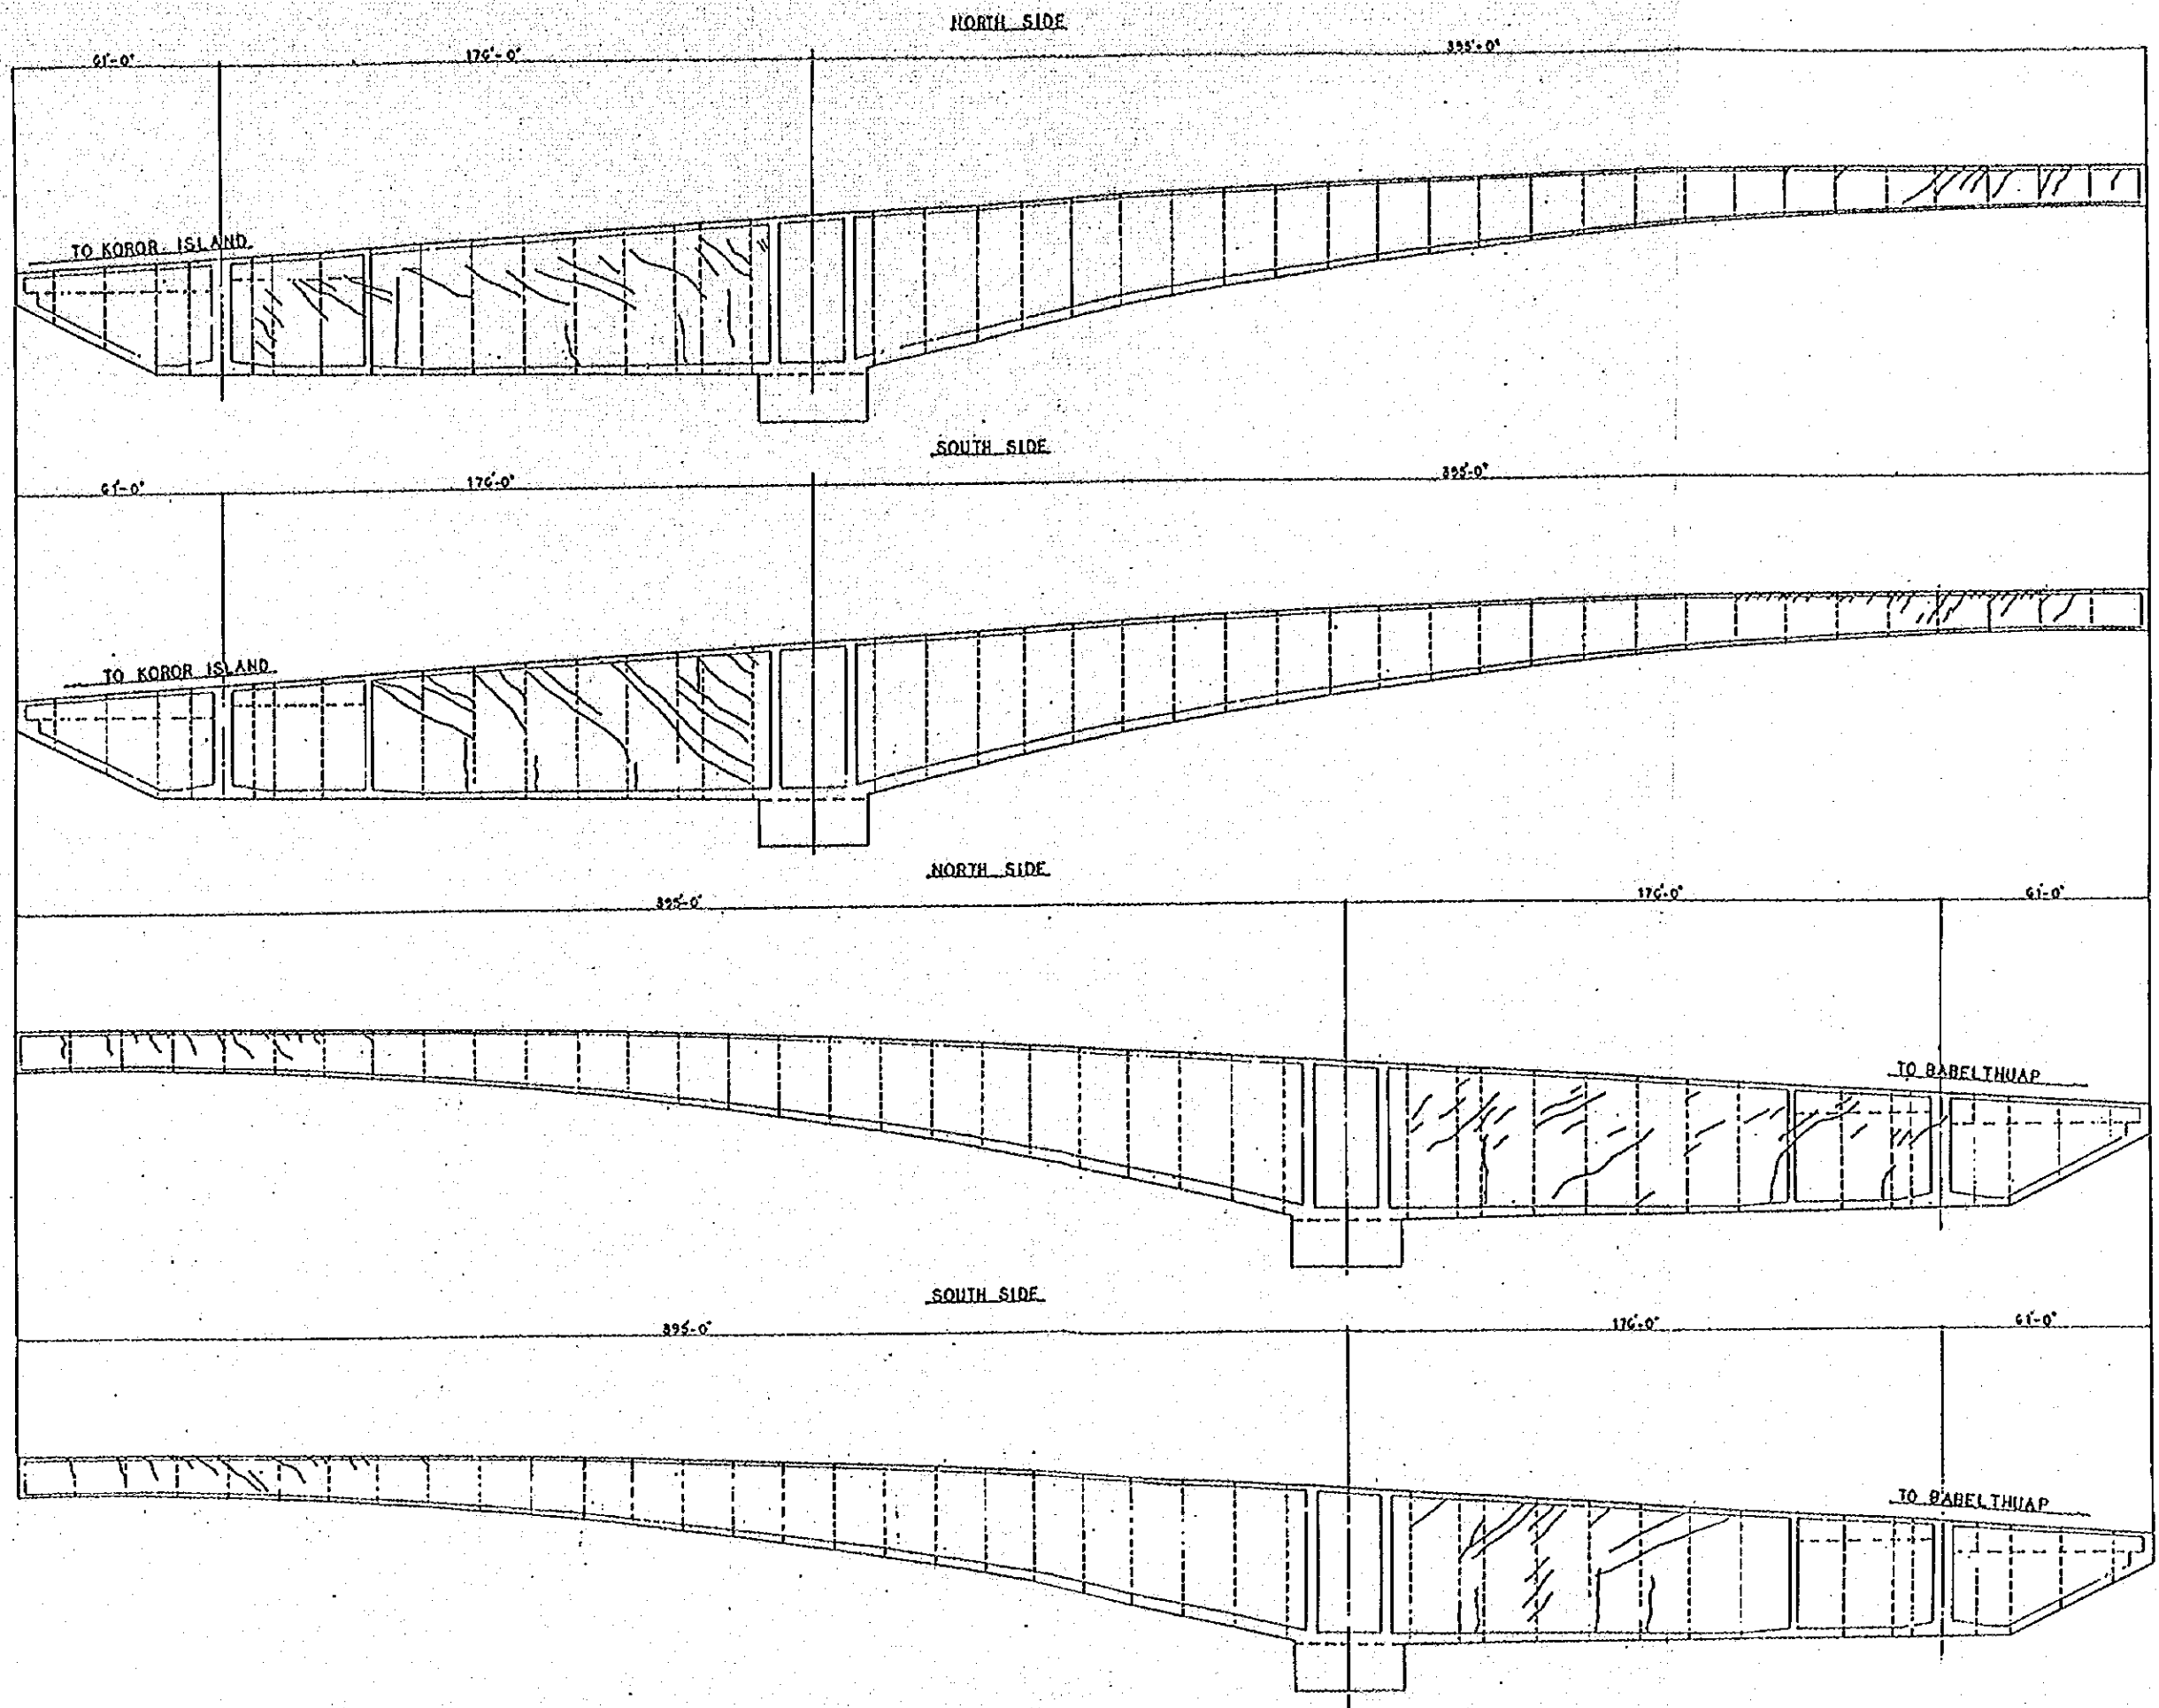
Cracks on the main beam at midspan were observed only from inside the girder box as shown in the following drawing.

The features of the cracks are as follows :

- Cracks were observed between the midspan and segments 7 ~ 8 on both sides.
- The cracks were observed on both sides of the main beam, the Koror Island side and the Babelthuap Island side, and on the webs on both the north side and the south side.
- The cracks start from where the upper slab and web meet and finish in the center of the web. The cracks run at an angle of 45° in opposite directions from the central segments.
- The width of cracks is about 0.04 ~ 0.1 inches.

Occurance of cracks on the main beam at sidespan is shown in the drawing.

There are both vertical and oblique cracks with the following features :

#### Vertical cracks

- Vertical cracks were observed on the main beam on both the Koror Island side and the Babelthuap Island side, also on the webs of the north and the south sides.
- They were observed where the lower slab and the web meet.
- The width of cracks is about 0.08 inches.

### Oblique cracks

- Oblique cracks were observed on the main beam of both the Koror Island side and the Babelthuap Island side, and on the webs of the north and the south sides.
- The cracks start from where the upper slab and the web meet and finish at the centre of the web. They run an angle of  $45^\circ$  in opposite directions from the central segments.
- Measurement of the width of cracks was not conducted.

Both oblique and vertical cracks on the main beam were probably created during construction. Since the main beam with cracks already experienced extreme loading conditions when the wagons were at midspan during the cantilever erection, the bridge would be structurally safe without any repairs considering the present traffic volume.

However because this bridge has no protection from oceanic winds, it is possible that reinforcing rods may be corroded and concrete

weakened by salt bearing winds through the cracks. Cracks will certainly become a cause of lower bridge durability and should be repaired in the future.

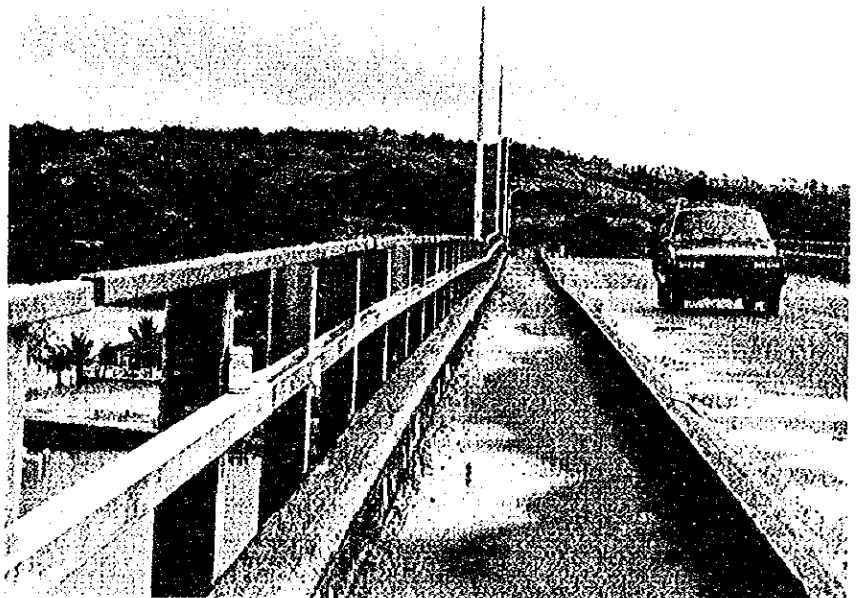
The measurement of the bridge elevations indicates that the central 7 ~ 8 midspan segments have sagged. The midspan expansion gap is partly closed at the top and open at the bottom. At the midspan expansion gap or cover plate, the curved angle of the gap is about 0.04 to 0.05 radians.

Bridge central hinge part  
( South side )

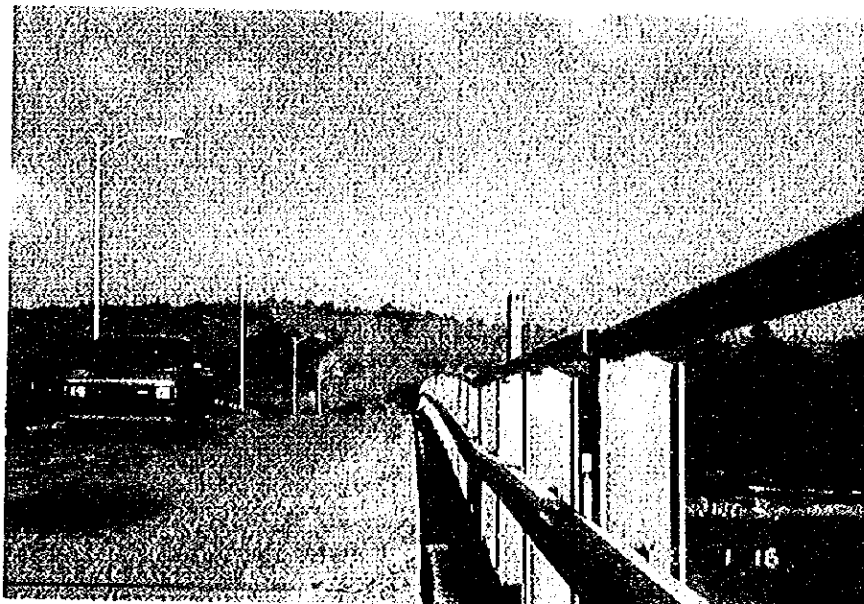
Bridge central hinge part  
( North side )

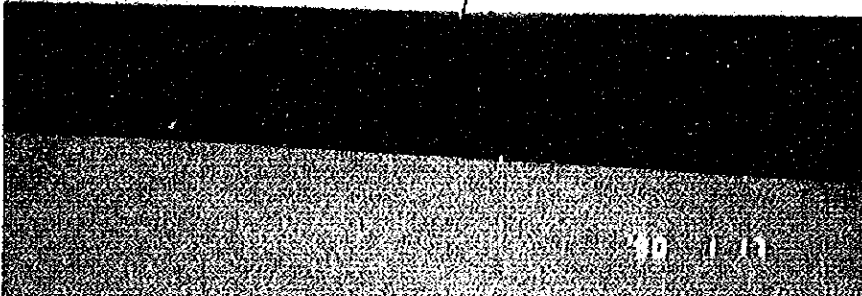
Close-up of the central hinge  
from underneath the bridge

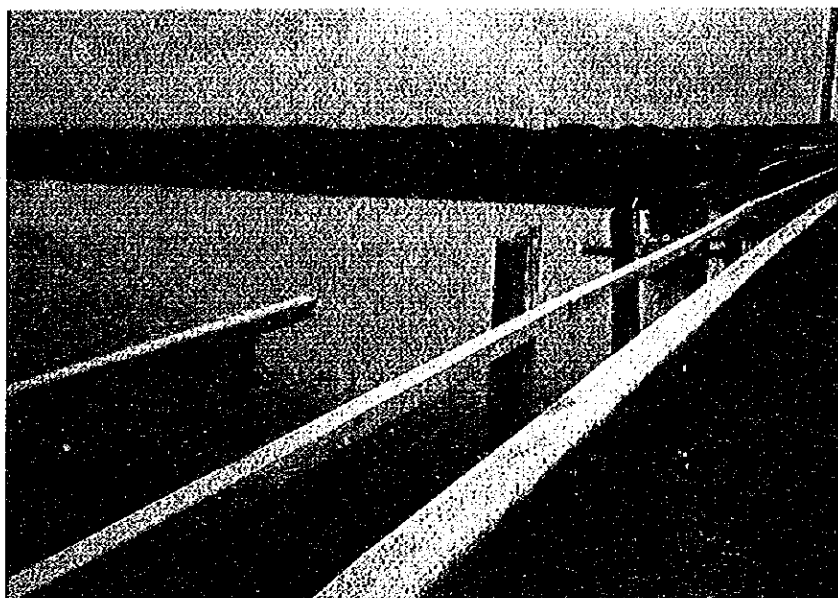
- About 0.6 in. diagonal shear stress was found at central midspan in all end pier rubber shoes.
- There is no gap in the rubber shoes.
- Deflections were found in the vinyl chloride pipe which covers tie-down steel rods in the end pier. Corrosion of the steel rods was observed.
- The concrete wearing surface of the bridge deck is in poor condition with numerous pot holes exposing the reinforcing mesh. Some have been poorly patched.
- The handrails are irregular, and in some cases the handrail standards have broken away from the bridge.

Defective hand rails

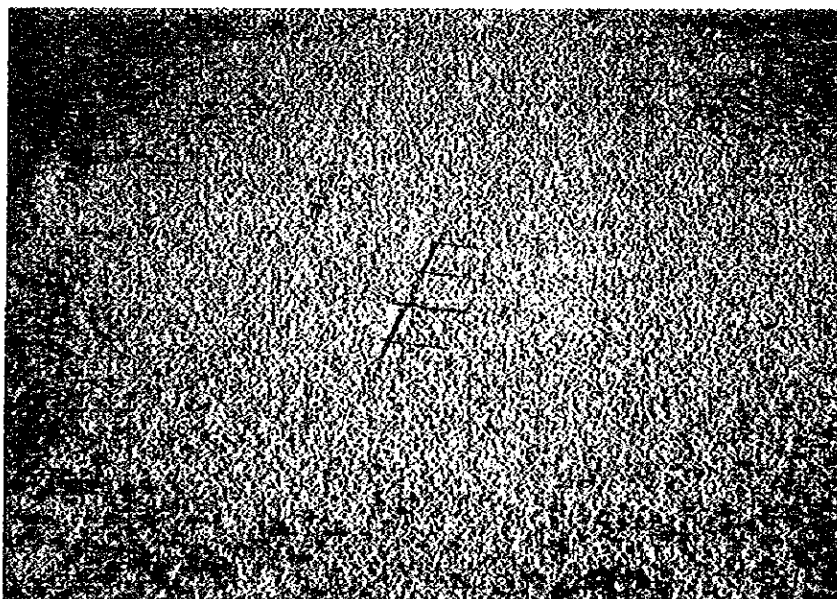
- Deflections in the pier on the Koror side are not obvious because of mortar repairs. Also, 0.2 cm cracks are in evidence.
- 3 to 3.5 in. of surface has worn away exposing the reinforcing meshing on the south side of the Babelthuap side.

Exposure of reinforcing  
mesh on the bridge
