**7.1.2.C. Fouled Membrane Analysis
of Duba SWRO Plant (1)**

**7.1.2.D. Fouled Membrane Cleaning
of Duba SWRO Plant**

**7.1.2.E. Foulant Analysis and Flat Membrane
Performance of Duba SWRO Plant**

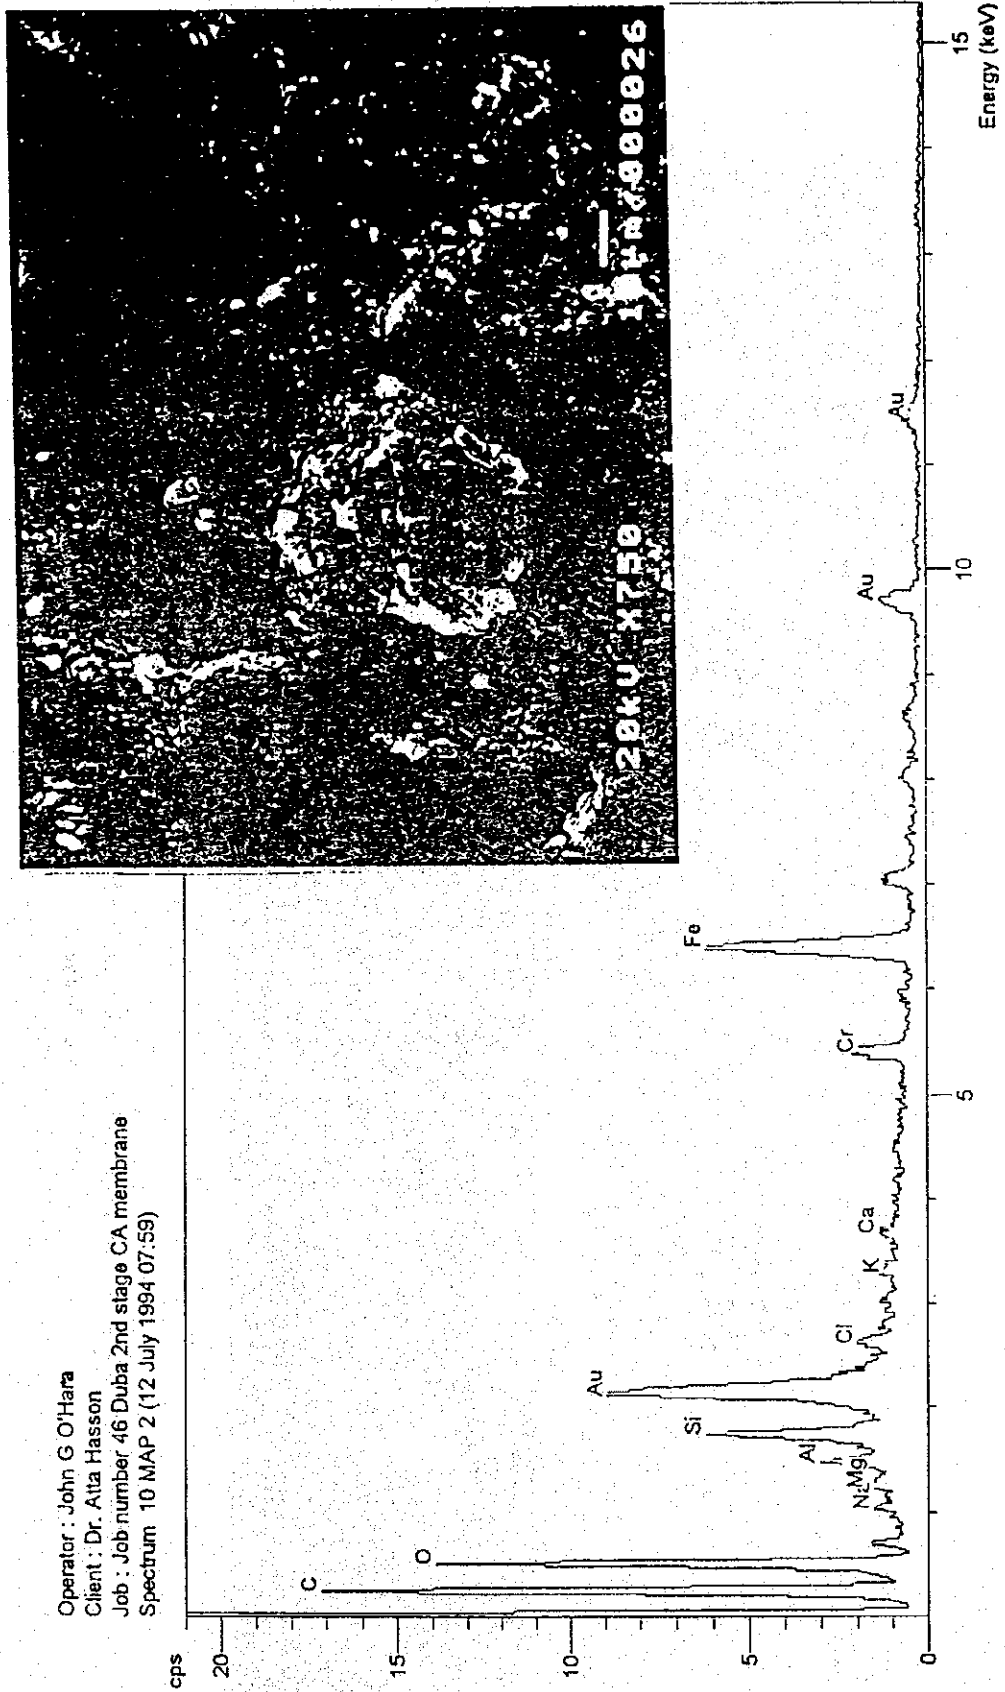
A general overview of the spiral wound membrane surface obtained at SEM magnification of 750 is shown in Figure 1 which also gives the elemental analysis of the foulant as determined by EDX the method. The X-ray elemental dot mapping gave the elements distribution in the fouled areas as given in Figure 2.

Main foulants present on spiral wound membranes were: C, O, Si, Al, Fe and Cr. Other elements such as Na, Mg, Cl, K and Ca were found at low concentration. The Fe and Cr distribution on the surface of the fouled membrane are not only similar but also has the same general appearance as that shown for the back scattered electron image, the first photo in Figure 2. The same general distribution is noticed for the Al and Si elements and to a lesser extent C and O which tend to have similar distribution. Similar elements distribution could indicate their presence in a combined or associated form. Thus, the Fe and Cr could arise from the accumulation on the membrane surface of stainless steel corrosion products. The other possibility that the

The analysis of foulants on Duba second stage spiral wound membrane using SEM and EDX reveal that it contains mainly Fe,Cr,C and O which are produced as a result of corrosion of stainless steel part and also due to deposition of carbonates on membrane.

Figure 1 : SEM Micrograph and EDX Spectrum of Fouled Spiral Wound Membrane

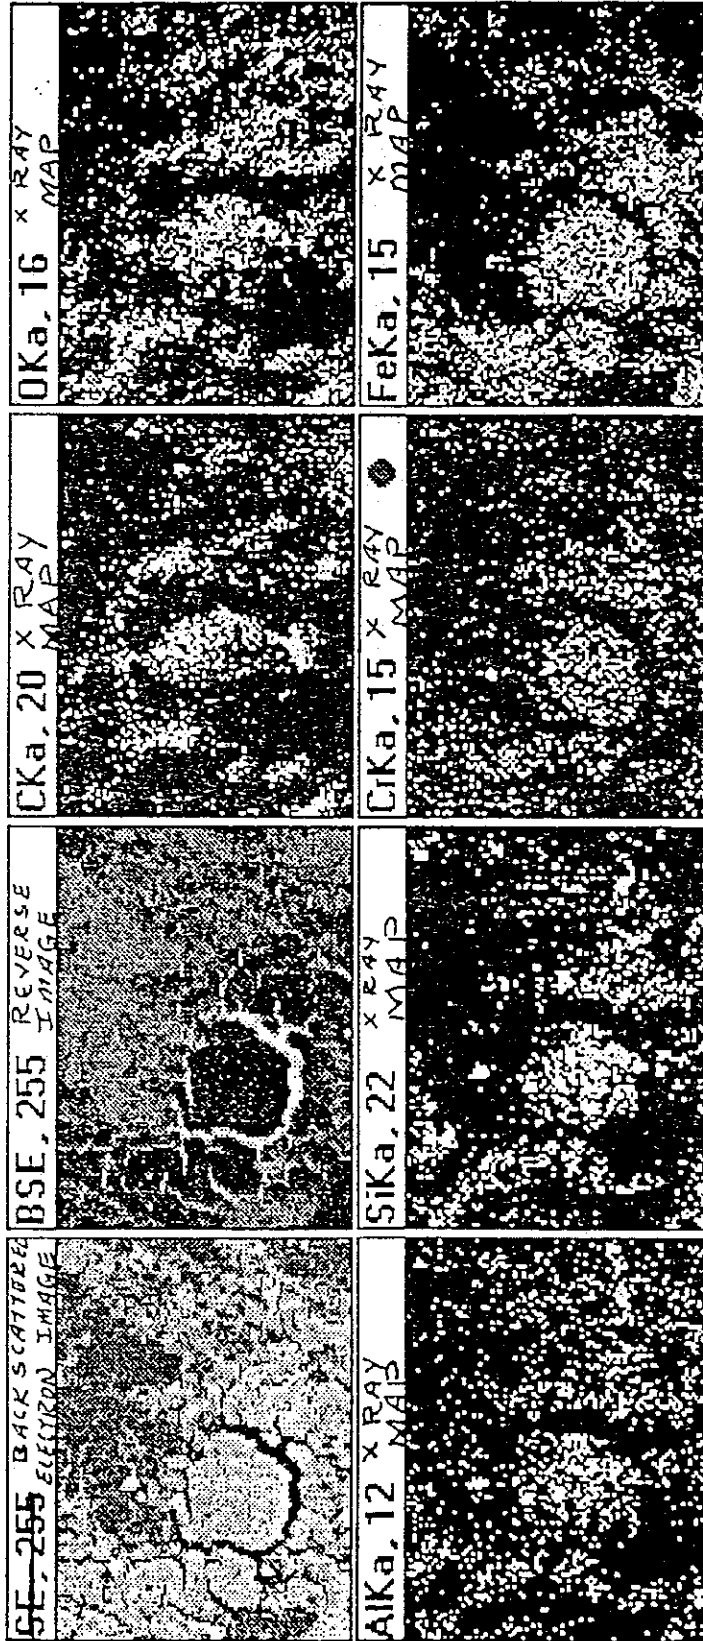
Figure 2 : The X-ray Dot Mapping of Elements Accumulated on the Surface of Fouled Spiral Wound Membrane

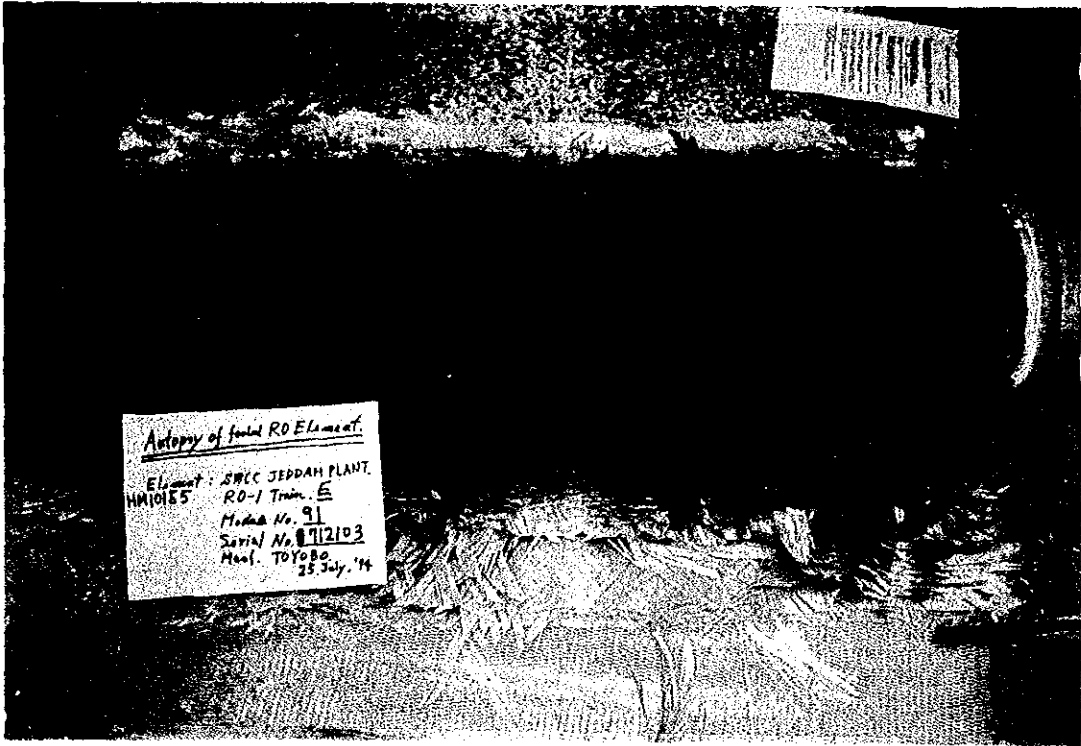
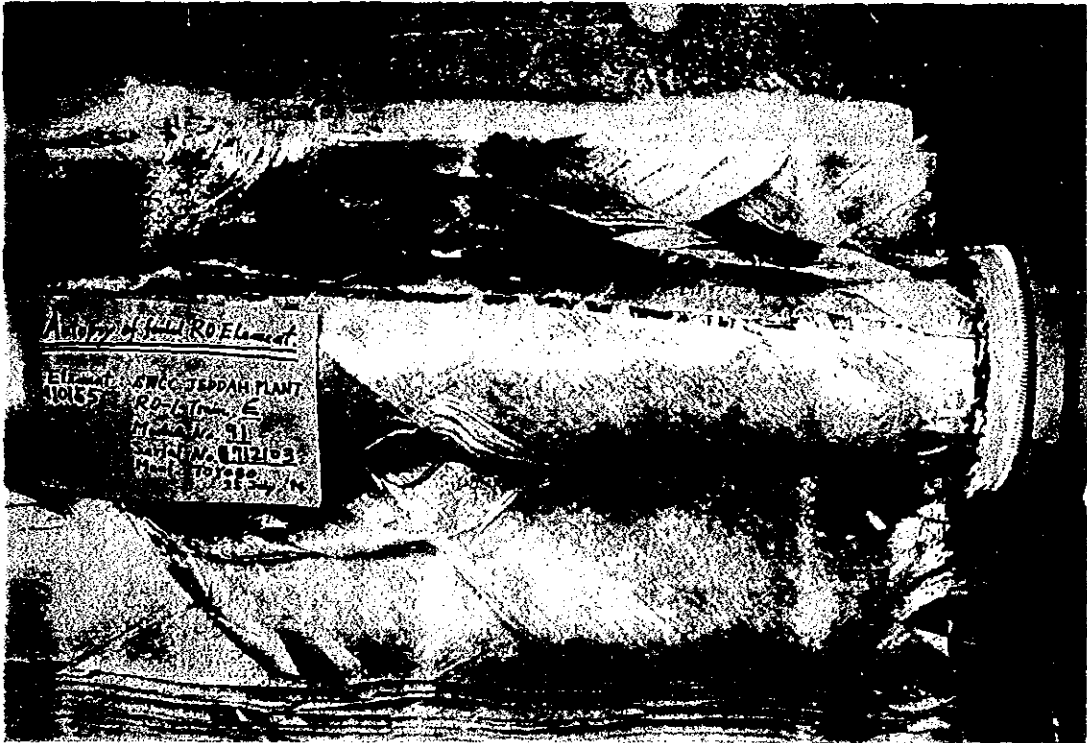
The general appearance of hollow fine fiber element at various stages of autopsy are shown in Figures 3. The physical examination of the membrane fibers reveal that the fibers close to the feed tube were deepest in color and largest amount of the deposits. Both the color intensity and the amount of deposits decrease as the fiber distance from the feed tube is increased. The fibers at the peripheral part of the element are slight yellowish in color and contains negligible amount of deposits. Qualitative analysis of this reddish brown deposits reveal that it was composed mainly of iron (Fe_3) deposits. In addition to the reddish brown deposits, some black particles and some fibrous sticky materials were also observed on the feed tube of the element. Results of SEM and EDX for the fibers from inner, middle and outer portion, the cleaned fibers, the black particles and the sticky fibrous materials are shown in Figures 4 to 14. Results of quantitative inorganic analysis of foulant collected from the hollow fine fiber Toyobo are given in Table 1.

Fig. 3 Various Stages of Fouled Hollow Fine Fiber Autopsy

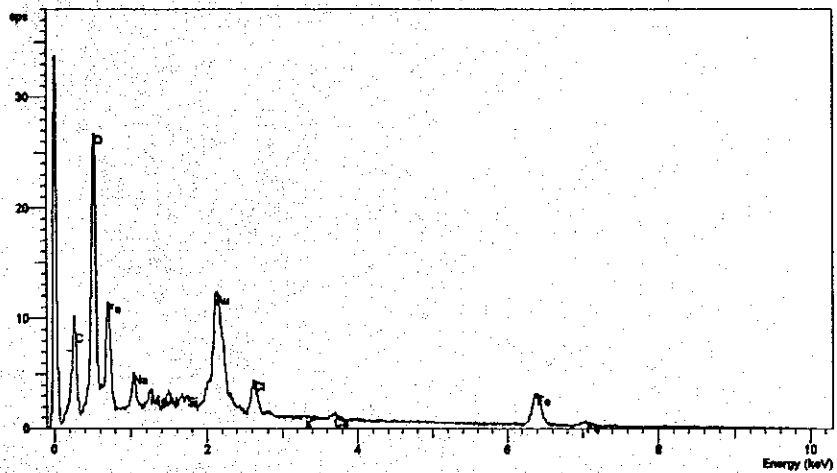
SEM results on the hollow fine fiber fouled membrane shows heavy deposits of foulants which mainly consists of C,O,Fe,Al and Si and also Na and Cl from the salt crystals and to lesser extent Mg,K, and Ca. Micrographs shows that the fiber closer to the feed tube (Figure 4) is heavily fouled whereas fibers away from feed tube, viz, from middle (Figure 5) and top (Figure 6) portions are less fouled. Cleaning using various chemical cleaning agents did not completely remove the foulants as can be seen from the SEM micrographs as well as from EDX (Figure 7 to 12). Oxalic acid was found to be the most efficient cleaning agent as it removes most of the foulants (see Figure 12).

Figure 4 : SEM Micrograph and EDX Spectrum of Fouled Inner Hollow Fine Fiber

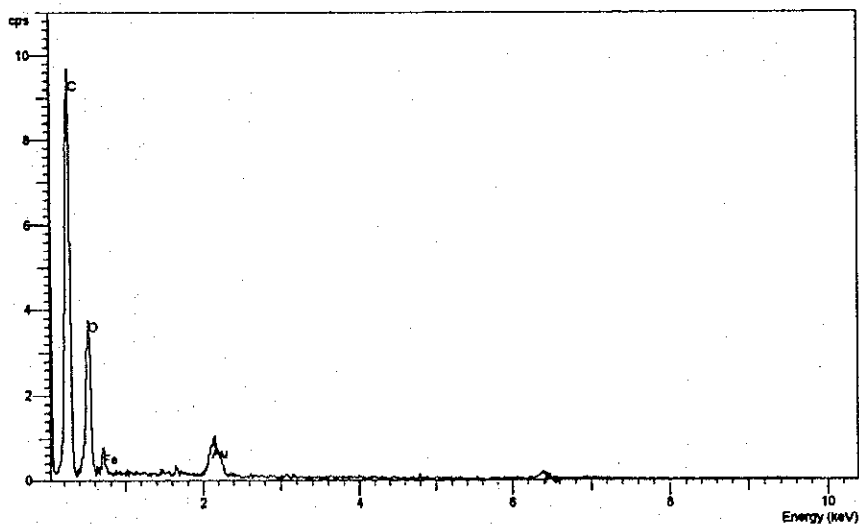
The analysis of hollow fine fiber reveals that it has large deposits of ferric from the coagulant. Also it has silt, anthracite and asbestos like material on the membrane surface. The study also reveals that oxalic could be used as cleaning agent as it removes most of the foulants.

Figure 12 : SEM Micrograph and EDX Spectrum of Oxalic Acid Cleaned Fouled Hollow Fine Fiber

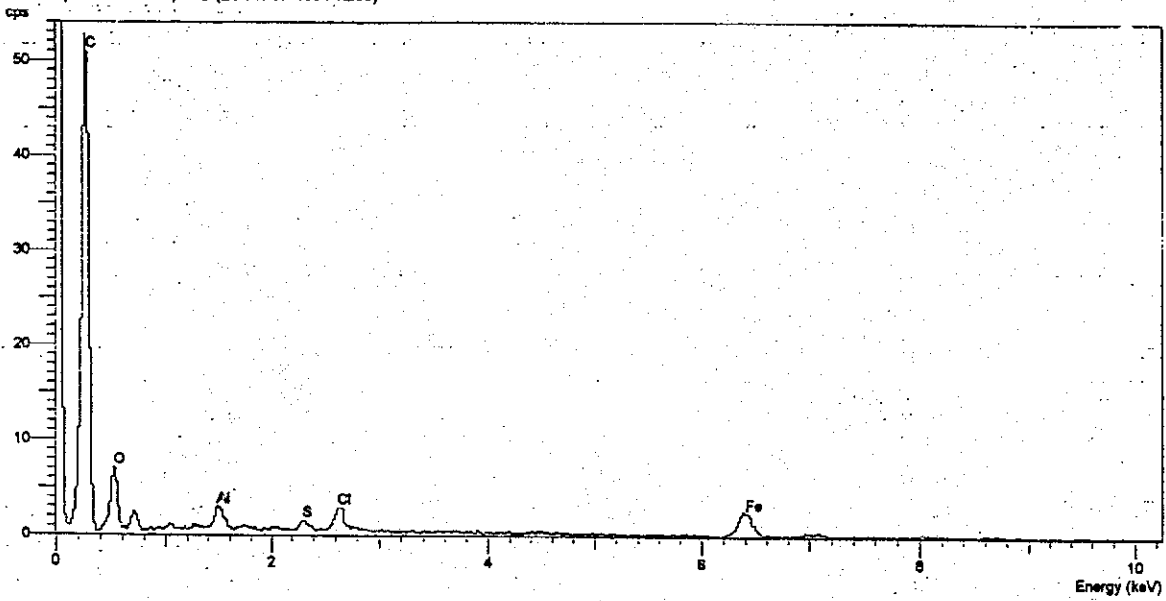
The chemical analysis of the deposits of fiber which was extracted using water, oxalic acid and hydrochloric acid are given in Table 1. In addition to the elements obtained using EDX, chemical analysis revealed the presence of trace amounts of Mn,Zn,Cu,Ni,Sr,Cr and P. It is surprising to observe the absence of SO_4 in the chemical analysis of deposits. The high amount of C and O could be due to the presence of carbonates or organic matter from the fiber itself or decayed biological matter. The Fe is from the usage of FeCl_3 as coagulant which were collected on the fiber passing through the media filters. The elements Al,Si and Mg originate from silt. Analysis of the black particle by using EDX reveal that it consists of mainly carbon, which could be anthracite particle from the media filter. whereas the fibrous material consists of mainly Si, Mg and Fe of which former two are the major constituents of asbestos.

Figure 13 : EDX Spectrum of Black Particle on the Fouled Hollow Fine Fiber

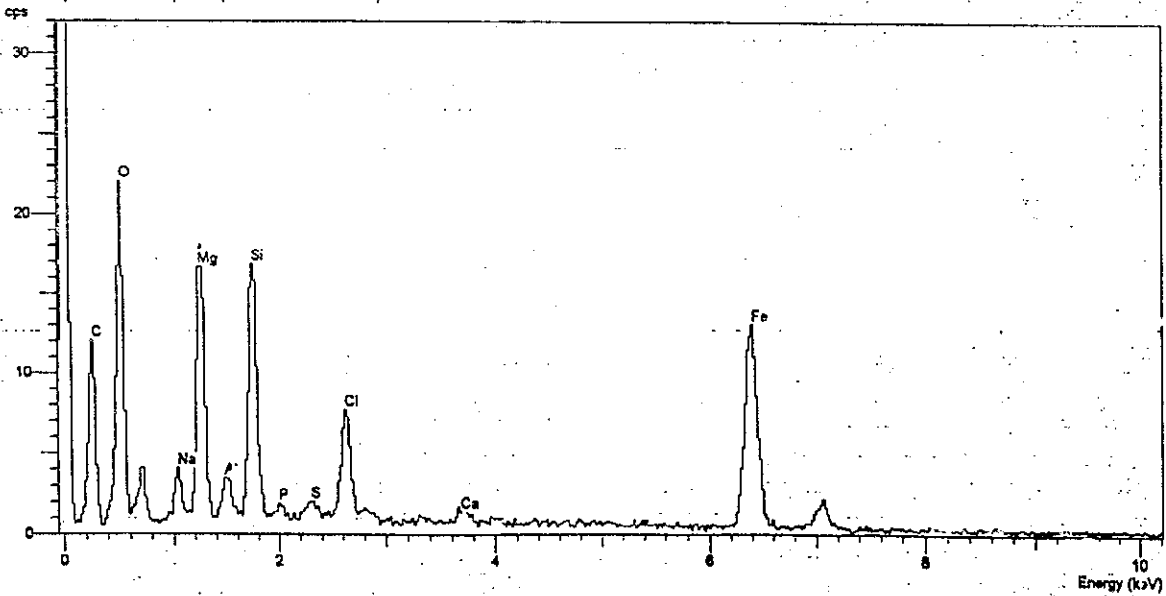
Figure 14 : EDX Spectrum of Fibrous Sticky Material on the Fouled Hollow Fine Fiber

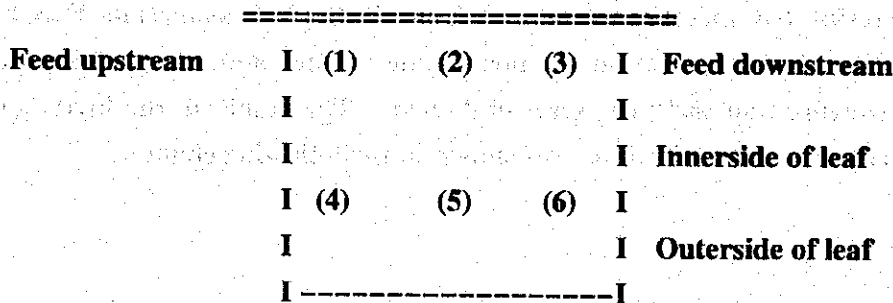
Figure 1. Obtained RO samples' location in the autopsied membrane leaf

As shown in Table 1, comparing between the locational performance with flat sheet membrane samples in the leaf of the autopsied element(see Figure 1) and RO performance, it was obvious that the gradient of rejection performances existed from upstream to down stream side changing bigger. In other words, the upstream portion was severely damaged than the down stream side, showing the tendency that the upper stream portions had the lower rejections and the higher fluxes than down portions. On the other hand, there were no changes between outer and inner side within the leaf.

If the wave strips on the membrane surface of SEM photos are concluded that these come from the RO operation, the ultrasonic sound generated from high pressure feed pump mostlikely created the mechanical damage and it should meet the typical membrane deterioration. Because it is well corresponded that the strength of ultrasonic sound affects upper stream side more stronger than the down stream side.

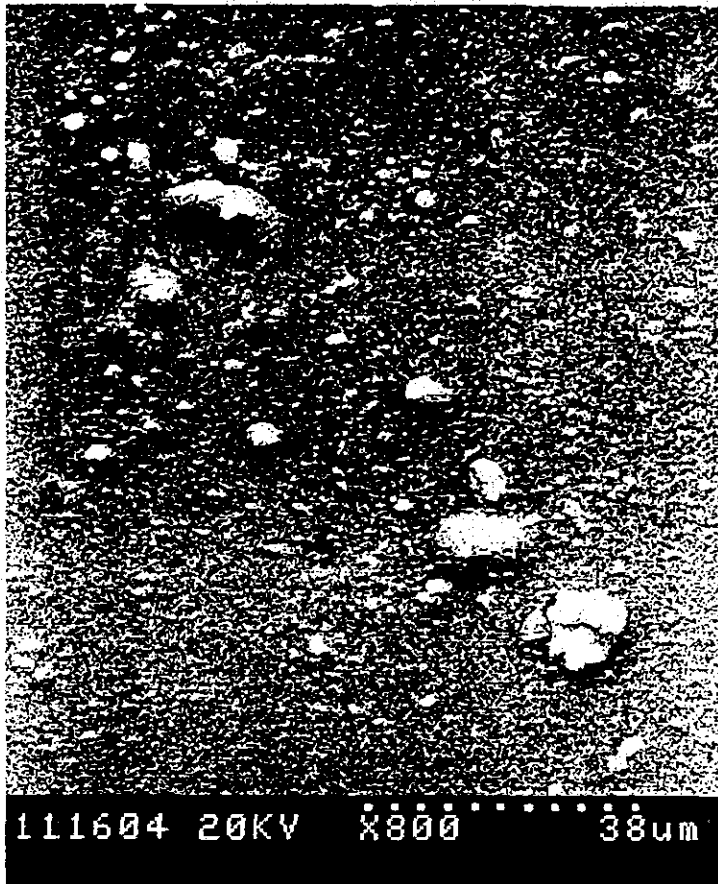
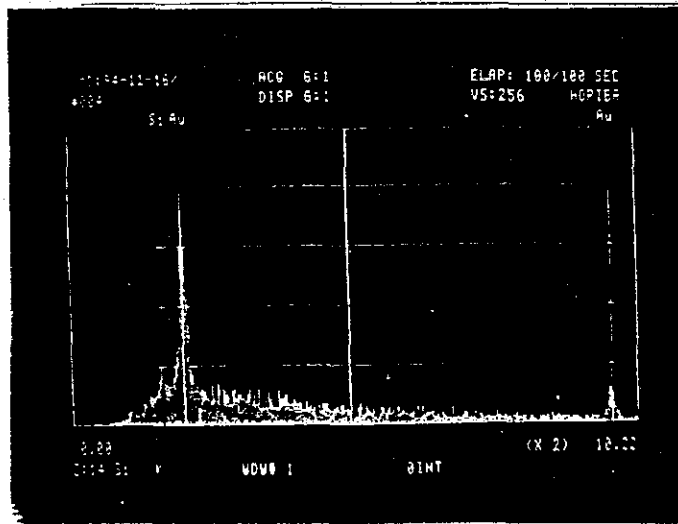
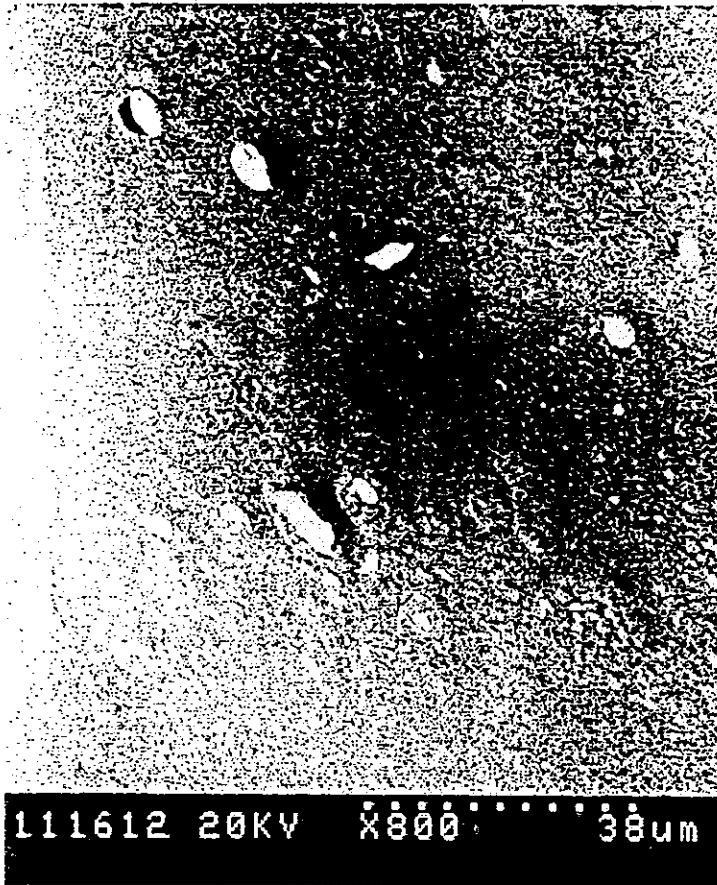
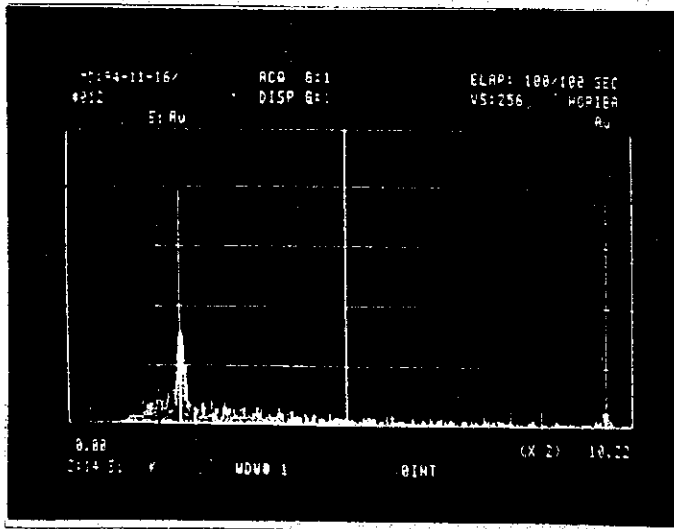
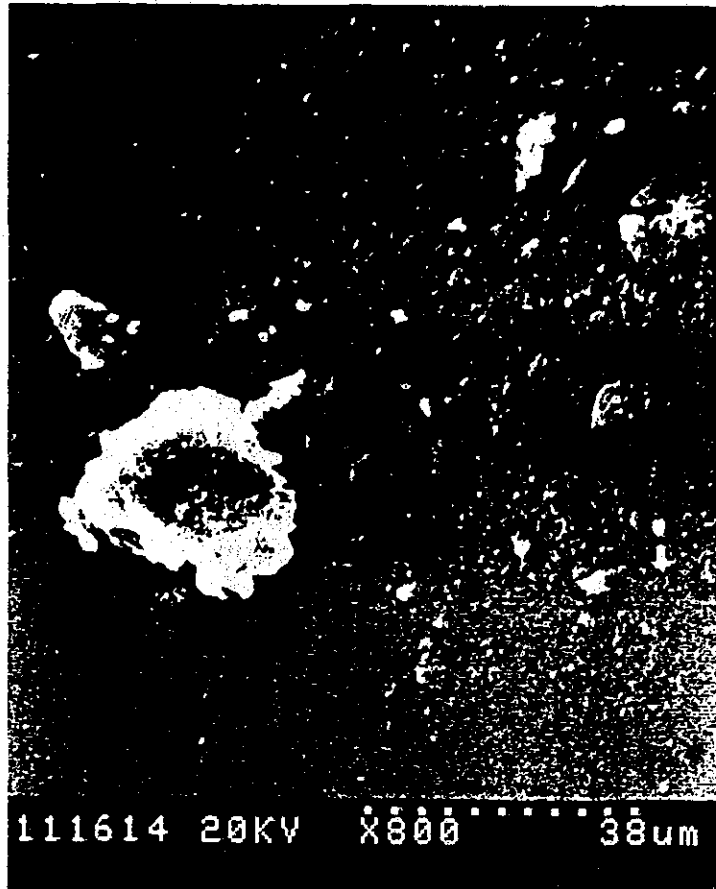
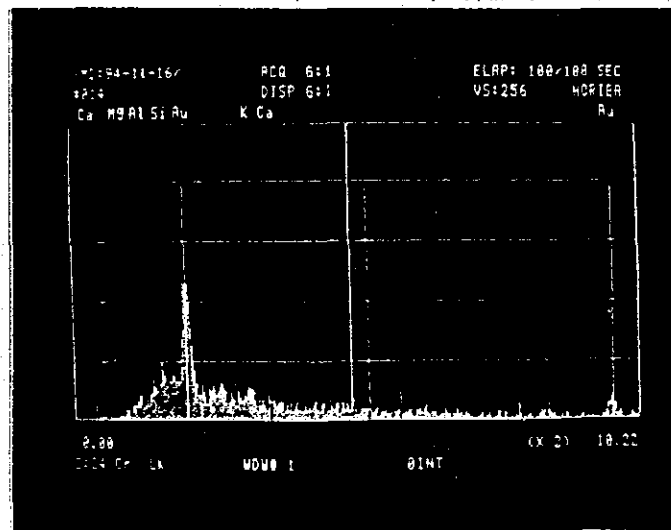
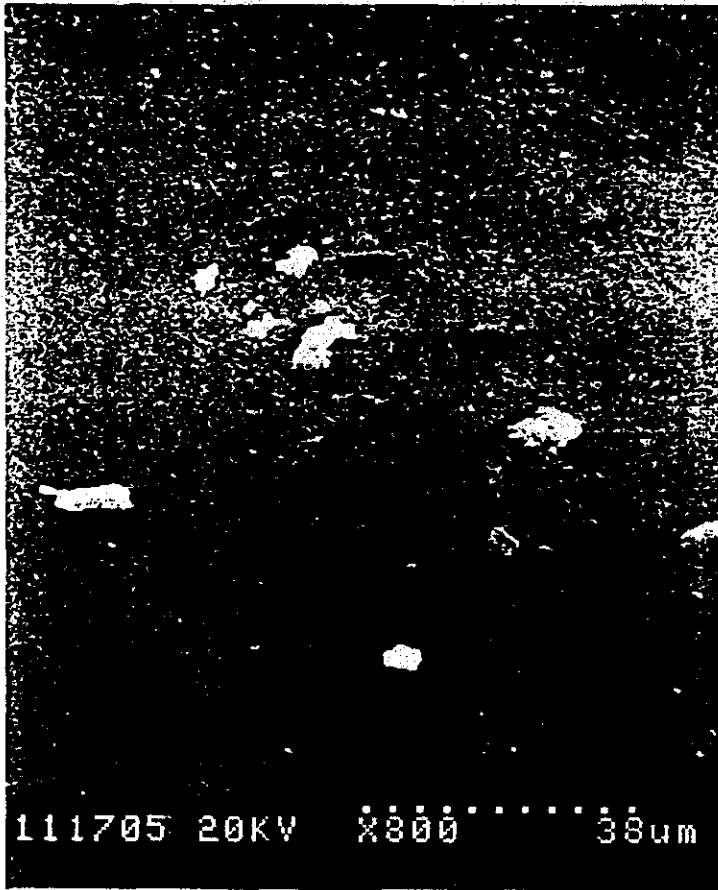
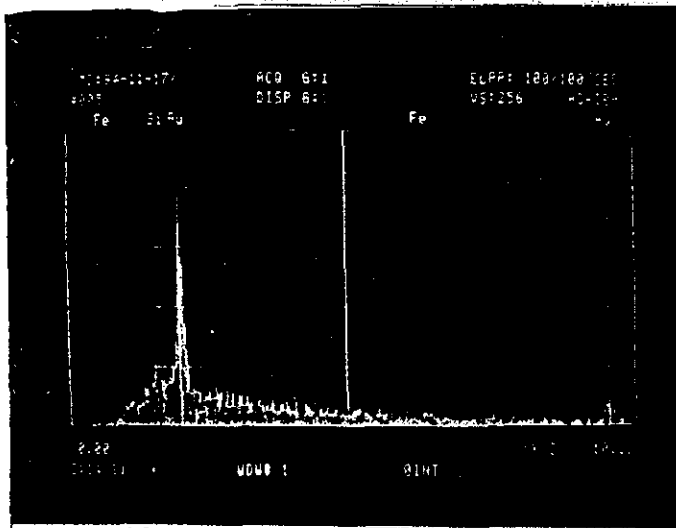
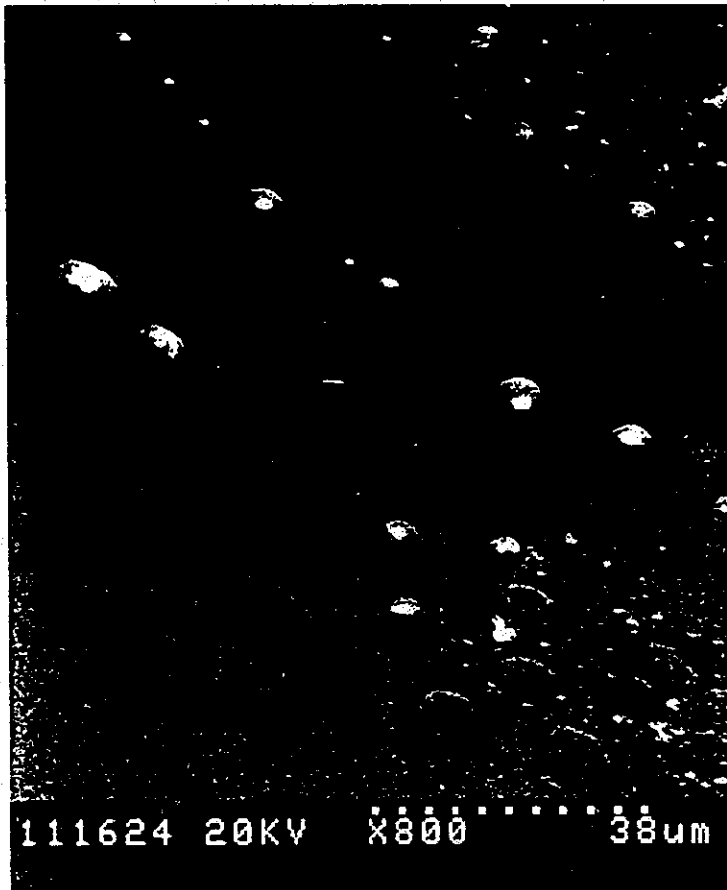
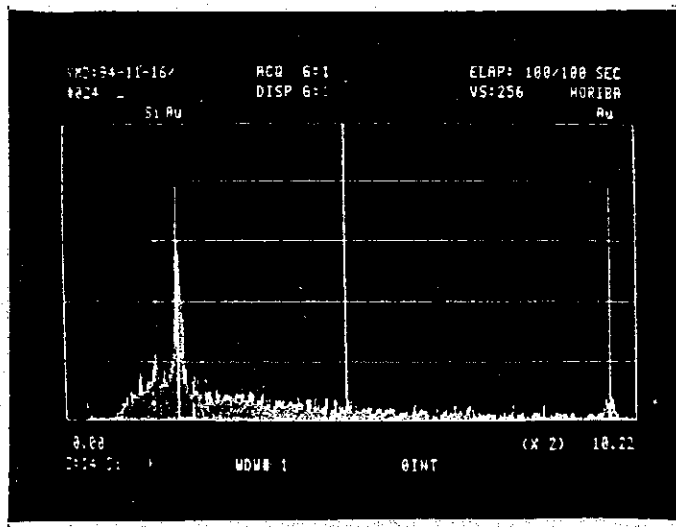
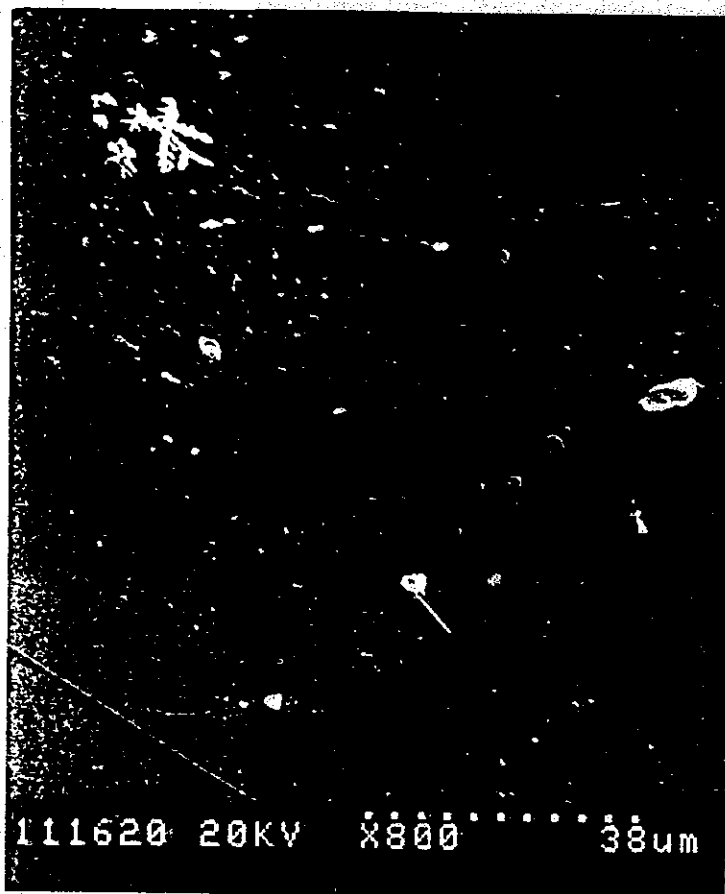
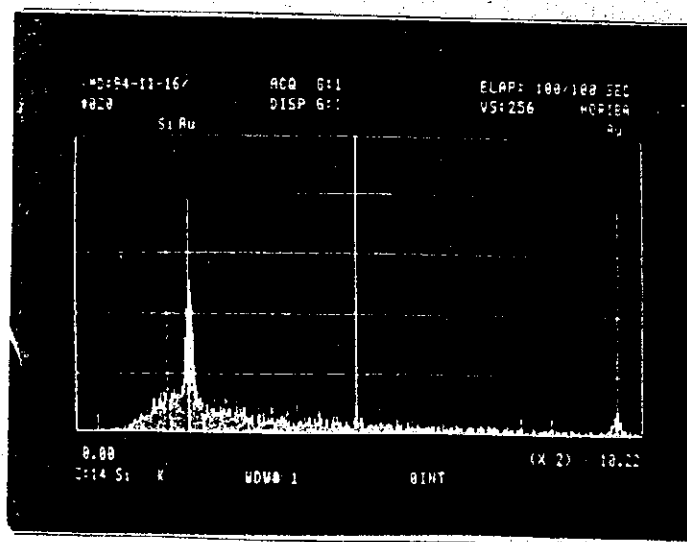
SEM photos and EDX charts of the membrane samples were shown in Figure 2-1(1)~(6) and Figure 2-2(1)~(6). These results showed that no deposition of microorganism significantly existed on the membrane surfaces. Since inorganic foulant also did not exist on the surfaces, so called membrane fouling did not occur.

Also, since the EDX results among the No.(1) to (6) samples showed no remarkable changes, it indicated that no site specific fouling existed on the leaf membrane.
