BASIC DESIGN STUDY REPORT
ON
THE PROJECT FOR THE CONSTRUCTION OF
MULTIPURPOSE CYCLONE SHELTERS (II)
IN
THE PEOPLE'S REPUBLIC OF BANGLADESH

(APPENDIX 6 RESULTS OF SITE CONDITIONS SURVEY
APPENDIX 7 RESULTS OF NATURAL CONDITIONS SURVEY)

JUNE , 1994

JAPAN ENGINEERING CONSULTANTS CO., LTD.

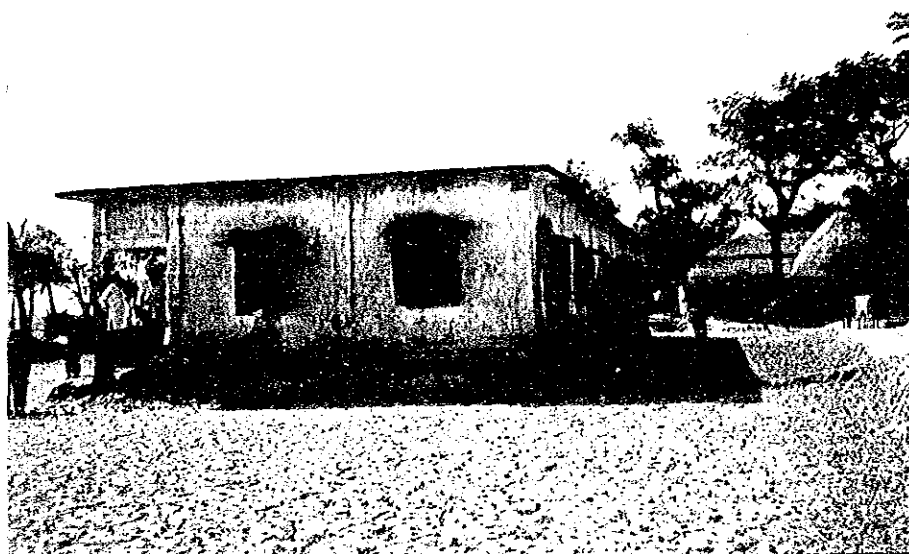
15) Maintenance of Building: Place; *Many cracks on the ceiling, walls and pillars. Roof (Leaking of rain?) - Pillar (Exfoliate of concrete?), Wall (Color painting?), Window (Window door fitting?),*

School building has been severely deteriorated.

Overall View of
the School Building

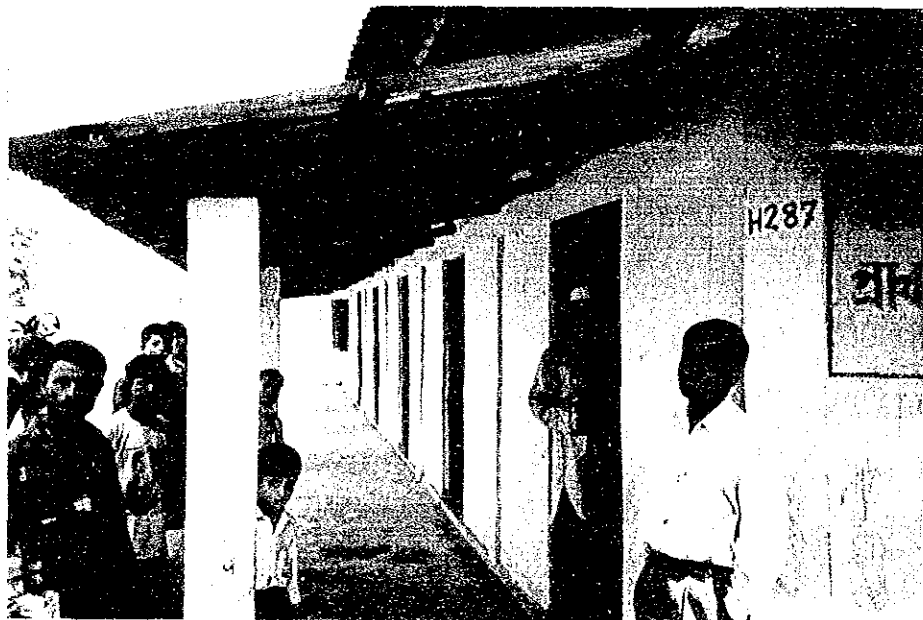
15) Maintenance of Building: Place; *Almost all the roof has been rusted. No exfoliation of concrete?; Wall (color painting?); Wall (color painting?); partially peeling off.*
 Window (Window-door fitting?); *all fitted partially*

View of the School
Building

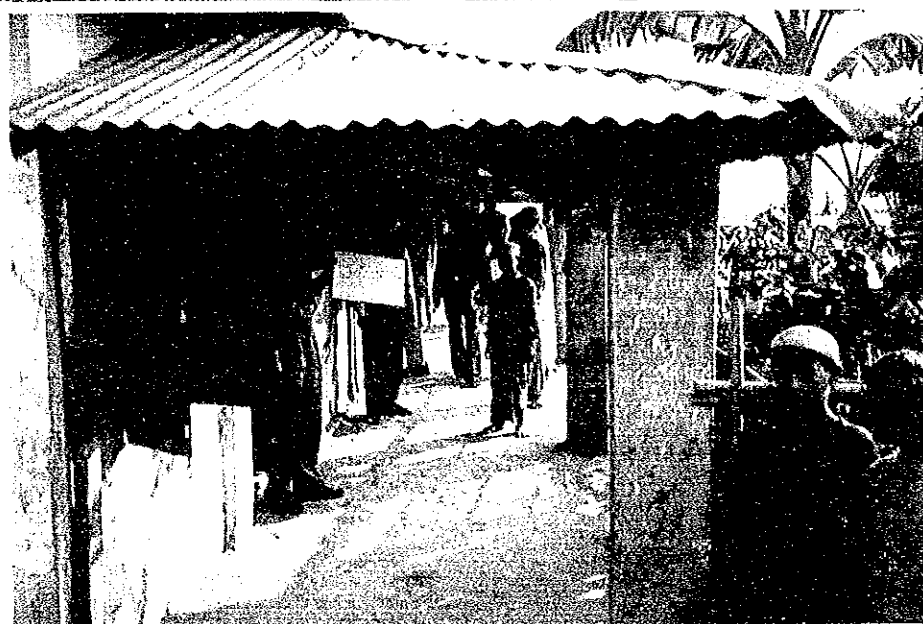
15) Maintenance of Building: Place; Roof (^{almost rusted} Leaking of rain?), Pillar (^{cracks on pillars} Exfoliate of concrete?), Wall (^{peeled off partially} Color painting?), Window (^{all fitted} Window door-fitting?);

View of the School
Building

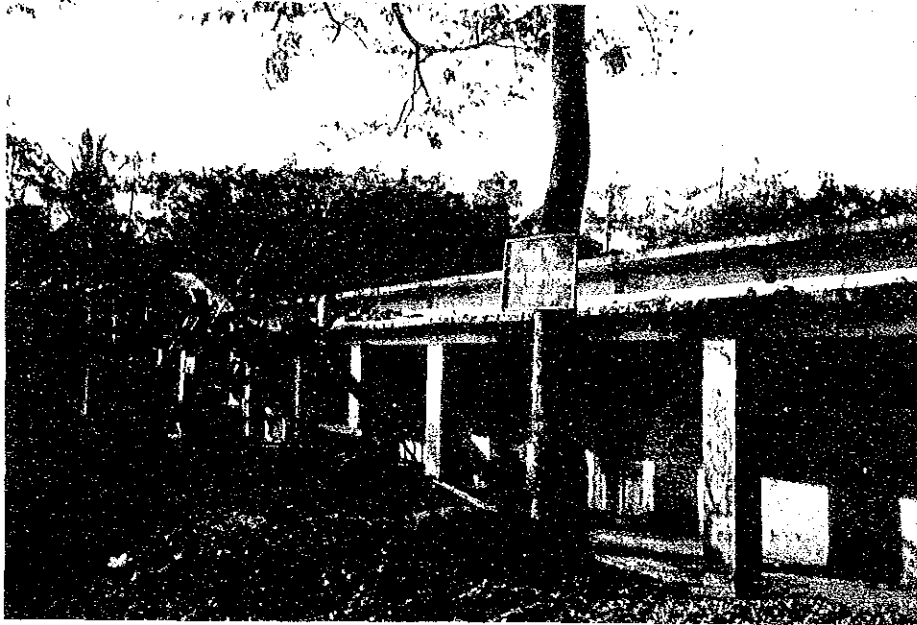
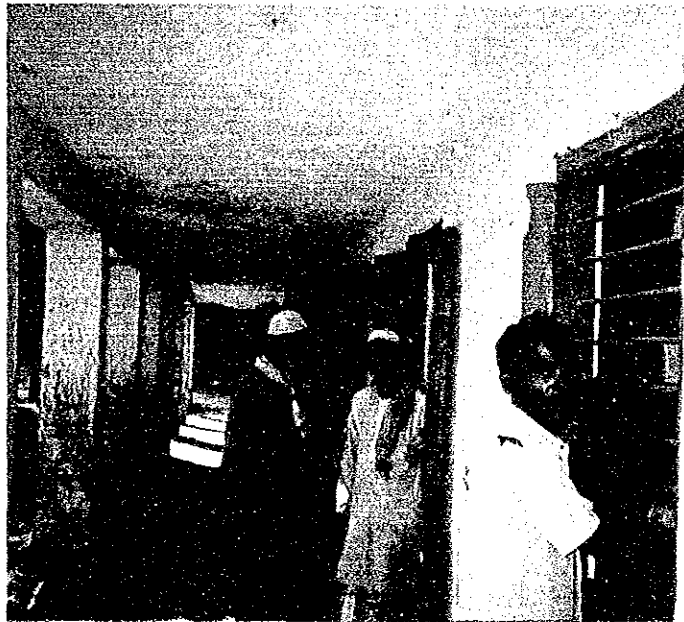
View of the School Building

15) Maintenance of Building: Place; Roof ^{Leakage} (Leaking of rain?), Pillar ^{wood} (Exfoliate of concrete?), Wall ^{Bamboo} (Color painting?), Window ^{all-fitting} (Window door fitting?),
