# SITE SURVEY CHECK LIST

1. Site No. 10
2. Name of School: Harbang G.P.S.
3. Site Location : District; Cox's Bazar Thana ; Chokoria  
Union ; Harbang Village; Harbang
4. Interviewee : Name ; Mr. Badinujjaman  
Head Master of School

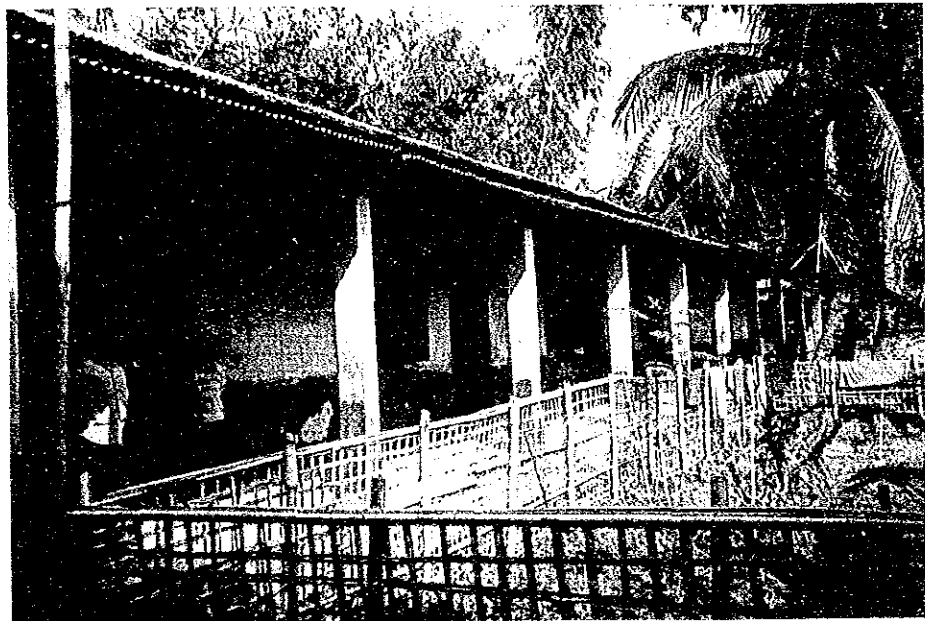
- 3) School Building : / no(s) (Floor Area; 32.8 m x 8.3 m = 322.09 m<sup>2</sup>)
  - 4) Type of Building : RD, Brick, Wooden
  - 5) Building Conditions : Good, Not so good, Bad ( 35 years after built)

15) Maintenance of Building: Place; Roof(<sup>No rust</sup>Leaking-of-rain?), Pillar(<sup>Cracks.</sup>Exfoliate-  
of concrete?), Wall(<sup>Plains/Wall Cracks.</sup>Color-painting?),  
Window(<sup>all-fitted</sup>door-fitting?), Furniture broken

View of the School  
Building

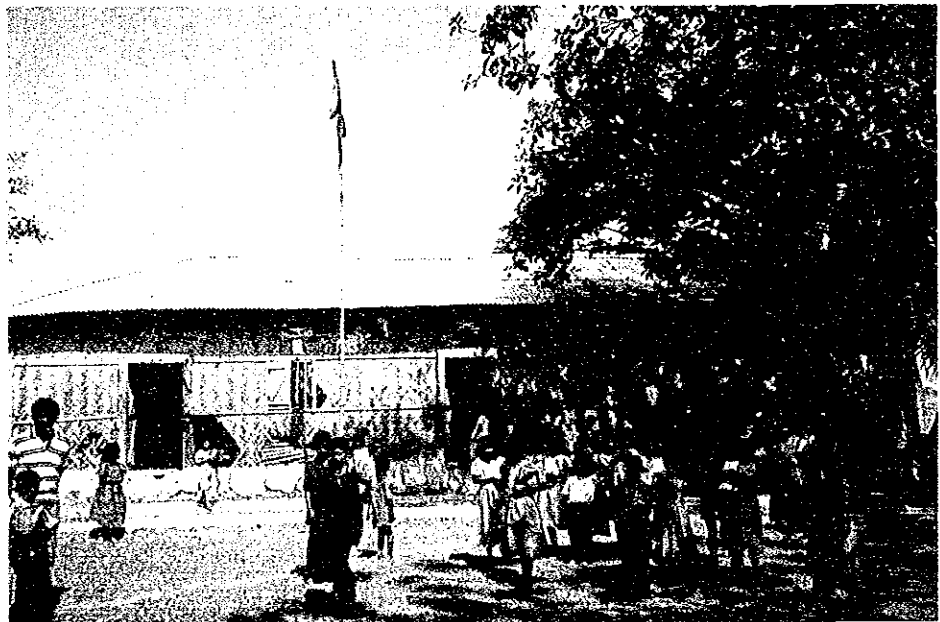
- 4) Type of Building : RC, Brick, Wooden *Bamboo*
  - 5) Building Conditions : Good, Not so good, *Bad* ( - years after built)
  - 6) Layout of Building : Class Room ; *7* nos ( m x m)  
Teacher's Room; *1* no(s) ( m x m)  
Other ; *0* no(s) ( m x m)

15) Maintenance of Building: Place; Roof(Leaking of rain?), Piller(Exfoliate-<sup>Wooden pillars (deteriorated)</sup> of-concrete?), Wall(Exfoliate-<sup>Barbed wall (partially broken)</sup> Color-painting?), Window(<sup>all-fitted</sup>door-fitting?),

Overall View of  
the School Building

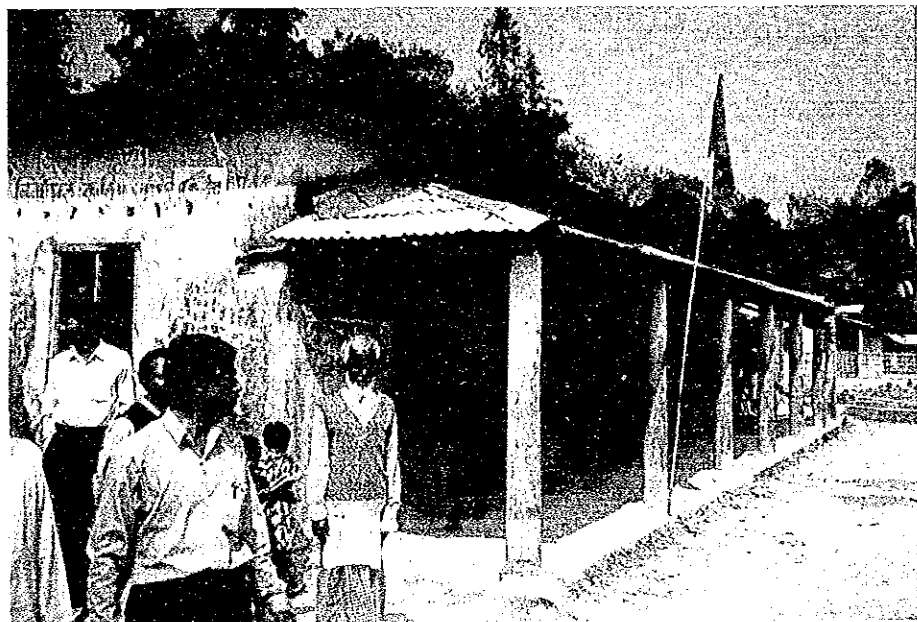
*initially*  
Roof and pillars are peeling off and showing reinforcing bars.  
Roof(Leaking of rain?), Pillar(Exfoliate  
of concrete?), Wall(Color-painting?),  
Window(*all fitted* door-fitting?),  
*Door*

Overall View of  
the School Building

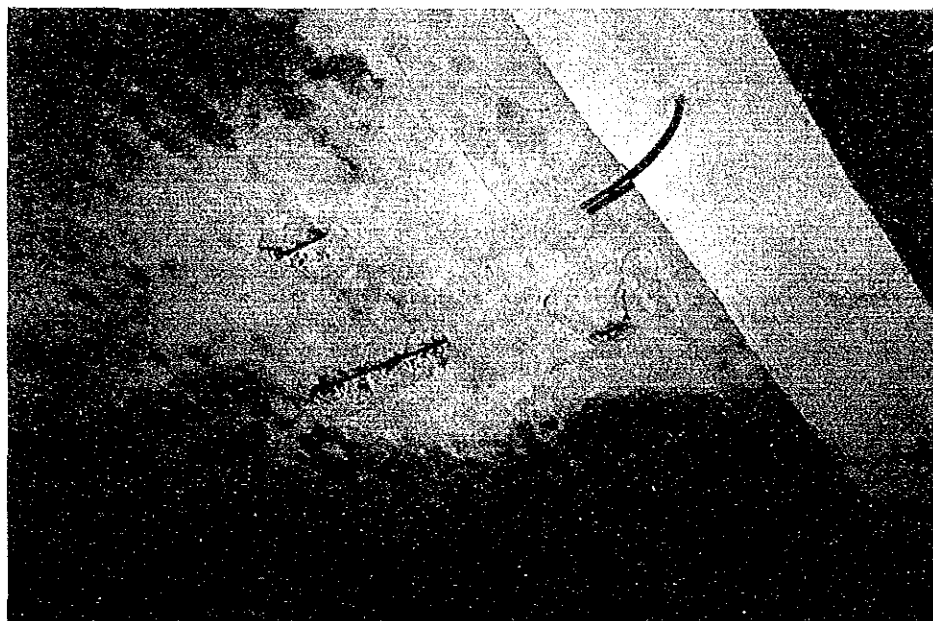
Ceiling of A Classroom

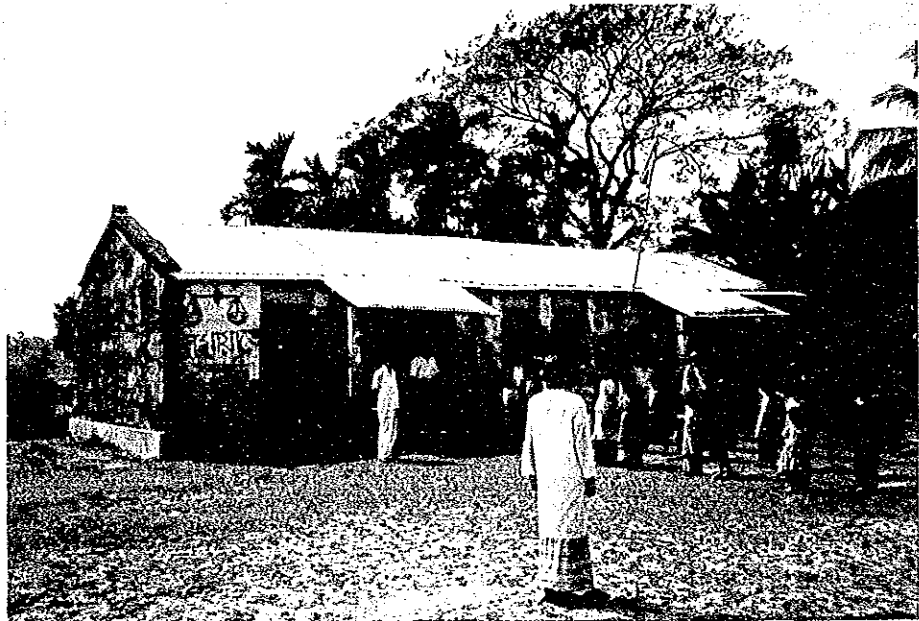
15) Maintenance of Building: Place; Roof (<sup>Partially rusted</sup> ~~leaking of rain?~~), Pillar (<sup>cracked</sup> ~~Exfoliate~~ of concrete?), Wall (<sup>dirty, masonry</sup> ~~Color painting?~~), Window (<sup>ill-fitted</sup> ~~Window-door fitting?~~), <sup>door</sup> ~~furniture broken~~

Overall View of  
the School Building

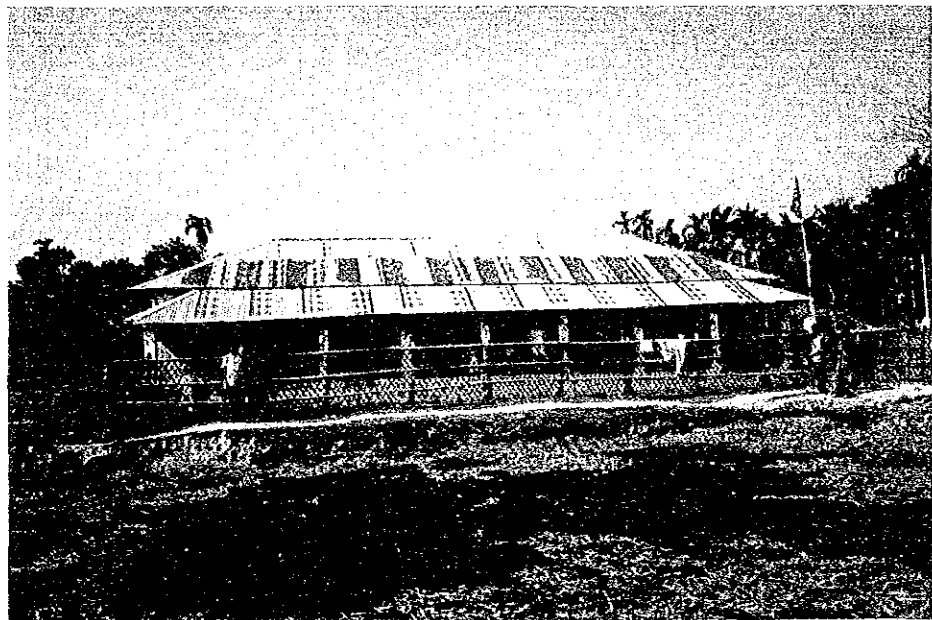
- 15) Maintenance of Building: Place; Roof (Leaking-of-rain?), Pillar (Exfoliate of concrete?), Wall (Color, painting?), Window-door fitting?; *Partially rusted*  
*No Leakage*  
*Some cracks*  
*Painted but dirty, no cleaning*  
*Well-fitted*  
*Door*  
 Method; Name of organization, Organizational unit for maintenance (H.Q. District, Thana or school), Procedure for repair (Requesting, Patrol by engineer-when)  
*No maintenance*  
*School Management Committee*  
*conducted a very minor repair.*  
*by School Management Committee.* **F/D**

Overall View of  
the School Building
