SITE SURVEY CHECK LIST

(Date: 1994/ 2/ 5)

1. Site No. 3/
2. Name of School: Fulchari G. P. S.
3. Site Location : District; Cox's Bazar Thana ; Chokoria
Union ; Khatakhali Village; Fulchari
4. Interviewee : Name : Mr. Ahmad Hossain
Head Master

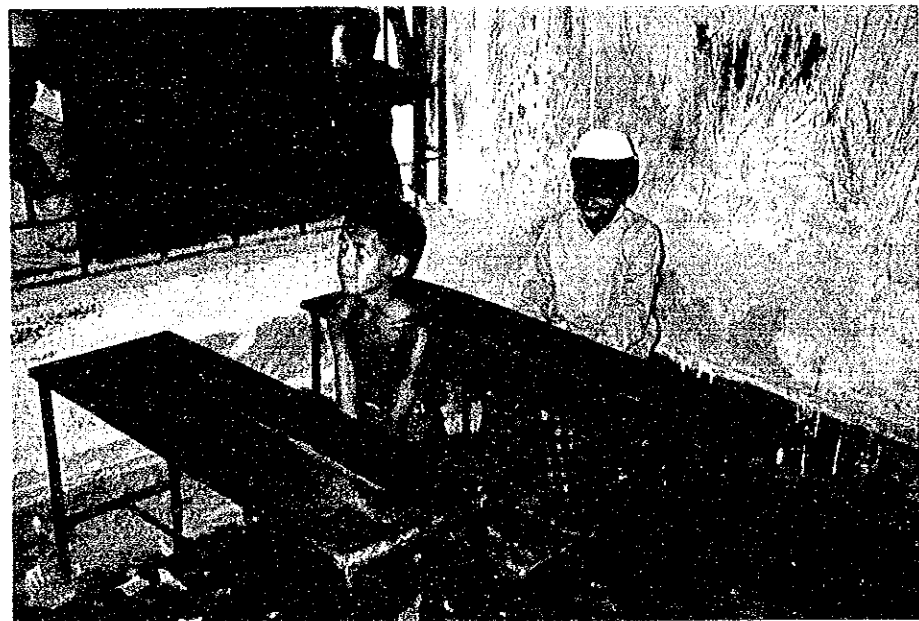
Current Conditions
of A Classroom

destroyed by 1991 cyclone

15) Maintenance of Building: Place; ^{large hole on roof} Roof (Leaking of rain?), Pillar (Exfoliate of concrete?), Wall (Color painting?), Window (Window door-fitting?),

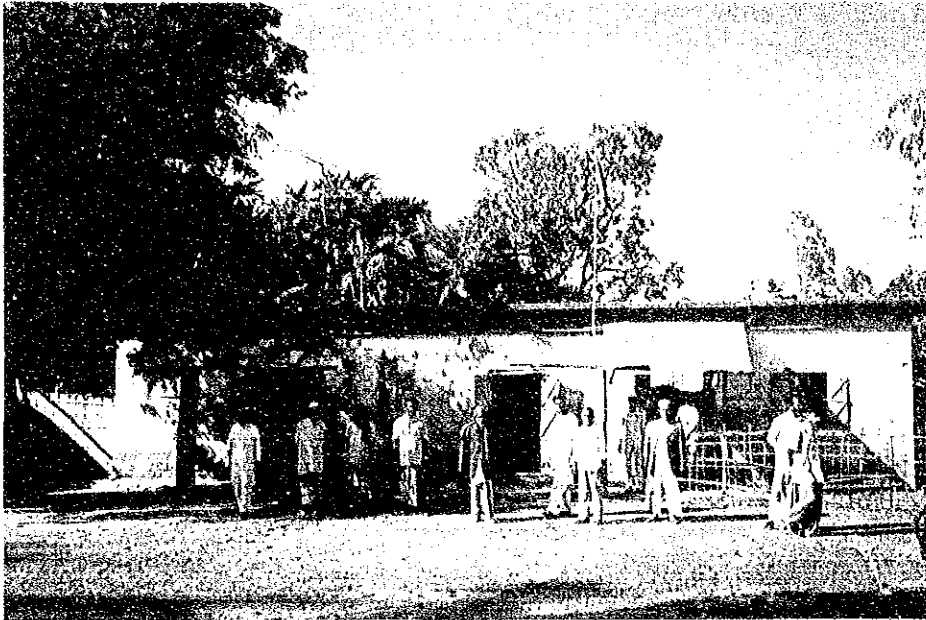
- 5) Building Conditions : Good, *Not so good*, Bad (30 years after built)
 - 6) Layout of Building : Class Room ; / nos (m × m)
Teacher's Room; / no(s) (m × m)
Other ; 0 no(s) (m × m)

View of the School
Building (A)

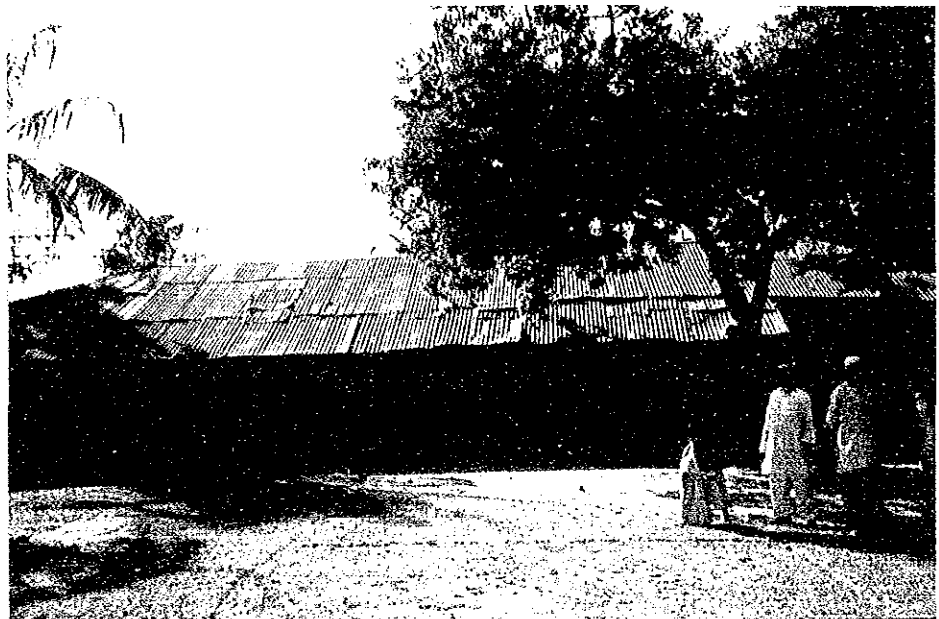
1. School Building (B) is so old that it should be demolished.
2. A access road for construction should be constructed to detour the market area.

View of the School
Building (B)

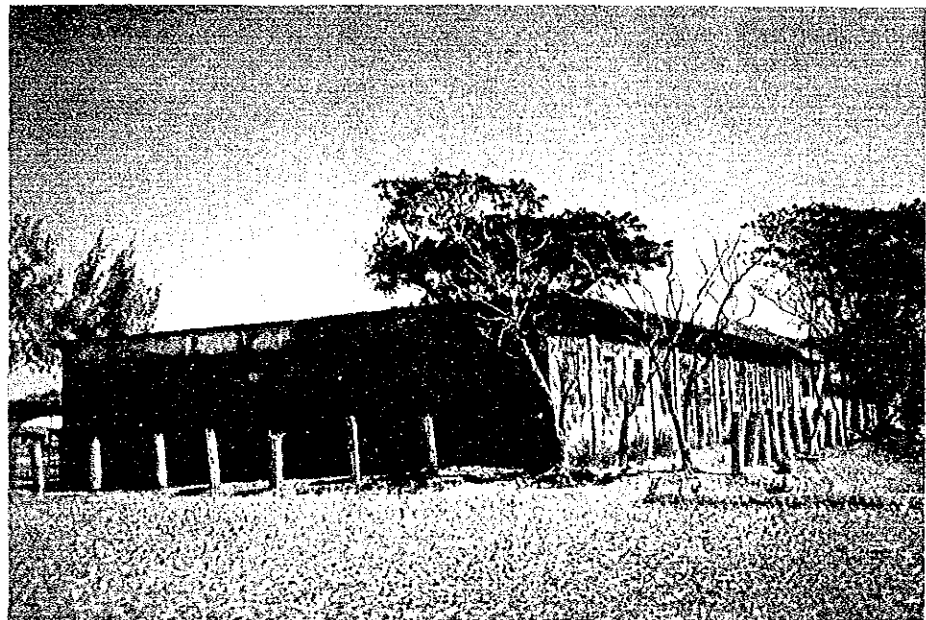
- Primary*
The school building is so deteriorated that it is not used now.
- 15) Maintenance of Building: Place; Roof(Leaking of rain?), Pillar(Exfoliate
of concrete?), Wall(Color painting?), *severely exfoliated*
Window(Window door fitting?), *Wall peeling off*
Method; Name of organization, Organizational LCED
unit for maintenance (H.Q., District, *through then*
Thana or school), Procedure for repair *Educator*
Committee
(Requesting, Patrol by engineer-when)
by School Management Committee

- ☒ *Primary*
The school building is too deteriorated. to be used as
facilities for education. It can be regarded as a abandoned
building.

Overall View of
the School Building

The new shelter-cum-primary school will be constructed
in the newly proposed site.

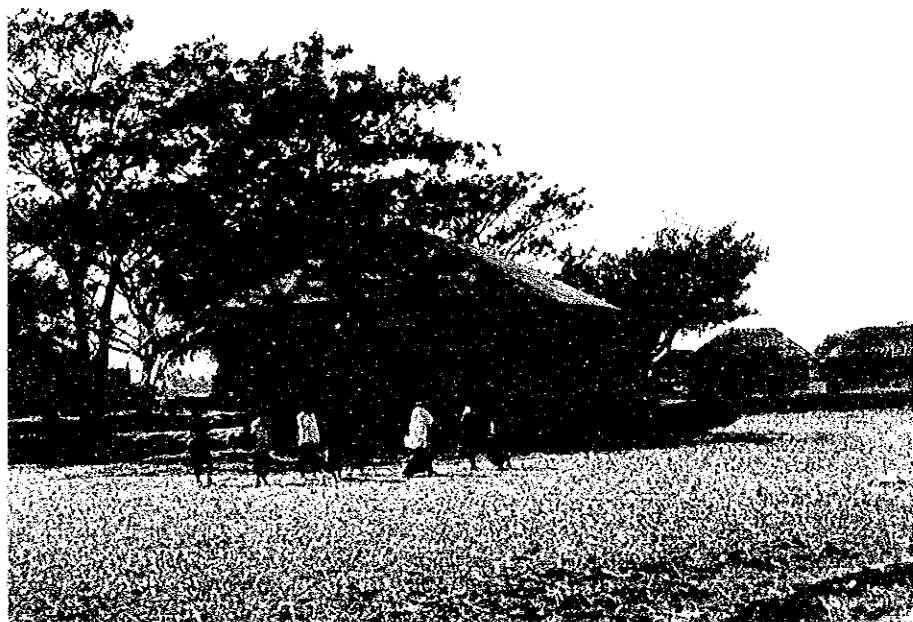
- 5) Building Conditions : Good, Not so good, *Bad* (*20* years after built)
 - 6) Layout of Building : Class Room ; *1* nos (m × m)
Teacher's Room; *0* no(s) (m × m)
Other ; *0* no(s) (m × m)

15) Maintenance of Building: Place; Roof (~~Leaking of rain?~~ ^{Partially rusted}), Pillar (~~Exfoliate~~ ^{Wounded pillar} of concrete?), Wall (Color painting?), Window (~~Window door fitting?~~ ^{Collapsed})
 Method; Name of organization, Organizational ^{Unit of rain blowing in} LGEU unit for maintenance (H.Q., District, ^{through Thana Education} Thana or school), Procedure for repair ^{committee} (Requesting, Patrol by engineer=when) ^{by School Management Committee}

Overall View of
the School Building

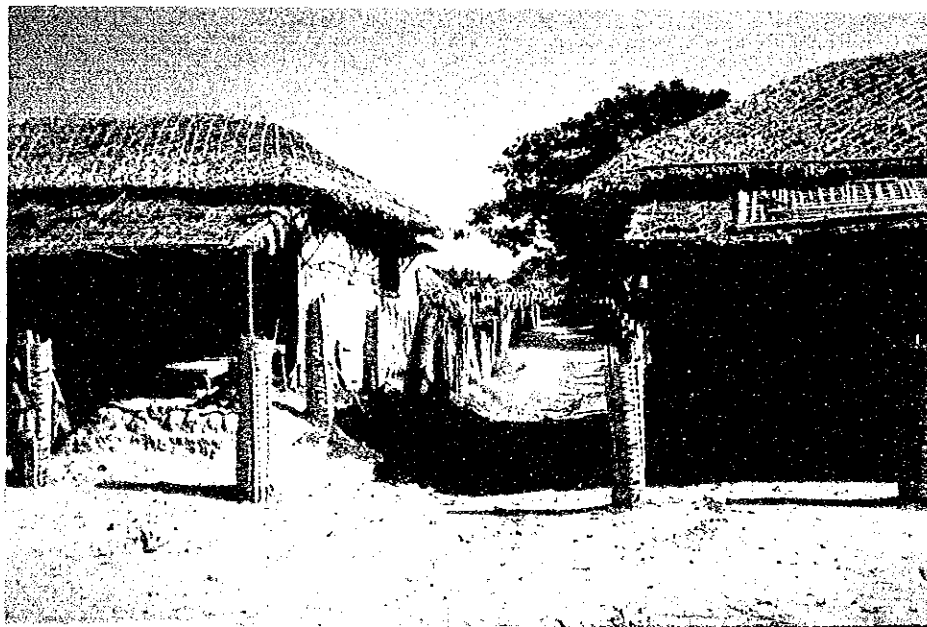
Road Conditions
near the Site

- Condition of Pavement: Good, Not so good, Bad,
 - Road Width : 2.5 m
 - Passable Vehicle: Motor cycle, Rikisha, Sedan, Jeep, Truck (10 ton)
 - Necessity for Repair of Road: Yes, No,
