サイト状況確認調査チェック・リスト

1. Site No. 18
2. Name of School: *Rahmaterbill G.P.S.*
3. Site Location : District; *Cox's Bazar* Thana ; *Ukhia*
 Union ; *Rahmaterbill* Village; *Rahmaterbill*

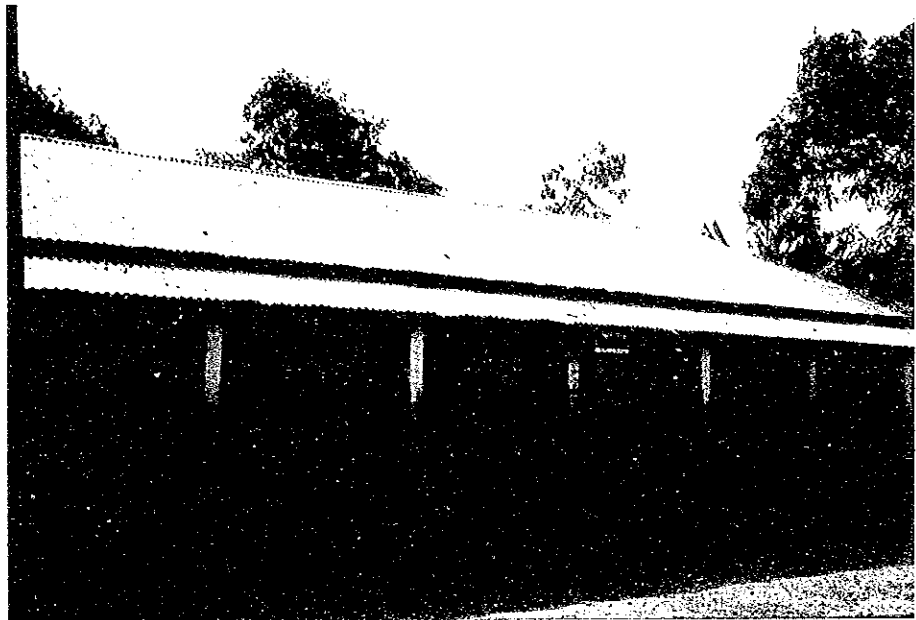
校舎風景

15) Maintenance of Building: Place; Roof (^{No rust} ~~Leaking of rain?~~), Pillar (^{No crack} ~~Exfoliate of concrete?~~), Wall (^{well painted} ~~Color painting?~~), Window (^{well-fitted} ~~door-fitting?~~),
 Method; Name of organization, Organizational ^{USED} unit for maintenance (H.Q., District ^{Thana} or school), Procedure for repair ^{Thana Education Committee} (Requesting, Patrol by engineer=when)

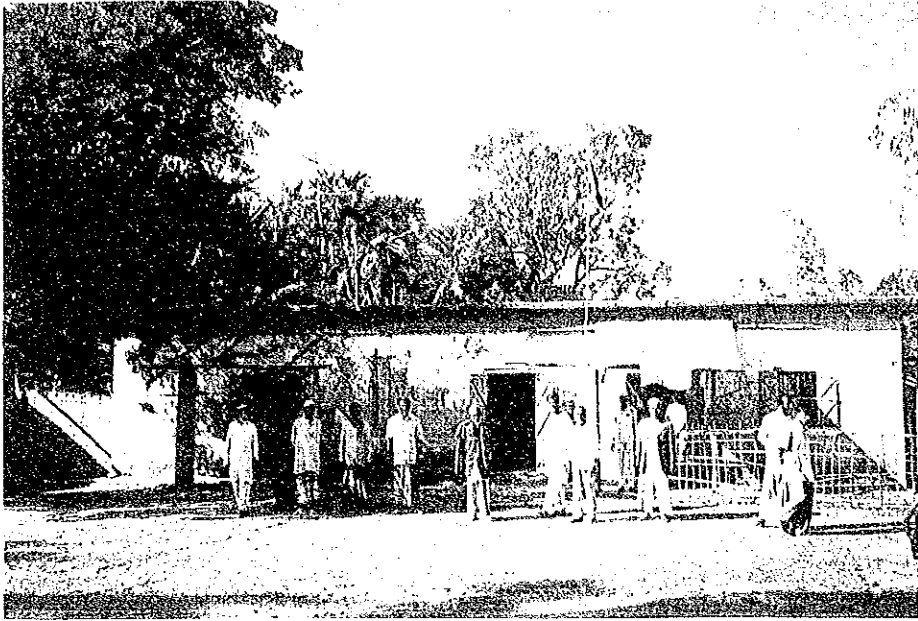
15) Maintenance of Building: Place; Roof (^{no leakage} Leaking or rain?), Piller (^{no efflorescence} Efflorescence of concrete?), Wall (^{peeled but dirty, w. cleaned} Color painting?), Window (^{with filled} Window door fitting?),
 Method; Name of organization, Organizational ^{DPO} LGED unit for maintenance (H.Q., District, ^{Thana Educational Committee} Thana of school), Procedure for repair (Requesting, Patrol by engineer-when)

校舎全景(A)

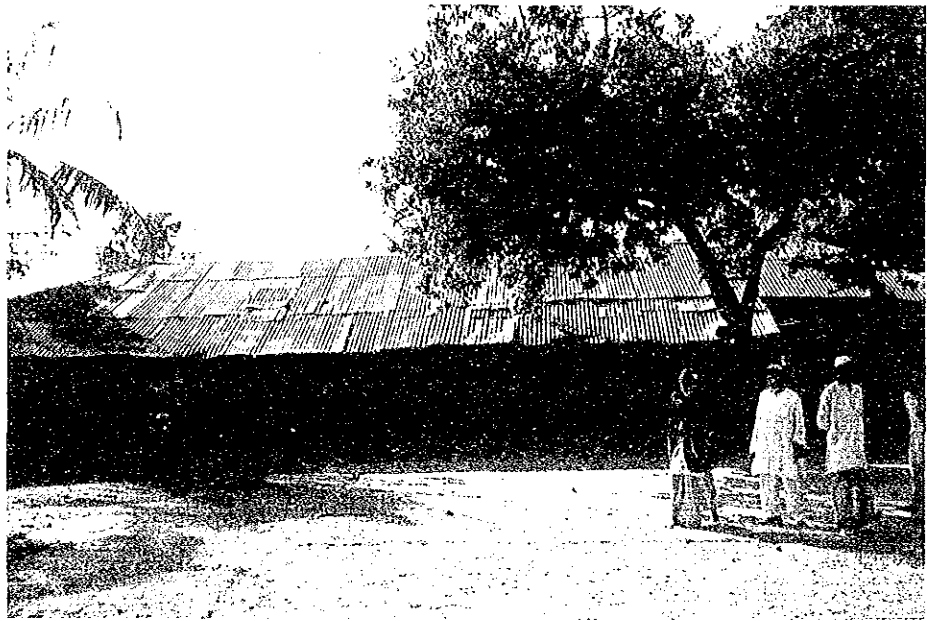
校舎全景(B)

1. School Building (B) is so old that it should be demolished.
2. A access road for construction should be constructed to detour the market area.

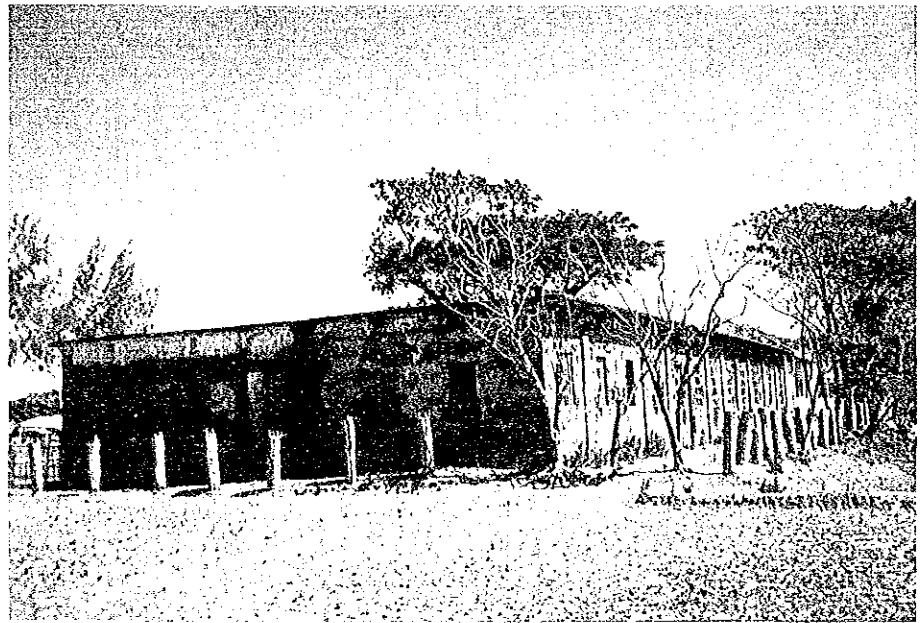
Primary
 The school building is so deteriorated that it is not used now.
 15) Maintenance of Building: Place; Roof (Leaking of rain?), Pillar (Exfoliate of concrete?), Wall (Color painting?), Window (Window-door fitting?),
 Method; Name of organization, Organizational unit for maintenance (H.Q., District, Thana or school), Procedure for repair (Requesting, Patrol by engineer-when)
severely ex-foliated
Wall peels off
Roof broken
through than Education Committee
by School Management Committee

Primary
 The school building is too deteriorated to be used as facilities for education. It can be regarded as a abandoned building.

校舎全景

The new shelter-cum-primary school will be constructed in the newly proposed site.

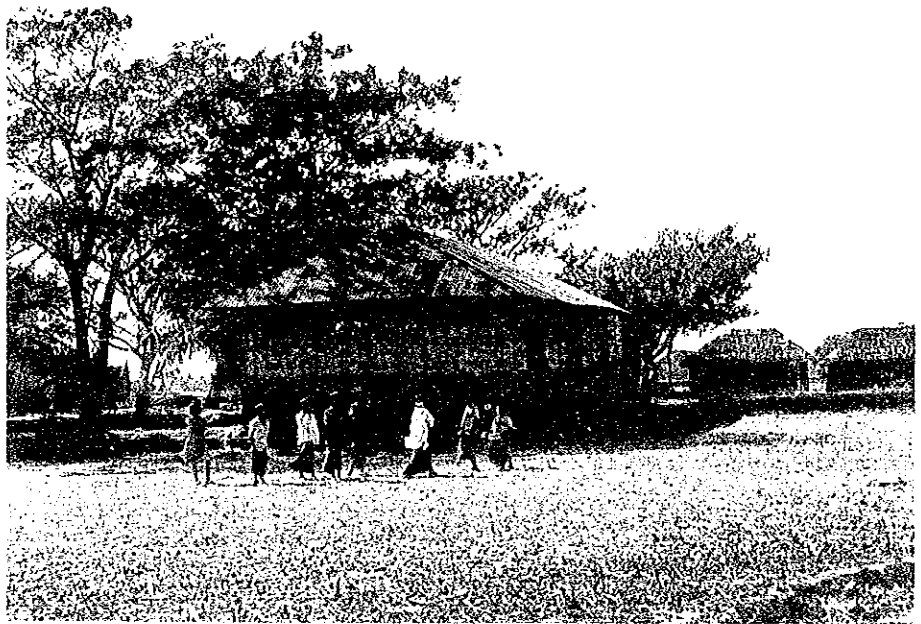
15) Maintenance of Building: Place; Roof (~~Leaking of rain?~~ ^{Partially rusted}), Pillar (~~Exfoliate~~ ^{Wooded pillar} of concrete?), Wall (~~Color-painting?~~ ^{Collapsed}), Window (~~Window door fitting?~~ ^{No windows})
 Method; Name of organization, Organizational unit for maintenance (H.Q., District, Thana or school), Procedure for repair (~~Requesting~~ ^{Requesting through Thana Education Committee}), Patrol by engineer=~~when~~ ^{by School Management Committee}

校舎全景

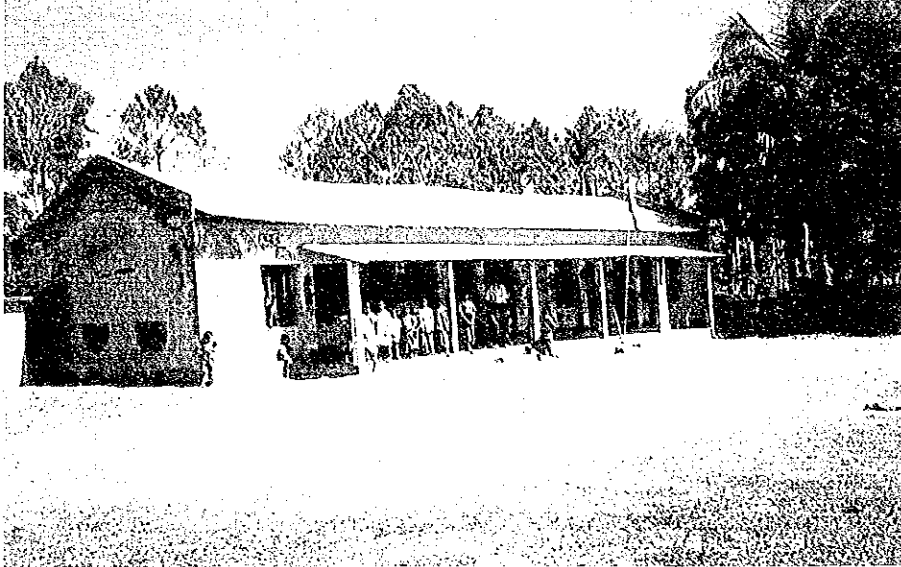
15) Maintenance of Building: Place; Roof (^{no rust, no leakage} Leaking of rain?), Pillar (^{no exfoliation} Exfoliate of concrete?), Wall (^{Painted but no clearing} Color painting?), Window (^{all fitted} Window door fitting?),
 Method; Name of organization, Organizational LGED unit for maintenance (H.Q., District, ^{through Thane Education Committee} Thana or school), Procedure for repair (Requesting, Patrol by engineer=when) ^{by School Management Committee}

校舎全景
