FEASIBILITY STUDY  
ON  
PAN-PHILIPPINE HIGHWAY REHABILITATION PROJECT  
(MINDANAO SECTION)

FINAL REPORT  
EXECUTIVE SUMMARY

MAY 1995

KATAHIRA & ENGINEERS INTERNATIONAL  
NIPPON ENGINEERING CONSULTANTS CO., LTD.

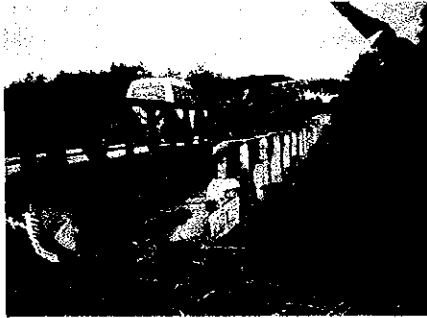
**PANAYTAY BRIDGE: SUPERSTRUCTURE  
NO LONGER FUNCTIONING**

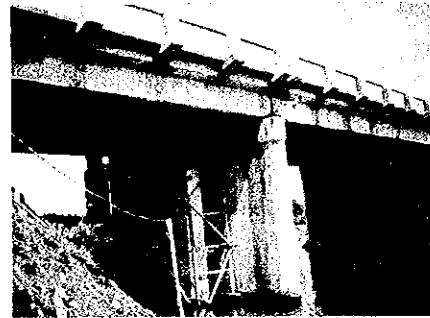
**LIBOGANON BRIDGE: SUFFERING  
FROM PIER SETTLEMENT**

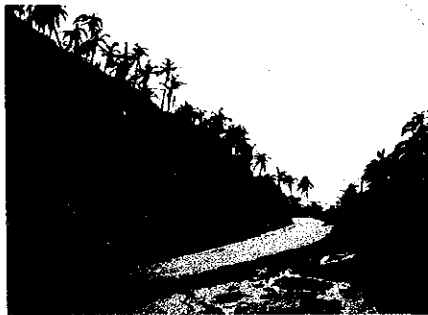
**Cut slope failures** are found in Surigao del Norte, Agusan del Norte, Davao del Norte and Davao City. The disaster slopes located in Surigao del Norte and Agusan del Norte are composed of igneous rock, mainly andesite, while those in the southern sections are composed of Tertiary rocks such as sandstone, mudstone and tuff, and/or gravely or sandy soil that were produced from the heavily weathered Tertiary rocks. Slopes are mostly inclined at an angle of 30 degrees or more regardless of their height. Since no slope protection work is provided on unstable slopes with steep gradient, surface failures have been often occurred.

**CUT SLOPE FAILURE IN  
SURIGAO DEL NORTE**

- Recutting of slope to stable gradient is an effective and economical way for cut slope failure if applicable. In addition, it is recommended to protect the cut slope surface by some measure such as vegetation, concrete spraying, concrete crib, etc. depending on surface material. Catch work is a possible alternative where enough space is available on hill side.

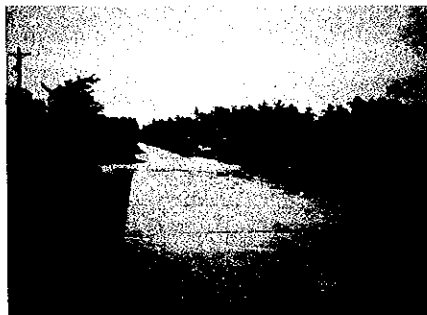
**FLOOD SECTION IN AGUSAN  
DEL NORTE. OVERFLOWED  
WATER FROM THE RIVER  
FLOODED THE HIGHWAY.**

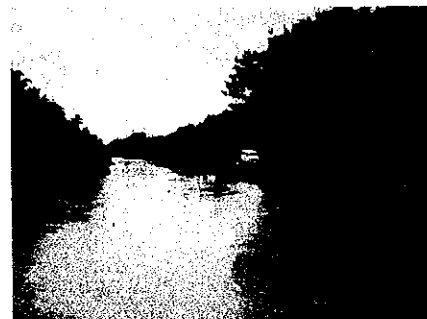
**FLOOD SECTION NEAR LIBOGANON  
BRIDGE IN DAVAO DEL NORTE.  
THE SECTION SUBMERGED 3 HOURS  
AFTER THIS PHOTO WAS TAKEN.**
