Table 3 - 13 Analyses of Remaining Life of Runner Buckets (1/3)

FEASIBILITY STUDY ON
REHABILITATION OF DA NHIM
POWER SYSTEM

MINISTRY OF ENERGY
JAPAN INTERNATIONAL COOPERATION AGENCY

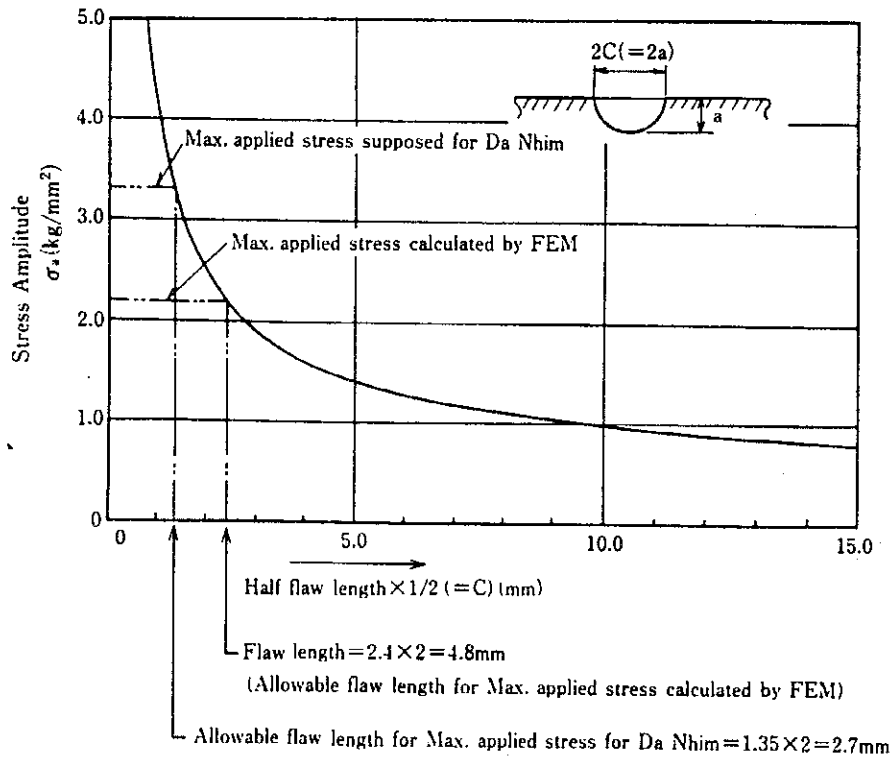
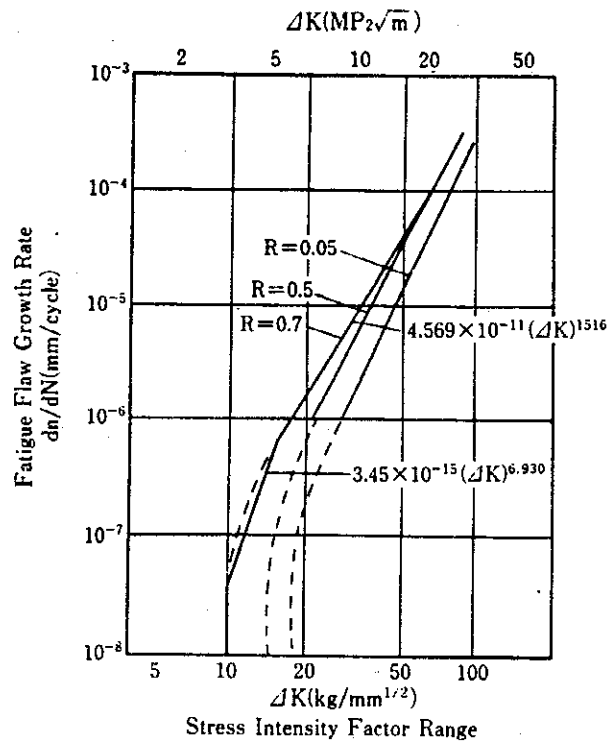
Fatigue Flaw Growth Curves for 13Cr~4Ni Stainless Steel Casting

d) Allowable crack length : 2.7 mm

Note: From relation curve between allowable crack length and stress amplitude shown in Figure 3.6, the allowable crack length was estimated.

The frequency of stress cycle to be extended the existing crack up to overall root length of runner is estimated using the fatigue crack growth curve in Figure 3.6.

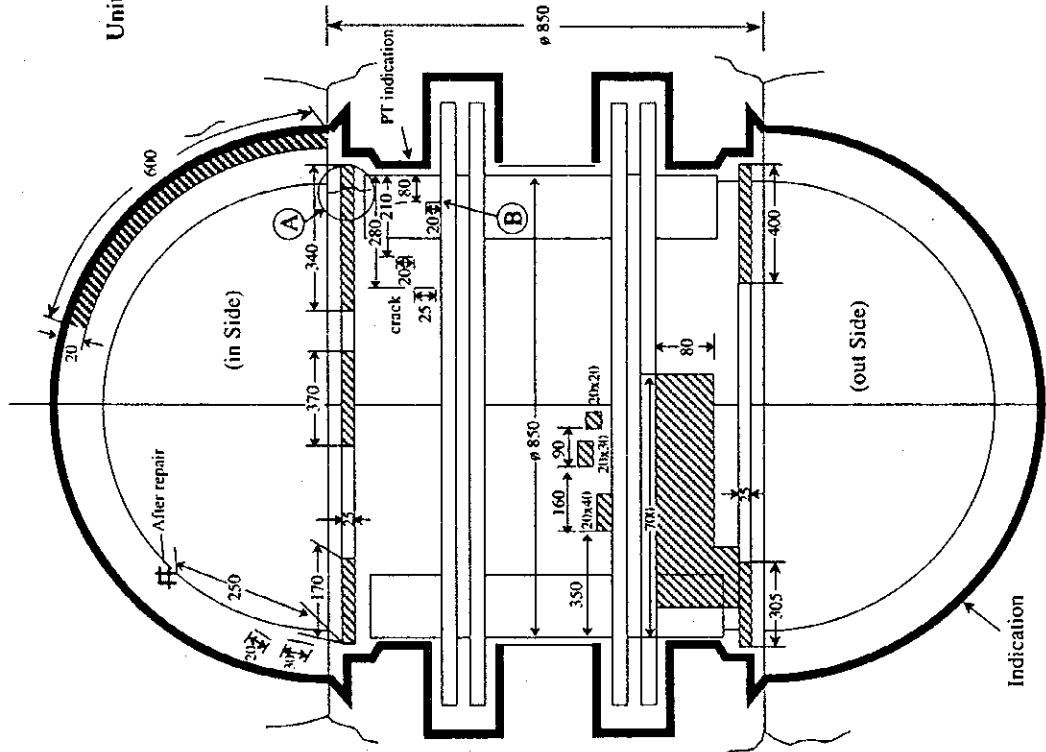
Figure 4.1
 Liquid Penetrant and Ultrasonic
 Examination Record

However, a deficit of the white metal of about 43 mm long exists on the upper part of the bearing metal on the turbine side of No.4 unit. Large crunched defects were observed on the spherical bearing on both turbine and exciter sides of No.2 and No.4 units. The defects might have been made in the time of disassembly and reassembly of the facilities.

The interior surface of the white metal, and joining parts between the bearing base metal and the white metal were inspected by the liquid penetrant examination. The examination found the defects of more than 1 mm depth on the white metals of the turbine side of No.2 unit, on the metals of the turbine side and the exciter side of No.4 unit.

Whole surface of the white metal was inspected by means of the pulse reflection. No bubbles or detachments beyond the allowable values were found on the lower part except defects beyond twice the allowable value on the upper metal of the turbine side of No.2 and No.4 units as seen in Figure 4.1.

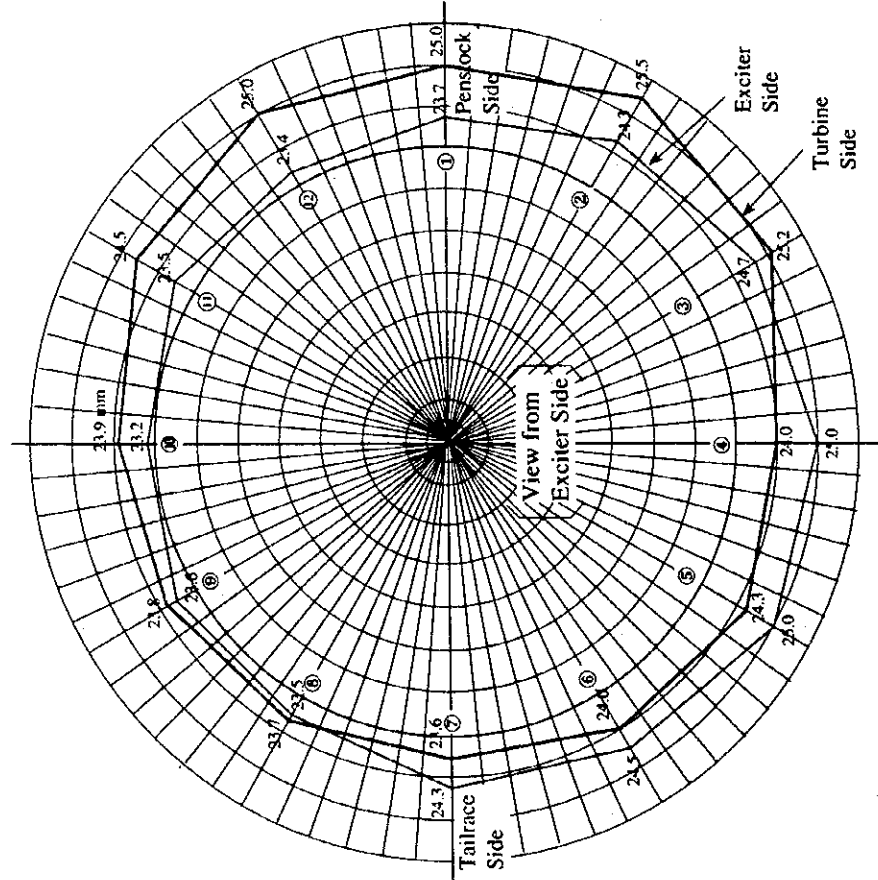
UNIT No. 1

Average Air Gap

Turbine side : 24.38 mm
Exciter side : 24.06 mm

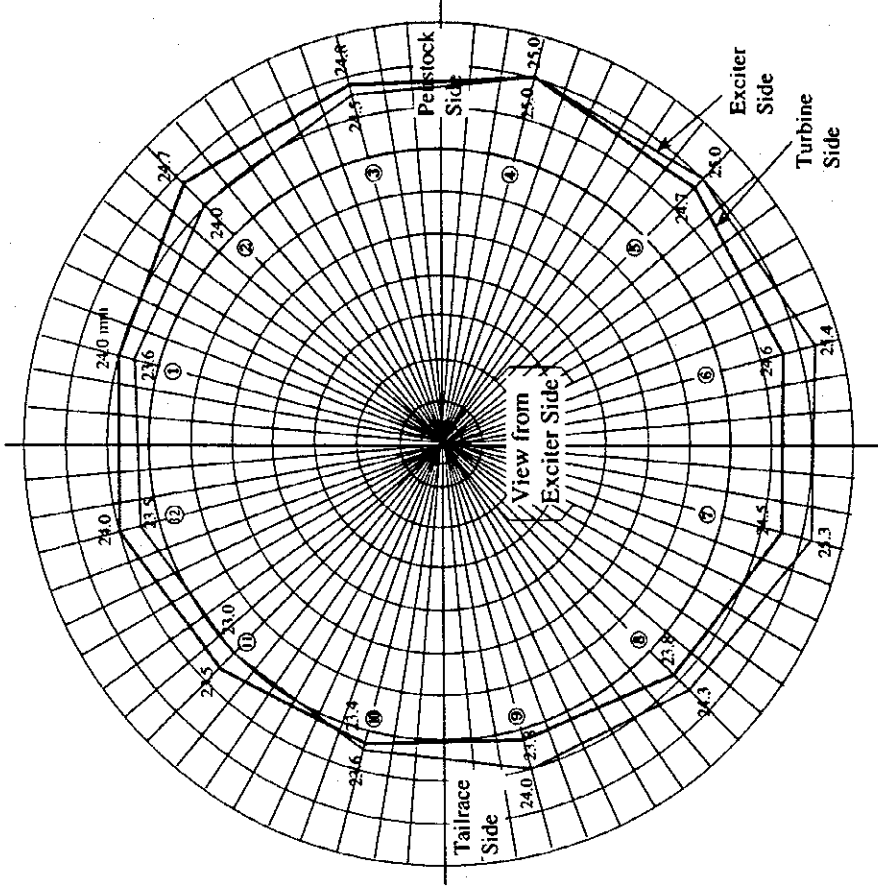
UNIT No. 2

Average Air Gap

Turbine side : 24.19 mm
Exciter side : 24.27 mm
