FEASIBILITY STUDY ON
REHABILITATION OF DA NHIM
POWER SYSTEM

CHAPTER 6

DAM AND CIVIL STRUCTURES

CHAPTER 6 DAM AND CIVIL STRUCTURES

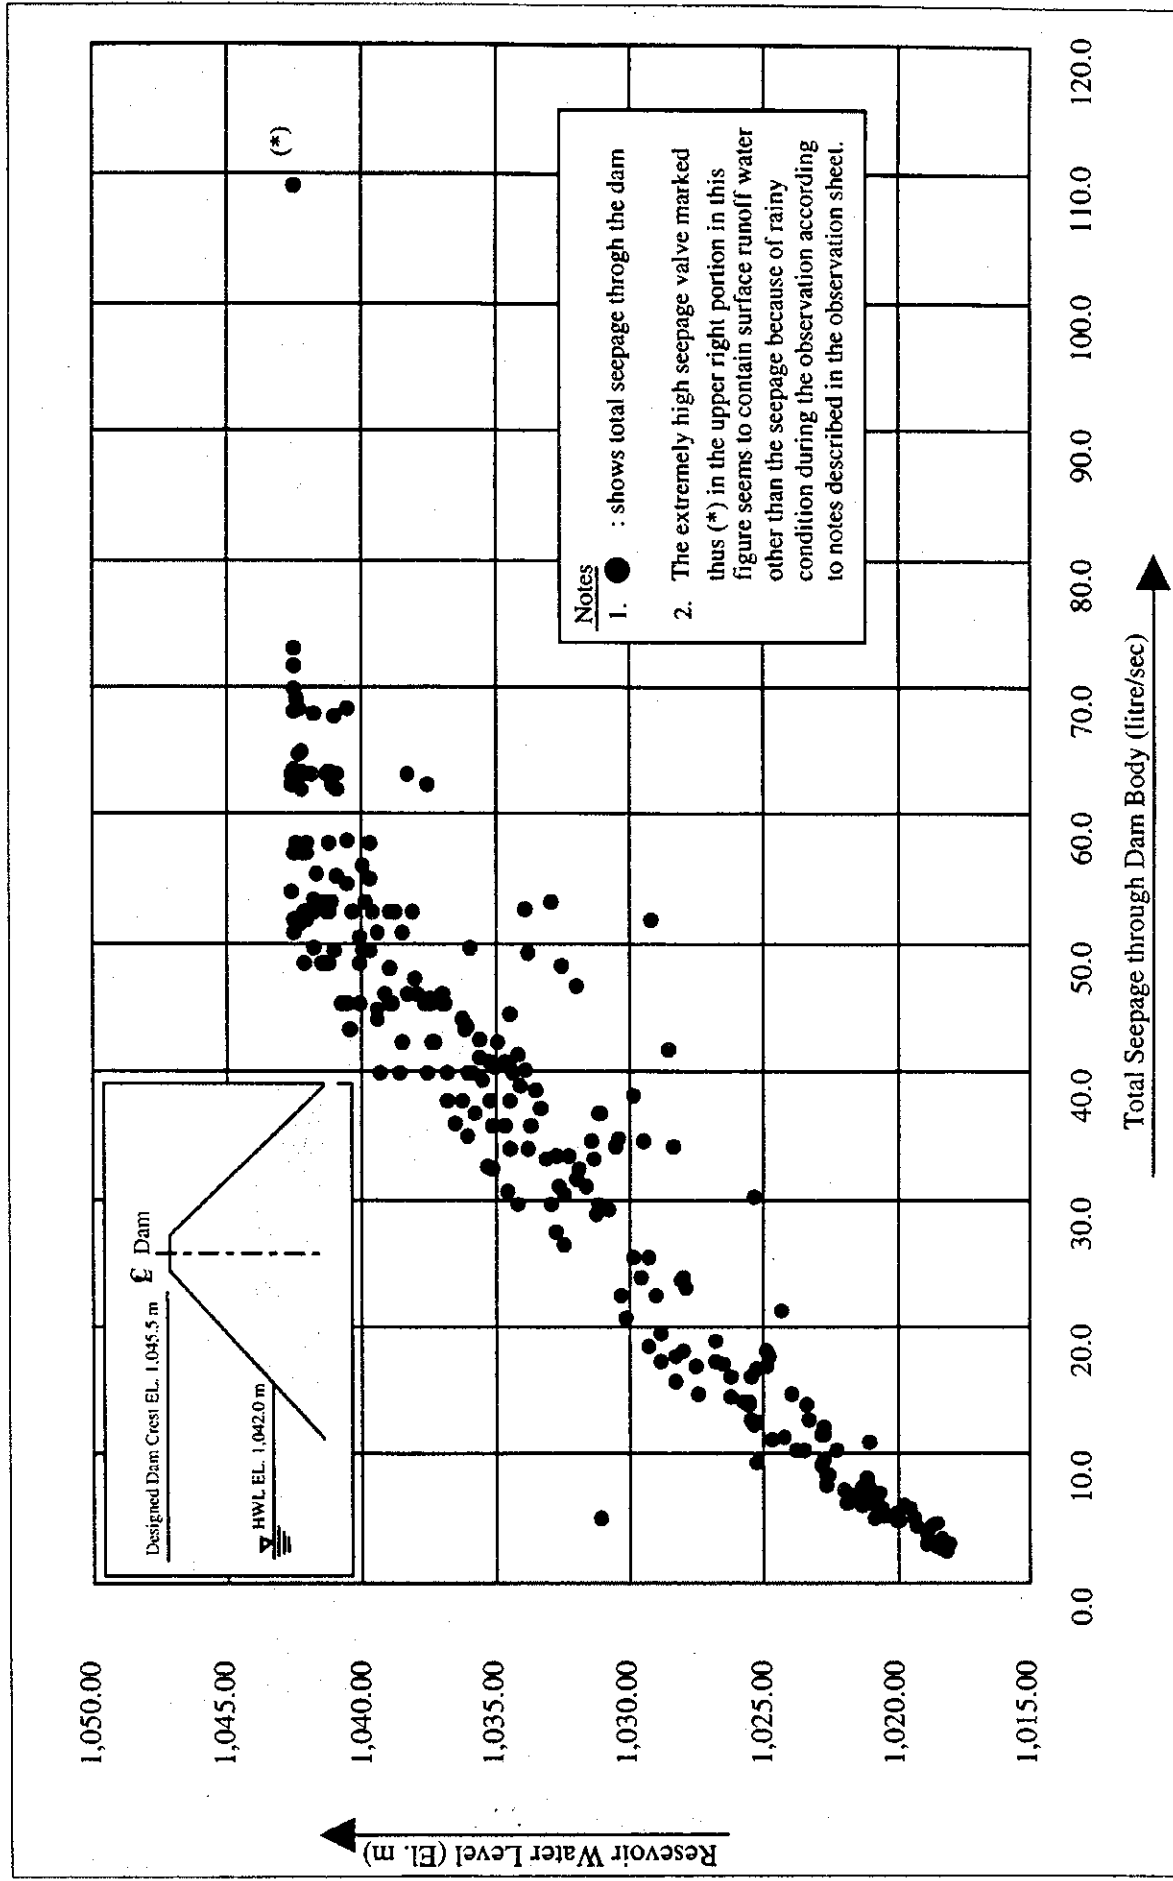
Figure 6.9
 Relation between Reservoir Water Level and Total Seepage through Dam

Figure 6.9 illustrates the relation between the reservoir water level and the total seepage through the dam which were measured between November 1980 and July 1994. As seen in the Figure, the total seepage volumes are mostly less than 80 litres/sec, excepting one record which seems to include rain water drained from the downstream area of the dam, according to the weather condition at the time of the measurement which is stated in the recording sheet provided by the Da Nhim P/S office. In addition, the total seepage volumes through the dam are wholly less than 180 litres/sec, which was estimated in the original design of the dam on the condition that the reservoir water level is equal to the high water level (HWL : EL.

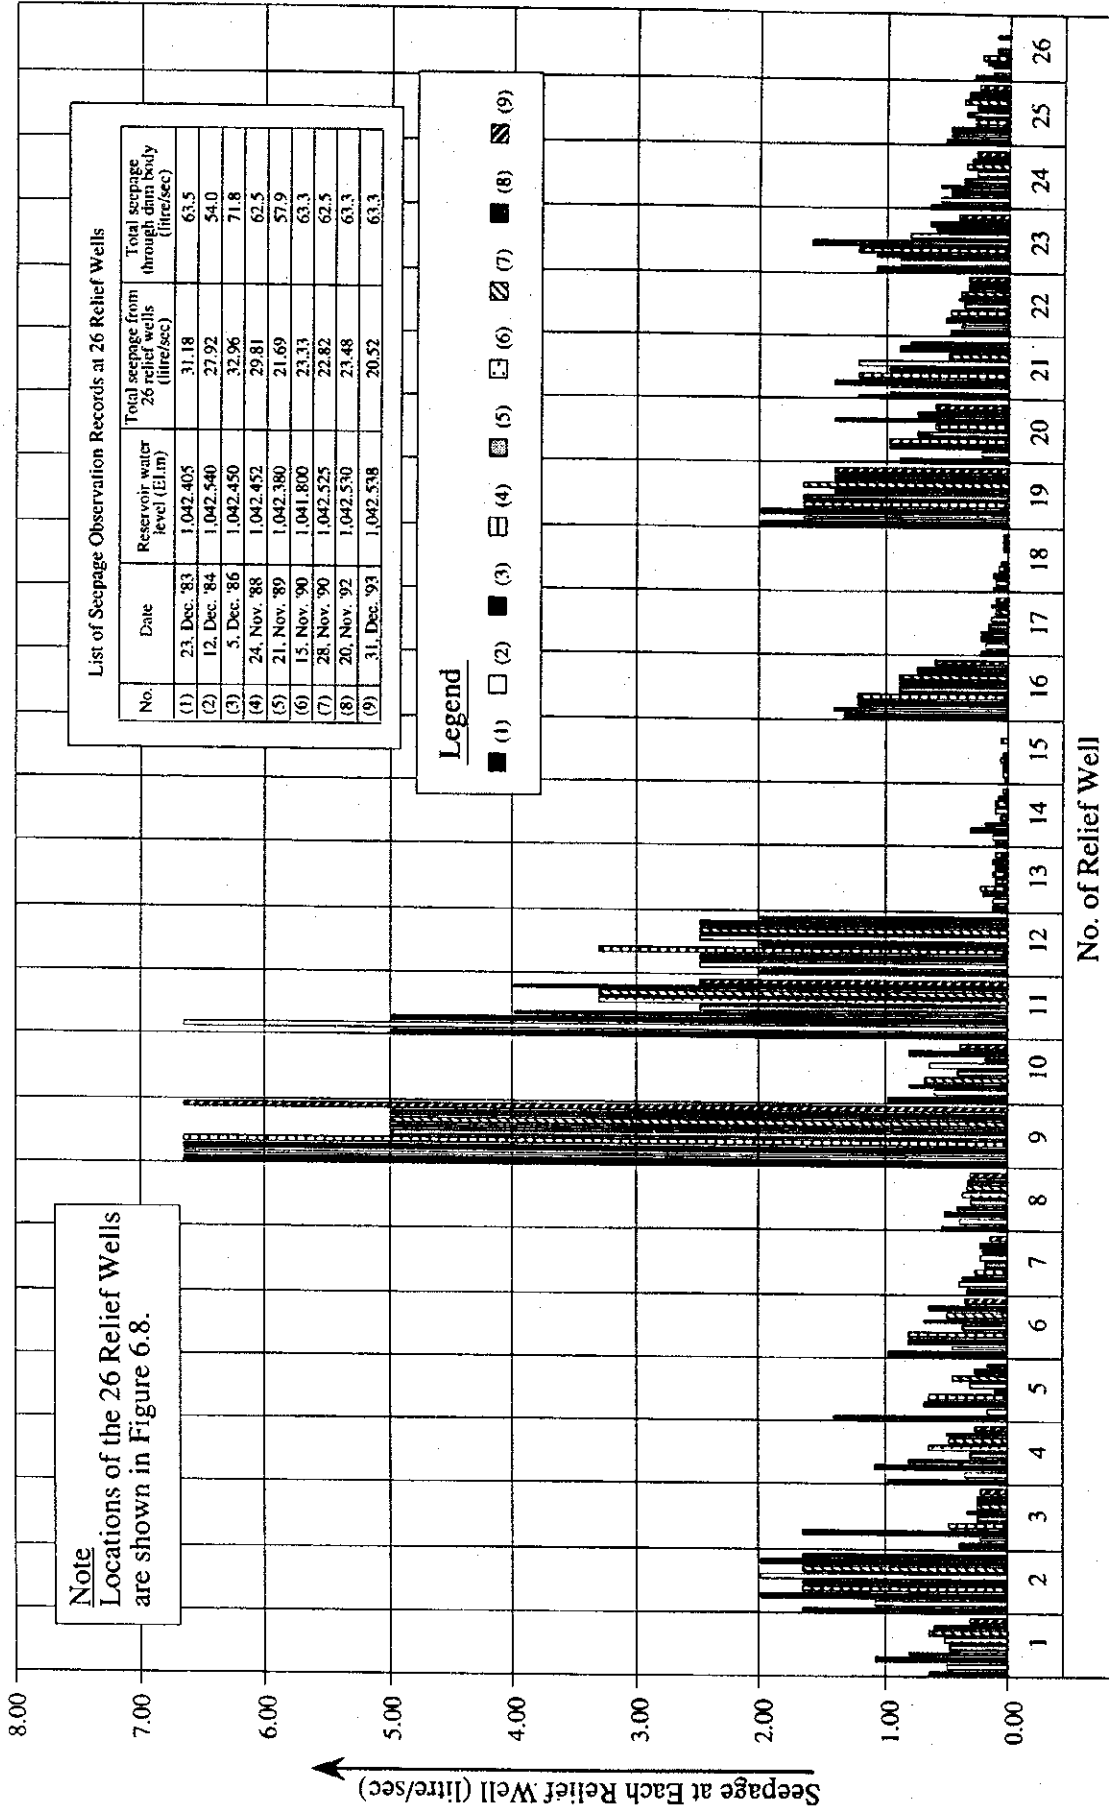
Figure 6.10
Seepage Volume at Each of Original
26 Relief Wells

Figure 6.10 and Table 6.4 show the distribution of seepage volumes measured at the 26 original relief wells at the time of the reservoir water level of more than or close to the HWL, exhibiting that the considerably higher rates are observed at the relief well No. 9, No. 11 and No. 12. In particular, the seepage volume which is close to the design volume per one relief well ($180 \text{ litres}/26 = 6.9 \text{ litres}$), was measured at relief well No. 9 at time of the reservoir water level higher than the HWL (EL. 1042.0 m) by around 50 cm. On the other hand, the long-term seepage records on the relief well No. 9 and other dam measurement records reveal:

- The high leakage has taken place for more than these ten (10) years when the reservoir water level exceeds the HWL, and no abnormal phenomenon on the dam has been experienced up to date,
- No significant settlement of the dam crest around the relief well No. 9 occurred to date.
- The seepage volume becomes low as well as other relief wells when the reservoir water level becomes low.

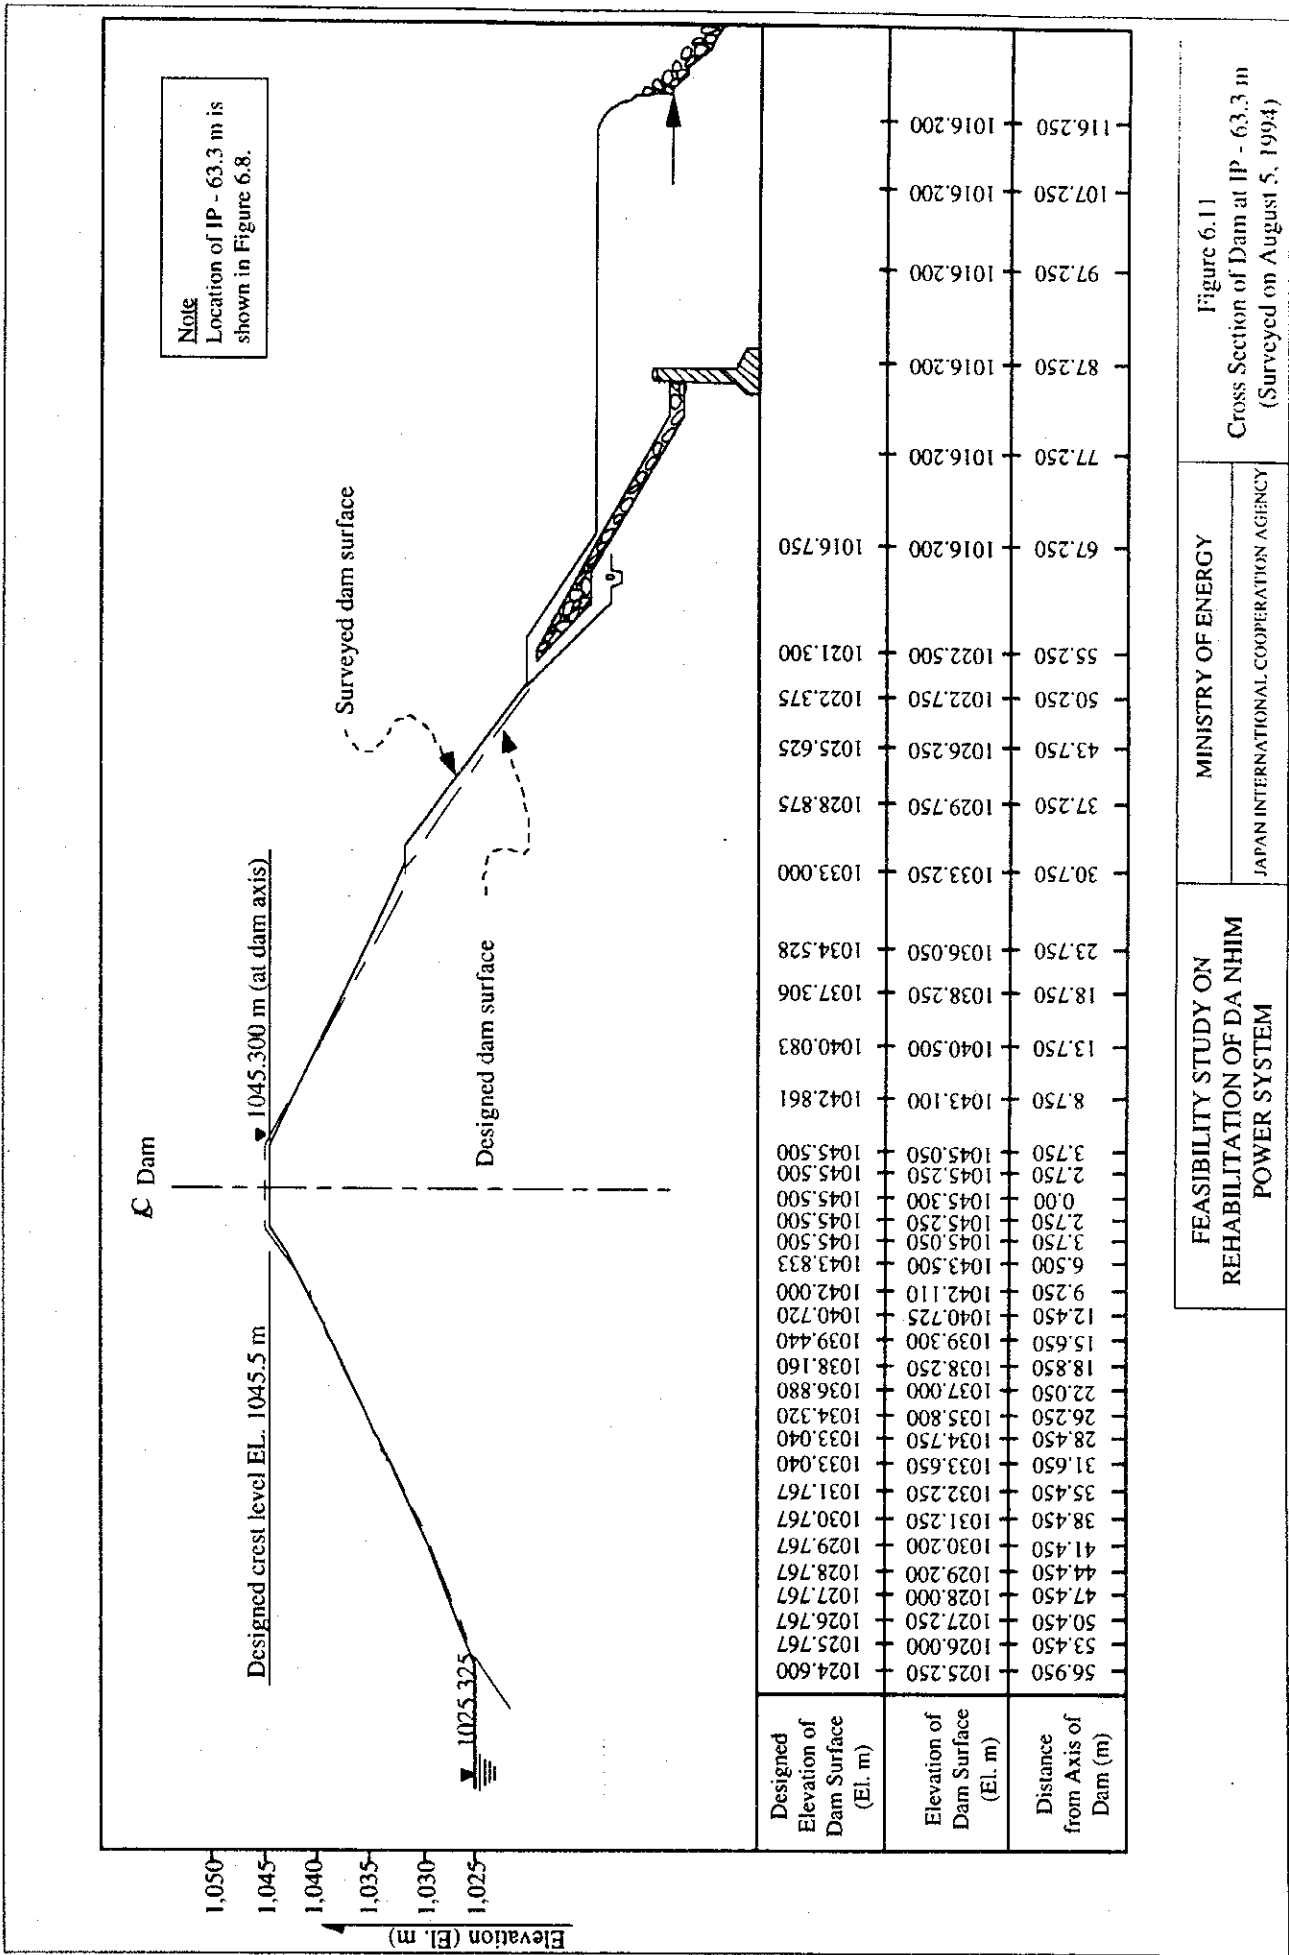
Figure 6.11

In the present topographic survey, the dam crest elevation was measured to be EL. 1045.3 m at the aforesaid point (IP-63.3) where the dam cross section survey was performed in August 1994 as shown in Figure 6.11. While, those at the neighboring locations about 2 m to 3 m distant from the point are measured at about EL. 1045.5 m, which is almost equal to the designed dam crest elevation. It is recommendable to perform, from now on, the leveling survey along the dam crest adjacent to the contact portion of dam and spillway with accuracy so as to monitor the settlement of the dam crest.

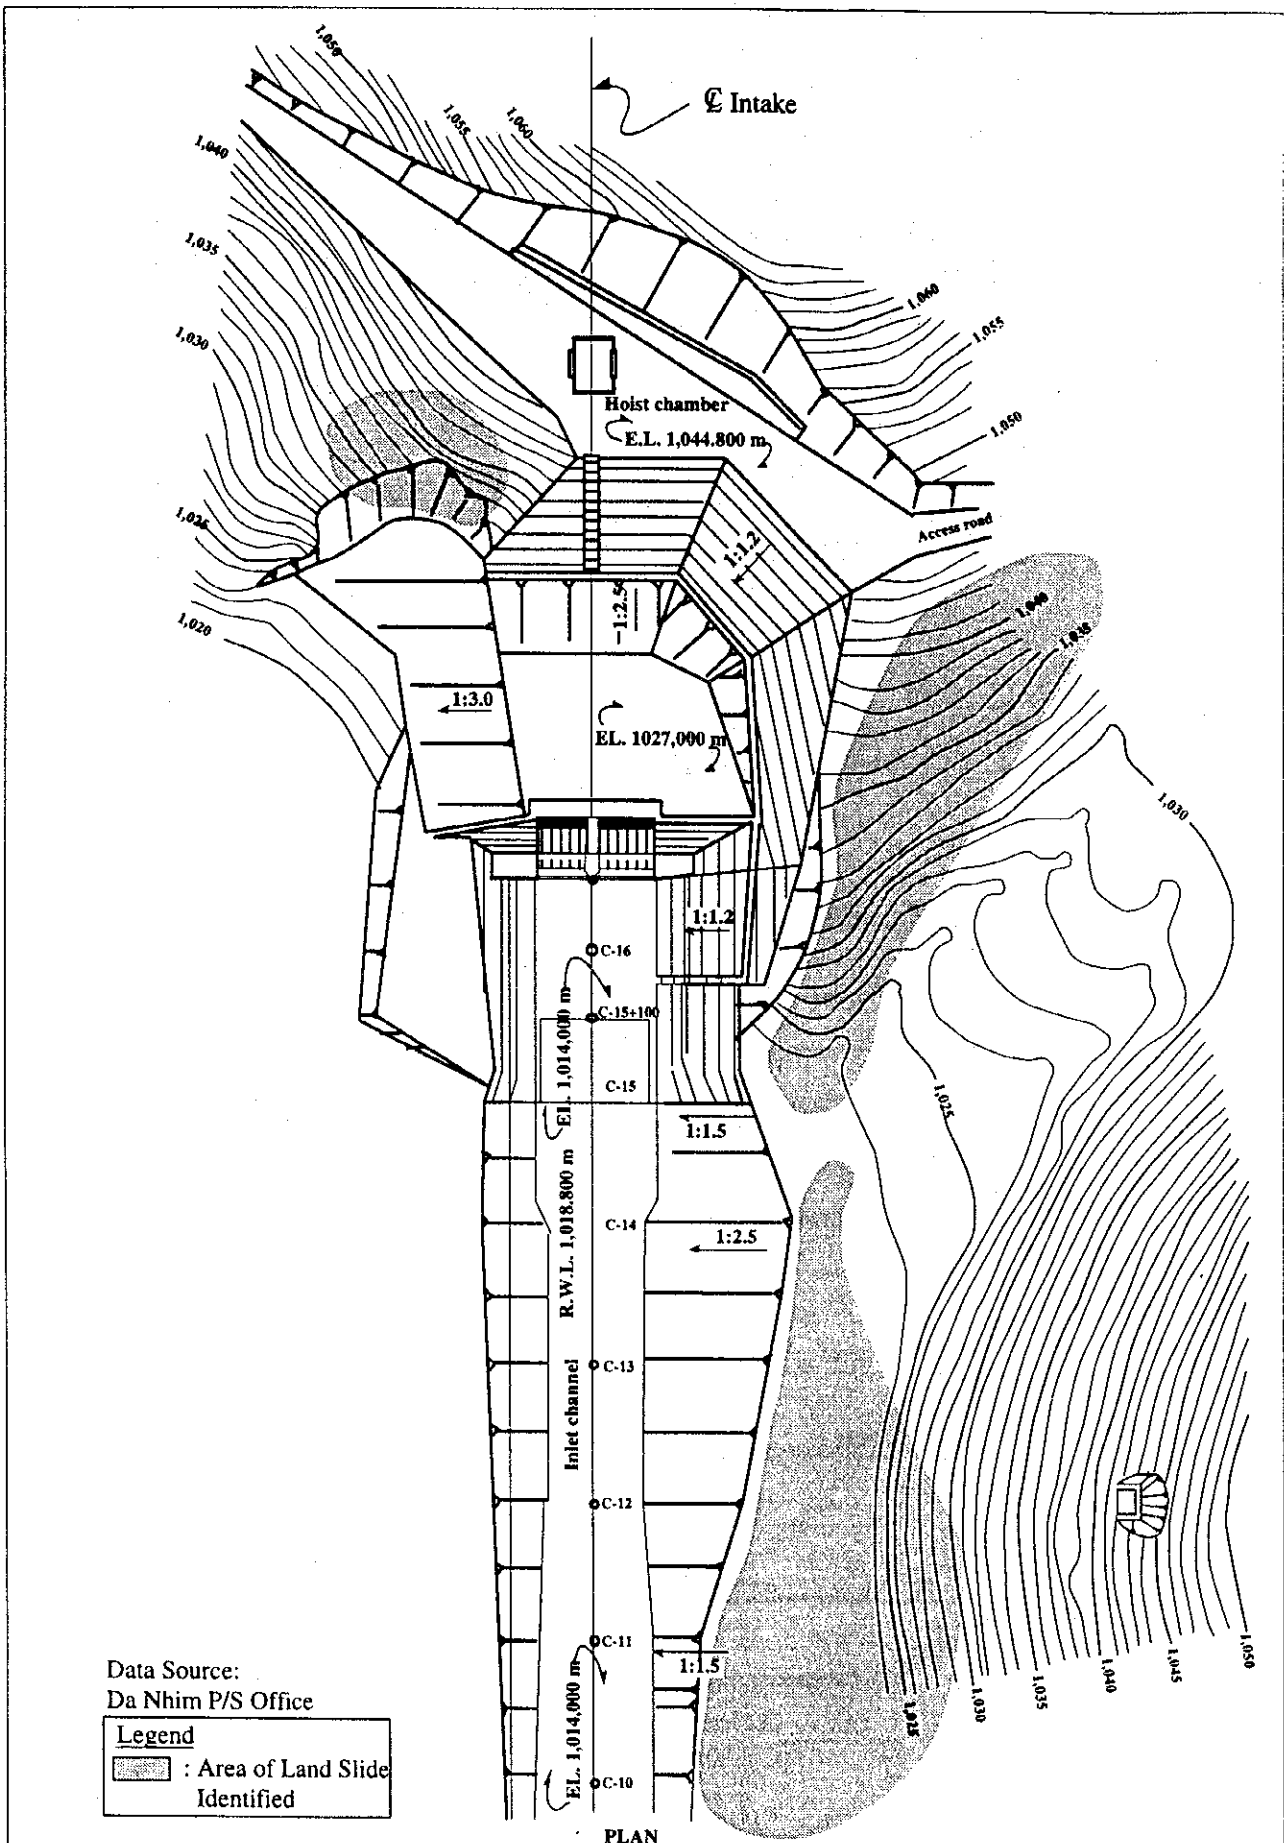
Figure 6.15
Location of Land Slide Occurring
around Inlet Channel of Intake Structure

- i) Partial loss of concrete inside of guide frames for movable trash racks, and
- ii) Occurrence of cracks in concrete of partition wall in intake shaft
- iii) Land slides in the downstream and upstream banks of inlet channel

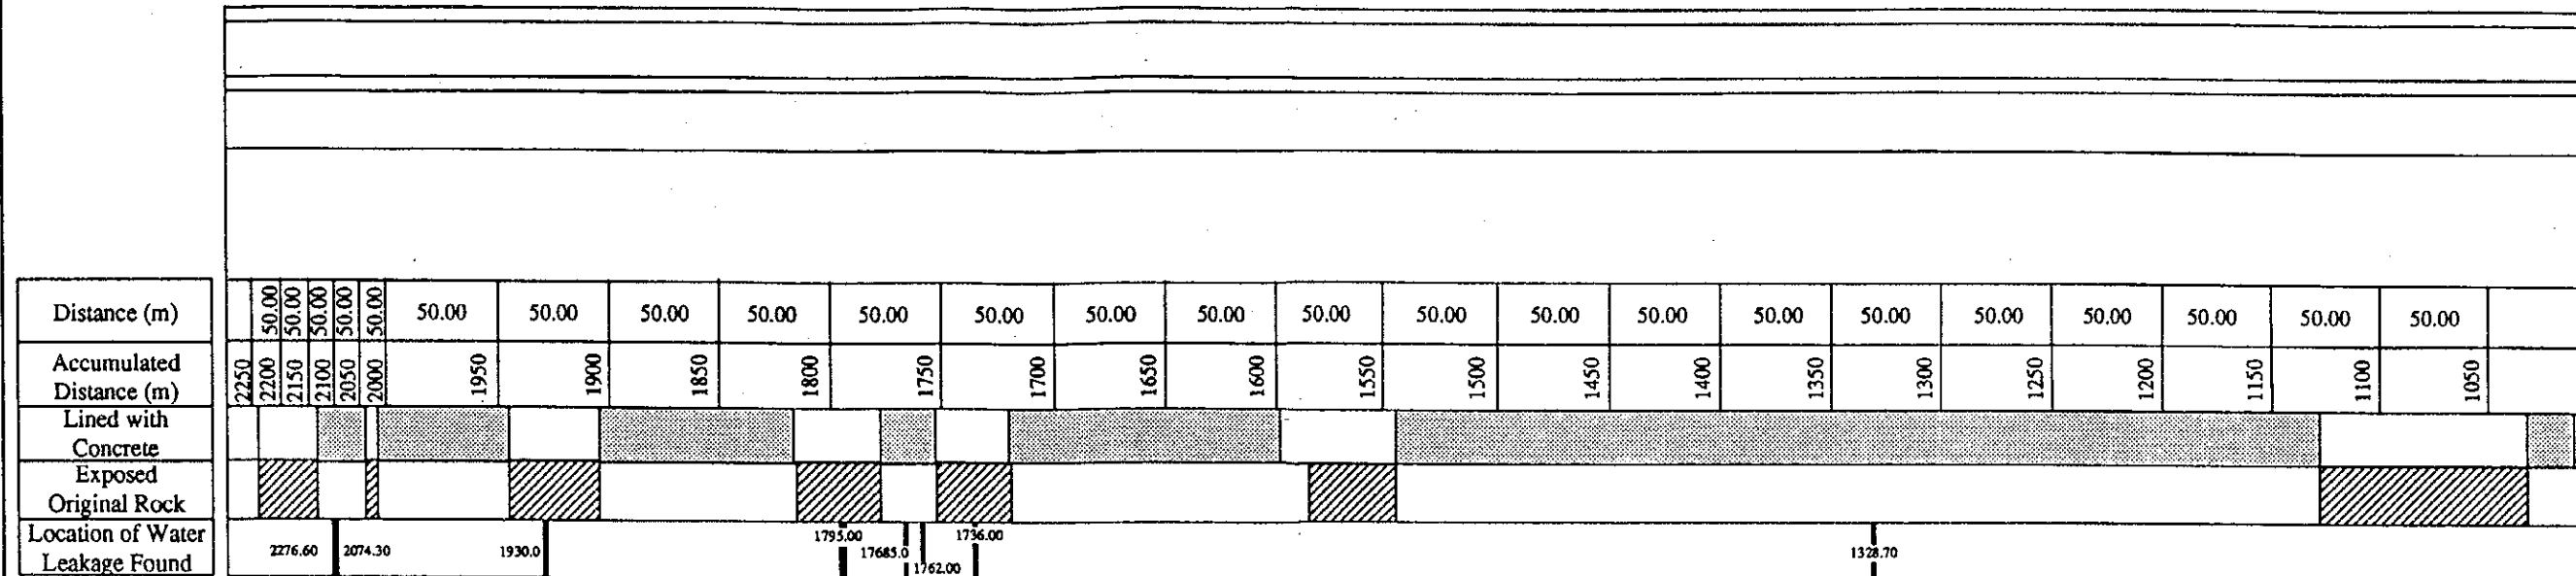
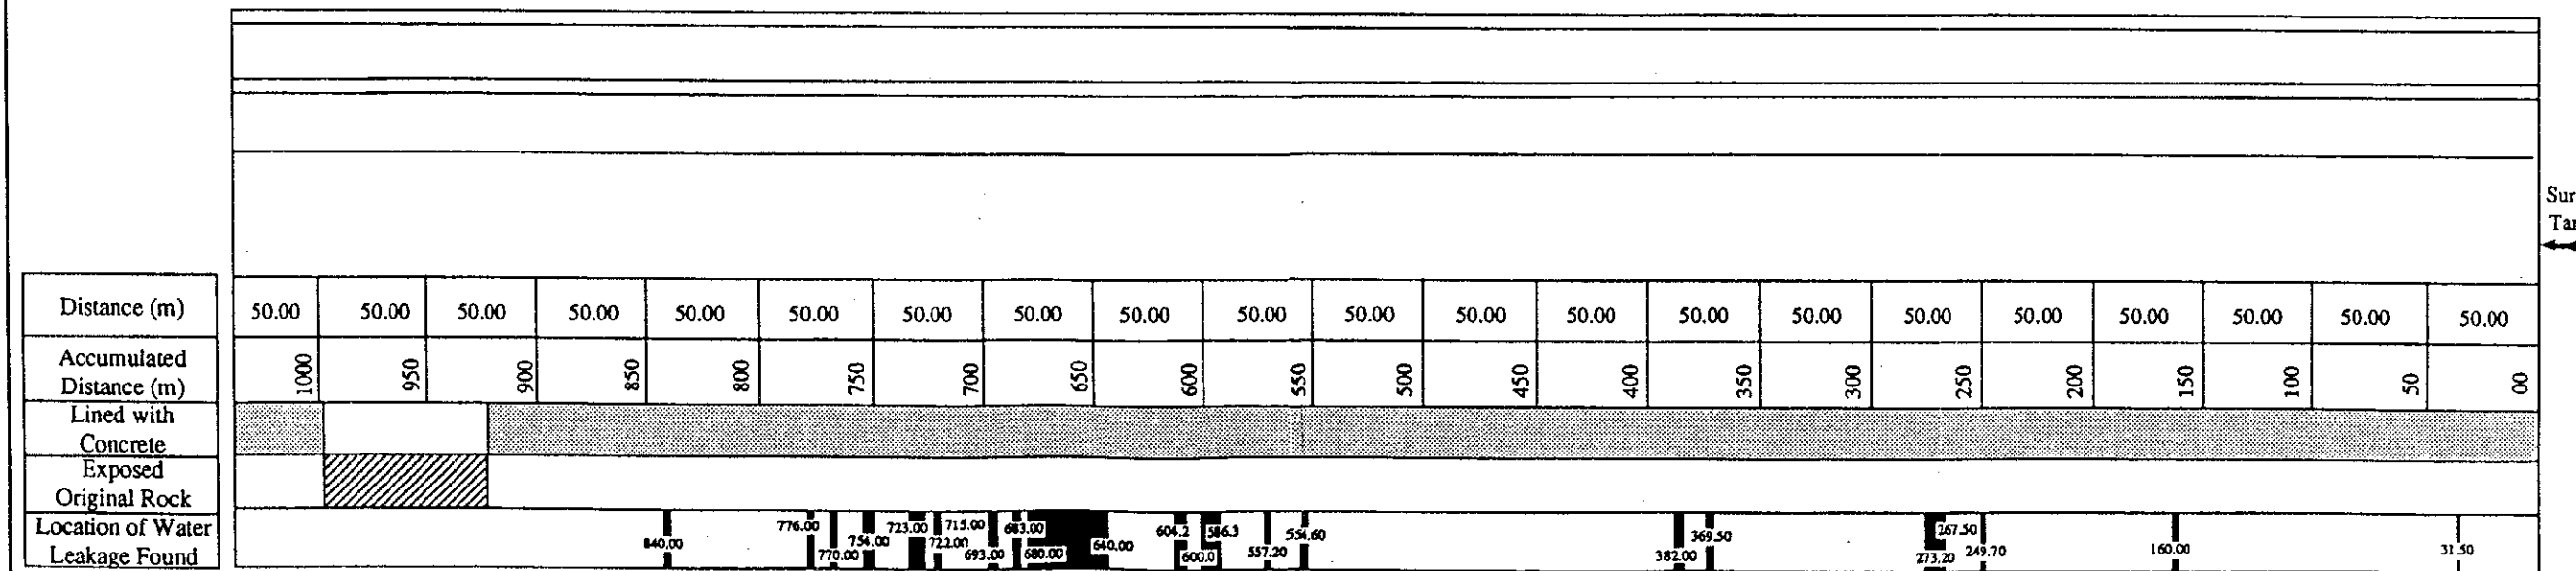
140 m Notable Water Leakage Portion

Figure 6.16 shows the results of inspection on the headrace tunnel, which was conducted by the Da Nhim P/S staff in March 1992. As seen in the Figure, there are two major portions where a notably high water leakage in the headrace tunnel took

place under the dewatered condition therein. These locations in headrace tunnel are listed below:

On the other hand, no issues on the headrace tunnel were reported in terms of the practical power generation. From the practical viewpoint, hence, these high leakage portions of headrace tunnel would not require the urgent rehabilitation works, since no adverse phenomenon take place in the surrounding mountainous areas along the route of headrace tunnel and its neighboring civil structures and it is foreseen that the present condition would not interrupt the ordinary power generation for some time.
