FEASIBILITY STUDY ON PAN-PHILIPPINE HIGHWAY
REHABILITATION PROJECT (MINDANAO SECTION)

SLOPE NO.: 4-38
TYPE OF DISASTER:

STATION: 1340+950
EMBANKMENT SLOPE FAILURE

DRAWING NO.
S-53

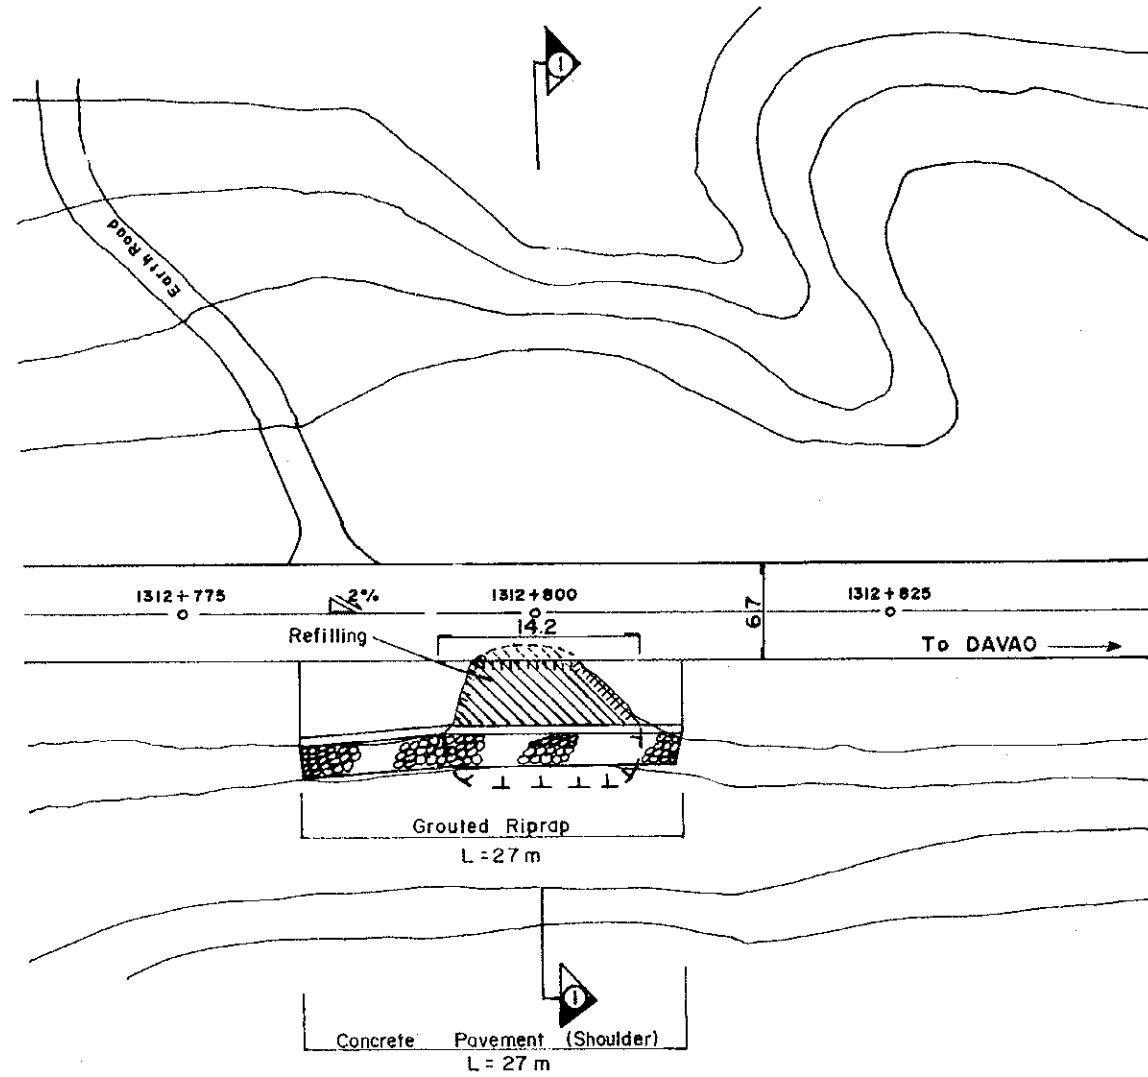
Cause of Disaster:

- 1) Insufficient compaction of embankment.
- 2) Scouring by water which was drained from feeder earth road and concentrated on the slope due to the geometric formation of road.

TYPE OF WORK	UNIT	TOTAL
5 - 5	REFILLING/ EMBANKMENT	CU.M	127
5 - 19	GROUTED RIPRAP	CU.M	40
5 - 13	CONCRETE PAVEMENT (SHOULDER)	SQ.M	135

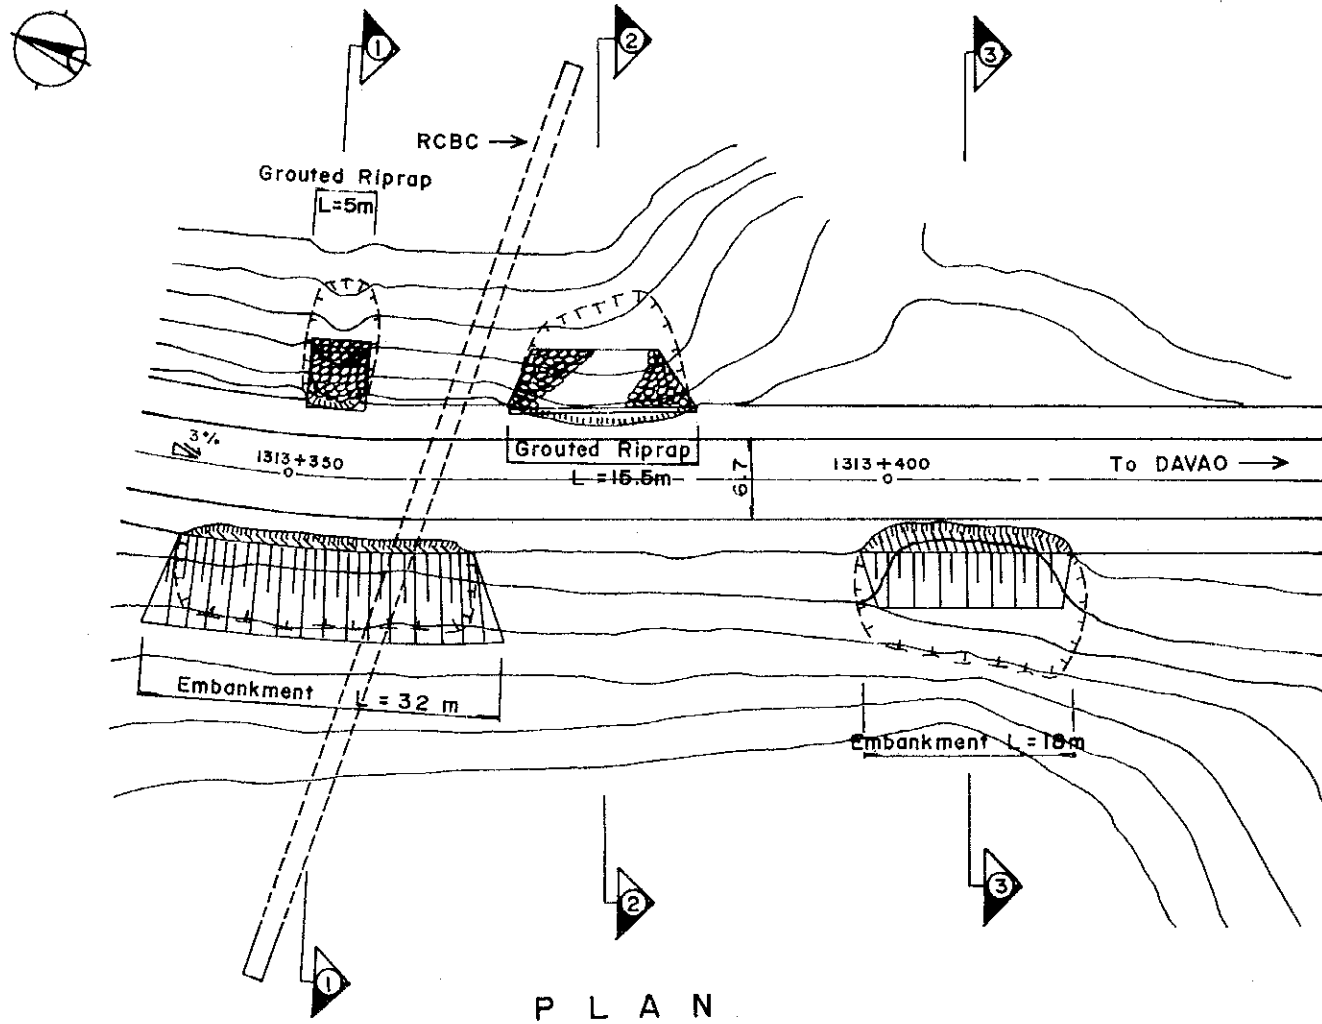
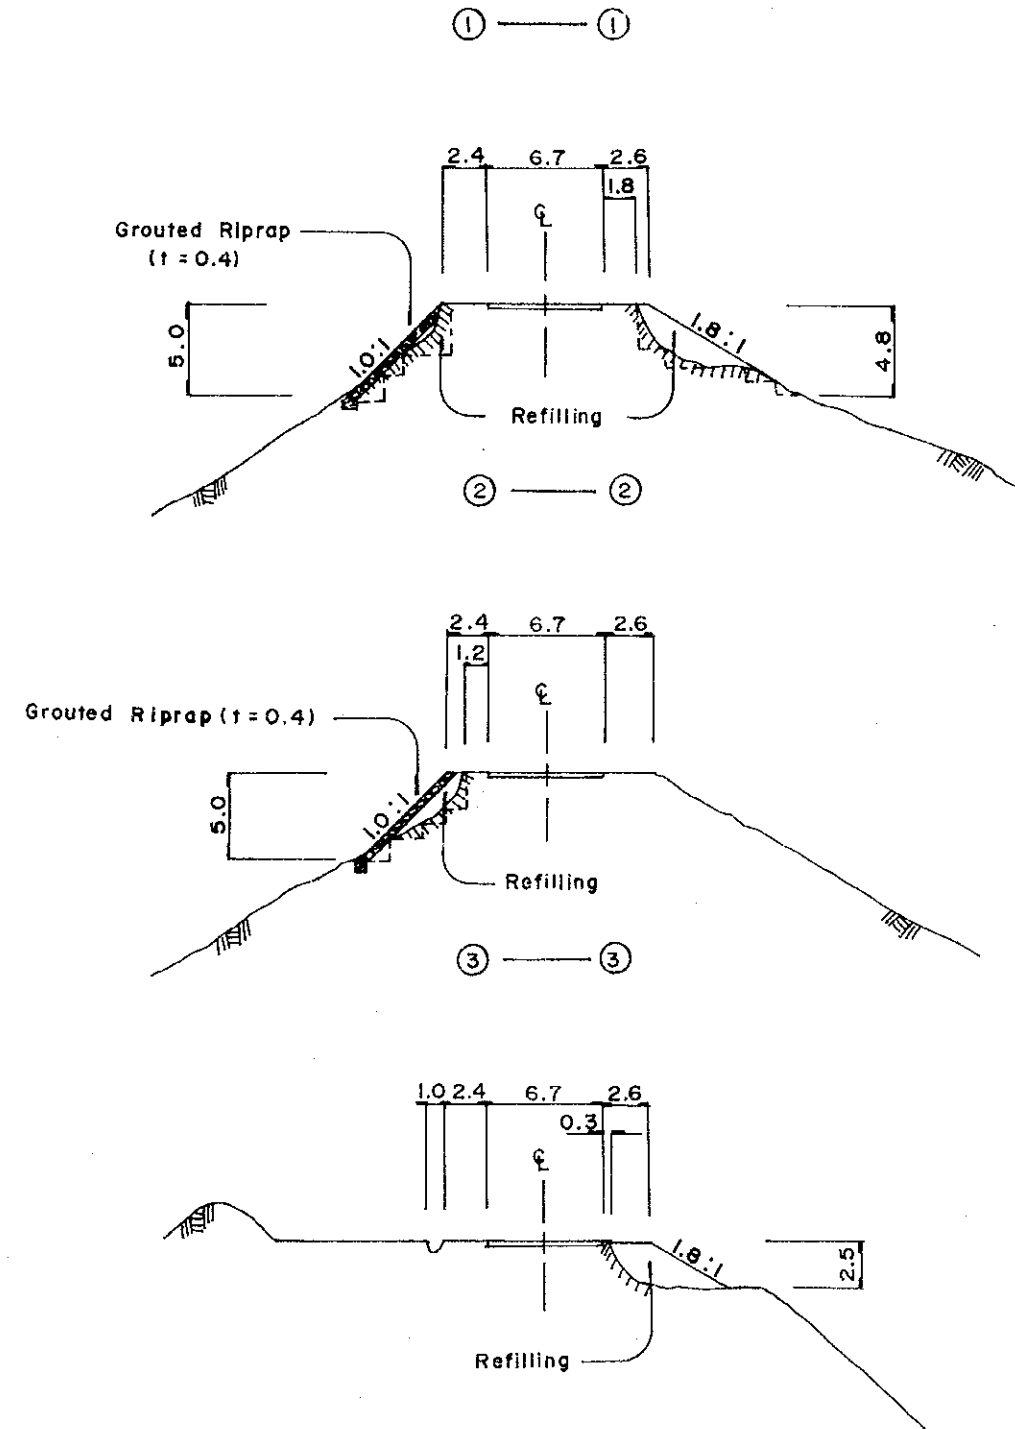
Cause of Disaster:

- 1) Insufficient compaction of embankment.
- 2) Embankment slope with an unstable grade.

TYPE OF WORK	UNIT	TOTAL
4-34 (1313+350)		
5-5 REFILLING / EMBANKMENT	CU. M	359
5-19 GROUTED RIPRAP	CU. M	16
4-35 (1313+380)		
5-5 REFILLING / EMBANKMENT	CU. M	87
5-19 GROUTED RIPRAP	CU. M	36
4-36 (1313+400)		
5-5 REFILLING / EMBANKMENT	CU. M	171

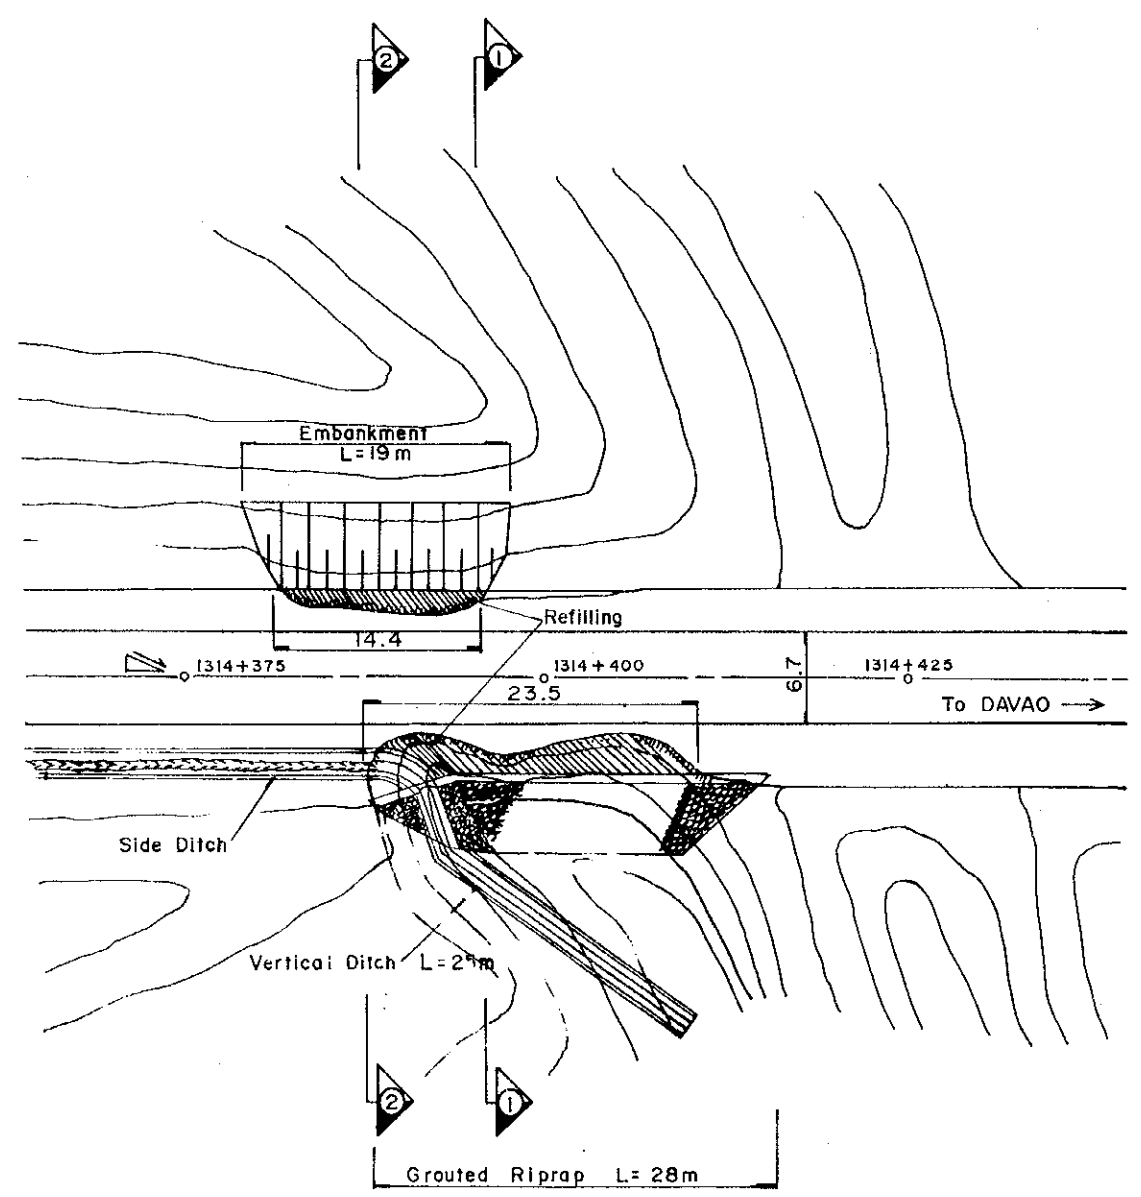
Cause of Disaster:

- 1) Insufficient compaction of embankment.
- 2) Embankment slope with an unstable grade.
- 3) Scouring by water which was drained from hill side and concentrated on the slope due to the geometric formation of road.

TYPE OF WORK	UNIT	TOTAL
5-5	REFILLING / EMBANKMENT	CU. M	644
5-19	GROUTED RIPRAP	CU. M	68
5-27	VERTICAL DITCH	L. M	25

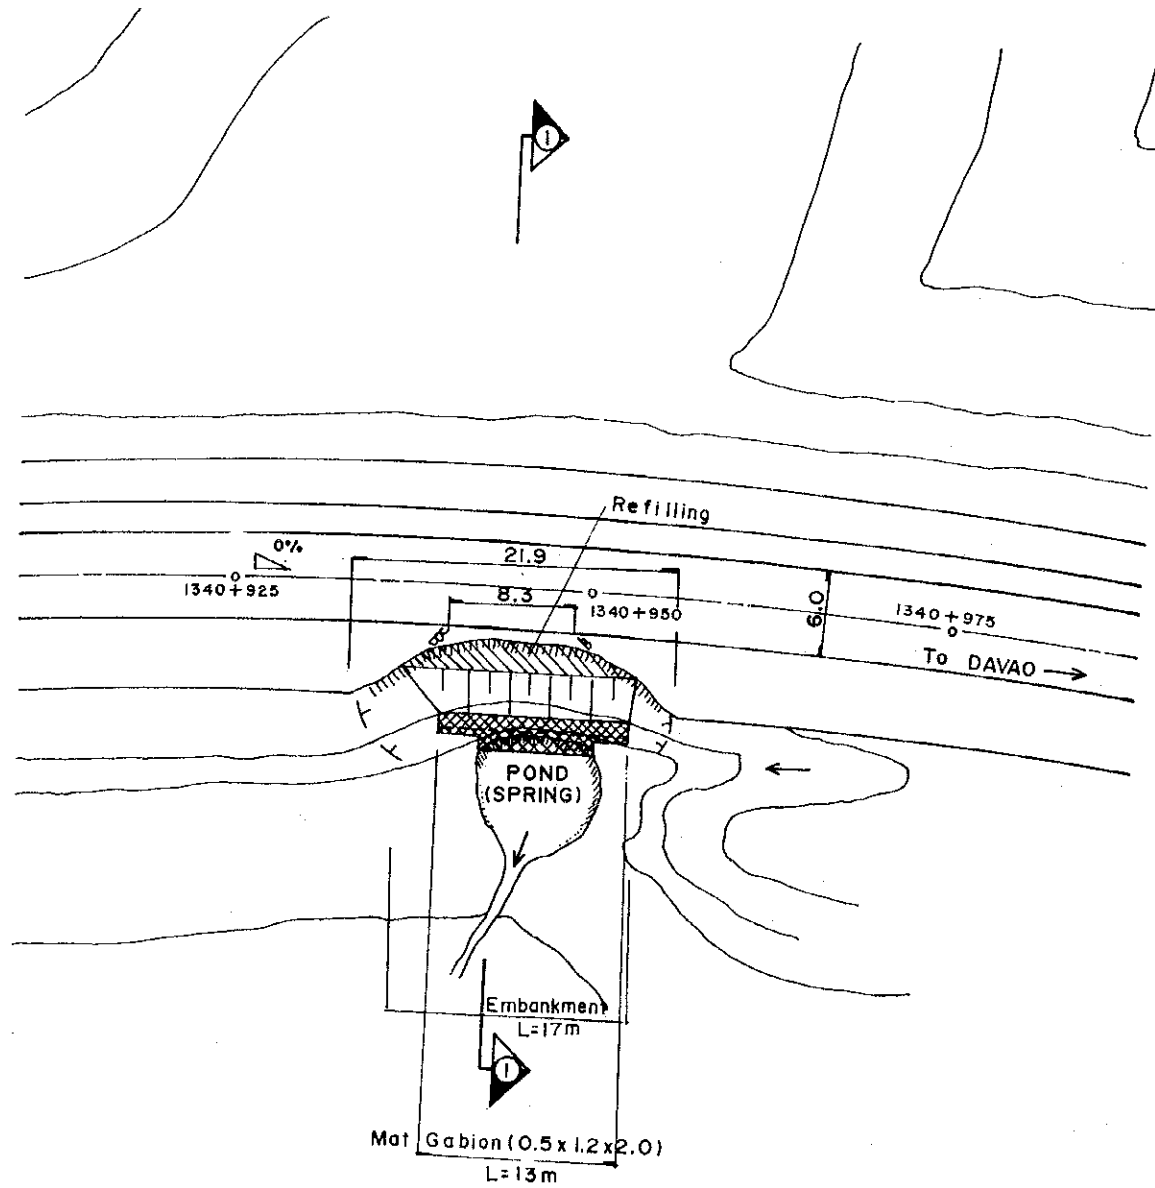
Cause of Disaster:

- 1) Erosion at the foot of slope by pond water.

TYPE OF WORK	UNIT	TOTAL
5-5	REFILLING / EMBANKMENT	CU. M	54
5-17	GABION WALL	CU. M	65

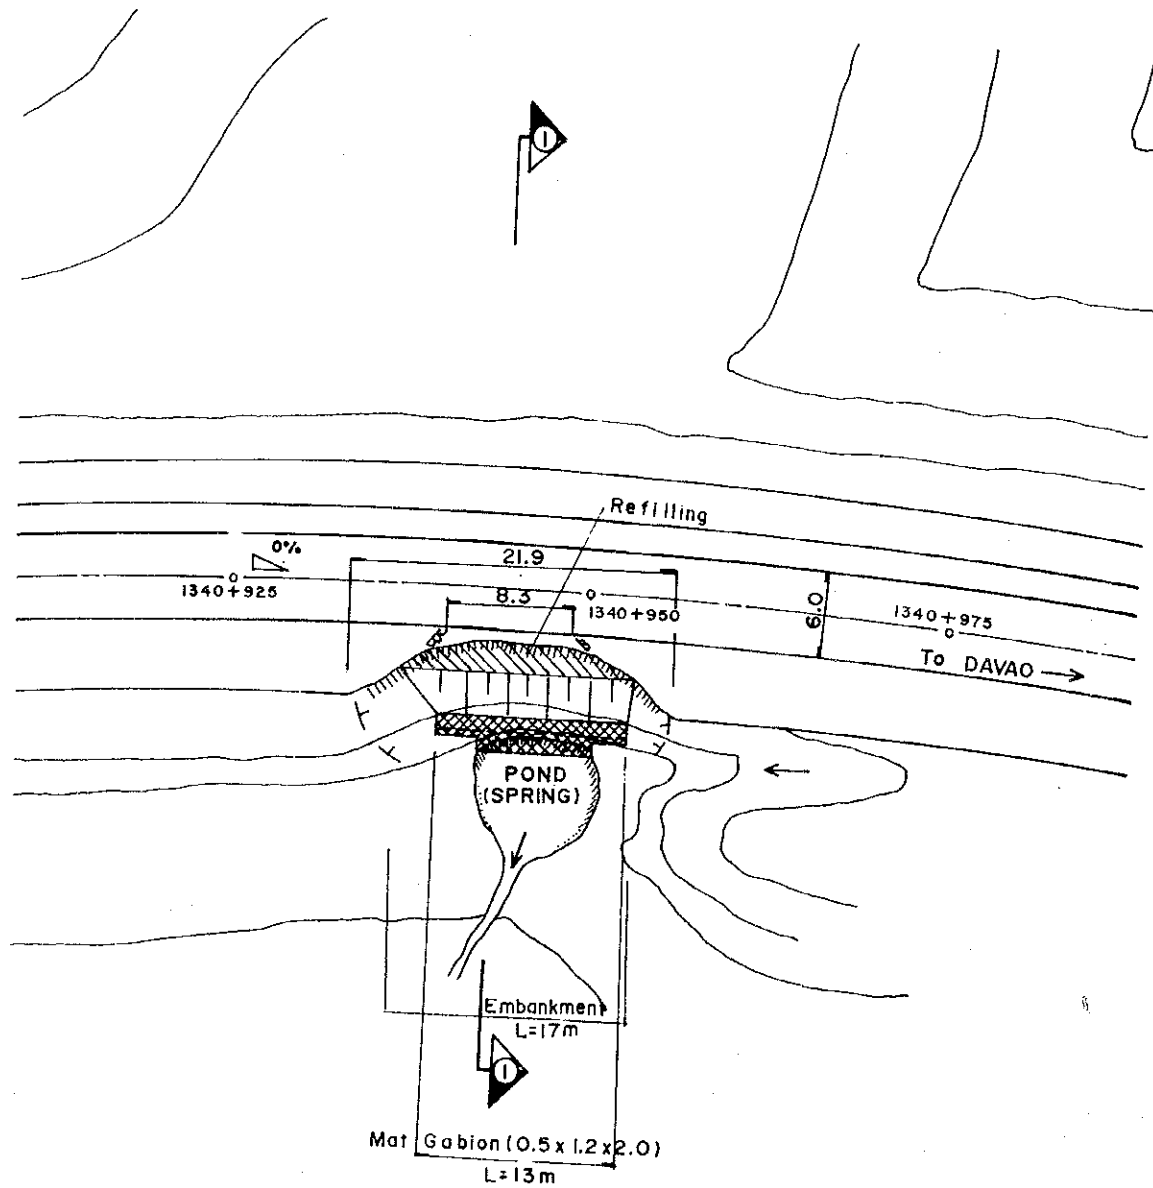
Cause of Disaster:

- 1) Erosion at the foot of slope by pond water.

TYPE OF WORK	UNIT	TOTAL
5-5	REFILLING / EMBANKMENT	CU. M	54
5-17	GABION WALL	CU. M	65

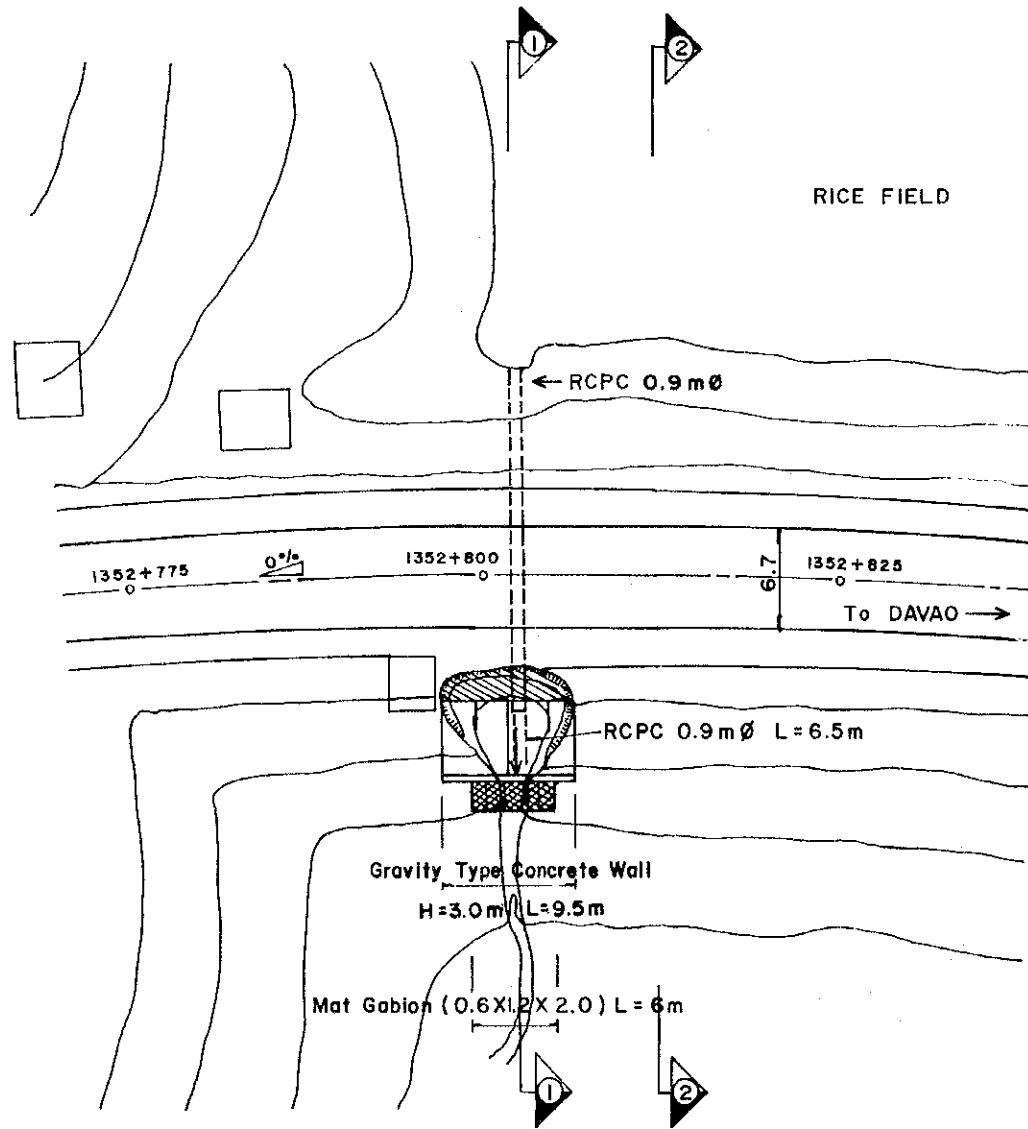
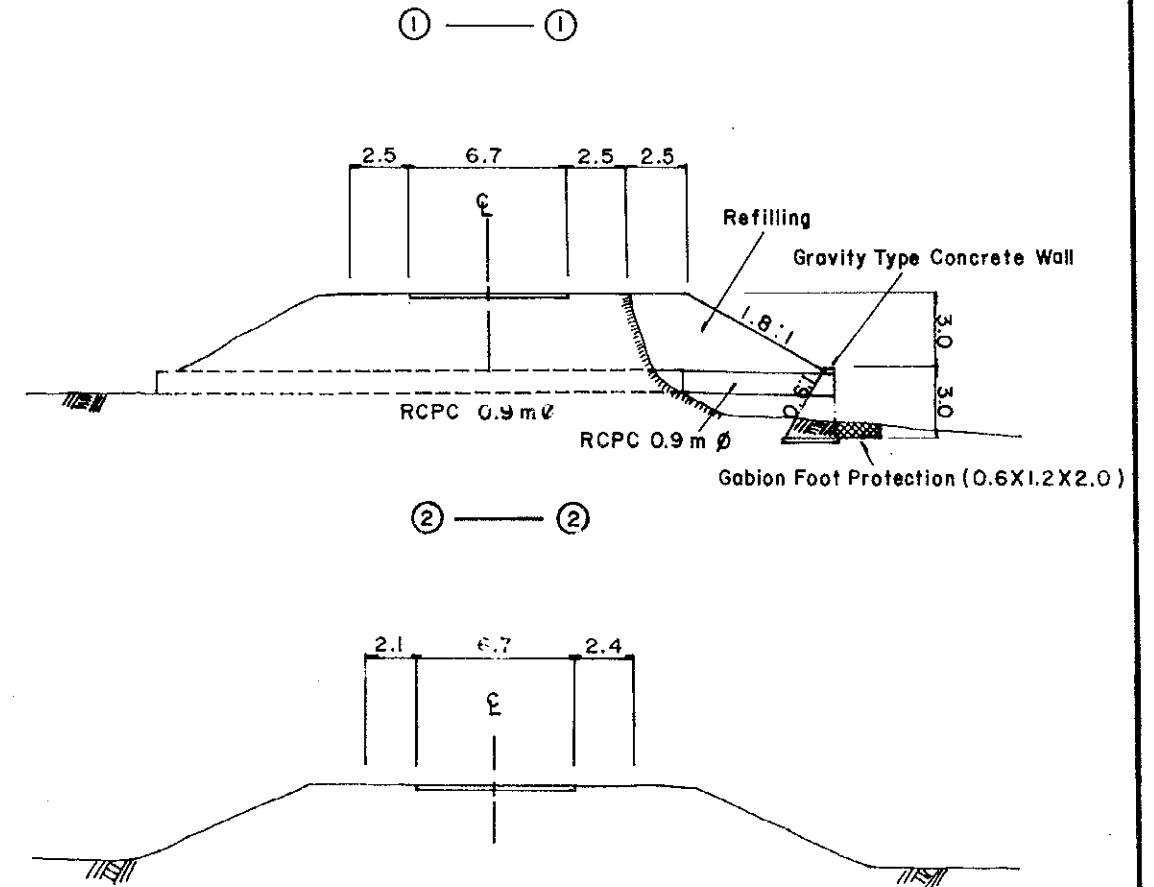
Cause of Disaster:

- 1) Inadequate outlet facility of pipe culvert.

TYPE OF WORK		UNIT	TOTAL
5-5	REFILLING/EMBANKMENT	CU.M.	161
5-14	GRAVITY TYPE CONCRETE WALL	CU.M.	37
5-26	GABION FOOT PROTECTION	CU.M.	7
5-31	RCPC (0.9m Ø)	L.M.	7
5-4	STRUCTURAL EXCAVATION	CU.M.	30
5-8	FOUNDATION FILL	CU.M.	5

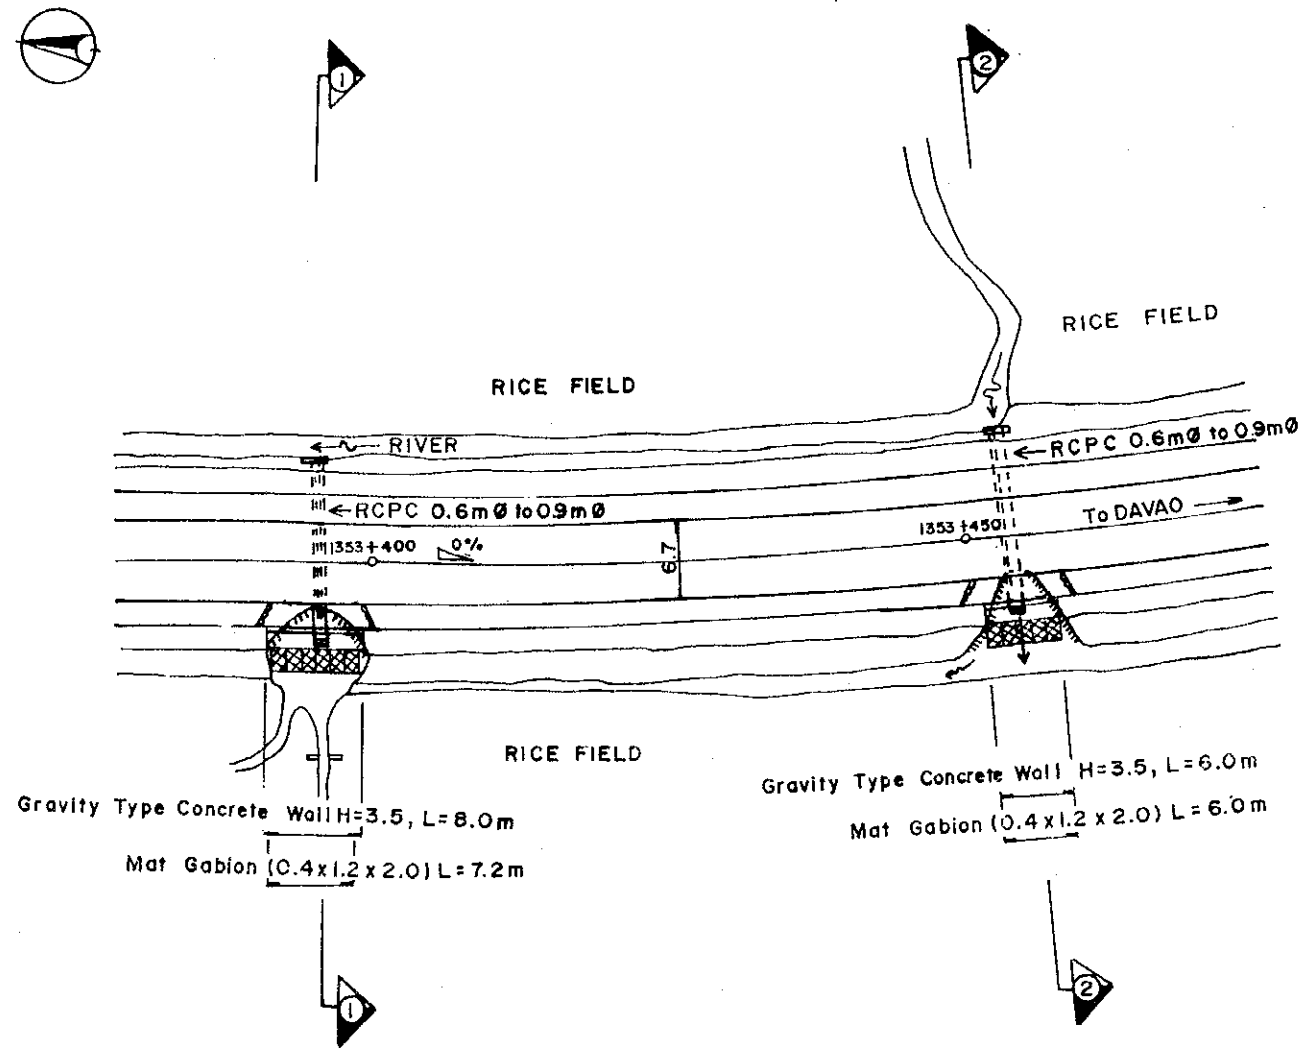
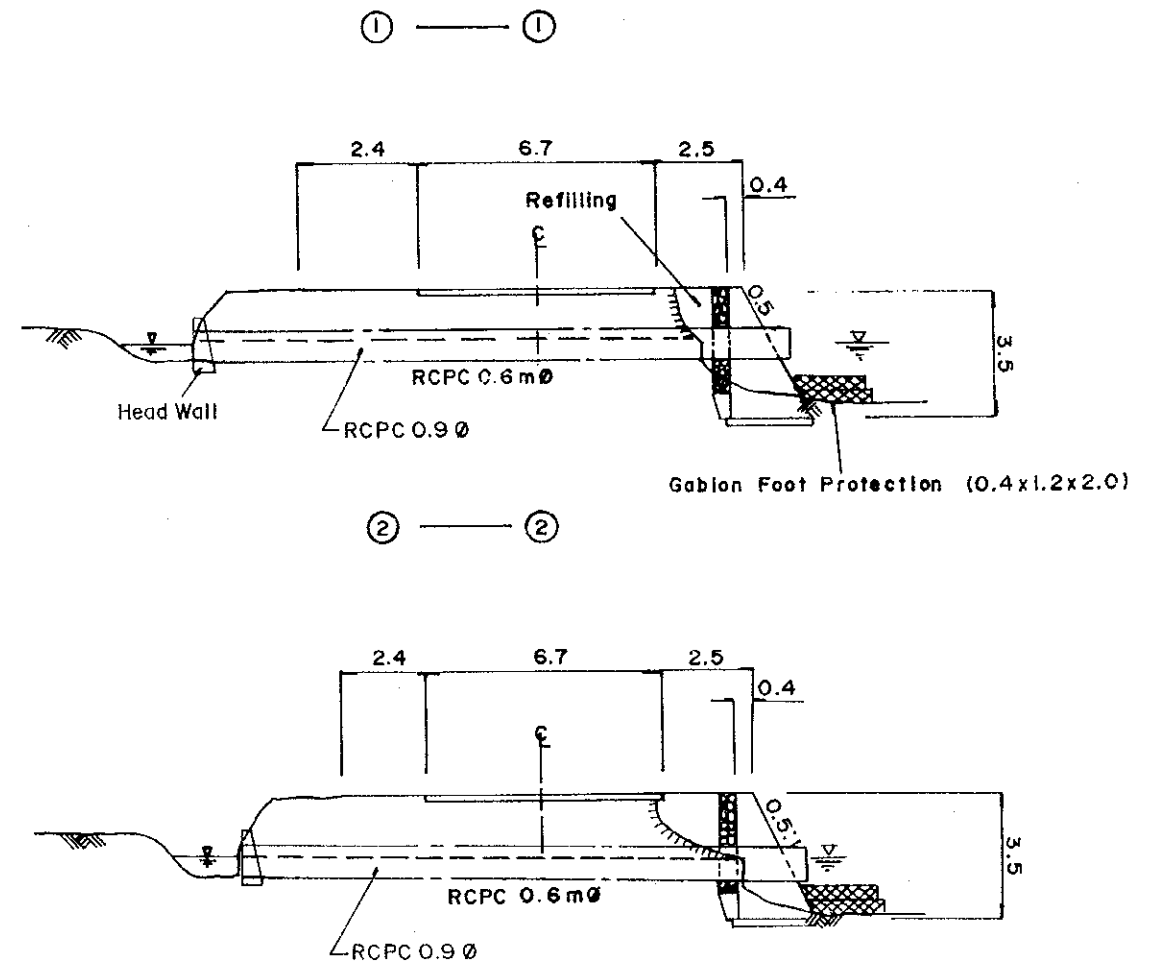
Cause of Disaster:

- 1) Scouring at the foot of slope by flow of river.
- 2) Insufficient drainage capacity of pipe culvert.

TYPE OF WORK	UNIT	TOTAL
4 - 40 (1353+400)		
5-5 REFILLING / EMBANKMENT	CU.M	4
5-14 GRAVITY TYPE CONCRETE WALL	CU.M	36
5-26 GABION FOOT PROTECTION	CU.M	12
5-31 RCPC (0.9m.Ø)	L.M	17
5-40 HEAD WALL FOR RCPC 0.9m.Ø	E.A	1
5-4 STRUCTURAL EXCAVATION	CU.M	22
5-6 FILLING OF BACKFILL MATERIALS	CU.M	11

TYPE OF WORK	UNIT	TOTAL
4 - 41 (1353+450)		
5-5 REFILLING / EMBANKMENT	CU.M	5
5-14 GRAVITY TYPE CONCRETE WALL	CU.M	27
5-26 GABION FOOT PROTECTION	CU.M	10
5-31 RCPC (0.9m.Ø)	L.M	16
5-40 HEAD WALL FOR RCPC 0.9m.Ø	E.A	1
5-4 STRUCTURAL EXCAVATION	CU.M	17
5-6 FILLING OF BACKFILL MATERIAL	CU.M	8

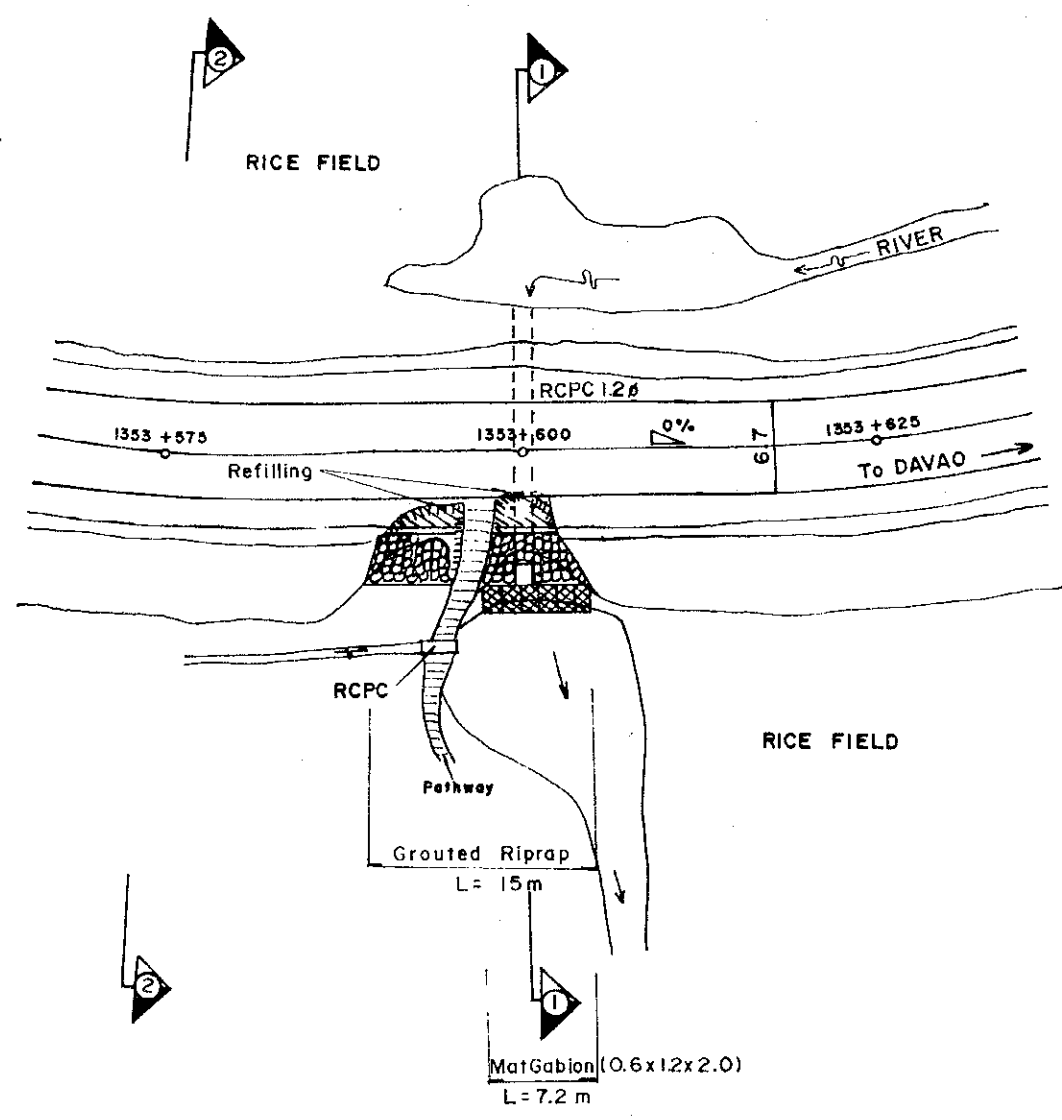
Cause of Disaster:
1) Erosion at the foot of slope by pond water.
2) Insufficient compaction of embankment.

TYPE OF WORK	UNIT	TOTAL
5-5	REFILLING/ EMBANKMENT	CU. M	23
5-19	GROUTED RIPRAP	CU. M	28
5-26	GABION FOOT PROTECTION	CU. M	9

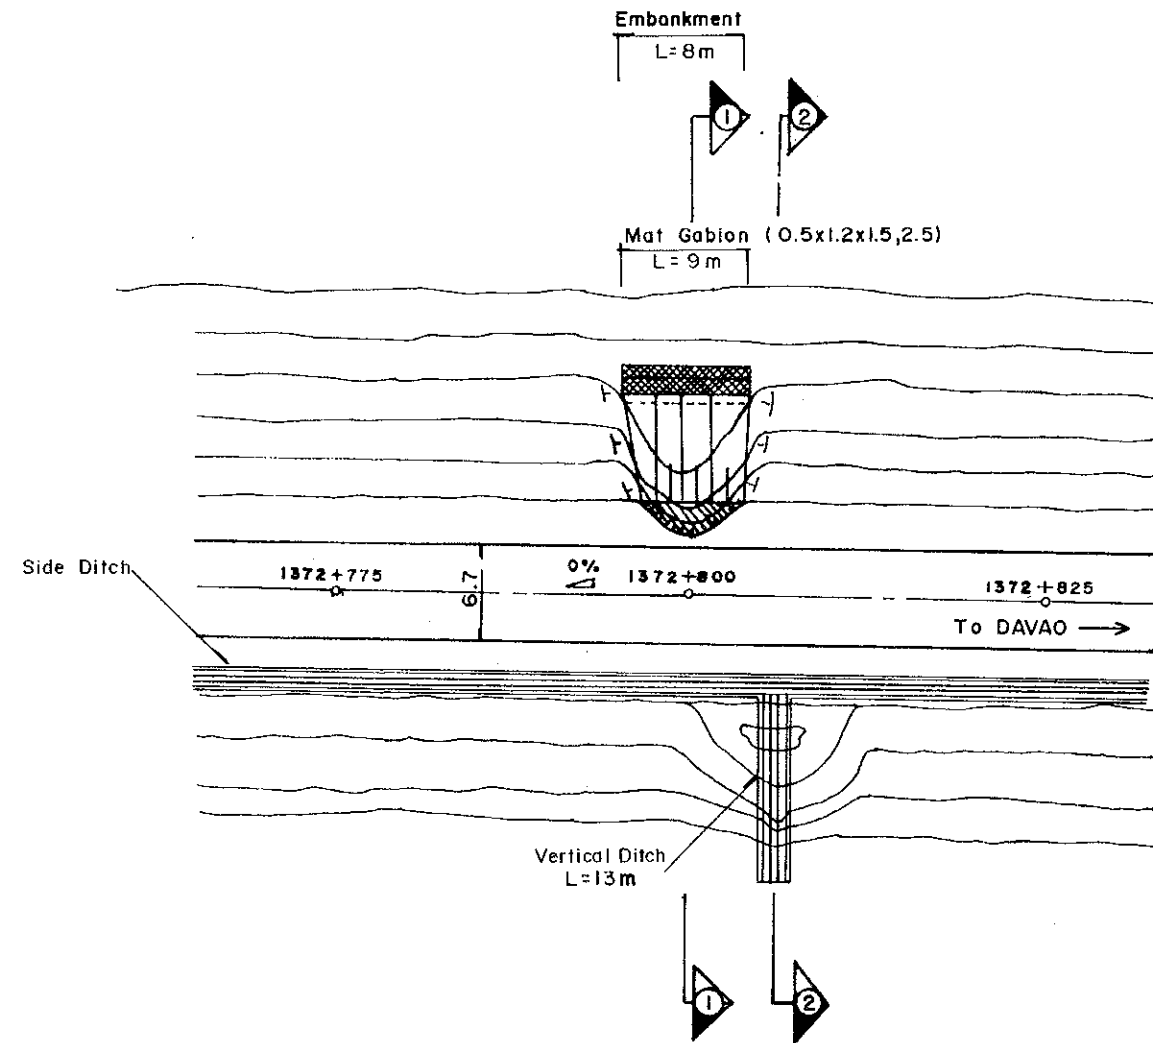
Cause of Disaster:

- 1) Infiltration of water into boundary surface between the ground and embankment.
- 2) Effect of ground water.
- 3) Embankment slope with an unstable grade.

TYPE OF WORK		UNIT	TOTAL
5-5	REFILLING/EMBANKMENT	CU.M	264
5-17	GABION WALL	CU.M	36
5-27	VERTICAL DITCH	L.M	13

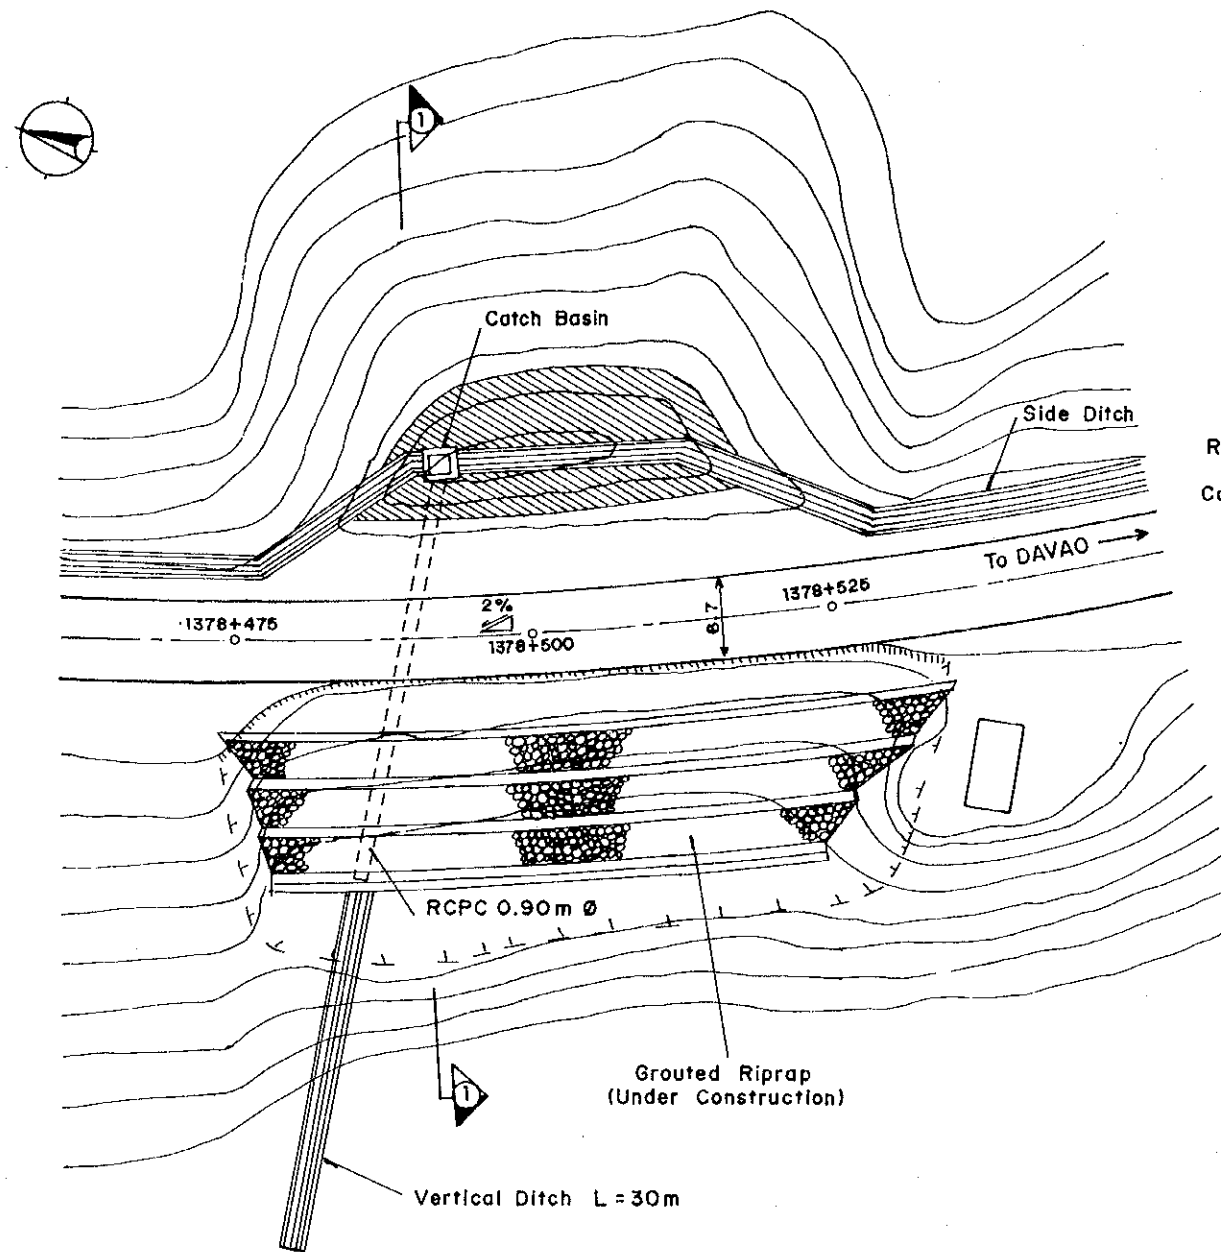
Cause of Disaster:

- 1) Inadequate inlet facility of pipe culvert.
- 2) Infiltration of water into boundary surface between the ground and embankment.

TYPE OF WORK	UNIT	TOTAL
5-5	REFILLING / EMBANKMENT	CU. M.	15
5-37	CATCH BASIN FOR RCPC 0.90m Ø	E. A.	1
5-27	VERTICAL DITCH	L. M.	30

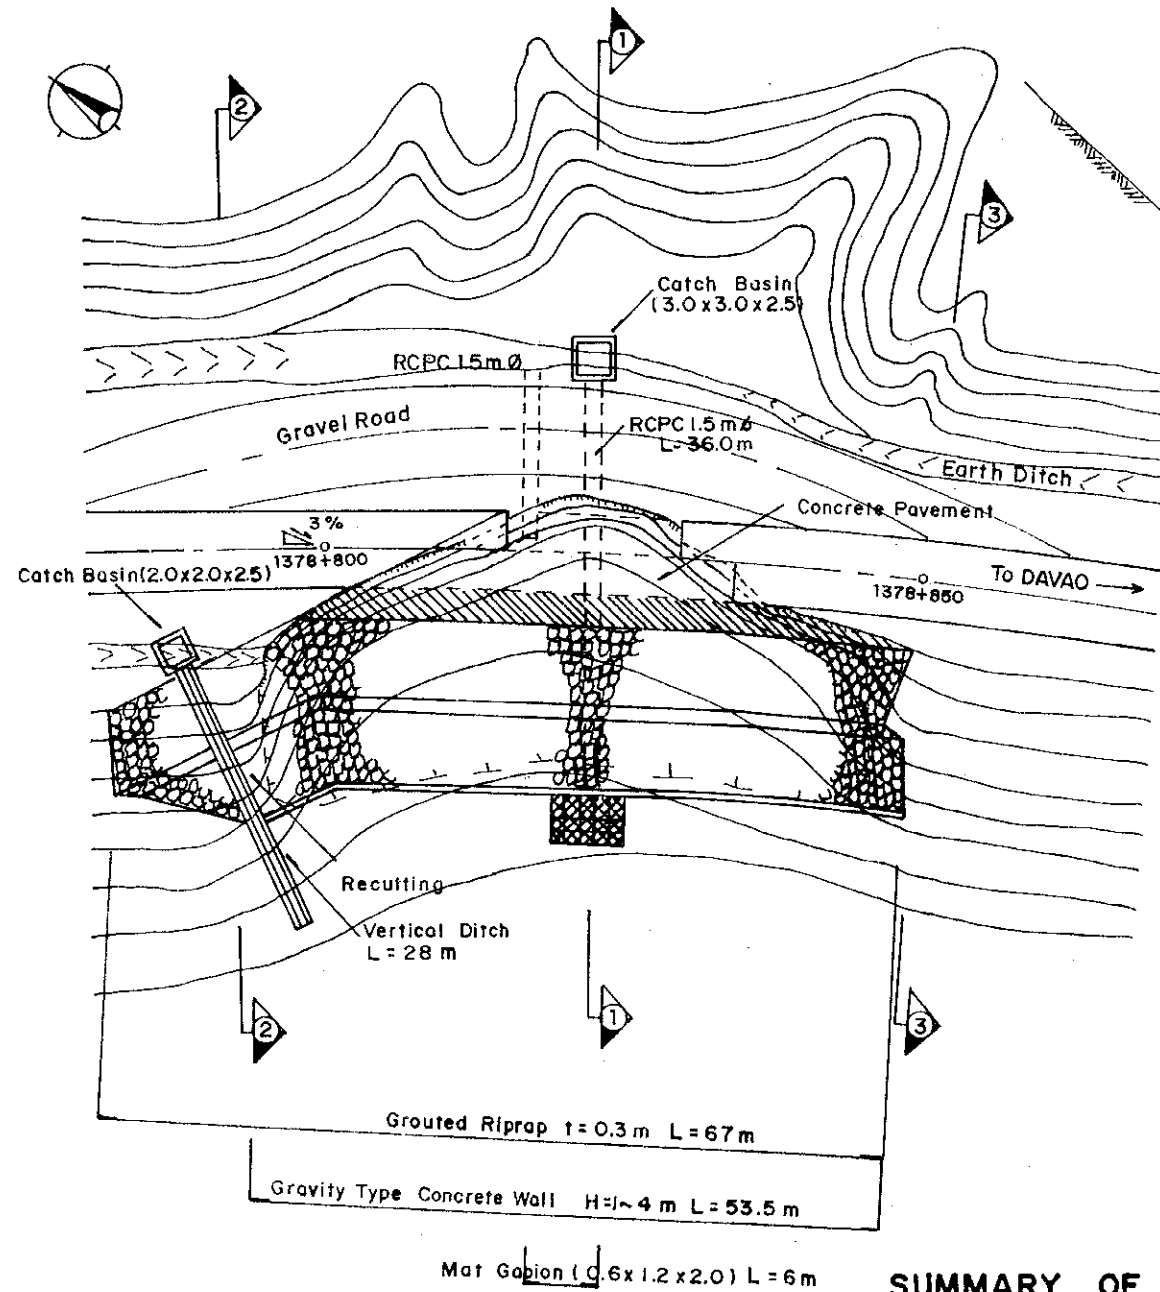
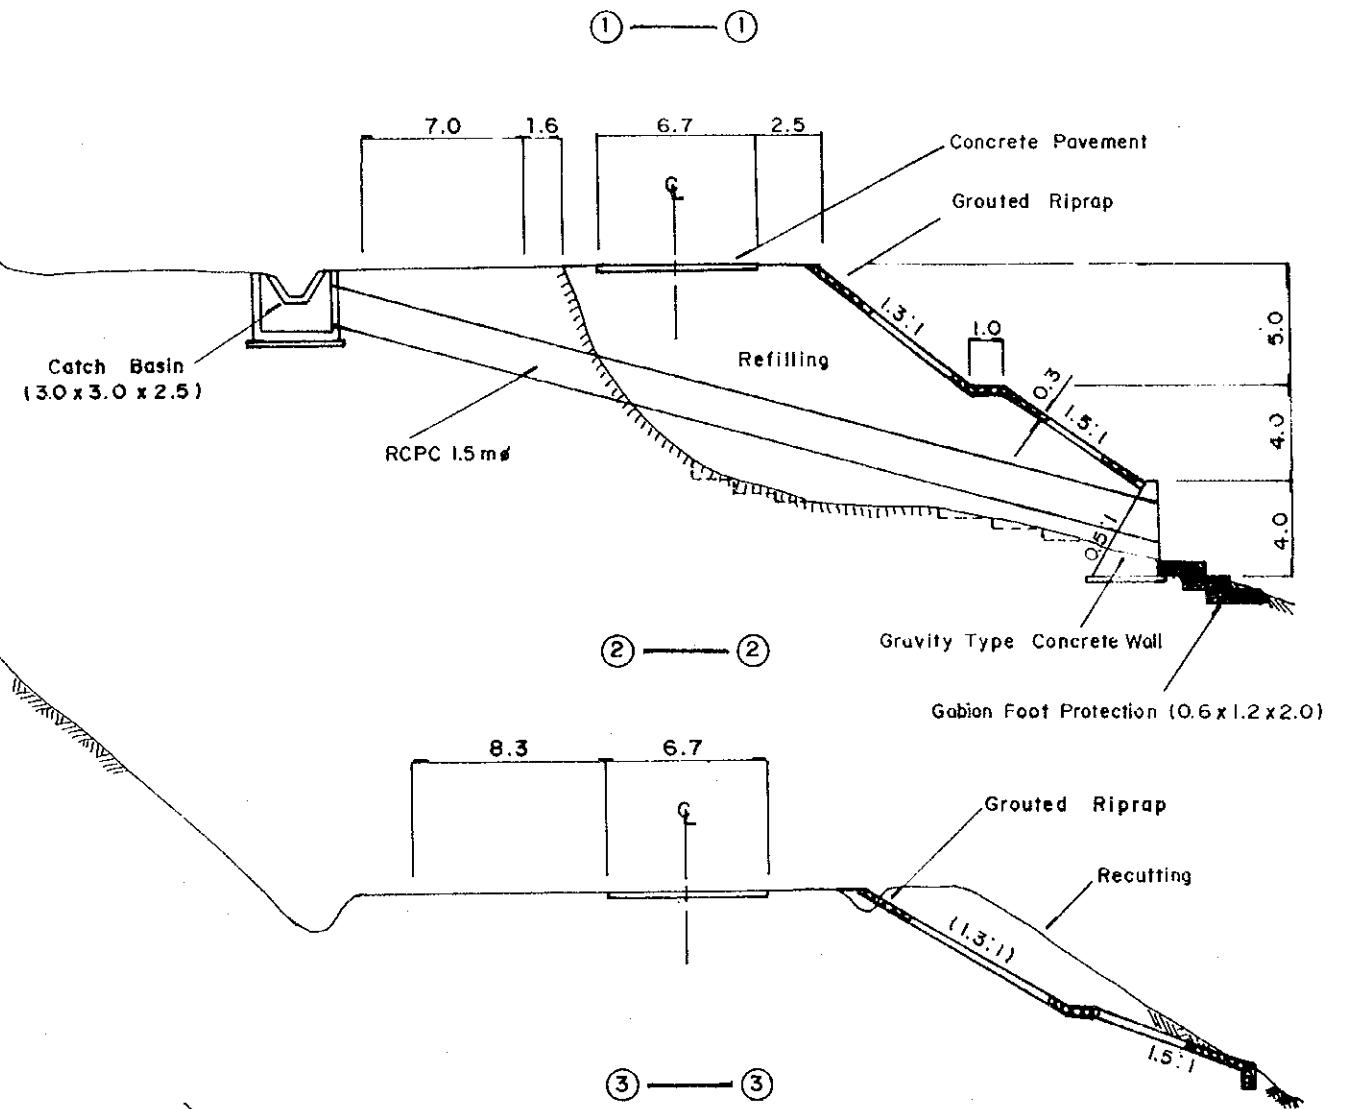
Cause of Disaster:

- 1) Creek overflowing and scoring the embankment.
- 2) Inadequate inlet facility of pipe culvert.
- 3) Infiltration of water into boundary surface between the ground and embankment.

TYPE OF WORK	UNIT	TOTAL
5-8	REFILLING/EMBANKMENT	CU.M	4,175
5-1	RECUITING OF SOIL	CU.M	137
5-14	GRAVITY TYPE CONCRETE WALL	CU.M	154
5-26	GABION FOOT PROTECTION	CU.M	22
5-19	GROUTED RIPRAP	CU.M	312
5-33	RCPC (1.5 m Ø)	L.M	36
5-27	VERTICAL DITCH	L.M	28
5-38	CATCH BASIN FOR RCPC 1.5 m Ø	E.A	1
5-39	CATCH BASIN (3.0 x 3.0 x 2.5)	E.A	1
5-4	STRUCTURAL EXCAVATION	CU.M	485
5-8	FOUNDATION FILL	CU.M	180
