FEASIBILITY STUDY ON PAN-PHILIPPINE HIGHWAY
REHABILITATION PROJECT (MINDANAO SECTION)

SLOPE NO.: 4-38
TYPE OF DISASTER:

STATION: 1340+950
EMBANKMENT SLOPE FAILURE

DRAWING NO.
S-53

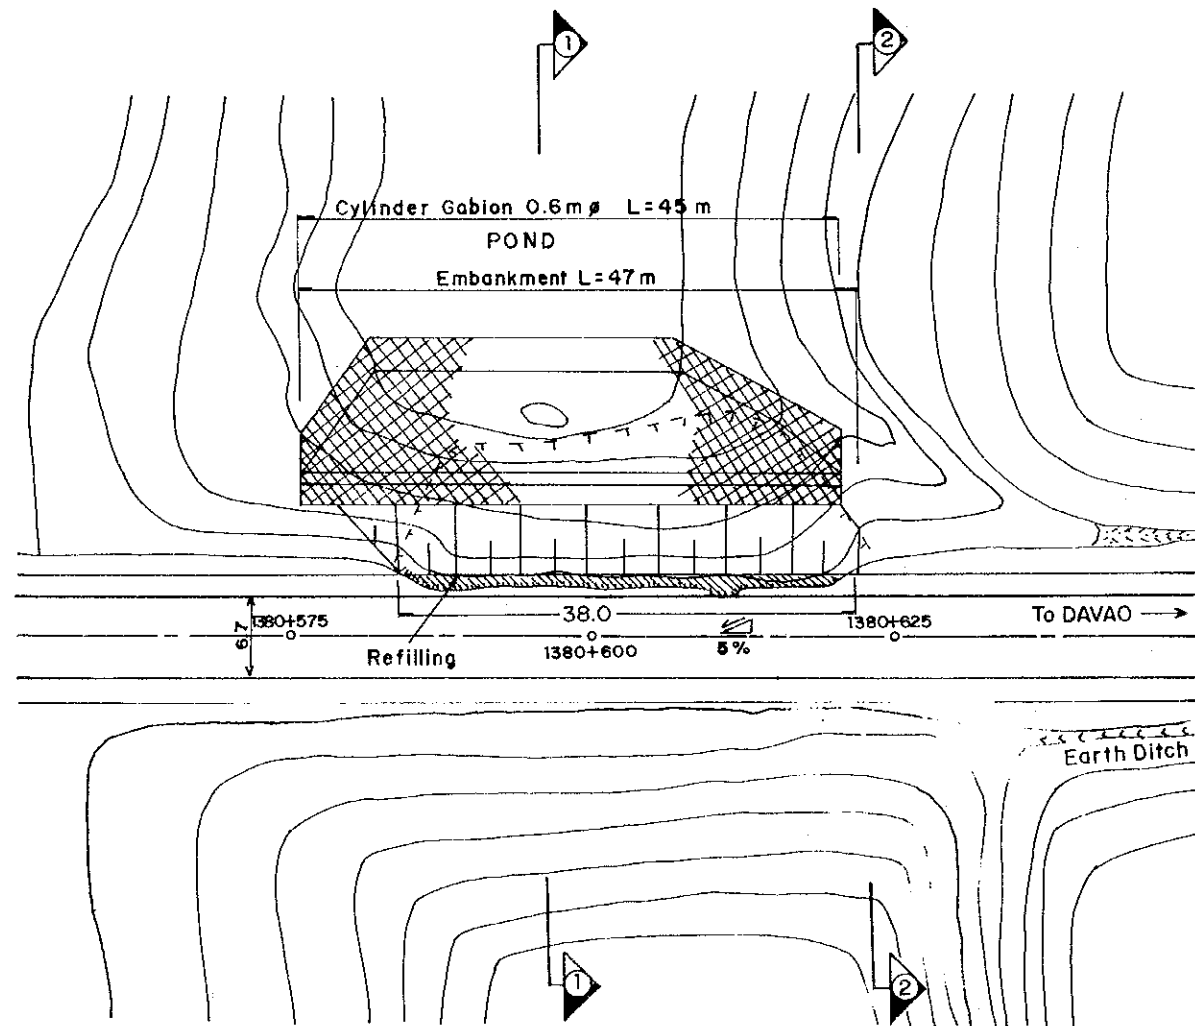
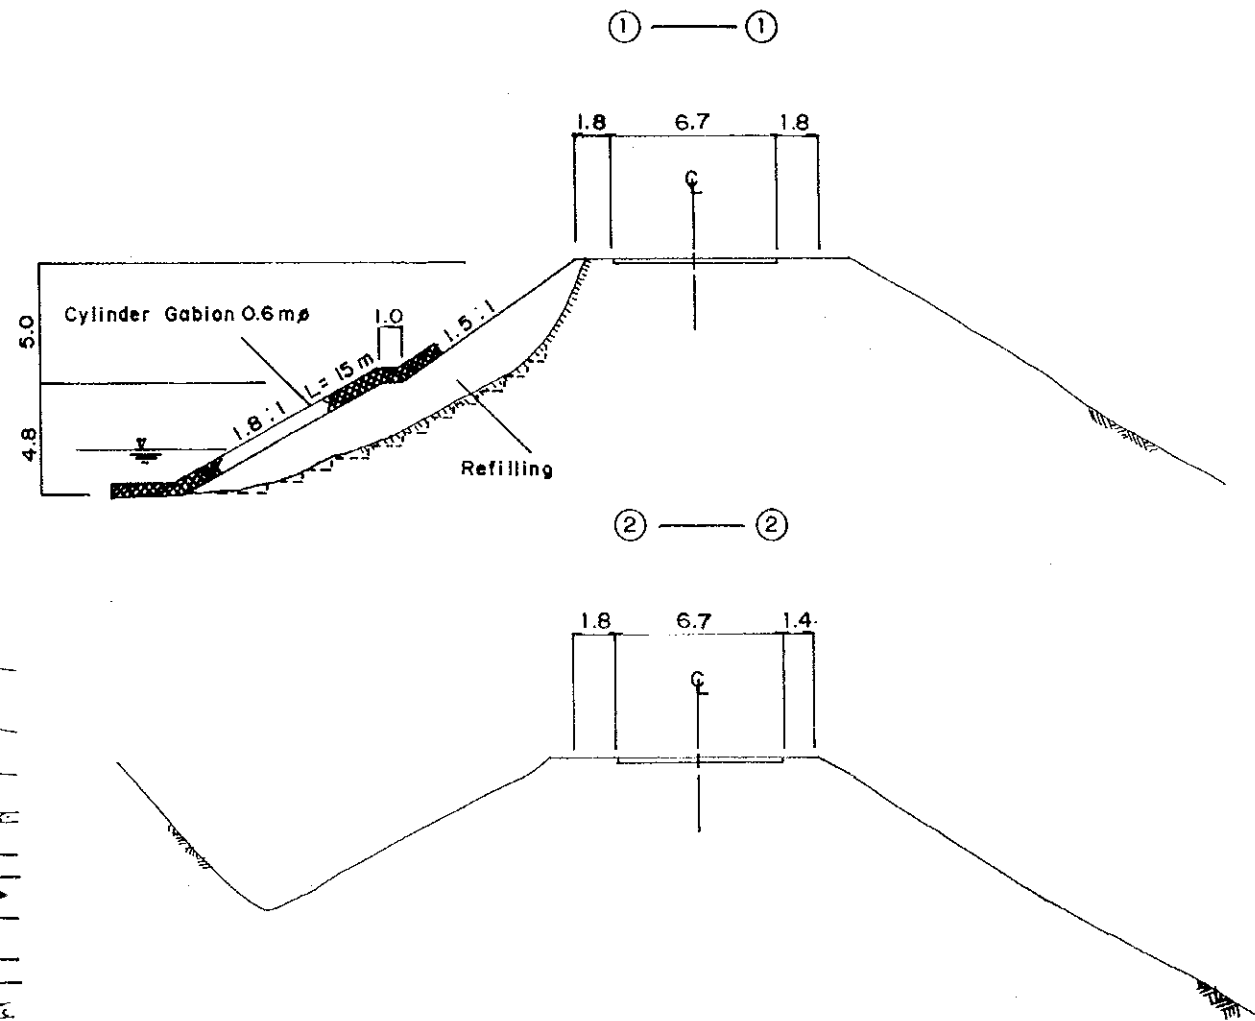
Cause of Disaster:
1) Erosion by water of pond with flood stage.
2) Embankment slope with an unstable grade.

TYPE OF WORK	UNIT	TOTAL
5-5	REFILLING/EMBANKMENT	CU.M	1,044
5-22	CYLINDER GABION	CU.M	285

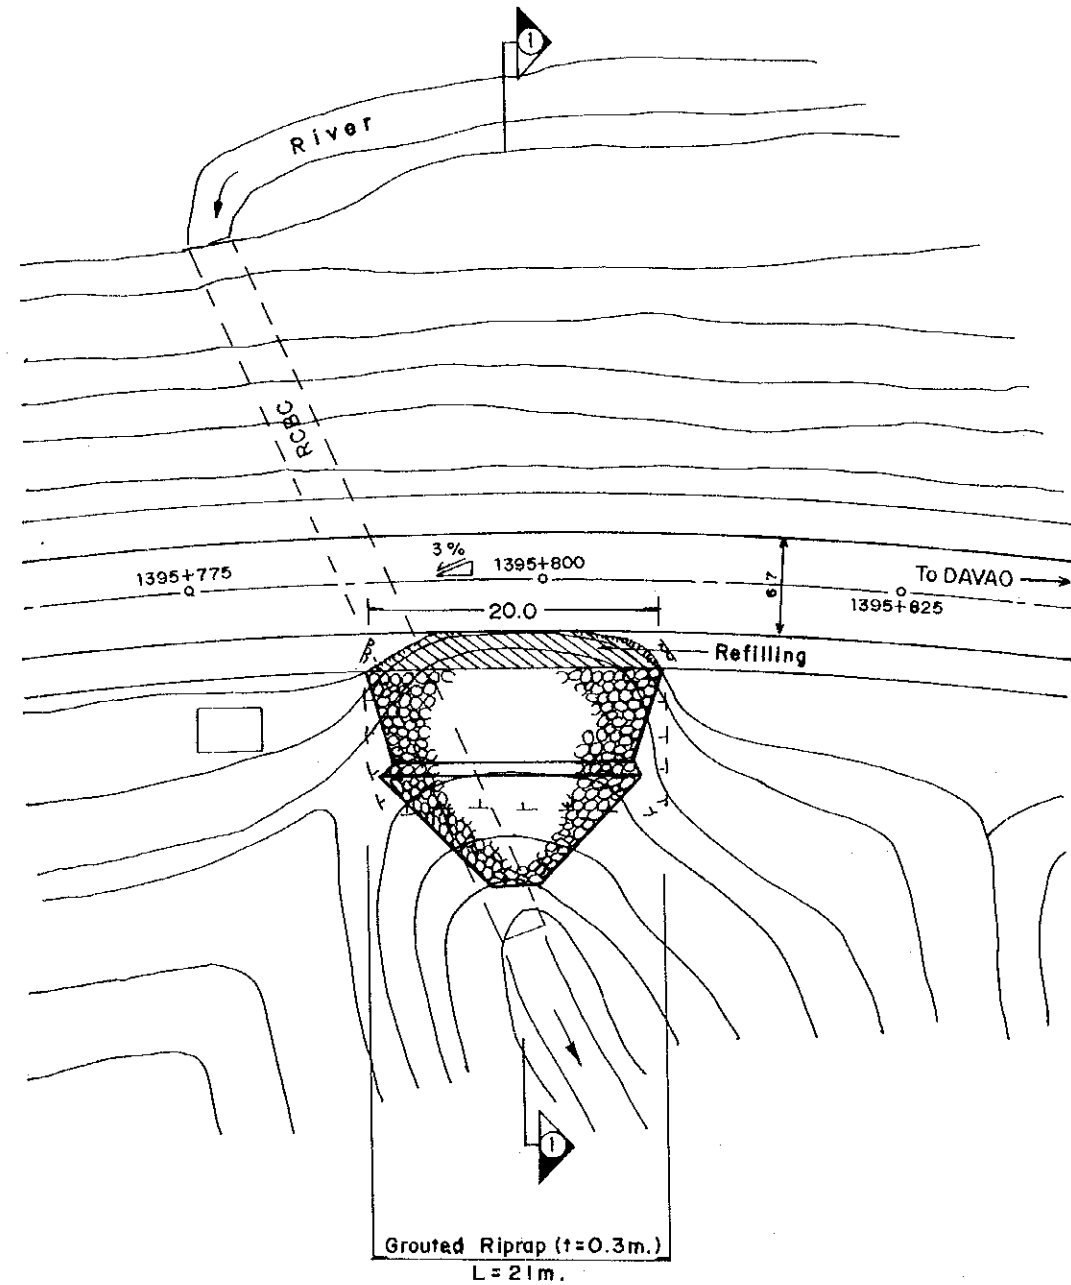
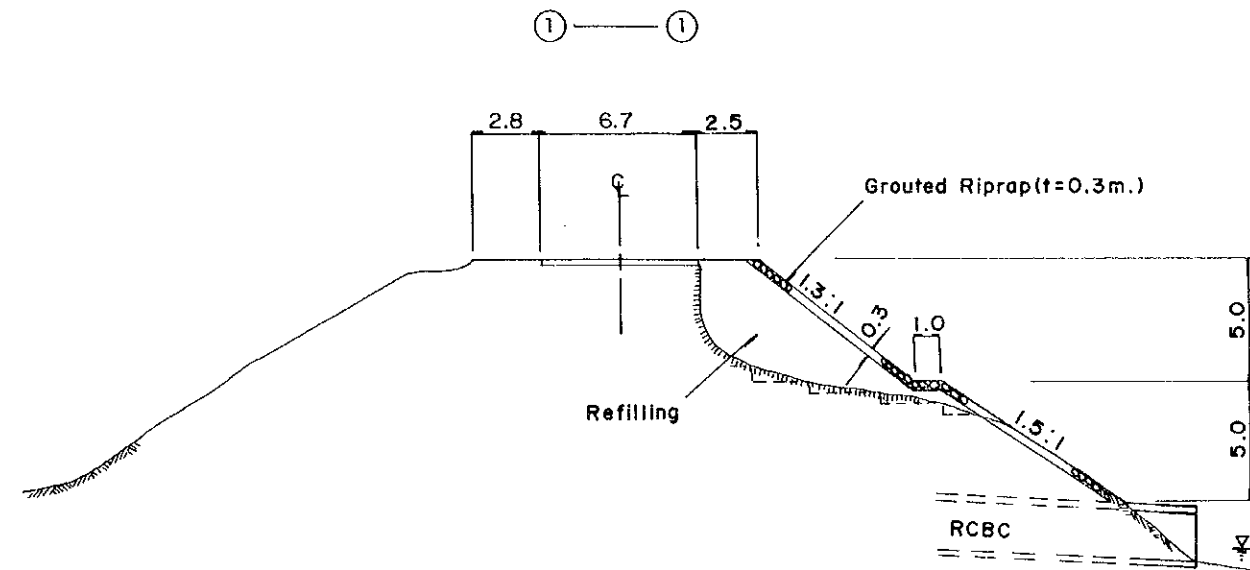
Cause of Disaster:

- 1) Insufficient compaction of embankment.
- 2) Embankment slope with an unstable grade.

TYPE OF WORK		UNIT	TOTAL
5-5	REFILLING / EMBANKMENT	CU. M.	384
5-19	GROUTED RIPRAP	CU. M.	81

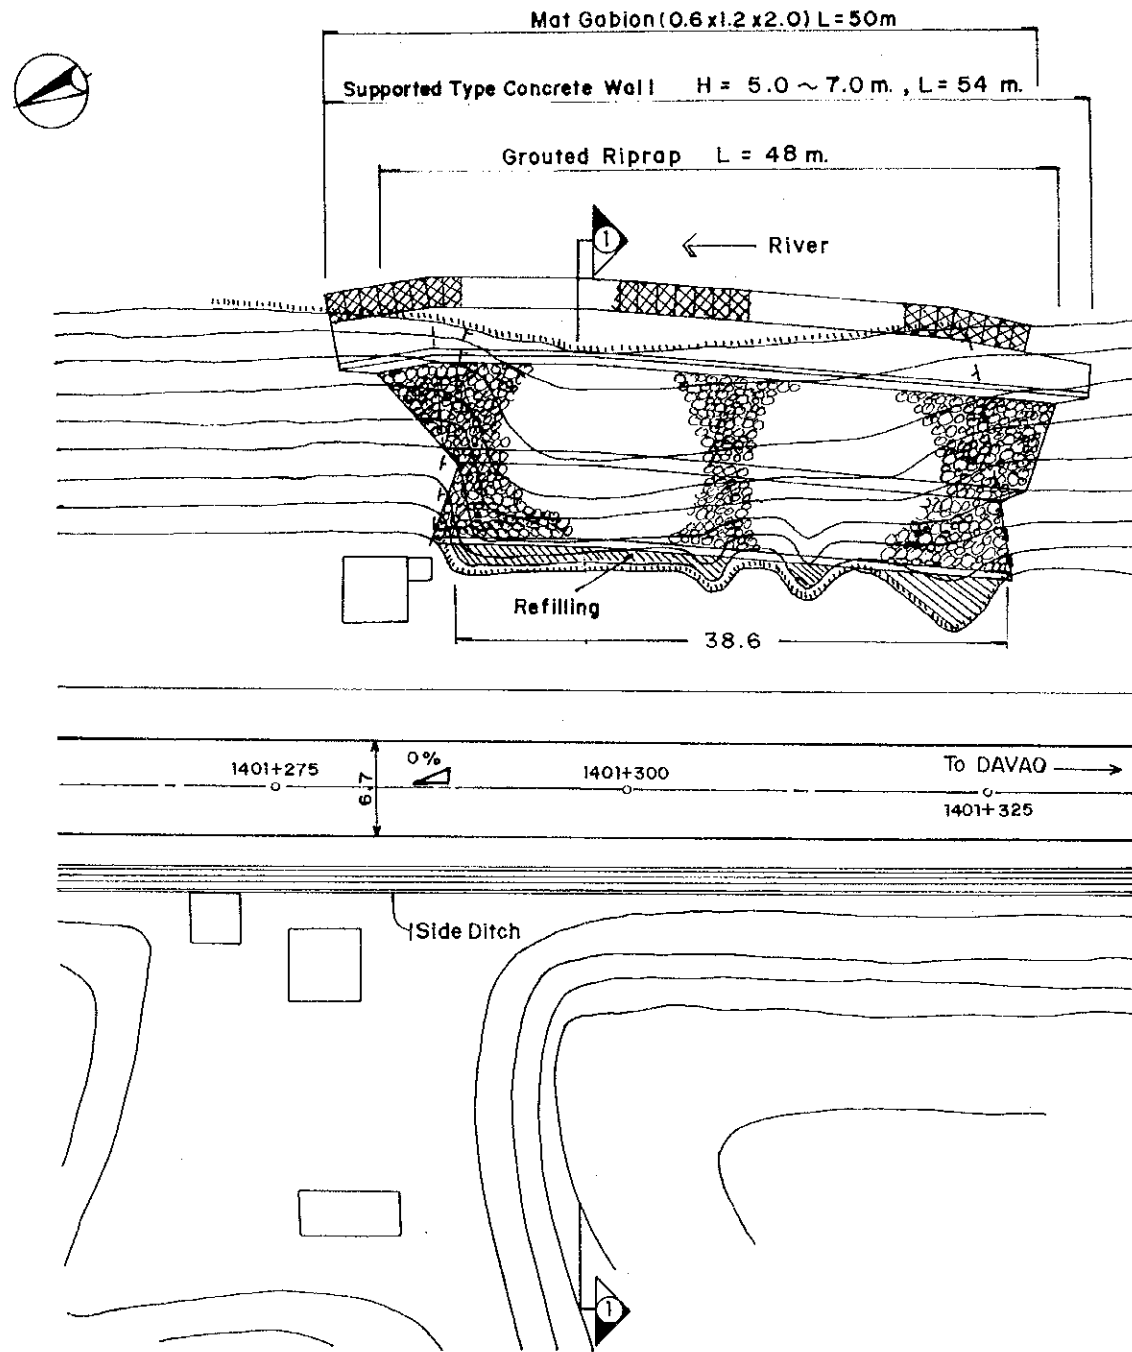
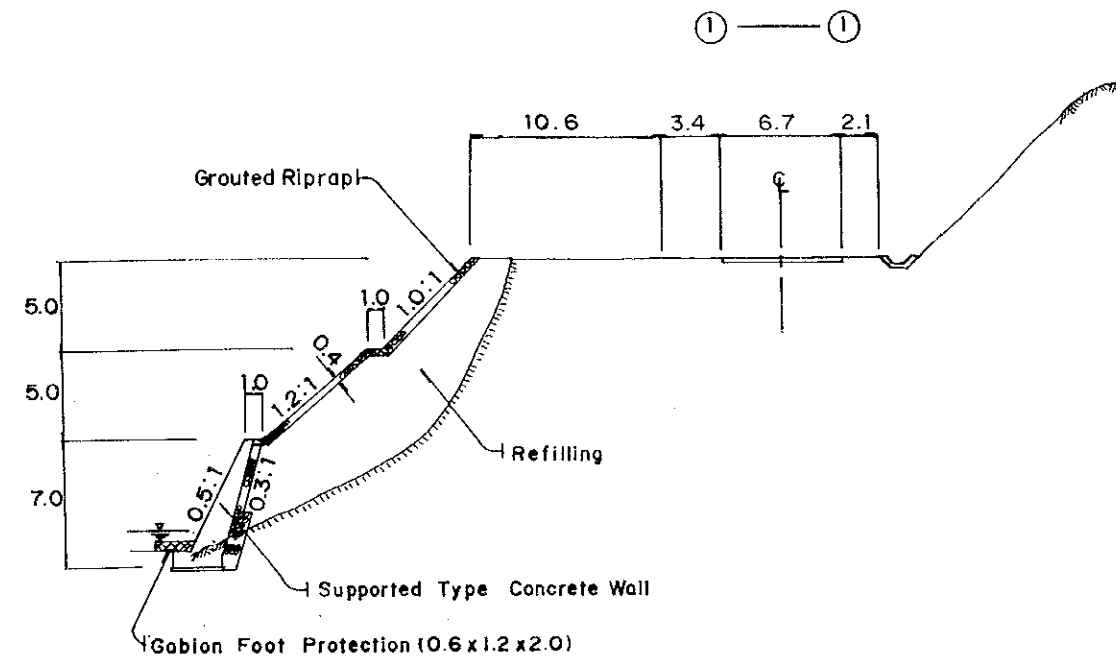
Cause of Disaster:
1) Scouring by flow of river with flood stage.

TYPE OF WORK		UNIT	TOTAL
5-5	REFILLING / EMBANKMENT	CU.M	2,441
5-19	GROUTED RIPRAP	CU.M	277
5-15	SUPPORTED TYPE CONCRETE WALL	CU.M	483
5-26	GABION FOOT PROTECTION	CU.M	59
5-4	STRUCTURAL EXCAVATION	CU.M	346
5-6	REFILLING OF BACKFILL MATERIAL	CU.M	193

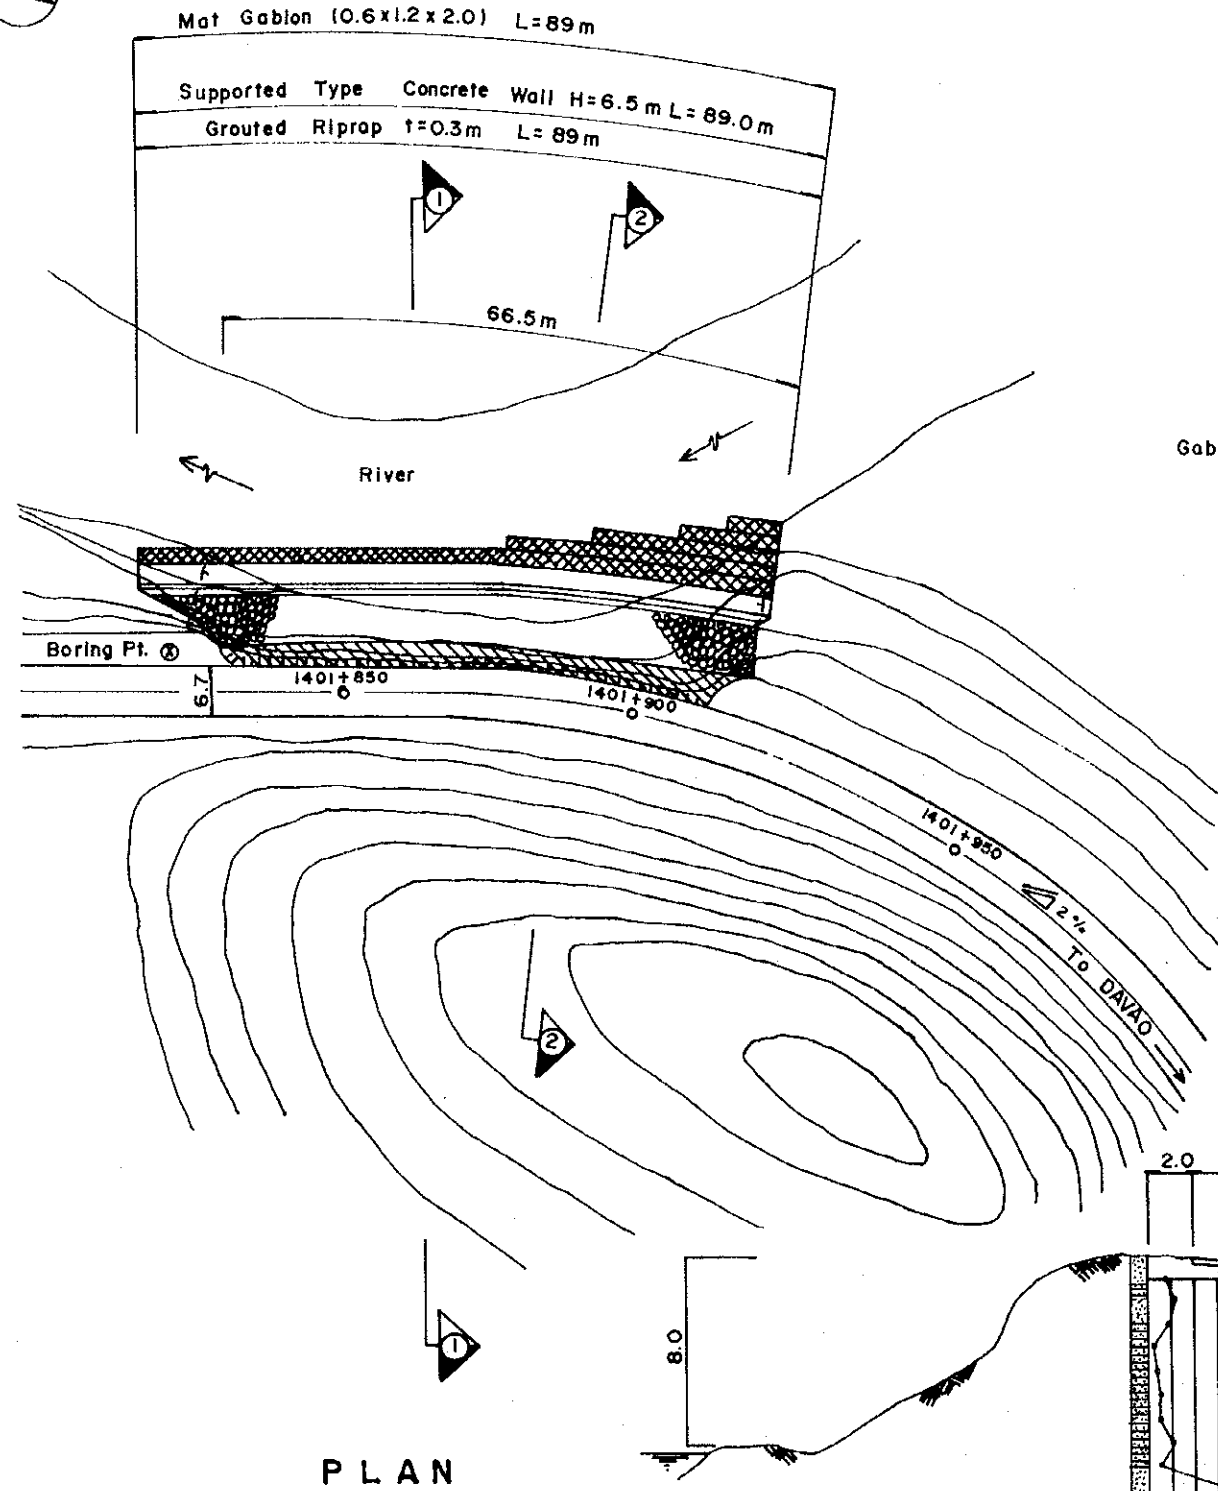
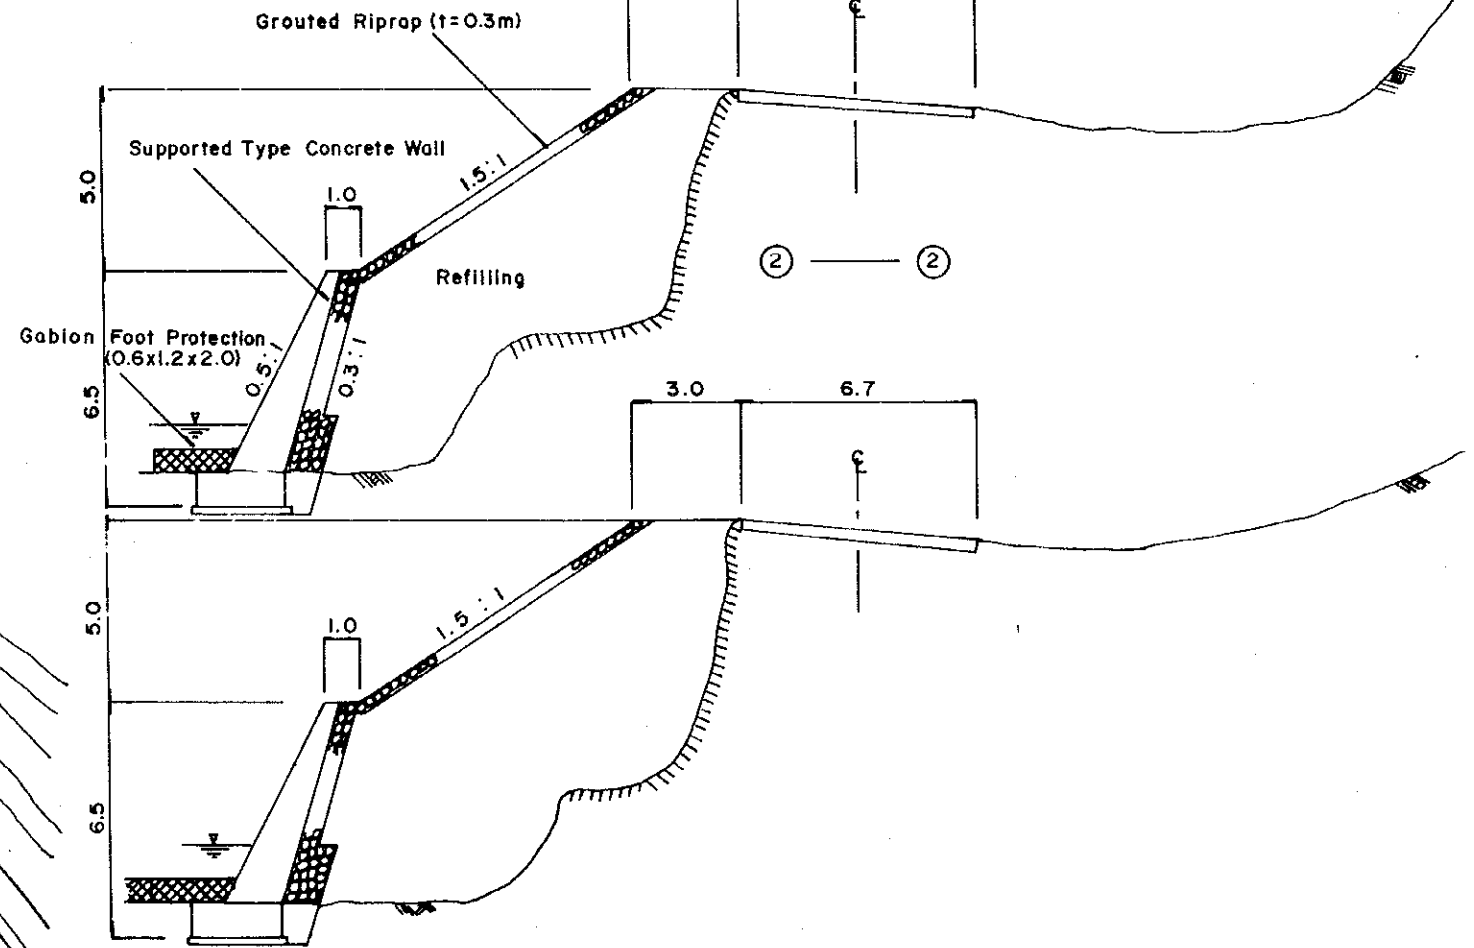
Cause of Disaster:

- 1) Scouring by flow of river with flood stage.
- 2) Embankment slope with an unstable grade.

TYPE OF WORK	UNIT	TOTAL
5-5	REFILLING/EMBANKMENT	CU.M	4,329
5-19	GROUTED RIPRAP	CU.M	224
5-15	SUPPORTED TYPE CONCRETE WALL	CU.M	659
5-26	GABION FOOT PROTECTION	CU.M	209
5-4	STRUCTURAL EXCAVATION	CU.M	530
5-6	FILLING OF BACKFILL MATERIAL	CU.M	280

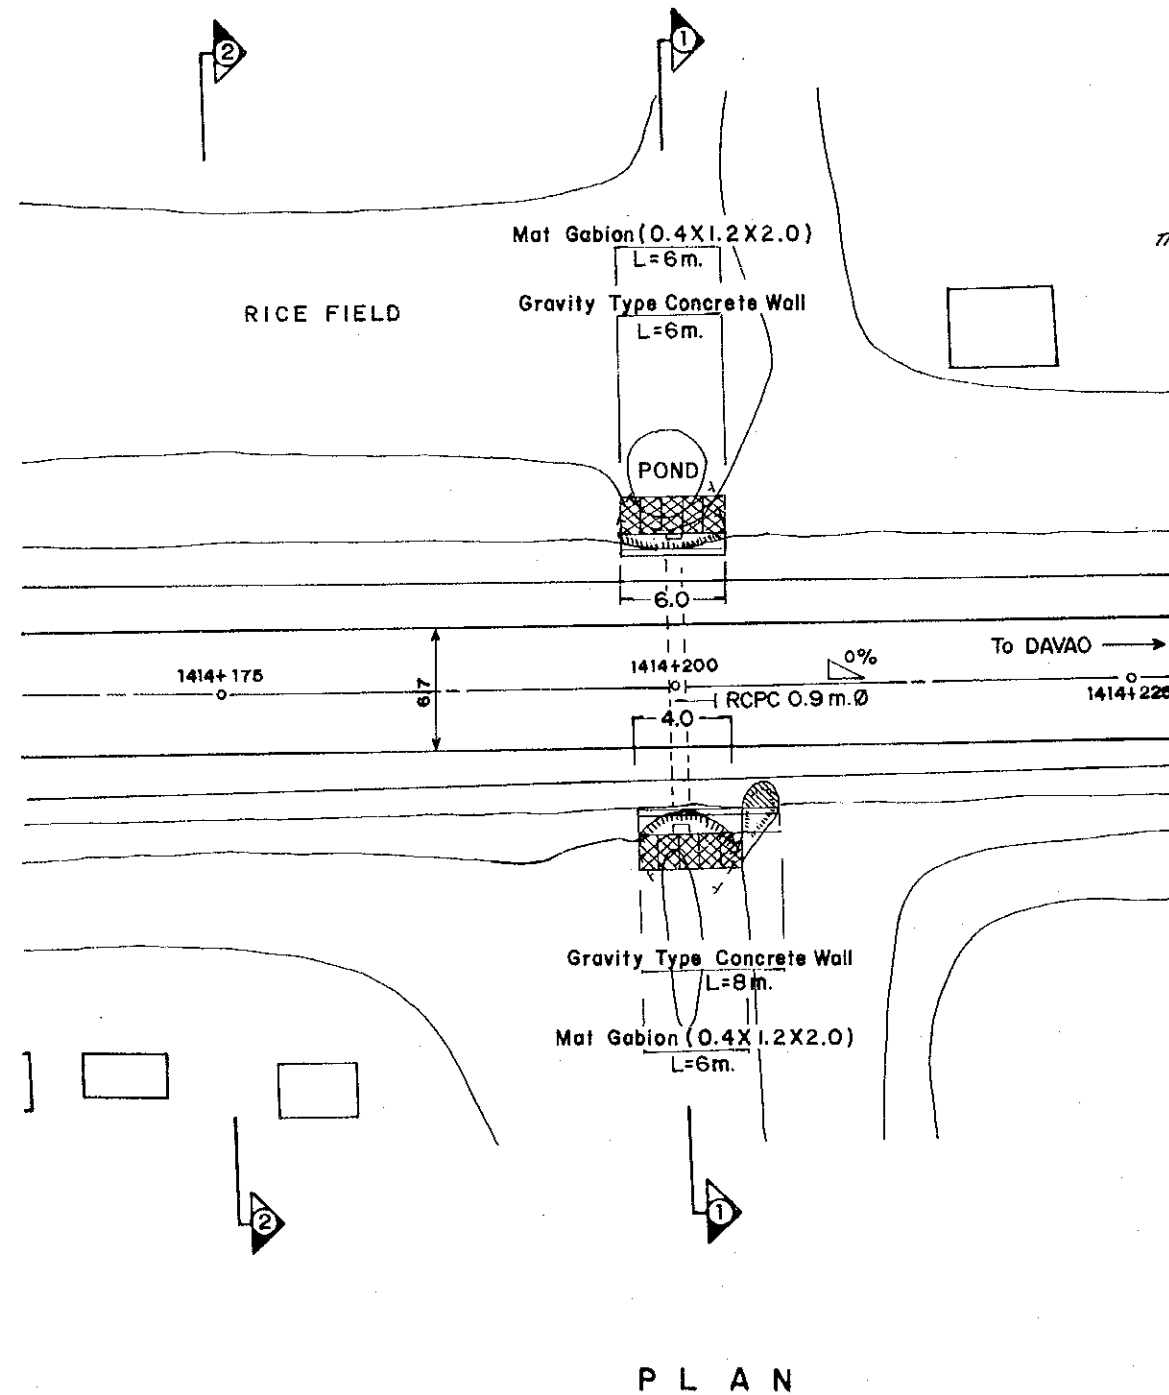
Cause of Disaster:

- 1) Erosion at the foot of slope by pond water.
- 2) Inadequate inlet facility of pipe culvert.

TYPE OF WORK	UNIT	TOTAL
5-14	GRAVITY TYPE CONCRETE WALL	CU.M	43
5-26	GABION FOOT PROTECTION	CU.M	10
5-4	STRUCTURAL EXCAVATION	CU.M	83
5-6	REFILLING OF BACKFILL MATERIAL	CU.M	16

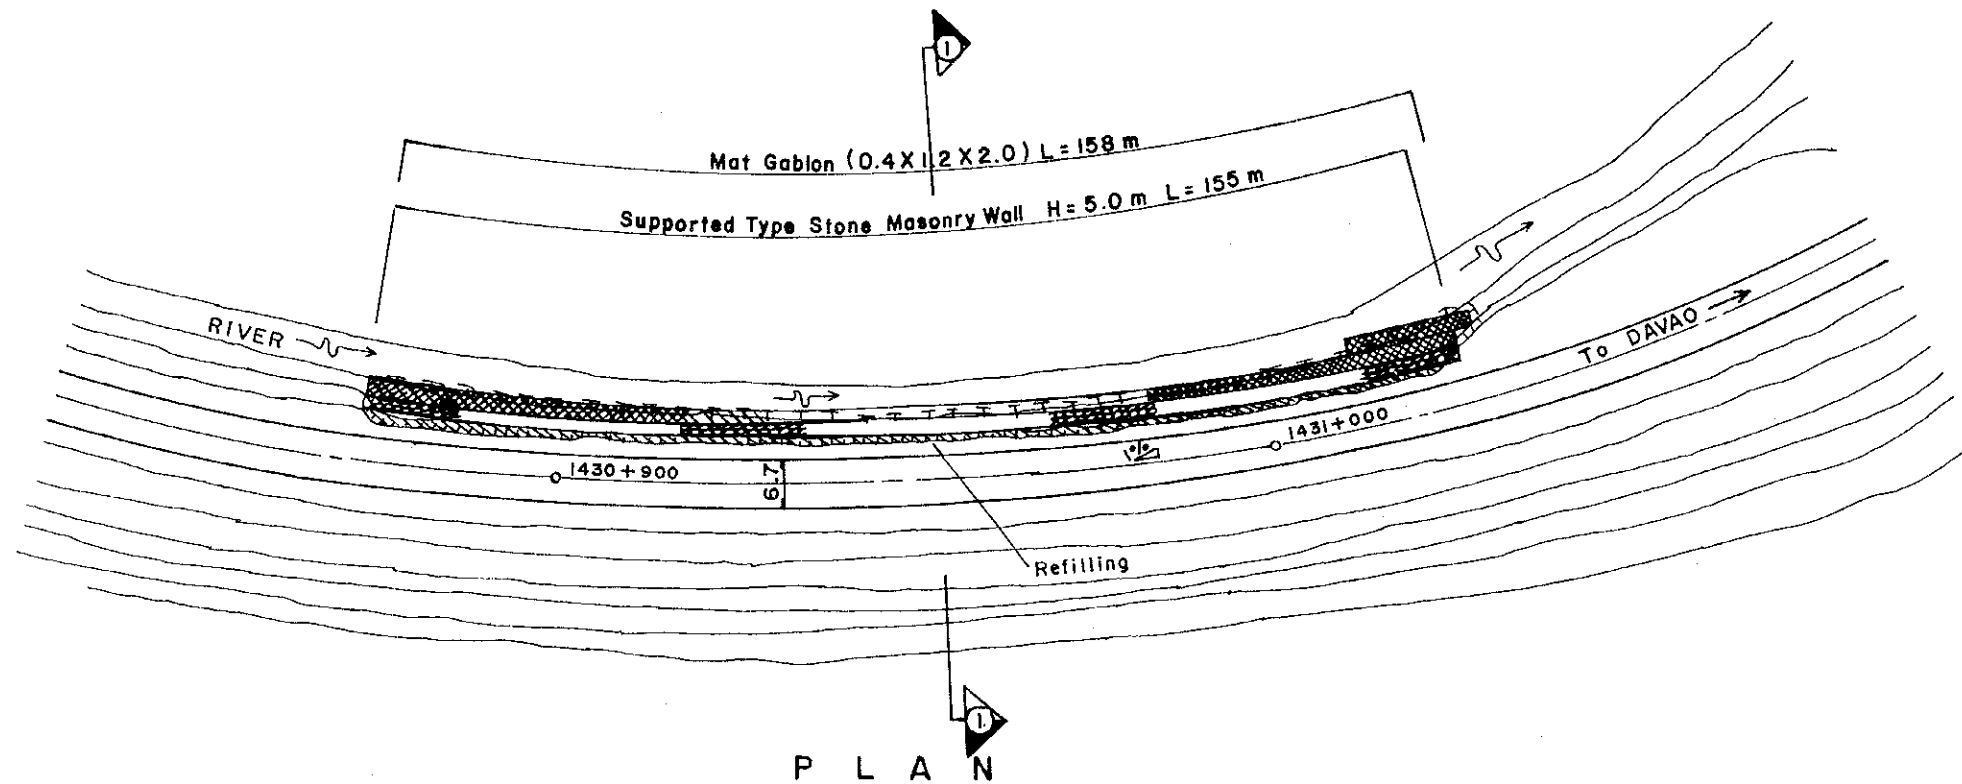
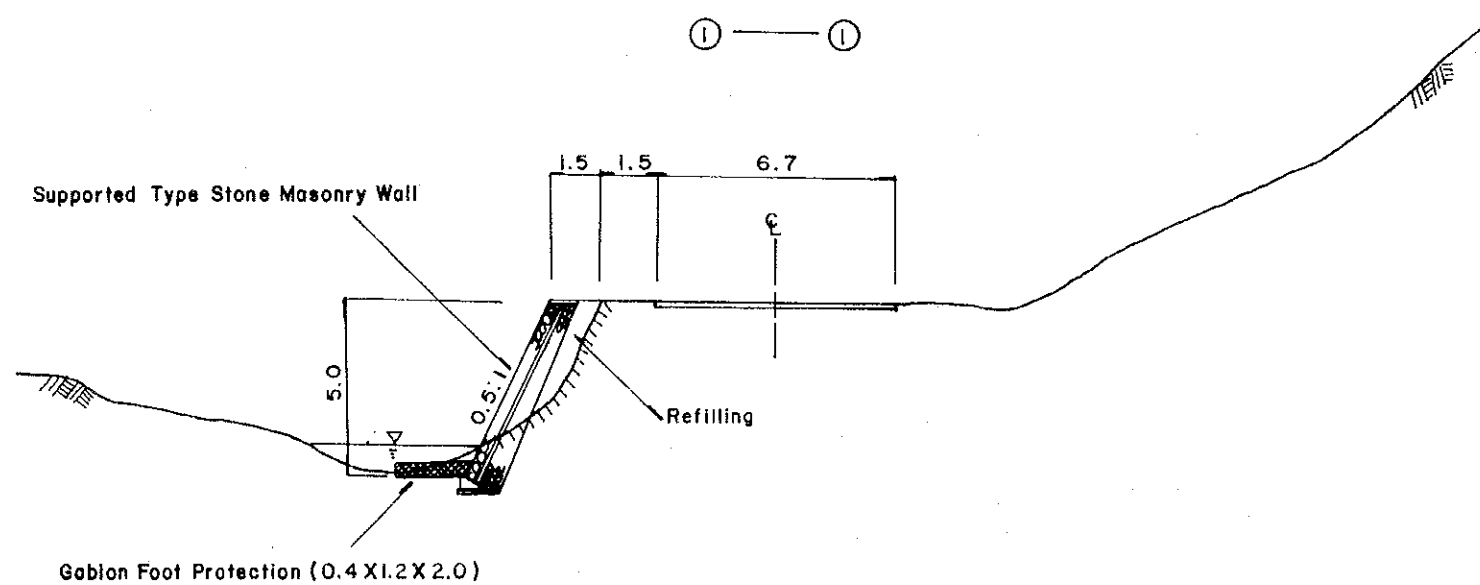
Cause of Disaster:

- 1) Scouring by flow of river with flood stage.

TYPE OF WORK	UNIT	TOTAL
5-5	REFILLING/ EMBANKMENT	CU.M	297
5-16	SUPPORTED TYPE STONE MASONRY WALL	CU.M	455
5-26	GABION FOOT PROTECTION	CU.M	138
5-4	STRUCTURAL EXCAVATION	CU.M	310
5-6	FILLING OF BACKFILL MATERIAL	CU.M	350

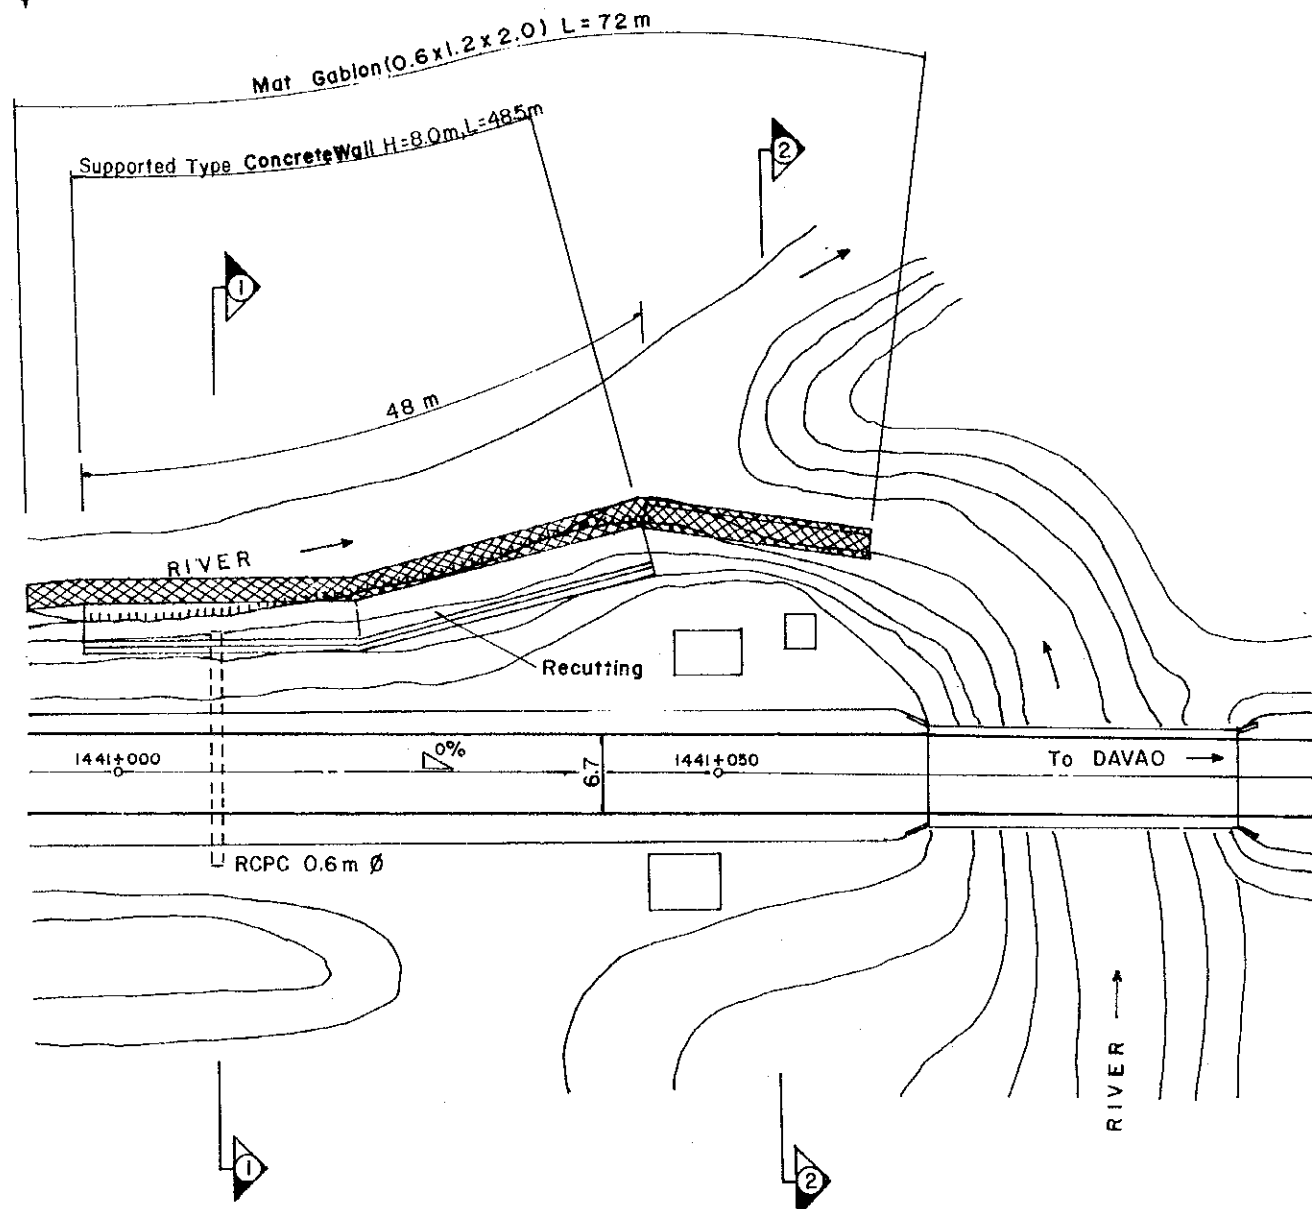
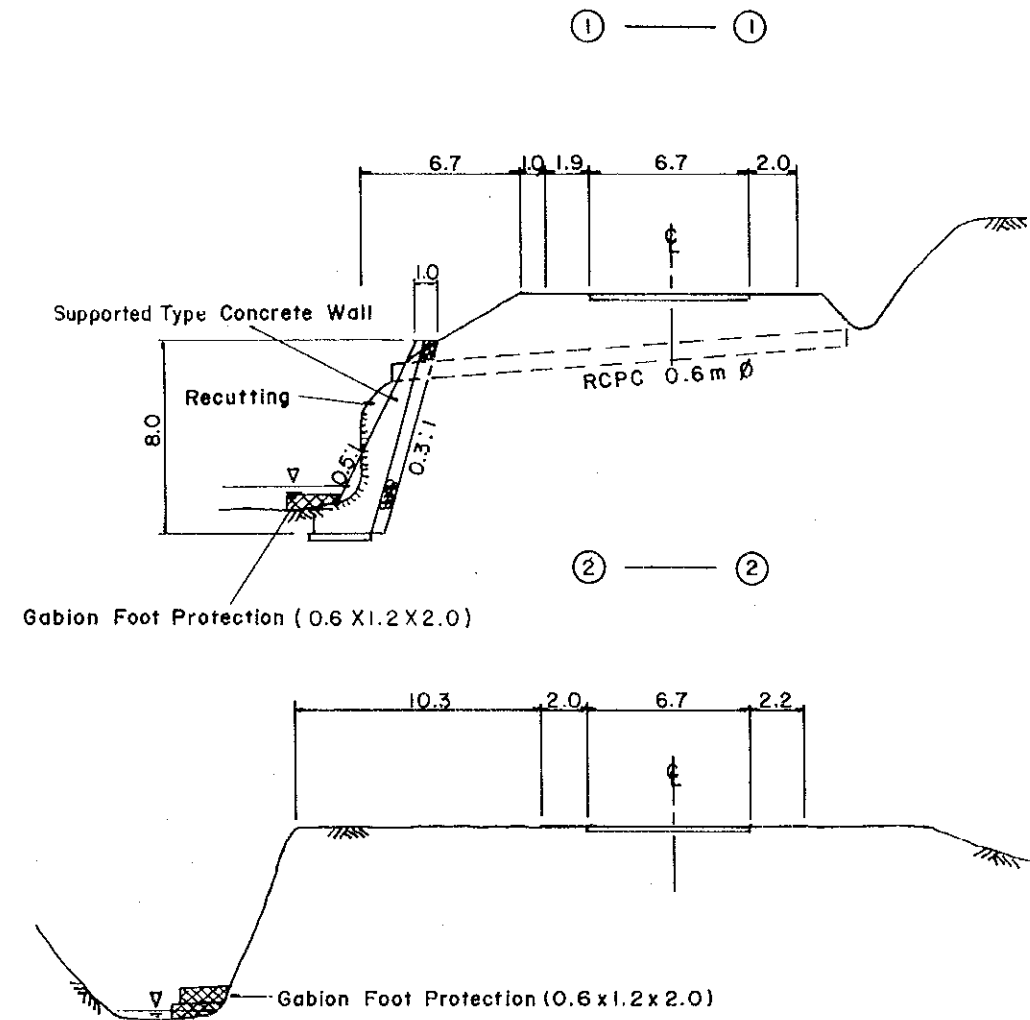
Cause of Disaster:
1) Scouring by flow of river with flood stage.

TYPE OF WORK		UNIT	TOTAL
5-1	RECUTTING OF SOIL	CU.M.	754
5-15	SUPPORTED TYPE CONCRETE WALL	CU.M.	517
5-26	GABION FOOT PROTECTION	CU.M.	109
5-6	REFILLING OF BACKFILL MATERIAL	CU.M.	140

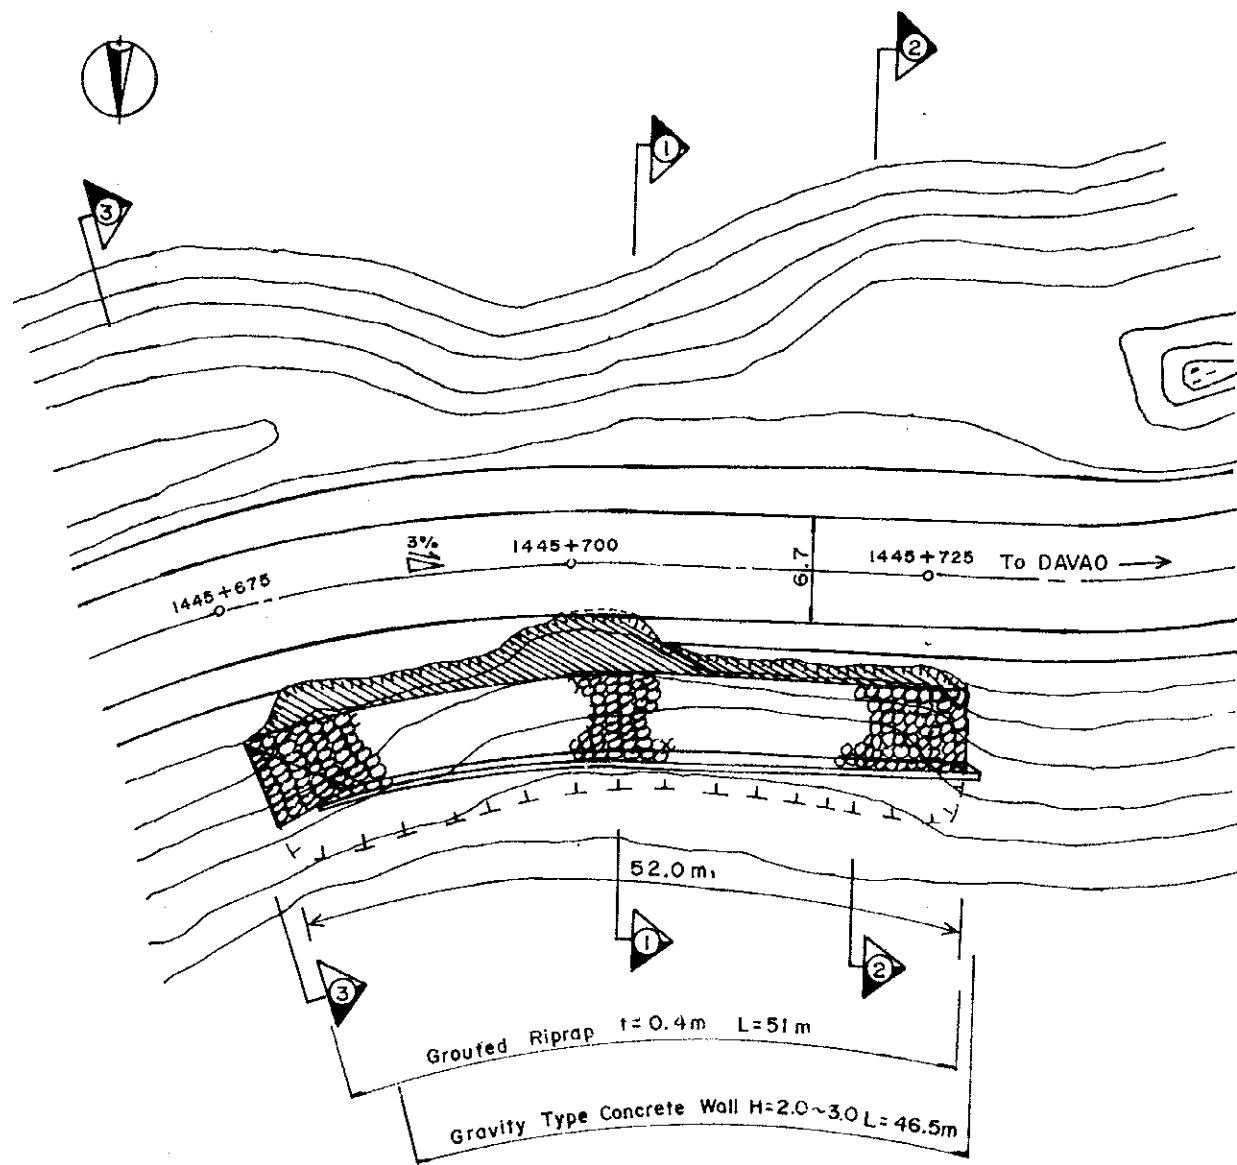
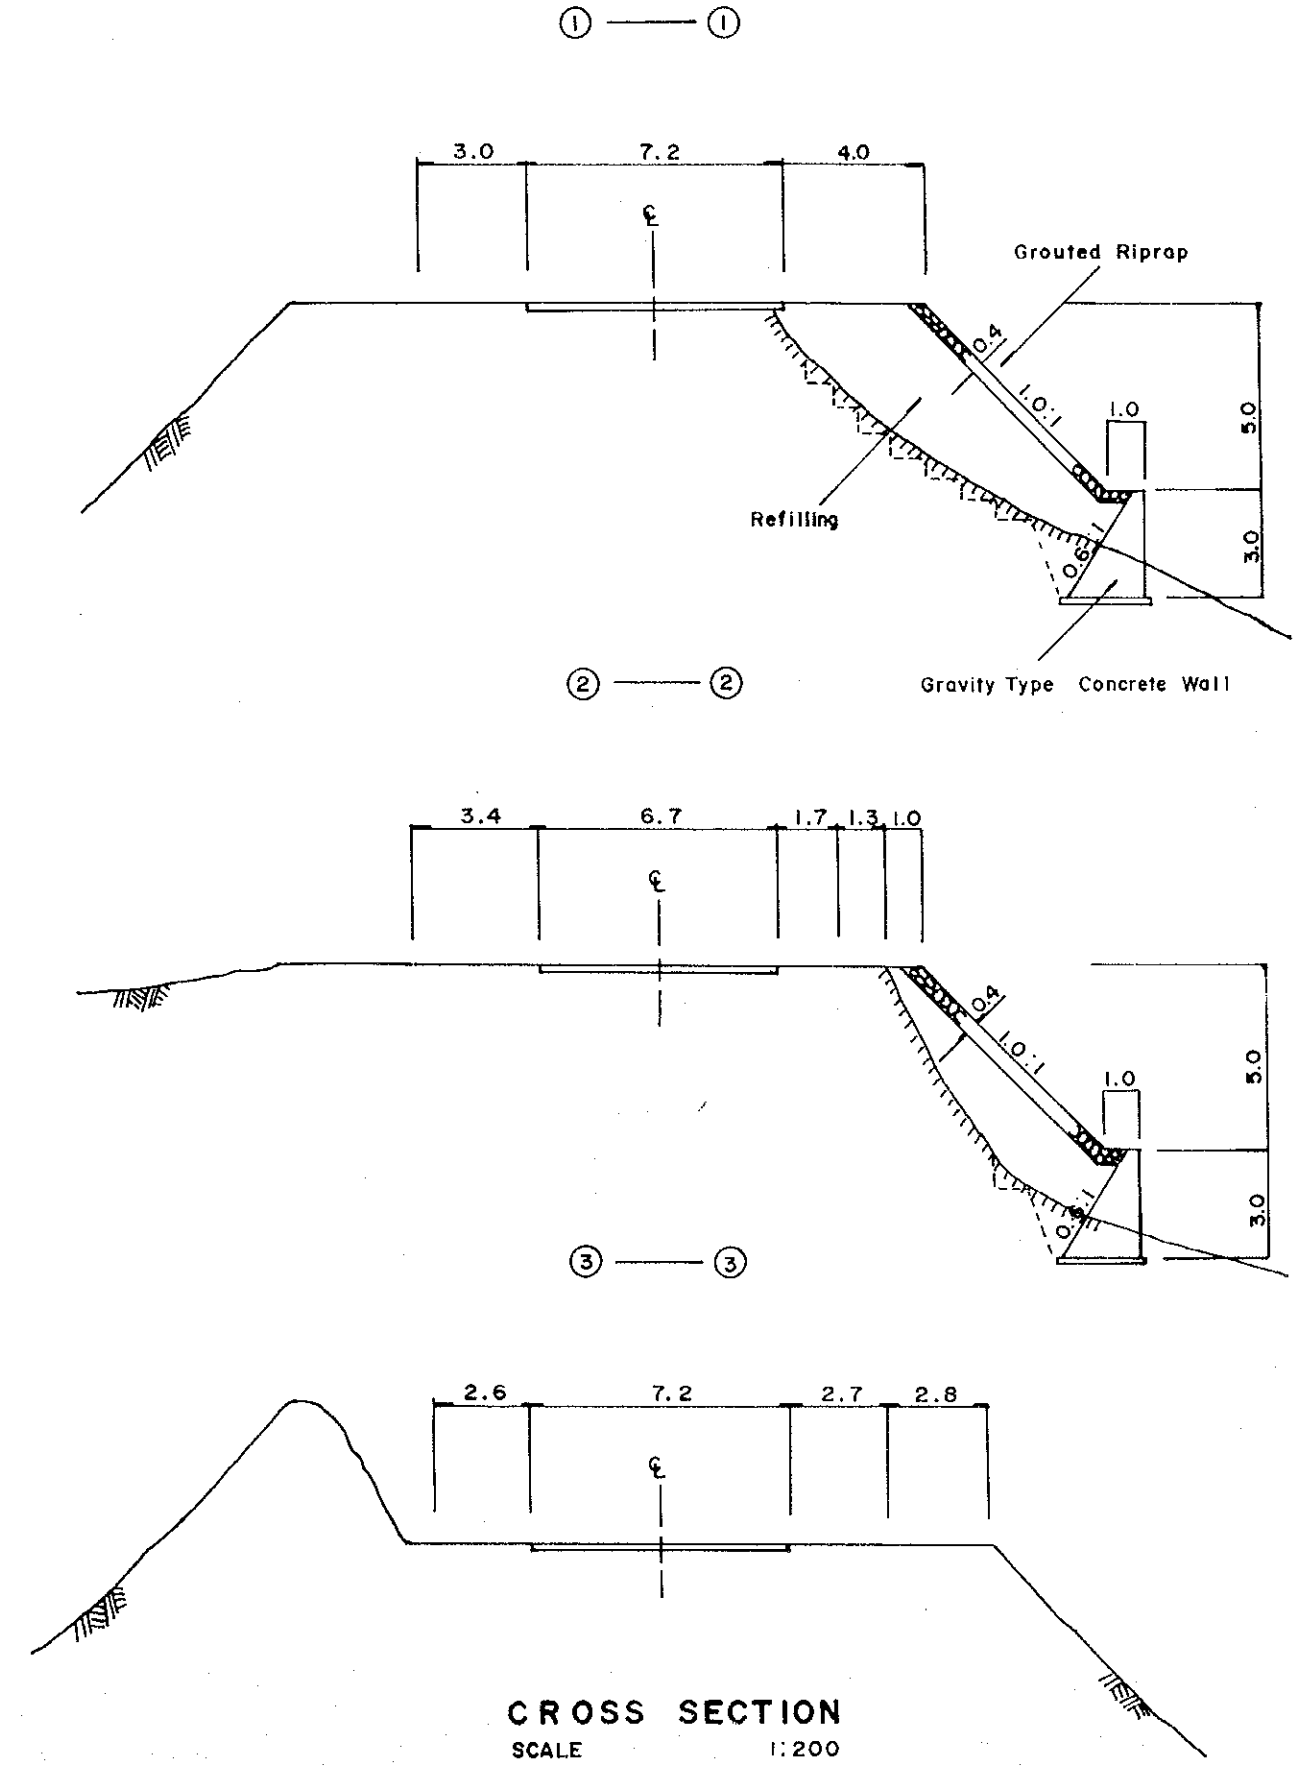
Cause of Disaster:

- 1) Erosion due to concentrated surface water on the curved portion of road.

TYPE OF WORK	UNIT	TOTAL
5-5	REFILLING/EMBANKMENT	CU.M	770
5-19	GROUTED RIPRAP	CU.M	153
5-14	GRAVITY TYPE CONCRETE WALL	CU.M	160
5-4	STRUCTURAL EXCAVATION	CU.M	260
5-8	FOUNDATION FILL	CU.M	105
