FEASIBILITY STUDY ON PAN-PHILIPPINE HIGHWAY
REHABILITATION PROJECT (MINDANAO SECTION)

SLOPE NO.: 4-38
TYPE OF DISASTER:

STATION: 1340+950
EMBANKMENT SLOPE FAILURE

DRAWING NO.
S-53

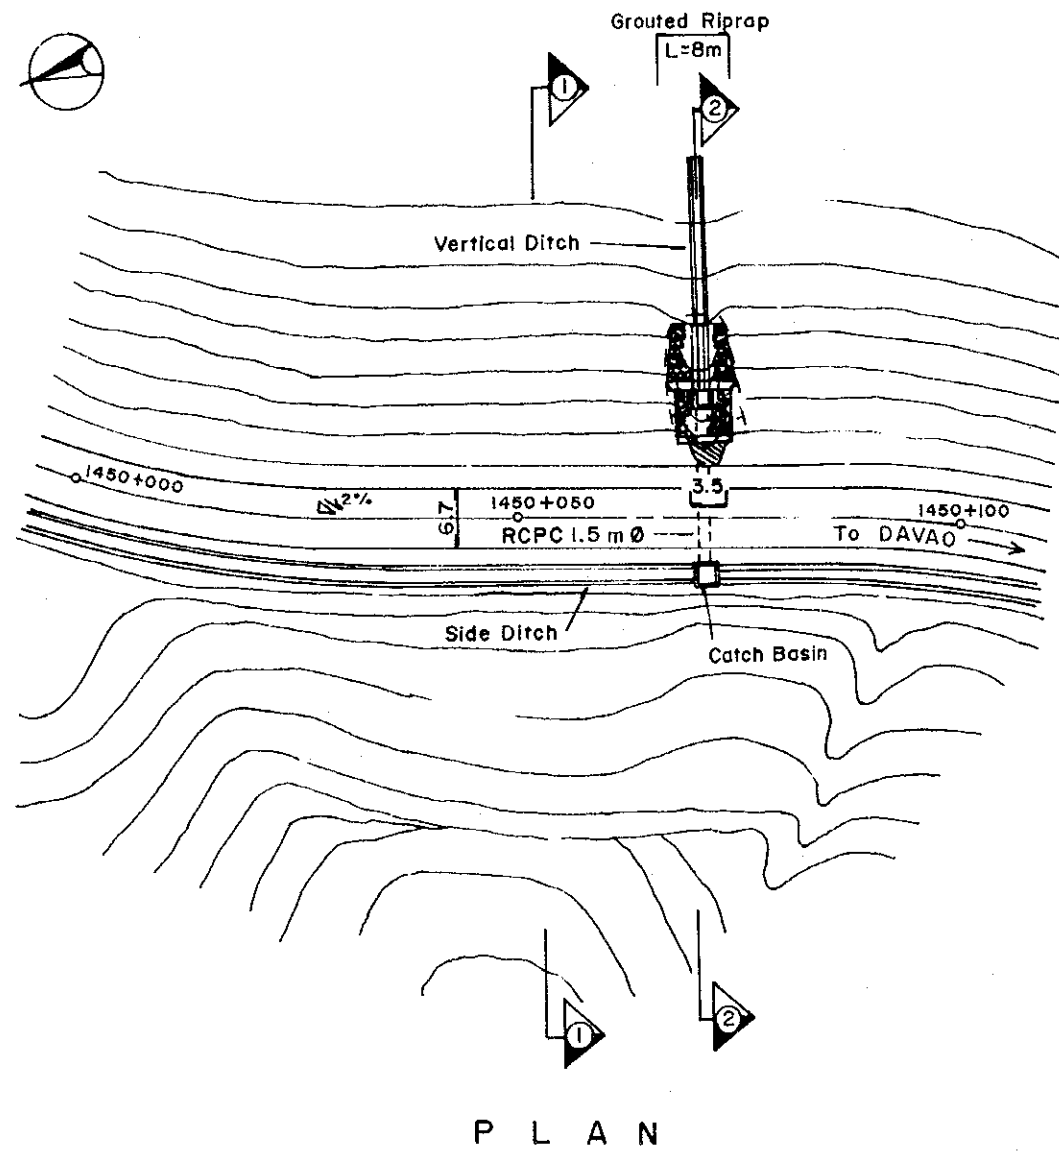
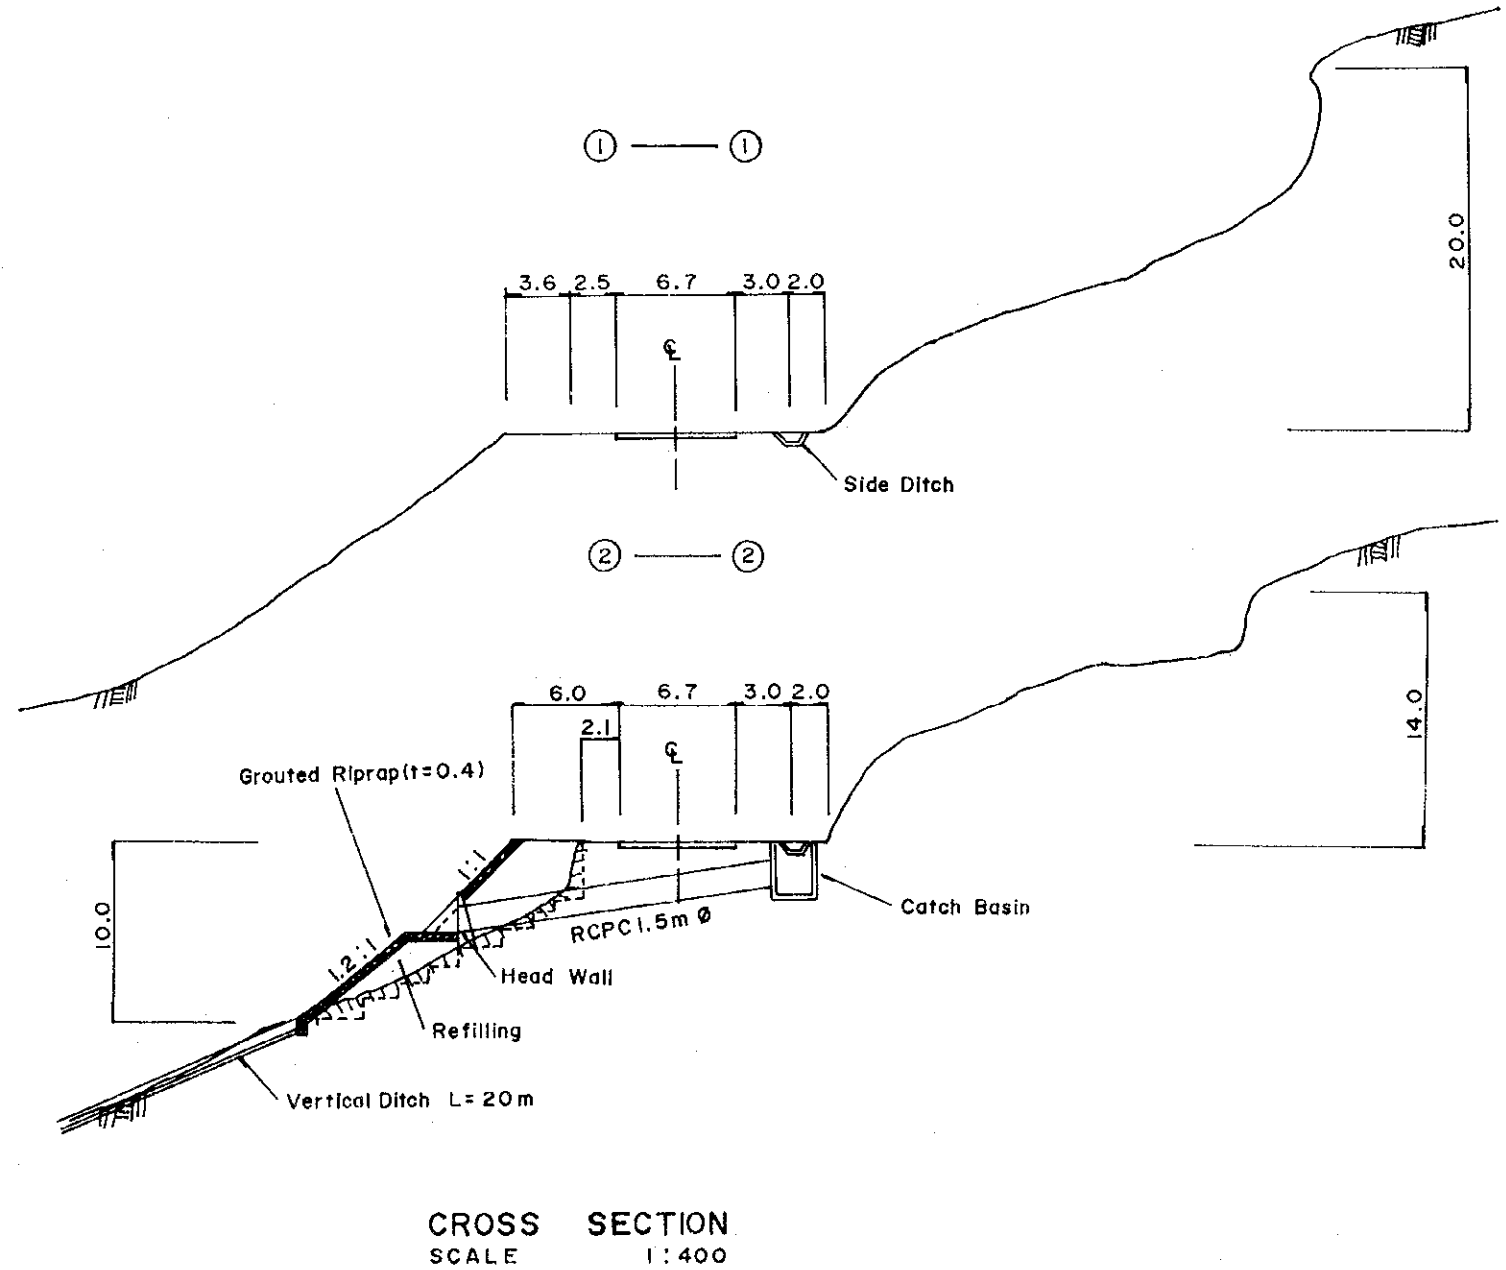
Cause of Disaster:

- 1) Infiltration of water into boundary surface between the ground and embankment.
- 2) Effect of ground water.
- 3) Embankment slope with an unstable grade.

TYPE OF WORK		UNIT	TOTAL
5-5	REFILLING/EMBANKMENT	CU.M	254
5-19	GRouted RIPRAP	CU.M	44
5-38	CATCH BASIN FOR RCPC 1.5 m Ø	E. A.	1
5-33	RCPC (1.5 m Ø)	L. M	18
5-27	VERTICAL DITCH	L. M	20
5-41	HEAD WALL FOR RCPC 1.5 m Ø	E. A.	1
5-4	STRUCTURAL EXCAVATION	CU. M	115
5-8	FOUNDATION FILL	CU. M	87

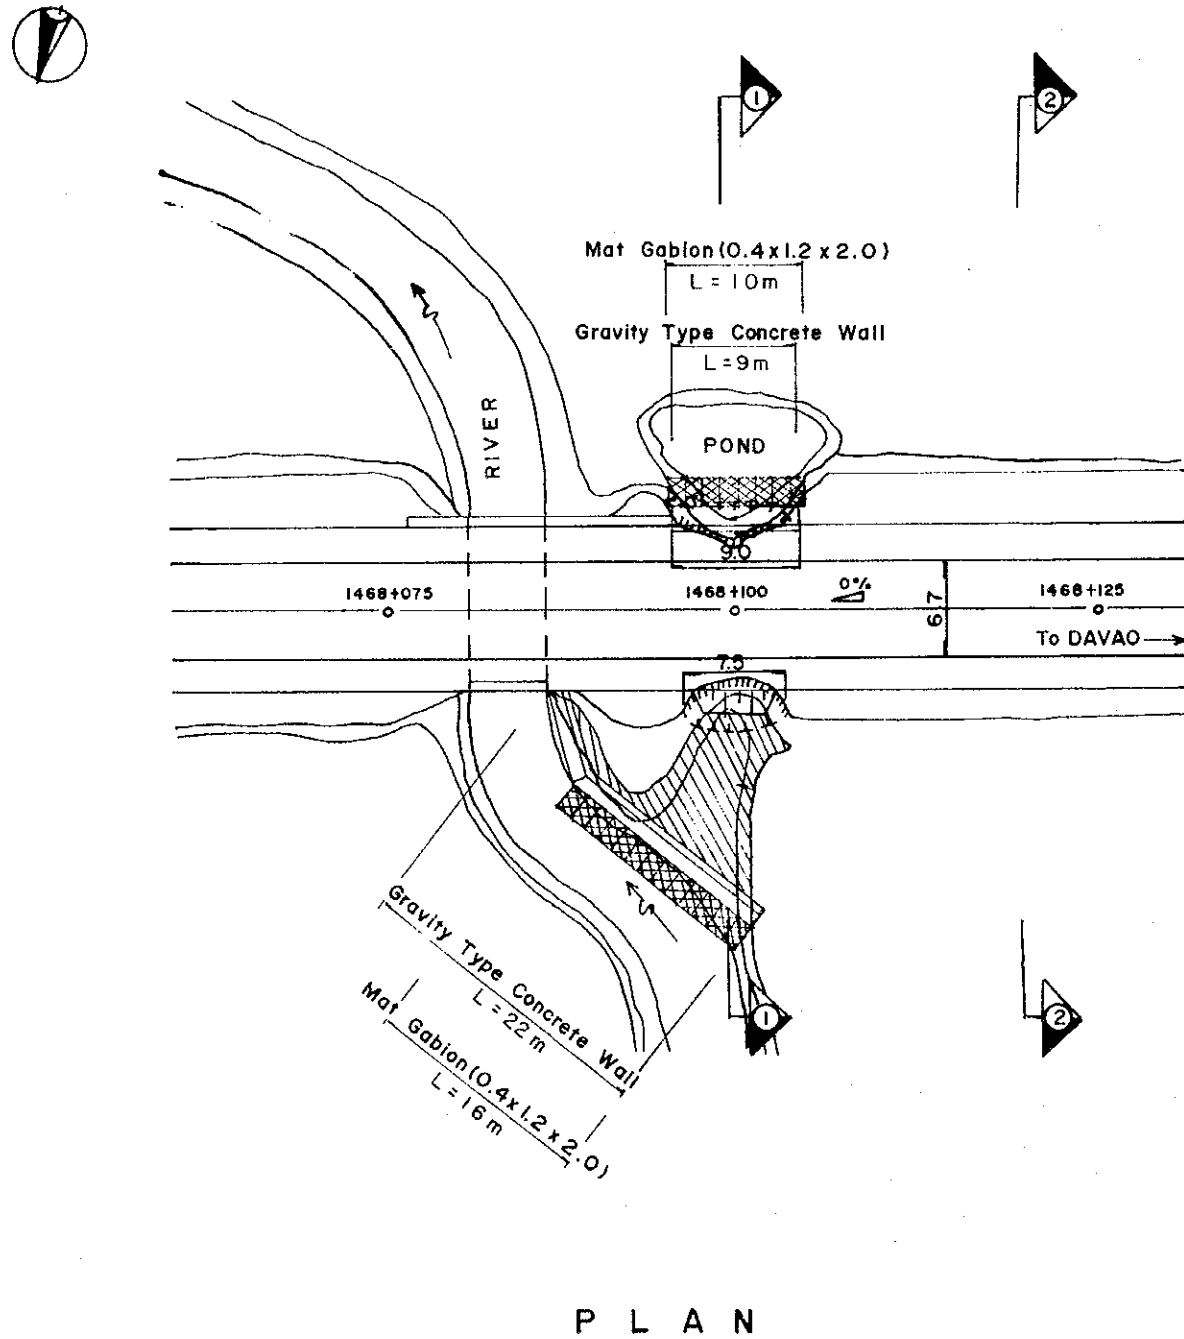
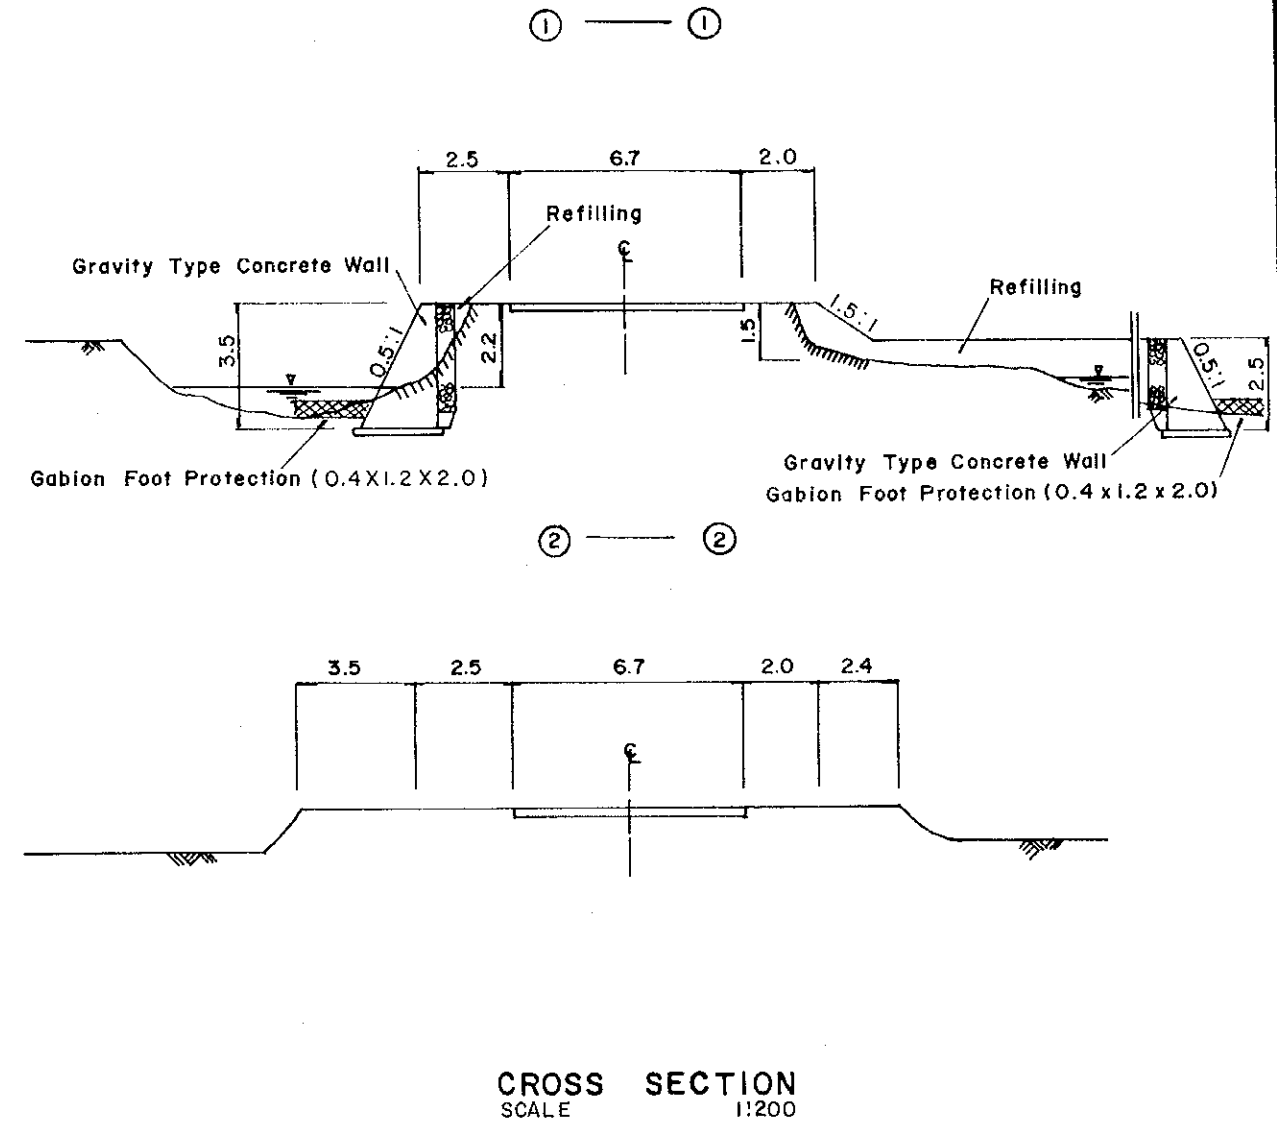
Cause of Disaster:
1) Erosion at the foot of slope by pond water.
2) Scouring by stream from river into the pond.

TYPE OF WORK	UNIT	TOTAL
5-5	REFILLING/EMBANKMENT	CU.M.	88
5-14	GRAVITY TYPE CONCRETE WALL	CU.M.	97
5-26	GABION FOOT PROTECTION	CU.M.	20
5-4	STRUCTURAL EXCAVATION	CU.M.	80
5-6	REFILLING OF BACKFILL MATERIAL	CU.M.	35

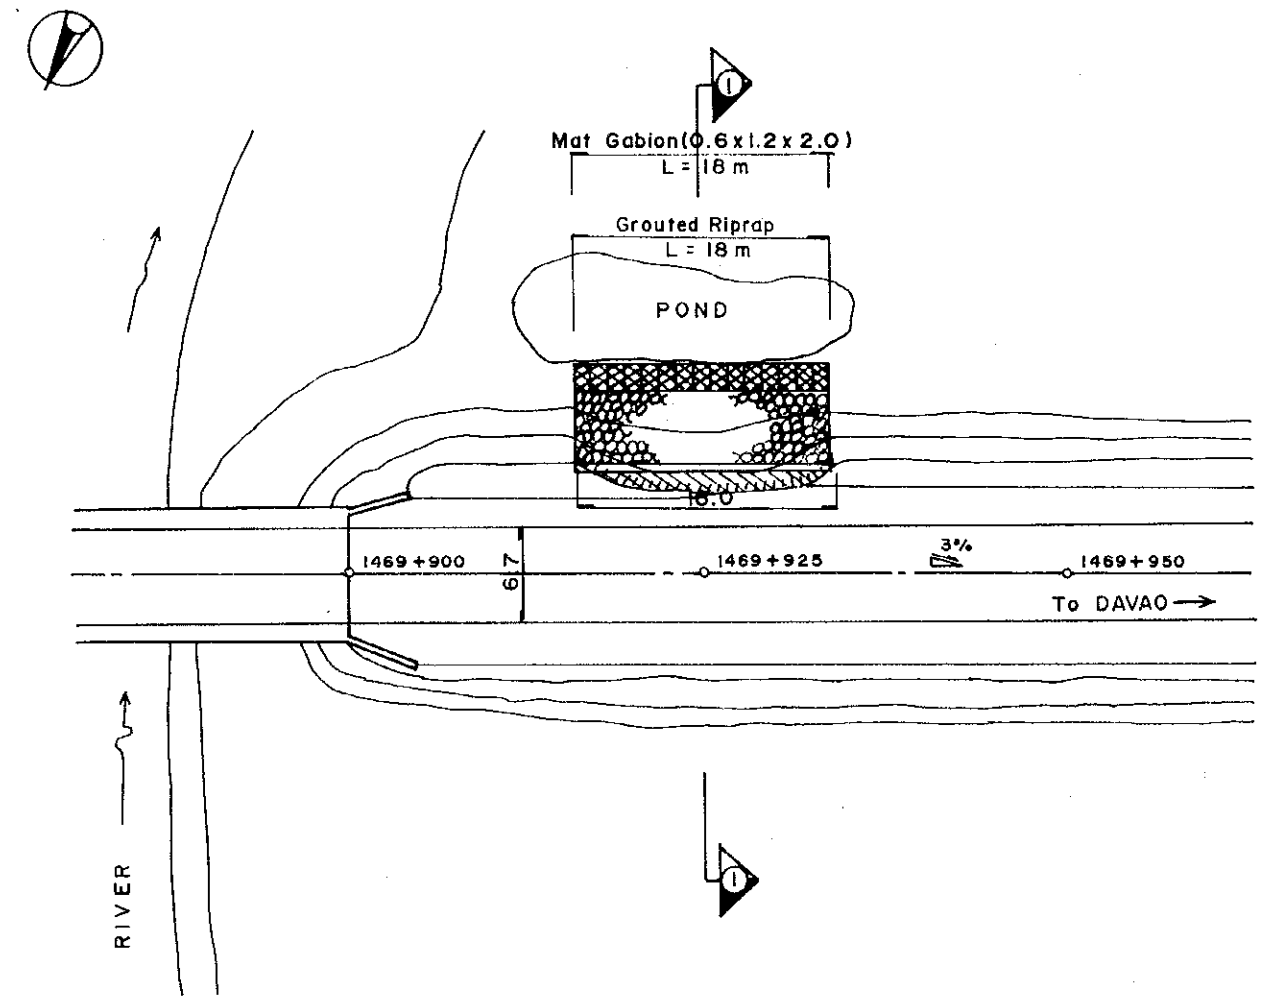
- Cause of Disaster:
- 1) Erosion at the foot of slope by pond water.
 - 2) Scouring by stream from river into the pond.
 - 3) Embankment slope with an unstable grade.

TYPE OF WORK	UNIT	TOTAL
5-5	REFILLING / EMBANKMENT	CU.M	117
5-19	GROUTED RIPRAP	CU.M	57
5-26	GABION FOOT PROTECTION	CU.M	22
