3.2.2 Road Collapsing

Chapter 4 Evaluation of Present Conditions on the Project Roads

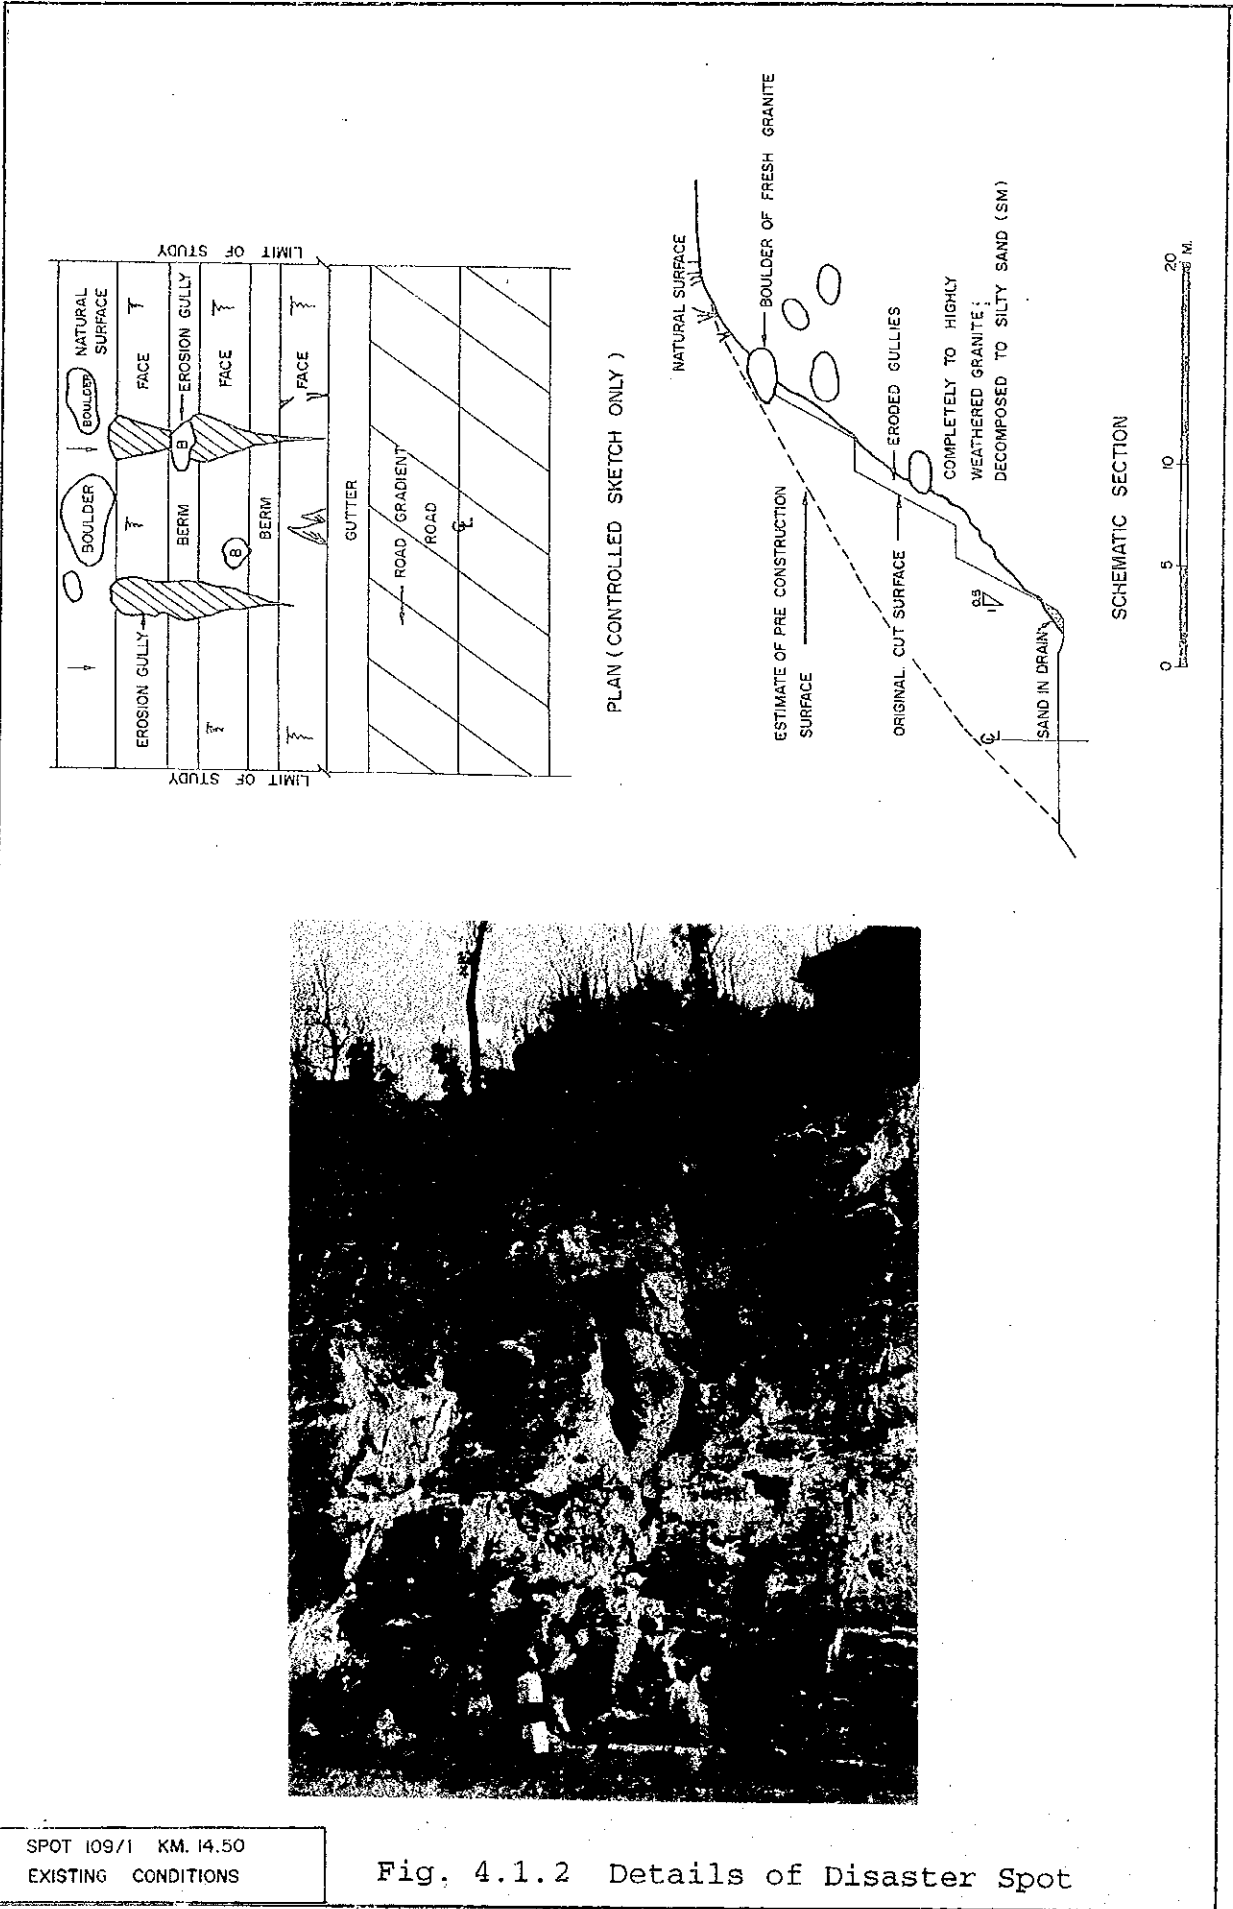
At Km. 14.50, an eroded section of cut slope in completely weathered granite contains embedded core stone boulders of fresh granite. The eroding matrix of silty sand, which comprises the weathered residual soil, is being washed out and exposing the boulders to the risk of falling onto the road's surface. This is relatively common along this route, but it is generally not that hazardous as falling boulders get trapped in the deep erosion gullies. At this site, the

This section of slope is only about 15m high, with 1.5m wide berms spaced vertically every 5m. The interberm angle is 0.5/1.; and the overall slope average is about 47 degrees. There is very little vegetation on the exposed surfaces. The existing conditions are shown in Fig. 4.1.2.

The very high rate of erosion removes any nutrients from the surface of this very poor leached soil, undercuts any seedlings and generally prevents the establishment of vegetation. Natural vegetation progression can not get started under these conditions.

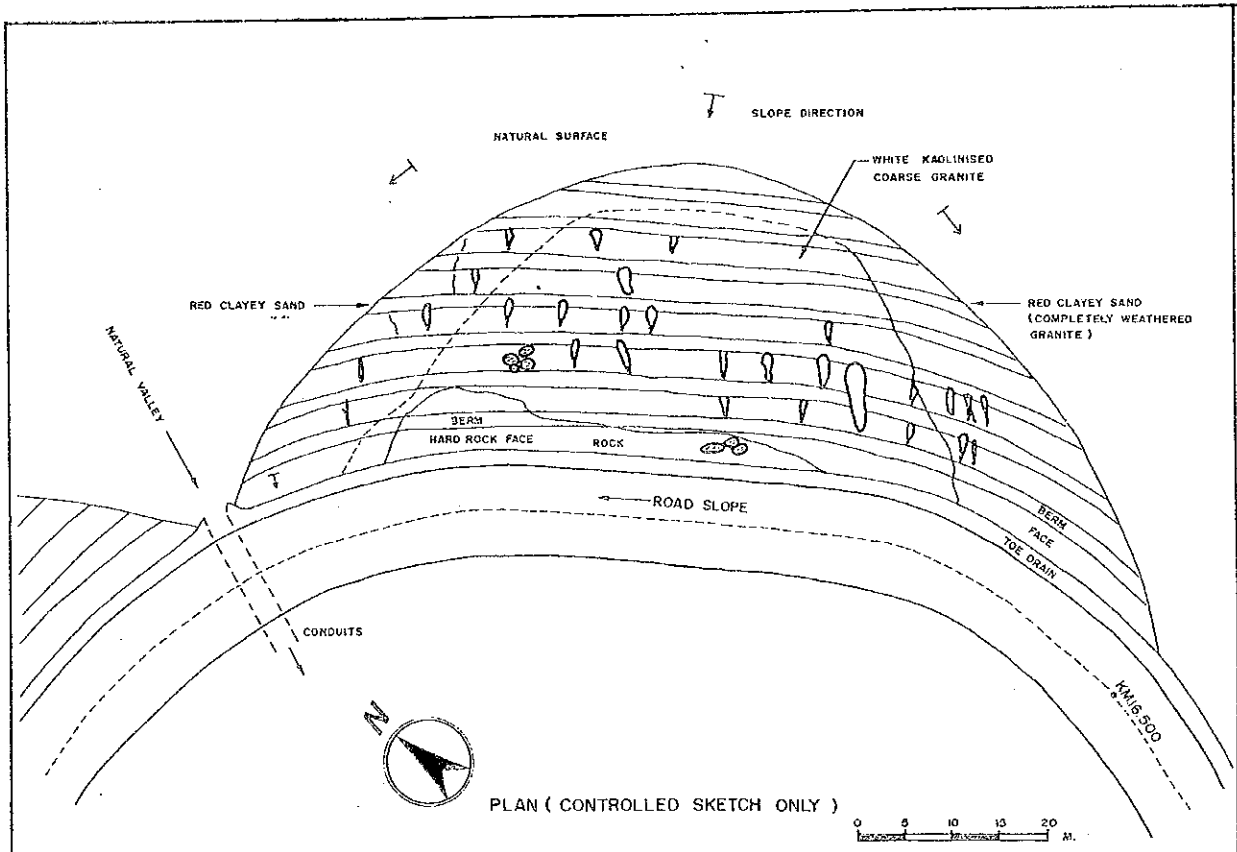
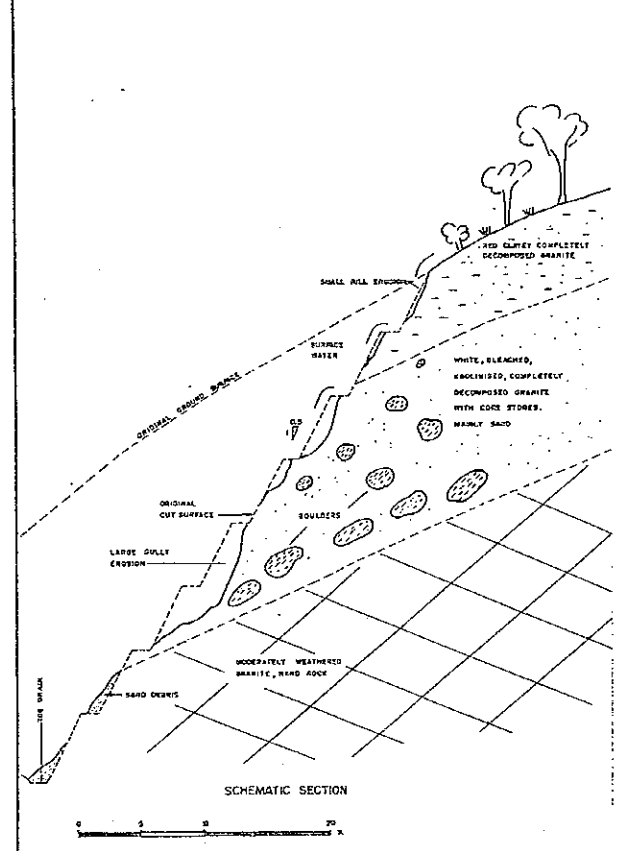
SPOT 109/2 KM. 16.500
EXISTING CONDITIONS

The geology of the site consists of highly to completely

weathered granite with core stones up to 2m in diameter. Groundwater can be seen seeping from the face of the damaged area approximately 10m above the slope base. Drilling results indicate loose fine granitic colluvium with imbedded boulders of granite. The drilling was terminated at a depth of 13.80m, and groundwater was hit at about 3m below the surface. The base of the slip surface was not found.

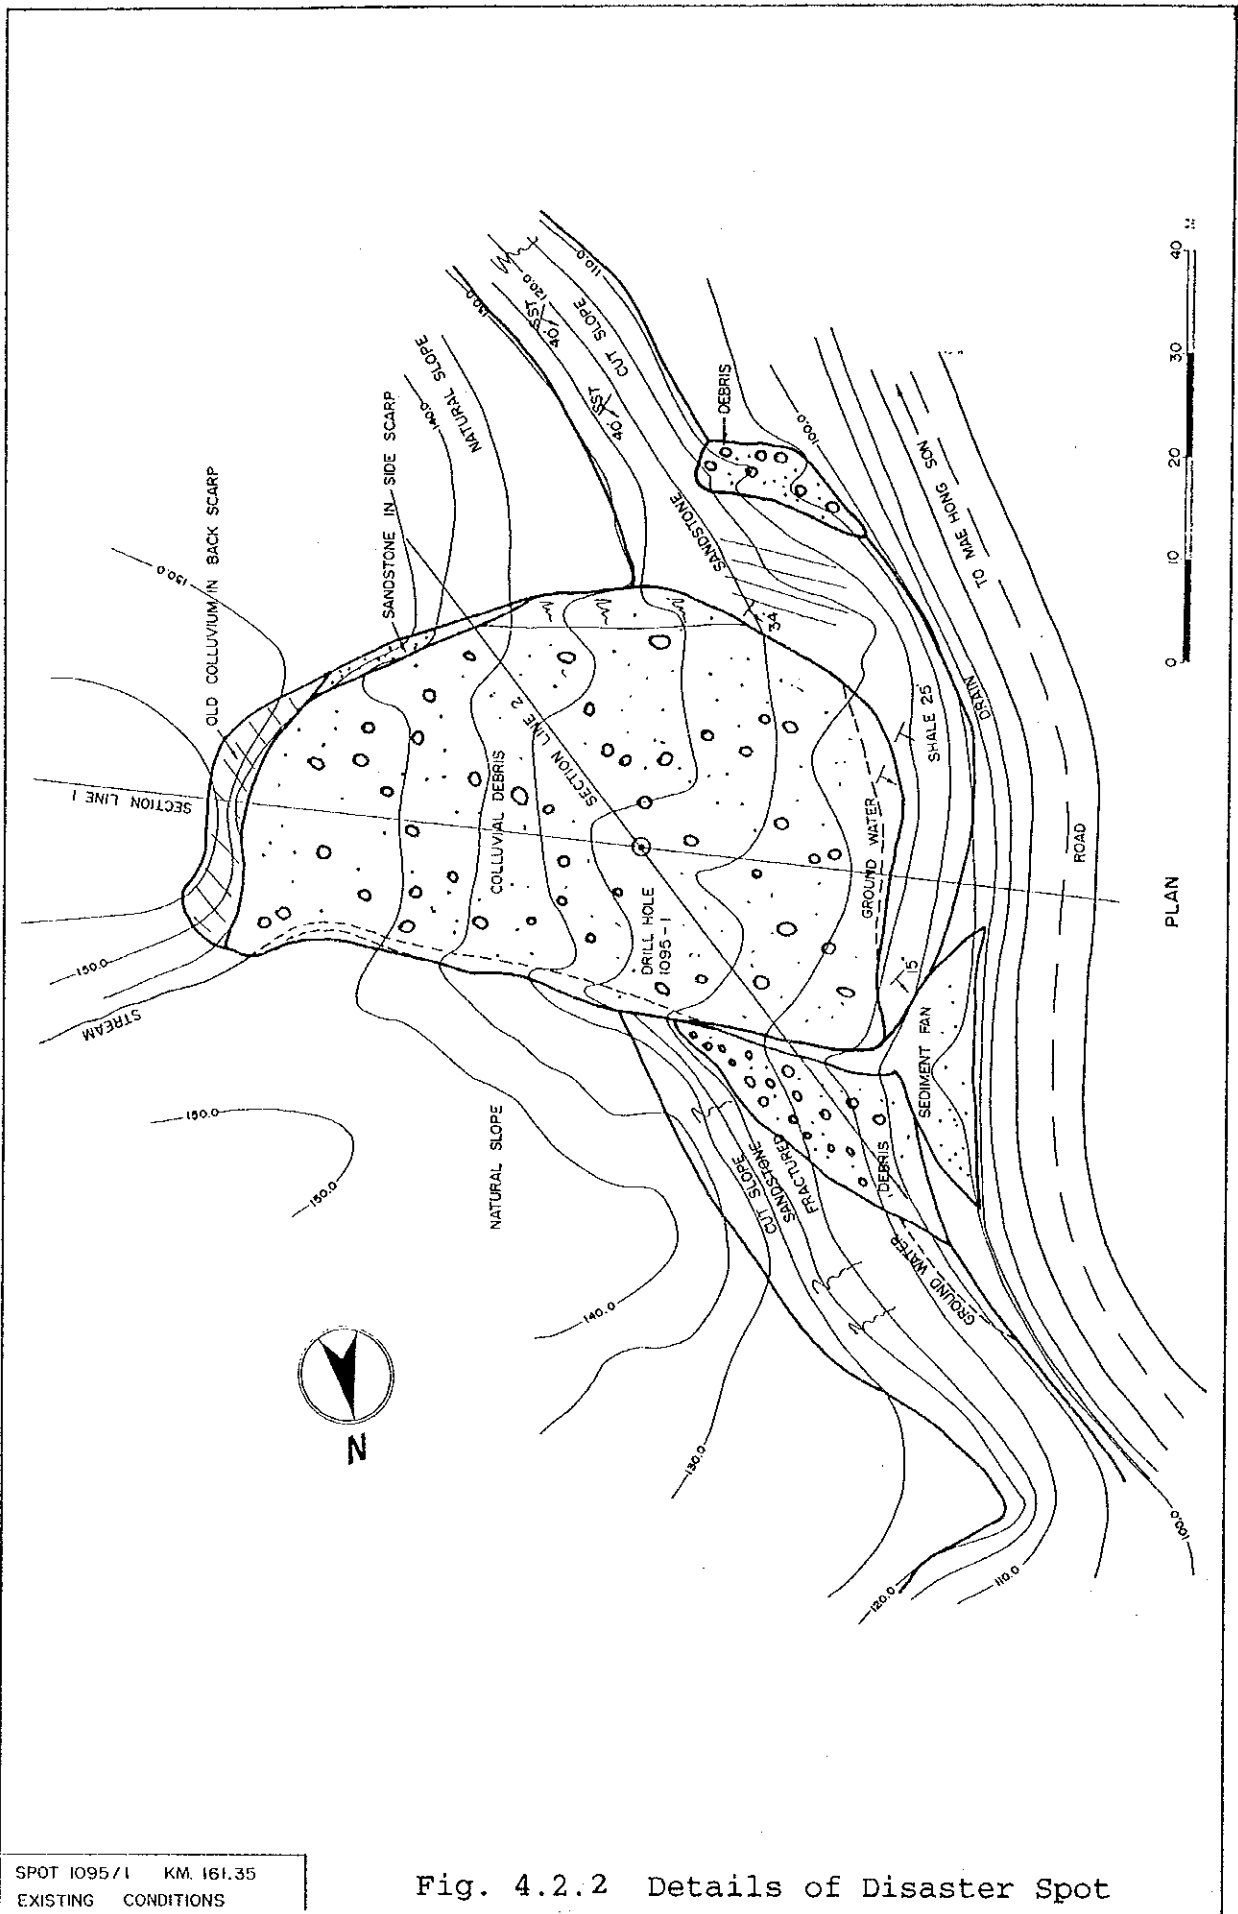
SPOT 1095/1 KM. 161.35
 EXISTING CONDITIONS

At Km. 161.35, the site contains a very large landslide that has slid on the bedding contacts between sandstones and shales. The on-site geological conditions are complex. An old lobe of colluvium about 12m thick is exposed in the backscarp but the base area has bedded sandstone and shales.

The combination of the geometry of the weak interface between shale and sandstone, the geometry of the original cut face and a high water pressure gradient has produced this slide. The existing conditions are presented in Fig.4.2.2 and 4.2.3.

The direction of movement of the failure was actually about 45 degrees to the road direction. The pre-existing drainage gully on the left side of the slope permitted this direction of sliding.

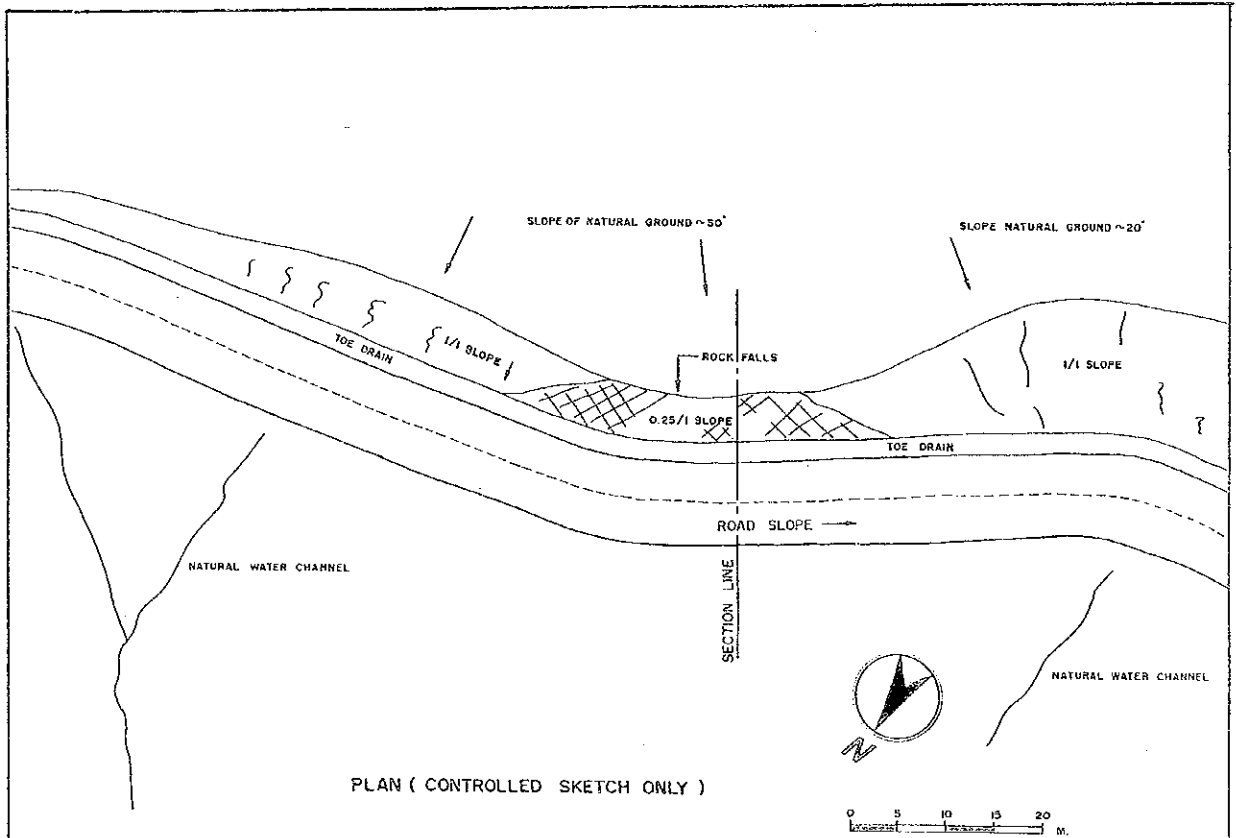
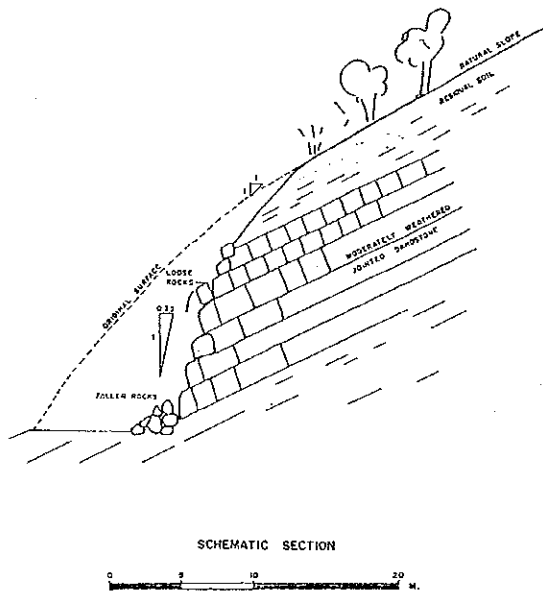
SPOT 1095/2 KM. 161.700
EXISTING CONDITIONS

At Km. 161.7, a very steep cut slope in strong but jointed sandstone has rocks falling due to toppling. The joints are orientated such that the individual blocks rotate away from the steep face when the back surfaces are filled with water during rain. The resulting falls are not large but they affect the roadway with small boulders and rock fragments when ever heavy rain occurs. The existing conditions are presented in Fig. 4.2.4.

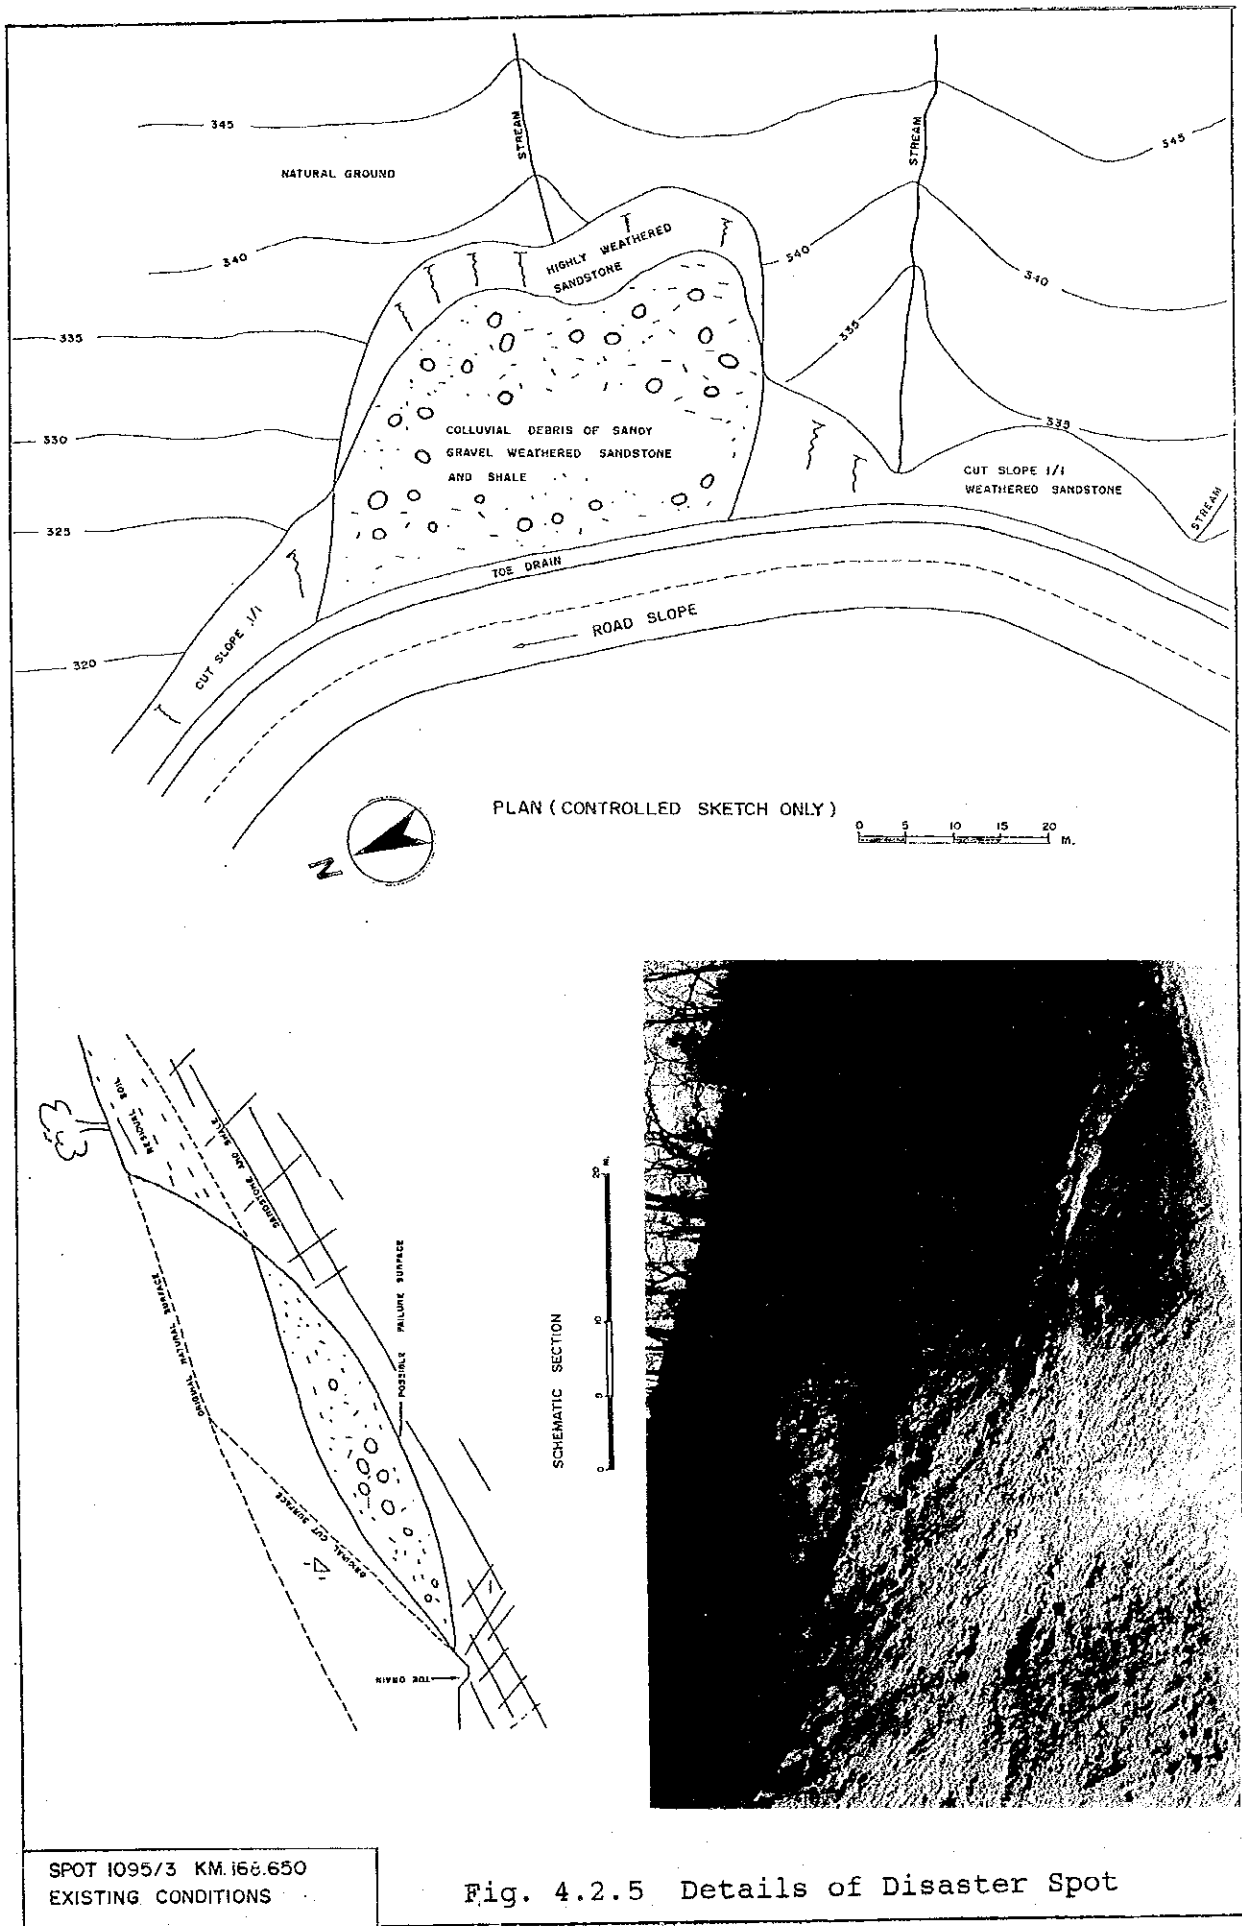
Fig. 4.2.5 Details of Disaster Spot

At Km. 168.65 a large, low angle slide has occurred that affects the natural ground and the original cut slope. The damaged surface is curved but probably is controlled to some degree by the bedding of the sandstone and shale. The damage is about 40m wide and around 20m high. The existing conditions are presented in Fig. 4.2.5.

In order to precipitate failure in the geometry found at this spot, it is necessary to assume a significant groundwater level or very low friction. The slide is reported to be still active and tends to move every time heavy rain falls.

The cause of the slide is probably a high groundwater pressure combined with low cohesion along the bedding and joint surfaces that combine to produce a curved failure surface.

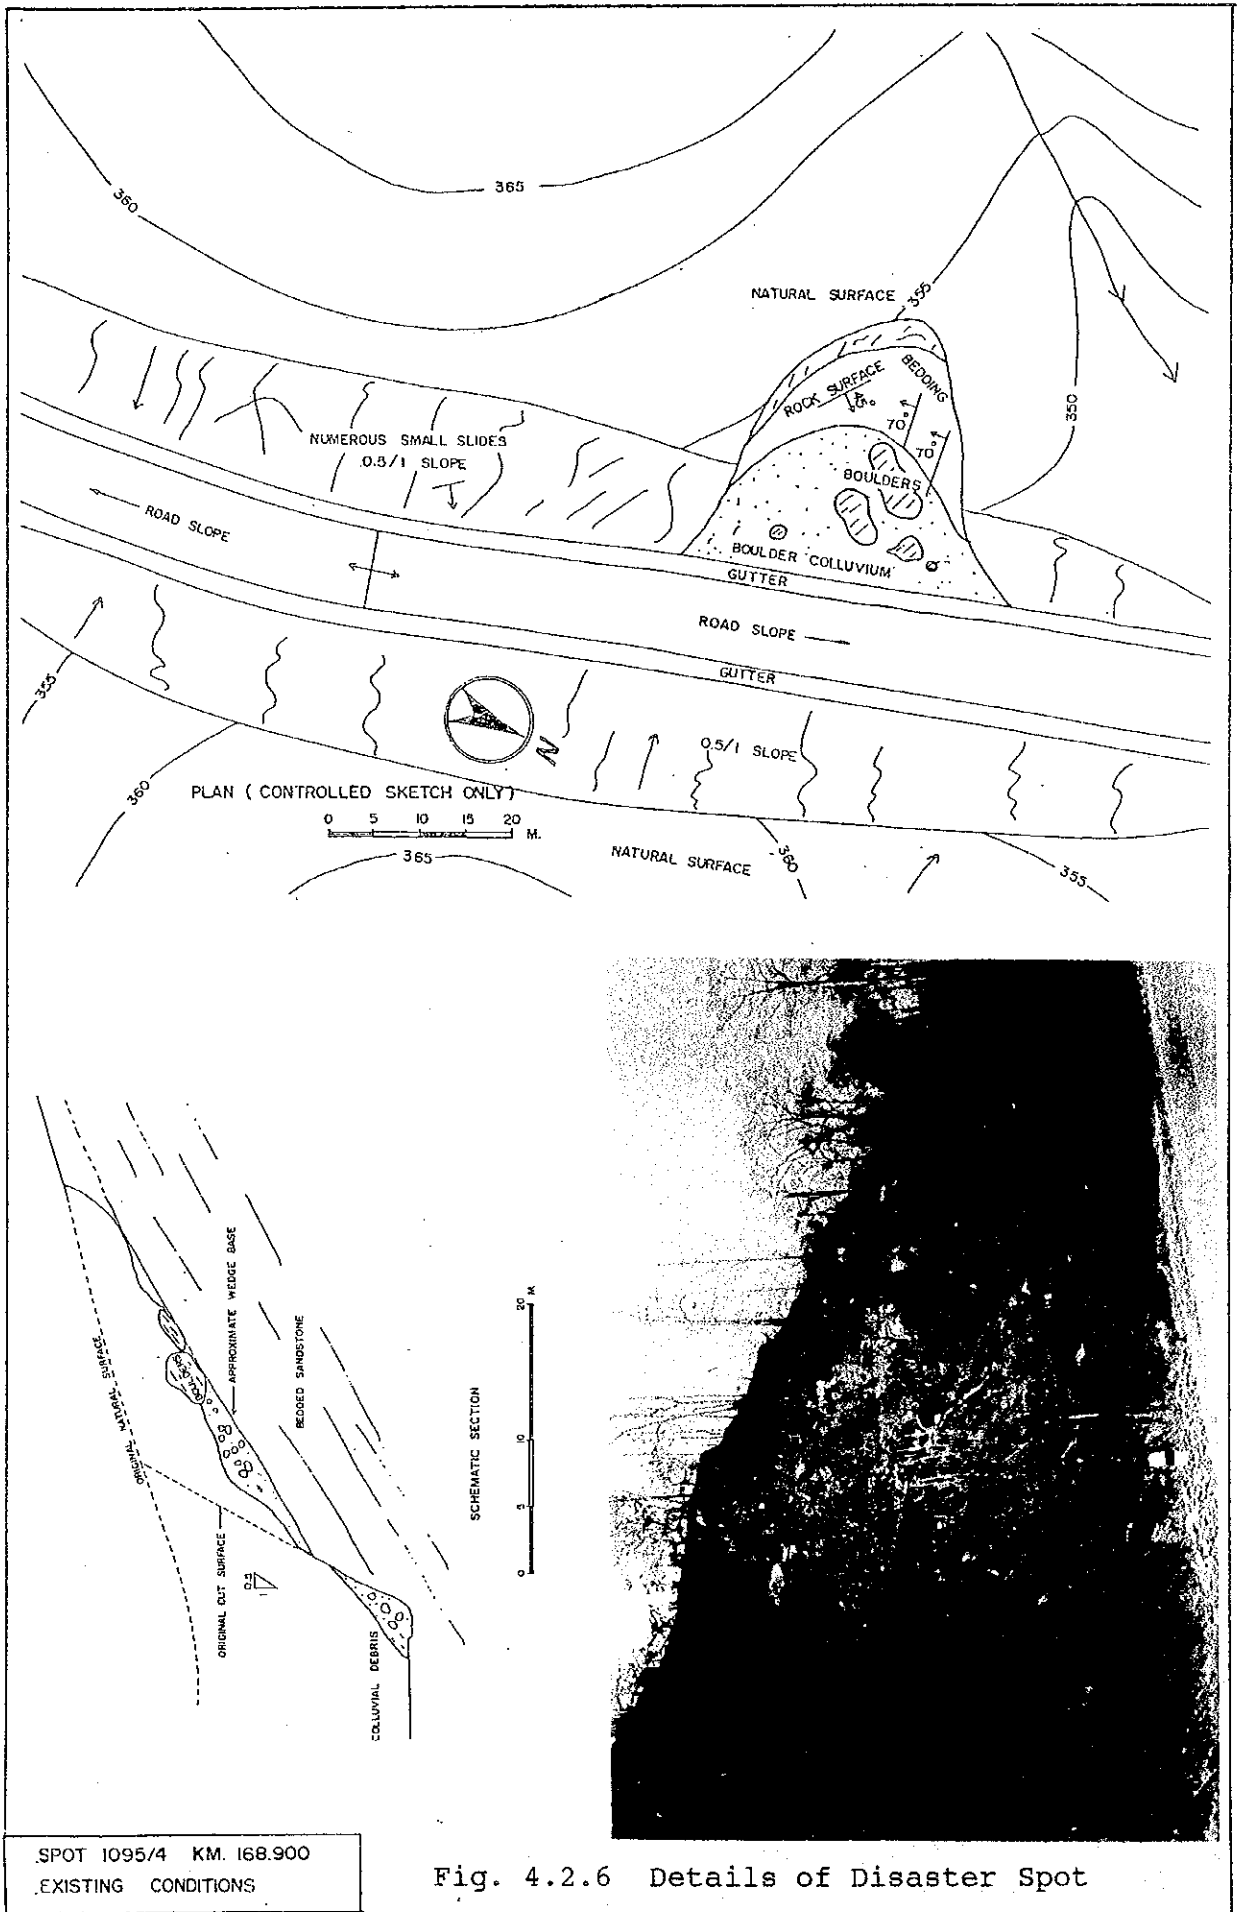
At Km. 168.900, a three-dimensional wedge type failure has occurred. The sliding mass is bounded by bedding planes and joint surfaces. The underlying rock is sandstone and shale. The failure is about 30m wide and 20 m high. The original cut slope was at 0.5/1 with no berms. The failure debris is

thin but contains a number of large intact blocks of sandstone that pose a hazard if they move again. The failure surfaces are exposed. The existing conditions are shown in Fig. 4.2.6.

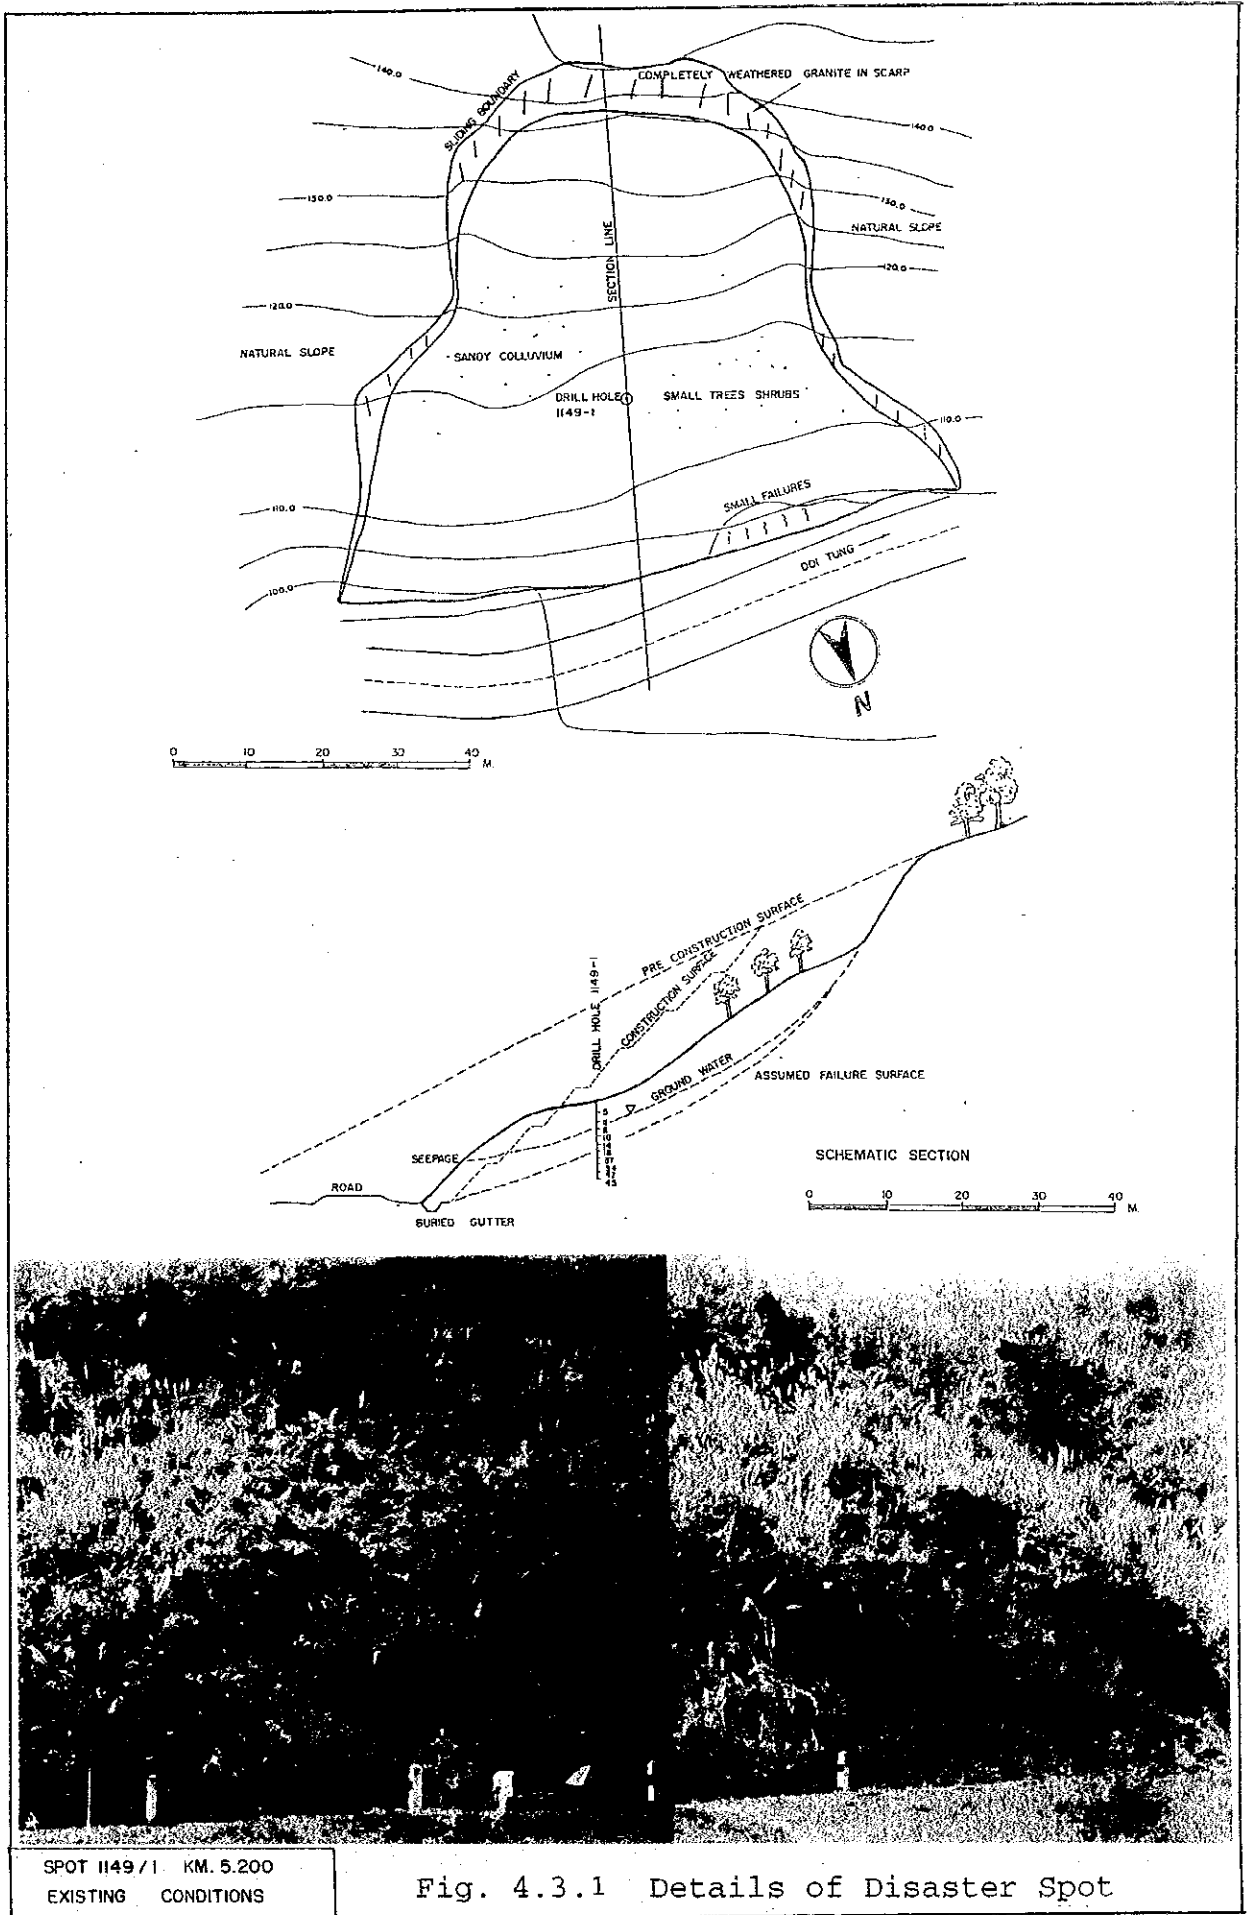
SPOT II49/1. KM. 5.200
 EXISTING CONDITIONS

At Km. 5.2, an 80m wide landslide has been moving over a period of years. The site is underlain by completely weathered granite. The preconstruction natural slope angle was about 25 degrees and the cut was designed at an average of about 42 degrees with 1/1 face angles with 1.5m - 2m wide berms spaced 5m vertically. Groundwater was seen seeping about 3-5 m above the base of the slope. Groundwater was also encountered in drilling at a depth of 2.6m. The existing conditions are illustrated in Fig. 4.3.1.

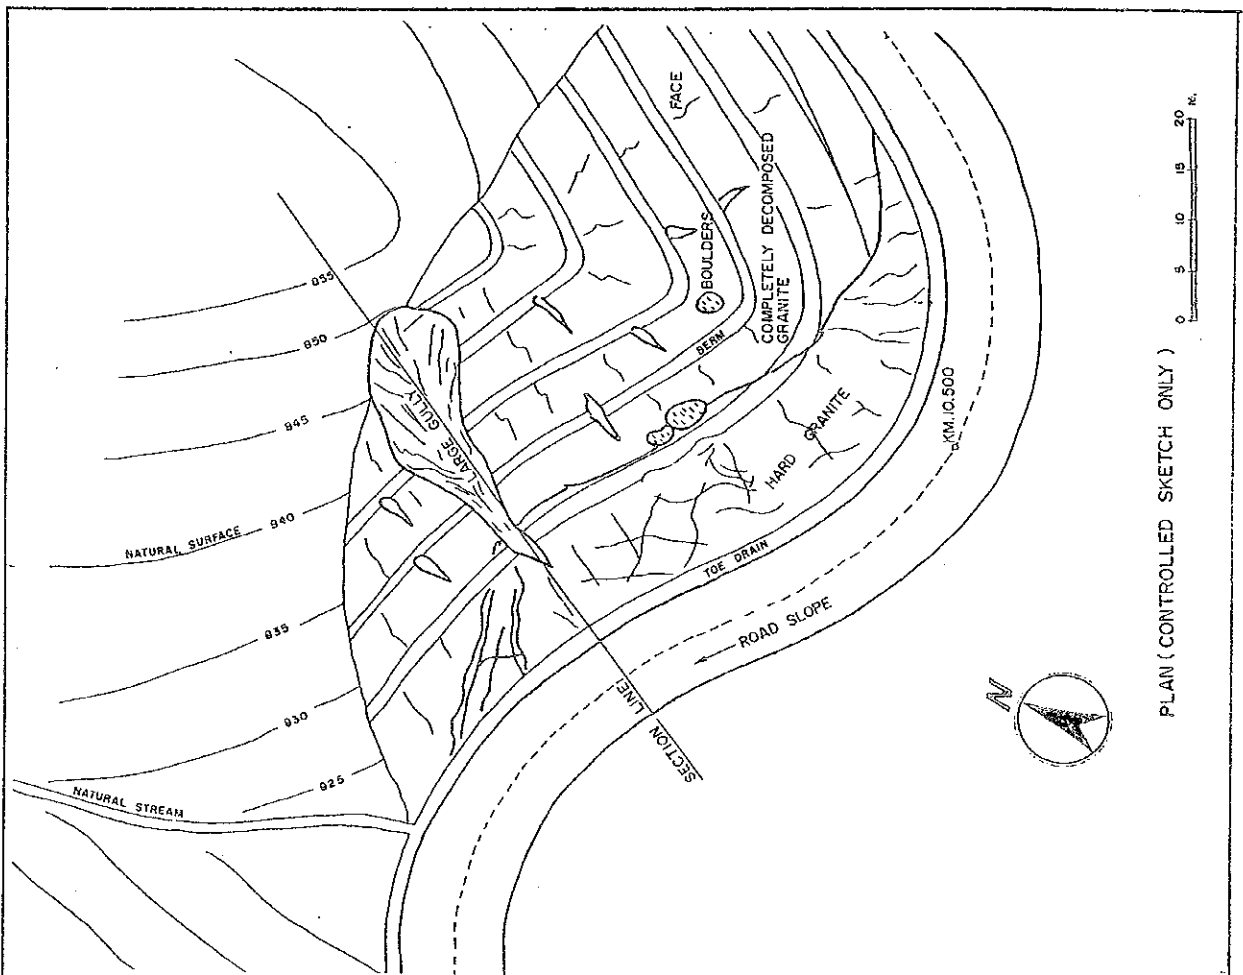
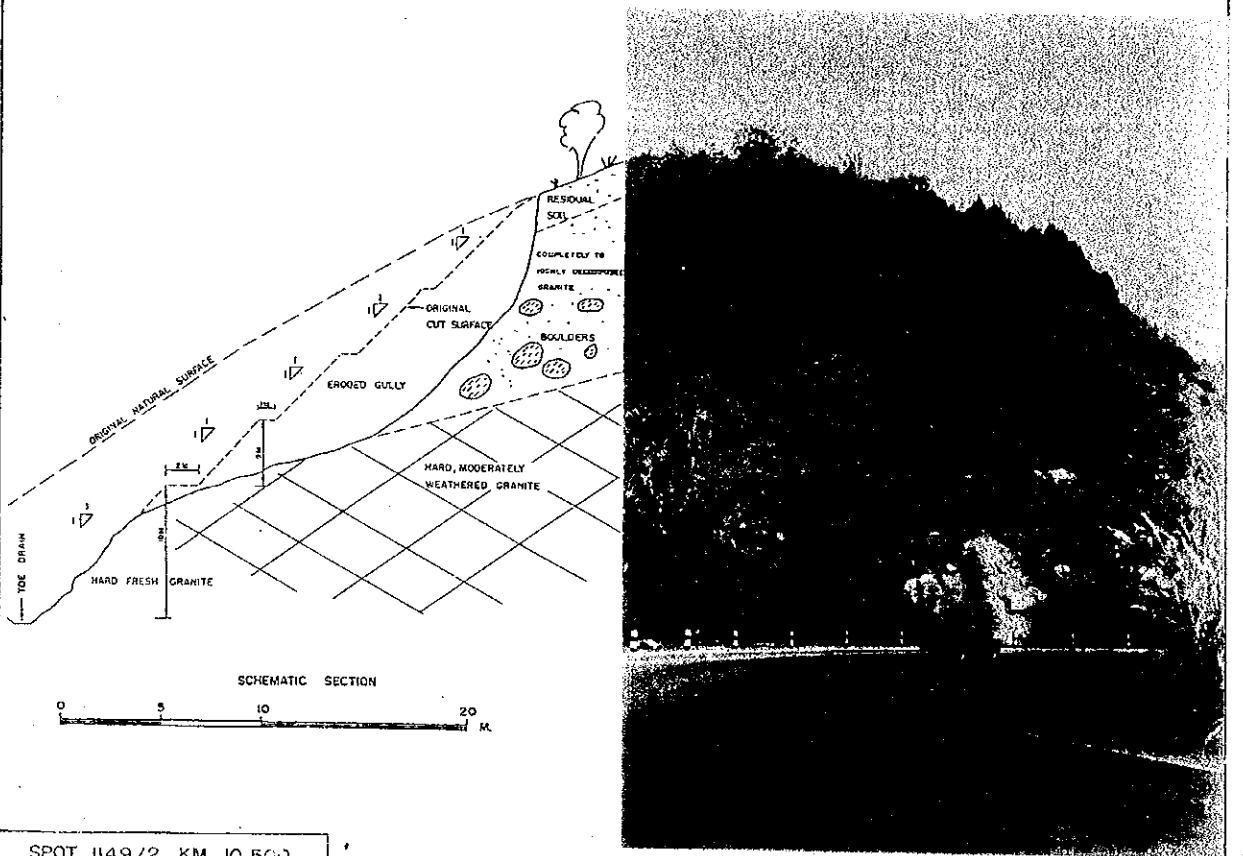
SPOT 1149/2 KM. 10.500
EXISTING CONDITIONS

At Km. 10.50, a very large erosion gully has developed. The rock is granite with the lower portion of the slope being relatively hard and unweathered. The upper section is, however, highly to completely weathered and surface runoff has produced a gully that is about 10m wide and 15m high. It

terminates on contacting hard granite 10m above the toe of the slope. The total cut slope height is about 30m with an angle of 1/1 or 45 degrees. The existing conditions are presented in Fig. 4.3.2.

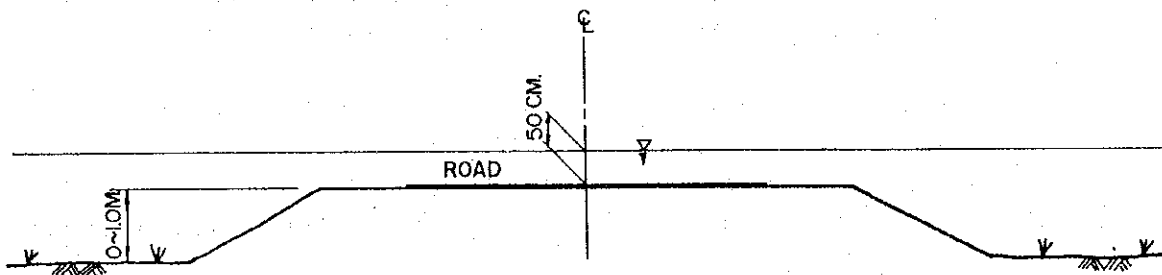
Fig. 4.4.2 Cross Section of Route 1256 at Km. 1.1

Due to inadequate hydraulic control of the natural drainage patterns, the discharge from the mountains to the south spreads over the flat terrain at times of heavy and sustained rainfall. Floods on this section occur almost every wet season.

It has a number of cross drainage installations consisting of pipe culverts that vary in diameter from 60, 80 to 100 centimeters. The approximate spacing of these culverts is 160 metres. A cross section of this road is presented in Fig. 4.4.2

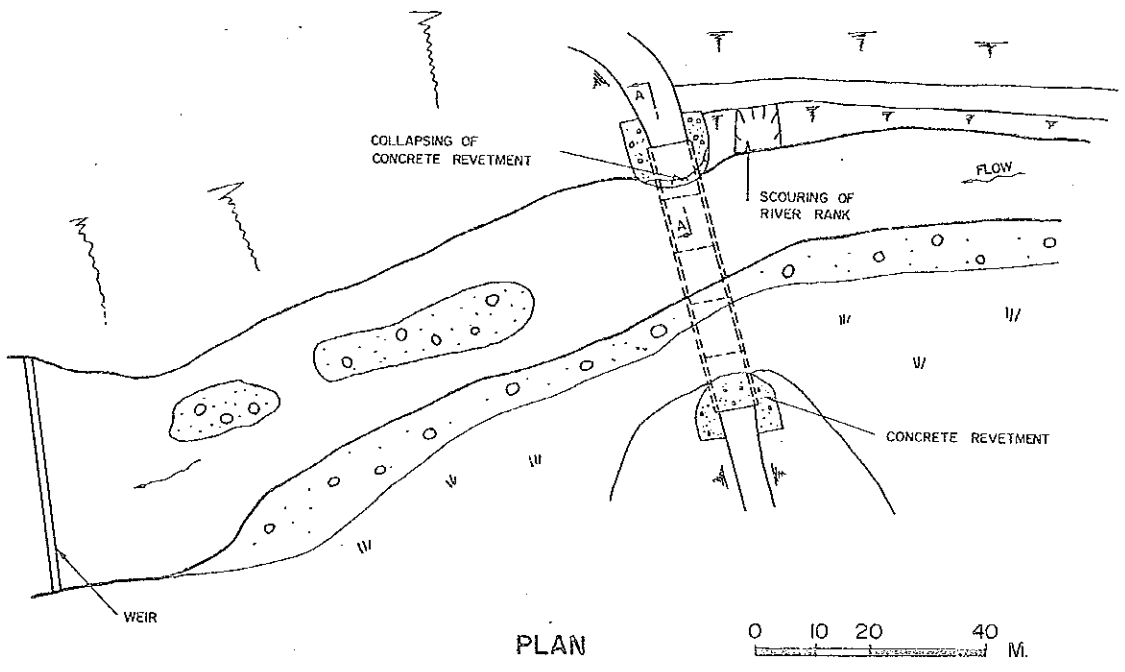
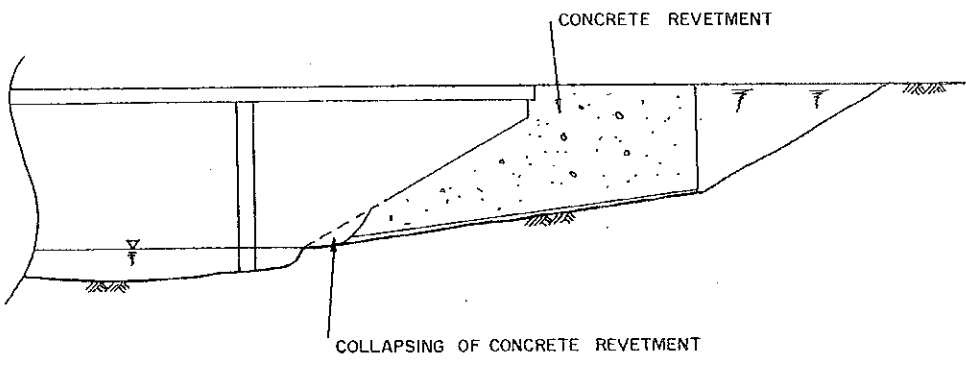
Fig. 4.4.3 Details of Disaster Spot

The base of the abutment protection revetments are inadequately embedded and have been subject to scouring by the outside curve of the stream on the western side of the bridge.

About 100 metres downstream of the bridge a weir has been built. This should serve to reduce riverbed degradation. The existing conditions are illustrated in Fig. 4.4.3.

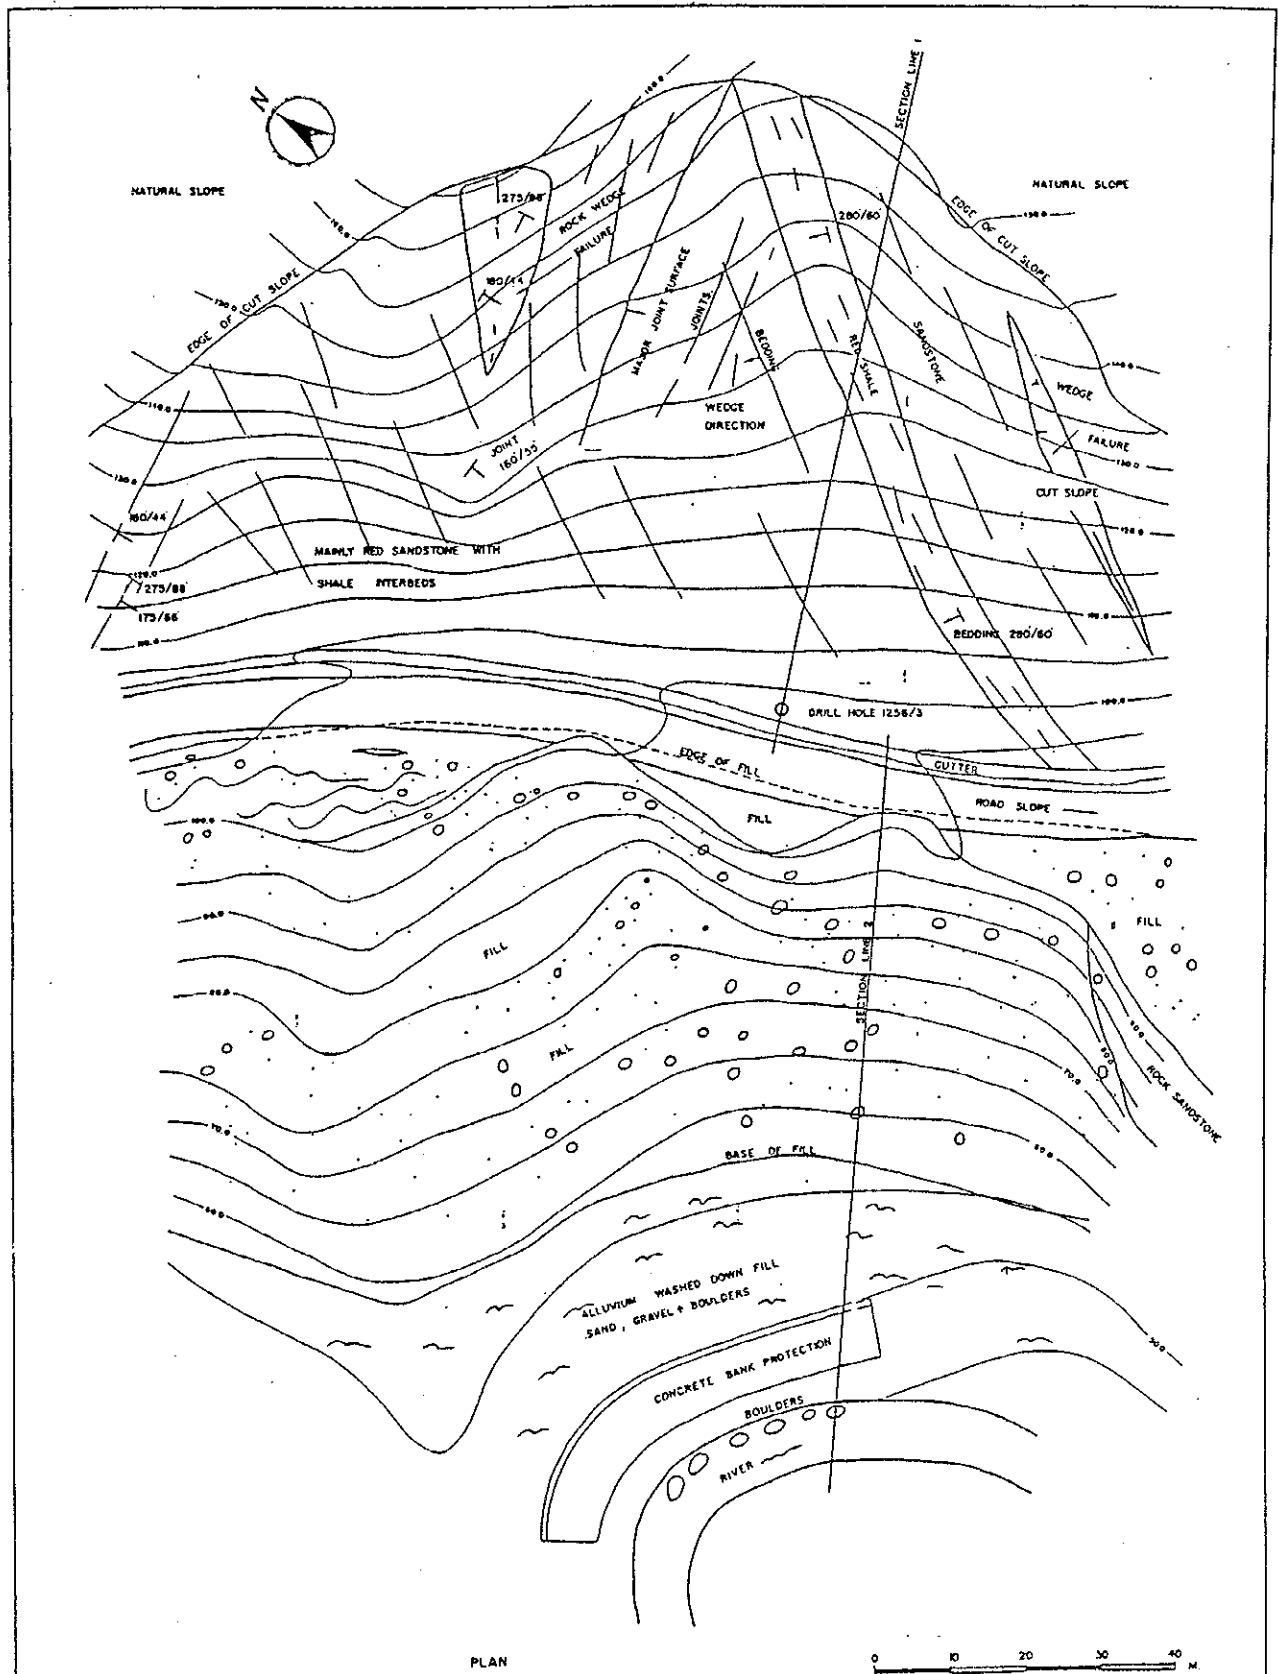
SPOT 1256/II KM. 45.675
EXISTING CONDITIONS

The construction of bank protection works on the stream adjacent to the fill slope has not prevented failure. The natural slope angle is over 45 degrees.

The geology of the site consists of steeply dipping alternating beds of massive red sandstone and thin beds of red shale. The natural conditions of the site are illustrated in Fig. 4.4.11 and Fig. 4.4.12.
