3.2.2 Road Collapsing

Chapter 4 Evaluation of Present Conditions on the Project Roads

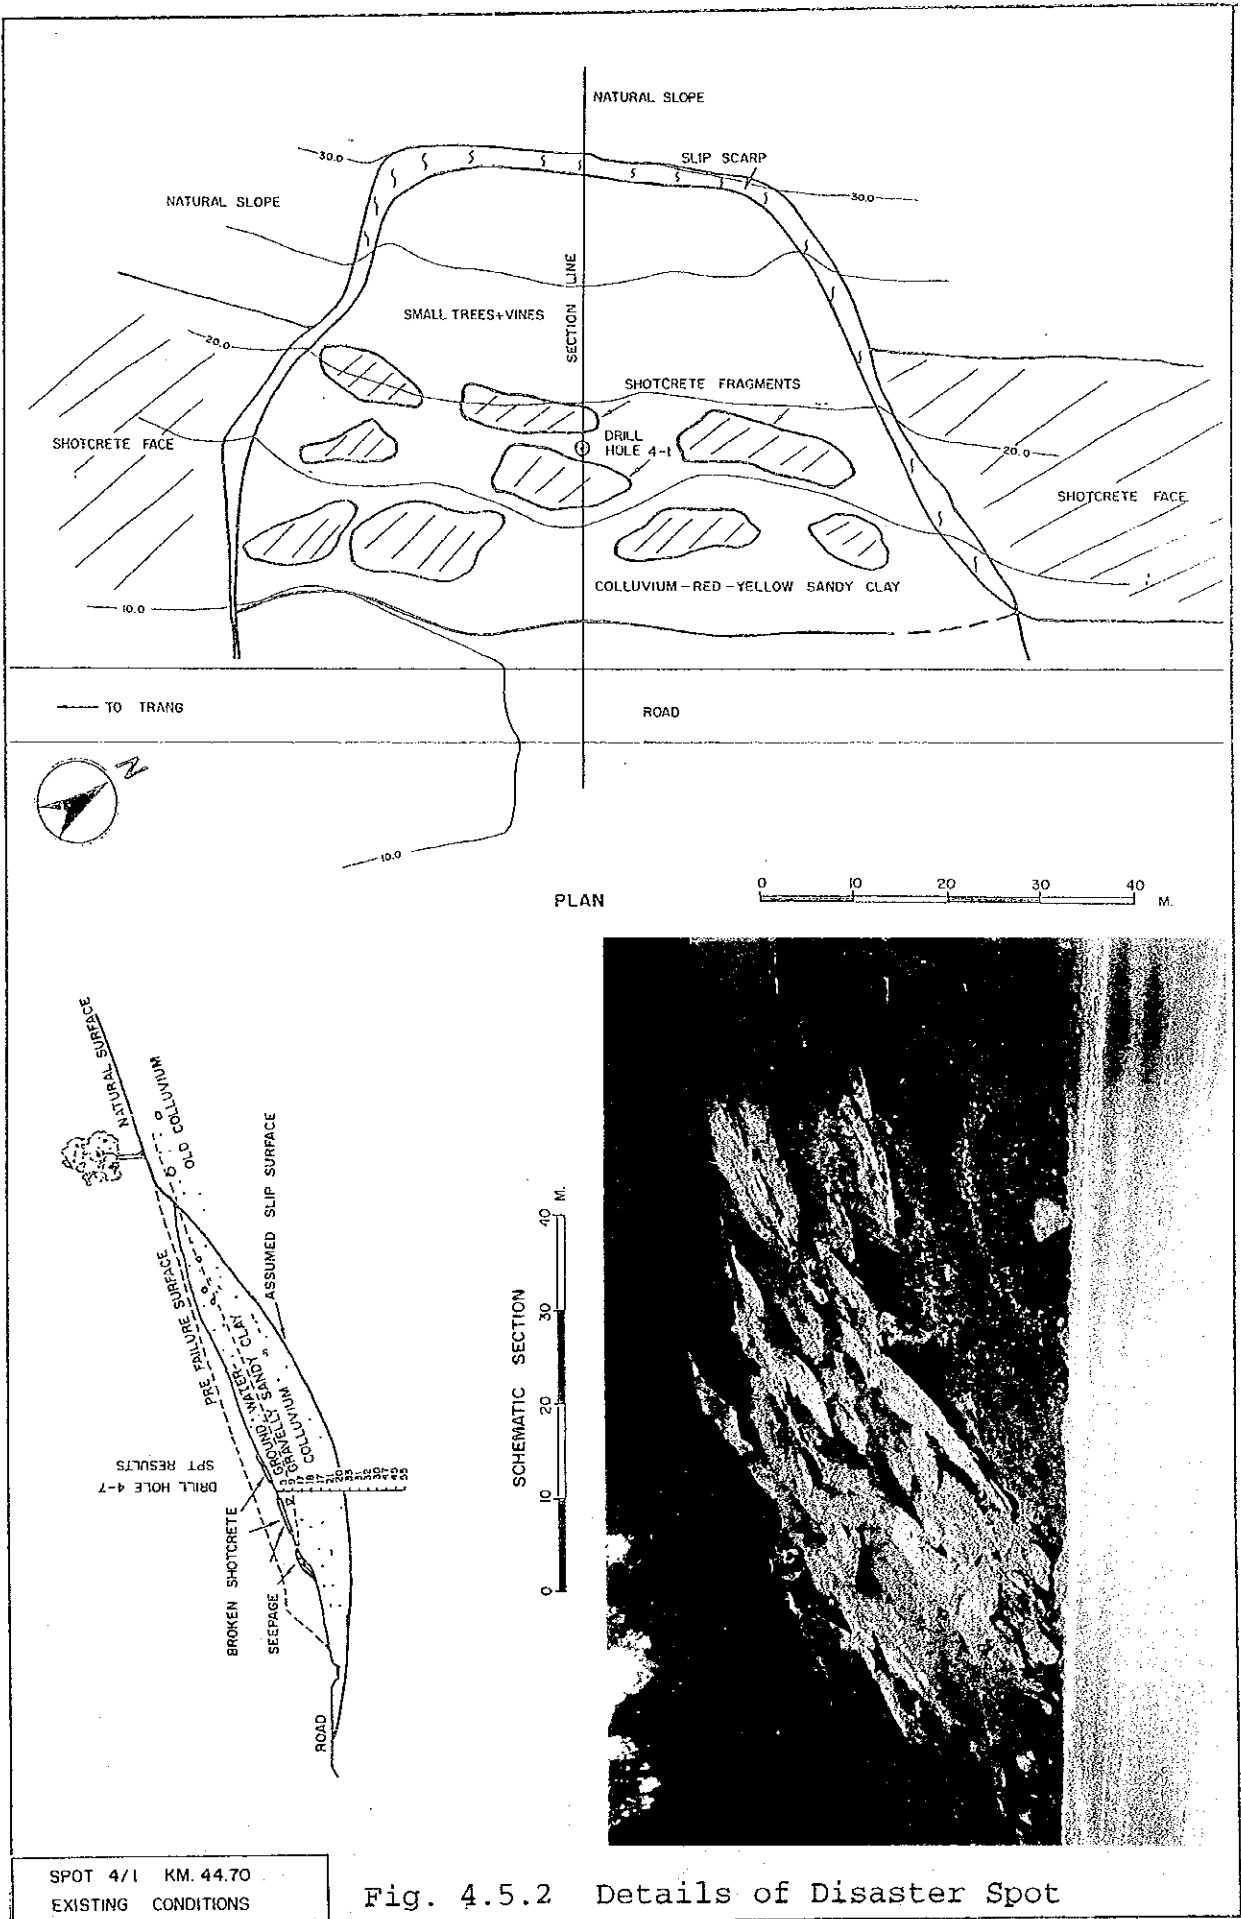
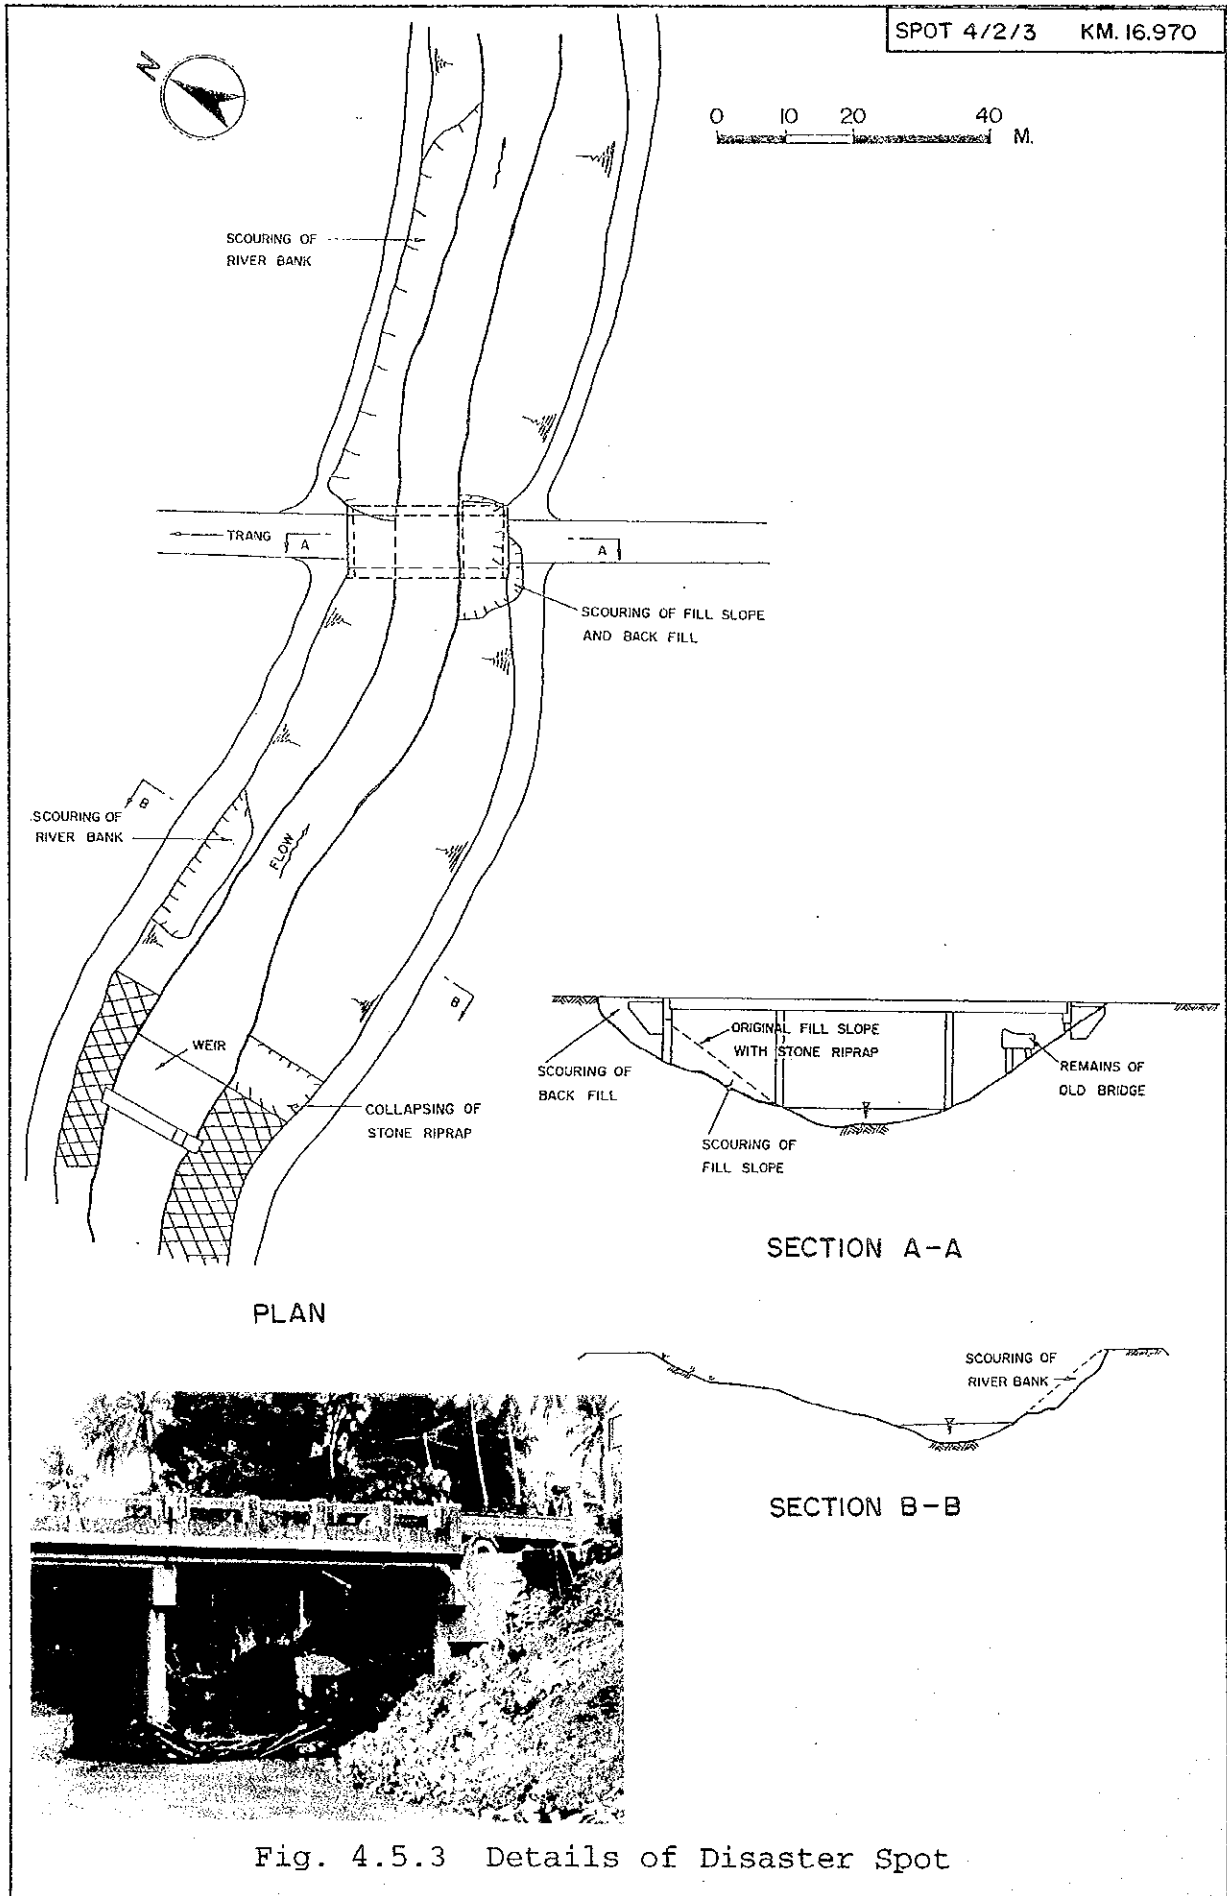
In the vicinity of the bridge, there is a weir installed about 170 metres upstream from the bridge to prevent the degrading of the riverbed due to the rapid stream flow.

The river banks are protected by stone riprap only in the vicinity of the weir, with after portions remaining unprotected. Due to the heavy rains mentioned above, some portions of the outside curves of the river banks were scoured.
