4.6.3 Existing Status of Damages

4.7.3 Existing Status of Damages

4.8.3 Existing Status of Damages

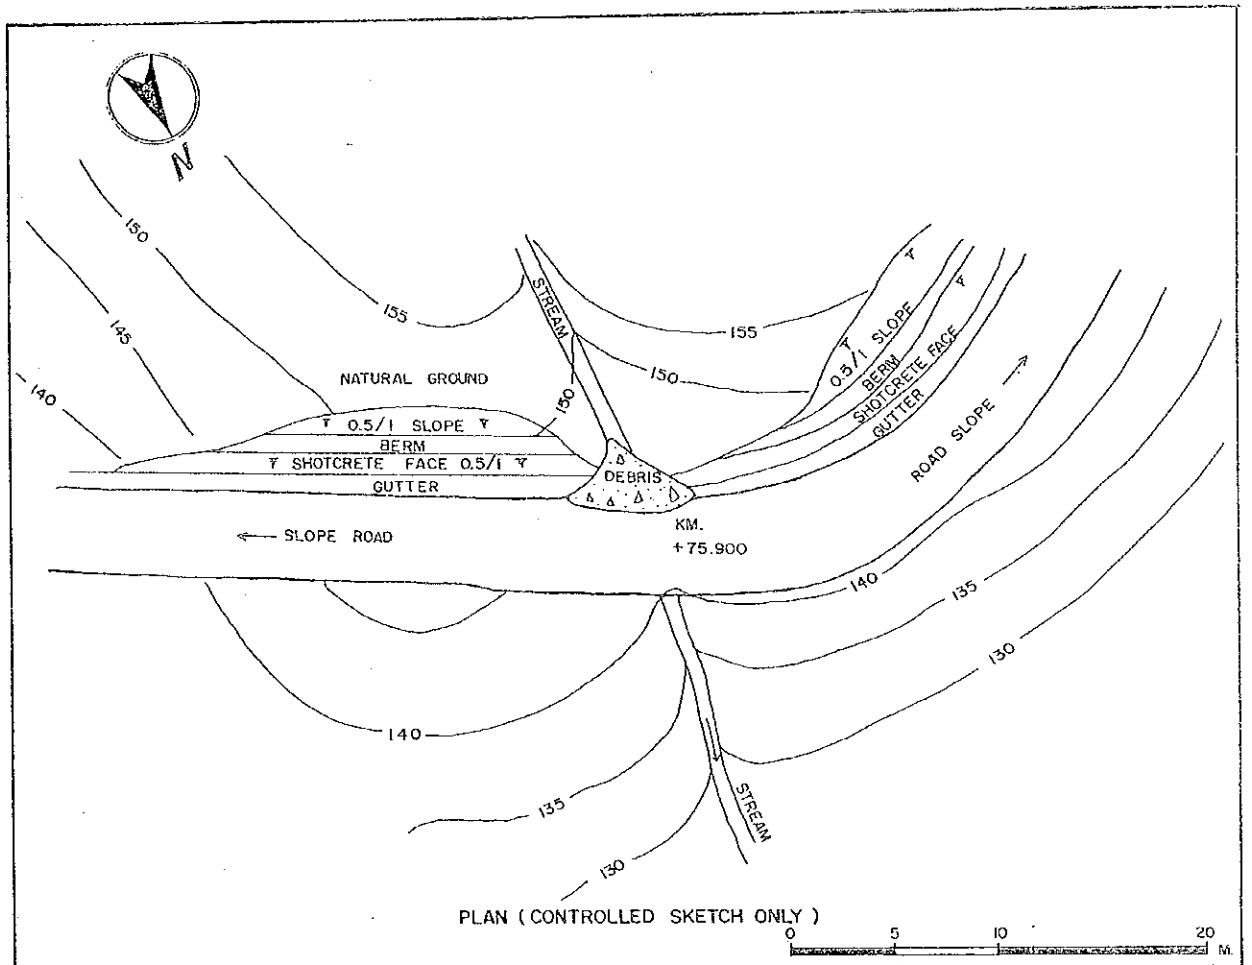
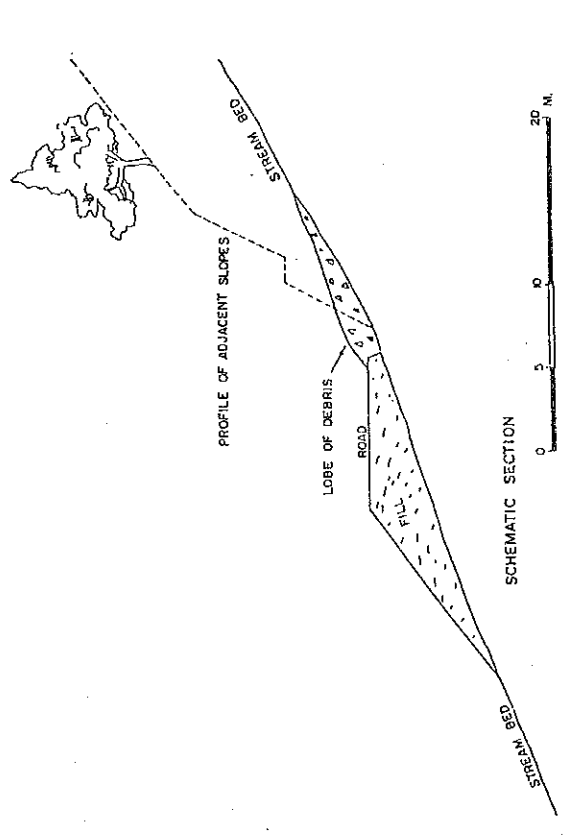
SPOT 410/1 KM. 75.950
EXISTING CONDITIONS

1. Spot 410/1: Debris Flow on an Embankment on Sloping Ground (RF-3-3)

At Km. 75.95, a lobe of debris spills across the road surface. Sediment from a natural stream is deposited due to a drop in stream velocity resulting from a gradient change near the road. The debris mass is about 15m wide. The existing conditions at this site are illustrated in Fig. 4.6.2.

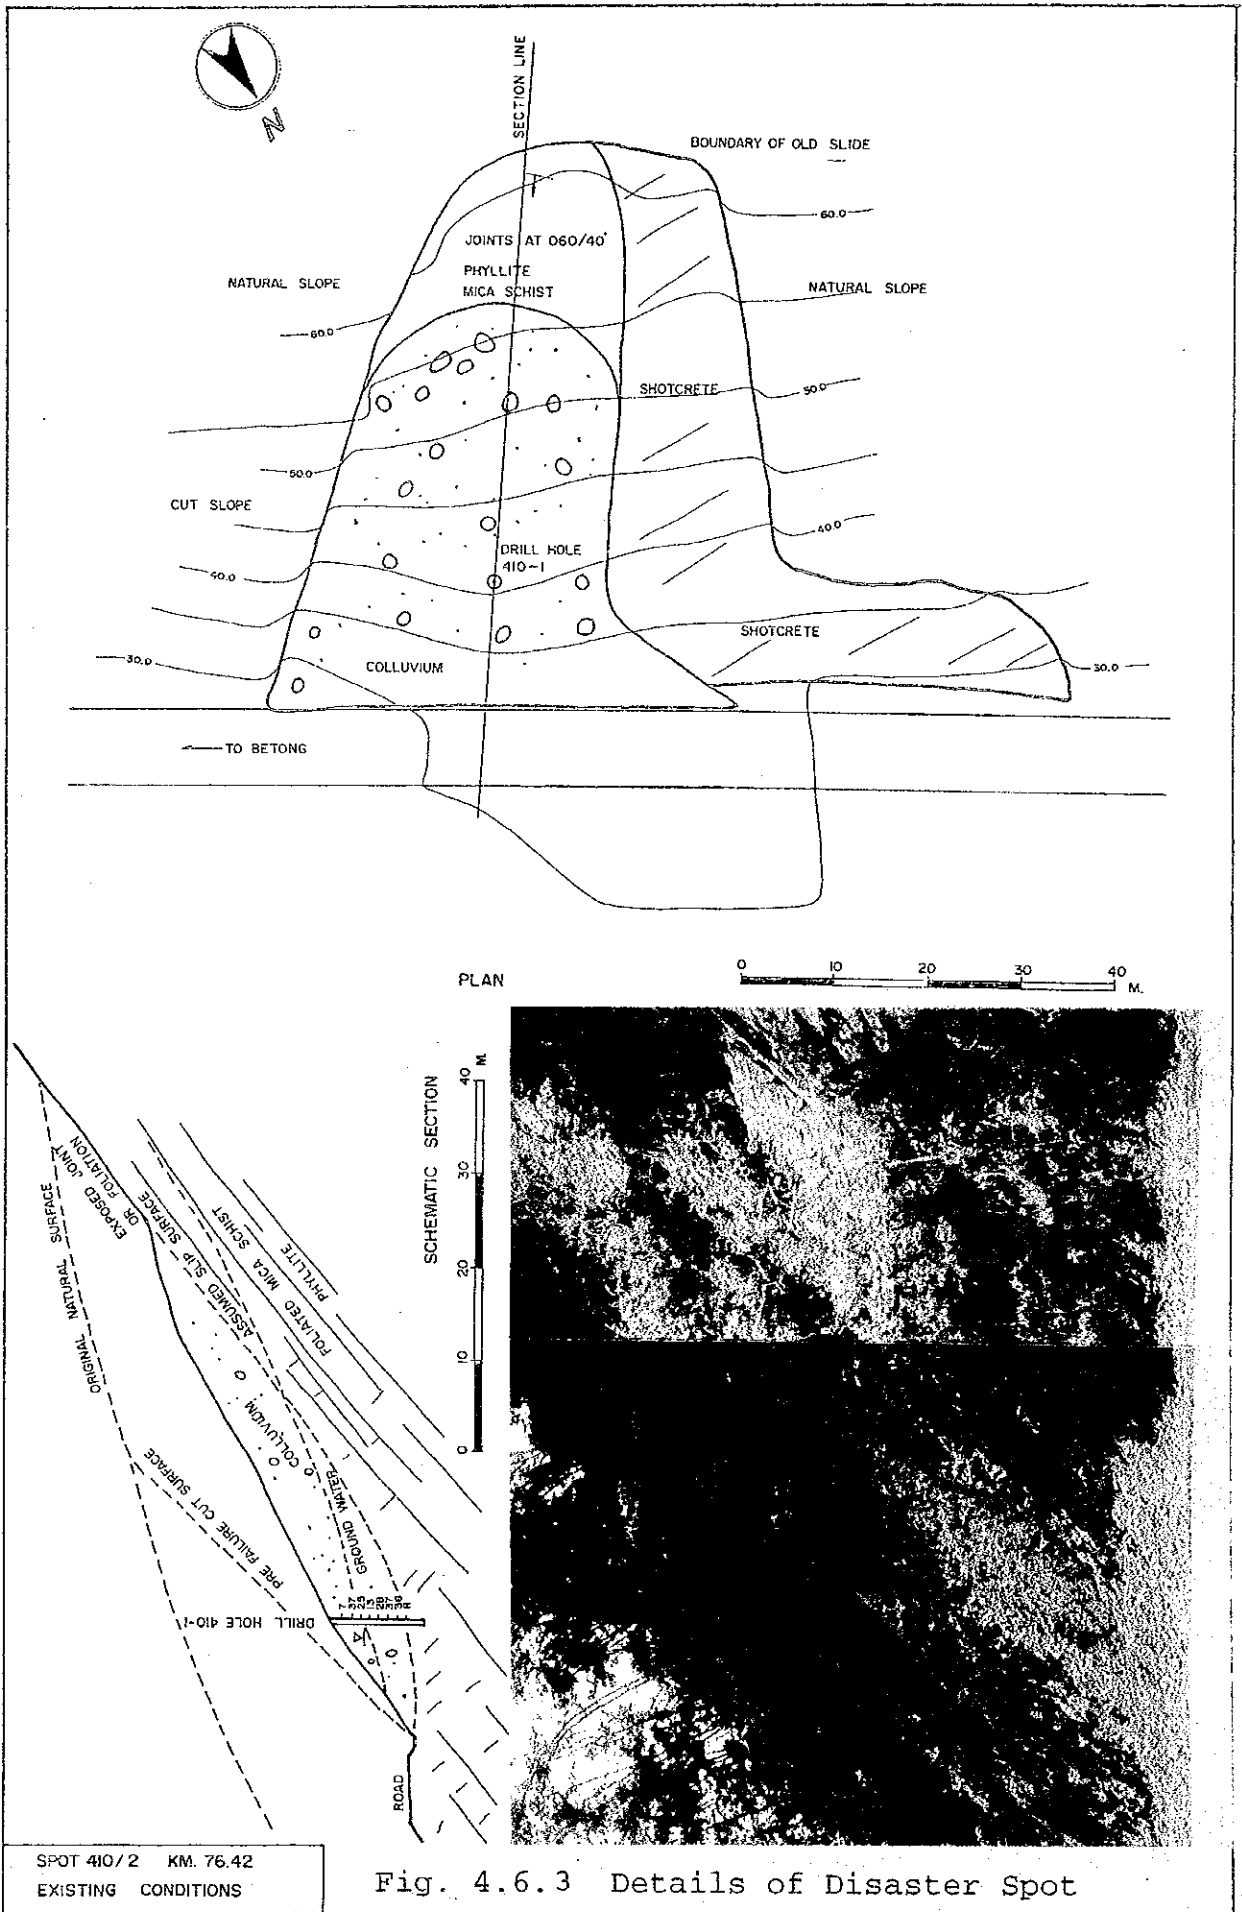
2. Spot 410/2: Two-Dimensional Translational Landslide on a Cut Slope (SD-2-7)

At Km. 76.42, a 35m-high cut slope failed after sliding along planes of schistosity in mica schist. The slope had been protected by shotcrete after a previous failure. The debris reaches the edge of the pavement, and the schistosity surface is dipping at an angle of 40 degrees.

Drilling at this site revealed that the colluvial debris is about 7m thick, and groundwater was found 3.2m from the surface. SPT results for the colluvium were high with an average over 30. The existing conditions of the site are illustrated in Fig. 4.6.3.

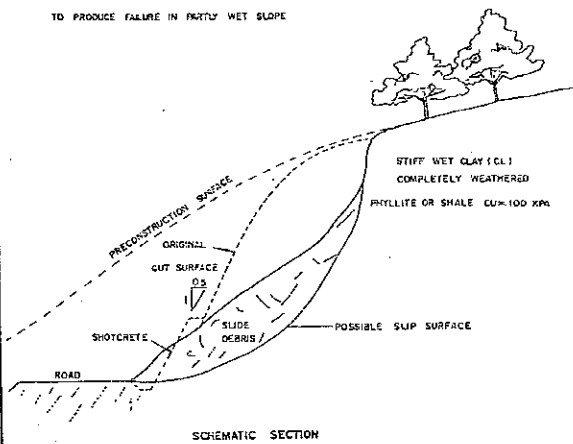
SPOT 410/3 KM. 82.100
EXISTING CONDITIONS

3. Spot 410/3: Rotational Landslide on a Cut Slope (SD-2-6)

At Km. 82.1, a 15m-high section of cut slope failed after a rotational movement. The original slope was cut at 0.5/1 and the lowest 5m was covered with shotcrete.

The shotcrete facing has been destroyed. Similar slides can be seen at Km. 81.75, 81.9 and 82.0, all containing similar material. The debris is lying at an angle of 33 degrees.

The existing conditions are illustrated in Fig. 4.6.4.

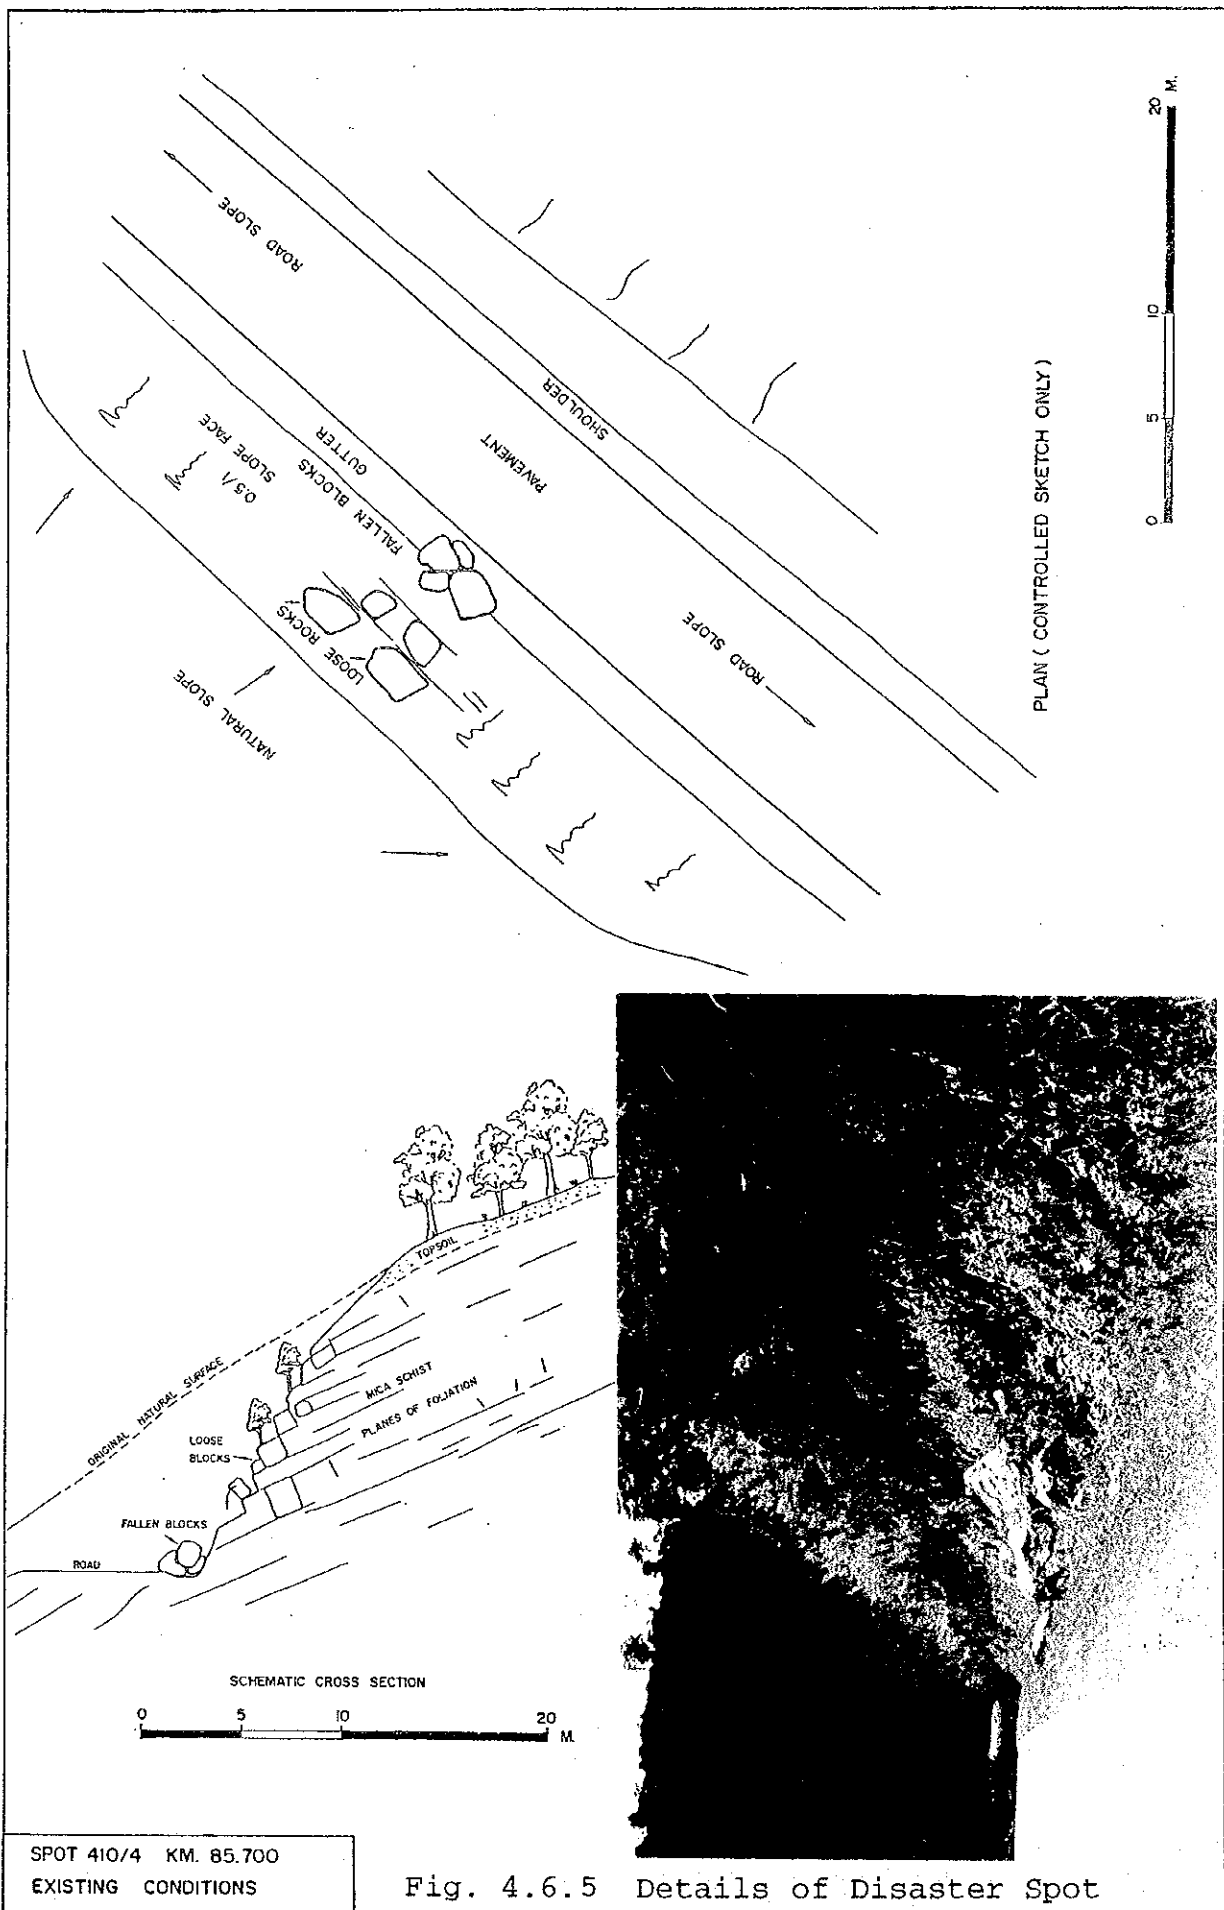
SPOT 410/4 KM. 85.700
EXISTING CONDITIONS

The rock is moderately to slightly weathered schist and phyllite. It contains numerous tectonic joints. The existing conditions are illustrated in Fig. 4.6.5.

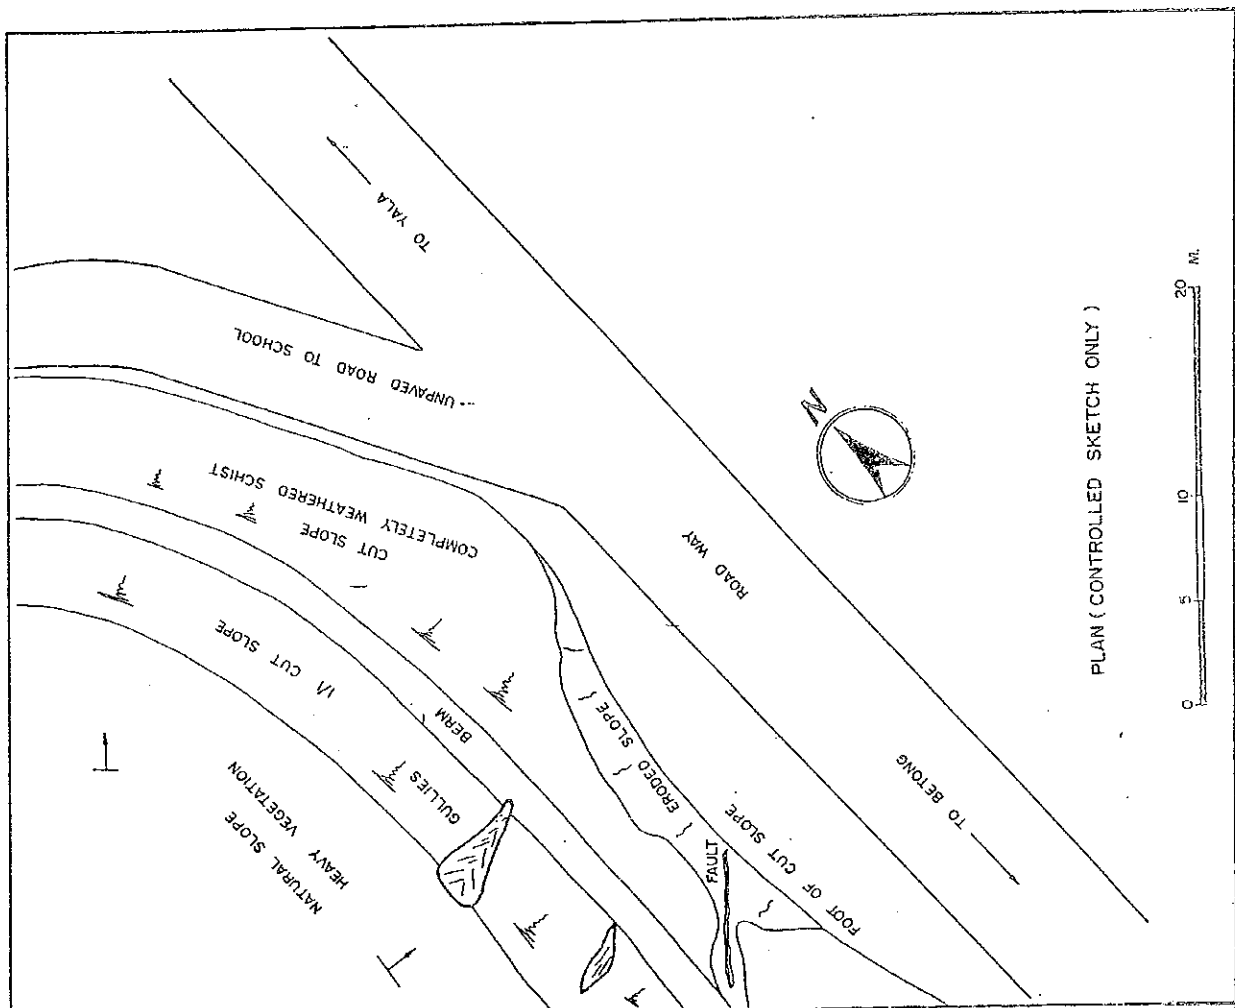
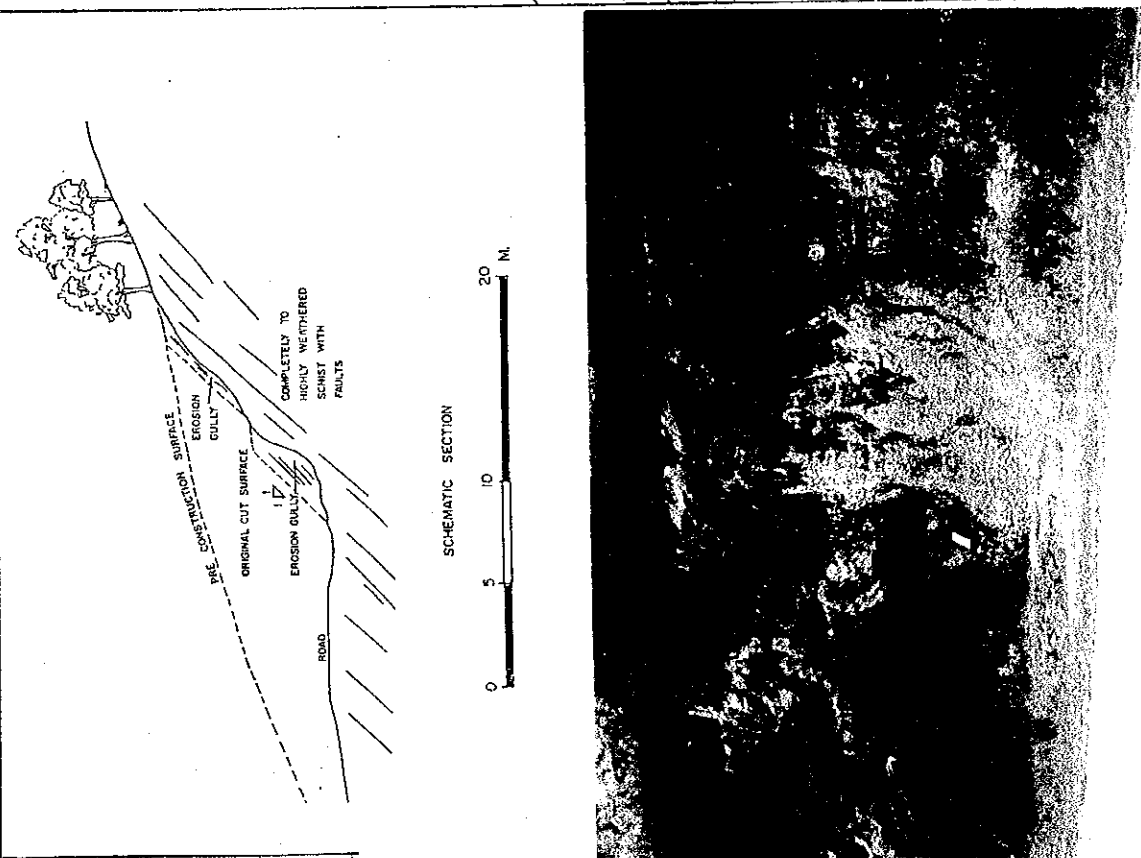
SPOT 410/5 KM. 96.300
EXISTING CONDITIONS

The slope is only about 10m high and was cut at 0.5/1. The erosion is occurring in the sheared areas. The existing conditions are illustrated in Fig. 4.6.6.

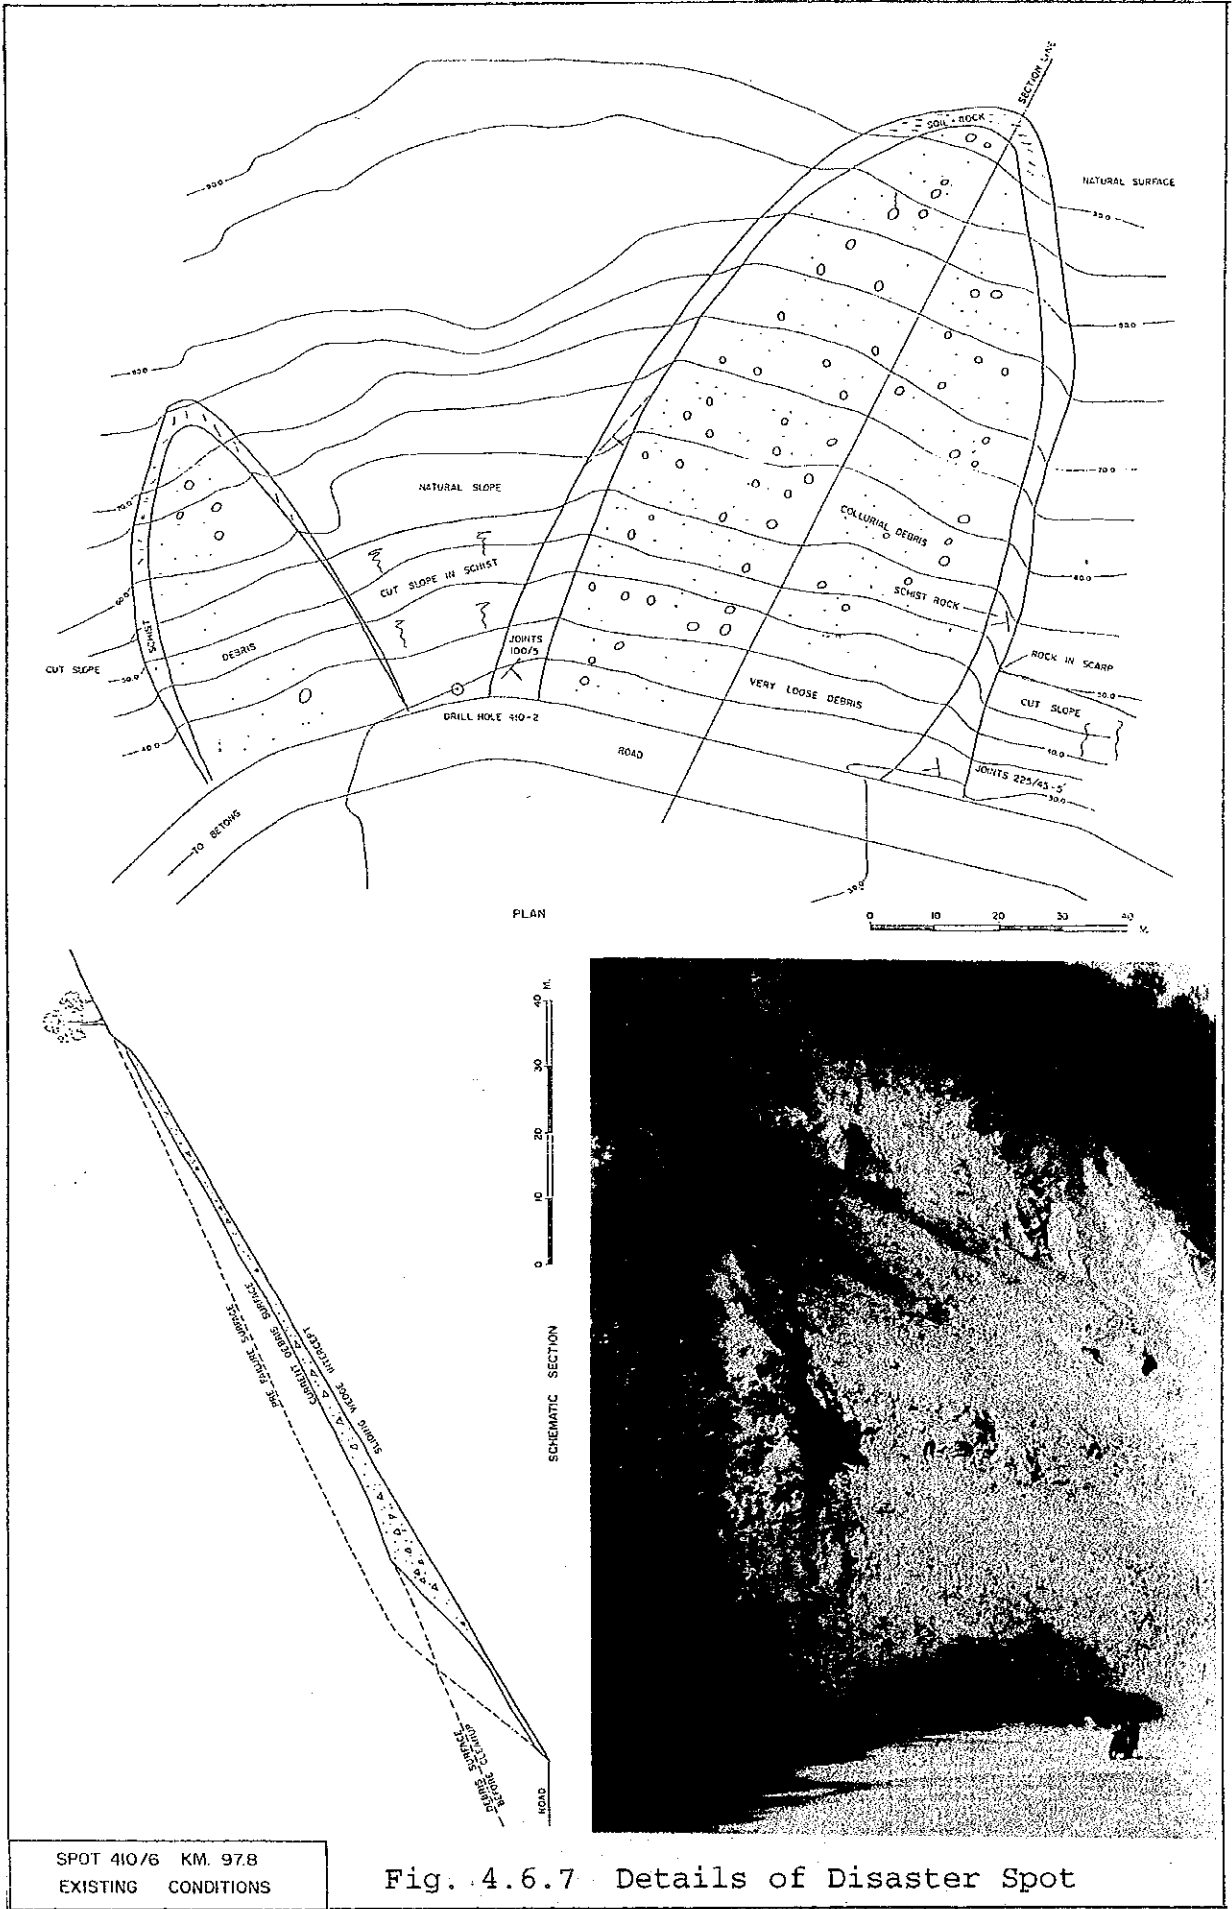
SPOT 410/6 KM. 97.8
EXISTING CONDITIONS

At Km. 97.8, three closely associated very large 3D translational landslides have occurred. The central slide is about 65 m high. The original cut slope was about 25m high with an angle of about 60-70 degrees. The rock is a fissile mica schist with extensive tectonic joints. The failed surface consists of a number of wedge intercepts rather than one very large wedge.

The natural ground slope is at an angle close to 34 degrees (1.5/1). The interception angle between the two main joint sets controlling the failure (DD225/D55, DD100/D50) is also at about 30 degrees and dips towards 162 degrees.

The natural slope dips towards 167 degrees. It is apparent that the original natural slope was controlled by these structures. The existing conditions are illustrated in Fig. 4.6.8.

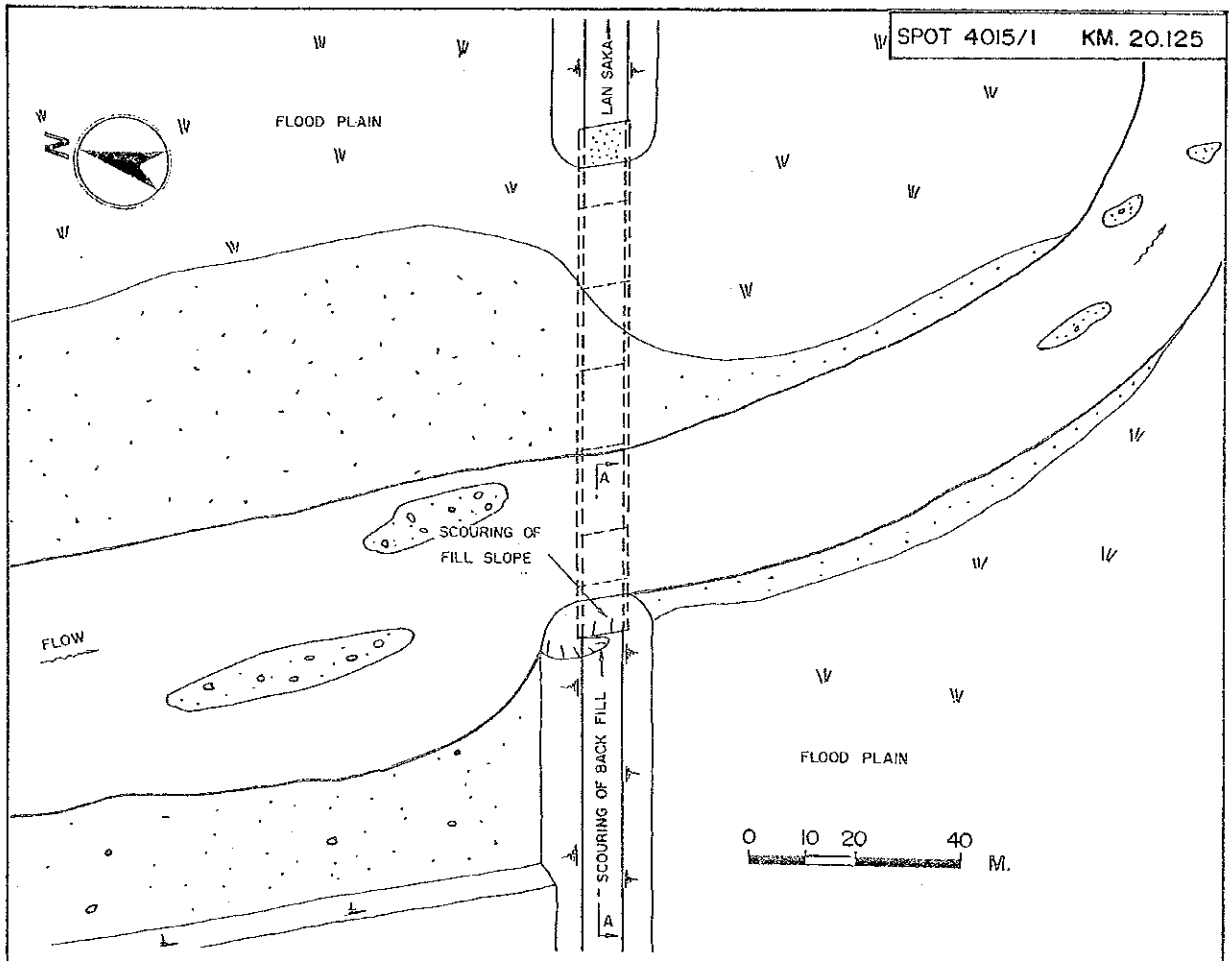
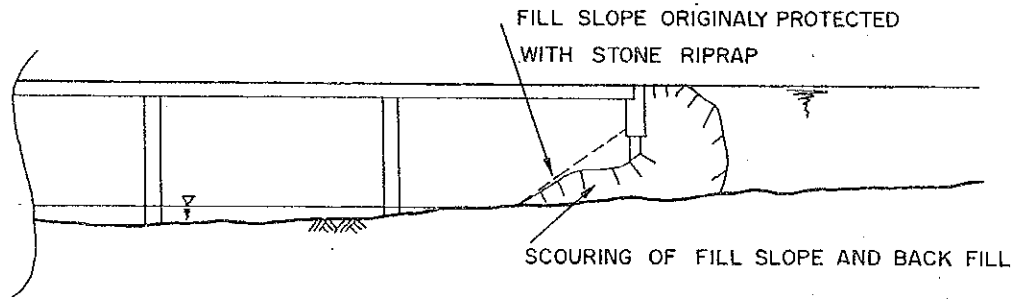
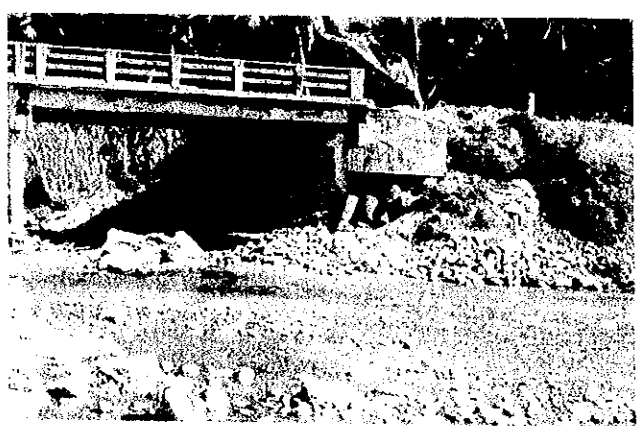
Fig. 4.7.3 Details of Disaster Spot

At Km. 20.15, a bridge is located that has had its abutments damaged by scouring. In the vicinity of the bridge, the road lies in a flood plain and follows a raised embankment. The superstructure and substructure of the bridge are made of reinforced concrete. The bridge has a total length of 100 metres and the height of the approach embankment above the natural ground is approximately 3 metres. The existing conditions are illustrated in Fig. 4.7.3.

The upstream side of the left abutment was damaged during heavy rainfall in December 1993. Even though the fill slope of the abutment was protected by stone riprap, it was completely destroyed and the back-fill of the abutment has eroded up to half the width of the carriageway.

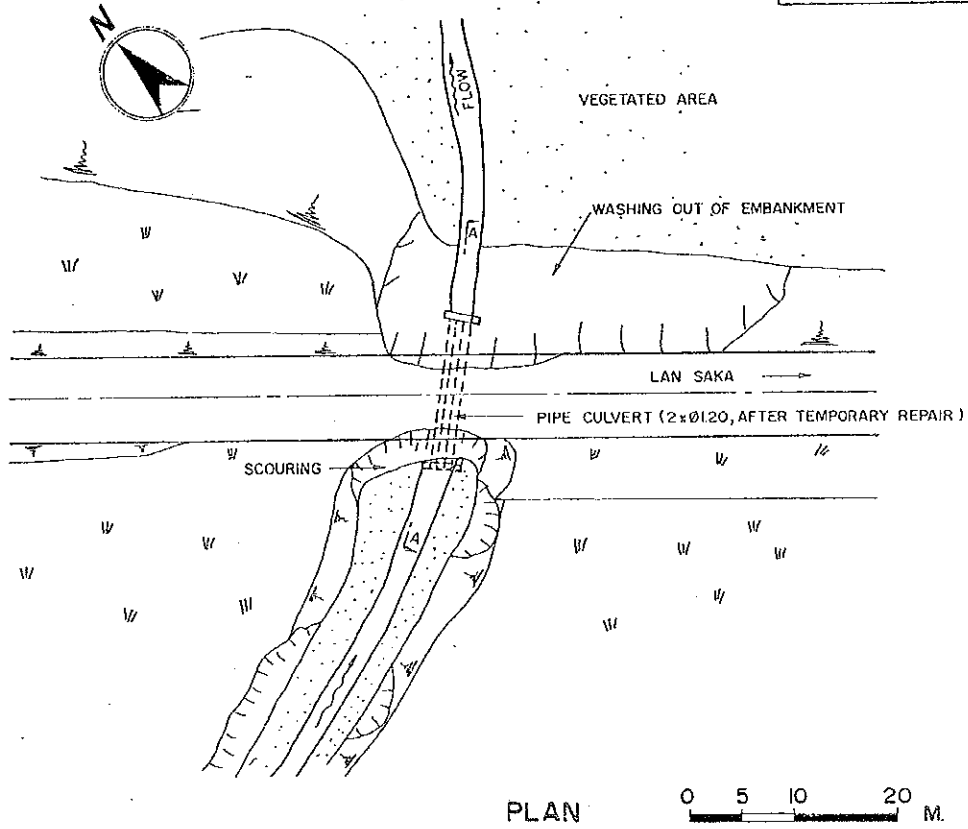
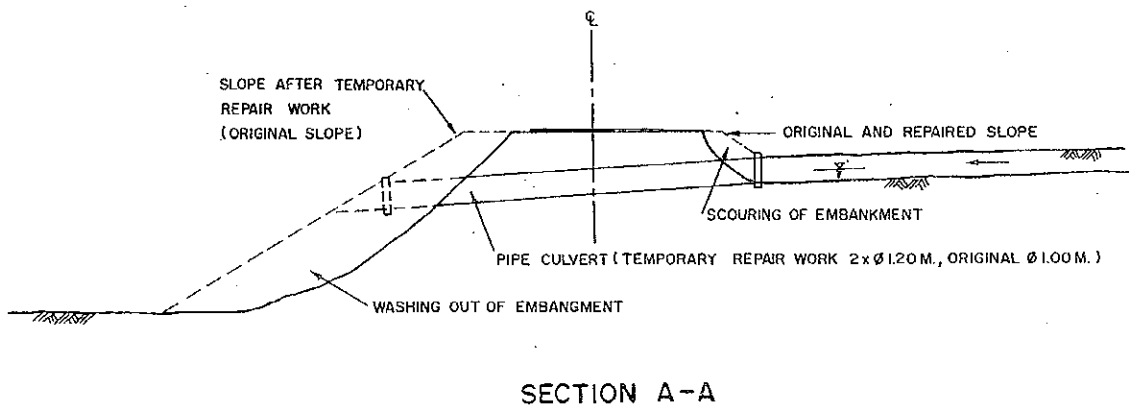
Fig. 4.7.4 Details of Disaster Spot

This disaster spot is situated in a valley floor in hilly terrain in the foothills of the Khao Luang Mountains at Km. 21.337. Before the road collapsed, a pipe culvert 1.0 metre in diameter was installed through the road embankment to discharge flood water. The existing conditions are illustrated in Fig. 4.7.4.

In November 1993, the area was hit by heavy rainfall and the embankment was heavily damaged by water overflowing from the inlet of the culvert.

It is apparent that the damage was caused by the inadequate capacity of the culvert. At present, the damage has been temporarily restored by the installation of two pipe culverts of 1.2 metres in diameter as a substitute for the old one.

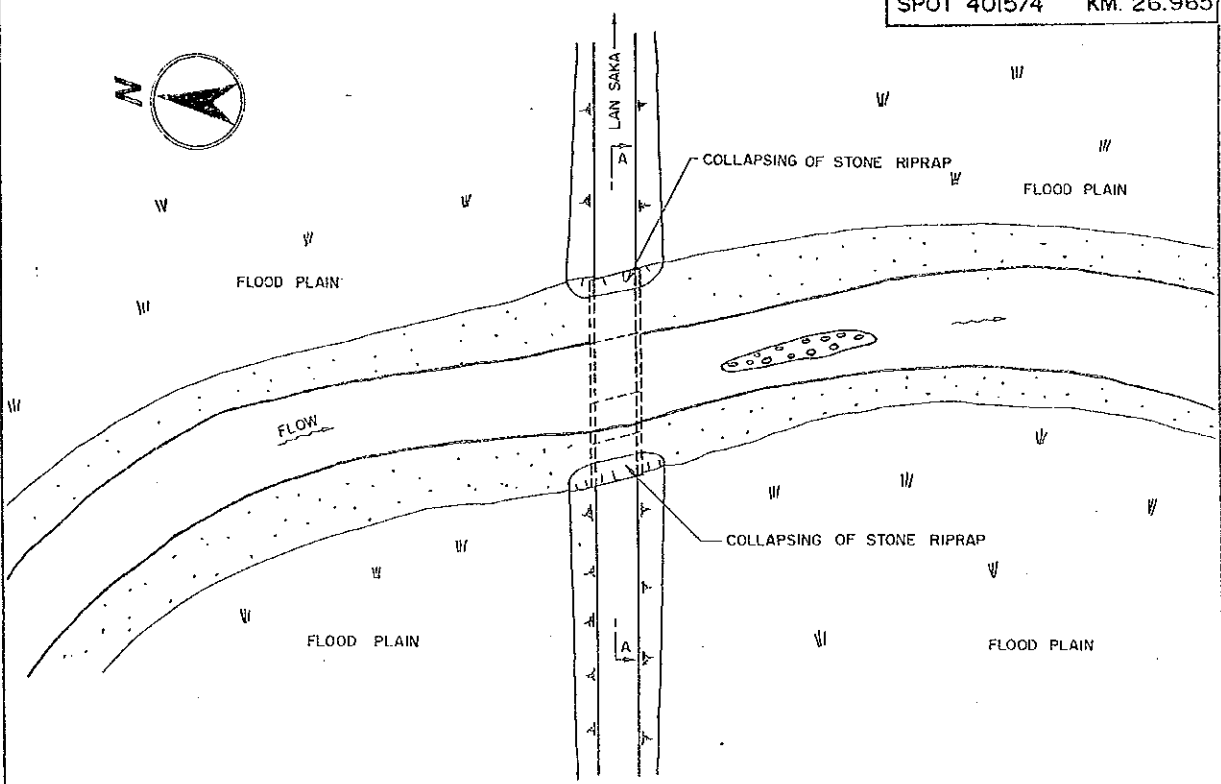
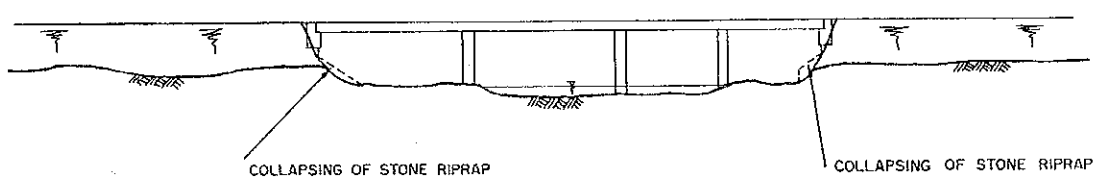
Fig. 4.7.6 Details of Disaster Spot

The bridge is located at Km. 26.965 in a flood plain and the roadway is constructed on a raised embankment. The bridge is 40 metres long and is built of reinforced concrete girders, piers and abutments. The fill slope of the abutment is protected with a combination of stone masonry and riprap. Refer to Fig. 4.7.6 for the existing conditions.

The fill slope riprap protection is damaged at both abutments and both slopes are not yet repaired.
