The Study on Road Disaster Prevention Plan in The Kingdom of Thailand

FINAL REPORT DRAWINGS

VOLUME 3

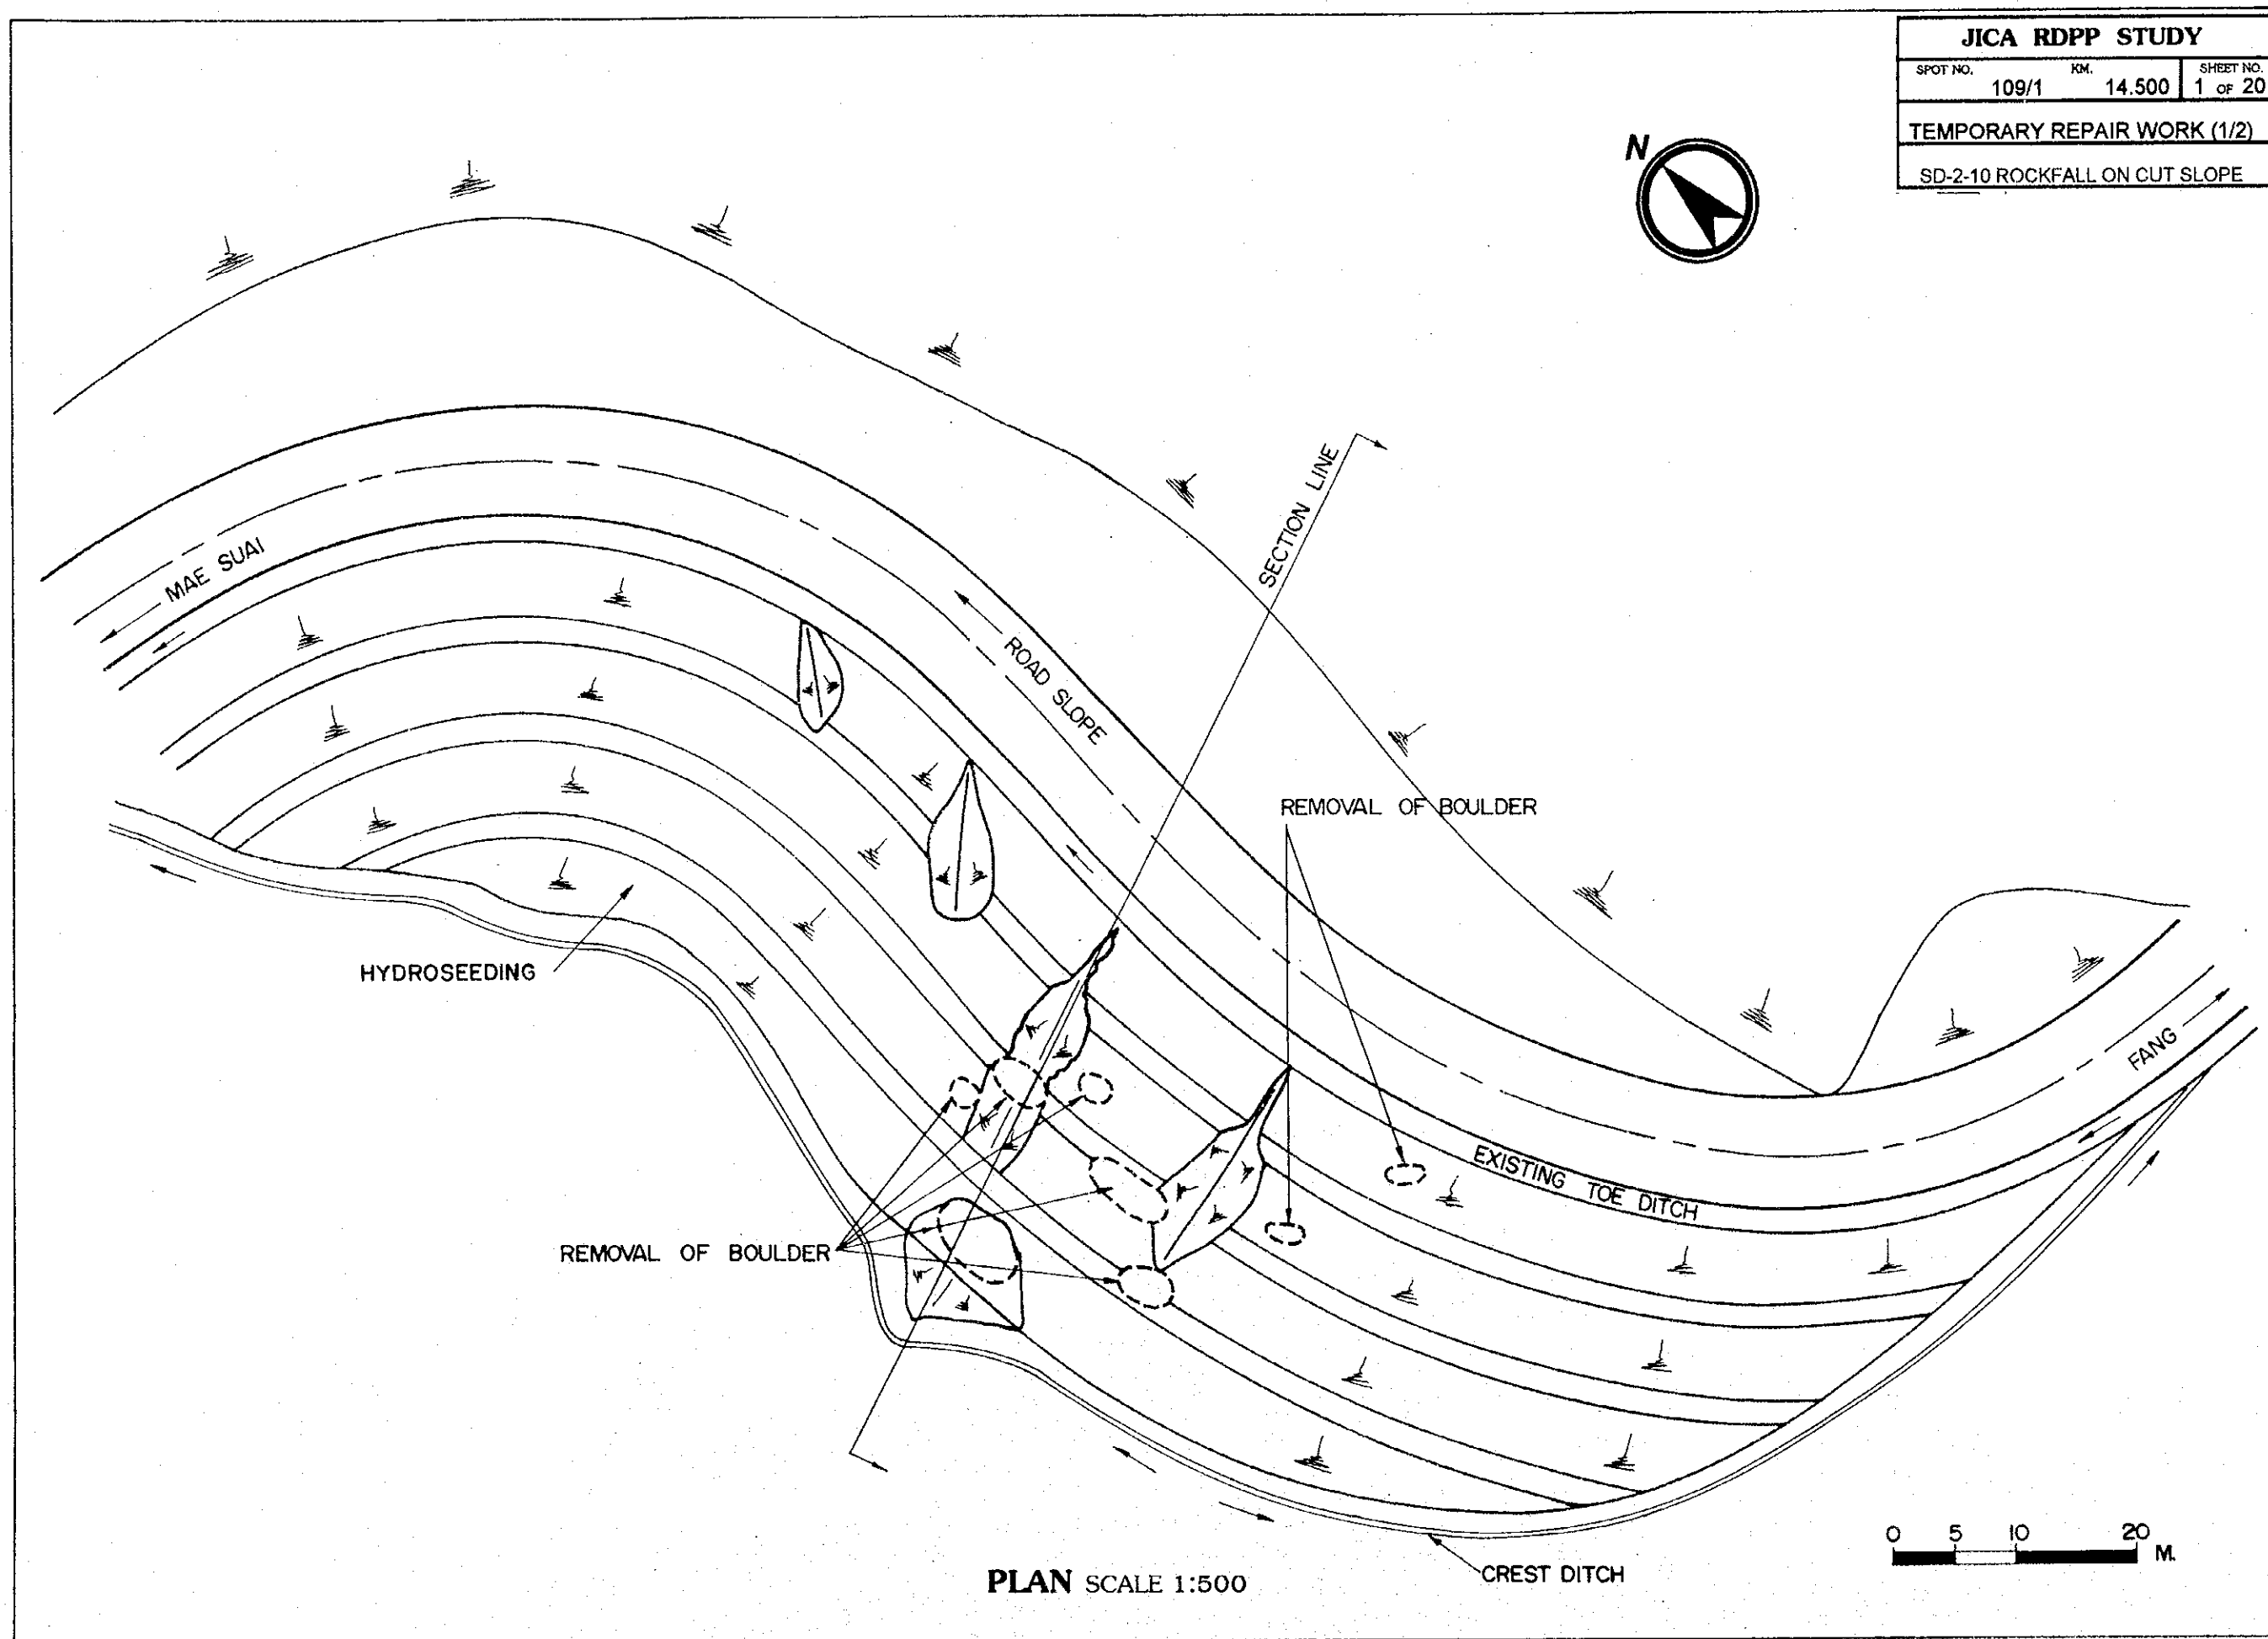
SPOT NO.	KM.	SHEET NO.
109/1	14.500	1 OF 20

SD-2-10 ROCKFALL ON CUT SLOPE

TEMPORARY REPAIR WORK (1/2)

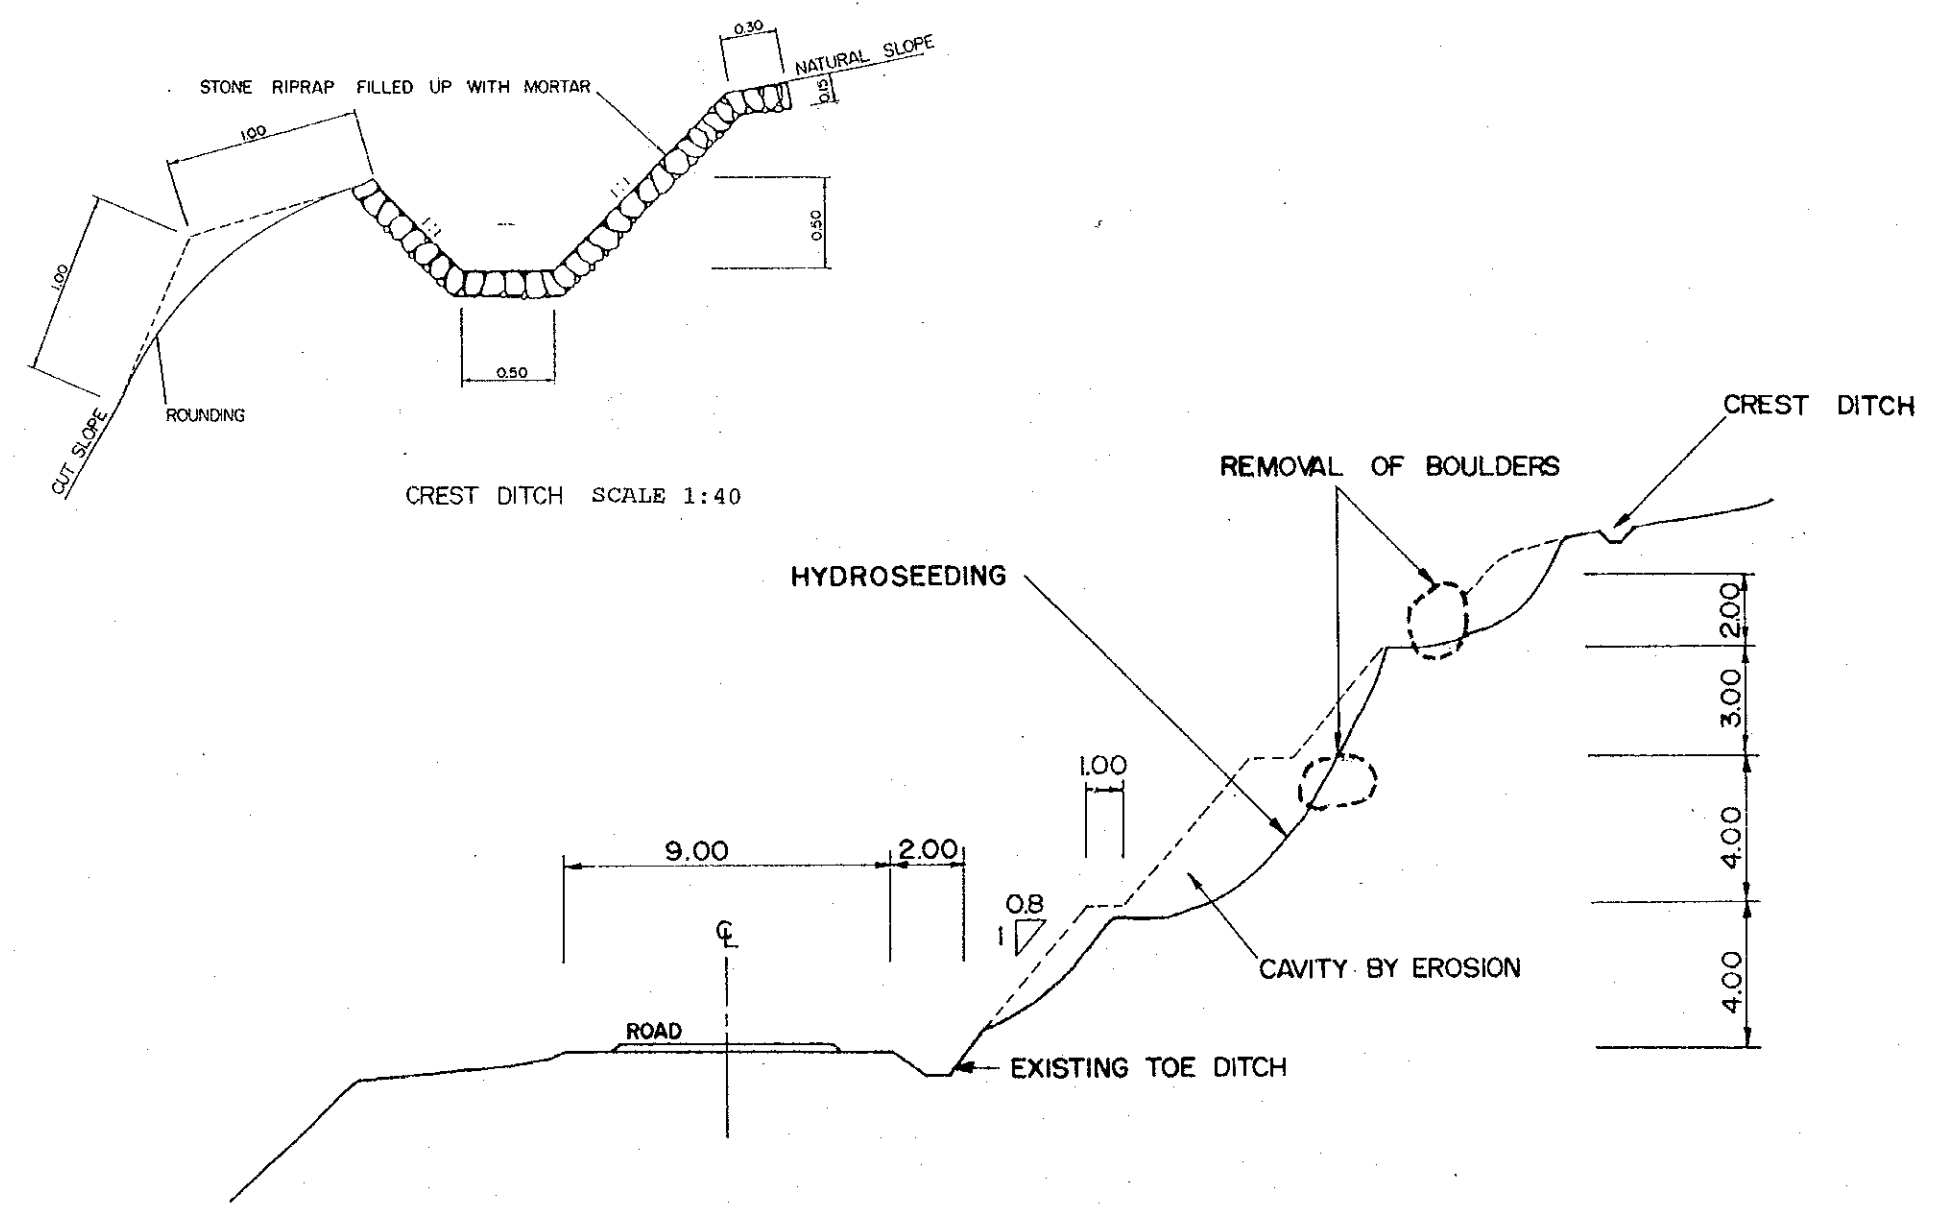
JICA RDPP STUDY		
SPOT NO.	KM.	SHEET NO.
109/1	14.500	2 OF 20
TEMPORARY REPAIR WORK (2/2)		
SD-2-10 ROCKFALL ON CUT SLOPE

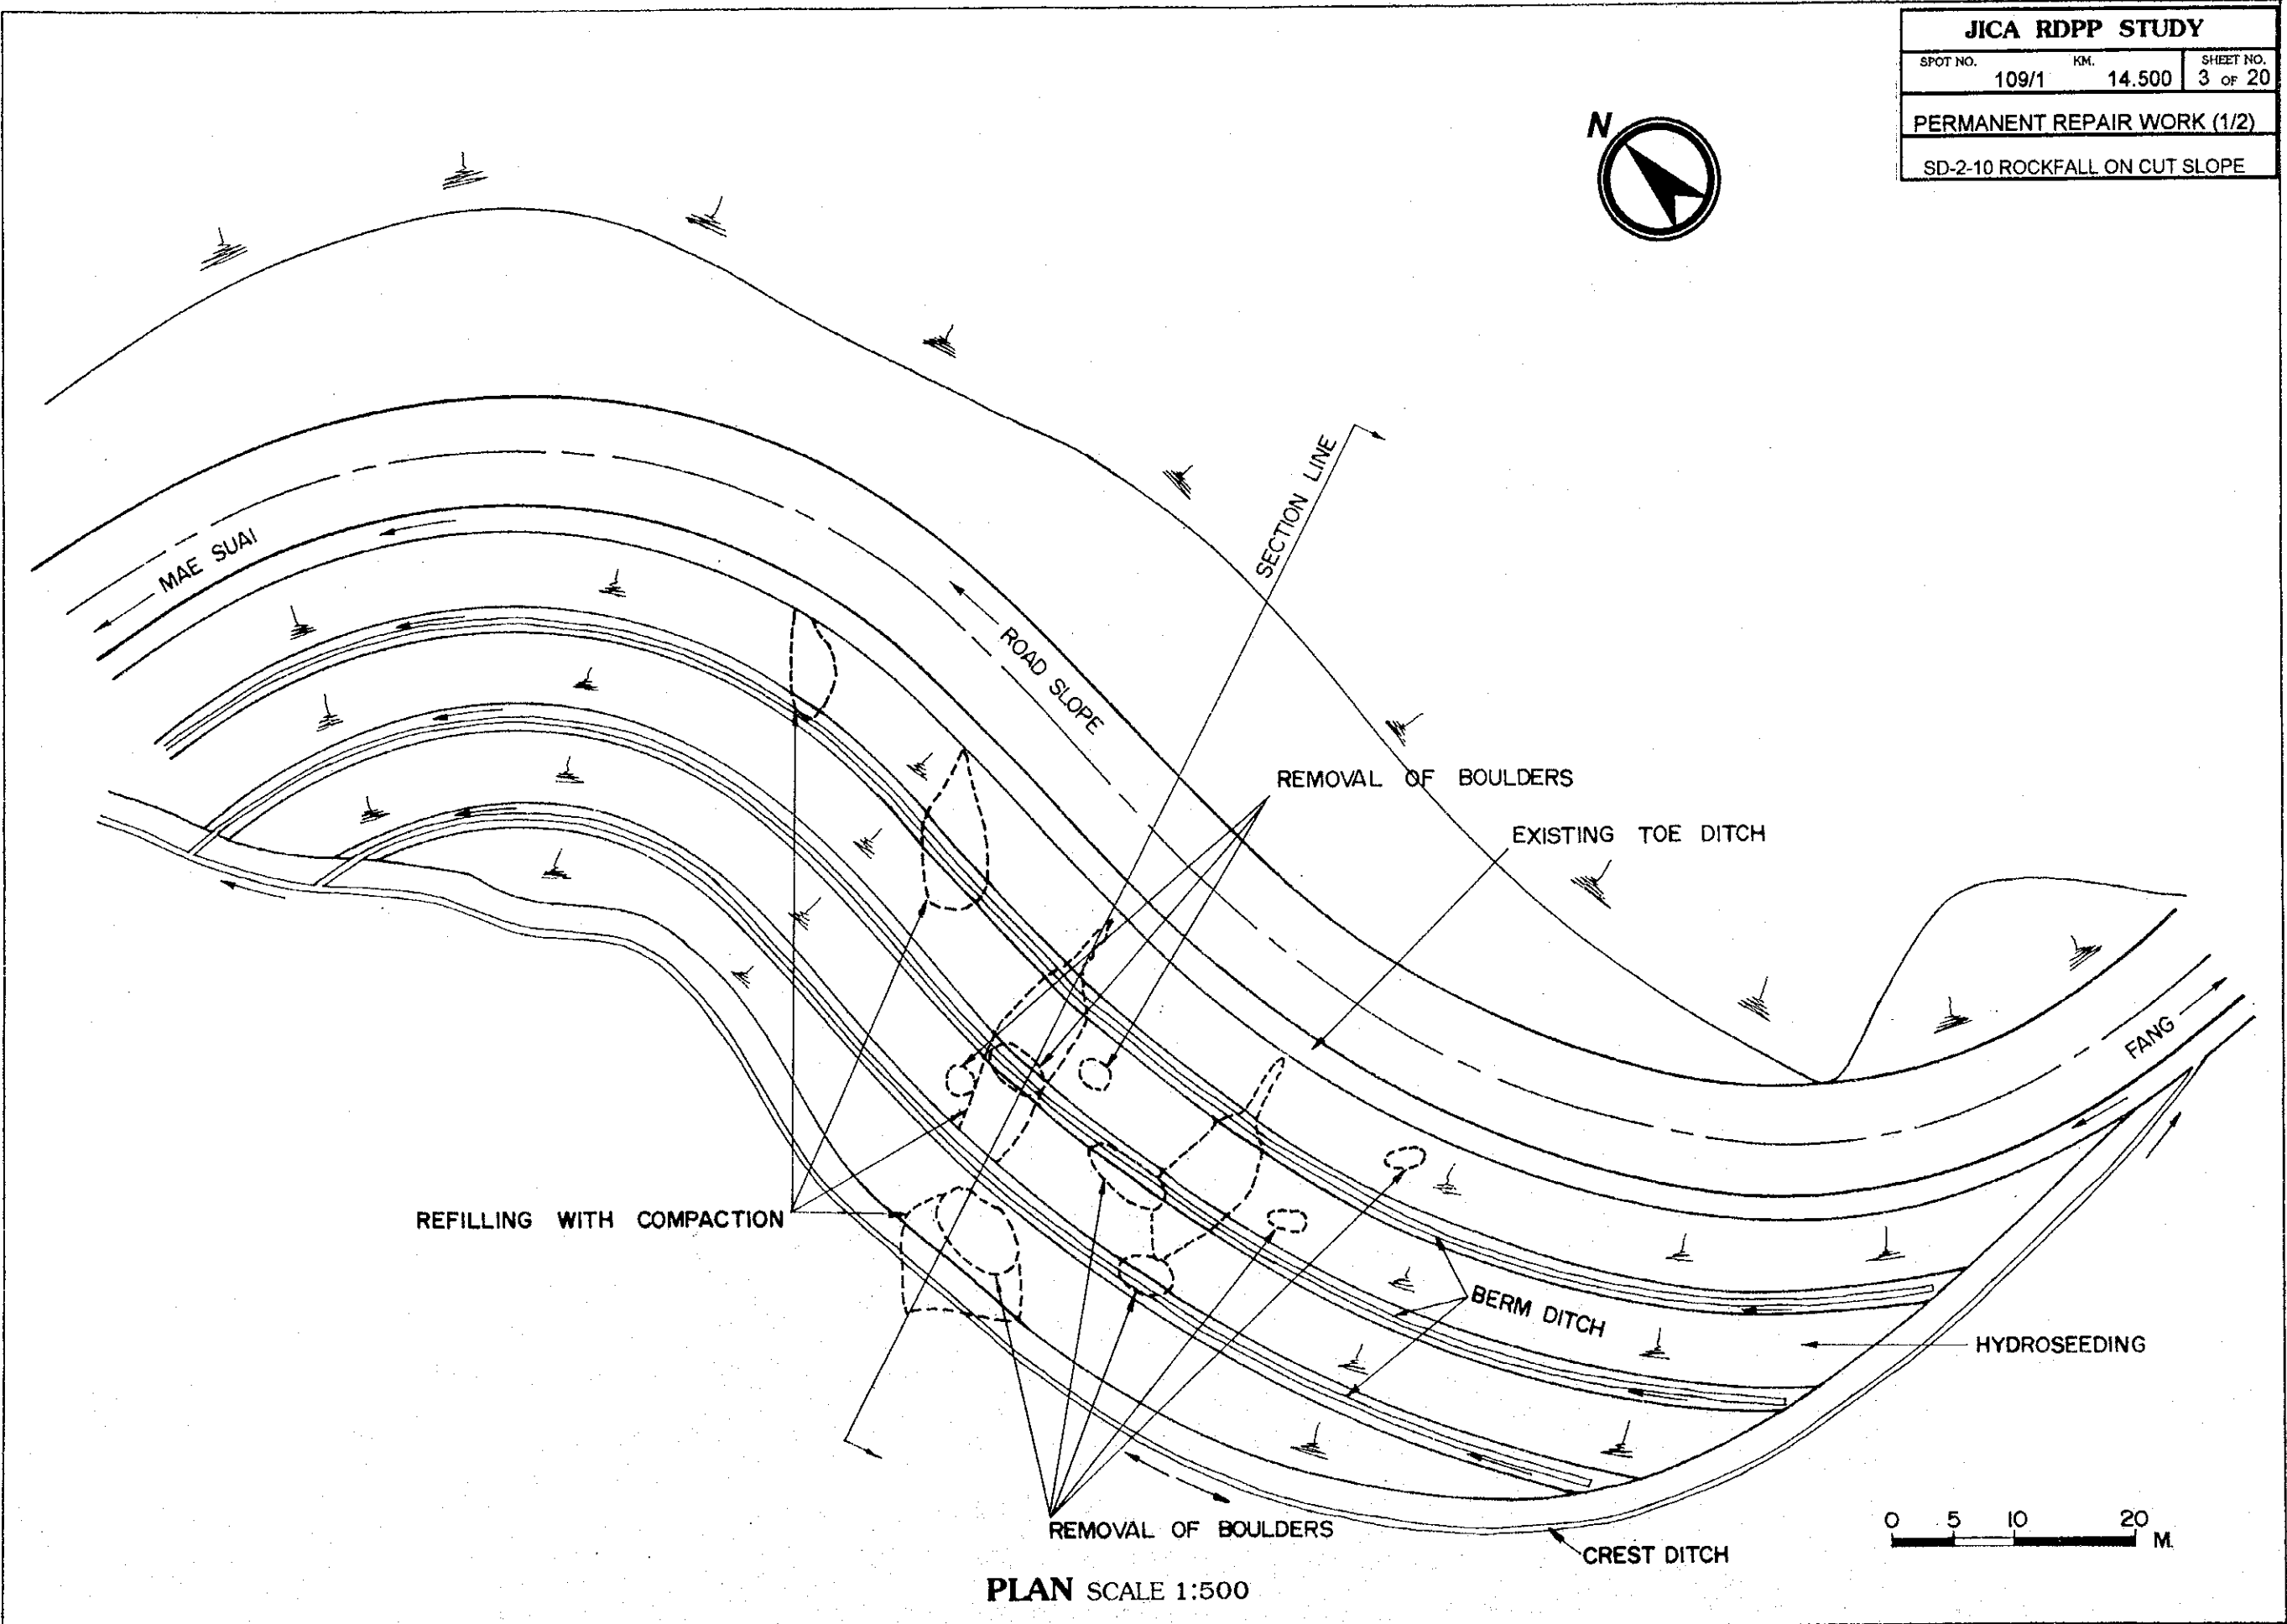
JICA RDPP STUDY		
SPOT NO.	KM.	SHEET NO.
109/1	14.500	3 OF 20
PERMANENT REPAIR WORK (1/2)		
SD-2-10 ROCKFALL ON CUT SLOPE

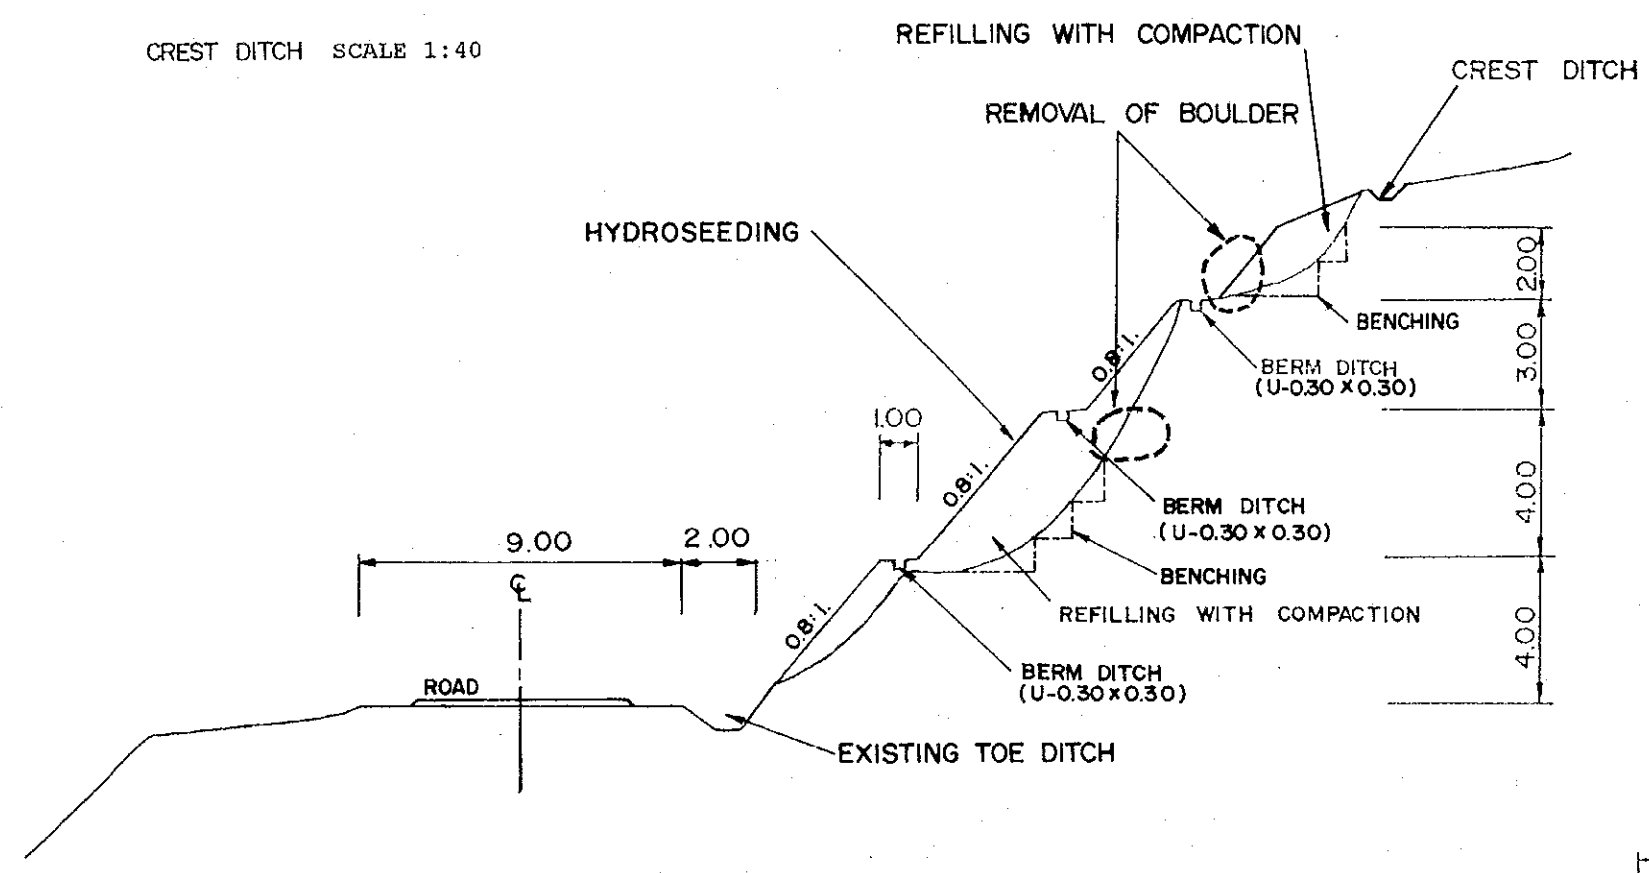
JICA RDPP STUDY		
SPOT NO.	KM.	SHEET NO.
109/1	14.500	4 OF 20
PERMANENT REPAIR WORK (2/2)		
SD-2-10 ROCKFALL ON CUT SLOPE

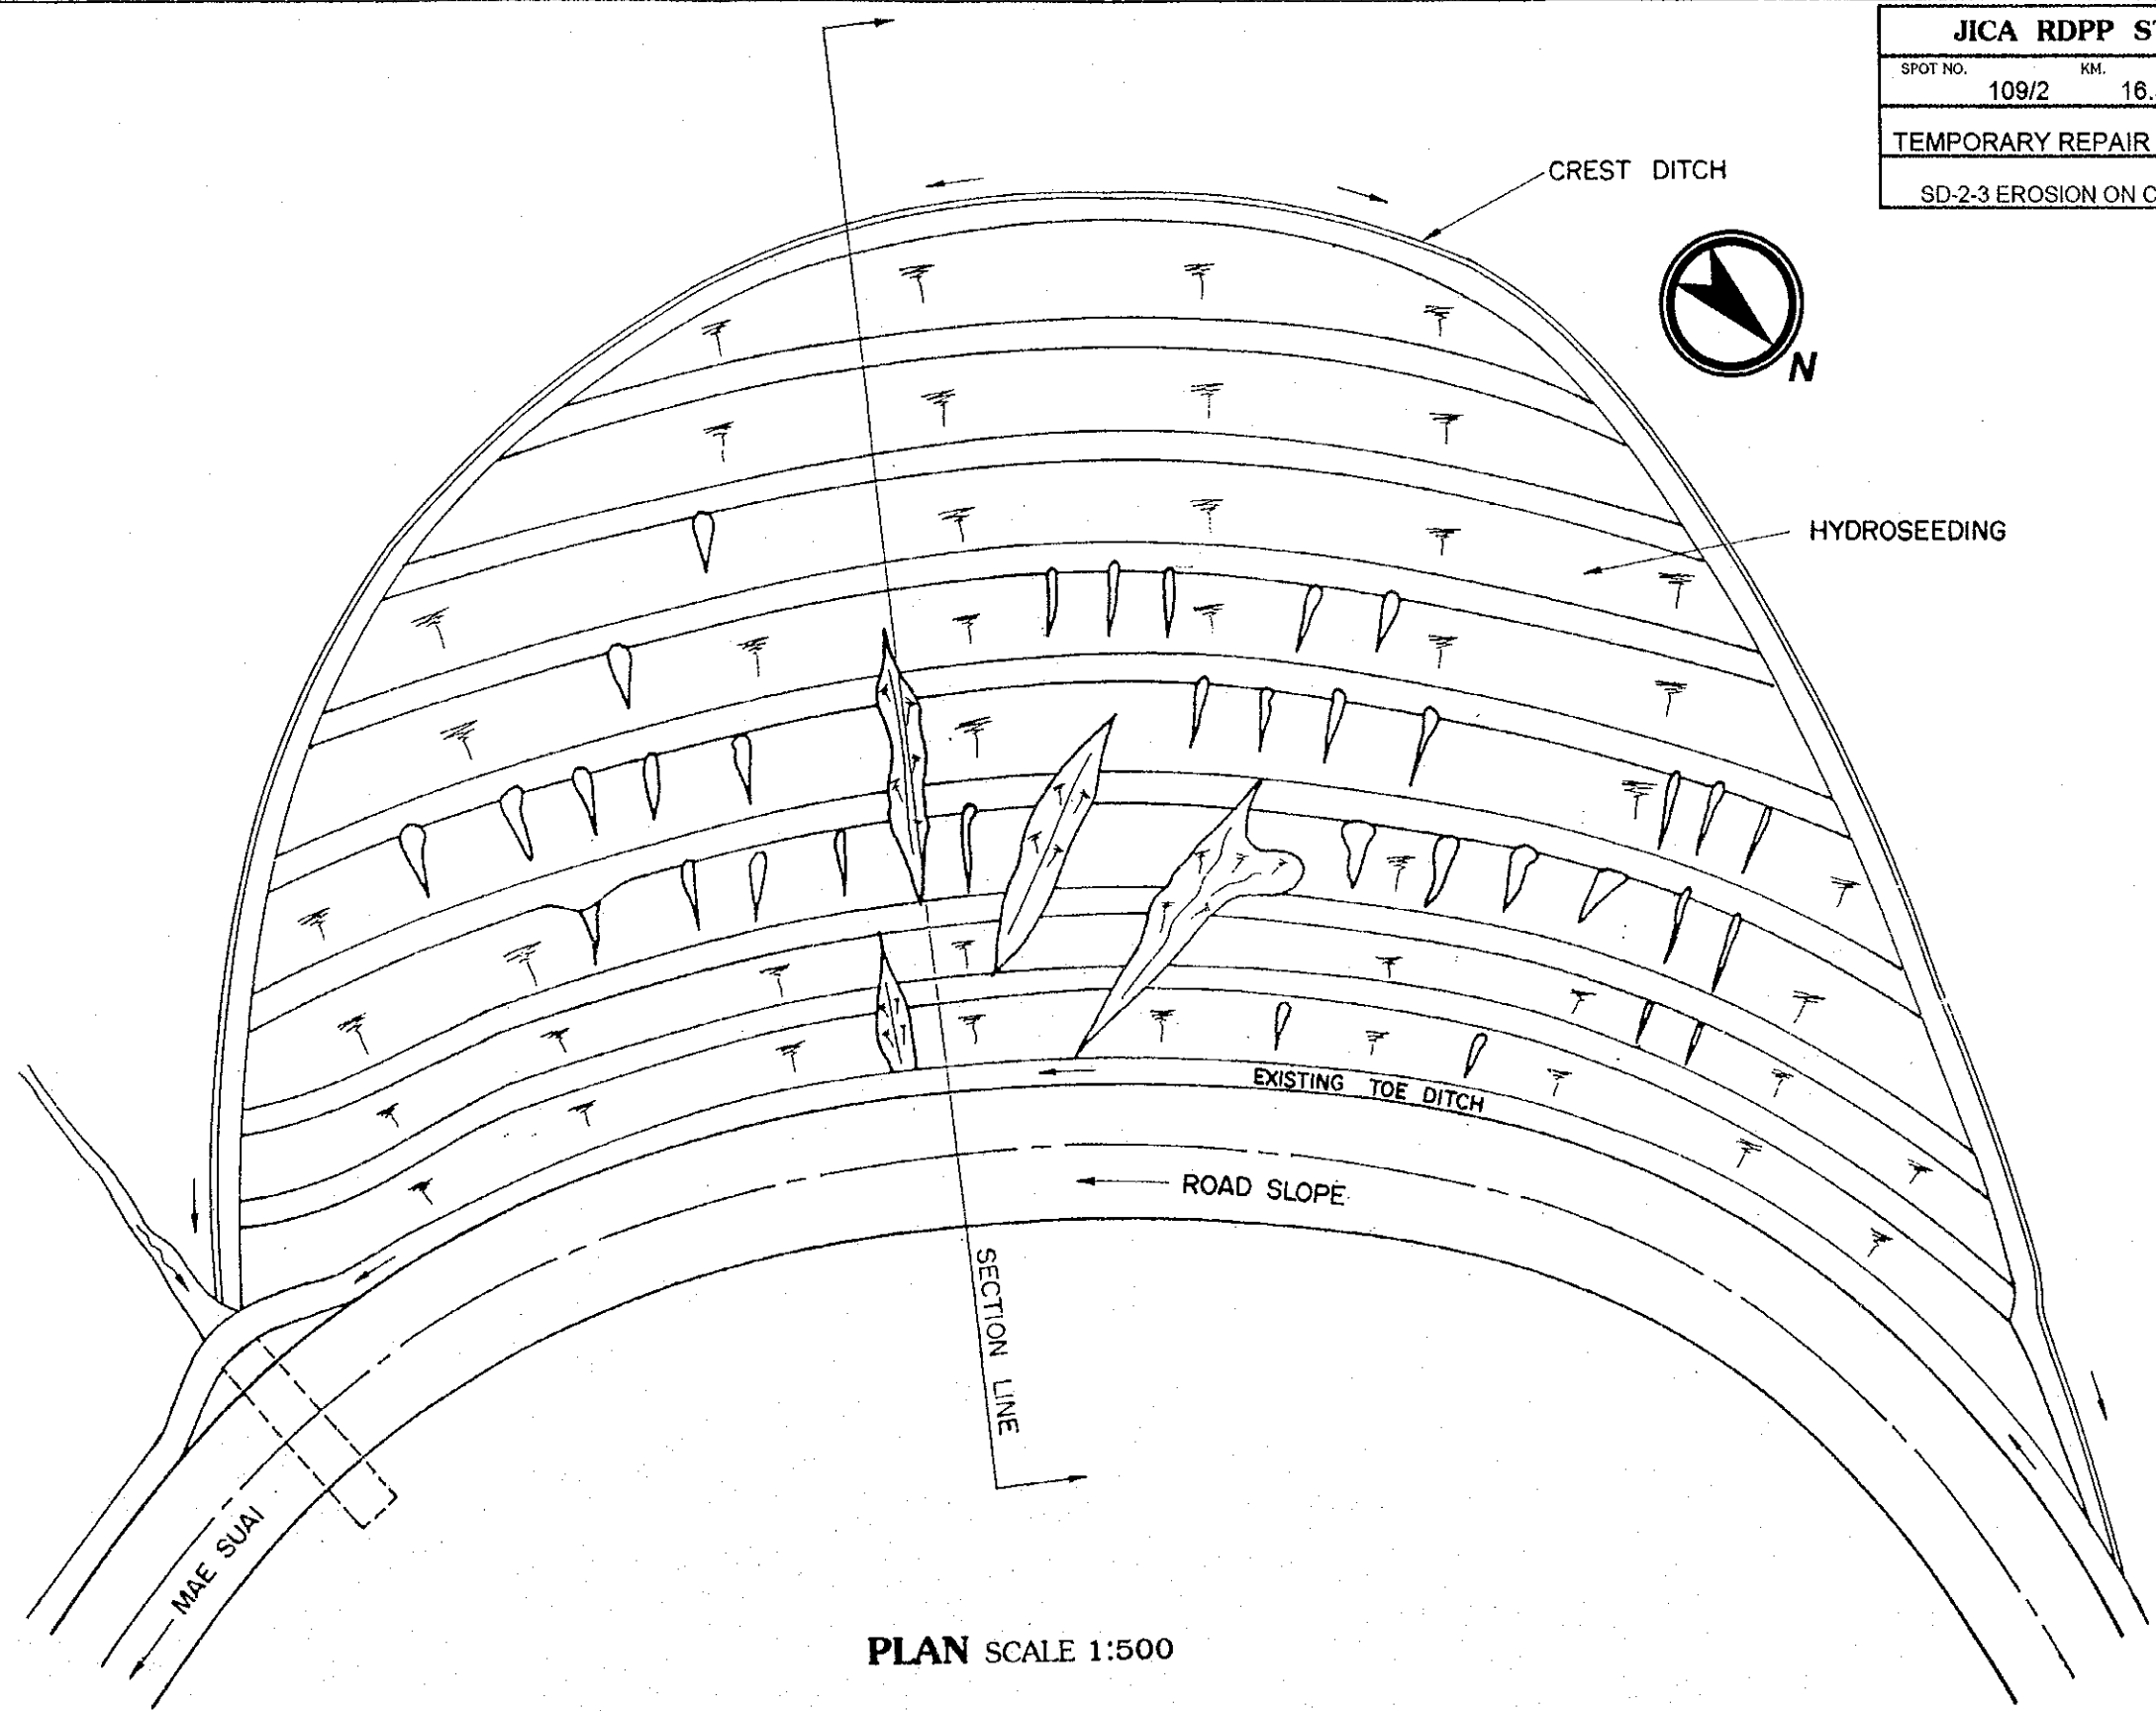
JICA RDPP STUDY		
SPOT NO.	KM.	SHEET NO.
109/2	16.500	5 OF 20
TEMPORARY REPAIR WORK (1/2)		
SD-2-3 EROSION ON CUT SLOPE

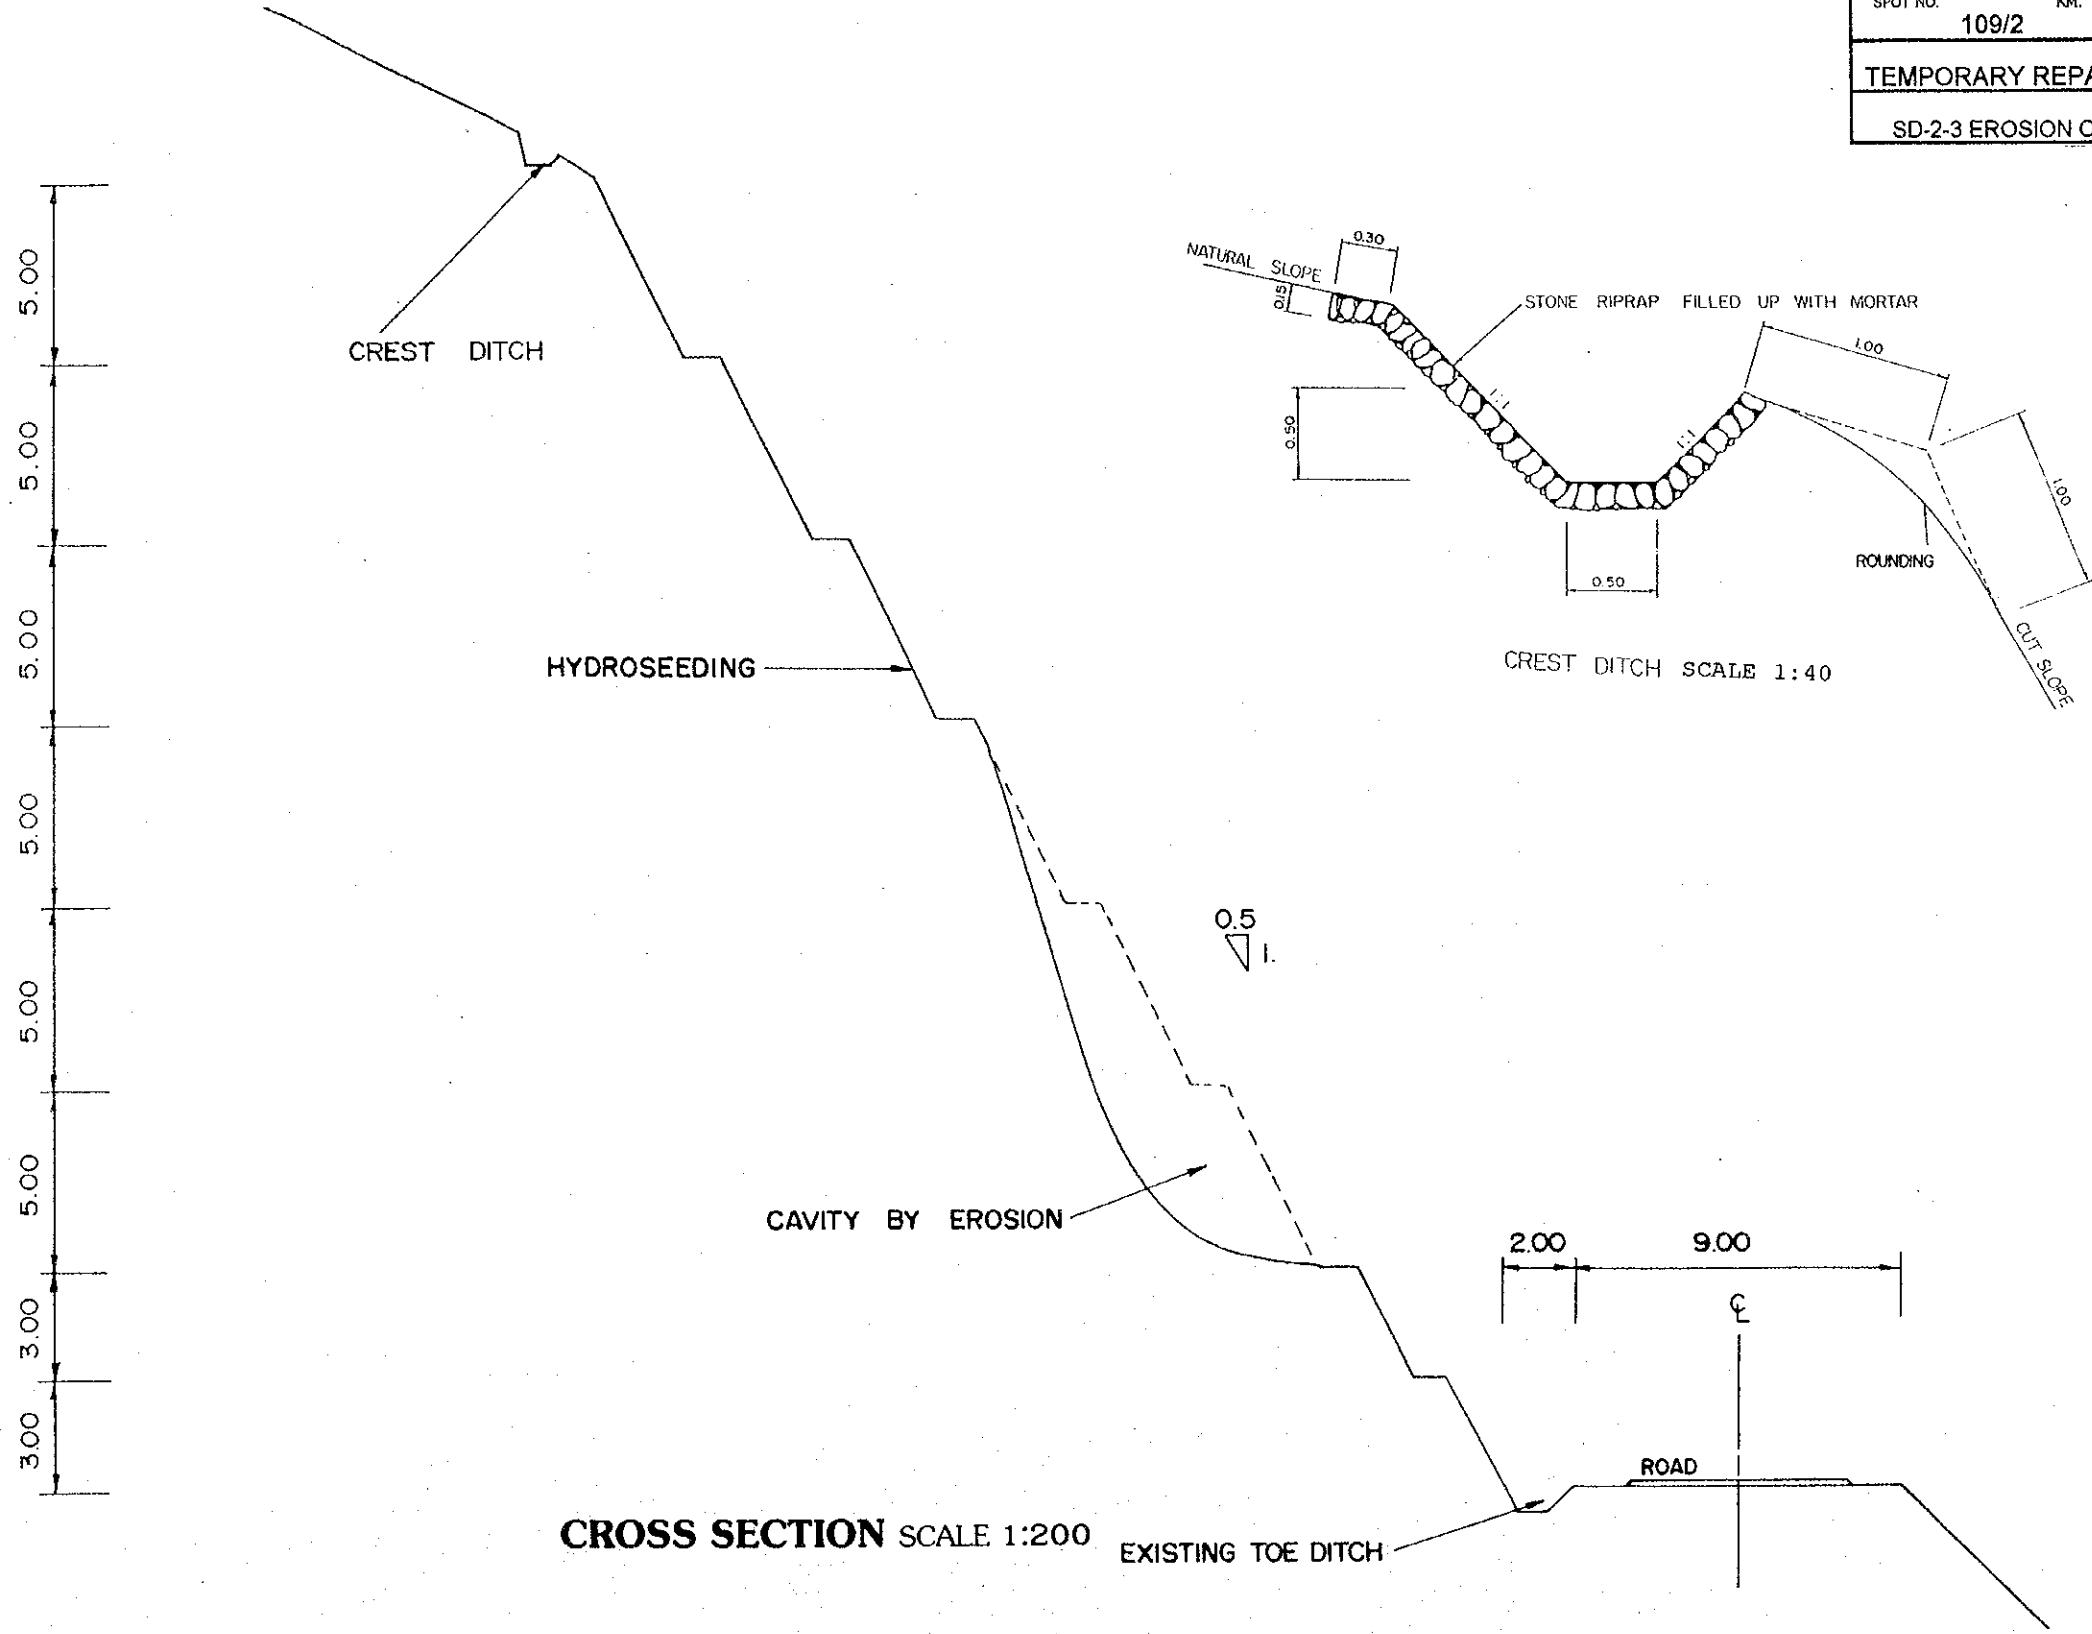
JICA RDPP STUDY		
SPOT NO.	KM.	SHEET NO.
109/2	16.500	6 OF 20
TEMPORARY REPAIR WORK (2/2)		
SD-2-3 EROSION ON CUT SLOPE

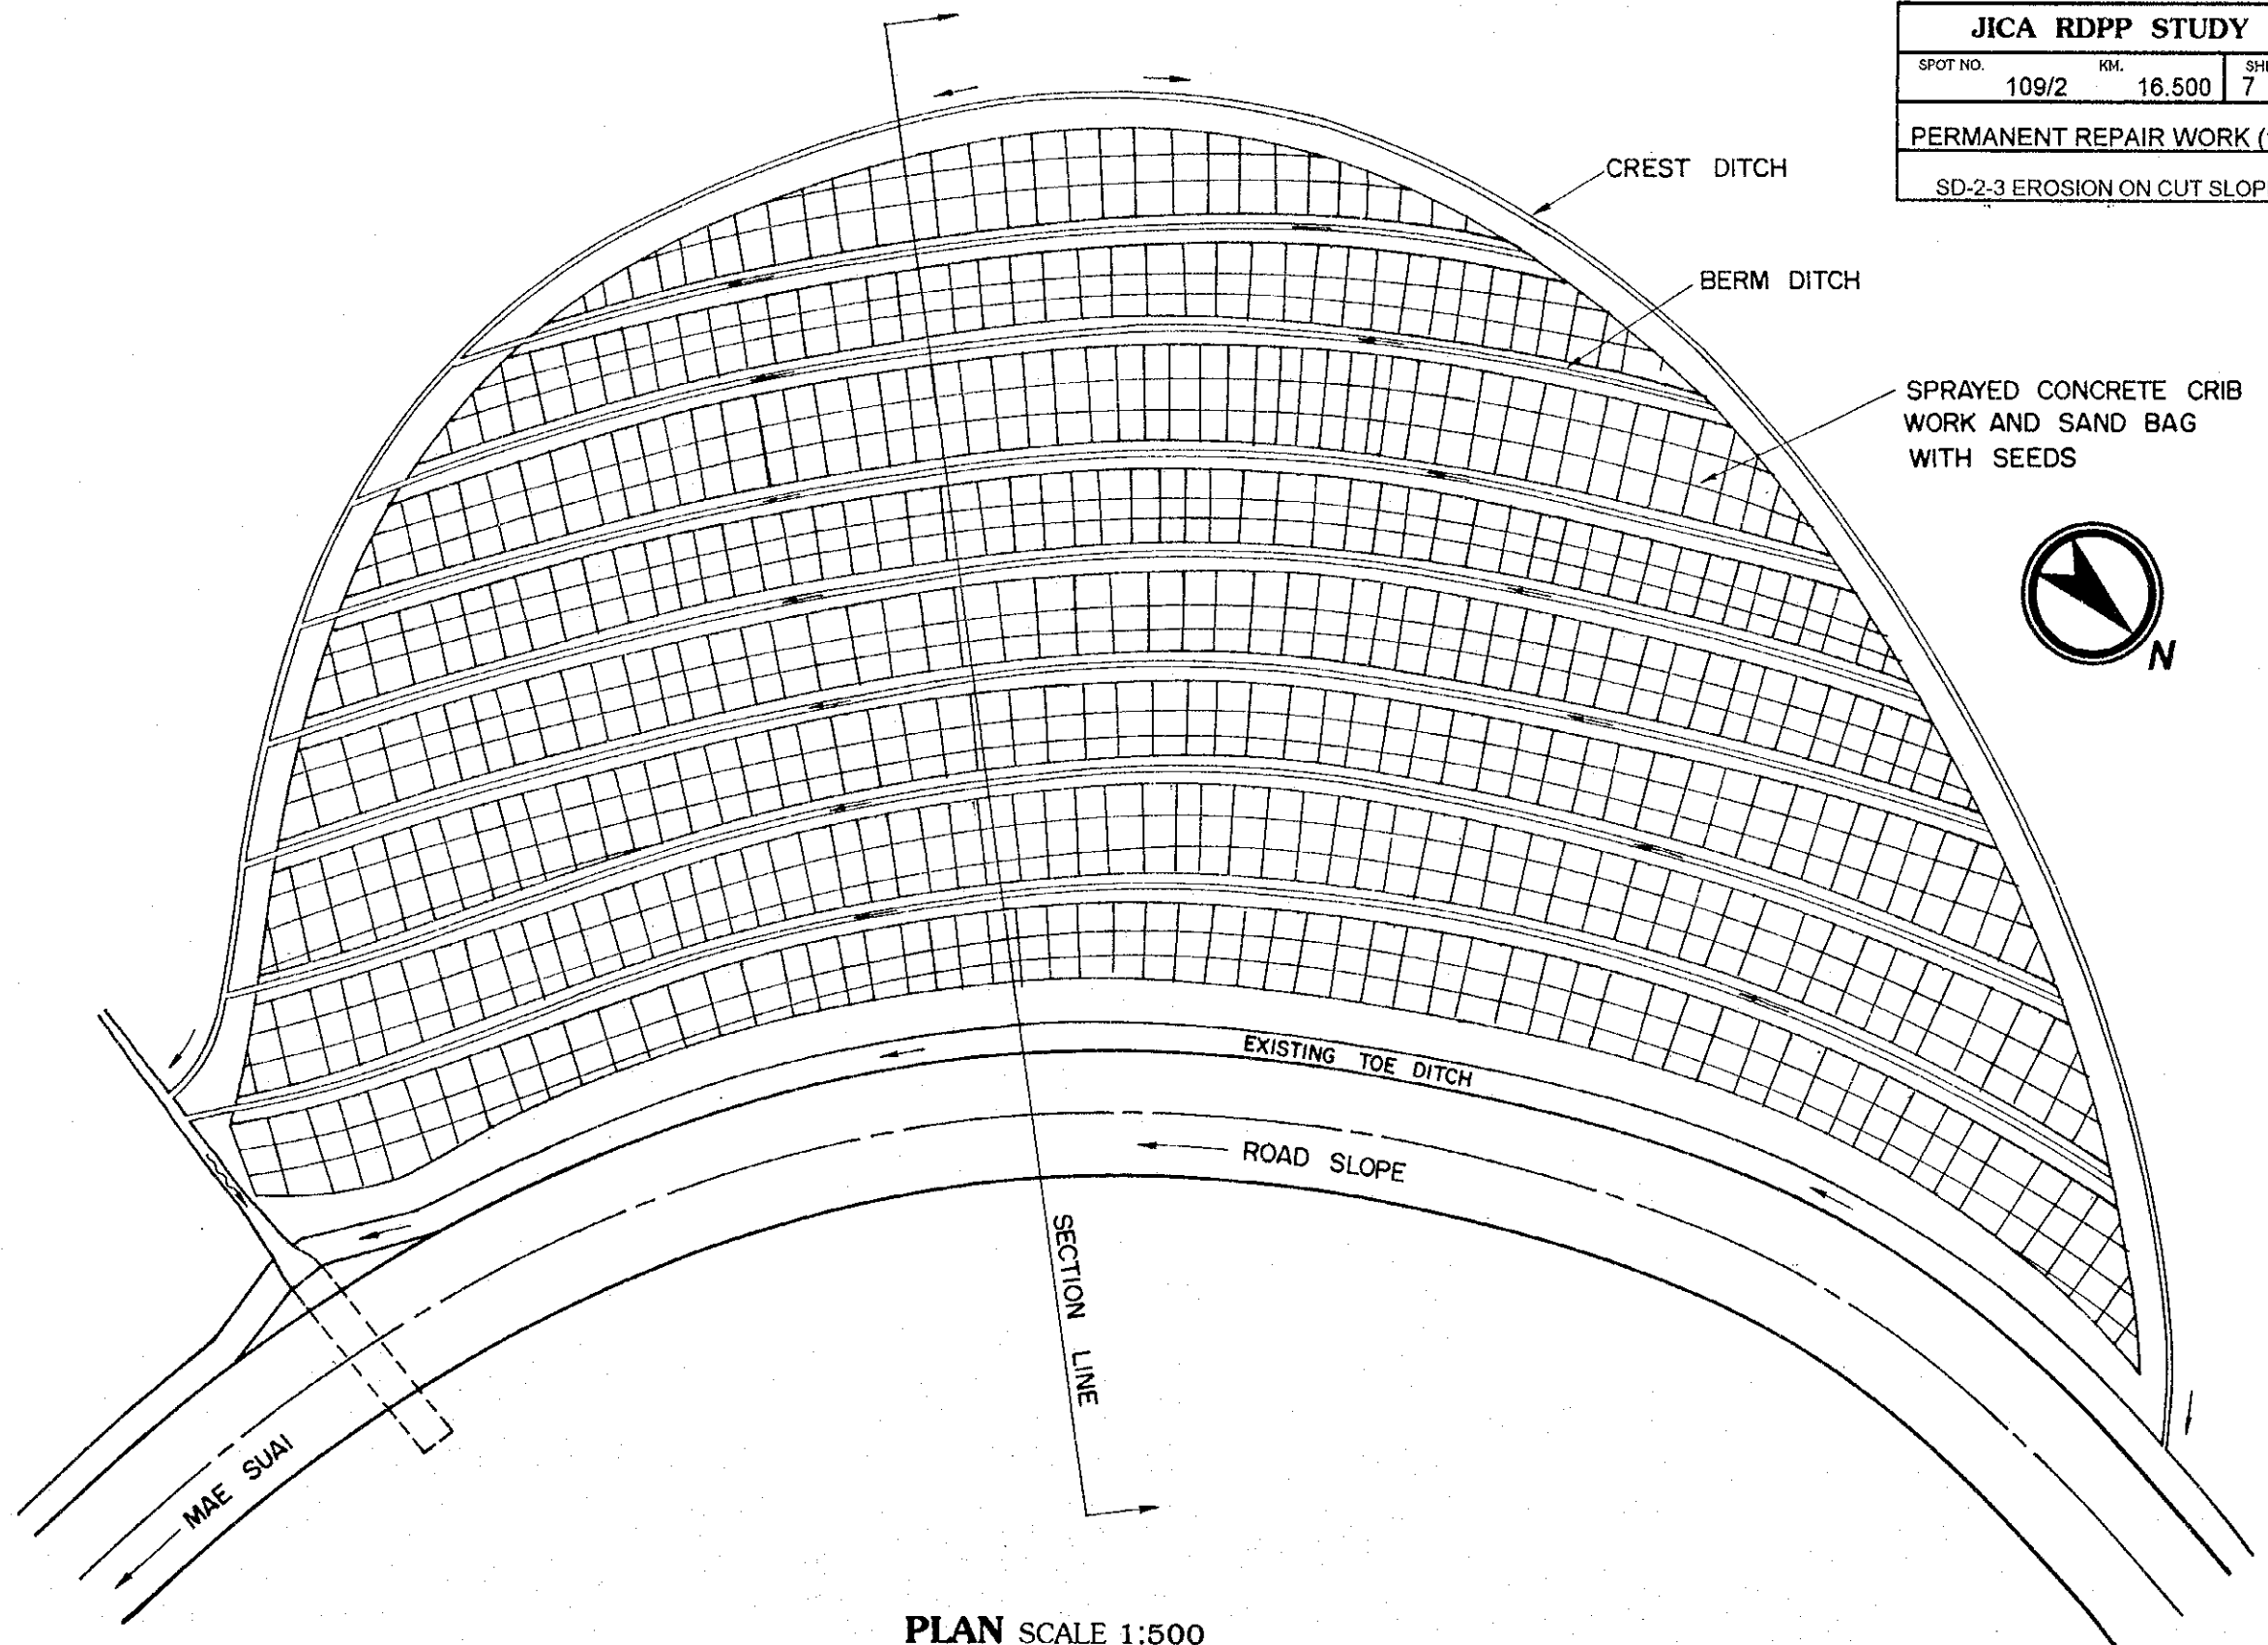
JICA RDPP STUDY		
SPOT NO.	KM.	SHEET NO.
109/2	16.500	7 OF 20
PERMANENT REPAIR WORK (1/2)		
SD-2-3 EROSION ON CUT SLOPE
