The Study on Road Disaster Prevention Plan in The Kingdom of Thailand

FINAL REPORT DRAWINGS

VOLUME 3

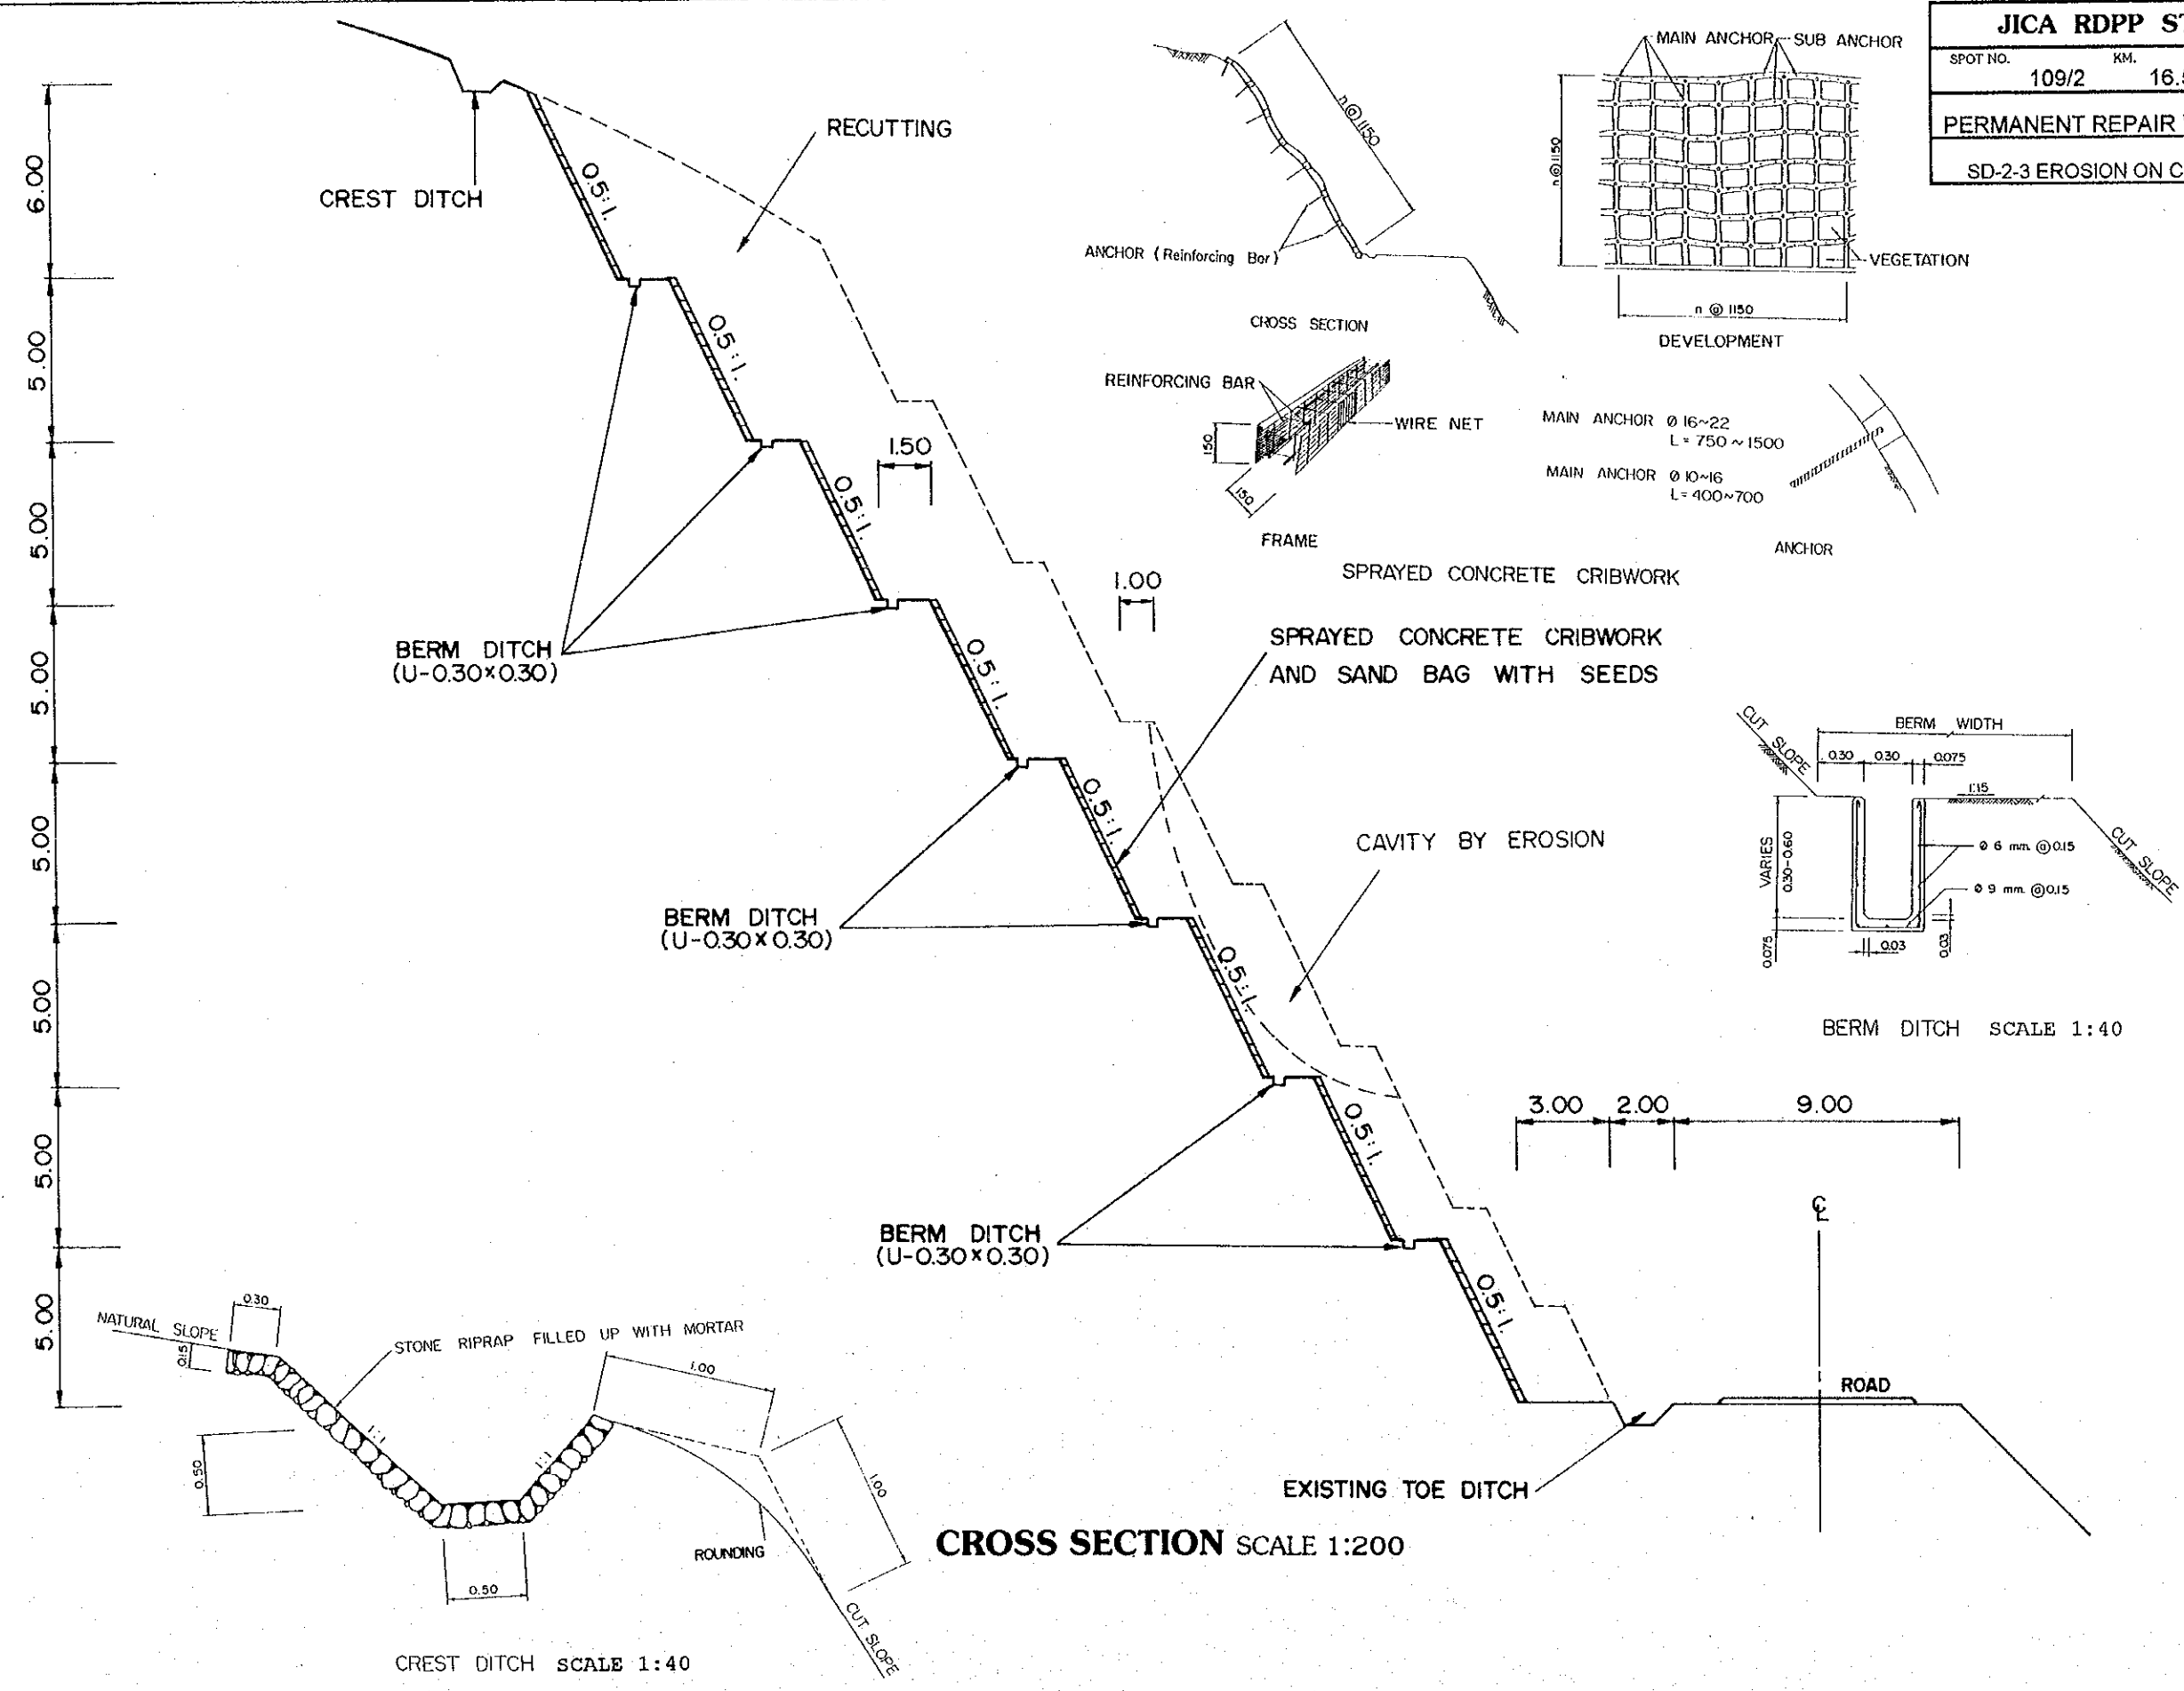
JICA RDPP STUDY		
SPOT NO.	KM.	SHEET NO.
109/2	16.500	8 OF 20
PERMANENT REPAIR WORK (2/2)		
SD-2-3 EROSION ON CUT SLOPE

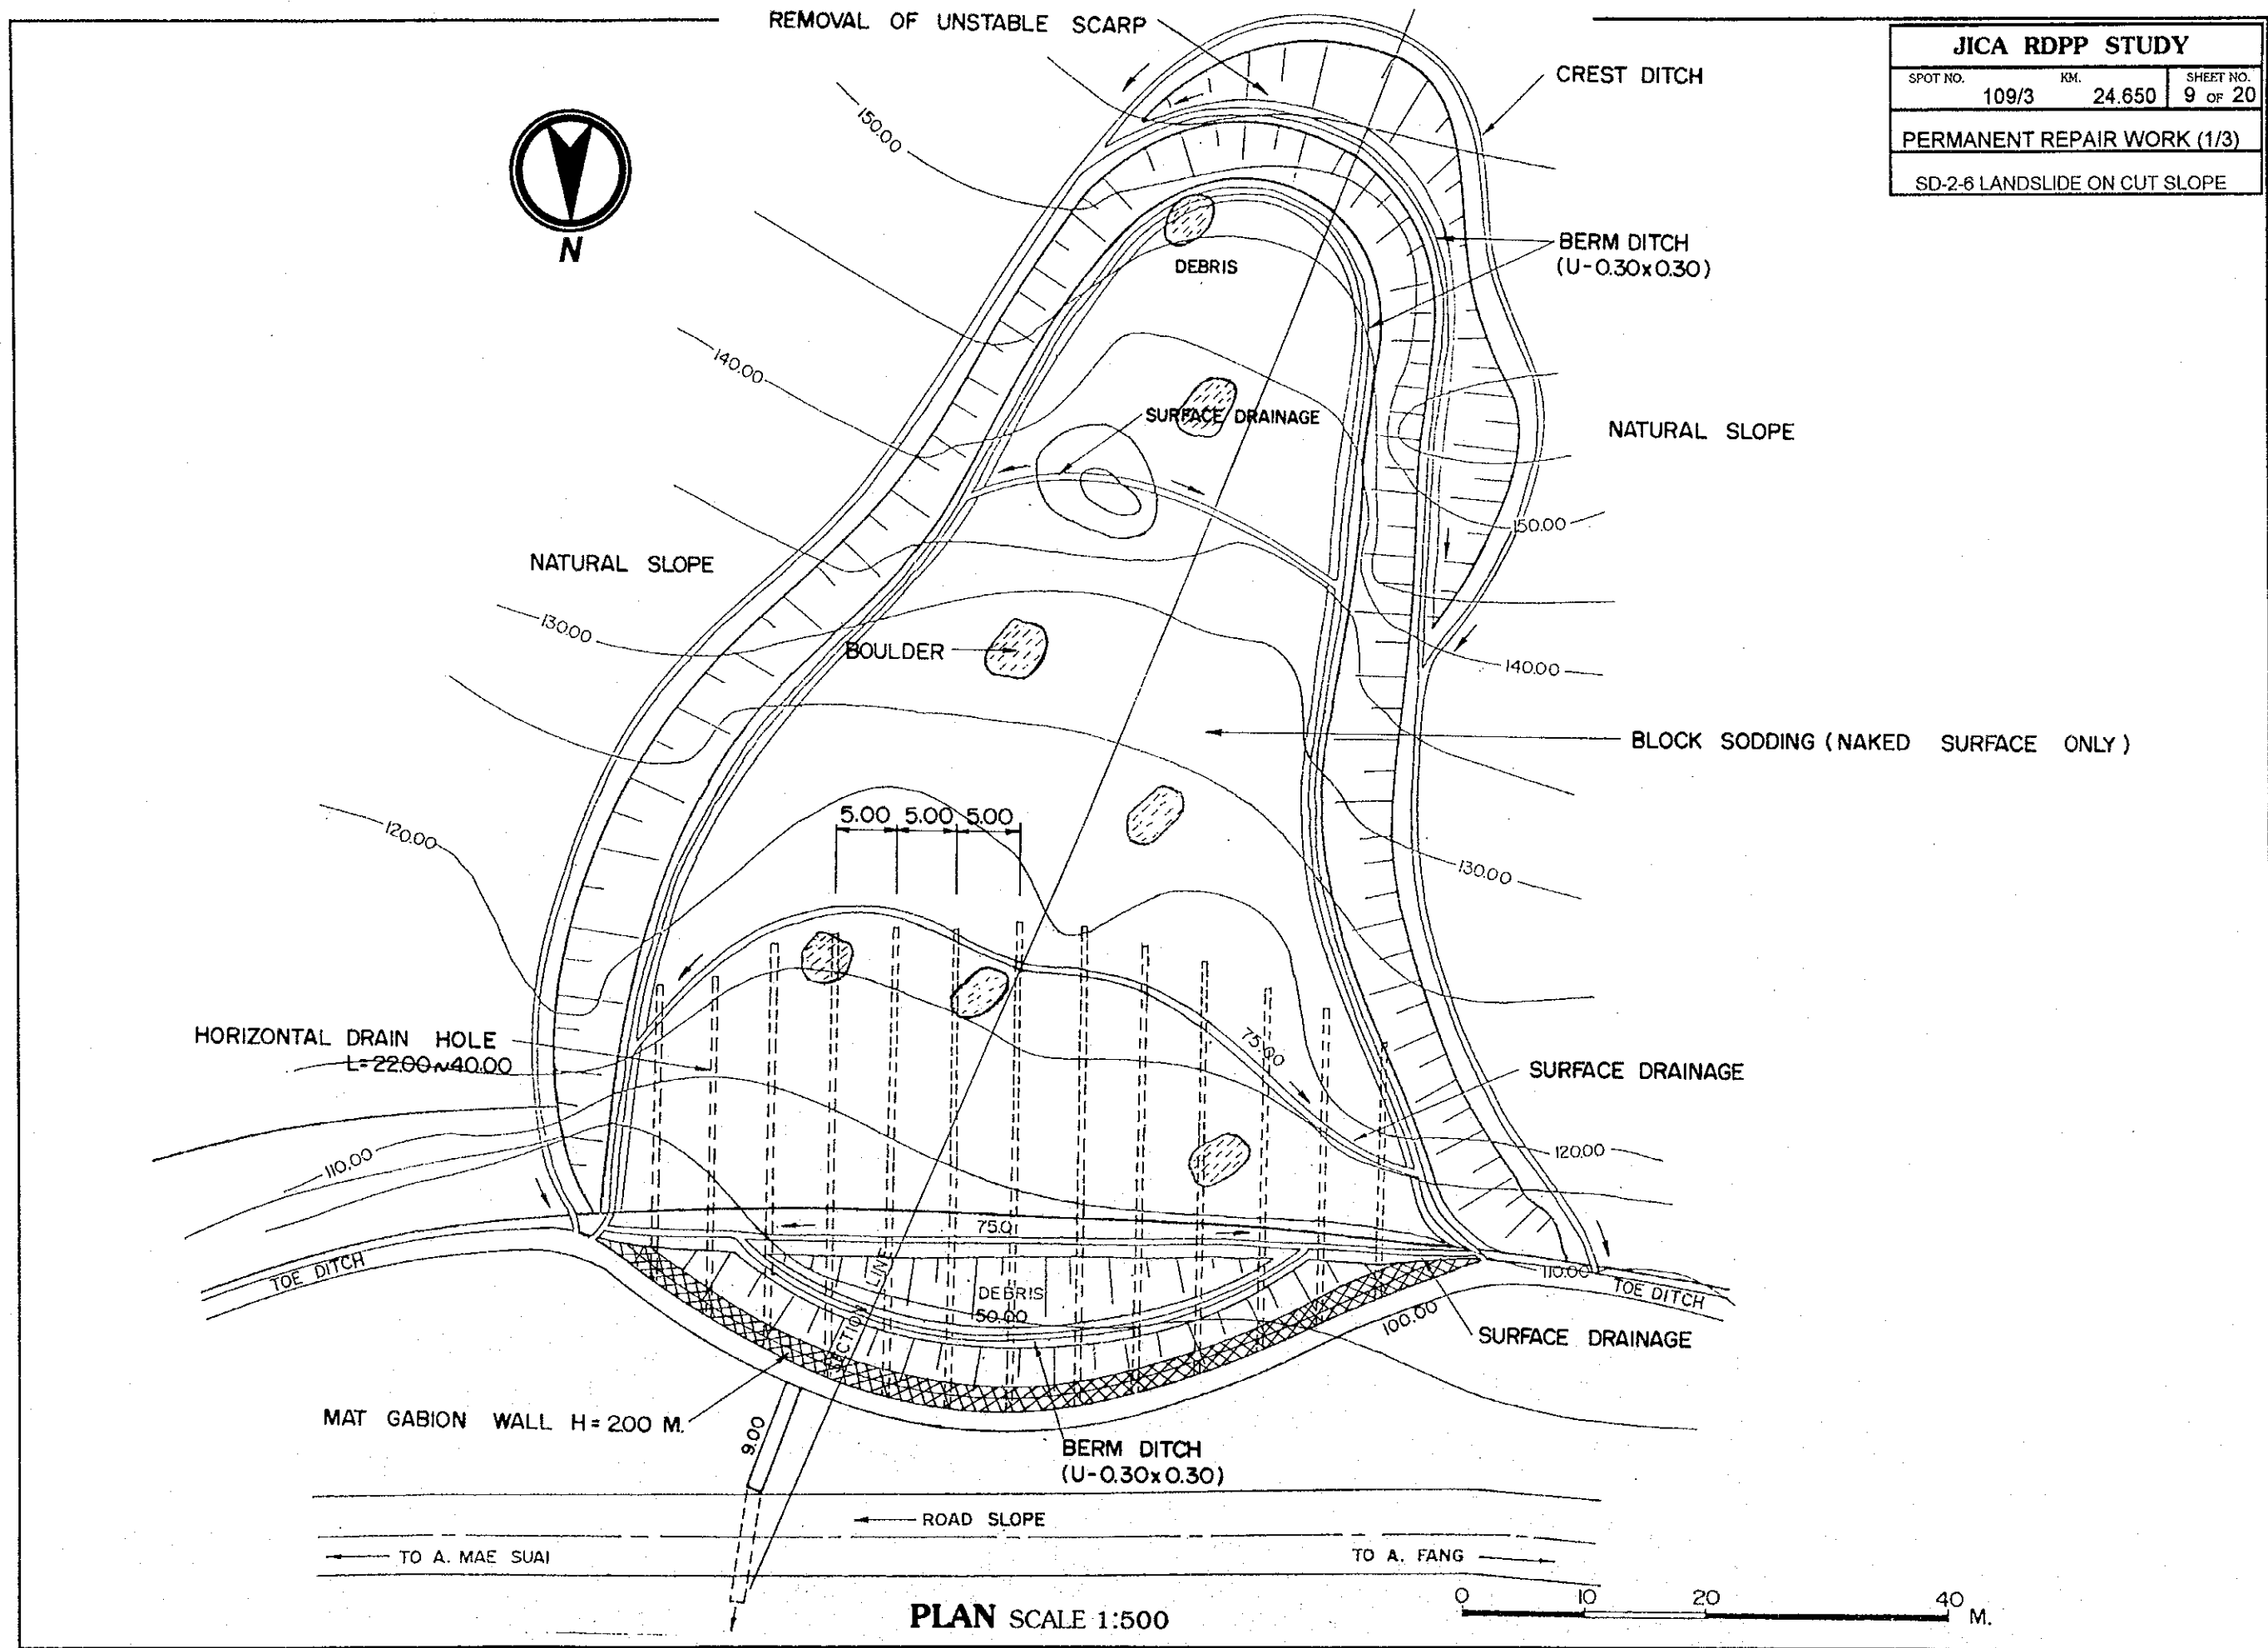
JICA RDPP STUDY		
SPOT NO.	KM.	SHEET NO.
109/3	24.650	9 OF 20
PERMANENT REPAIR WORK (1/3)		
SD-2-6 LANDSLIDE ON CUT SLOPE

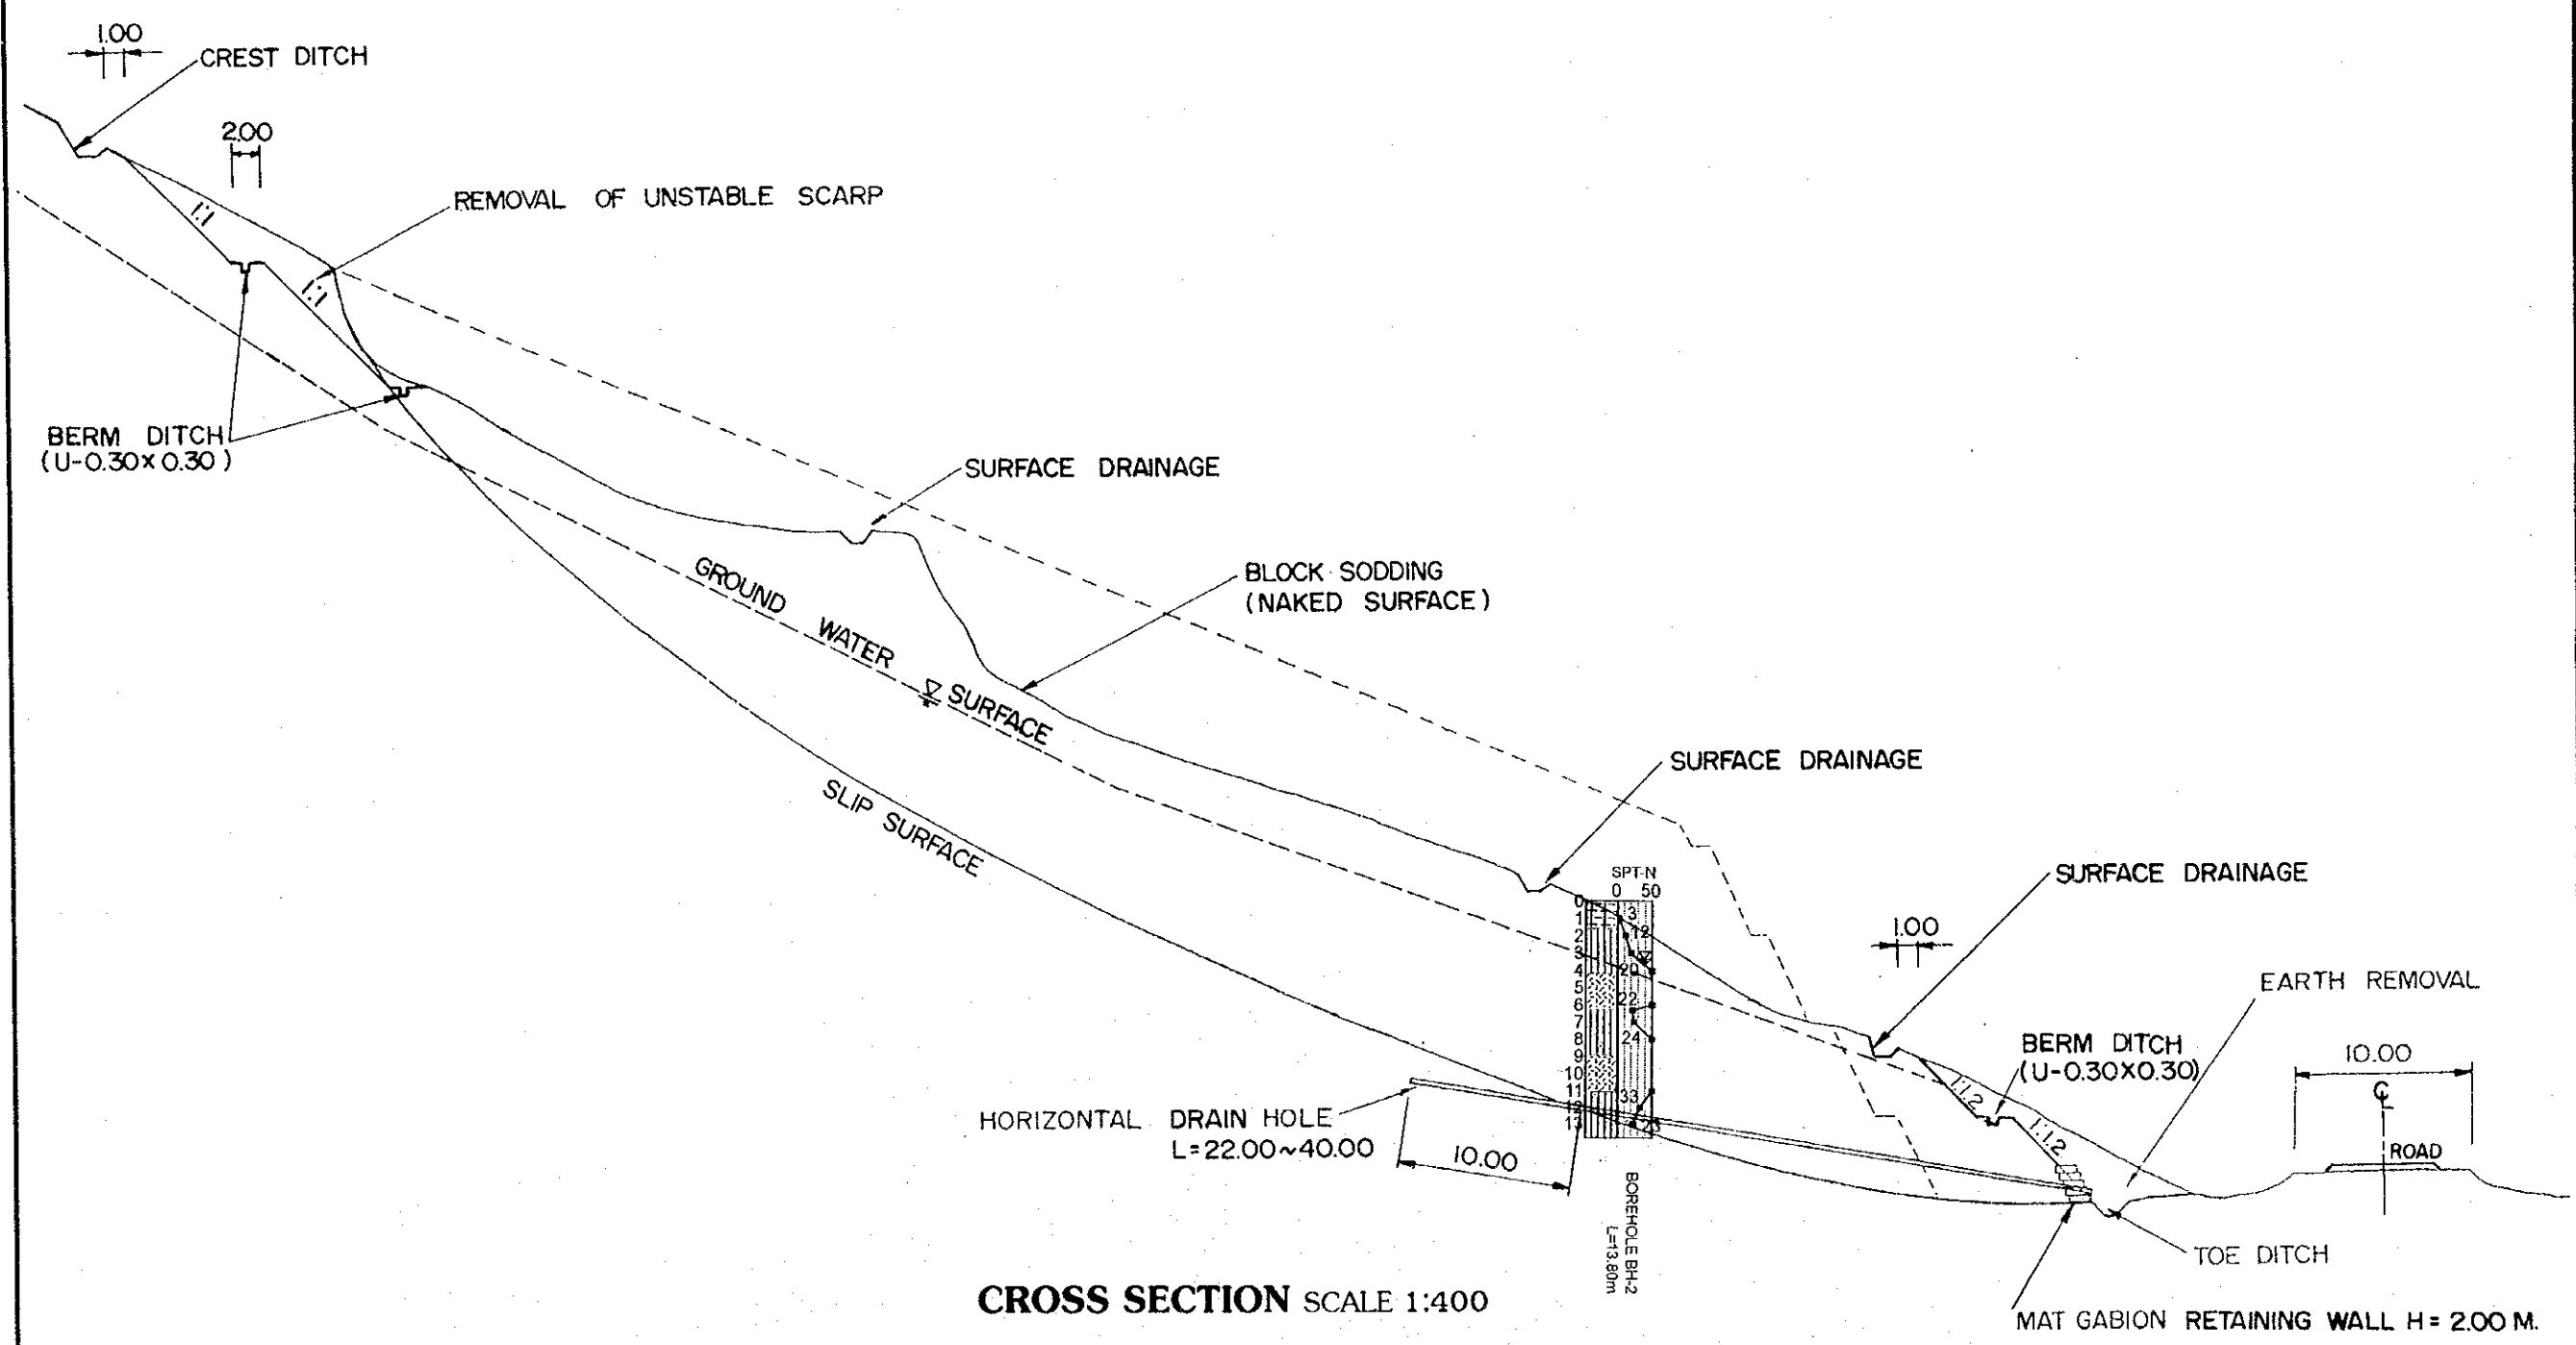
JICA RDPP STUDY		
SPOT NO.	KM.	SHEET NO.
109/3	24.650	10 OF 20
PERMANENT REPAIR WORK (2/3)		
SD-2-6 LANDSLIDE ON CUT SLOPE

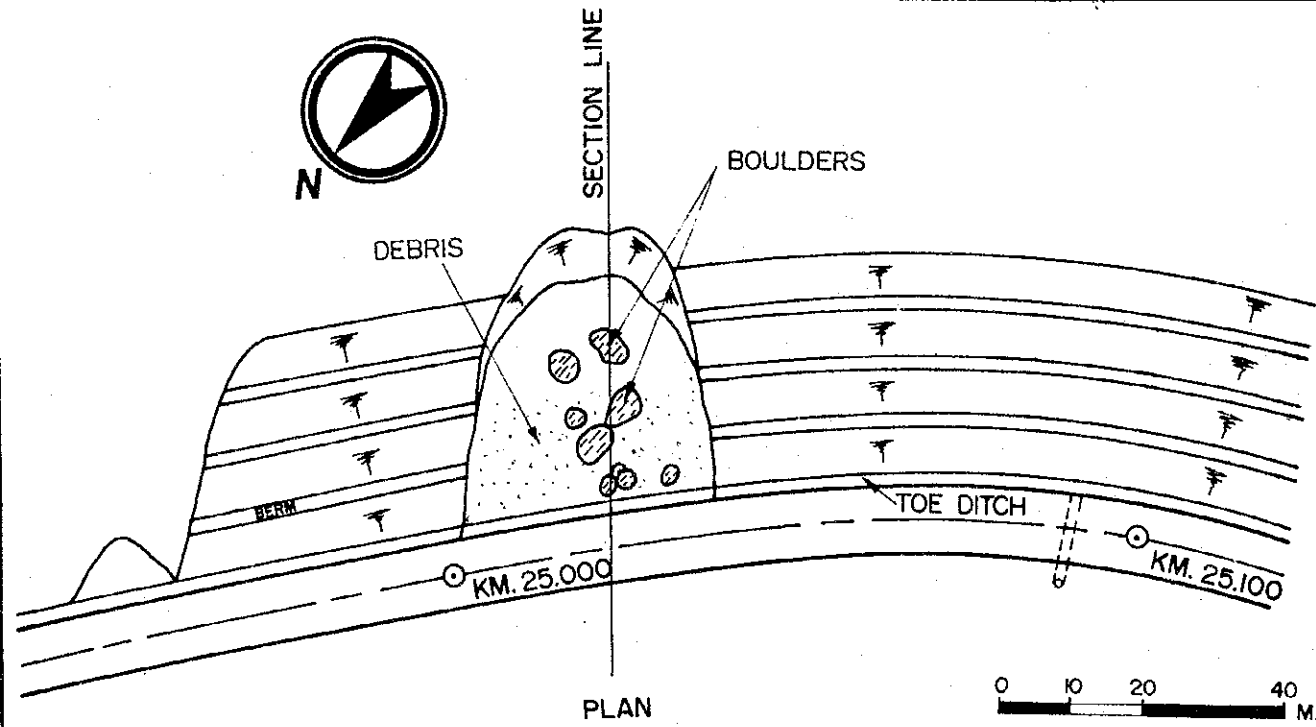
SPOT NO.	KM.	SHEET NO.
109/C3	25.200	14 OF 20

SD-2-6 LANDSLIDE ON CUT SLOPE

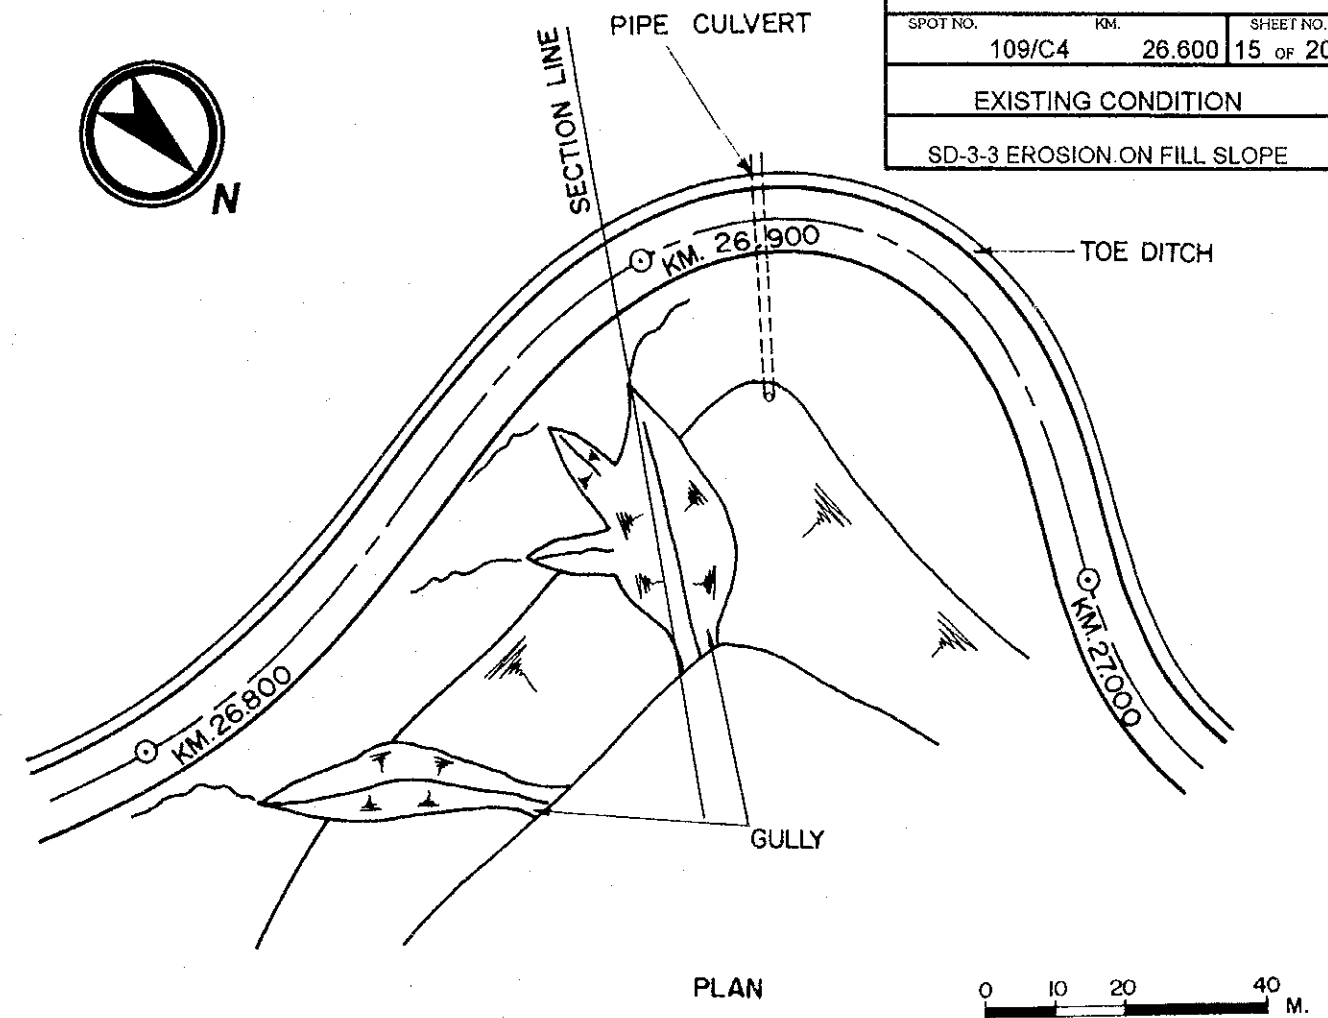
SPOT NO.	KM.	SHEET NO.
109/C4	26.600	15 OF 20

SD-3-3 EROSION ON FILL SLOPE

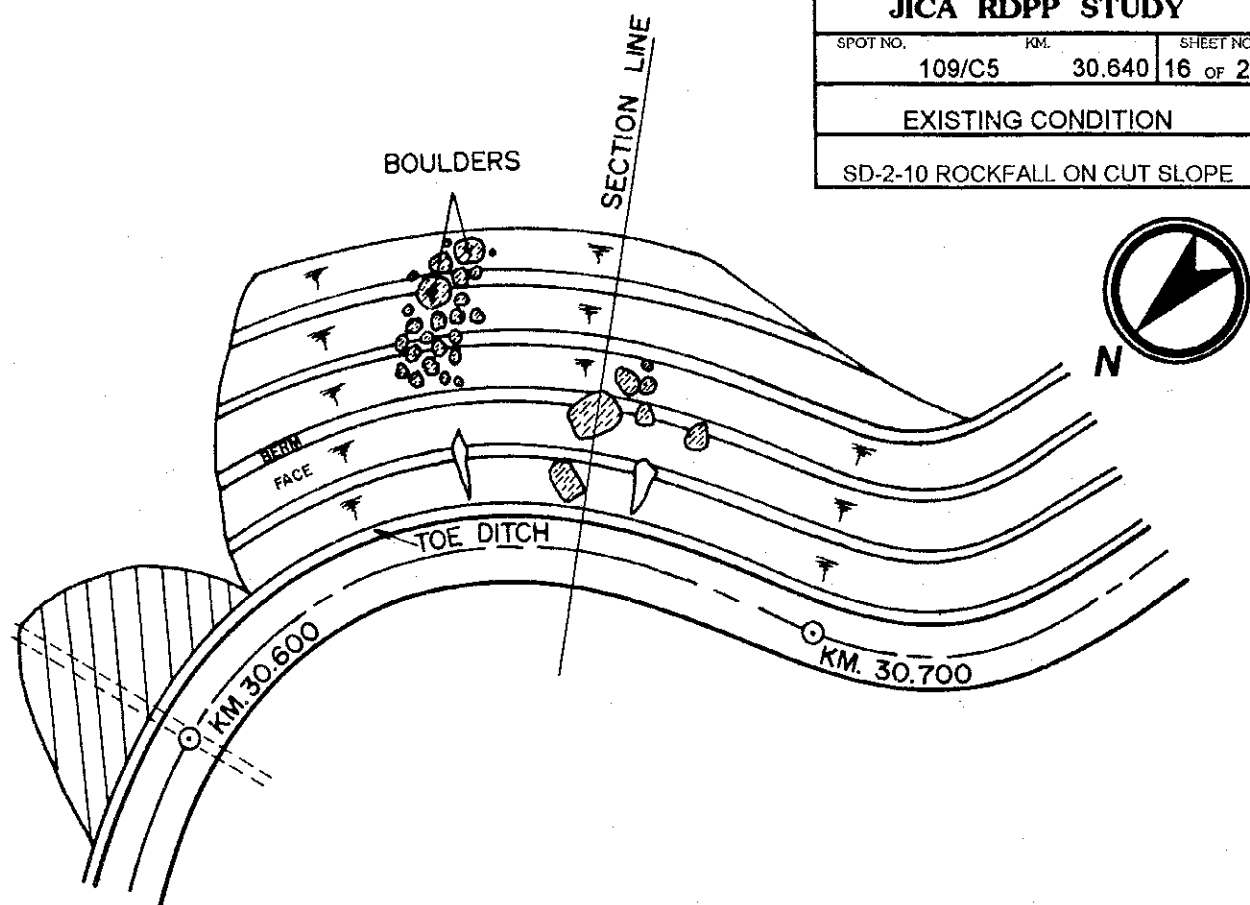
SPOT NO.	KM.	SHEET NO.
109/C5	30.640	16 OF 20

SD-2-10 ROCKFALL ON CUT SLOPE

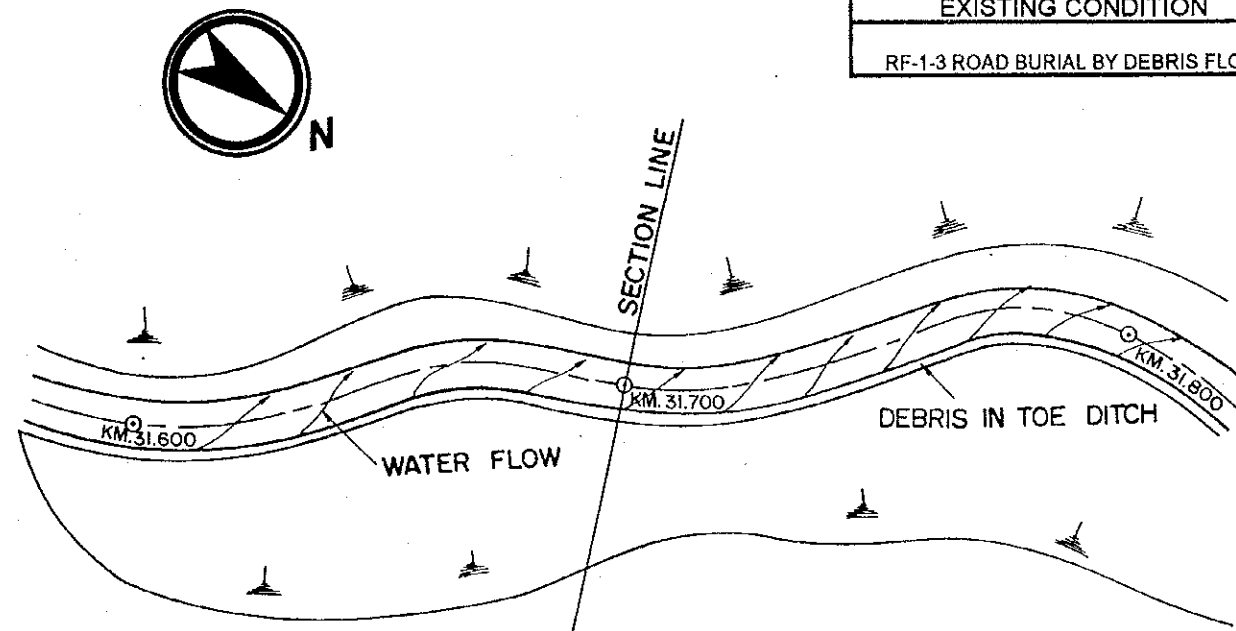
SPOT NO.	KM.	SHEET NO.
109/C6	31.620	17 OF 20

RF-1-3 ROAD BURIAL BY DEBRIS FLOW

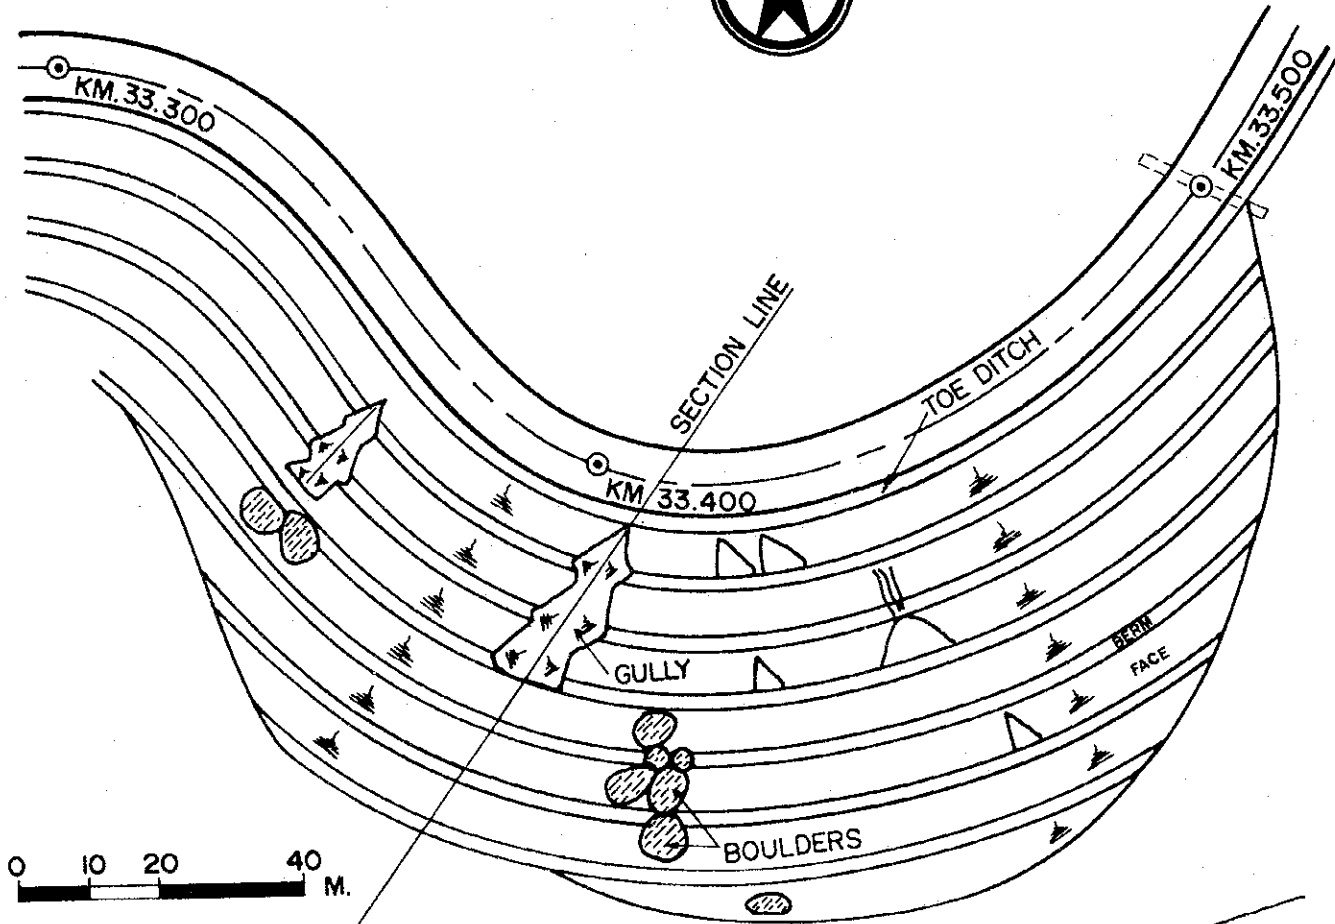
SPOT NO.	KM.	SHEET NO.
109/C7	33.420	18 OF 20

SD-2-10 ROCKFALL ON CUT SLOPE

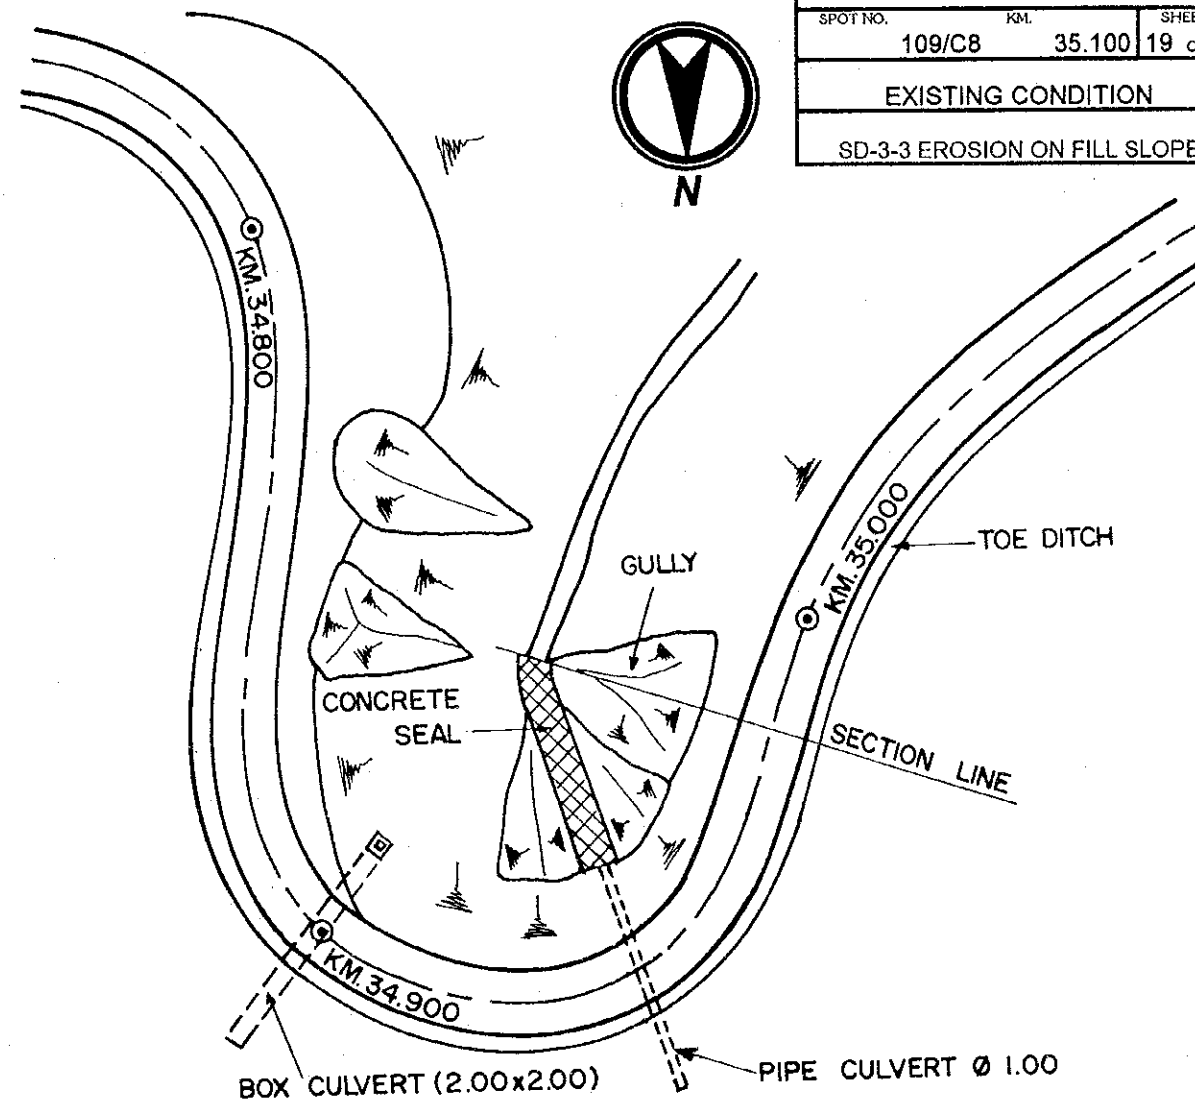
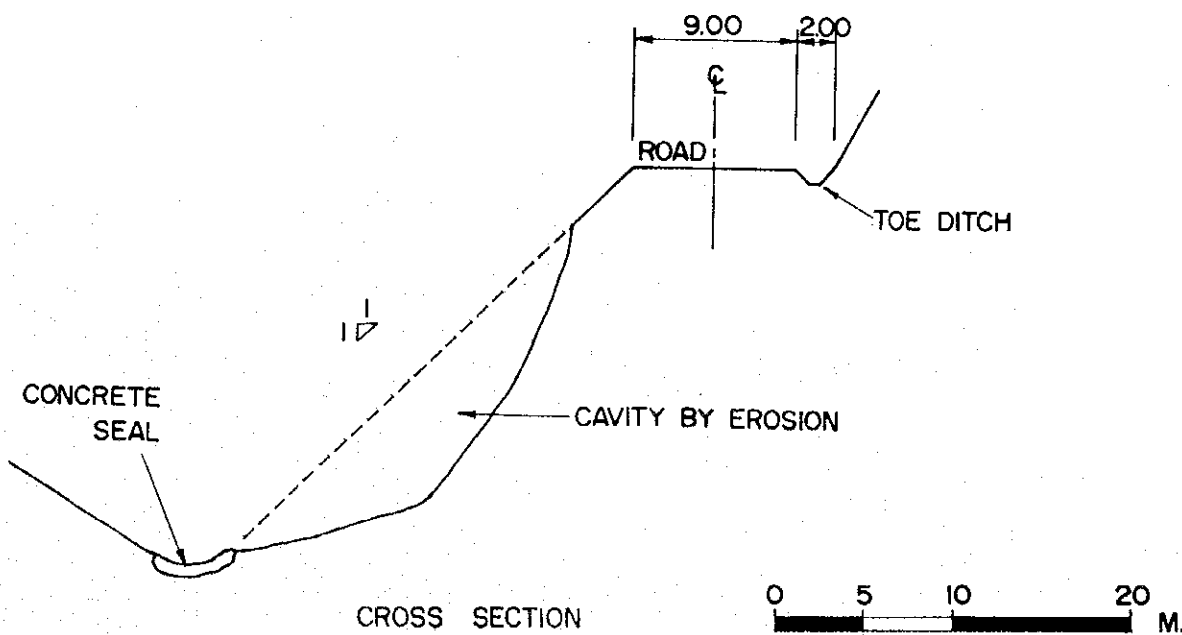
SPOT NO.	KM.	SHEET NO.
109/C8	35.100	19 OF 20

SD-3-3 EROSION ON FILL SLOPE

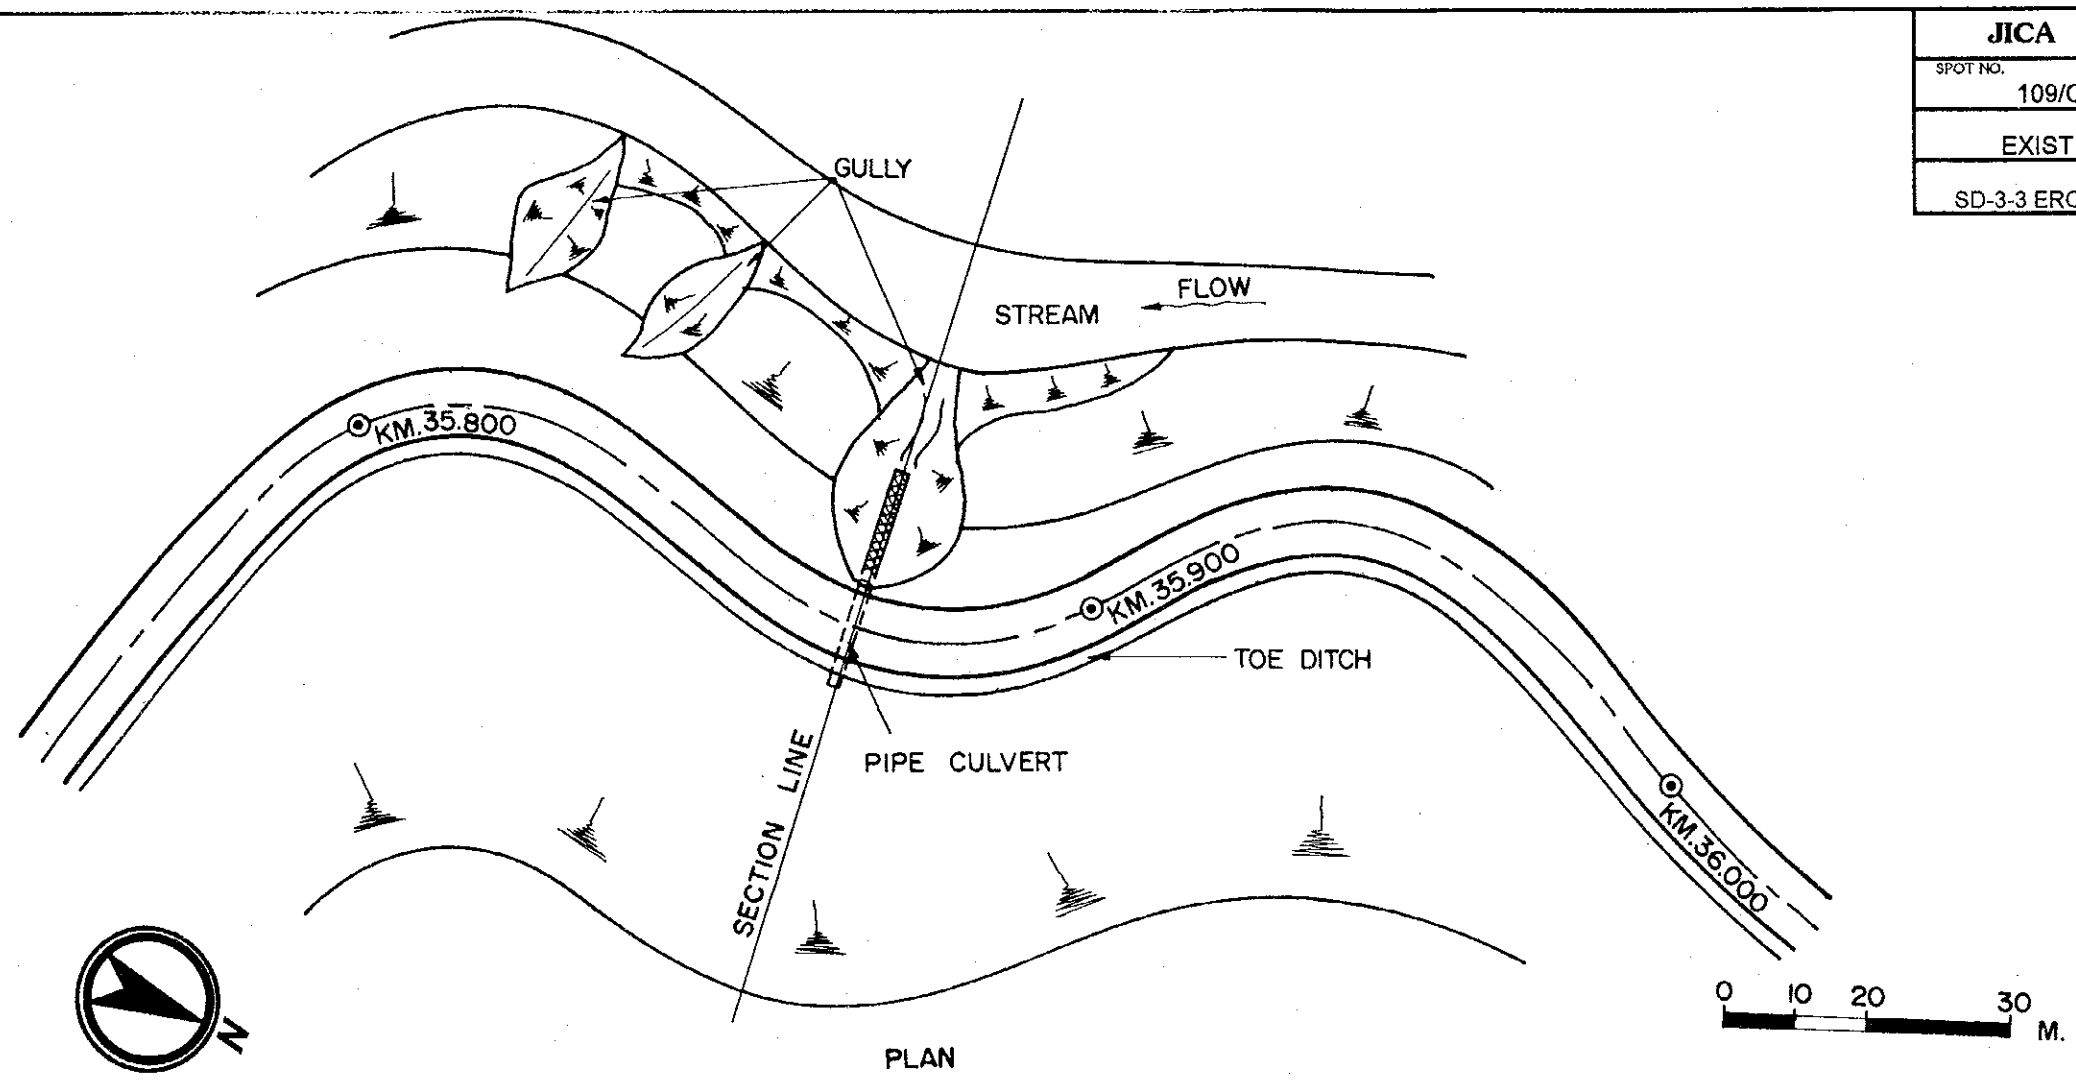
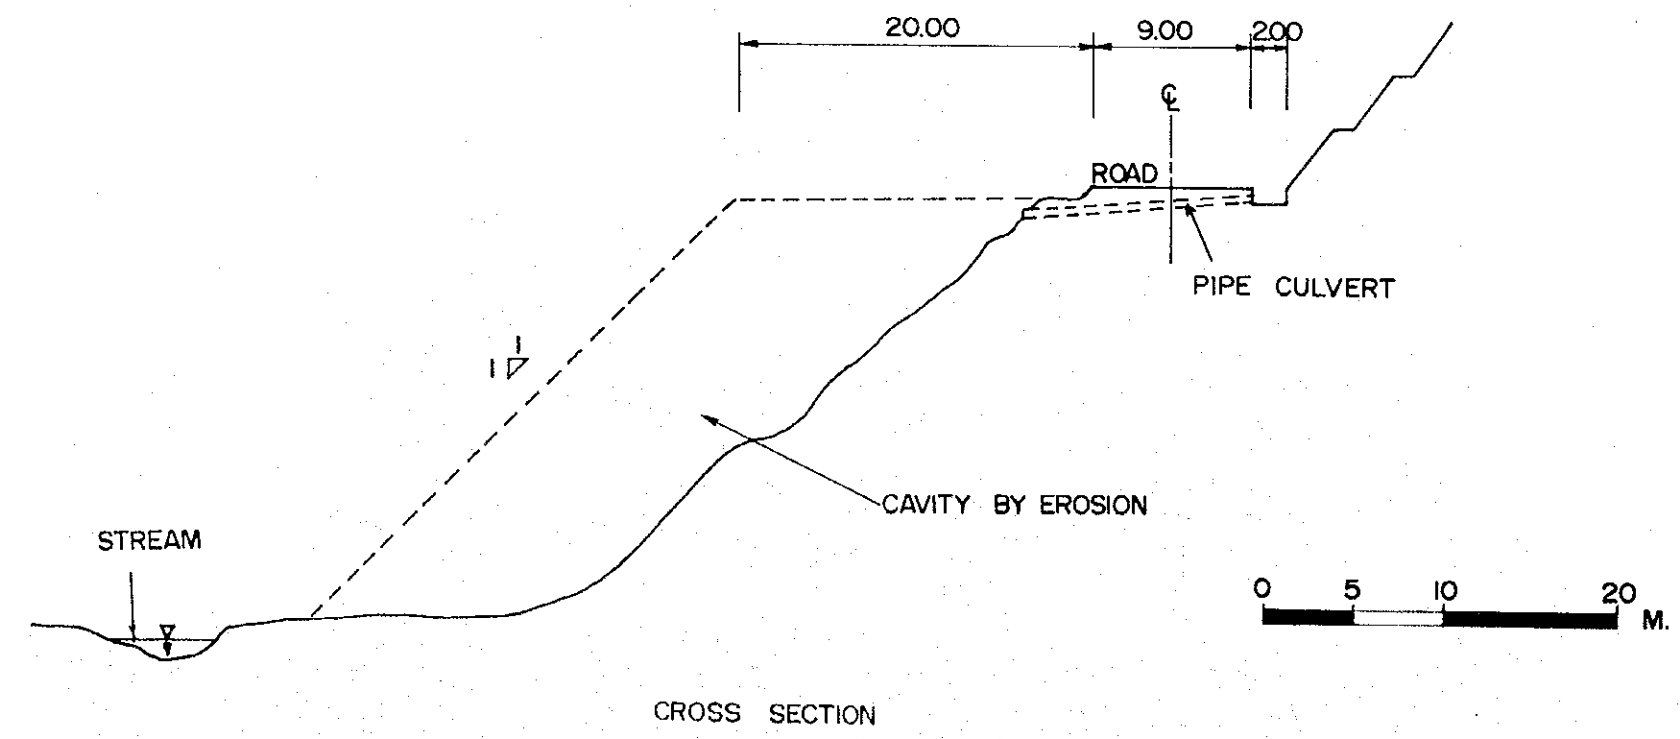
JICA RDPP STUDY		
SPOT NO.	KM.	SHEET NO.
109/C9	35.900	20 OF 20
EXISTING CONDITION		
SD-3-3 EROSION ON FILL SLOPE

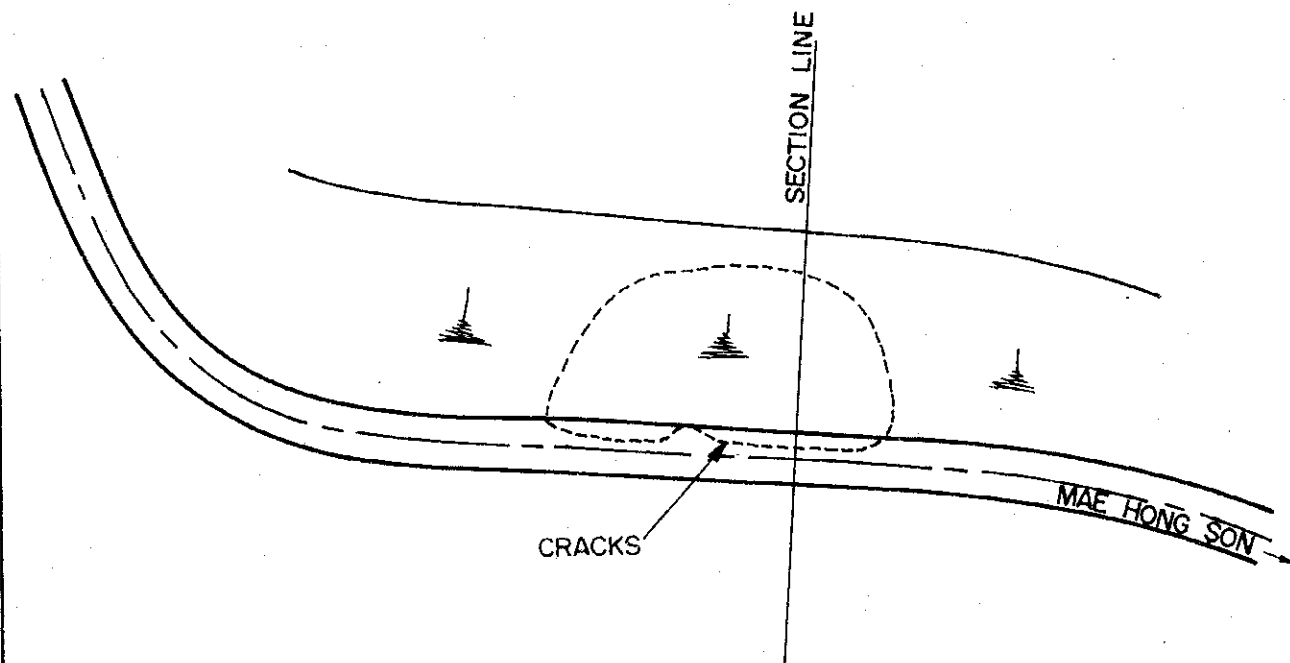
SPOT NO.	KM.	SHEET NO.
1095/C1	154.250	9 OF 49

SD-3-6 LANDSLIDE ON FILL SLOPE

CRACKS
