The Study on Road Disaster Prevention Plan in The Kingdom of Thailand

FINAL REPORT DRAWINGS

VOLUME 3

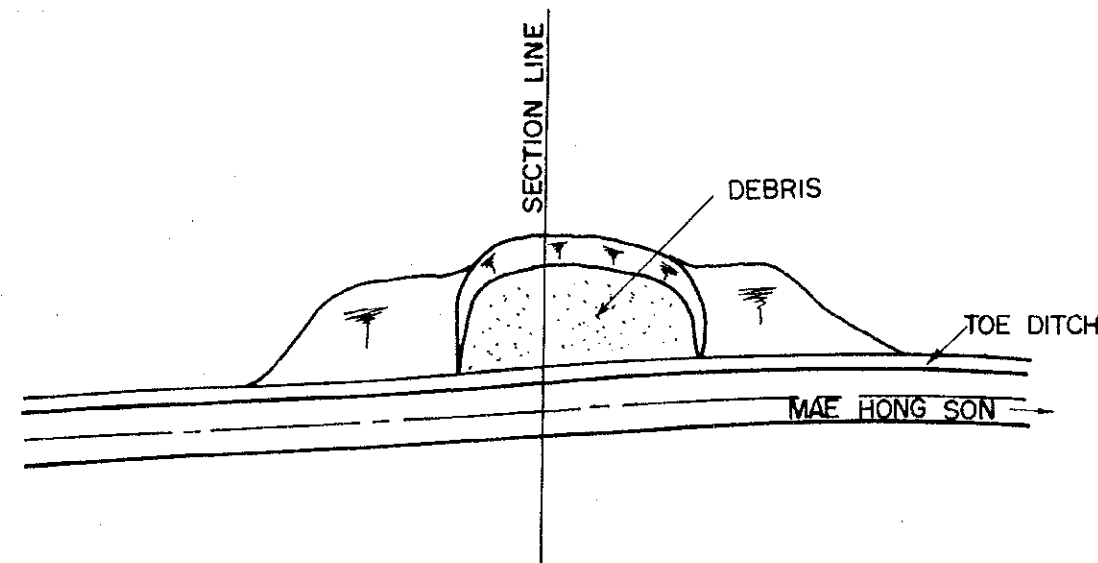
SPOT NO.	KM.	SHEET NO.
1095/C2	156.050	10 OF 49

SD-2-6 LANDSLIDE ON CUT SLOPE

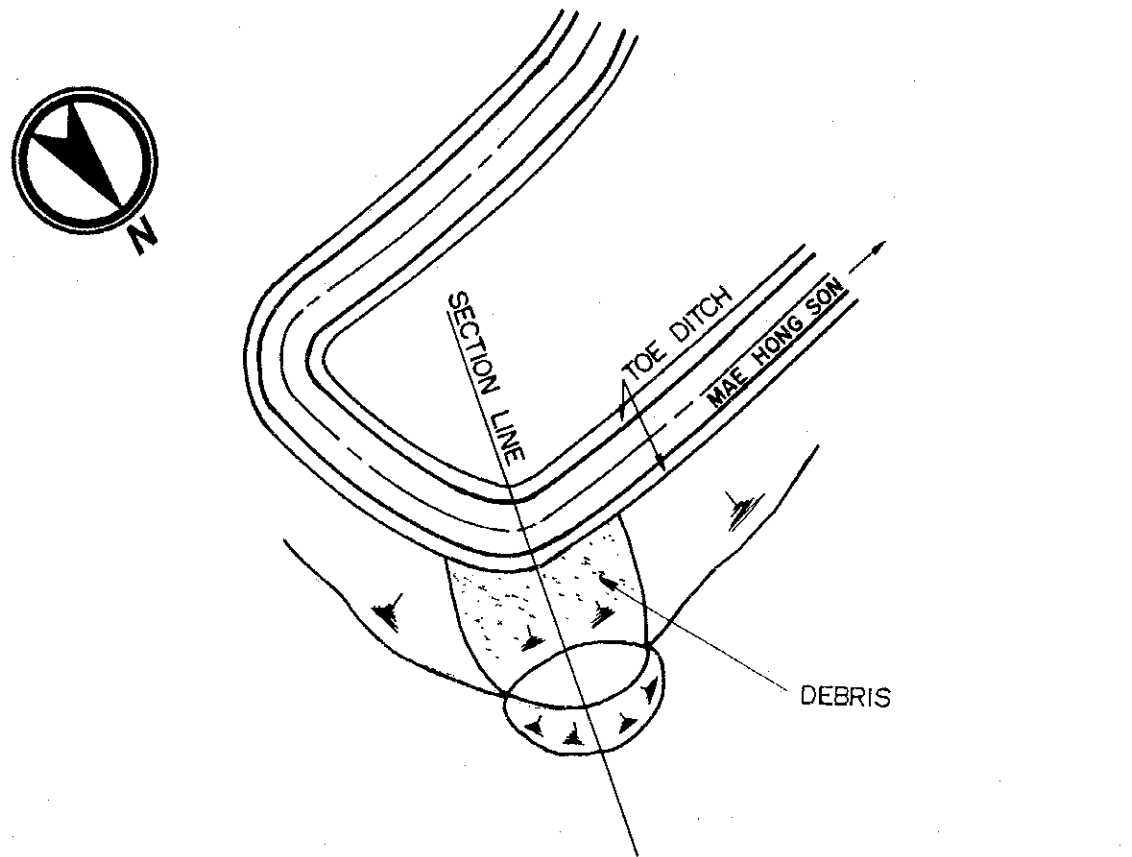
JICA RDPP STUDY		
SPOT NO.	KM.	SHEET NO.
1095/C5	157.500	13 OF 49
EXISTING CONDITION		
SD-2-6 LANDSLIDE ON CUT SLOPE

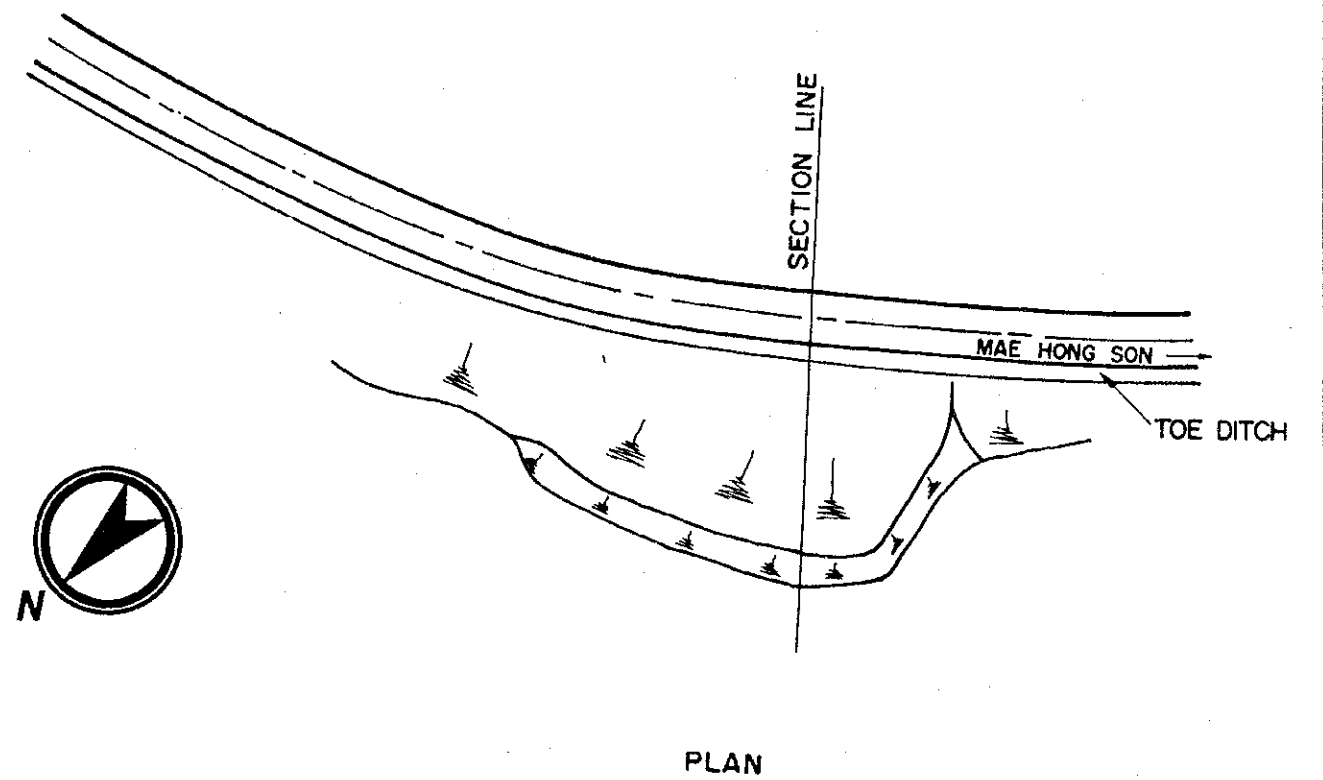
JICA RDPP STUDY		
SPOT NO.	KM.	SHEET NO.
1095/C6	157.700	14 OF 49
EXISTING CONDITION		
SD-2-8 LANDSLIDE ON CUT SLOPE

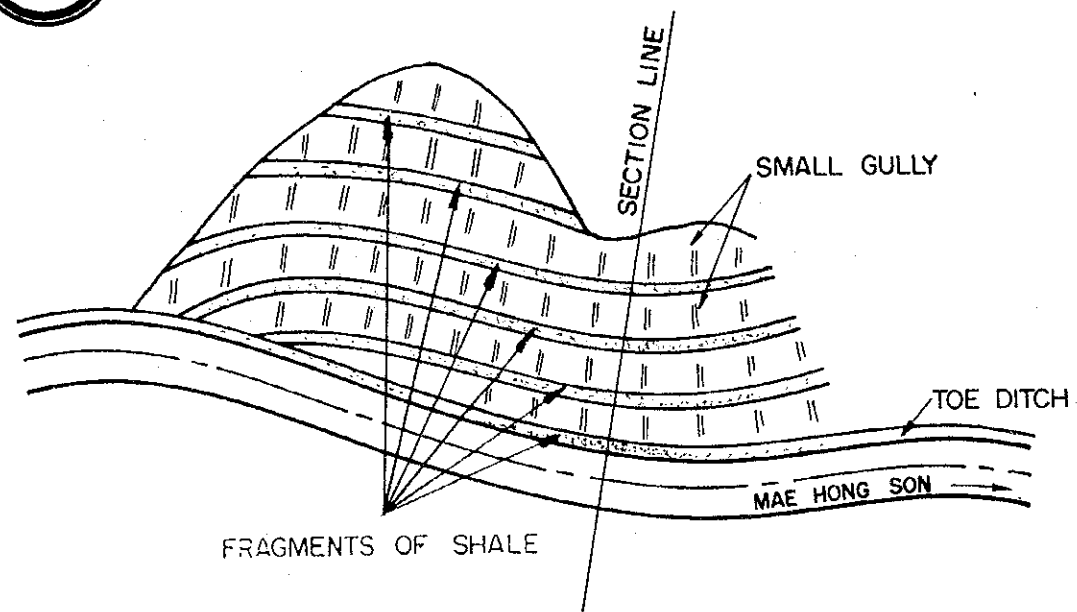
SPOT NO.	KM.	SHEET NO.
1095/C7	157.900	15 OF 49

SD-2-3 EROSION ON CUT SLOPE

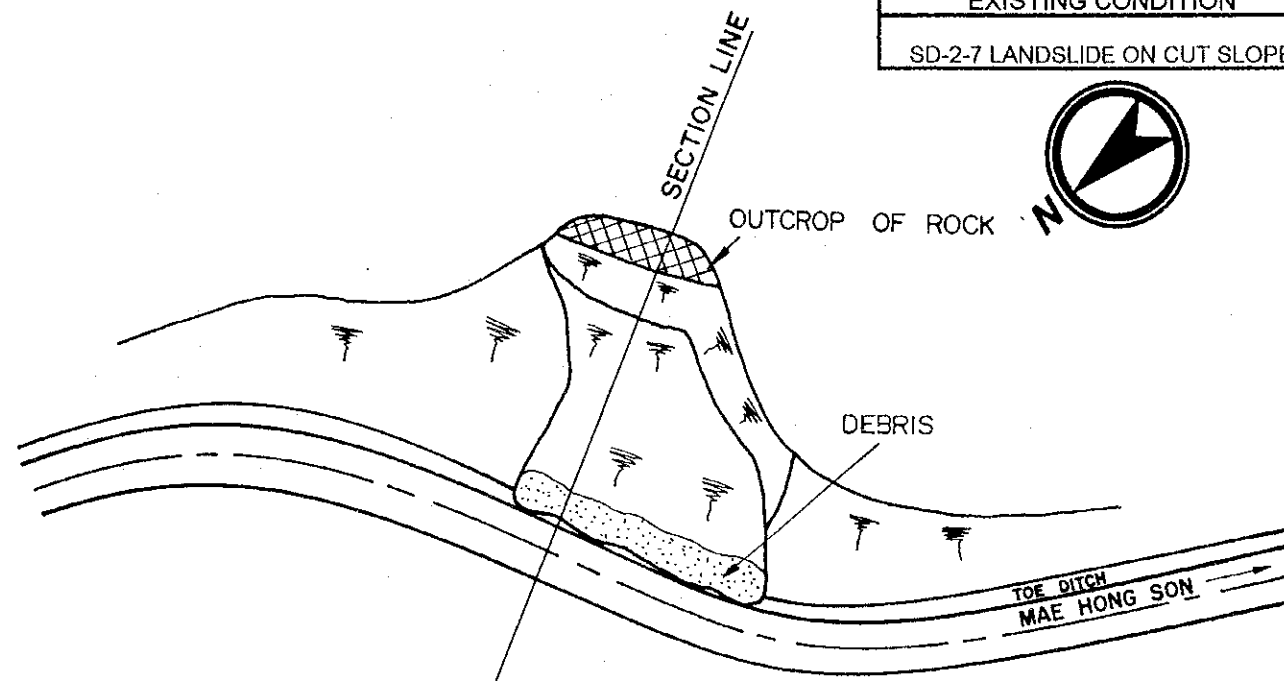
SPOT NO.	KM.	SHEET NO.
1095/C8	158.800	16 OF 49

SD-2-7 LANDSLIDE ON CUT SLOPE

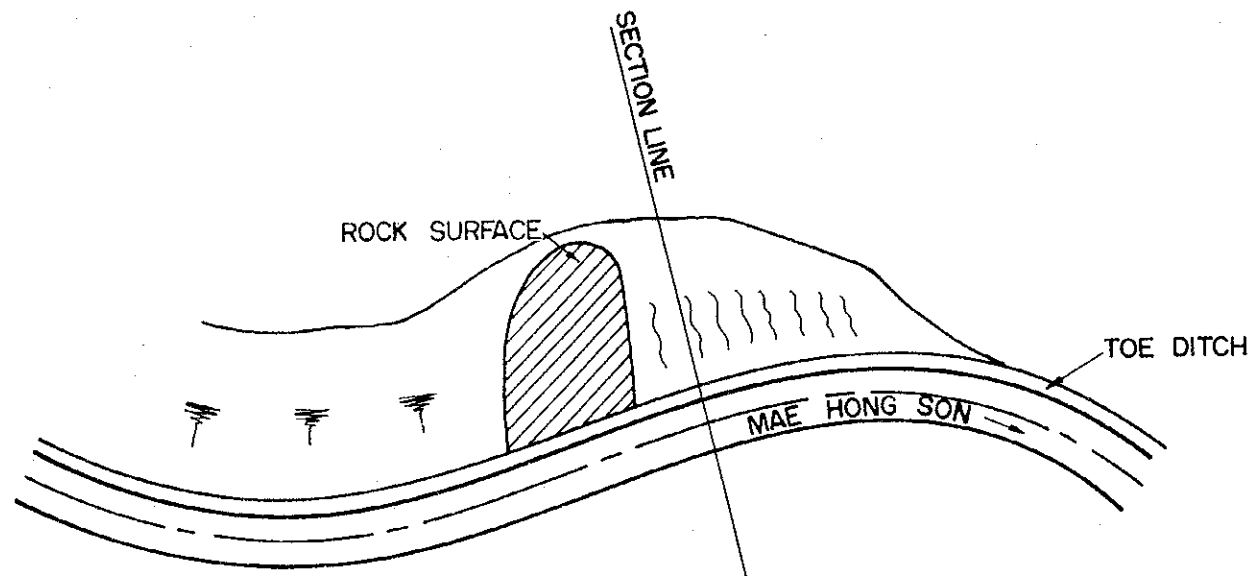
SPOT NO.	KM.	SHEET NO.
1095/C9	159.000	17 OF 49

SD-2-2 EROSION ON CUT SLOPE

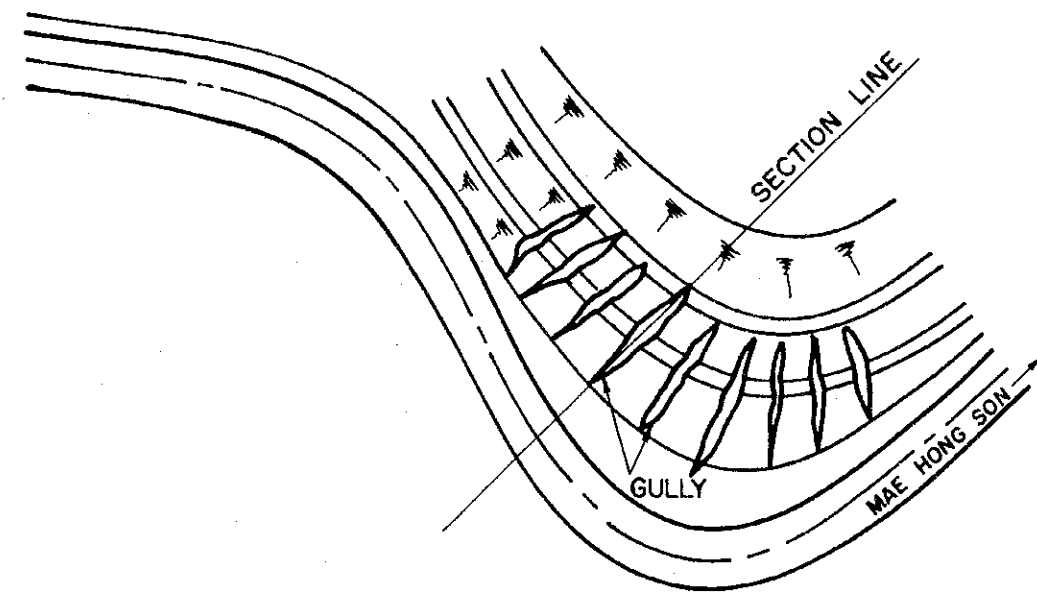
SPOT NO.	KM.	SHEET NO.
1095/C10	159.450	18 OF 49

SD-2-3 EROSION ON CUT SLOPE

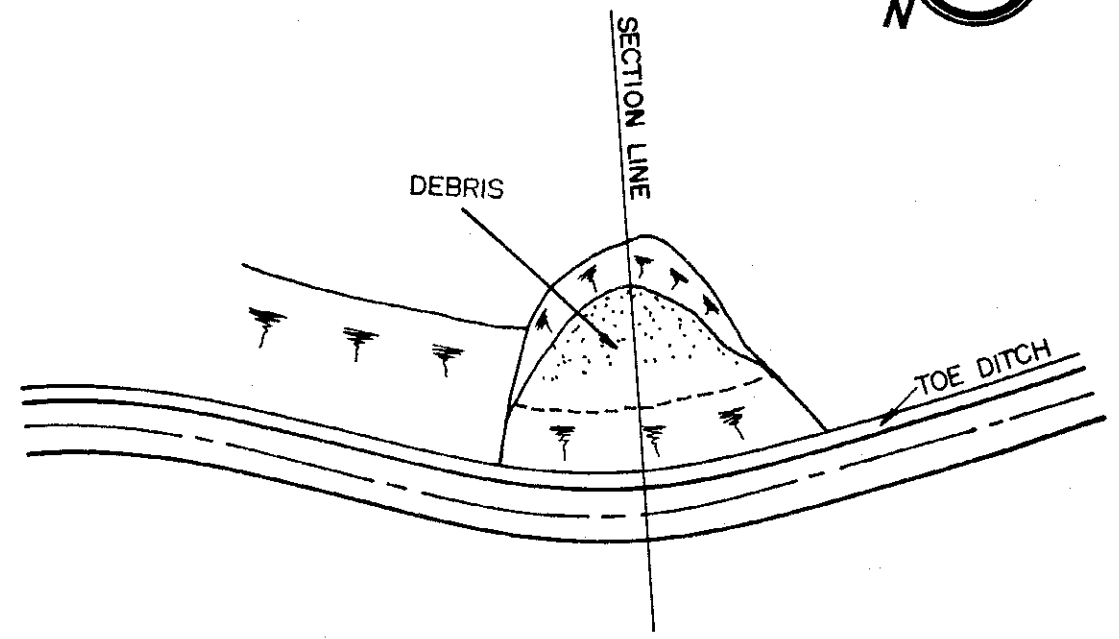
JICA RDPP STUDY		
SPOT NO.	KM.	SHEET NO.
1095/C11	159.900	19 OF 49
EXISTING CONDITION		
SD-2-6 LANDSLIDE ON CUT SLOPE

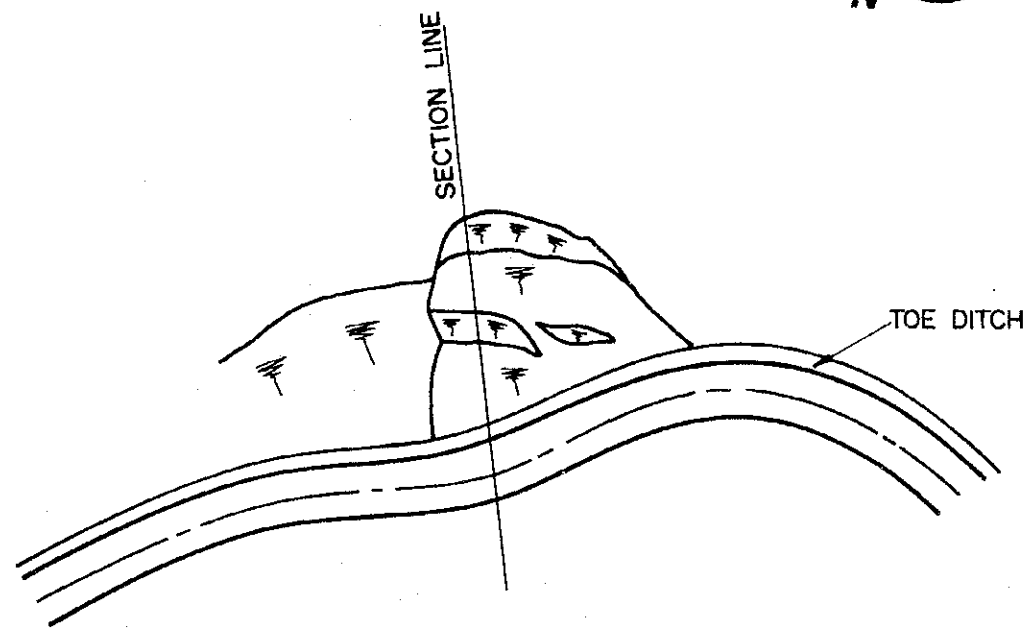
JICA RDPP STUDY		
SPOT NO.	KM.	SHEET NO.
1095/C12	160.000	20 OF 49
EXISTING CONDITION		
SD-2-7 LANDSLIDE ON CUT SLOPE

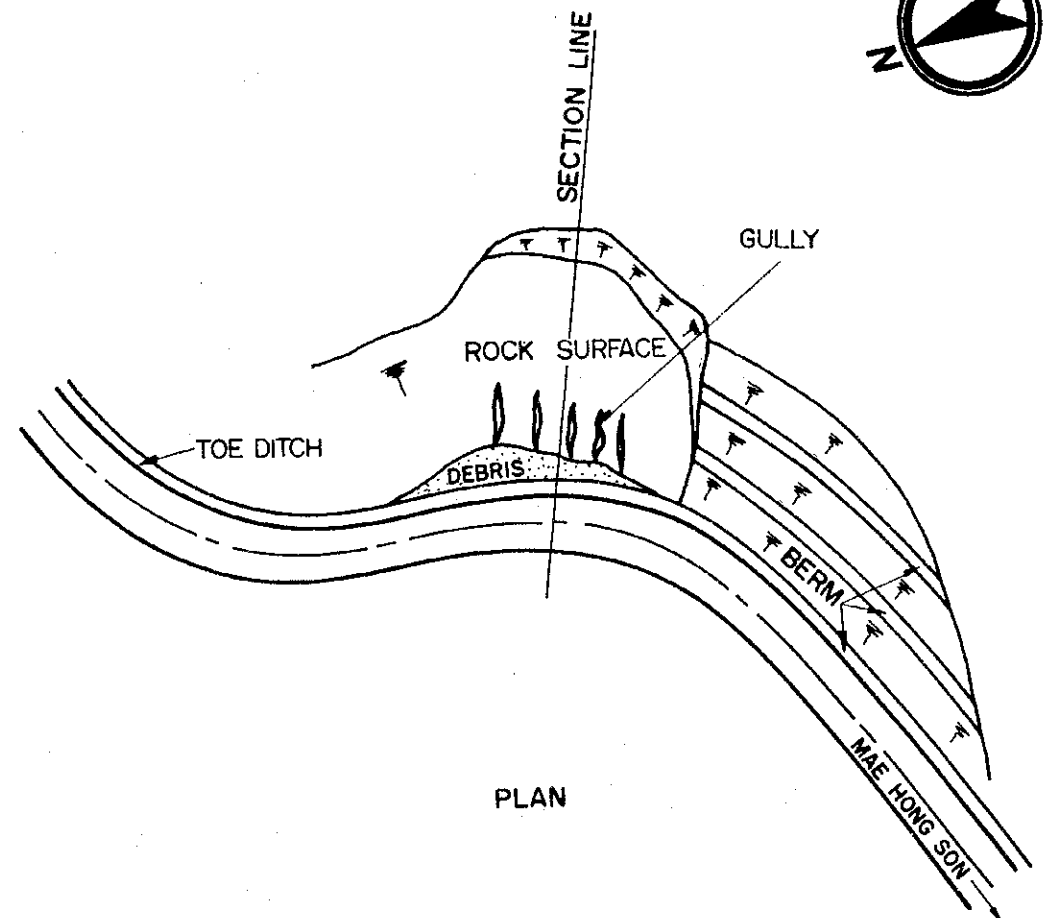
JICA RDPP STUDY		
SPOT NO.	KM.	SHEET NO.
1095/C16	160.850	24 OF 49
EXISTING CONDITION		
SD-2-7 LANDSLIDE ON CUT SLOPE

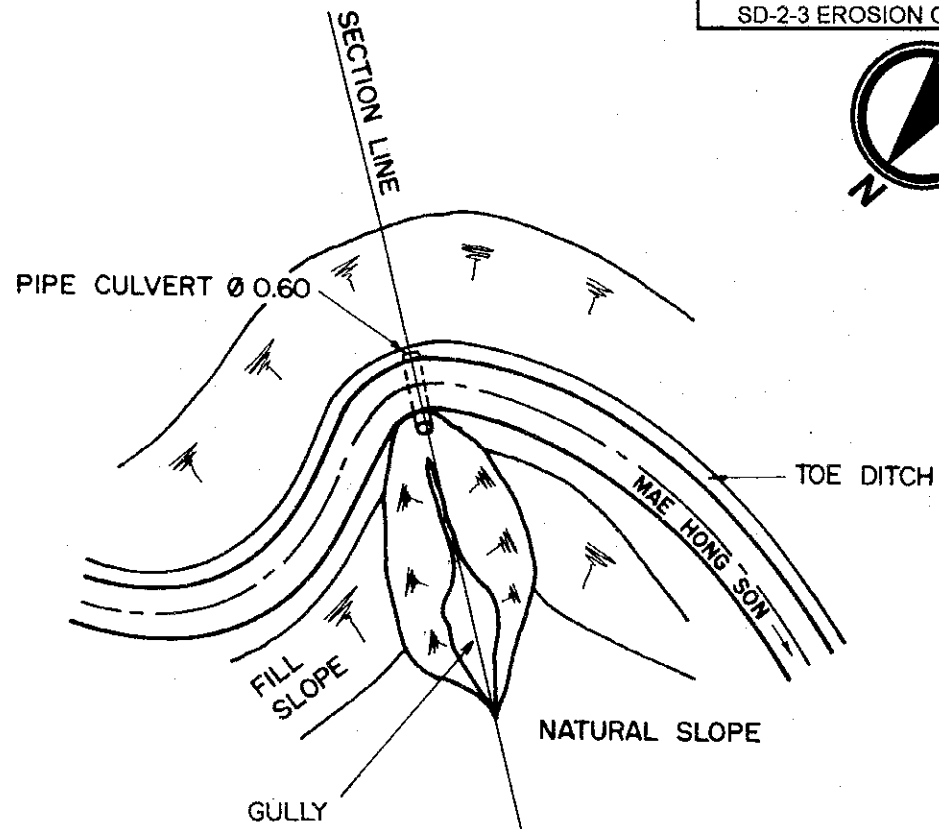
SPOT NO.	KM.	SHEET NO.
1095/C17	161.600	25 OF 49

SD-2-3 EROSION ON CUT SLOPE

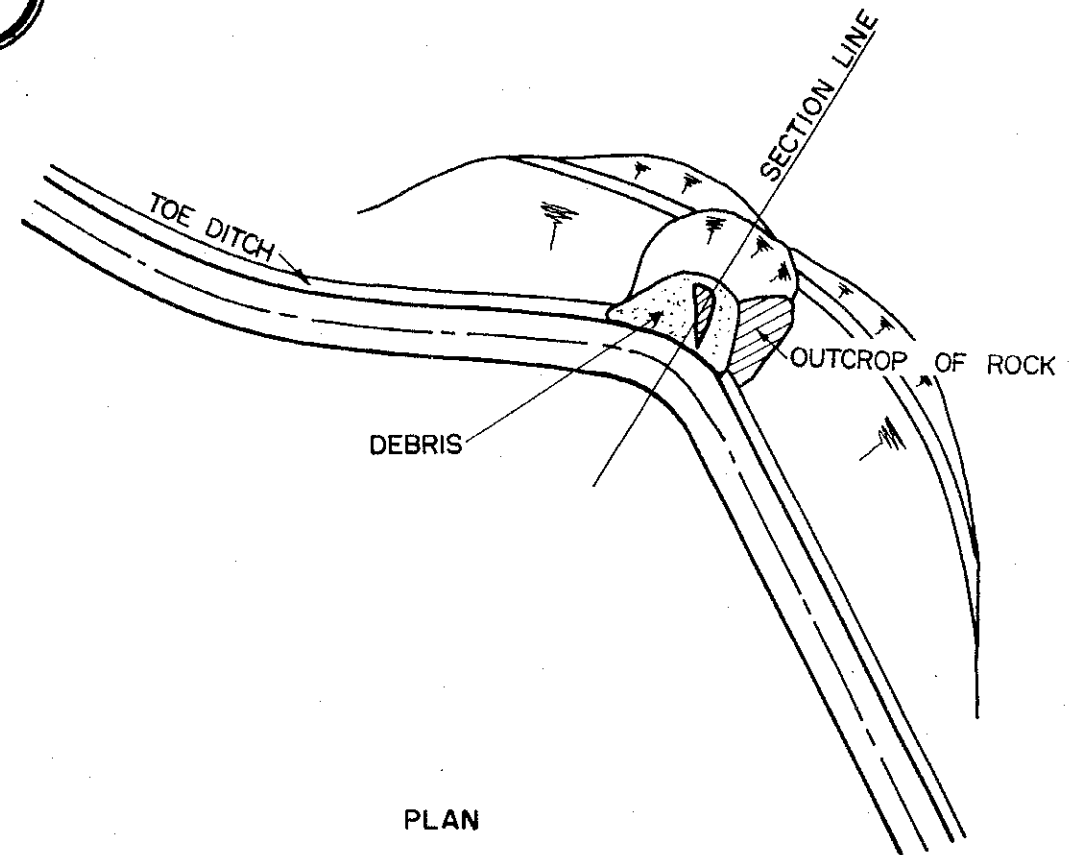
SPOT NO.	KM.	SHEET NO.
1095/C18	162.350	26 OF 49

SD-2-6 LANDSLIDE ON CUT SLOPE

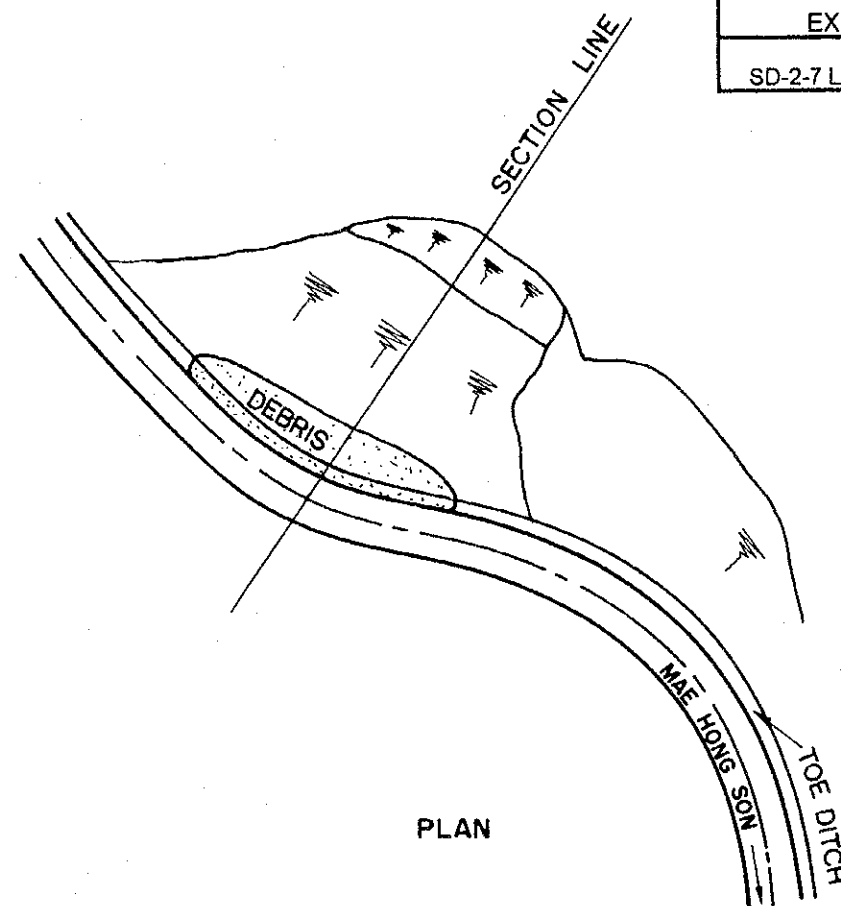
SPOT NO.	KM.	SHEET NO.
1095/C20	162.800	28 OF 49

SD-2-7 LANDSLIDE ON CUT SLOPE

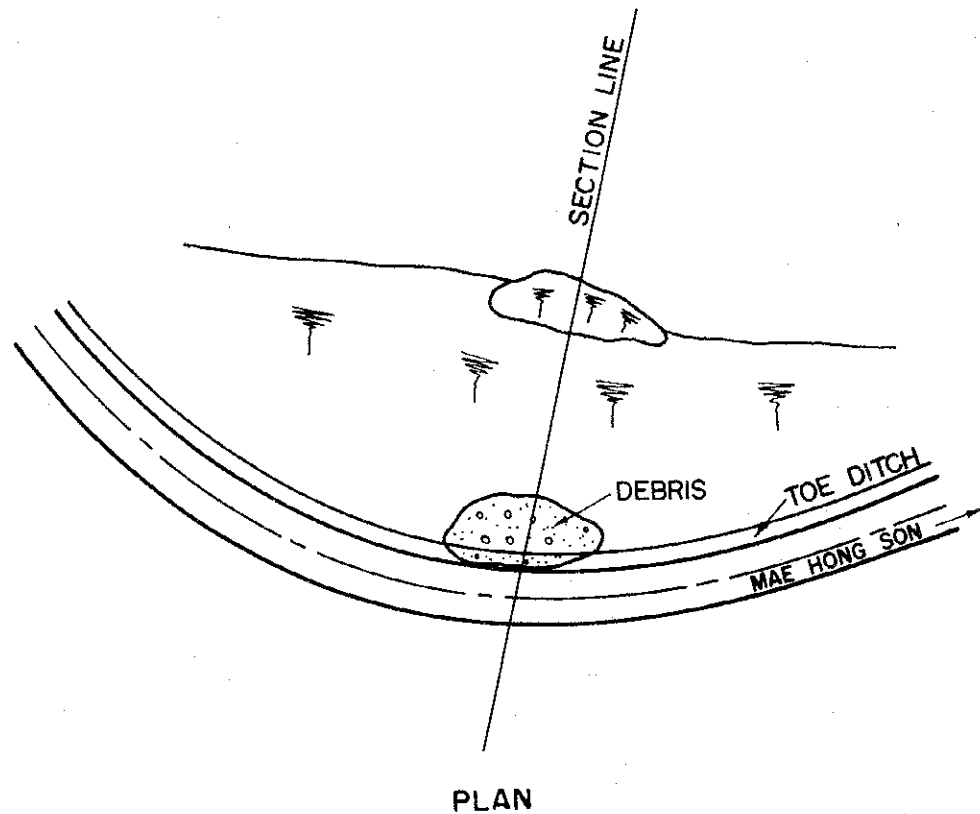
SPOT NO.	KM.	SHEET NO.
1095/C21	163.450	29 OF 49

SD-2-6 LANDSLIDE ON CUT SLOPE

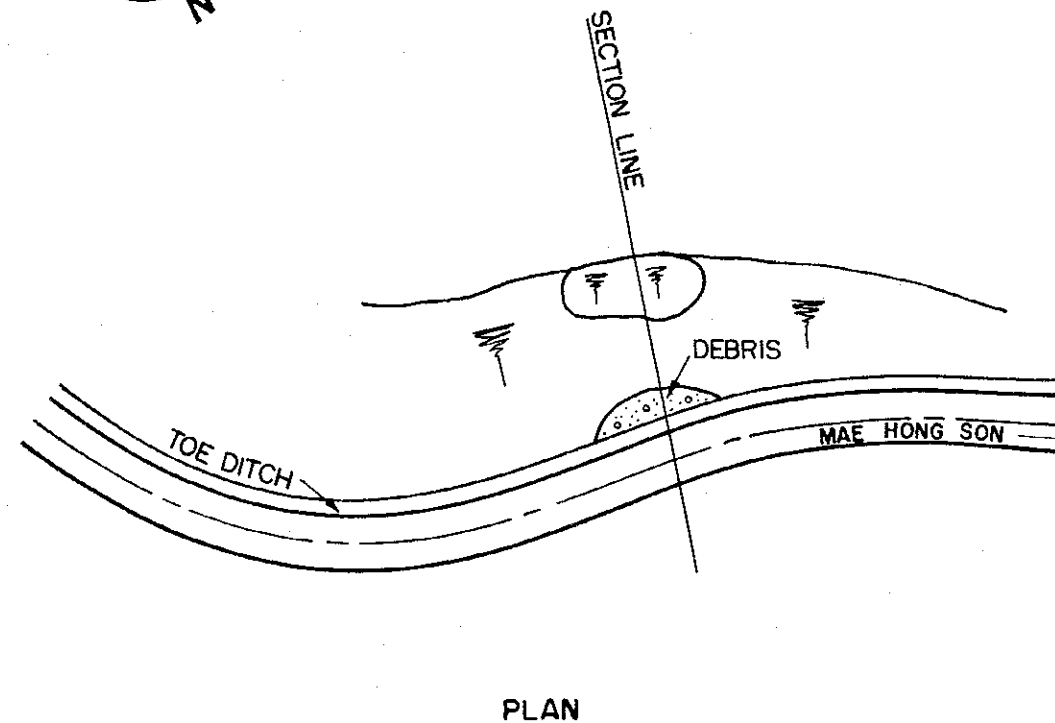
SPOT NO.	KM.	SHEET NO.
1095/C22	163.500	30 OF 49

SD-2-6 LANDSLIDE ON CUT SLOPE

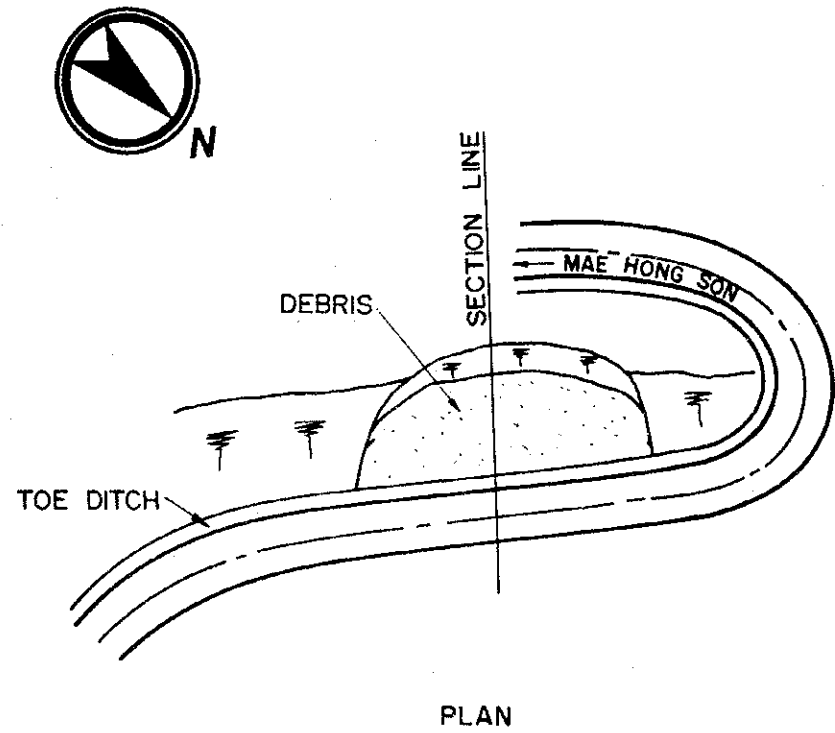
SPOT NO.	KM.	SHEET NO.
1095/C27	168.000	35 OF 49

SD-2-6 LANDSLIDE ON CUT SLOPE

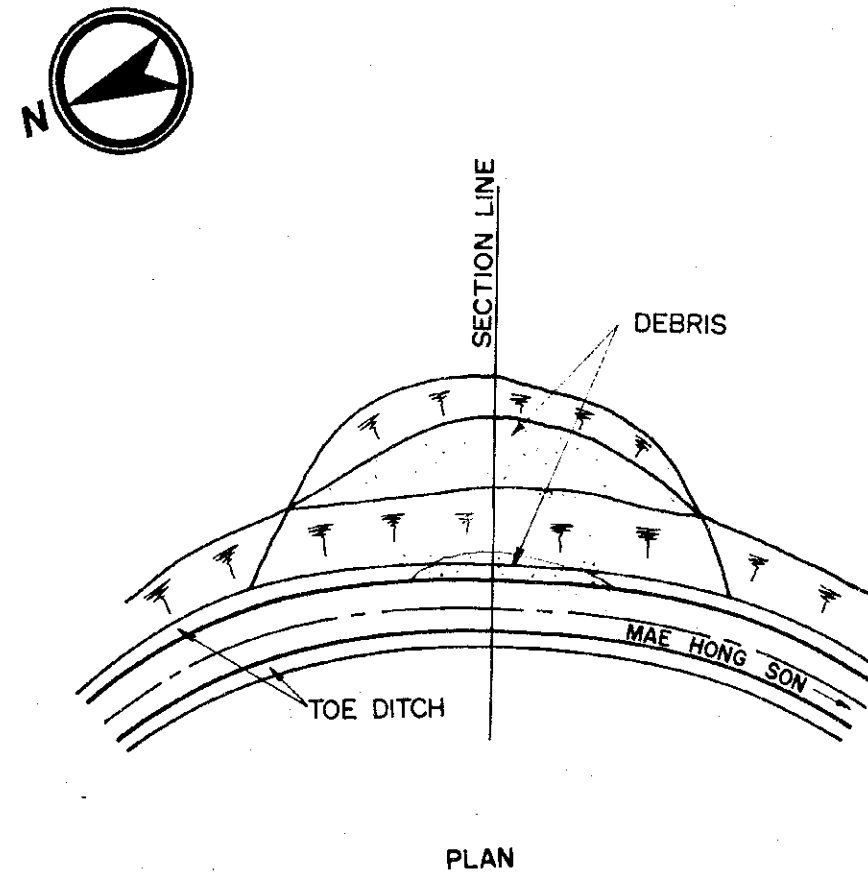
SPOT NO.	KM.	SHEET NO.
1095/C28	168.400	36 OF 49

SD-2-7 LANDSLIDE ON CUT SLOPE

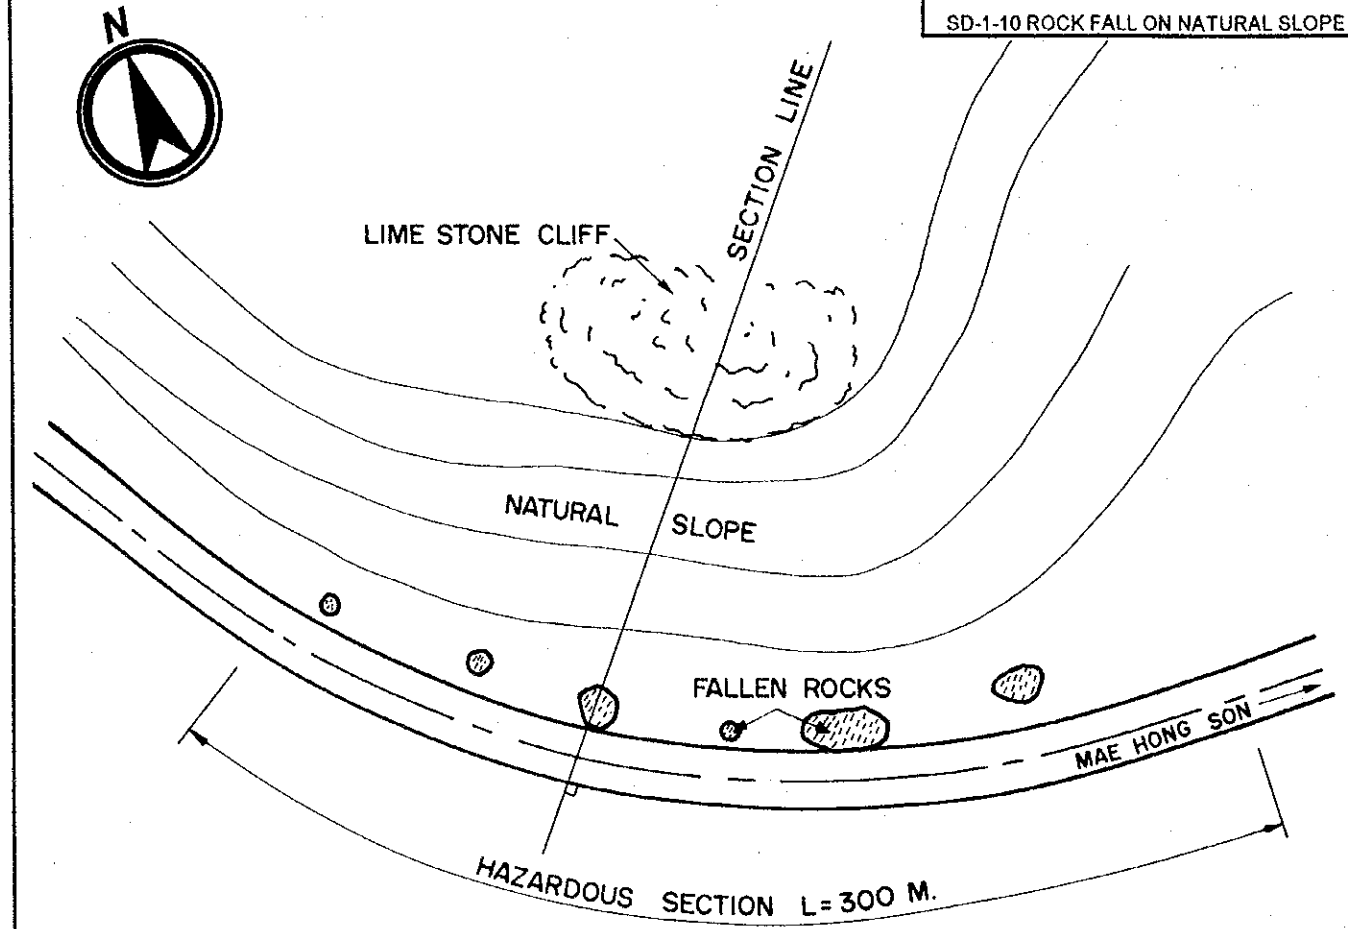
JICA RDPP STUDY		
SPOT NO.	KM.	SHEET NO.
1095/C31	170.000	39 OF 49
EXISTING CONDITION		
SD-1-10 ROCK FALL ON NATURAL SLOPE

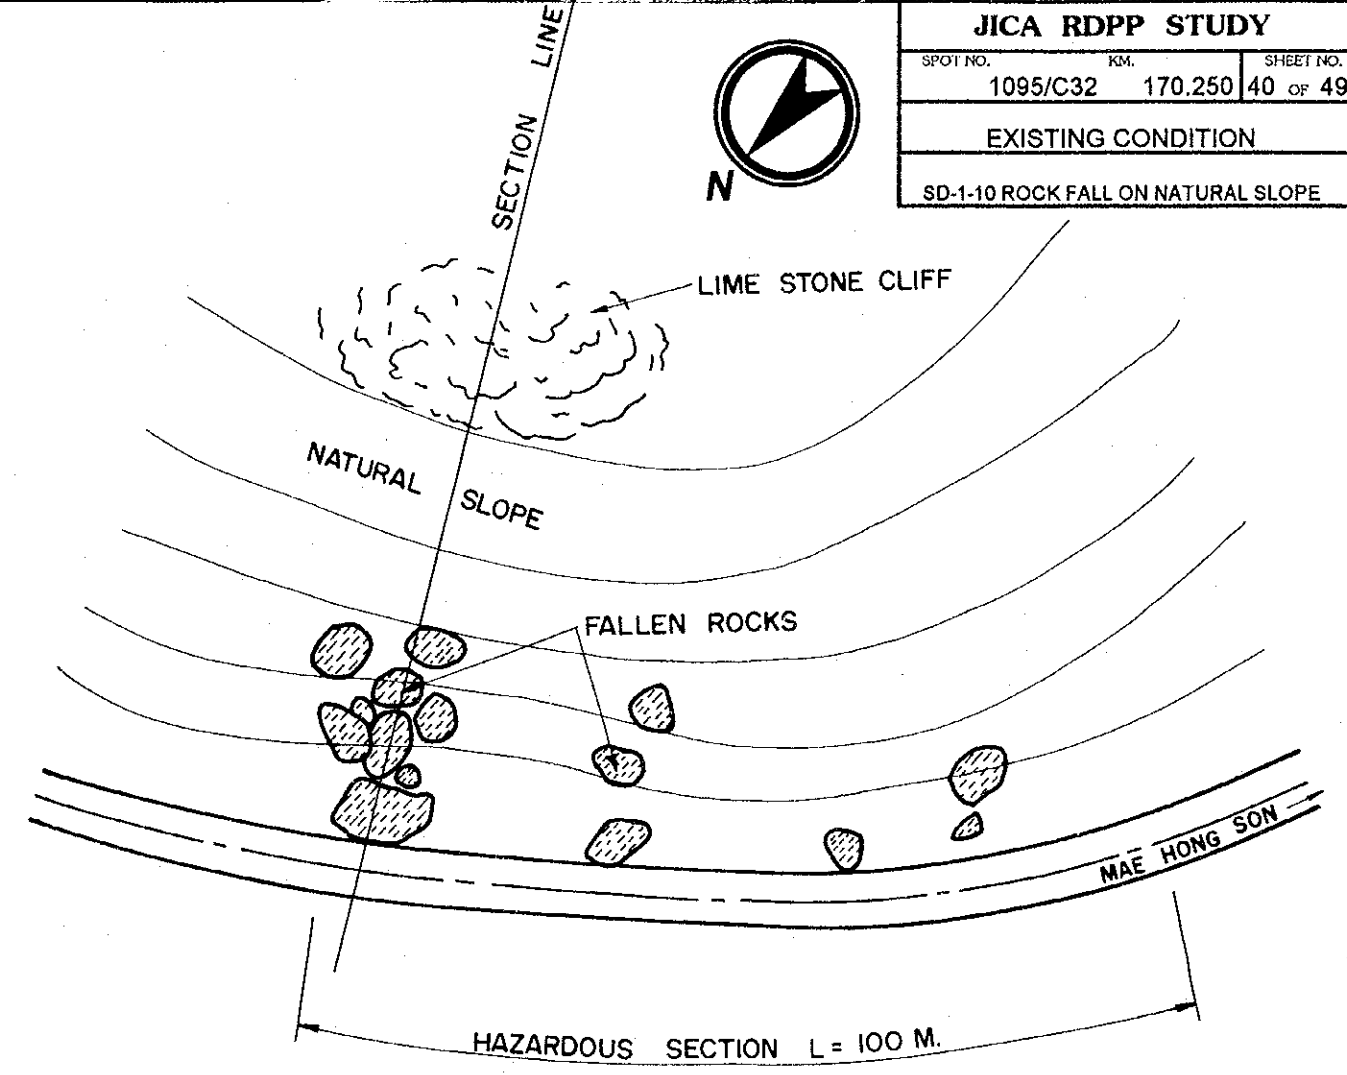
JICA RDPP STUDY		
SPOT NO.	KM.	SHEET NO.
1095/C32	170.250	40 OF 49
EXISTING CONDITION		
SD-1-10 ROCK FALL ON NATURAL SLOPE

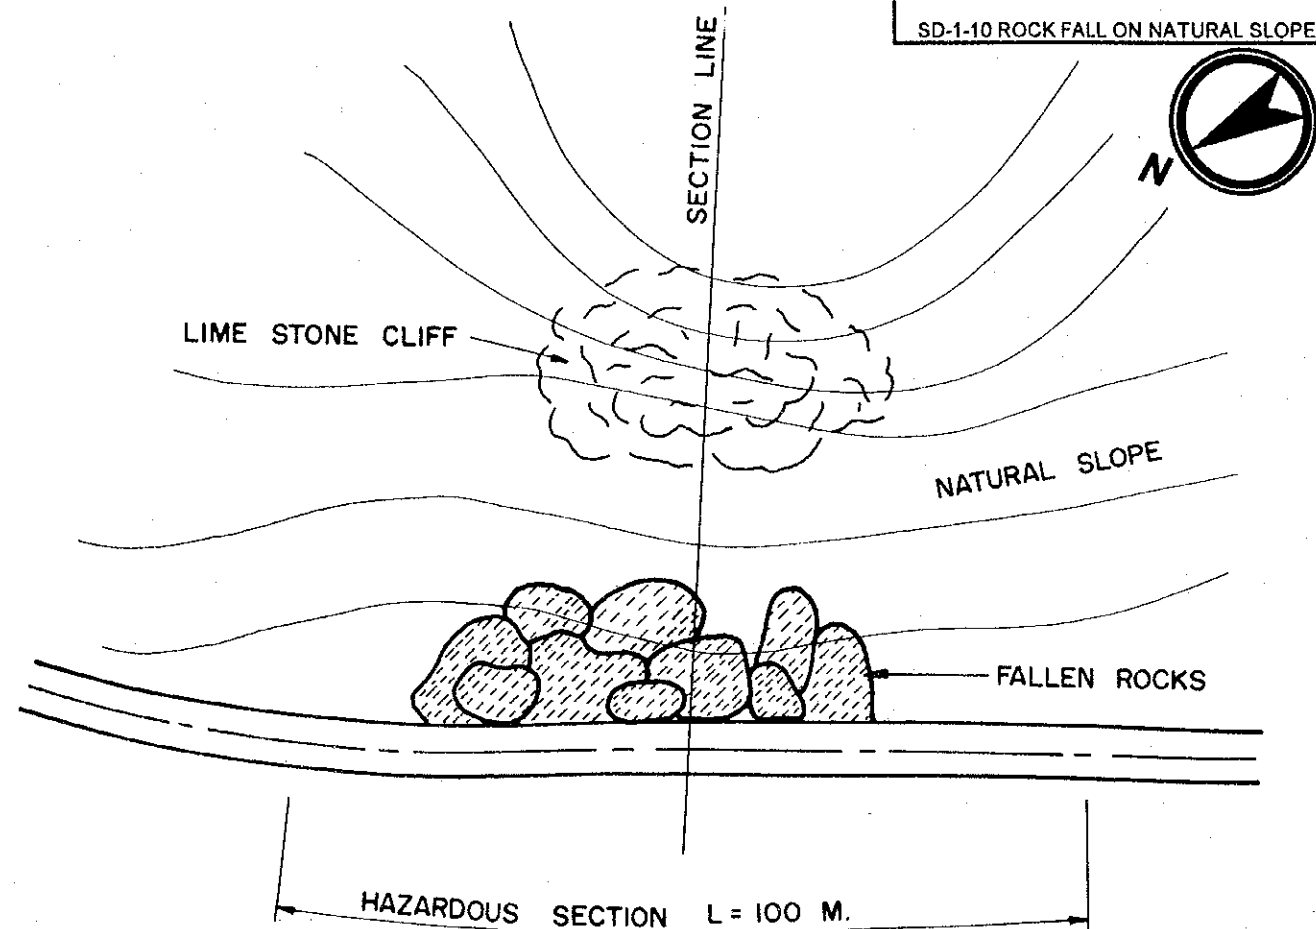
SPOT NO. 1095/C33 KM. 172.000 SHEET NO. 41 OF 49

SD-1-10 ROCK FALL ON NATURAL SLOPE

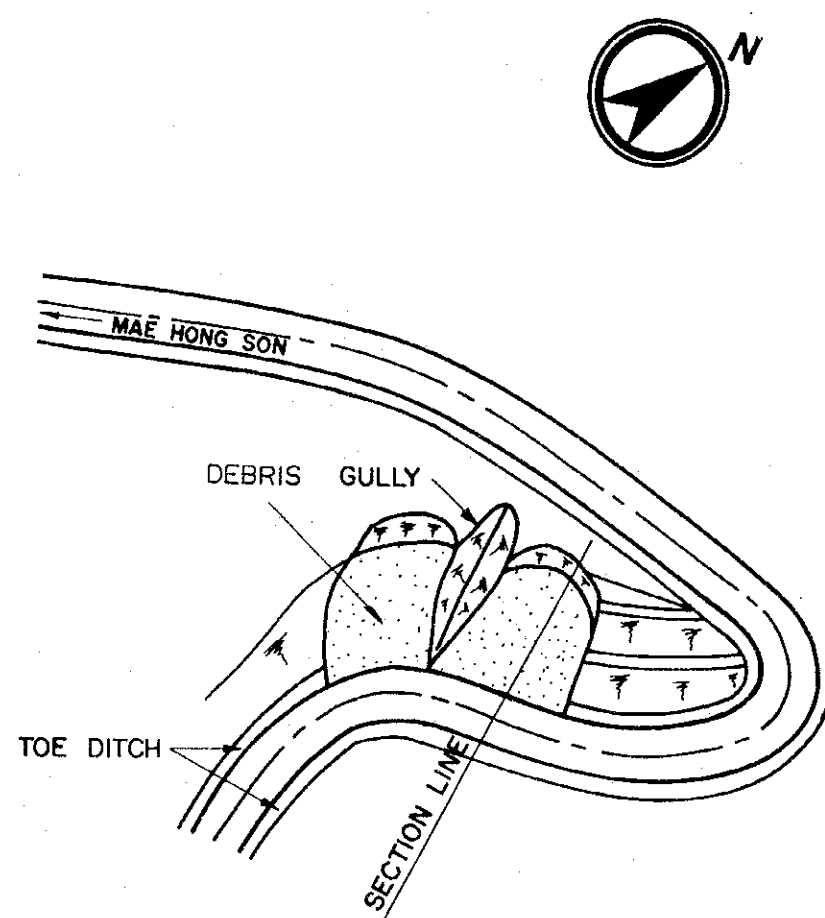
SPOT NO. 1095/C34 KM. 177.100 SHEET NO. 42 OF 49

SD-2-7 LAND SLIDE ON CUT SLOPE

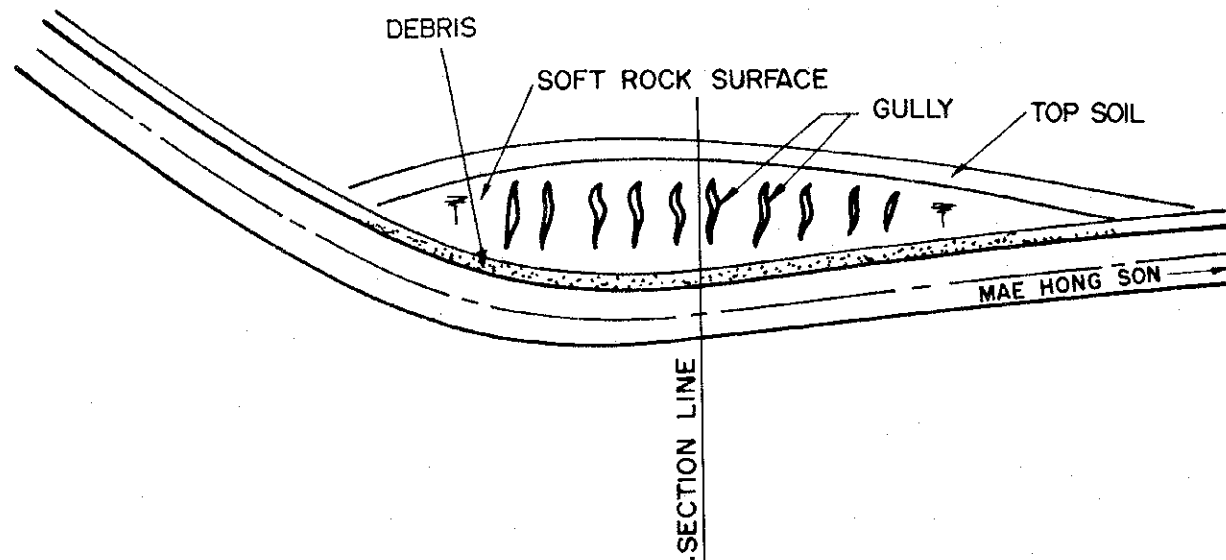
SPOT NO.	KM.	SHEET NO.
1095/C35	177.800	43 OF 49

SD-2-3 EROSION ON CUT SLOPE

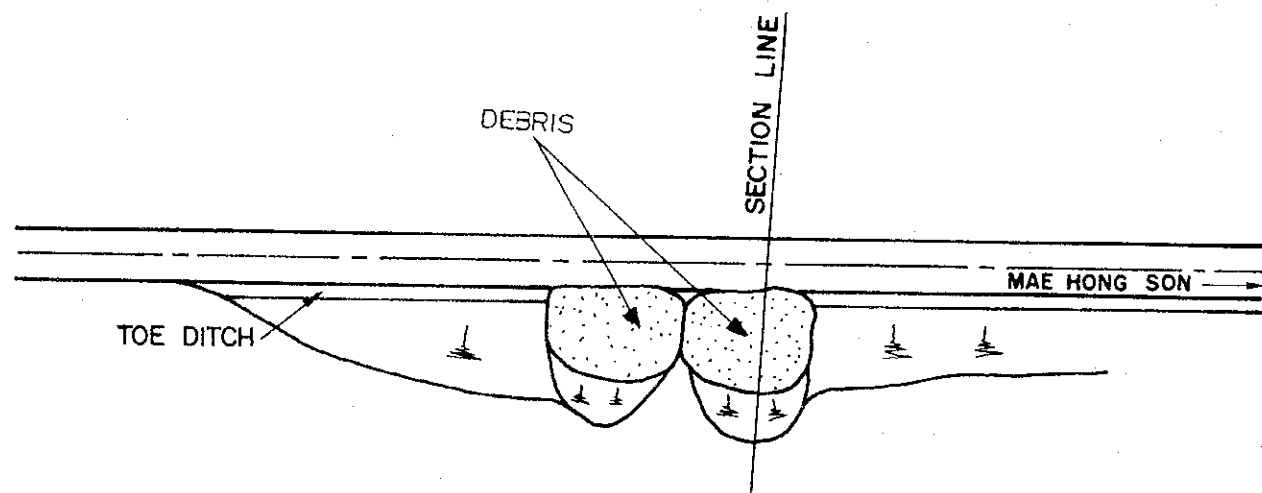
SPOT NO.	KM.	SHEET NO.
1095/C37	179.100	45 OF 49

SD-2-6 LANDSLIDE ON CUT SLOPE

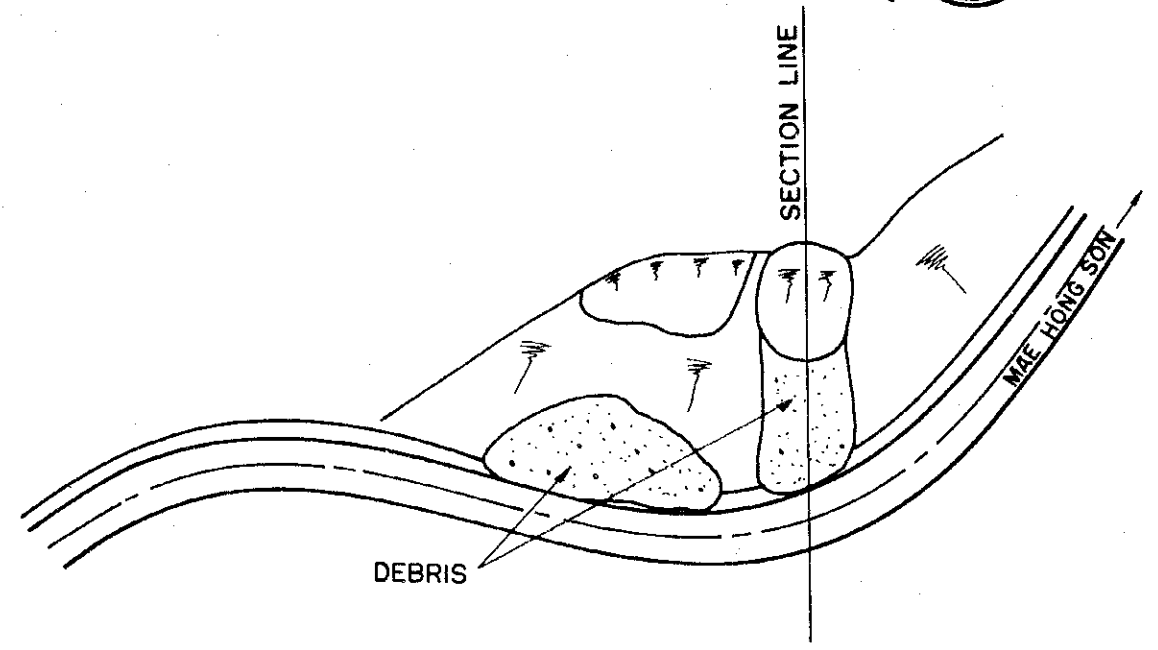
SPOT NO.	KM.	SHEET NO.
1095/C39	179.400	47 OF 49

SD-2-6 LANDSLIDE ON CUT SLOPE

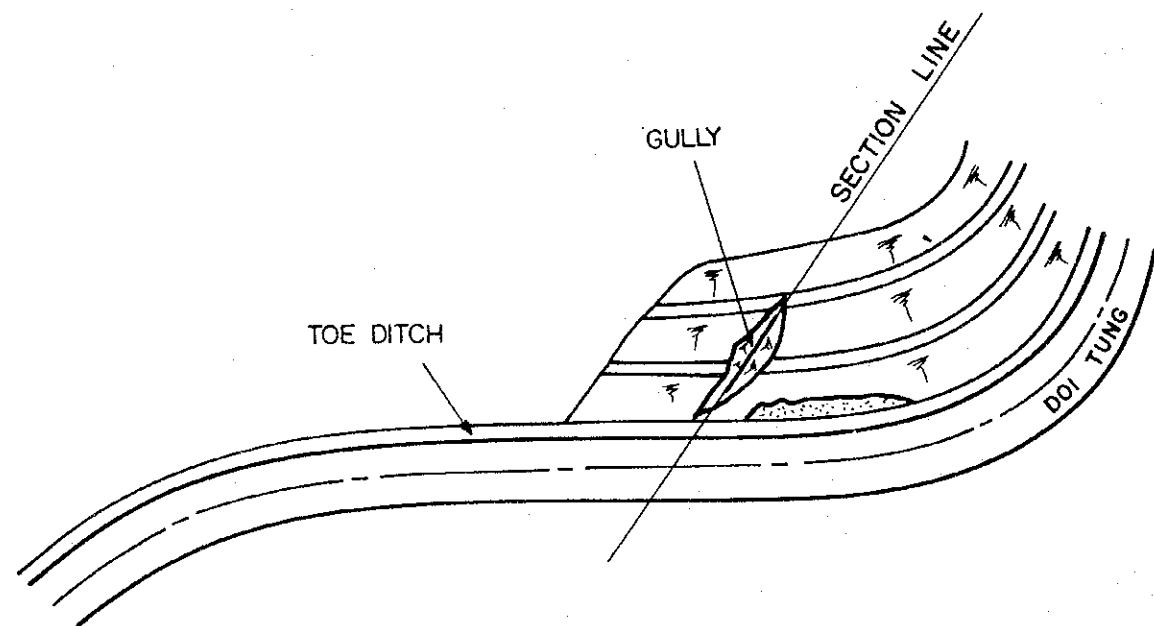
SPOT NO.	KM.	SHEET NO.
1149/C1	4.200	7 OF 16

SD-2-3 EROSION ON CUT SLOPE

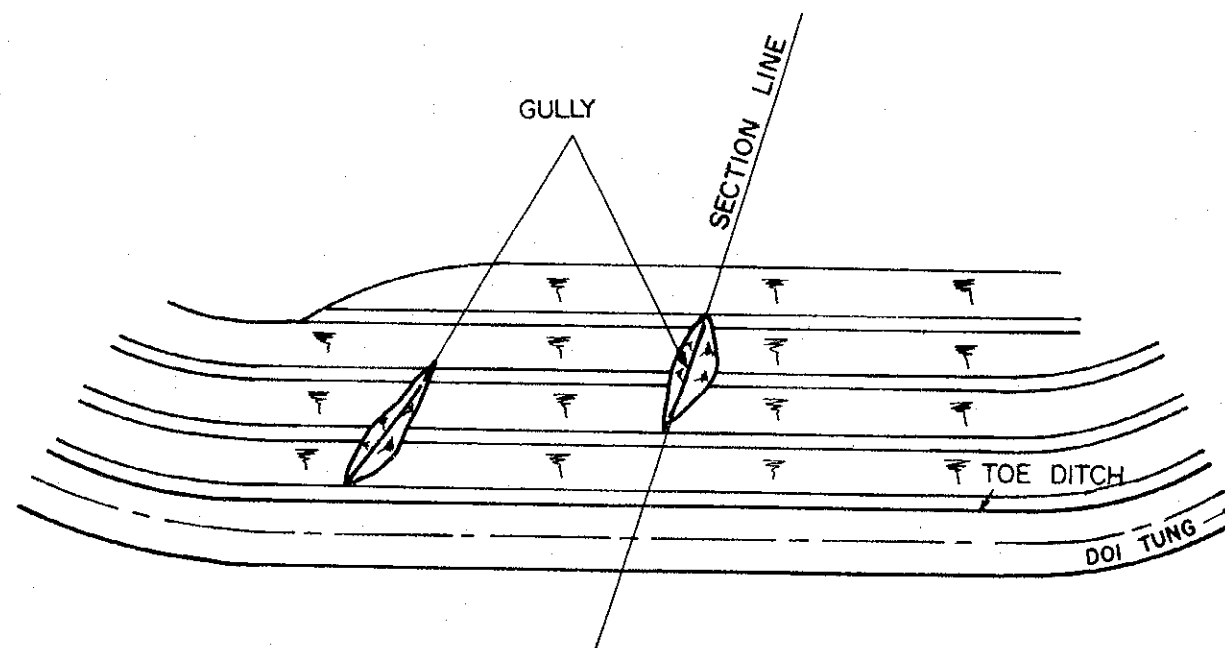
SPOT NO.	KM.	SHEET NO.
1149/C2	4.500	8 OF 16

SD-2-3 EROSION ON CUT SLOPE

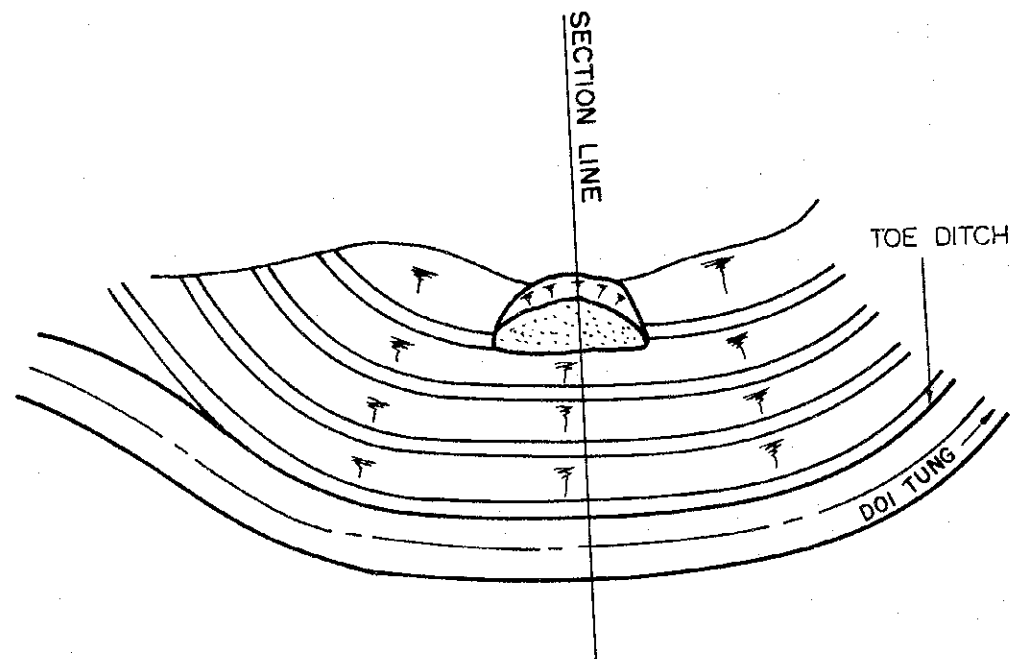
SPOT NO.	KM.	SHEET NO.
1149/C3	4.600	9 OF 16

SD-2-3 EROSION ON CUT SLOPE
