The Study on Road Disaster Prevention Plan in The Kingdom of Thailand

FINAL REPORT DRAWINGS

VOLUME 3

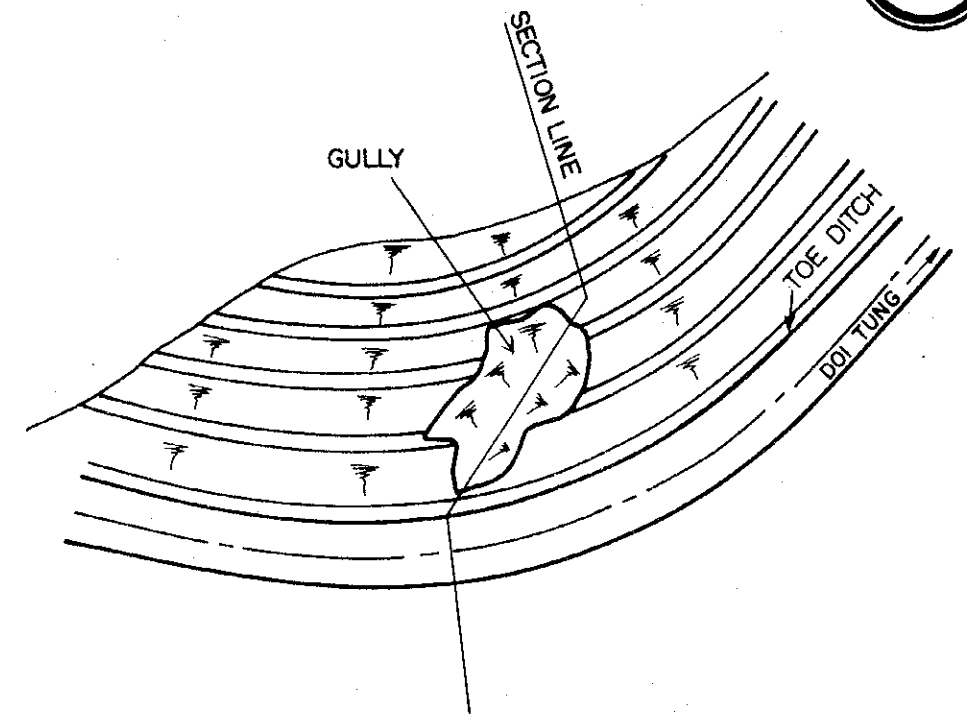
SPOT NO.	KM.	SHEET NO.
1149/C5	6.700	11 OF 16

SD-2-3 EROSION ON CUT SLOPE

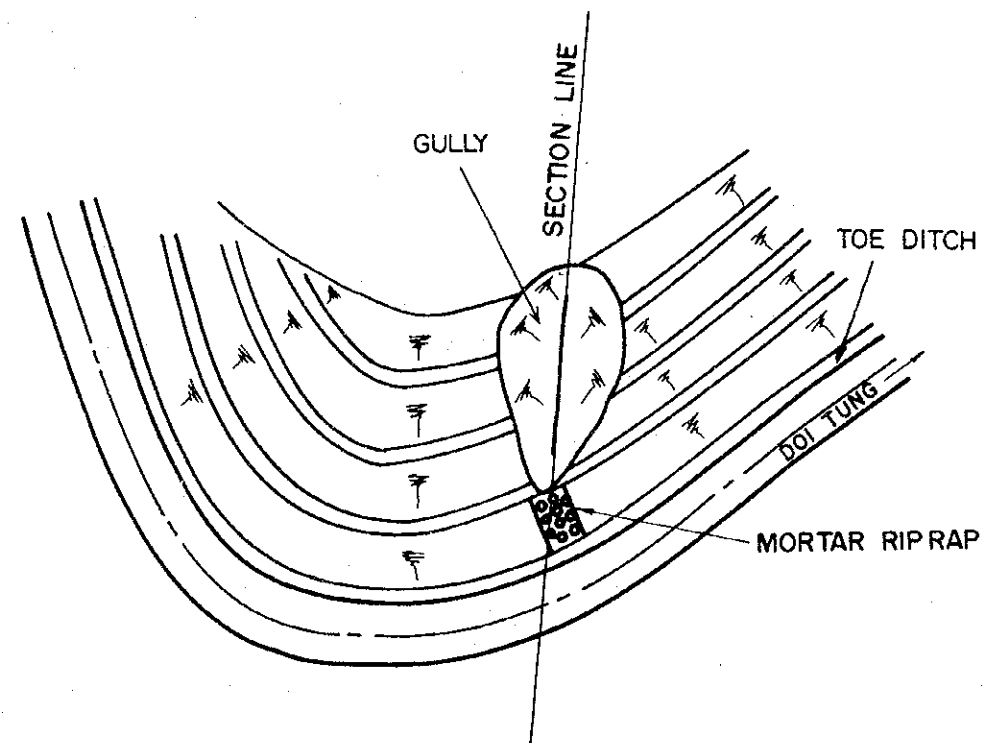
SPOT NO.	KM.	SHEET NO.
1149/C8	9.500	14 OF 16

SD-2-3 EROSION ON CUT SLOPE

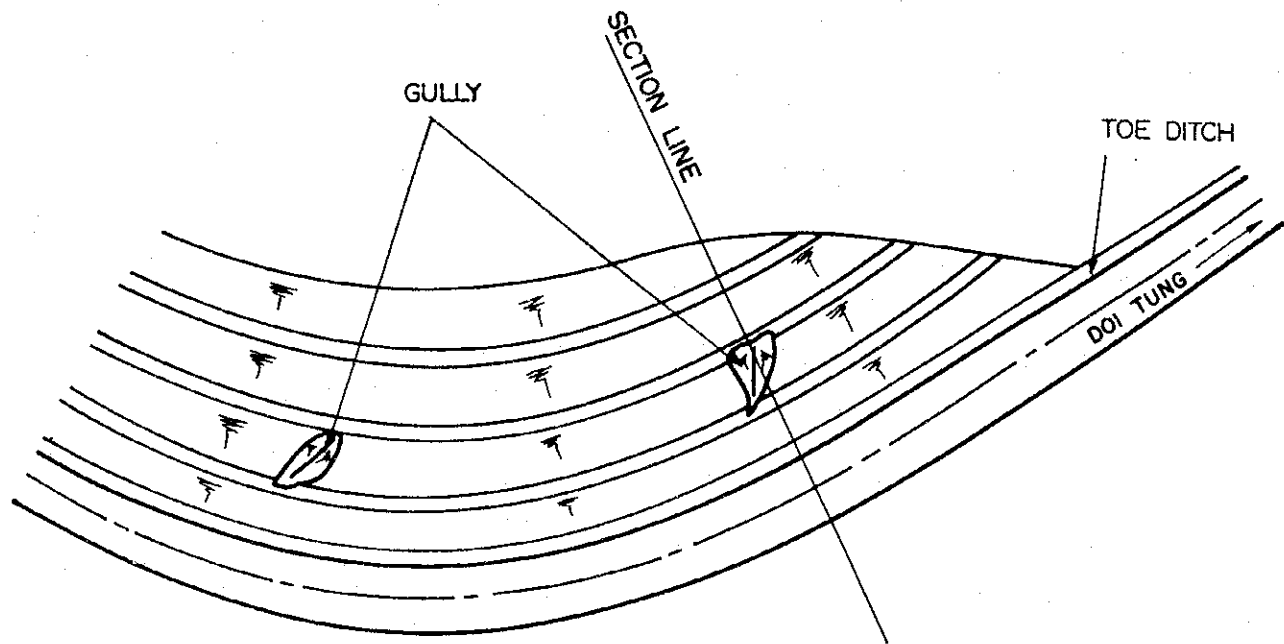
SPOT NO.	KM.	SHEET NO.
1149/C10	11.700	16 OF 16

SD-2-6 LANDSLIDE ON CUT SLOPE
