LOCAL GOVERNMENT ENGINEERING DEPARTMENT,
MINISTRY OF LOCAL GOVERNMENT, RURAL DEVELOPMENT
AND COOPERATIVES
THE PEOPLE'S REPUBLIC OF BANGLADESH

BASIC DESIGN STUDY REPORT
ON
THE PROJECT FOR THE CONSTRUCTION OF
MULTIPURPOSE CYCLONE SHELTERS (II)
IN
THE PEOPLE'S REPUBLIC OF BANGLADESH

(APPENDIX 9. RESULTS OF SITE CONDITIONS SURVEY
APPENDIX 10. RESULTS OF NATURAL CONDITIONS SURVEY)

JAPAN INTERNATIONAL COOPERATION AGENCY
JAPAN ENGINEERING CONSULTANTS CO., LTD.

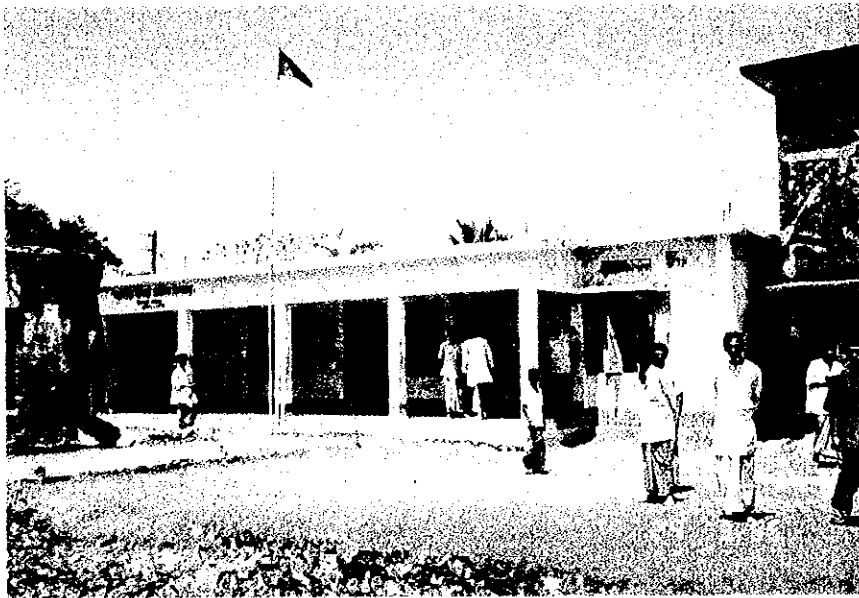
Abandoned Building to be demolished at the School Site
