SITE SURVEY CHECK LIST

(Date: 1995/ 3 / 24)

1. Site No. 27
2. Name of School: East Char Algi Registered NGPS
3. Site Location : District; Laxmipur Thana : Rangate
 Union : Char Algi no. 9 Village: Char Algi

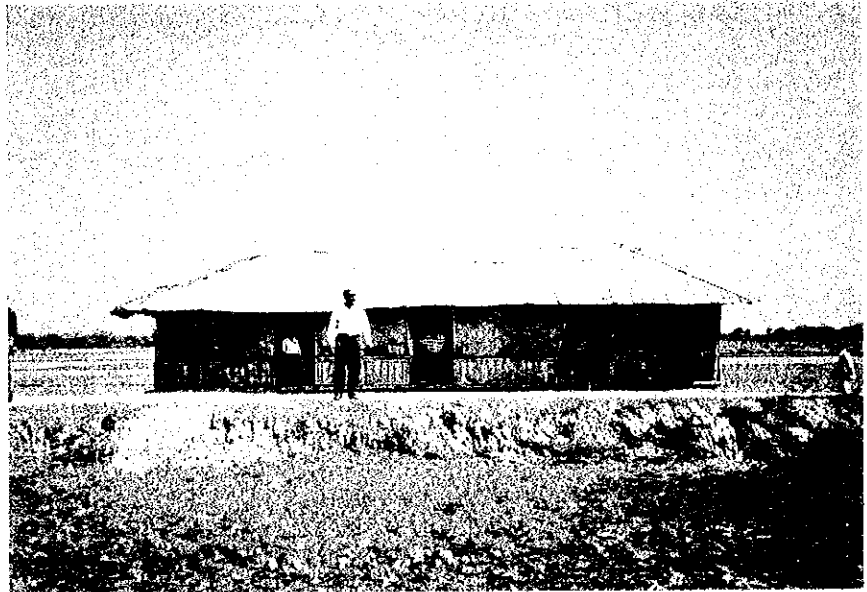
Overall View of
the School Site

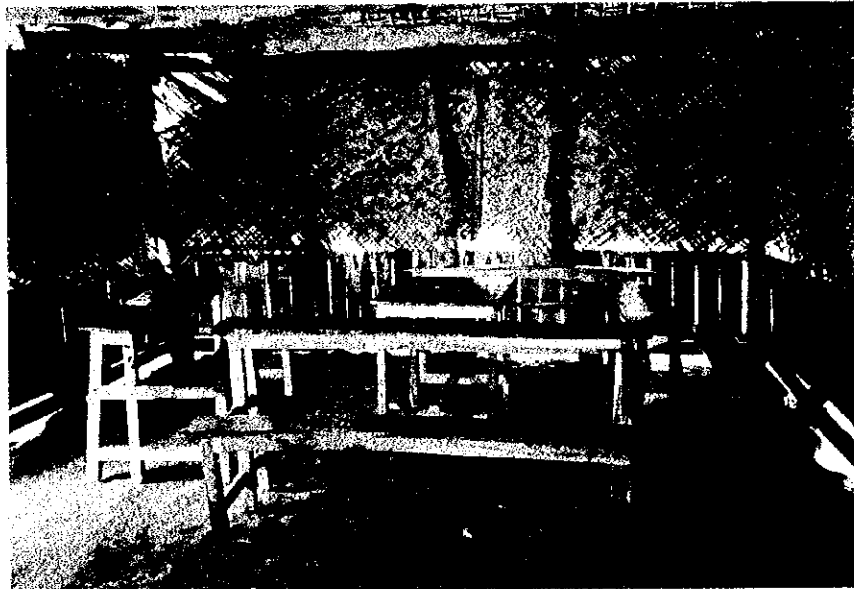
Overall View of
the School Building

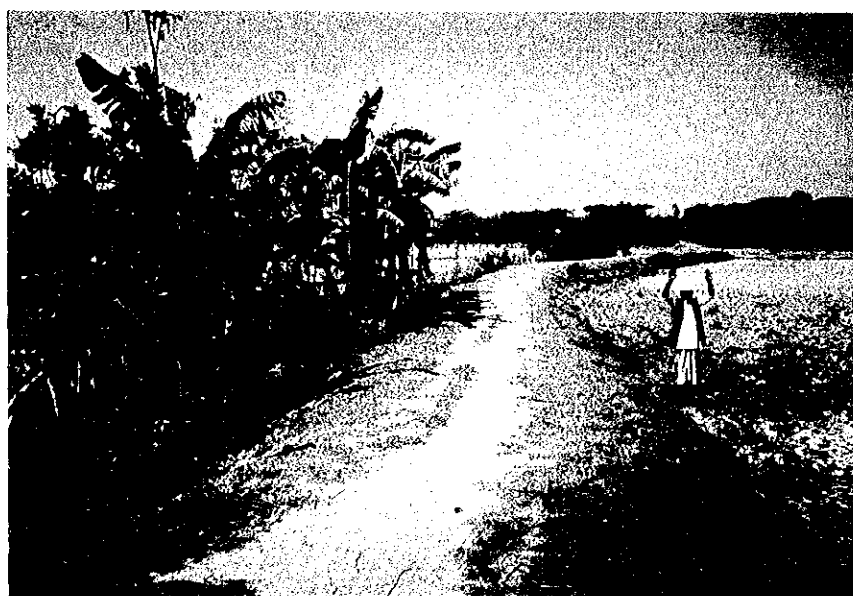
Road Conditions
near the Site

- Condition of Pavement: Good, Not so good, Bad
 - Road Width : 2.0/3.5 m *Earth road gets muddy in rainy season.*
 - Passable Vehicle: Motor cycle, Riksha, Sedan, Jeep Truck (*only in dry season.*)

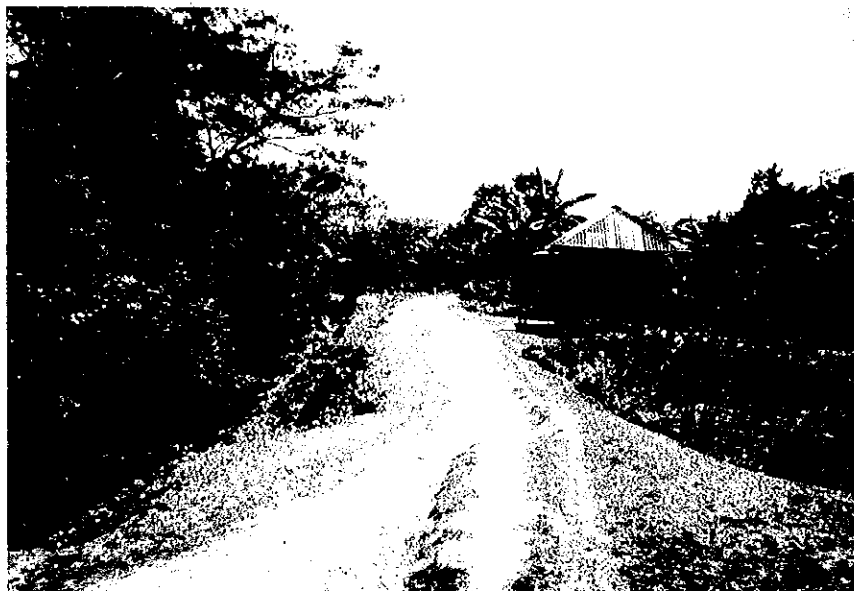
Road Conditions
near the Site

- 2) Road Conditions
 - Kind of Pavement: *Earth*, Gravel, Brick, Asphalt, Concrete, *& Walk.*
 - Condition of Pavement: Good, Not so good, *Bad*
 - Road Width : *1.5* m

- Passable Vehicle: Motor cycle, Rikisha, Sedan, *Jeep* Truck (*2 on foot (2.0 km)* ton)
 - Necessity for Repair of Road: *Yes*, No.
 - Necessity for Repair of Bridges or Culverts: ~~Yes, No.~~

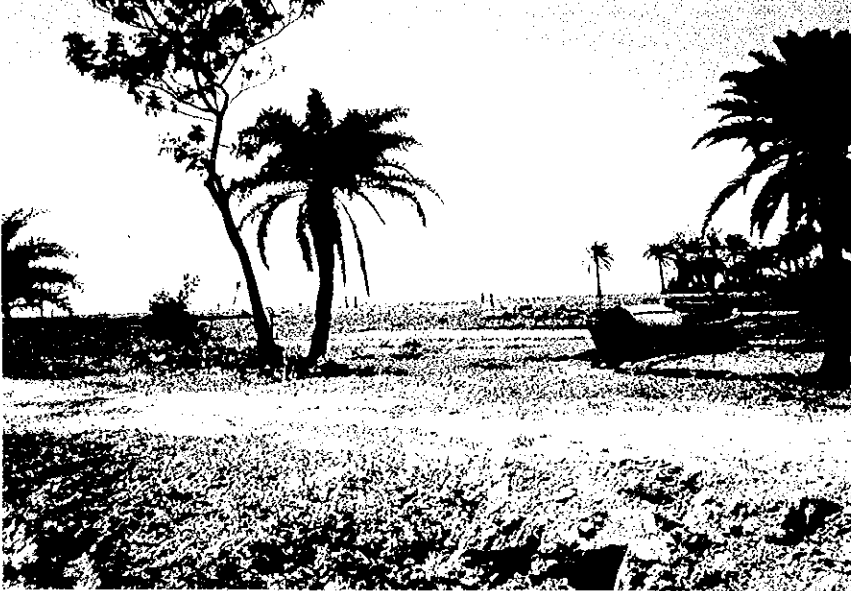
Current Conditions
near the Site
(including topographic
features)

- 4) Neighbouring Killa : Distance from the School: m
 Size(Top) : ~~m x m~~ m, Height: m
~~None - Existing~~ Progres Ratio: %
- 5) Topographic Conditions Nearby : *this site is located outside the embankment facing the sea.*
 (Obstruction for School Attendance or Evacuation at Cyclone Time)

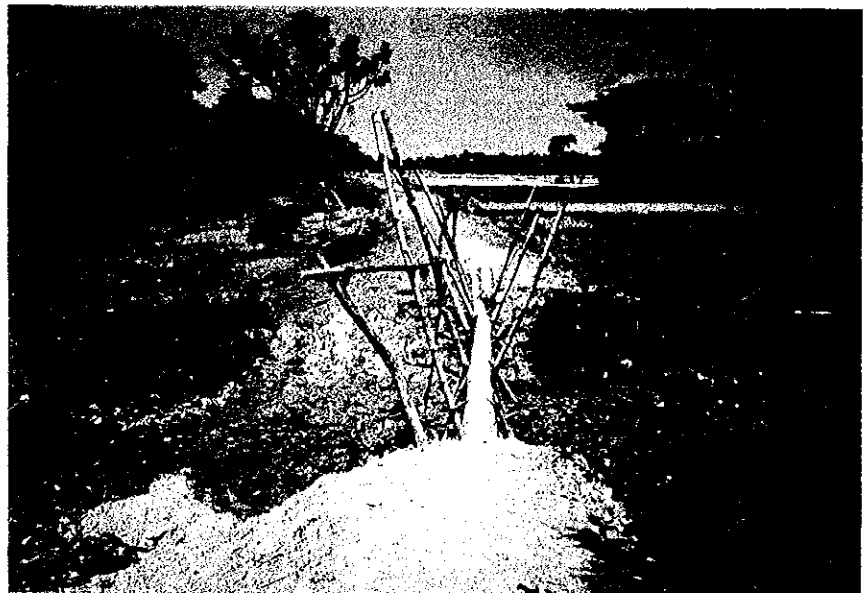
Road Conditions
near the Site

2) Road Conditions
 - Kind of Pavement: ~~Cartle~~ Gravel, Brick, Asphalt, Concrete.
 - Condition of Pavement: Good, Not so good, Bad
 - Road Width : *2.5* m *Road gets muddy in rainy season* & on foot (2km)

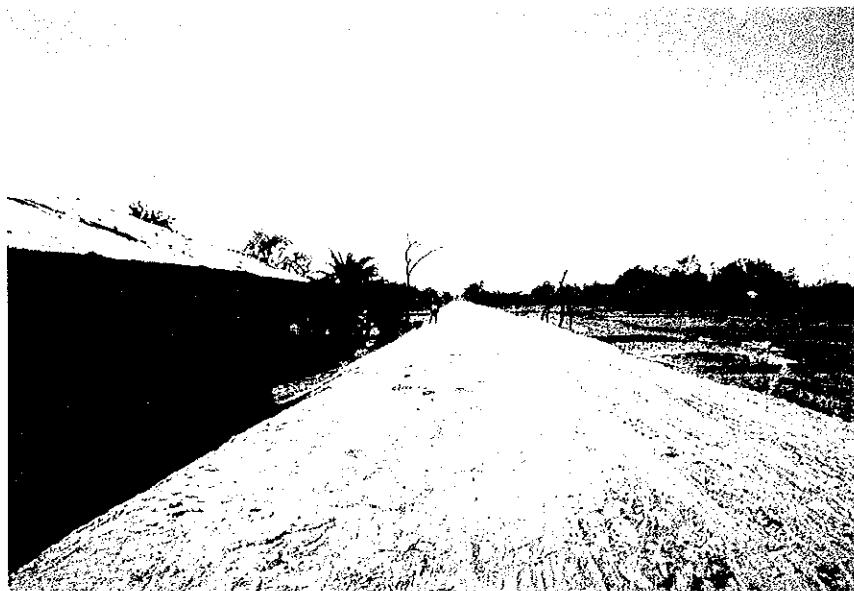
Road Conditions
near the Site

- 2) Road Conditions
 - Kind of Pavement: Earth, Gravel, Brick, Asphalt, Concrete.
 - Condition of Pavement: Good, Not so good, Bad
 - Road Width : 2.5 x 3.0 m *Road gets muddy in rainy season.*

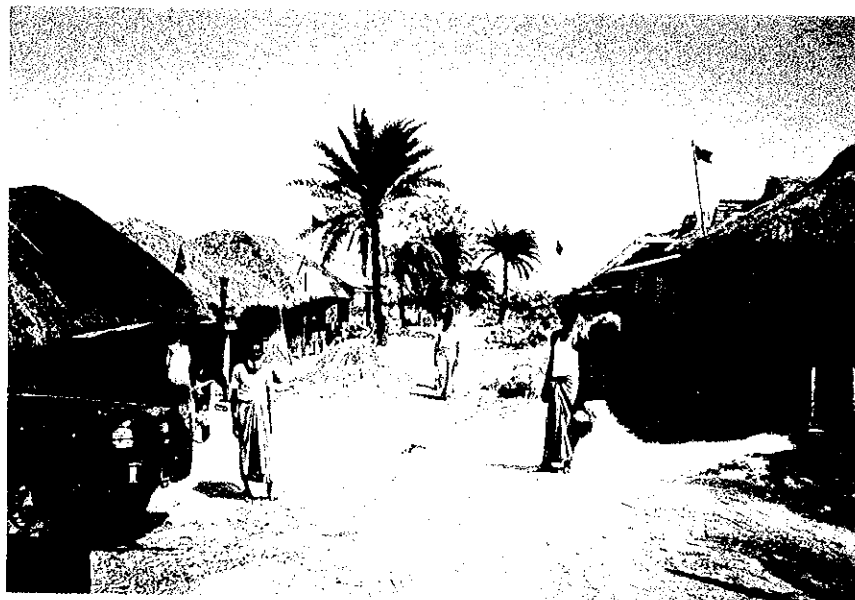
Road Conditions
near the Site

- Necessity for Repair of Road: Yes, No partially bad in rainy seasons
 - Necessity for Repair of Bridges or Culverts: Yes, No
6. Conditions of School
 1) Name of Landowner : School Management Committee

- 4) Neighbouring Killa : Distance from the School: _____ m
 Size(Top) : _____ m x _____ m. Height: _____ m
 Progress Ratio: _____ %
None-Existing
- 5) Topographic Conditions Nearby : *Access road gets muddy in the rainy season.*
 (Obstruction for School Attendance or Evacuation at Cyclone Time)
