サイト状況確認調査チェック・リスト

1. Site No. 30
2. Name of School: *Char Gazi*
3. Site Location : District: *Larmipur* Thana : *Rangati*
 Union : *Barakhari* Village: *Barakhari*
4. Interviewee : Name : *Mr. G.K.R. Chowdhury* Position: *Headmaster*

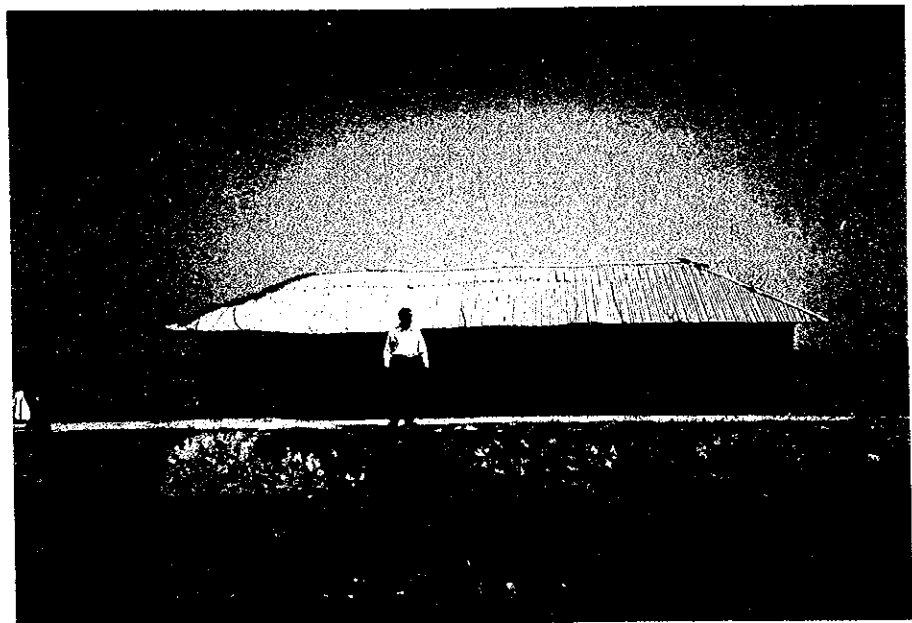
校舎全景

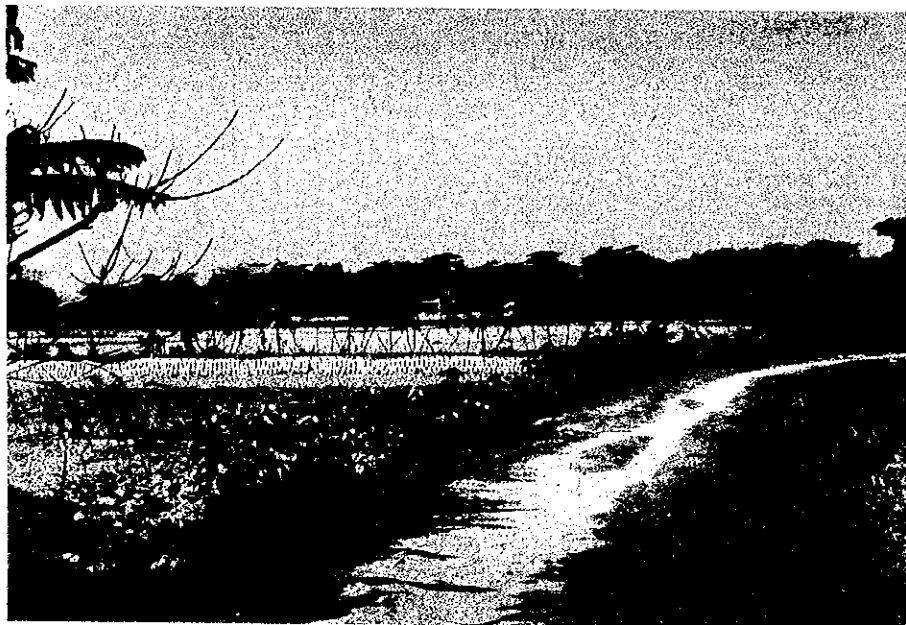
約0.4km離れて
位置する建設中の
シェルター

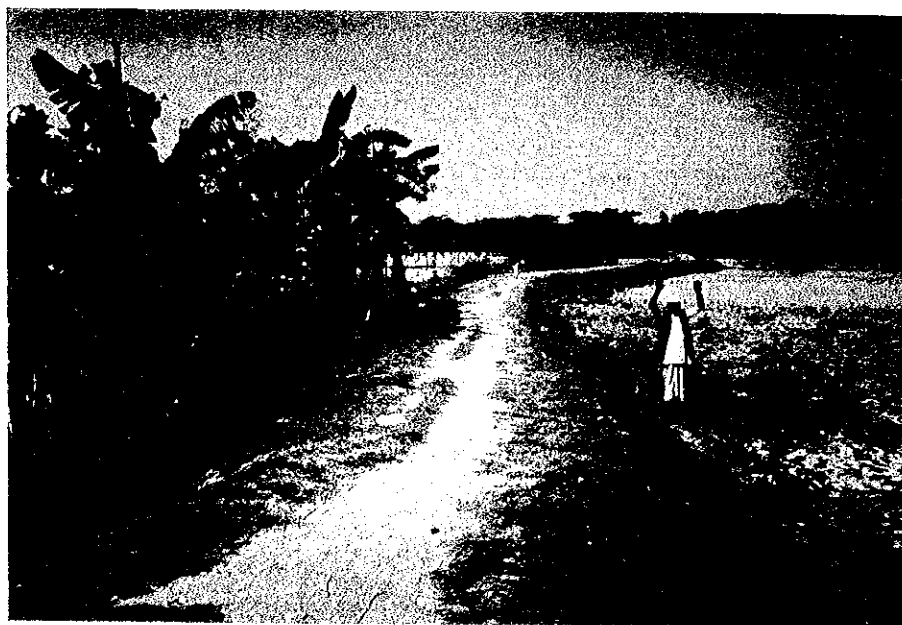
周辺の道路状況

- Condition of Pavement: Good, Not so good, Bad
 - Road Width : *2.0/3.5* m *Earth road gets muddy in rainy season.*
 - Passable Vehicle: Motor cycle, Ricksha, Sedan, Jeep Truck (*only in dry season.*)

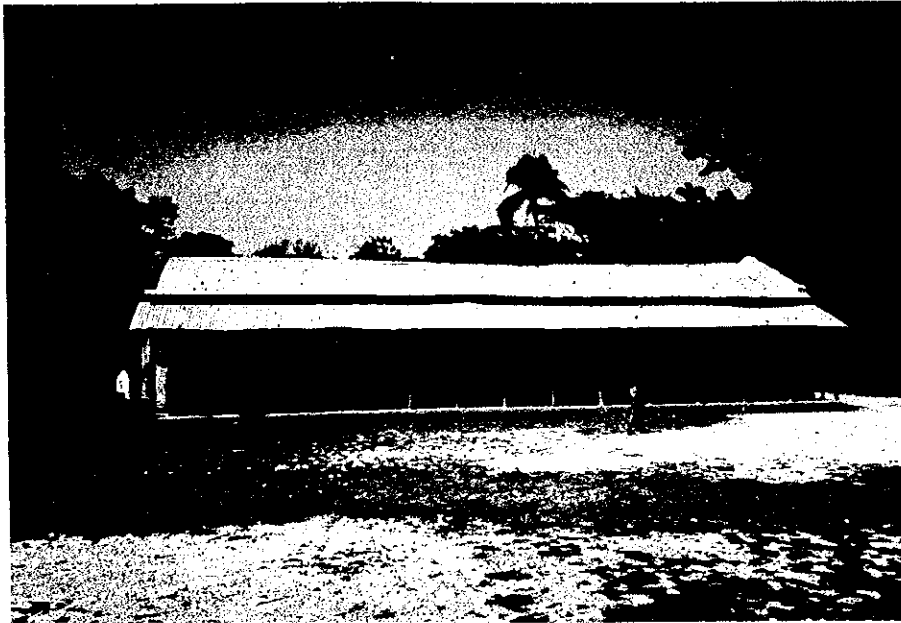
学校敷地全景

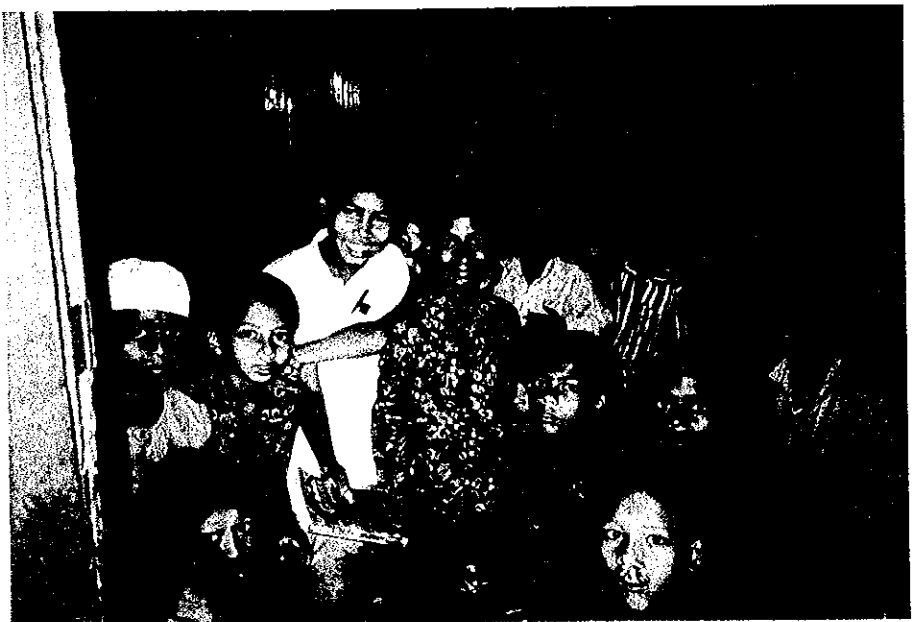
教室内の状況

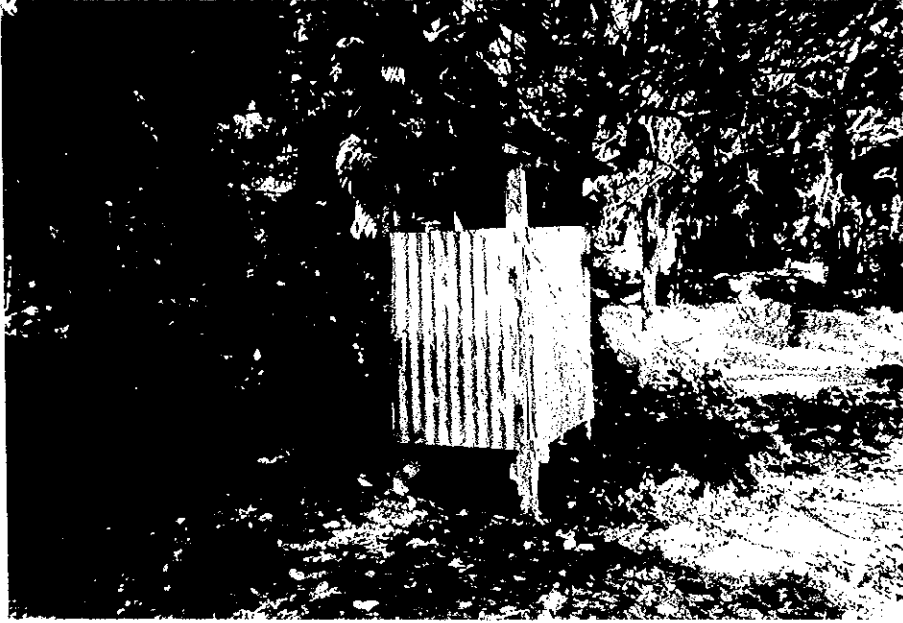
付属施設の状況

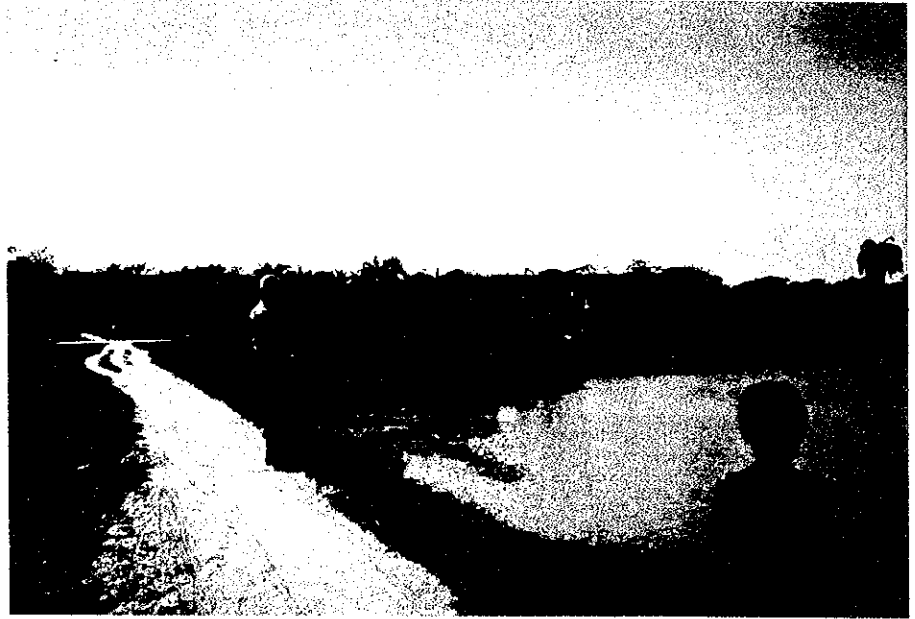
学校周辺の地形・状況

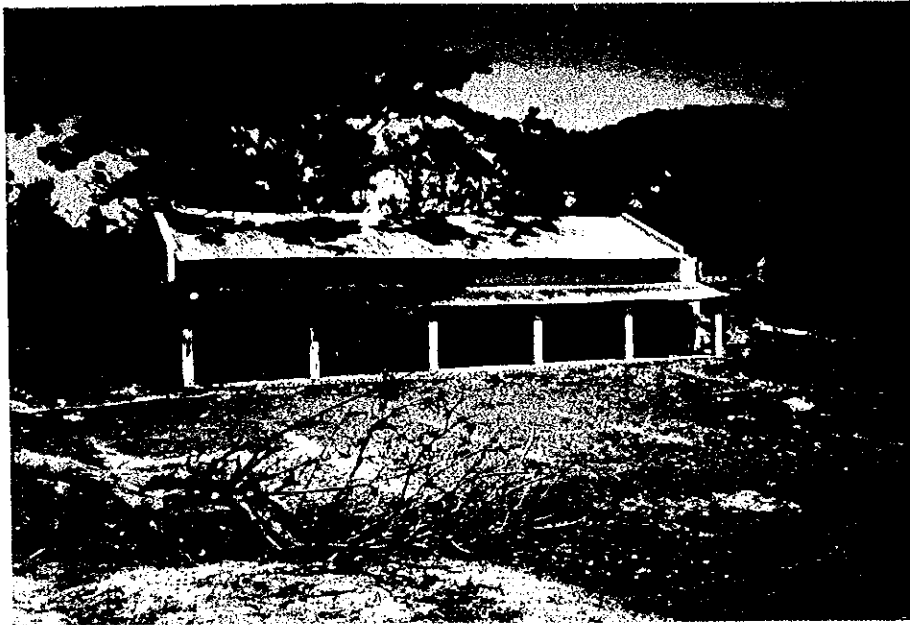
学校敷地全景

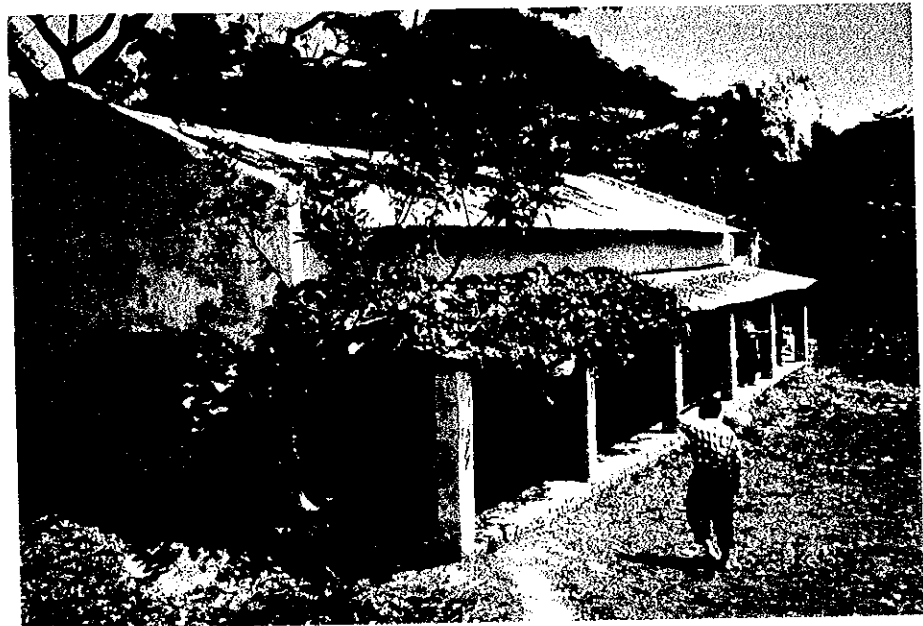
校舎全景

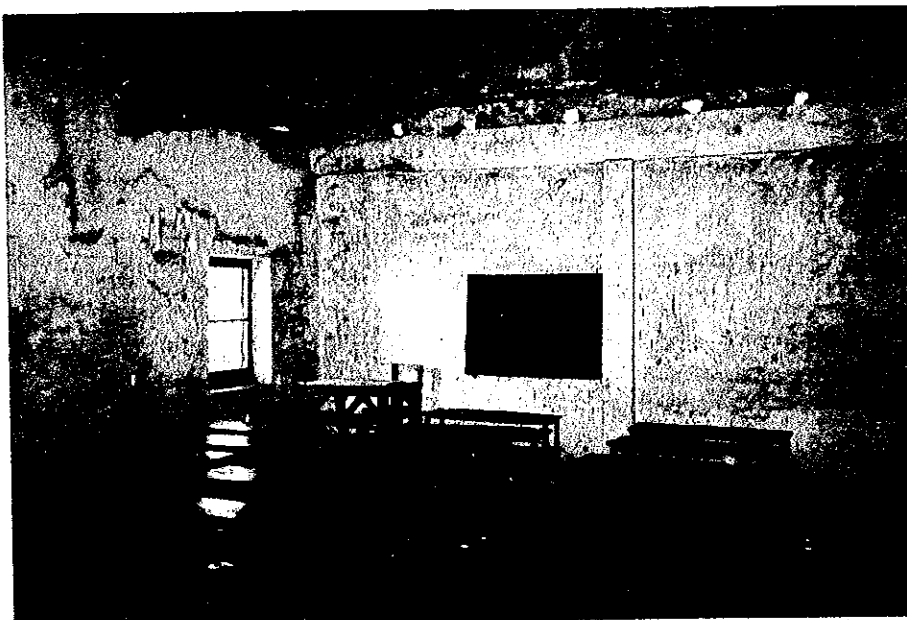
教室内の状況

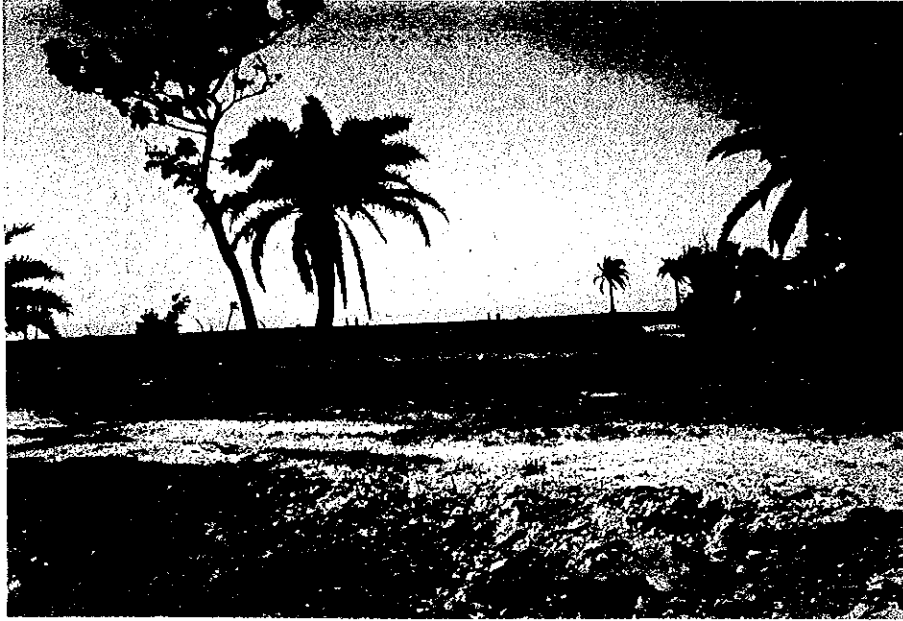
学校周辺の地形・状況

- 4) Neighbouring Killa : Distance from the School; _____ m
 Size(Top) : _____ m x _____ m. Height: _____ m
~~Progress Ratio: _____ %~~
None - Existing
- 5) Topographic Conditions Nearby : *This site is located outside the Embankment facing the sea.*
 (Obstruction for School Attendance or Evacuation at Cyclone Time)

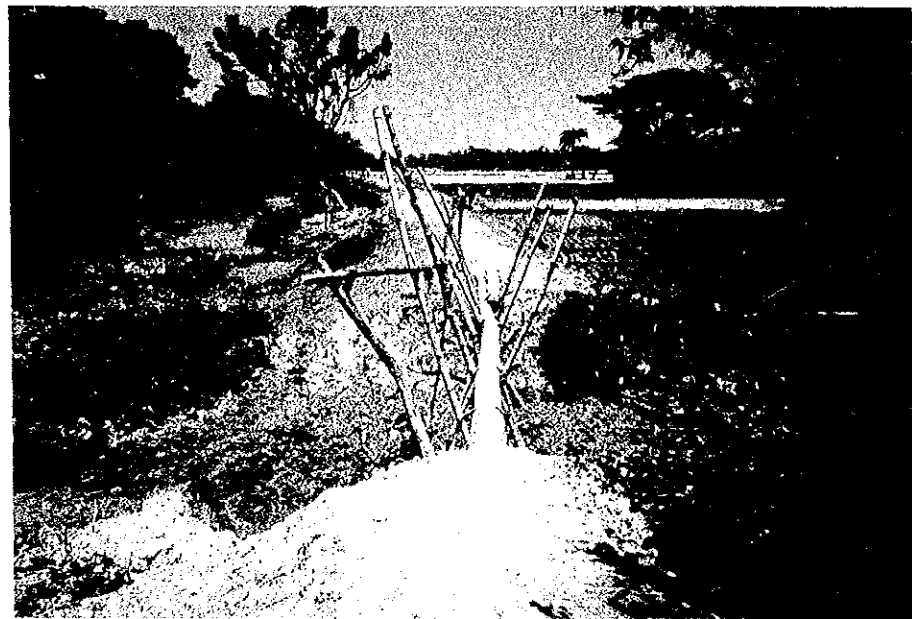
周辺の道路状況

2) Road Conditions
 - Kind of Pavement: Earth, Gravel, Brick, Asphalt, Concrete.
 - Condition of Pavement: Good, Not so good, Bad
 - Road Width : *2.5* m *Road gets muddy in rainy season* & *on foot (2km)*

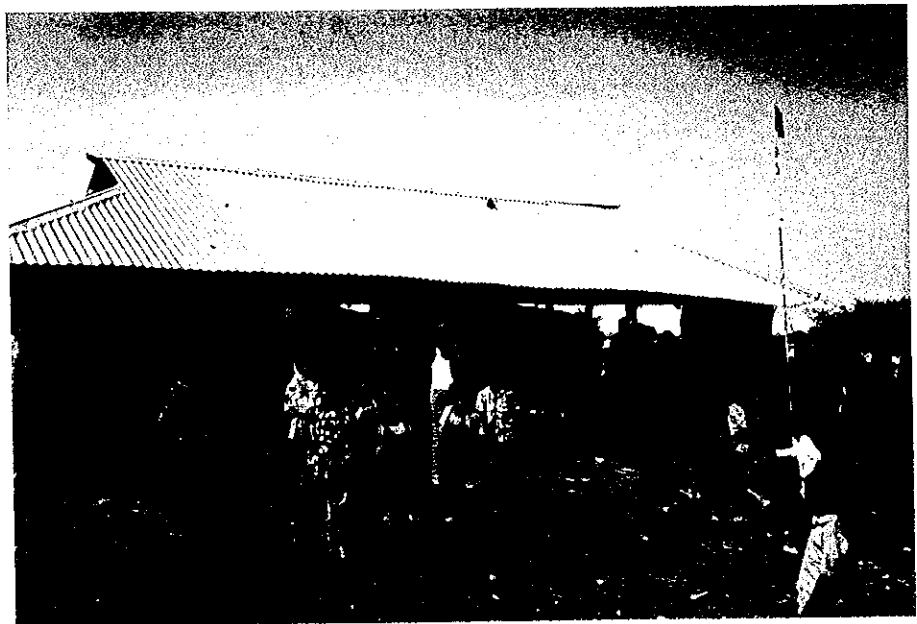
校舎全景

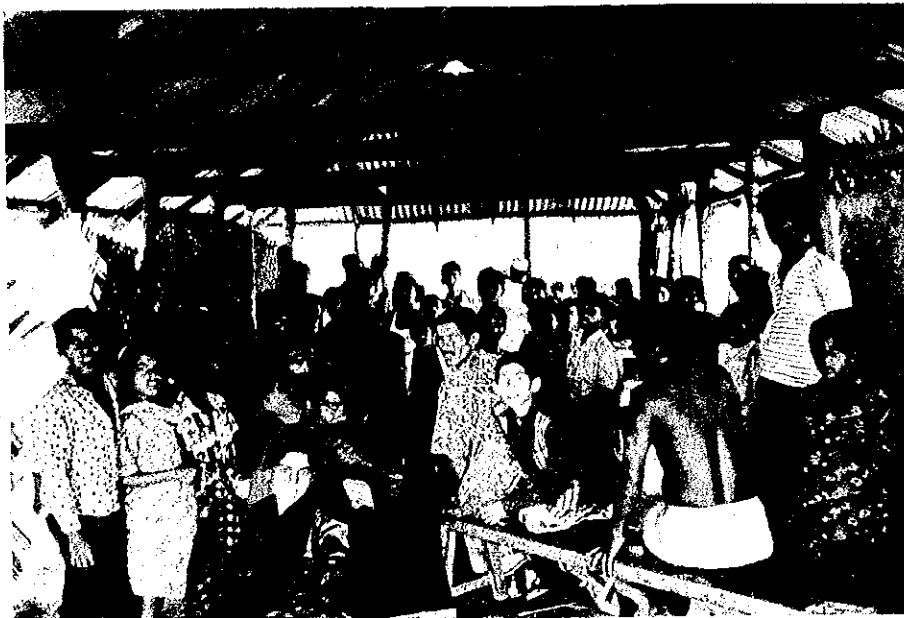
教室内の状況

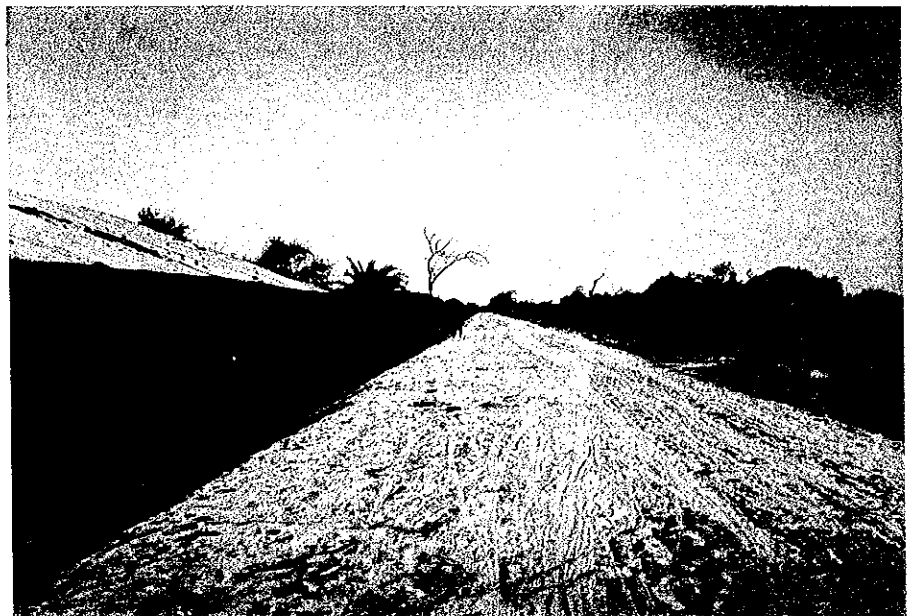
周辺の道路状況

- 2) Road Conditions
 - Kind of Pavement: Earth, Gravel, Brick, Asphalt, Concrete,
 - Condition of Pavement: Good, Not so good, Bad
 - Road Width : 2.5 x 3.0 m *Road gets muddy in rainy season*

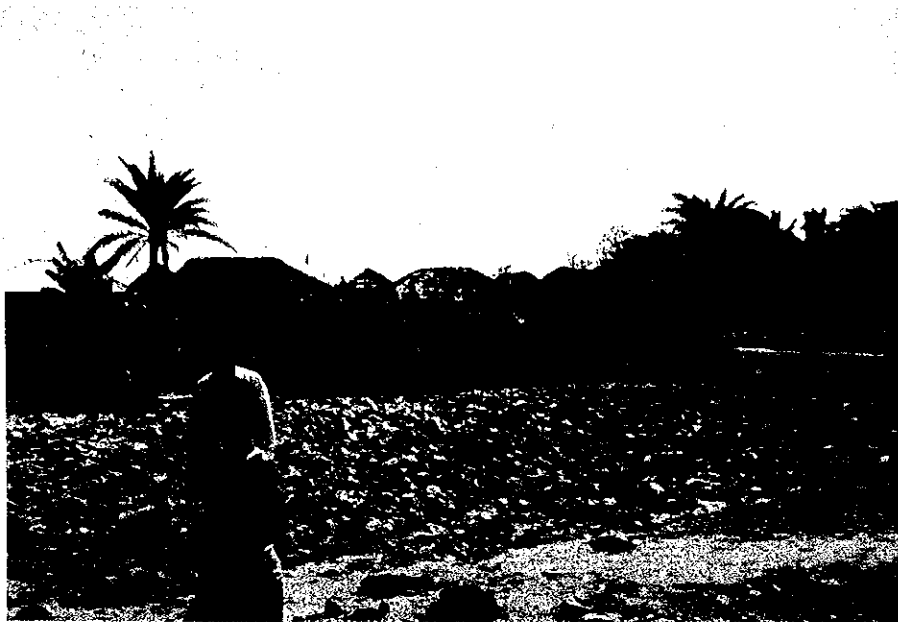
学校周辺の地形・状況

- 4) Neighbouring Killa : Distance from the School: _____ m
 Size(Top) : _____ m x _____ m, Height: _____ m
None-Existing Progress Ratio: _____ %
- 5) Topographic Conditions Nearby :
 (Obstruction for School Attendance or Evacuation at Cyclone Time) *Access road gets muddy in the rainy season.*

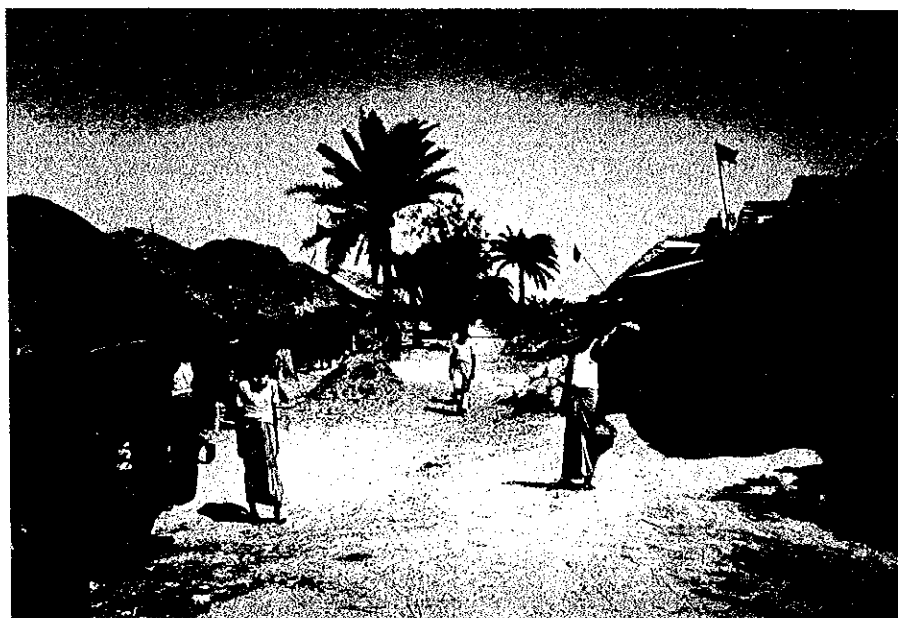
周辺の道路状況

- Passable Vehicle: Motor cycle, Rikisha, Sedan, Jeep, Truck (4 ton)
 - Necessity for Repair of Road: Yes, No, partially bad in rainy season
 - Necessity for Repair of Bridges or Culverts: Yes, No.

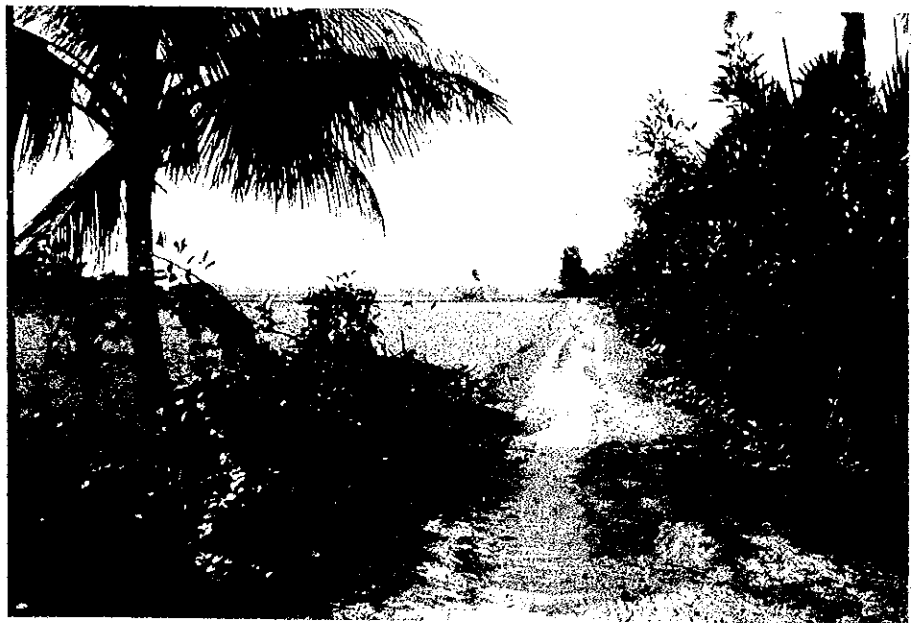
周辺の道路状況

2) Road Conditions
 - Kind of Pavement: *Earth*, Gravel, Brick, Asphalt, Concrete.
 - Condition of Pavement: Good, Not so good, *Bad*
 - Road Width : *3.0* m

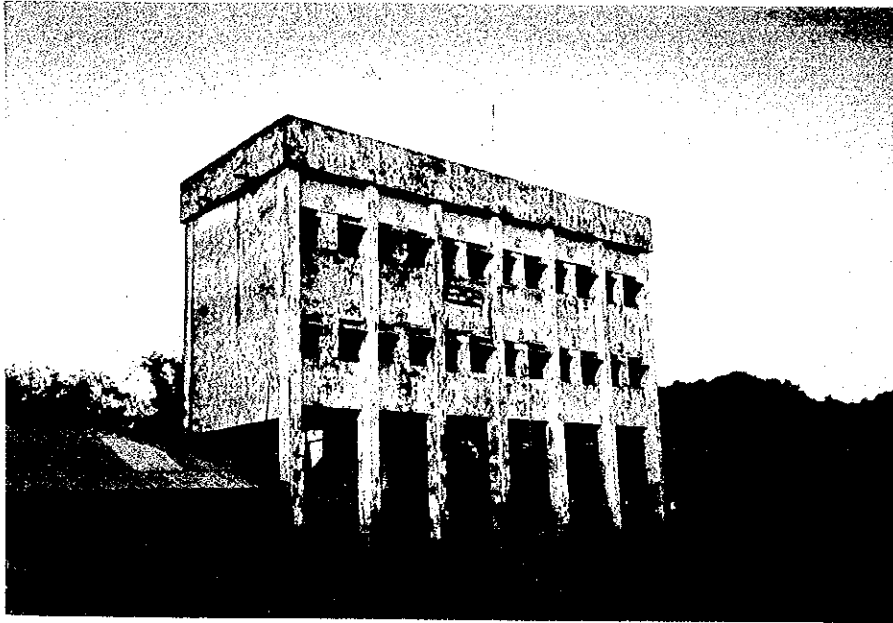
約0.9km離れて位置する
既存シェルター

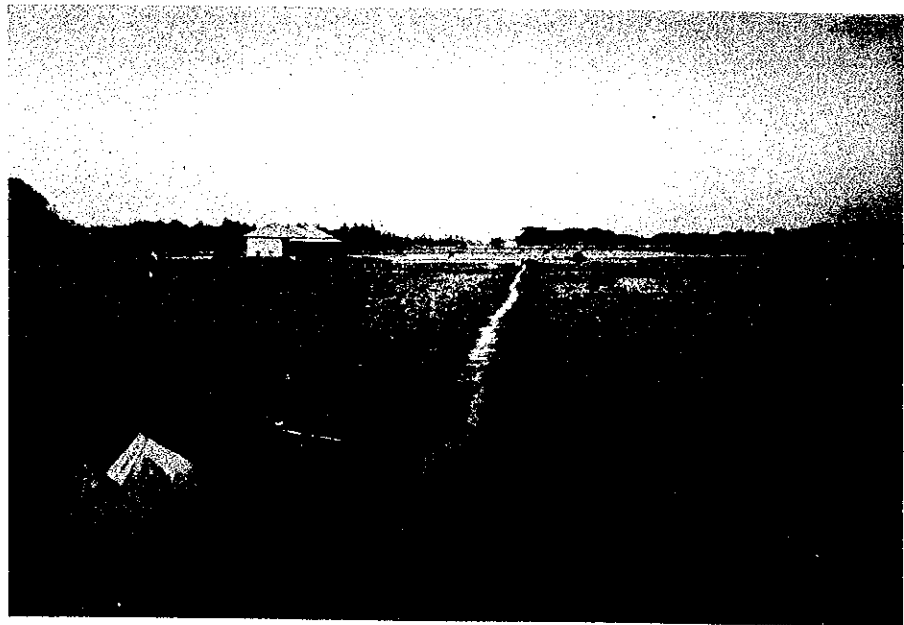
周辺の道路状況

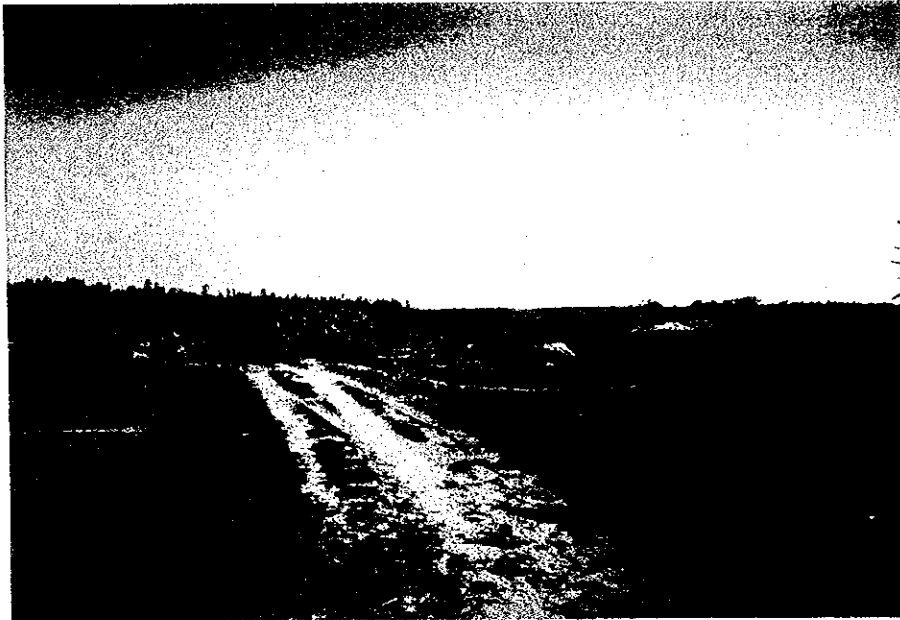
学校周辺の地形・状況
[建設中の堤防]

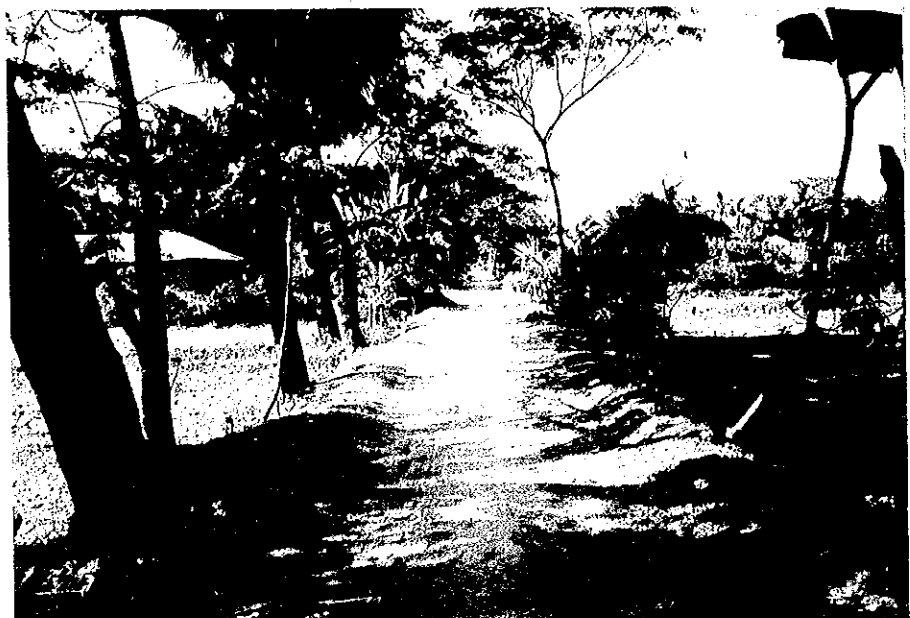
周辺の道路状況

- Condition of Pavement: Good, Not so good, Bad
 - Road Width : 1.5 ~ 2.0m & pushcart *Road gets muddy in rainy seasons,*
 - Passable Vehicle: Motor cycle, Riksha, Sedan, Jeep, Truck (ton)

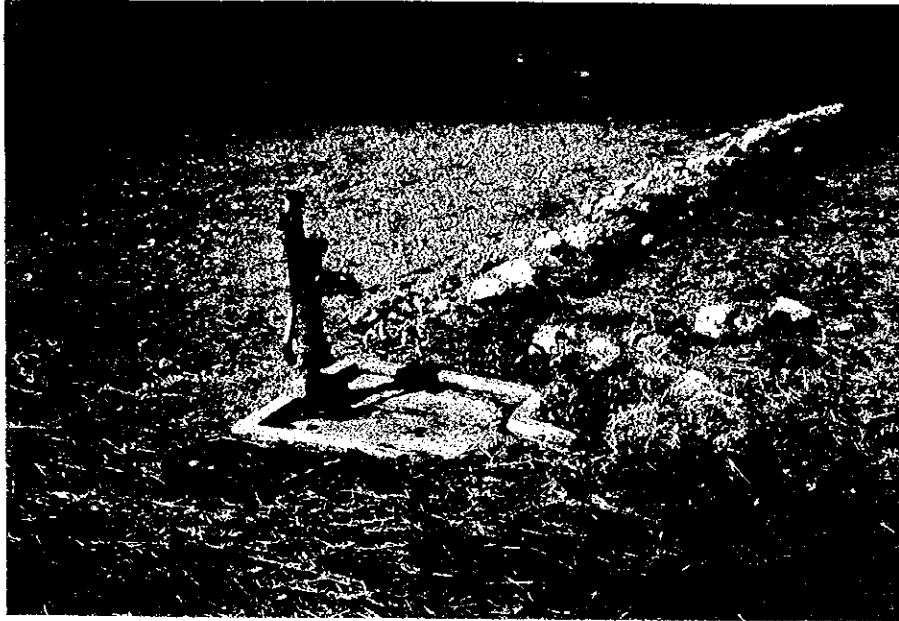
付属施設の状況
