**BASIC DESIGN STUDY REPORT
ON
THE RECONSTRUCTION PROJECT
OF
THE FISHERIES HARBOUR AT VAITUPU
IN
TUVALU**

JANUARY 1995

NIPPON TETRAPOD CO., LTD.

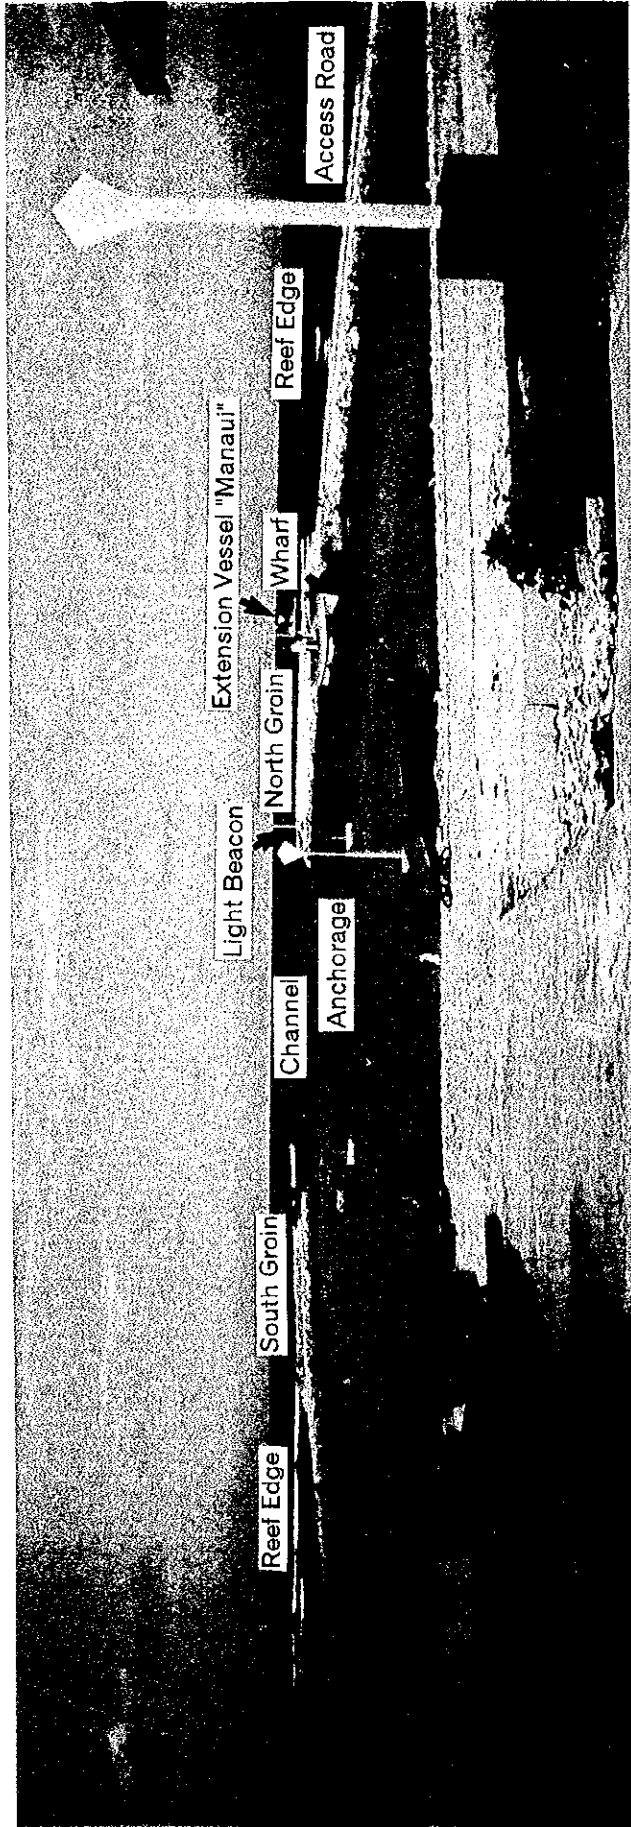
Photo 1 Fisheries Harbour before Cyclones

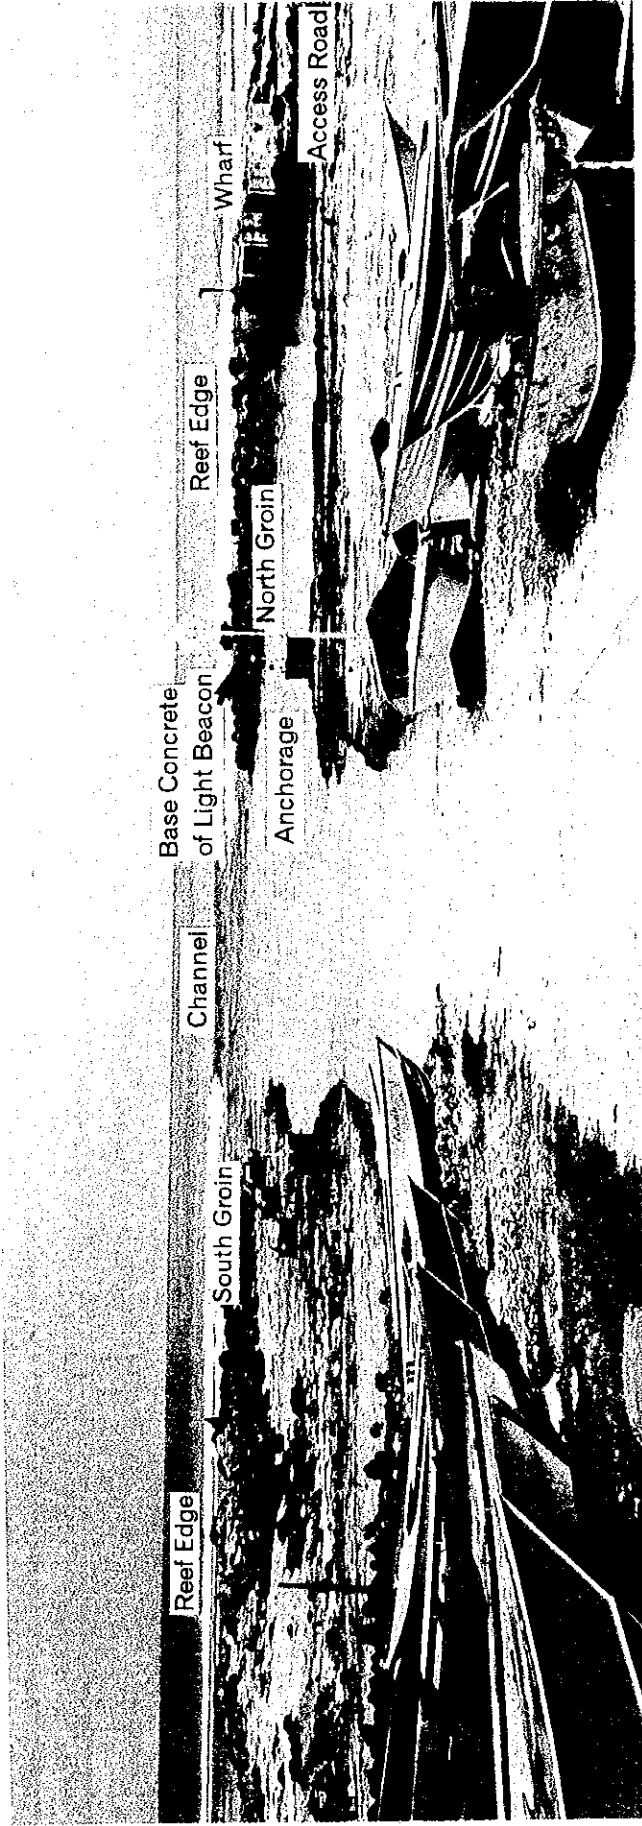
Photo 2 Fisheries Harbour After Cyclones

Fishery facilities such as the groins and channel in Asau, Vaitupu Island, which were constructed in Phase IV Project, have been seriously damaged soon after completion by the waves attributable to two large cyclones, "Kina" and "Nina", and most of their functions have been lost, hindering thus the fishing activities.

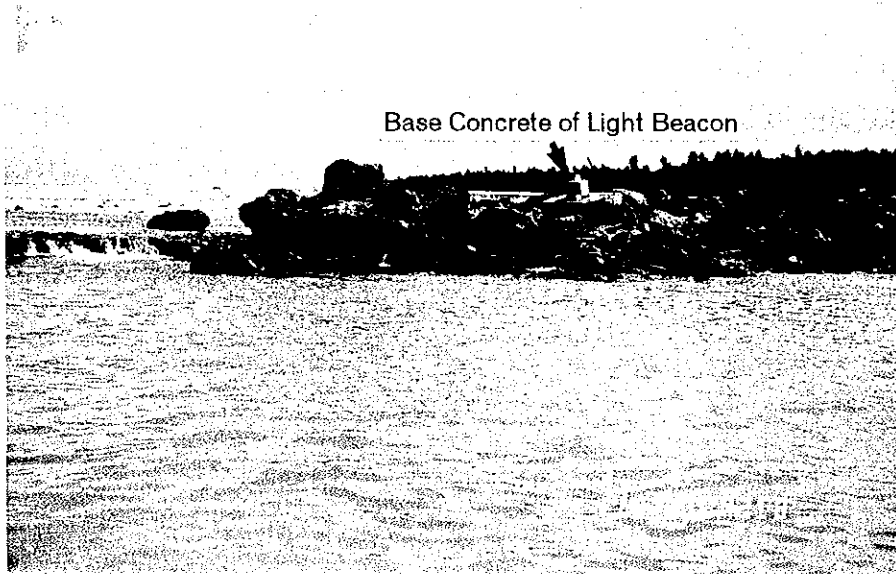
Photo③ Top of North Groin

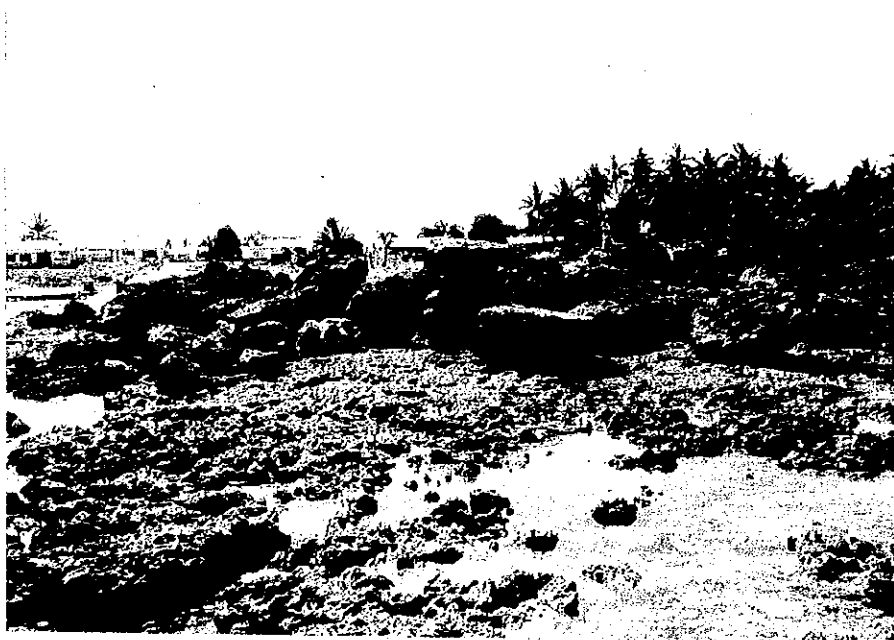
Photo④ Top of South Groin

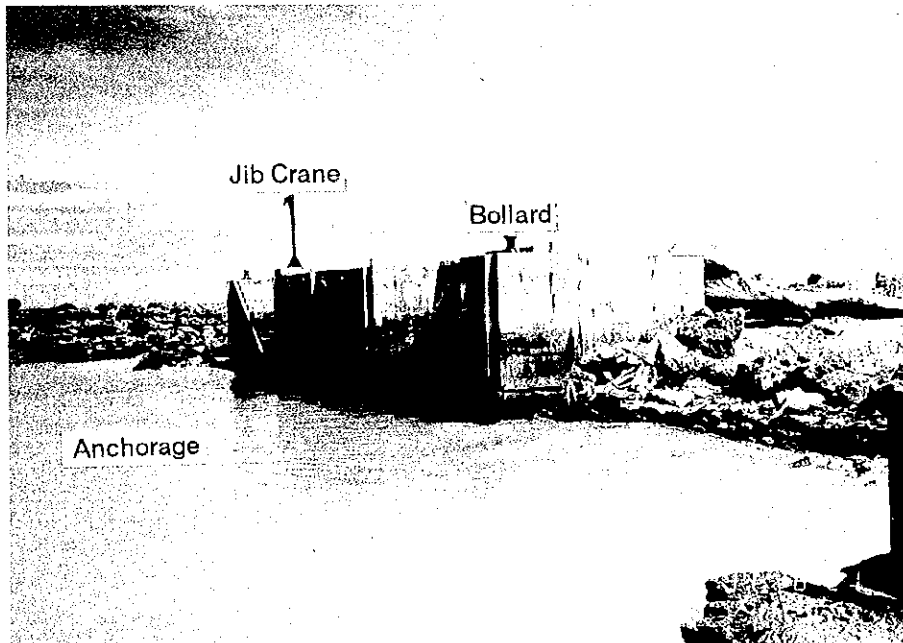
Photo⑤ Wharf

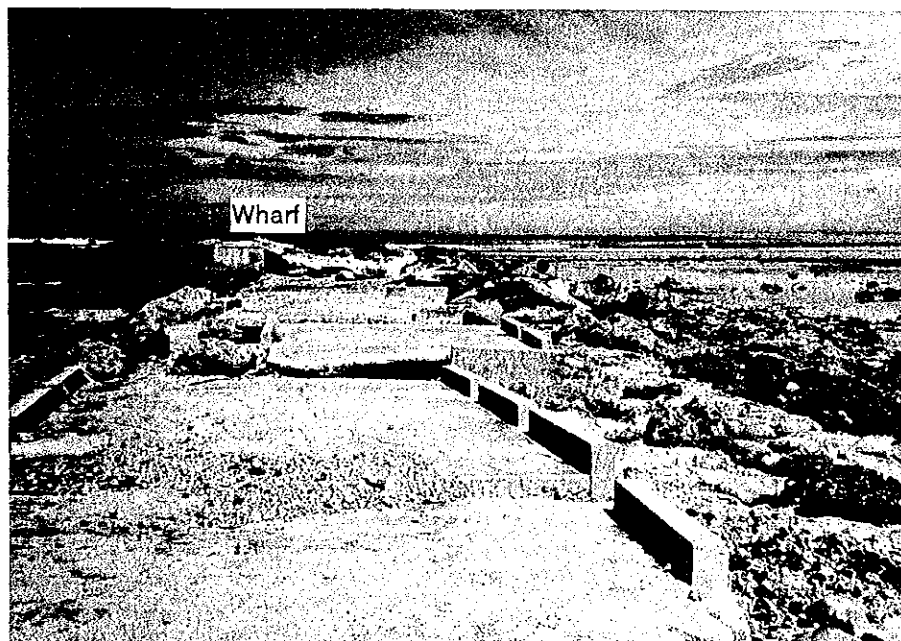
Photo⑥ Access Road
