2-3-4 Damages to Fisheries Harbour Facilities

The Asau Fisheries Harbour on Vaitupu Island suffered considerable damages by the two large scale cyclones in early January, 1993. The fact finding study was conducted by System Science Consultants Inc. and Dai Nippon Construction immediately following the disaster. Fig. 2-21 shows damages revealed by the study.

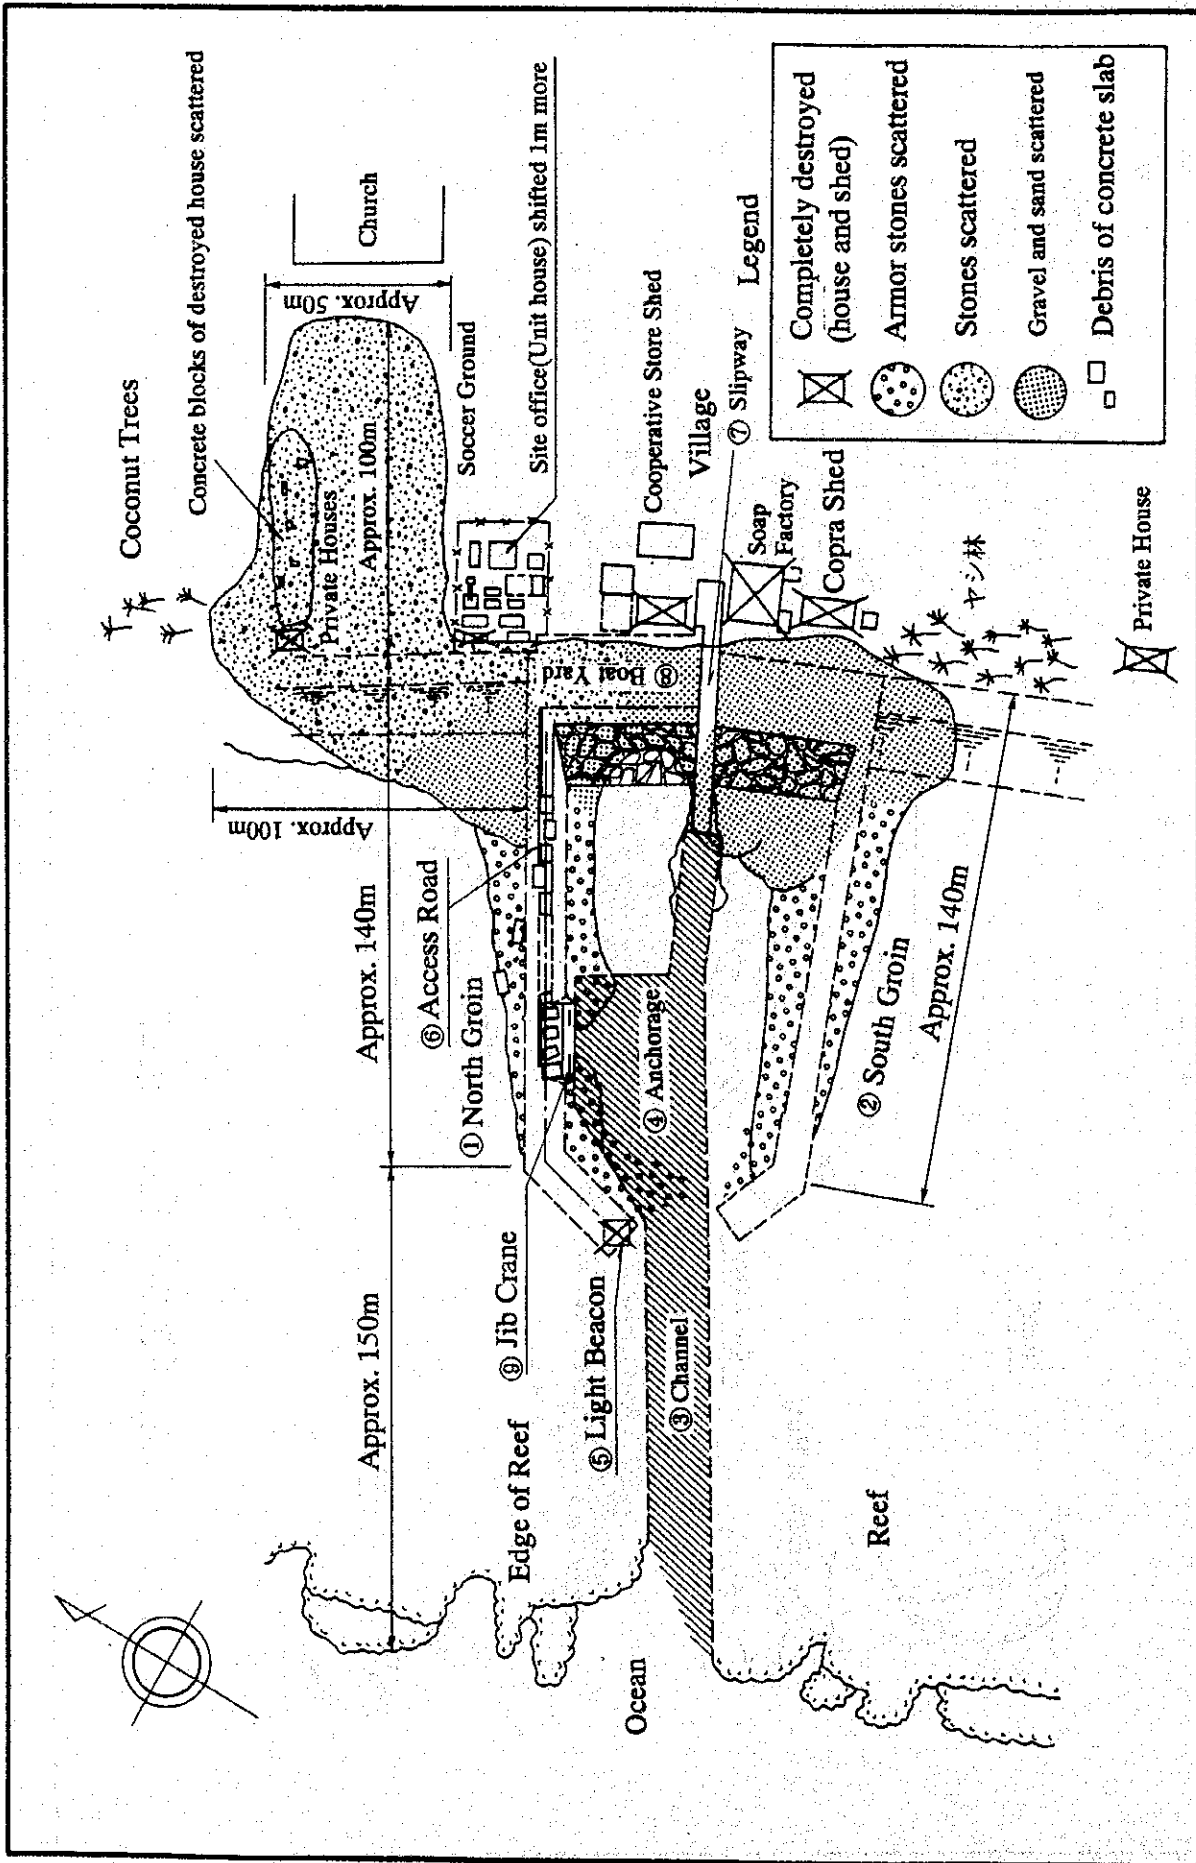
Fig. 2-21 Layout of the Asau Fisheries Harbour after Cyclones

Both groins were totally destroyed from the top to the toe. Both the filling sand and sand bags have flowed out and were scattered, and the

lightweight coral stones on the top were scattered whereas the bigger ones of 1 ton class remained at their original positions.

The access road on the north groin was planned to connect the wharf and the hinterland, but destruction proceeded from the side as the groin could not resist the waves sufficiently, leading to destruction of the entire structure. Fragments from the concrete pavement of access road and the armour stones from the groin surface were scattered all over the area.

As Fig. 2-22 shows, the armour stones and sand near the groin heads fell into and filled the channel and the anchorage.

The anchorage in front of the wharf at the approximate center of the north groin was also filled by filling sand from the groin. Some of the armour stones which fell into the channel have been removed, thereby allowing free entry into the port of small boats with outboard engines but not of extension vessel of "Manau" class (30 tons).

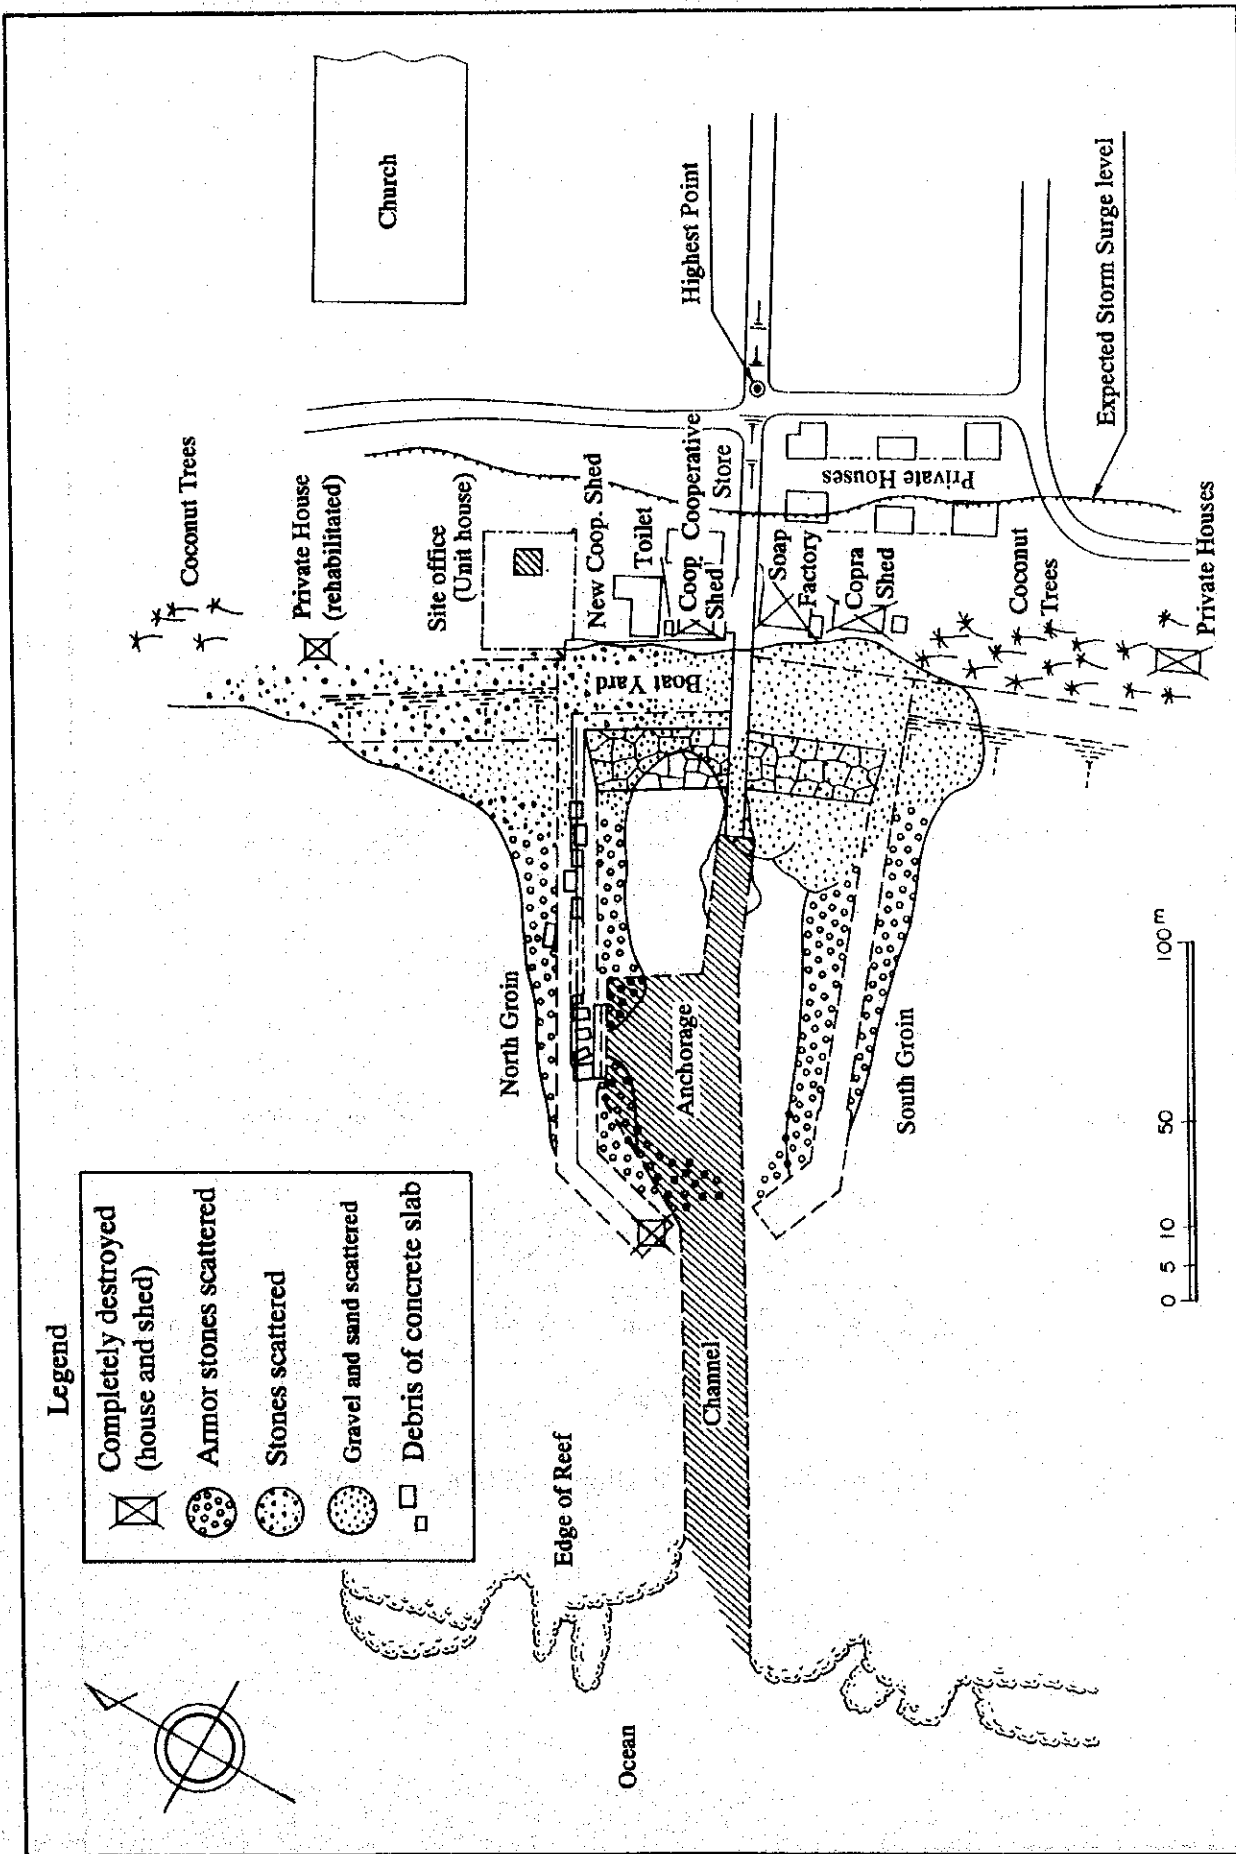
Fig. 2-22 Current Layout of the Asau Fisheries Harbour

The present study was conducted about one year and a half later and therefore the damages ascertained by the present study were quite different thanks to the emergency repair measures taken by the Government of Tuvalu and Dai Nippon Construction immediately following the disaster. The major changes are discussed below.

Fig. 2-22 shows damages to the sheds and private houses. The harbour area sandwiched between the north groin and the south groin is congested with many buildings and the damages concentrated in this area.

The cooperative shed, the soap factory, the copra shed and two private houses were destroyed entirely. The houses on the northern side were built quite sturdily with solid concrete blocks and were repaired immediately after the cyclones. Those on the southern side stood in the palm groves and would have been protected by the palm trees except the fact that they were mainly obsolete and fragile. Fallen buildings such as the sheds and the factory have been removed, leaving only the foundation and many armour stones showing the signs of the major disaster. These buildings acted to protect private houses and the cooperative store standing behind them and flooding was about the only damage suffered. Hardly any damages were observed to private houses in the areas other than the harbour area.

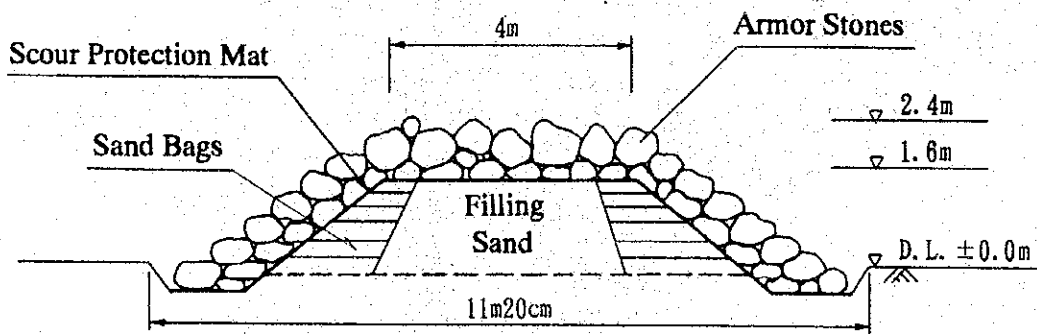
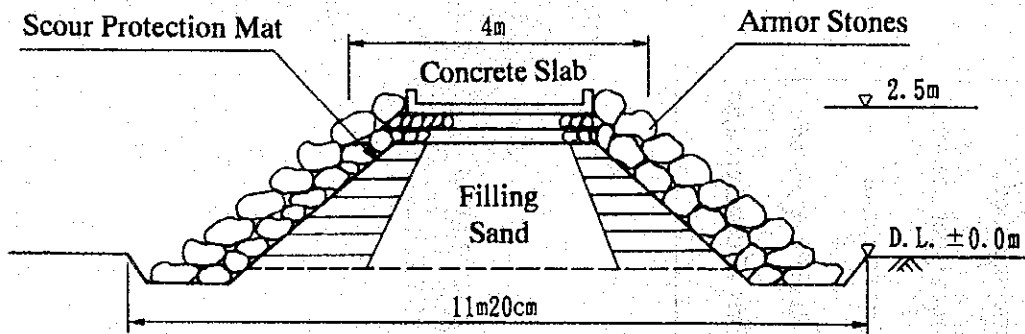
Fig. 2-23 Typical Cross Section of the Groin before Cyclones

Fig. 2-20 is a plan view of the fisheries harbour before the disaster, Fig. 2-21 that immediately after the disaster, and Fig. 2-22 is its current status. Fig. 2-23 shows the typical cross section of the groin before the disaster. As shown in the figures, the groins were the armour stone type and built on the coral reef with filling sand, over which were placed sand bags and mats to prevent sand from flowing out and then with coral stones of about 500 kg.
