4) Tafila FDS

Table 2-3-2-5 summarizes present state of Tafila FDS.

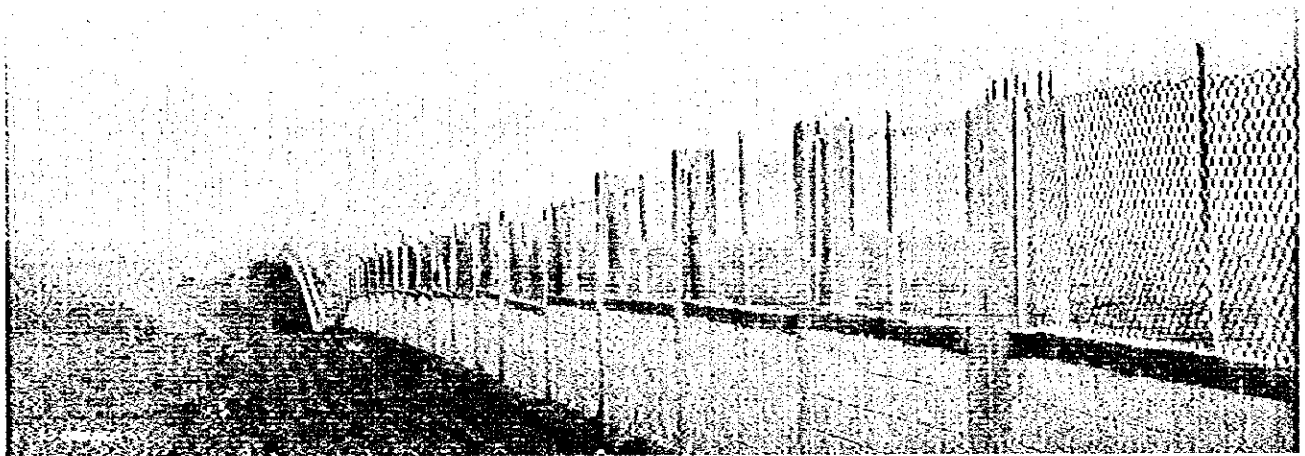
Guard fence are set up along landfill site boundary.

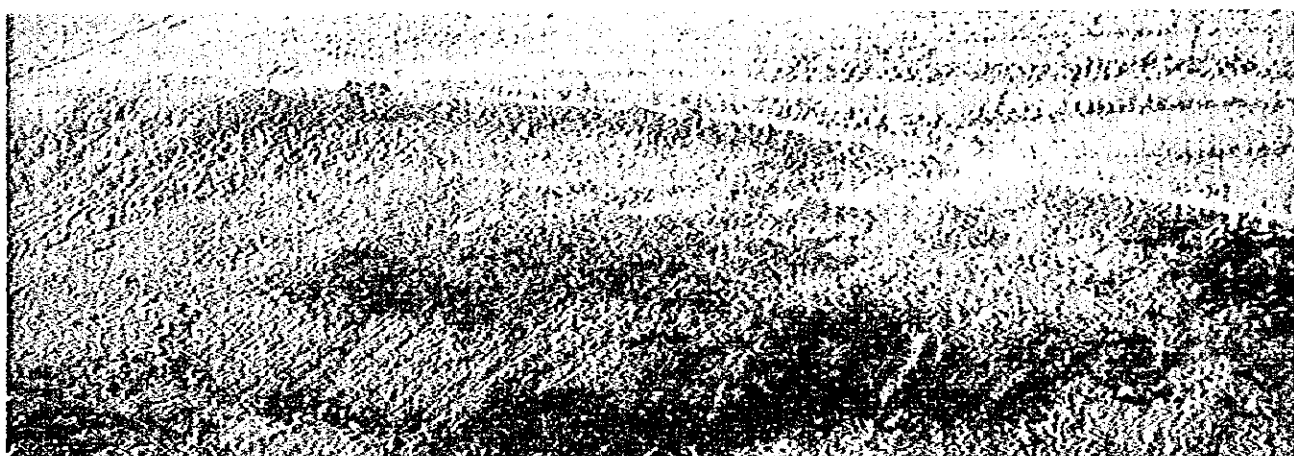
(5) Air pollution :A	<ul style="list-style-type: none"> * Complaints from farmers since open burn are executed at any time. * No problem of exhaust gas because of few number of hauling trucks. * No problem of dumping dusts because the major waste component is food wastes

View of open burning.

The current problem is the fact that flies and sanitarilly harmful insects give influences to nearby villages. Actions should be taken against the insects, scattered wastes, offensive odor and open burn.

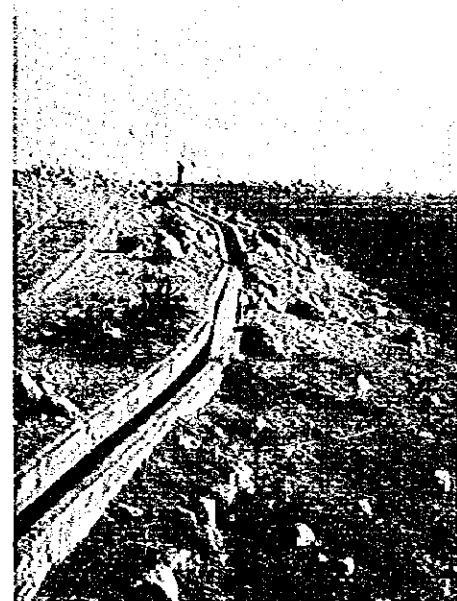
Side ditch of the farm beside landfill.

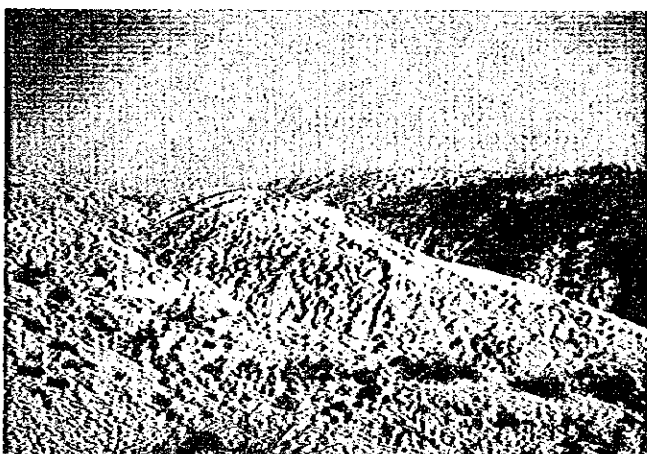
View from the bottom of FDS.

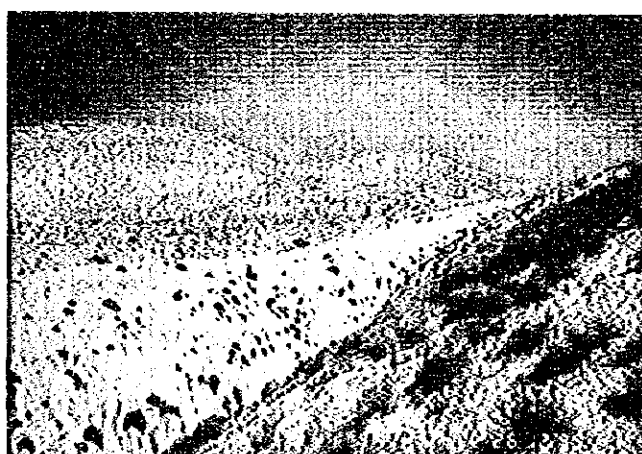
To construct new Kufrinja FDS,
the mound at the center of this photo will be excavated.

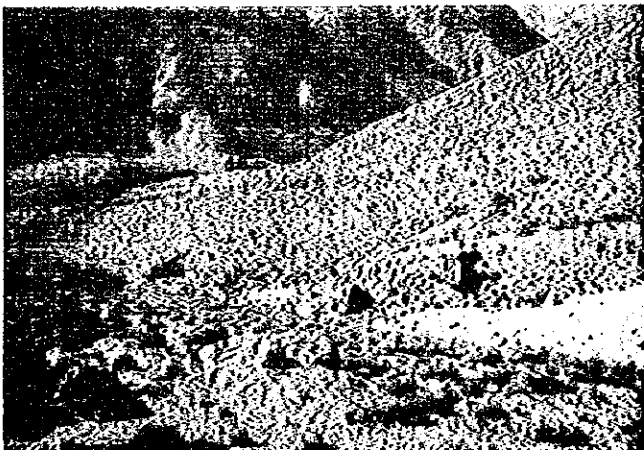
View of the flat area at the bottom
where a regulating reservoir will be constructed.

Same to the above.

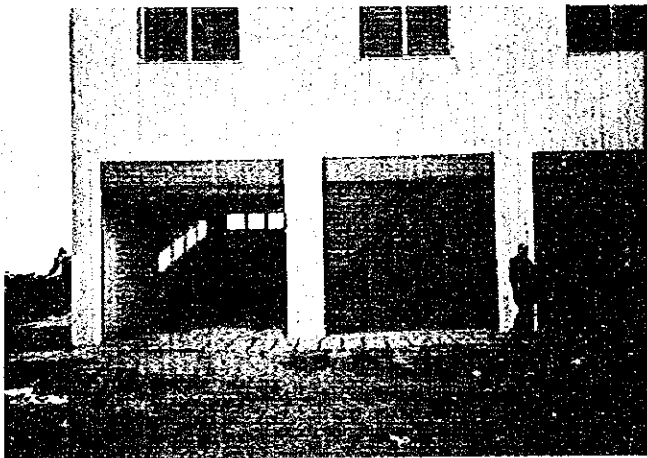
Three storied control office

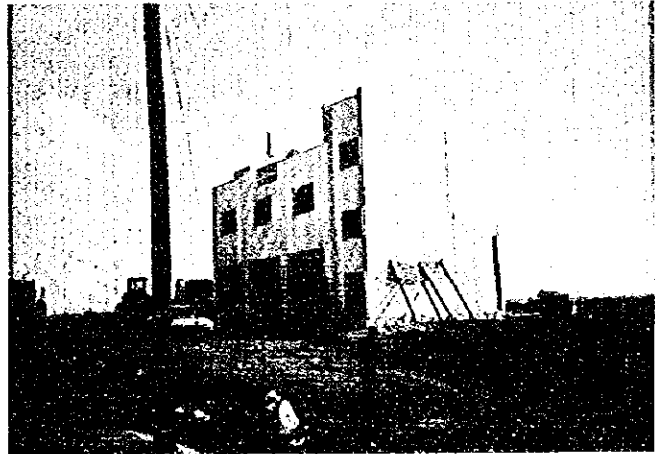
The space of first floor is kept for parking.
