### 3.7 Bridge Detailed Investigation

## CHAPTER 4 BRIDGE ASSESSMENT PROCEDURE

**Table 4-1 Degree of Defects of Each Rating**

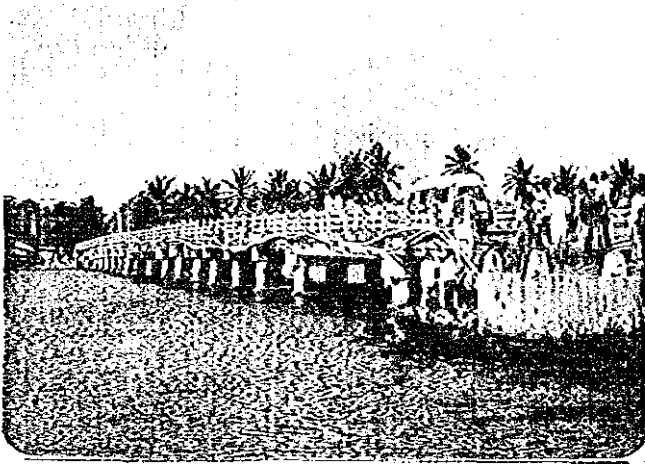
Ser No. 7 B425 20/4 km

A2 - A1 Overall view

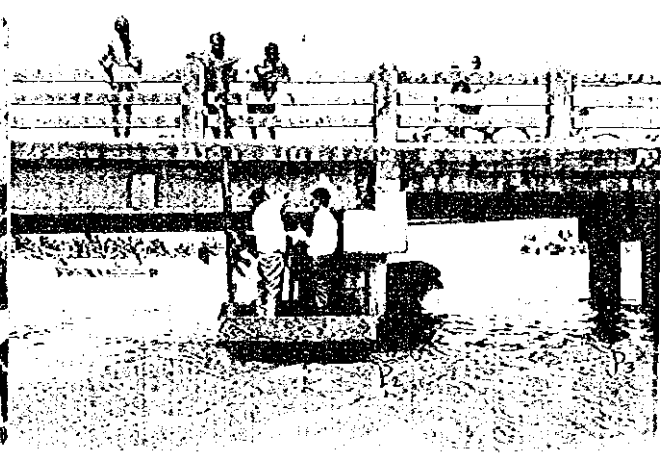
P17 - A2 Schmidt hammer test

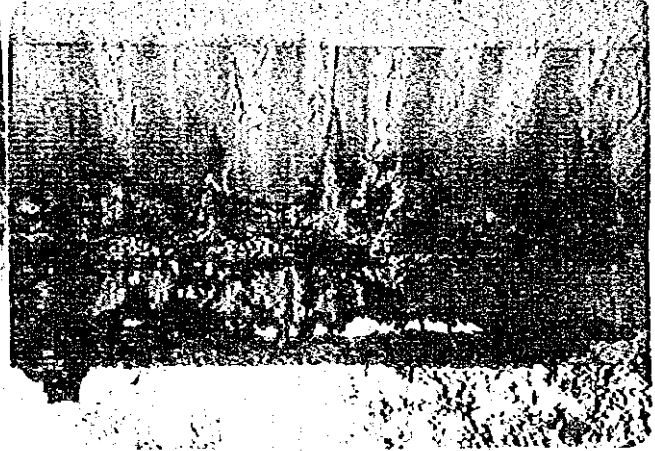
P1 - A2 Main girder G1

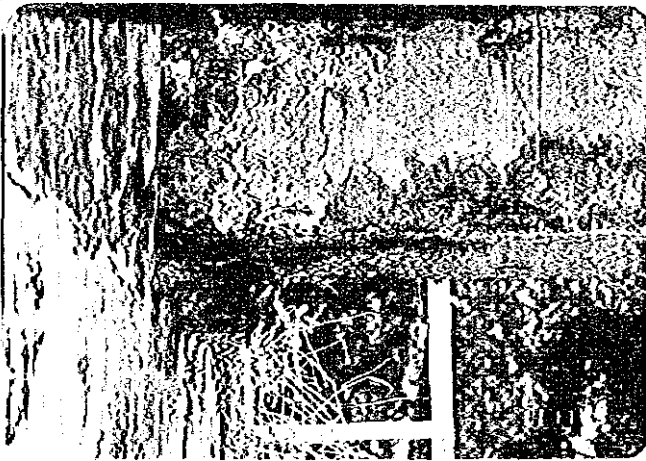
P1 G1 Bearing

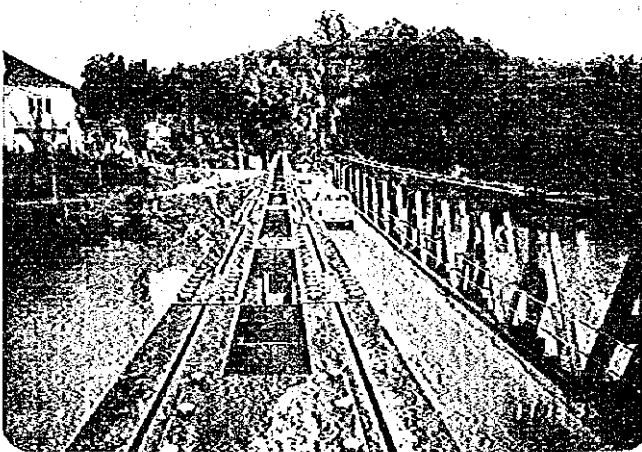
Top surface of chord members

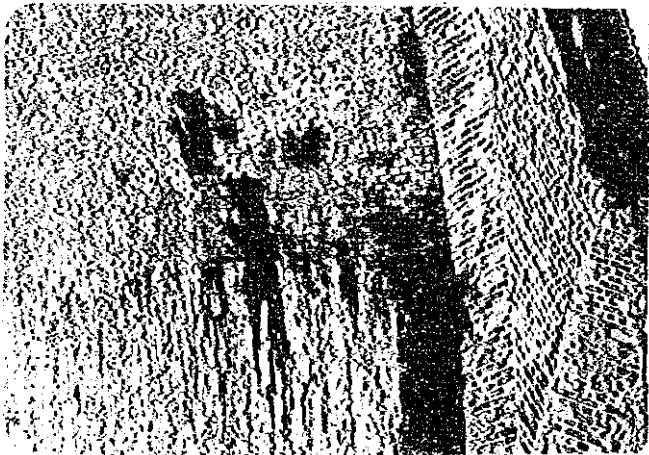
Bottom surface arch rib

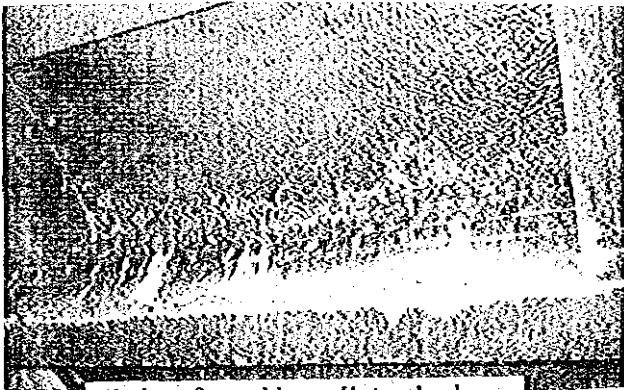
Rating 4

Major free lime Waterleakage

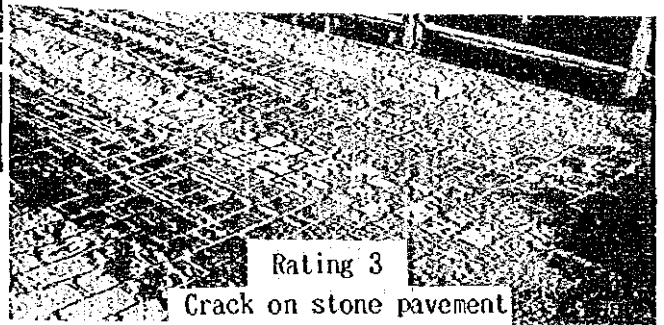
Rating 3

Crack on stone pavement

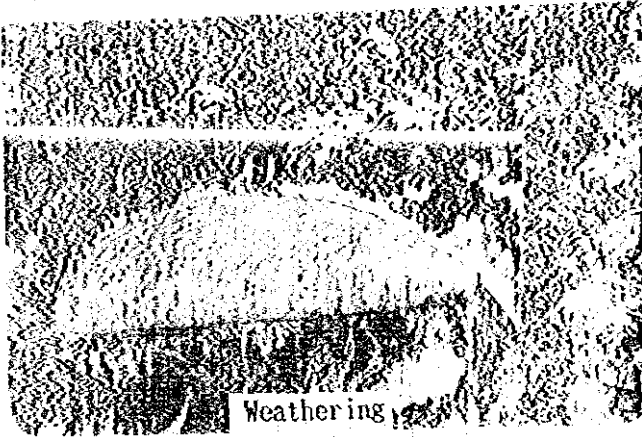
Weathering

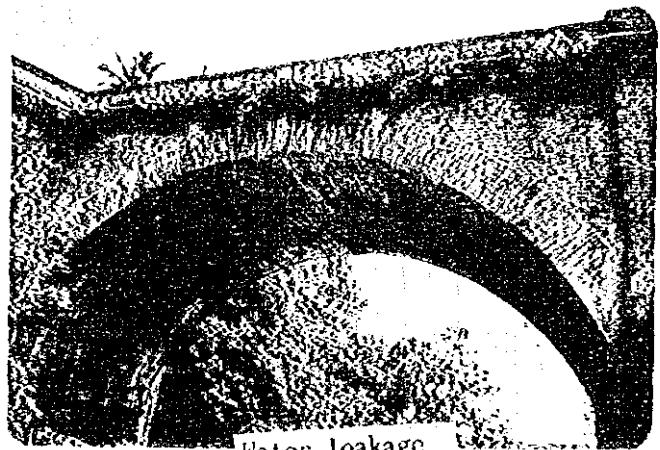
Water leakage
