7. Alkali-Aggregate Reaction Problems

7.1 Initial Findings

8. Conclusions and Recommendation of the MARHB Study

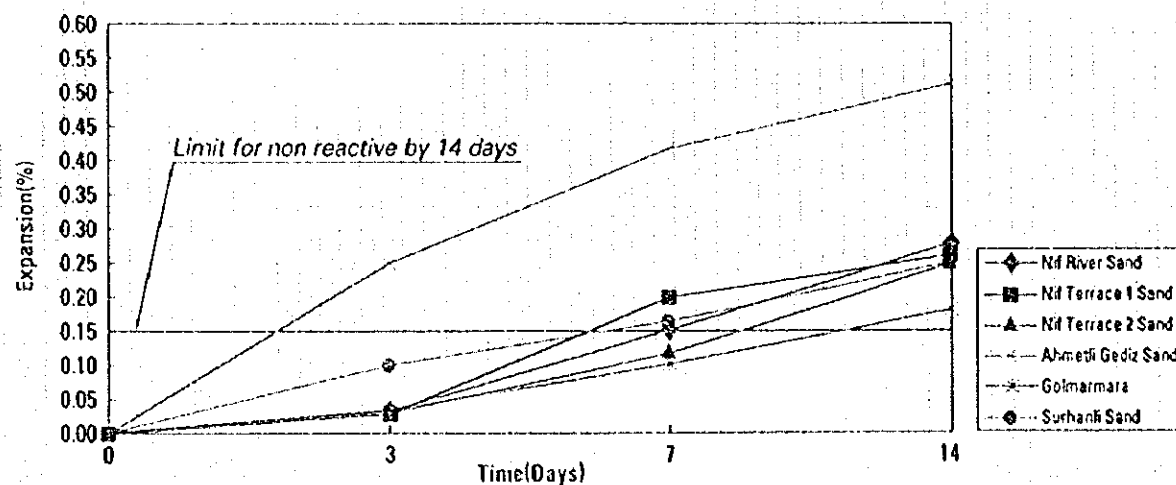
bridges and viaducts which were out of initial scope, to determine the extent of the problem. Generally the structures constructed within the last 12 years were showing cracking problems. Among many damaged ones several were selected to have them put in an order of ages of structures, ie. 1, 3, 5, 7-8 and more than 10 years. More sand samples were collected from suspect quarry sites and are shows the result of test in Table 7.2.1 and Figure - 7.2.1.

Presently some of testings are still under going, however, the results obtained so far show that all the sand samples show reactive behaviour although the degree of reaction differ by sample to sample, and structures of younger age show faster reaction than older ones. Figure - 7.2.2 shows the ample photograph of AAR.

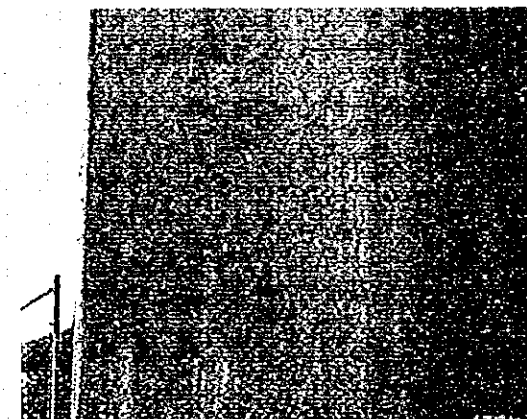
During the initial general inspection of the objective bridges, at the time of first visual inspection in Turkey, evidence of extensive cracking was found to substructures of several of the bridges in the Izmir region. The study team, jointly with the engineers from Izmir Division (KGM 2nd Division) and the laboratory people from the KGM Headquarters, the cracks were further inspected and Alkali Aggregate Reaction (AAR) of the concrete was suspected as the primary cause.

Cracks by AAR (Abutment)

Structure with smaller than 0.2mm cracks shall be covered with an elastic crack bridging paint to further prevent water vapour penetrating into the structure.

Ones with larger than 0.2mm cracks to seal them with either polyurethane or epoxy based resin by crack injection method.

Where concrete surface spalled, urgent repair is needed to reduce further deterioration of structure.

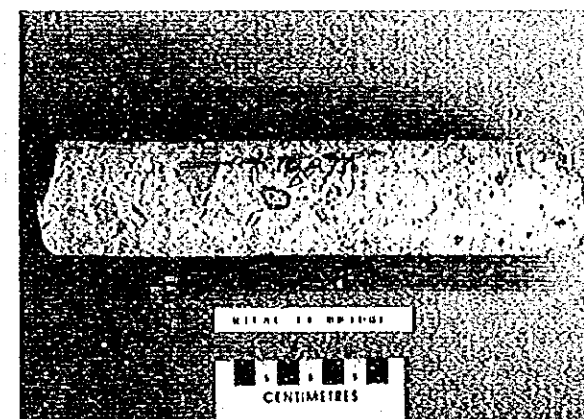
Concrete core sample contains a reacted gravel x 0.4

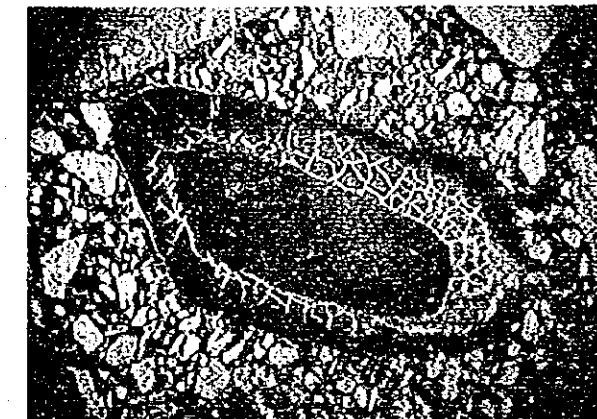
Close-up view of thin section showing minute cracks in the reaction rim x 6
