6.4 Structural Investigation

THE STUDY ON
 THE MAINTENANCE AND REHABILITATION of
 HIGHWAY BRIDGES in THE REPUBLIC of TURKEY
 AUGUST, 1996
 ORIENTAL CONSULTANTS COMPANY LIMITED
 in association with
 JAPAN OVERSEAS CONSULTANTS COMPANY LIMITED

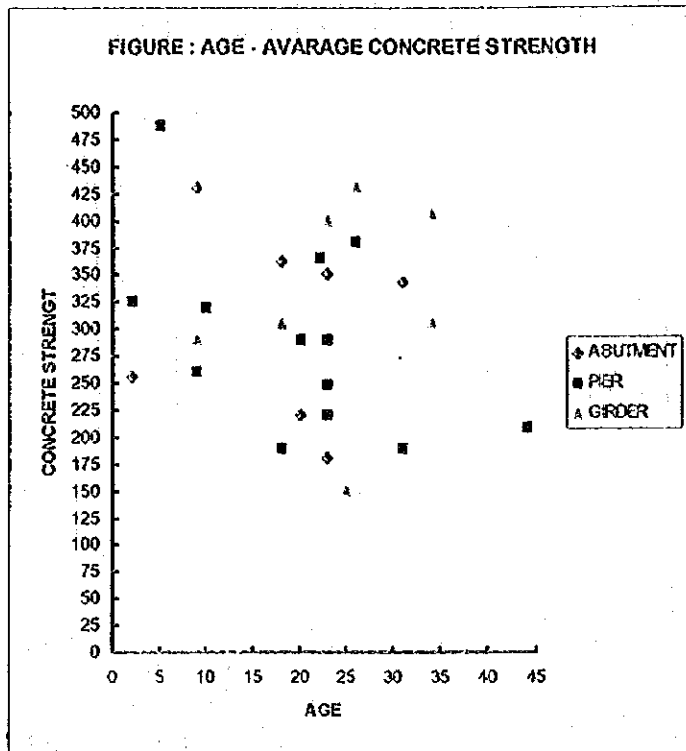
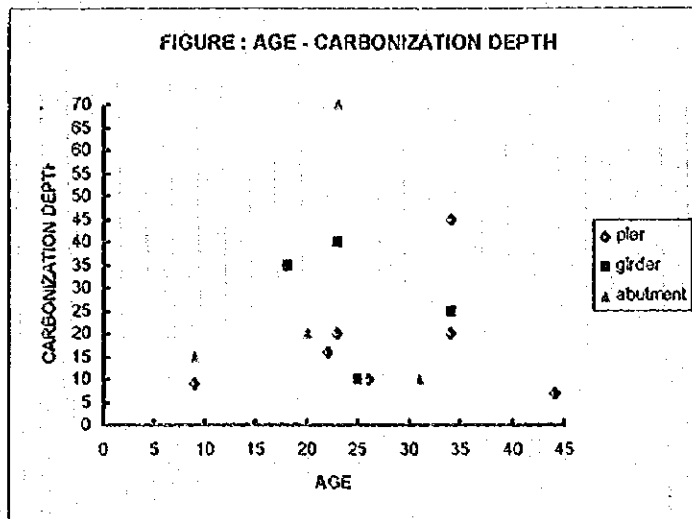
Figure - 6.4.1 Concrete Strength of the Bridge

Compressive concrete strength was investigated using a Schmidt Hammer for concrete components for which the damage rating was more serious than rating 'B'. Some locations for investigation were changed to enable testing to be undertaken without a platform. Investigated results are summarized in Table - 6.4.3 and Figure - 6.4.1.
