THE STUDY ON  
 THE MAINTENANCE AND REHABILITATION OF  
 HIGHWAY BRIDGES in THE REPUBLIC of TURKEY  
 AUGUST, 1996  
 ORIENTAL CONSULTANTS COMPANY LIMITED  
 in association with  
 JAPAN OVERSEAS CONSULTANTS COMPANY LIMITED

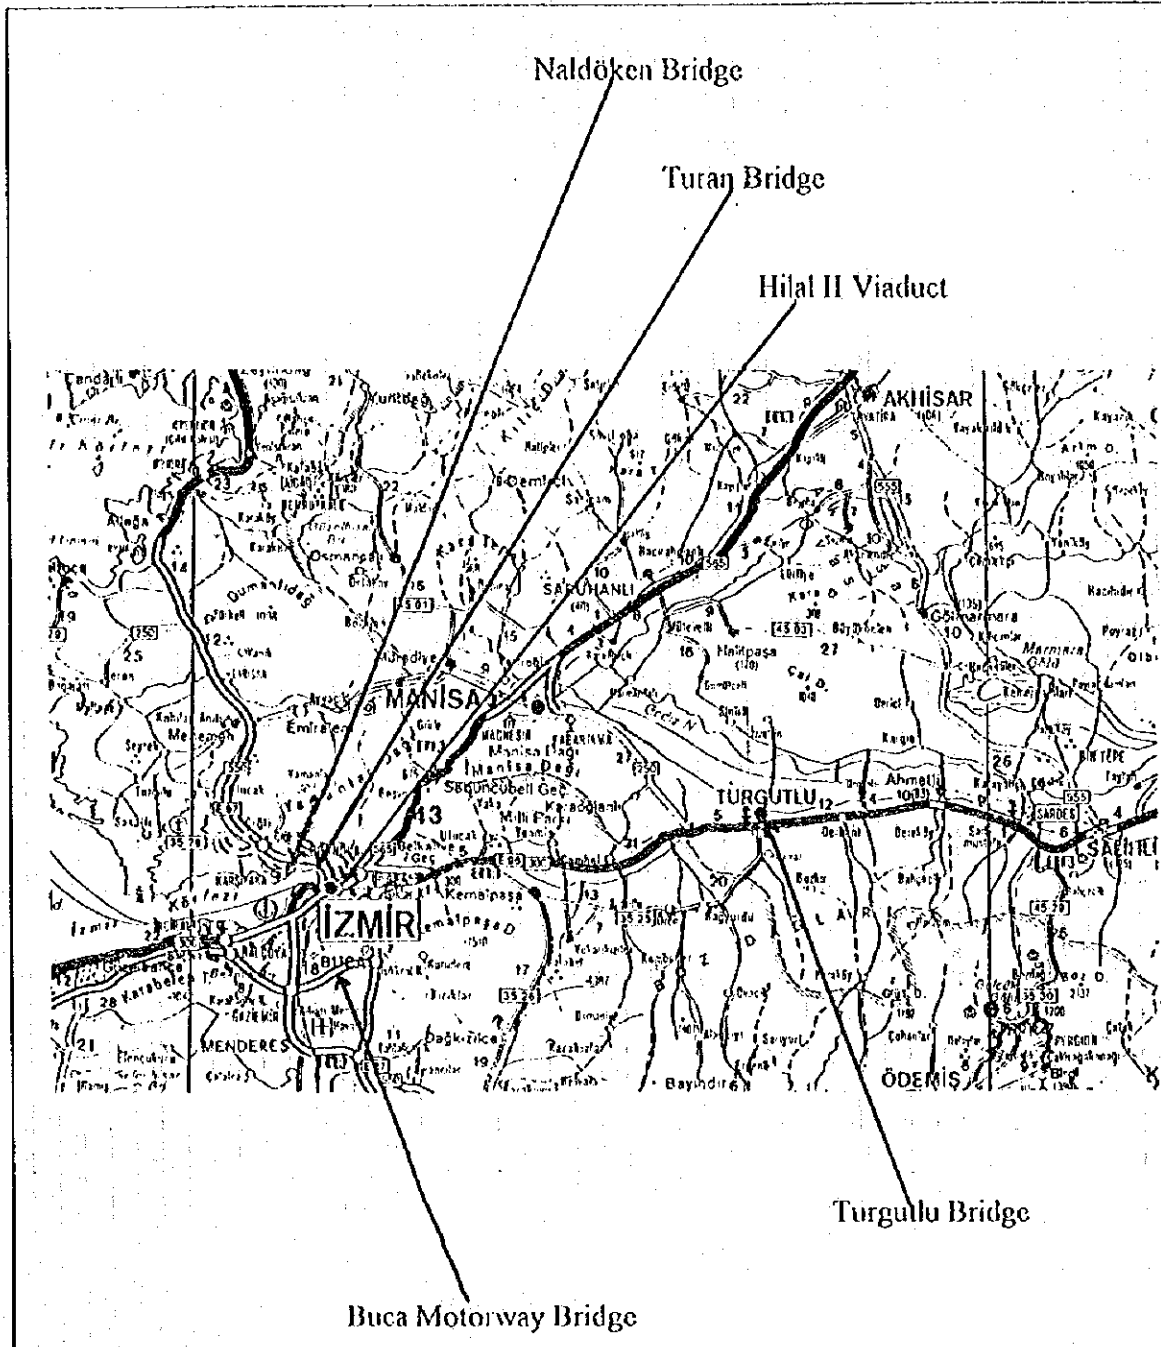
Figure - 12.3.1  
 Location of Bridges Investigated

Buca Motorway Bridge has a primary cracking pattern which appears to follow the line of the horizontal reinforcement. These cracks are approximately up to 0.3mm in width. A secondary random cracking pattern has developed with cracks up to 0.25mm width. The cracks are far more evident in areas exposed to direct rain, such as the abutments between the two bridge decks and the abutment wingwalls.

The primary cracks (0.25mm) were sealed last year (September 1994) with an epoxy based sealant. In areas exposed to direct rain the cracks have continued to develop cracking the sealant. This suggest that the cracks are 'live' and are continuing to propagate.

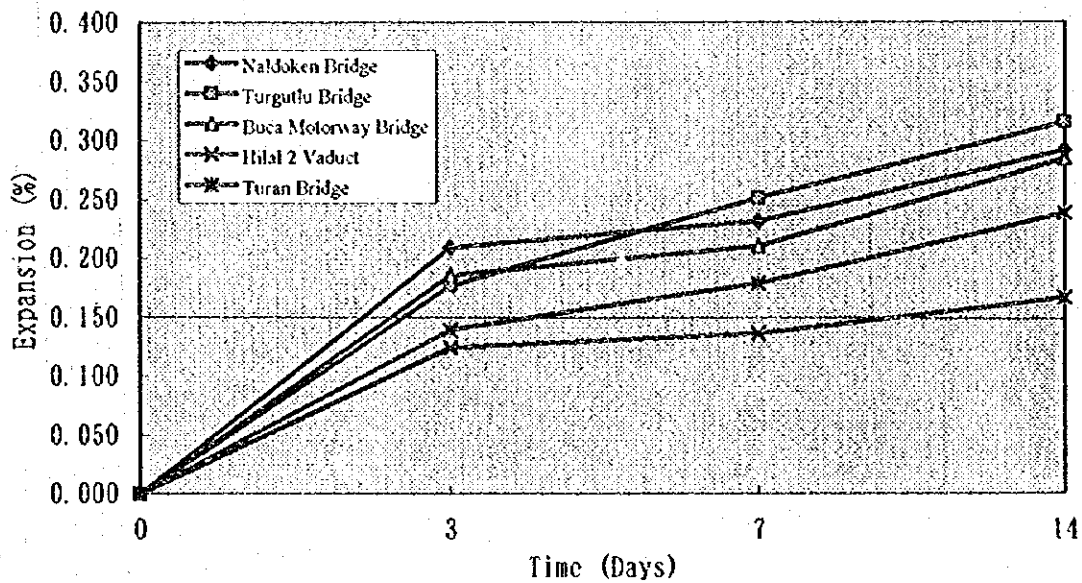
Figure - 12.6.2  
Results of Accelerated Concrete Core Test  
(CSA A23.2-25A Modified) Testing Carried Out in KGM  
Laboratories Ankara, Turkey

Structure Name	Location	Concrete Core No.	Expansion(%)		
			3 Days	7 Days	14 Days
Naldoken Bridge	Abutment	3	0.225	0.318	0.418
	Pier	4	0.230	0.217	0.257
	Pier	7	0.172	0.159	0.198
	Average	-	0.209	0.231	0.291
Turgutlu Bridge	Pier	1	0.192	0.265	0.370
	Pier	4	0.105	0.204	0.259
	Abutment	5	0.235	0.285	0.316
	Average	-	0.176	0.251	0.315
Buca Motorway Bidge	Abutment	1	0.189	0.258	0.388
	Abutment	2	0.146	0.133	0.200
	Abutment	3	0.219	0.239	0.266
	Average	-	0.185	0.210	0.284
Hilal2 Vaduct	Pier1	1	0.069	0.076	0.083
	Pier7	6	0.178	0.197	0.250
	Average	-	0.124	0.136	0.166
Turan Bridge	Column	1	0.138	0.257	0.336
	Abutment	5	0.142	0.109	0.136
	Abutment	6	0.137	0.169	0.242
	Average	-	0.139	0.178	0.238
