APPENDIX 6.2

Levels of Service (USA Federal Highway Board)

**THE STUDY ON
 THE MAINTENANCE AND REHABILITATION OF
 HIGHWAY BRIDGES in THE REPUBLIC of TURKEY
 AUGUST, 1996
 ORIENTAL CONSULTANTS COMPANY LIMITED
 in association with
 JAPAN OVERSEAS CONSULTANTS COMPANY LIMITED**

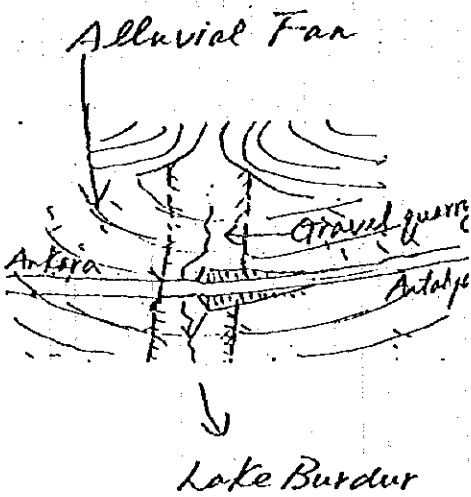
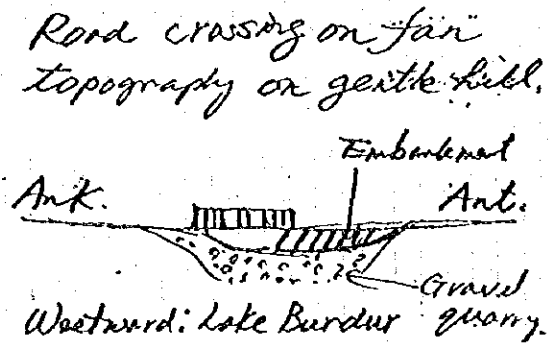
Fig 9-2-2 INSPECTION SHEET

<p style="text-align: center;"><i>Alluvial Fan</i></p> <p style="text-align: center;"><i>Lake Burdur</i></p>

<p style="text-align: center;"><i>Road crossing on fan topography on gentle hill.</i></p> <p style="text-align: center;"><i>Embankment</i></p> <p style="text-align: center;"><i>Ank. Ant.</i></p> <p style="text-align: center;"><i>Wetward: Lake Burdur quarry.</i></p>		
Remarks:

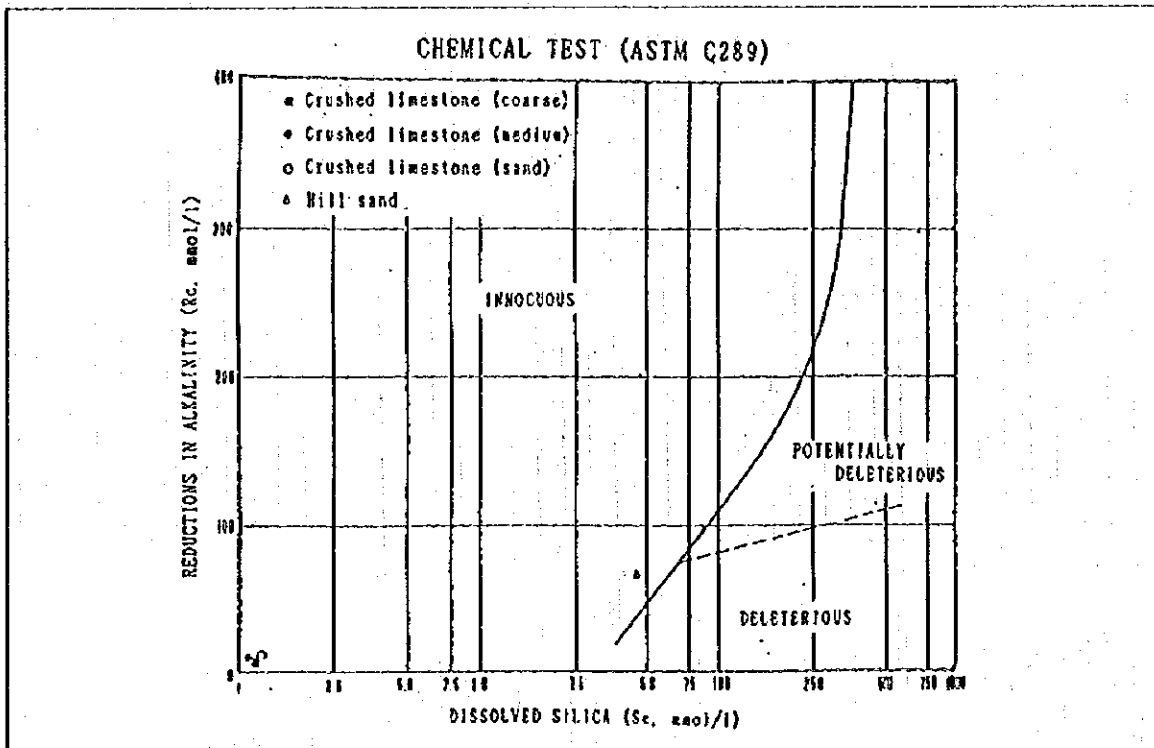
Figure - 9.1.1
 Result of Chemical (ASTM C289)

Result of the chemical test (ASTM C289)

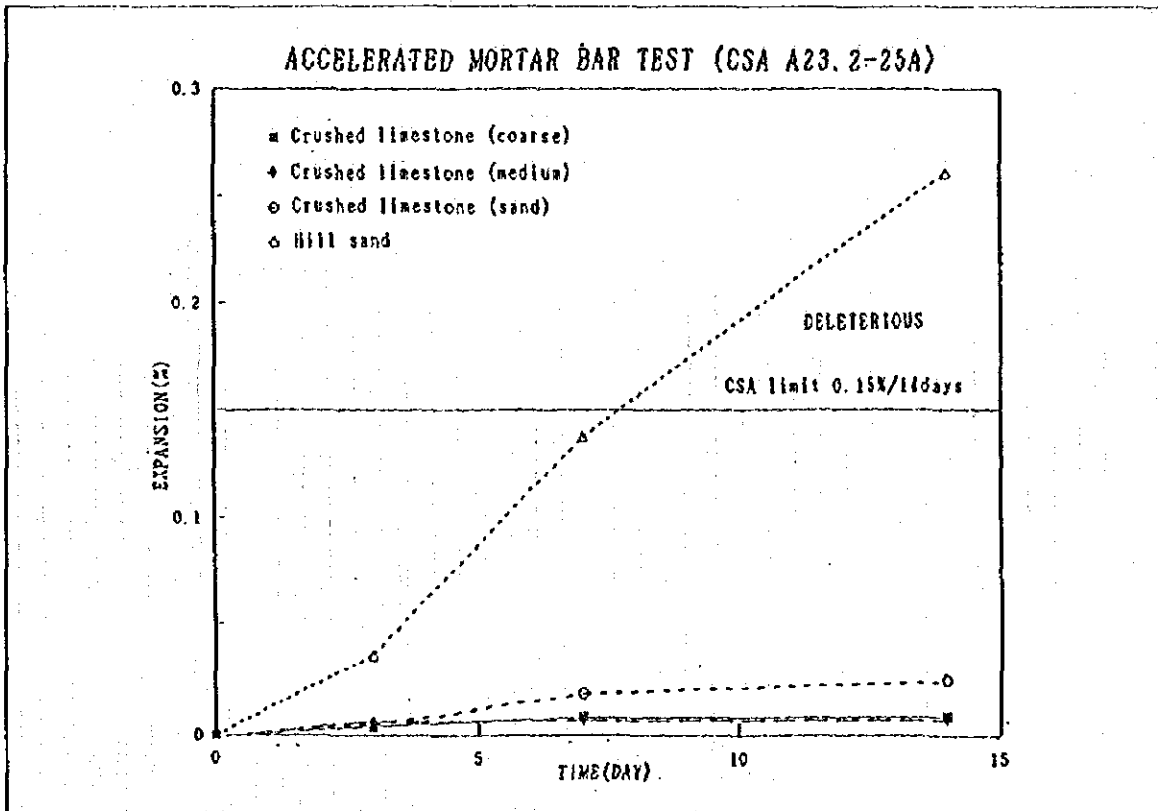
Figure - 9.1.2
 Result of Accelerated Mortar Bar Test
 (CSA A23.2-25A)

Result of the accelerated mortar bar test (CSA A23.2-25A)

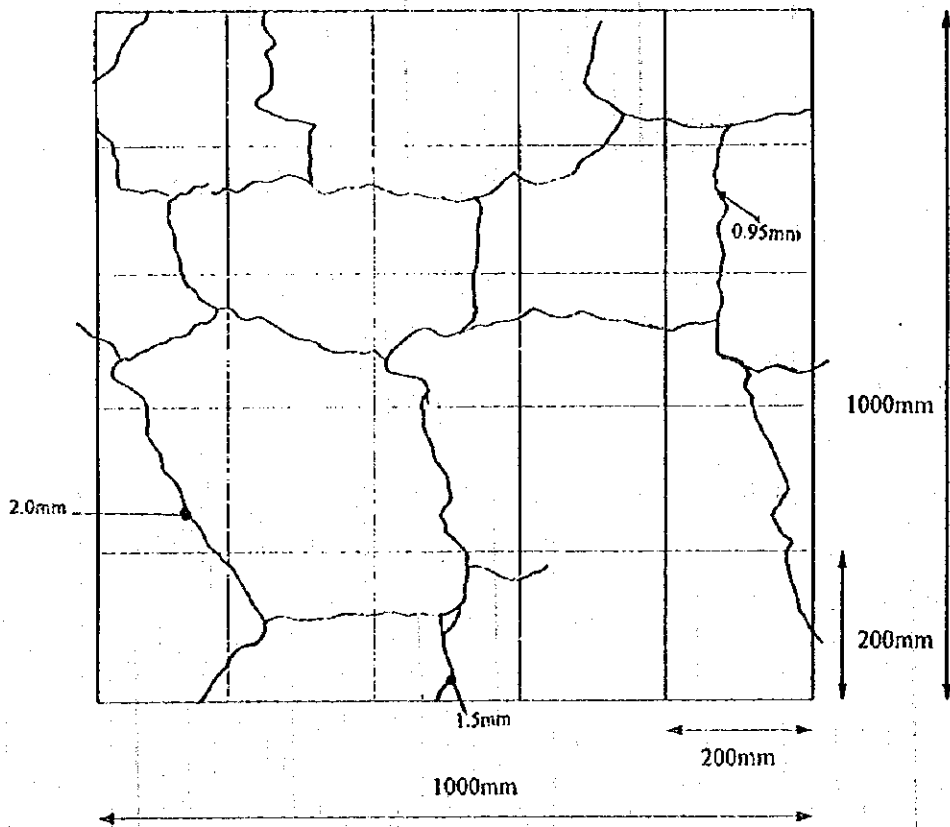
Figure - 9.1.16

Existing Cracks on Abutment I/
 Kahramanlar Side

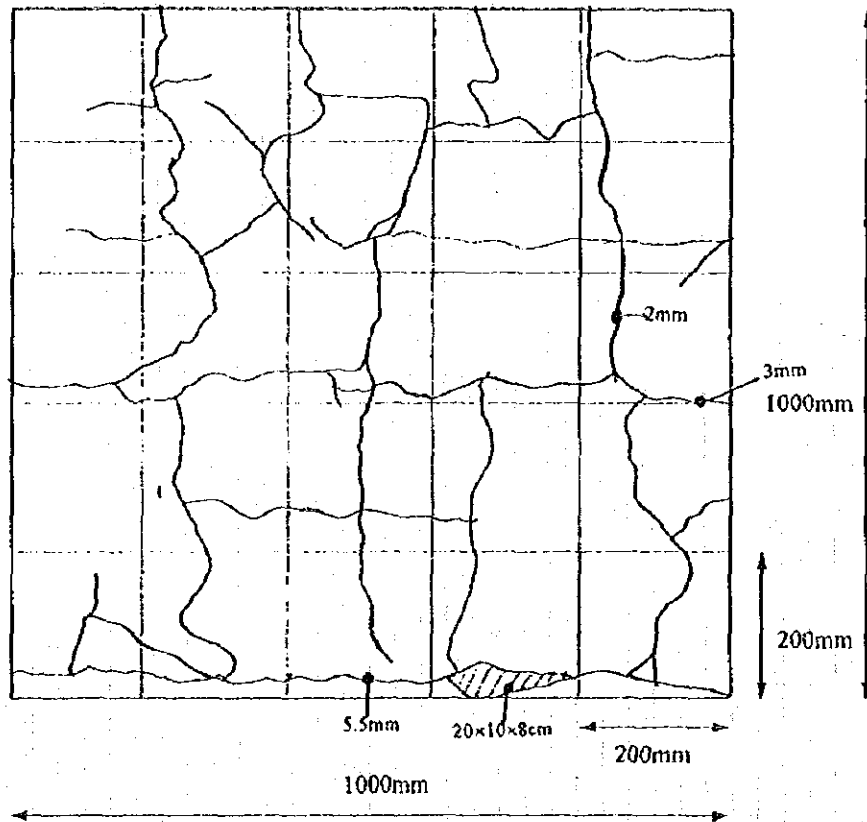
Figure - 9.1.17
 Existing Cracks on Pier I Crossbeam/
 Yesildere Side

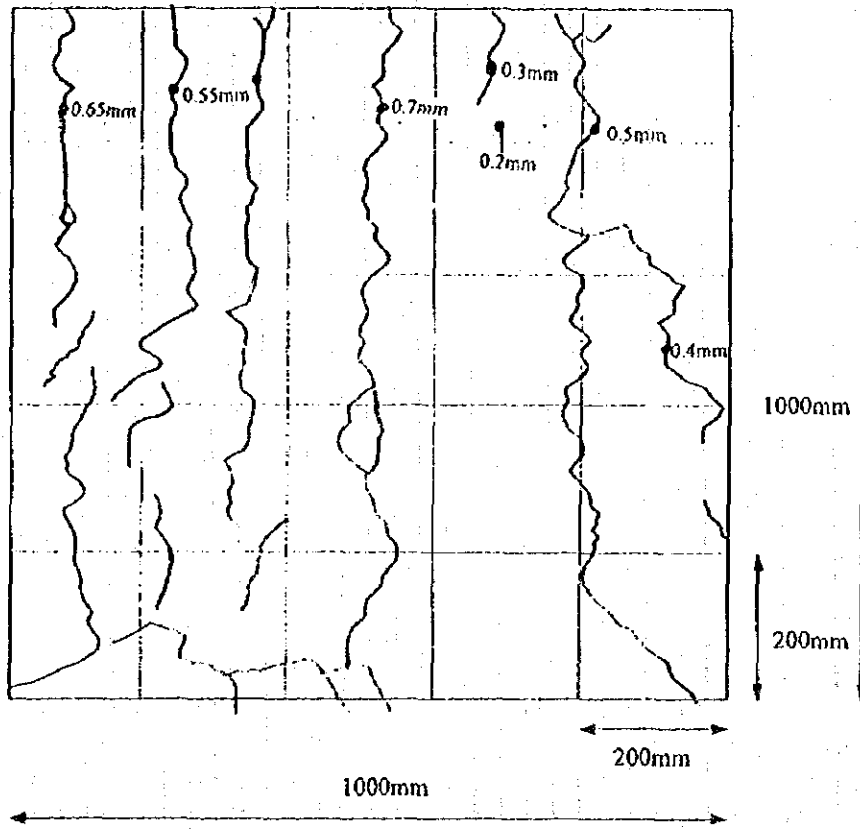
Figure - 9.1.19
 Existing Cracks on Pier 7/Ankara Side
