THE STUDY  
ON  
THE IMPROVEMENT  
OF  
WASTEWATER MANAGEMENT  
IN  
THE GUATEMALA METROPOLITAN AREA

FINAL REPORT

VOLUME IX  
DATA BOOK

**DATA BOOK DA**  
**SURVEY ON EXISTING SMALL-SCALE**  
**SEWAGE TREATMENT PLANTS**

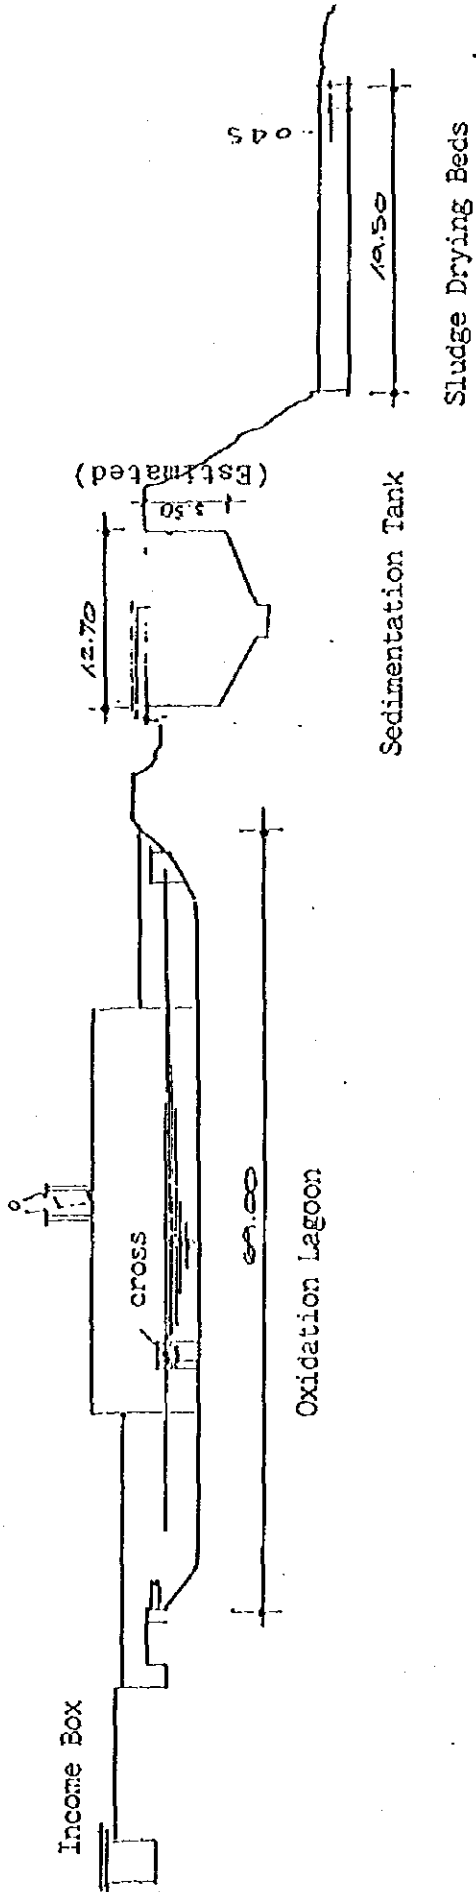
HYDRAULIC SKETCH

The inlet pipe present 3 broken sections on the bridge over the EL CAMPANERO river.

- 7.1 Because of the three broken sections of the inlet pipe, it is estimate they only the 50% of the flow goes to the treatment area, and the rest goes directly to El Campanero River.

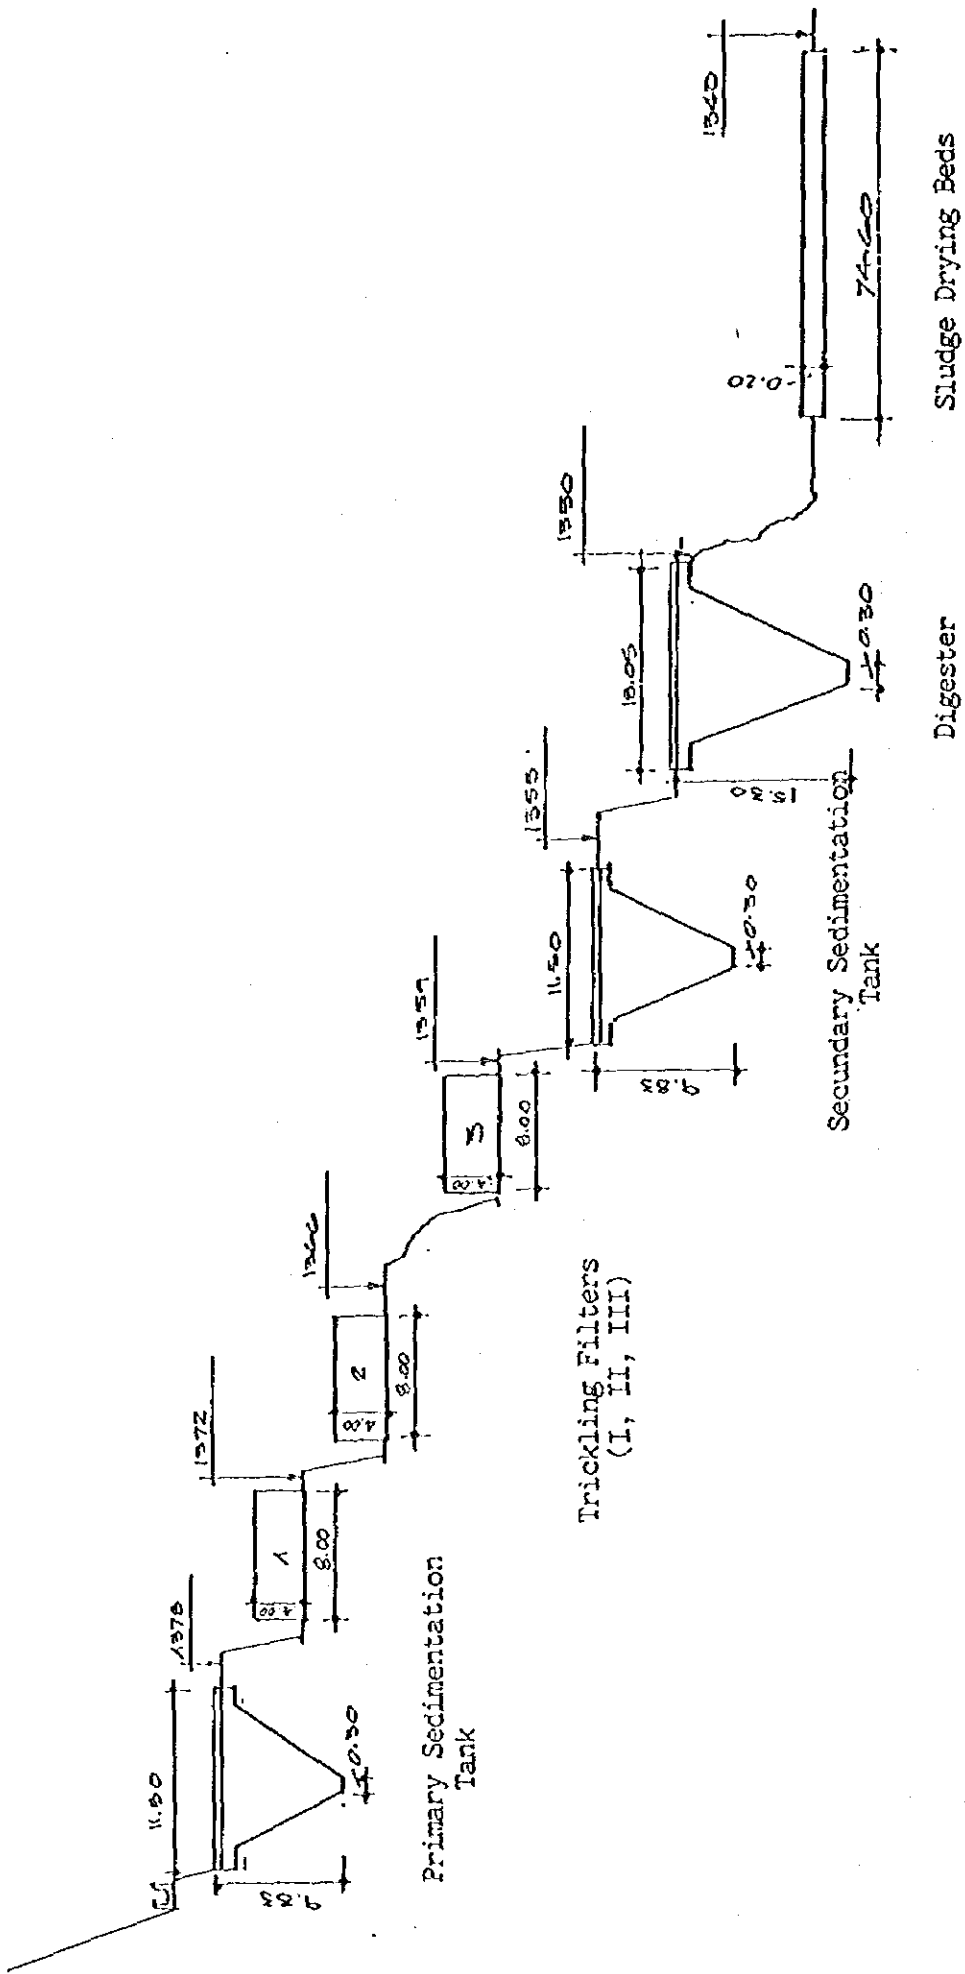
HYDRAULIC SKETCH

it is estimated that only 60 % of the water is treated,  
because the distribution flow pipes on trickling  
filters are damage.

Pipes on Trickling filters are with corrosion.

Valves on trickling filter with corrosion, 84 valves.

The cover of the first box for sludge removal is broken, this is causing an overflow during the removal of sludge from the primary sedimentation tank.

It is necessary to change 84 pipes of 2" HG, and repair connection in firts box for removal sludge.

It is necessary to change HG 2" 84 valves in trickling filters, wich the screw-thread have corrosion.

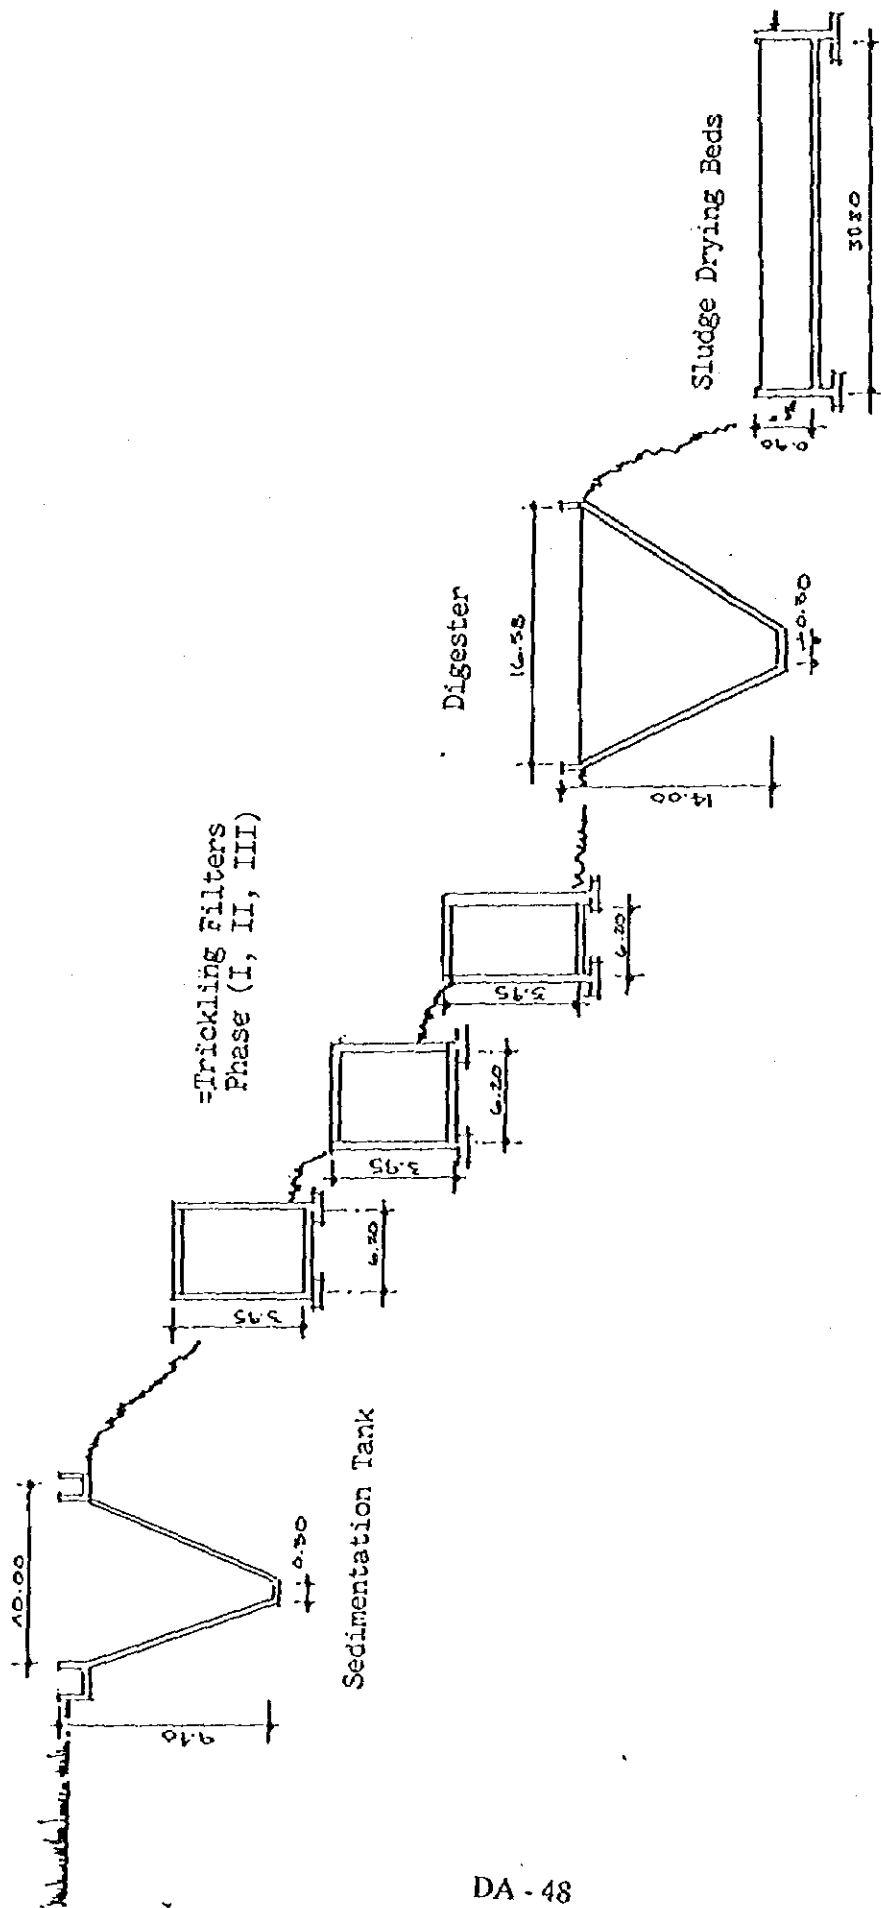
HYDRAULIC SKETCH (Section A-A)

- 5.1 STRUCTURAL STATE
  - The two sedimentation tanks has damage in the internal walls, reason for the filtration out of the flow.
  - The bridges over the structures (sedimentation tanks), have corrossion.

- 5.2 STATE OF PIPES
  - There is corrosion in the distribution pipes of the trickling filters.

- 5.3 FLOODGATE VALVES FOR OPERATIONS CONTROL
  - There is corrosion on the valves of the distribution flow on trickling filters.

- 6.1 STRUCTURES  
Sedimentation tank: it is necessary plastering on the inside of the sedimentation tanks (impermeabilization), and the pannel of the central module of the tank has to be replaced (5.00 x 5.50 mts), the pipes for the sludge removal has to be replaced (3 pipes and 1 TEE of 6" diameter).

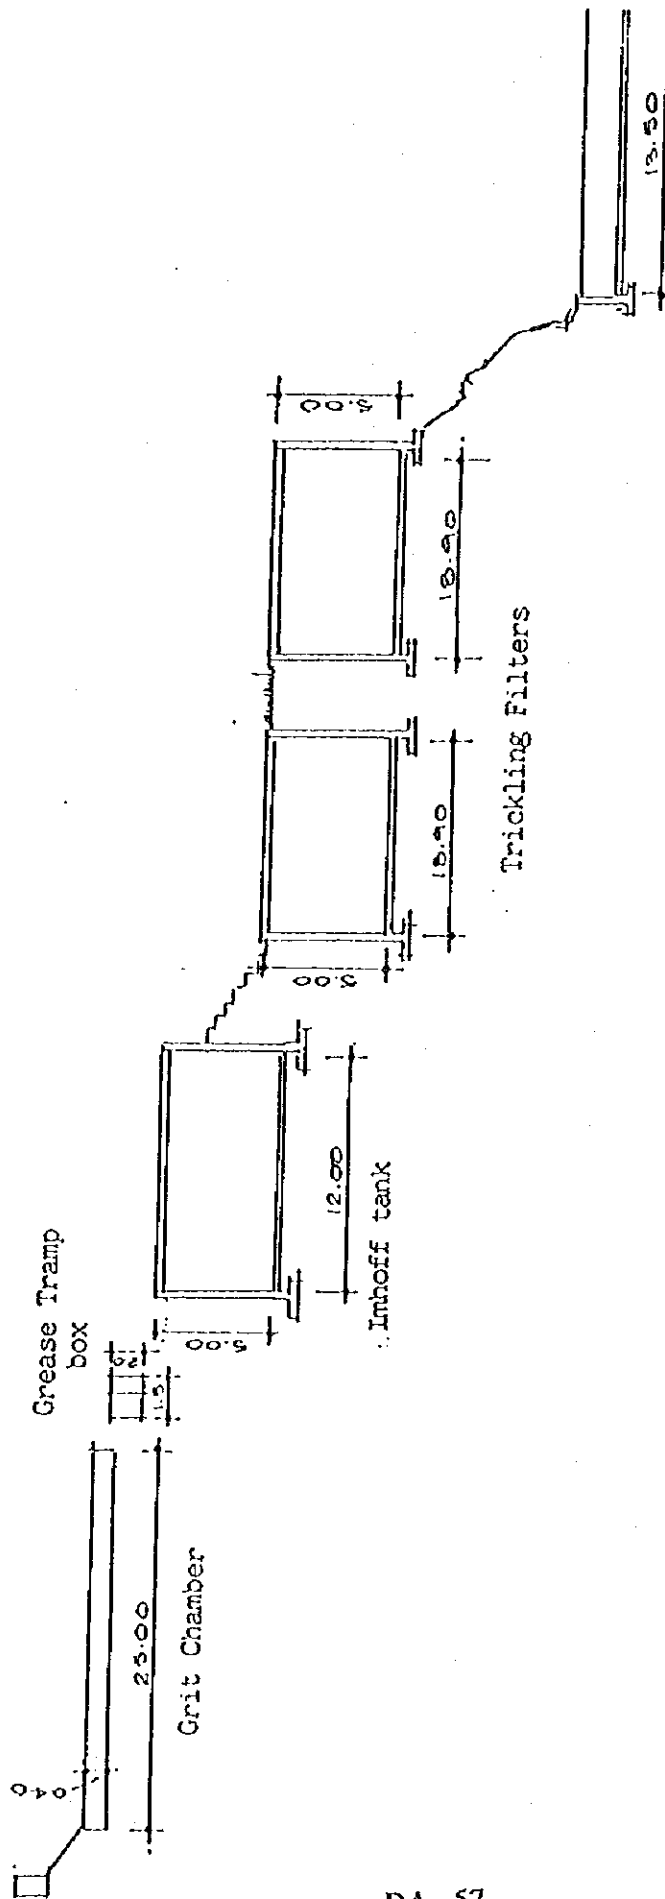
HYDRAULIC SKETCH (Section A-A)

It is estimated that only 30 % of the water is treated because of the bad conditions of the trickling filters do to the lack of operation of the distribution pipe.

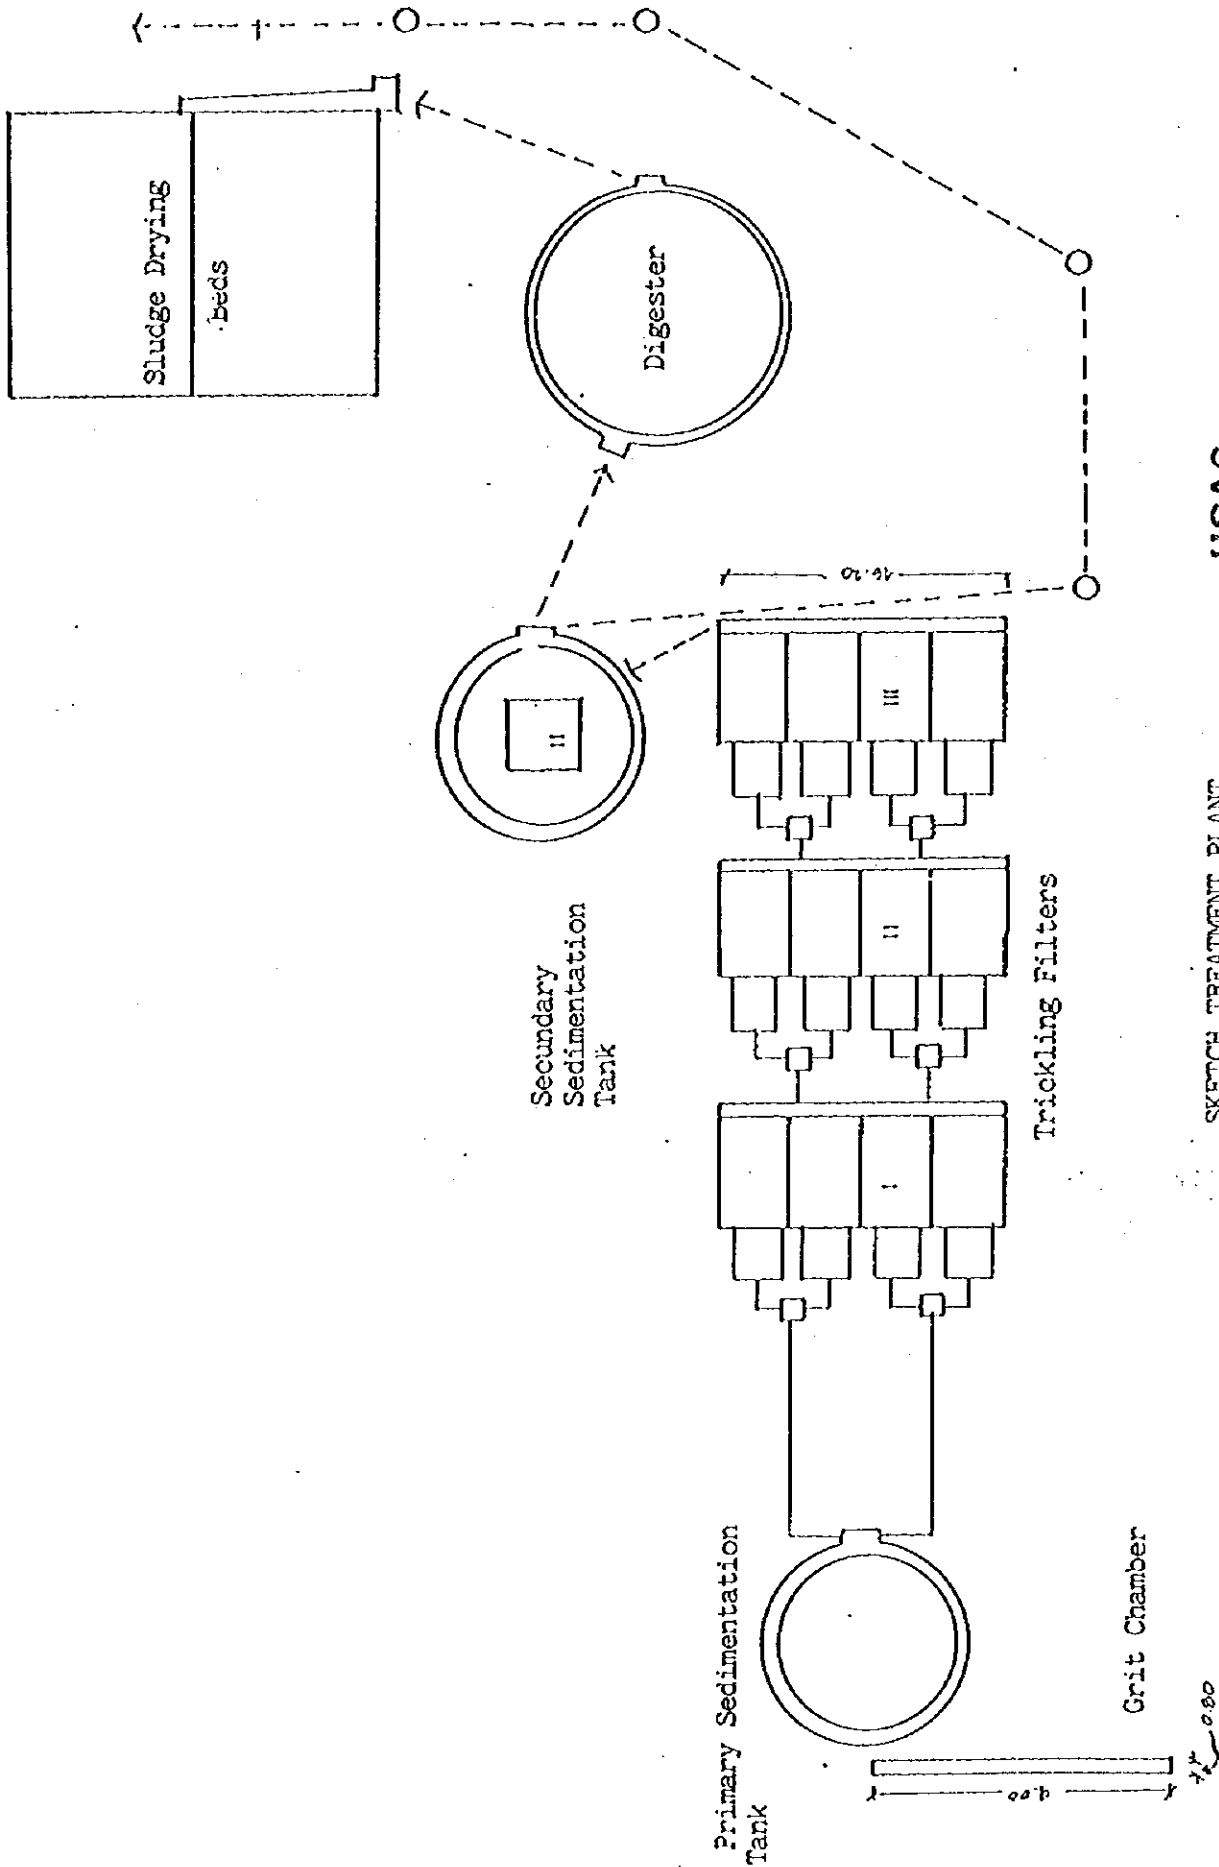
SKETCH TREATMENT PLANT

5.1 STATE OF STRUCTURES  
Generally good conditions.  
There are problems with external plastering.

- 5.2 PIPES  
Trickling filters:  
Module I: Corrosion in 28 metallic pipes 2"  
Module II: Corrosion in 26 metallic pipes 2"  
Module III: Corrosion in 19 metallic pipes 2"
- 5.3 GATE VALVES FOR OPERATIONAL CONTROL  
Trickling filters I, II, III  
63 gates valves in bad condition
- 5.4 BOXES AND COVERS FOR VALVES PROTECTION  
In good conditions
- 5.5 COUNTERDRAIN  
They have not cleaning and maintenance
- 5.6 INTERCOMMUNICATION SIDEWALK AND STAIRS  
They have faults and cleaning
- 5.7 GENERAL ACCES ROAD  
Good conditions

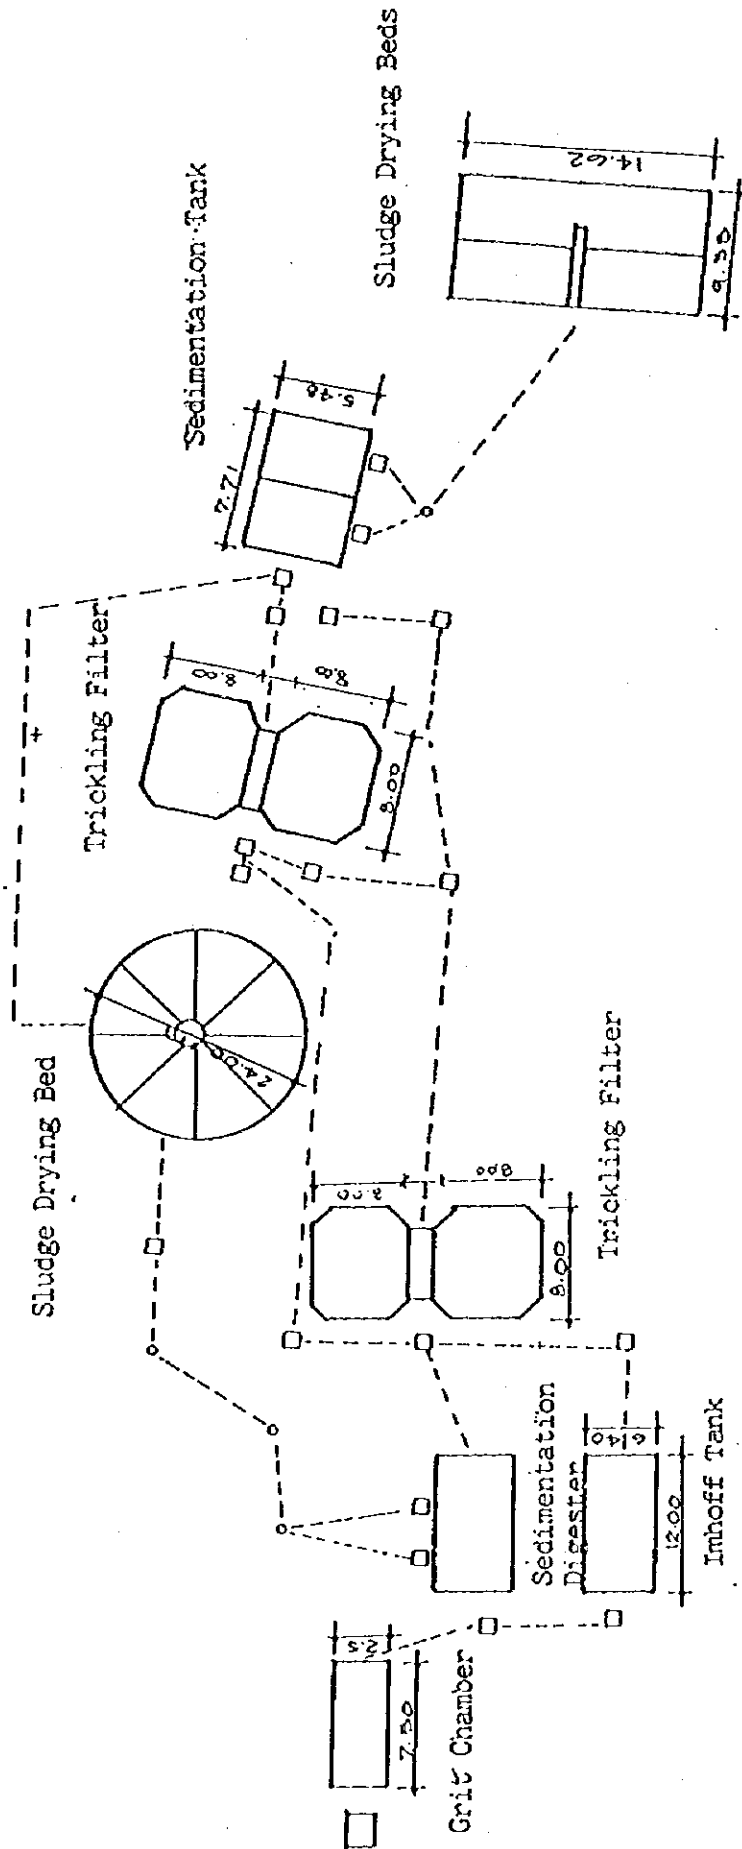
SKETCH TREATMENT PLANT

In generally all in good conditions. Only in the sludge drying bed a sinking in on ceel is observed. Then the treatment process is not doing.

Corrosion in trickilg filter in metalic pipes 2".

It is necessary to repair the floor of the sludge drying bed.

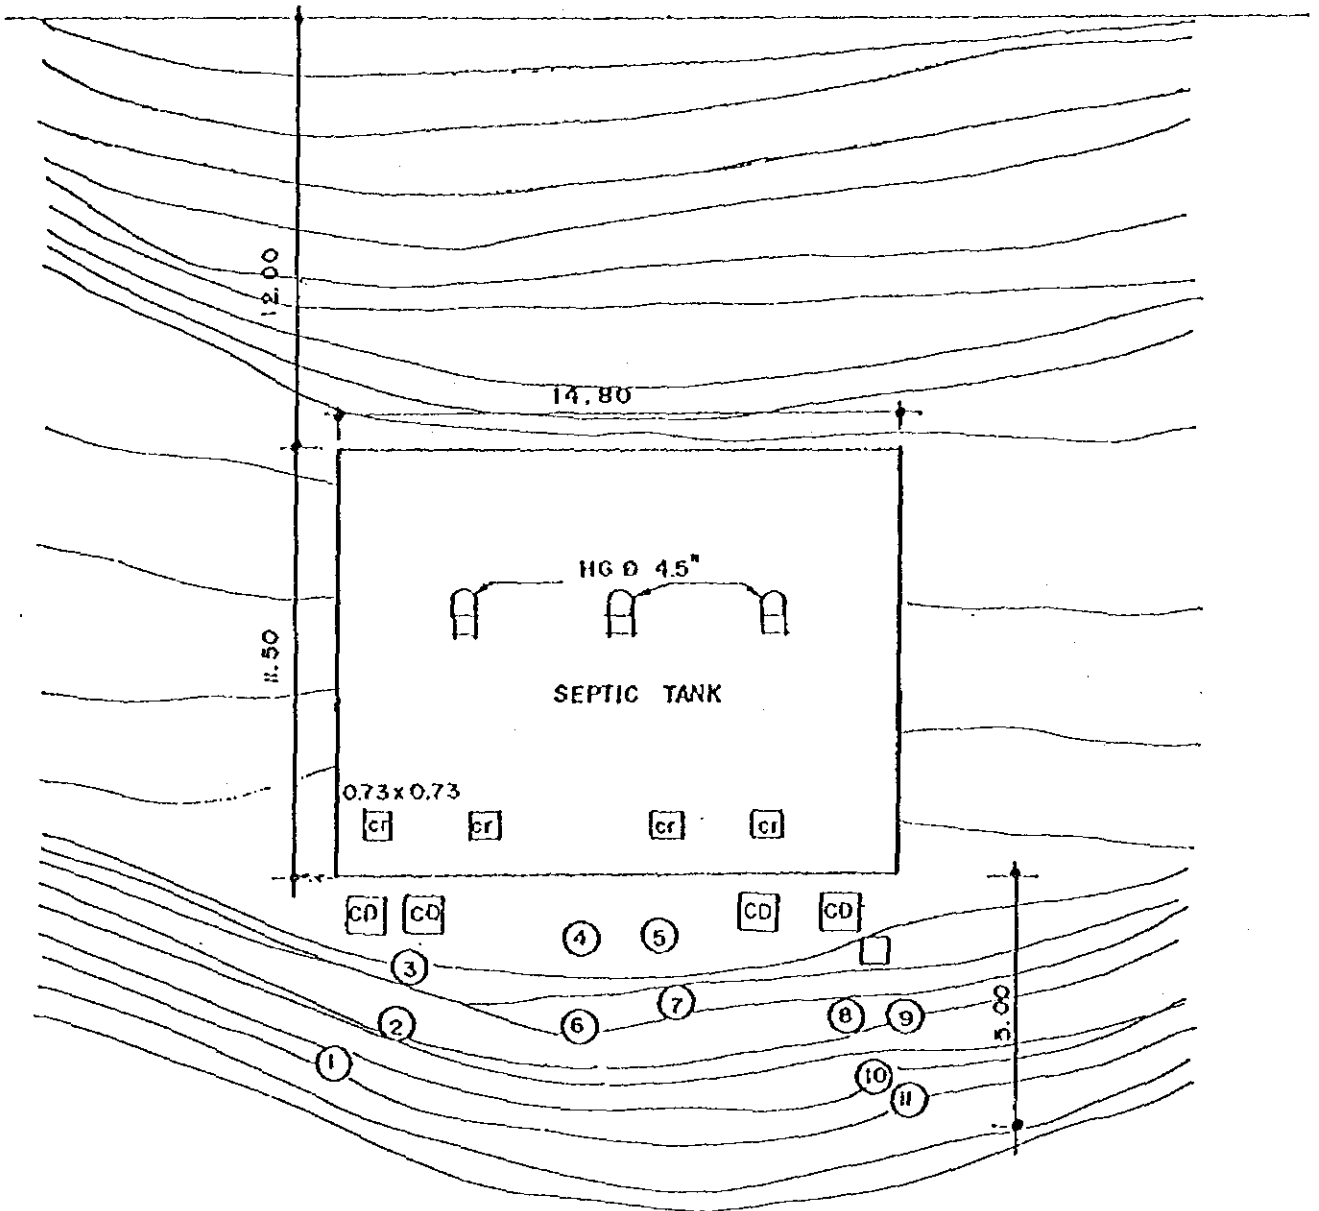
SKETCH TREATMENT SYSTEM

The septic tank is in good structural conditions of operation, it has 4 boxes of distribution flow of 1.00 m x 1.00 m, and then to 11 wells of infiltration (two of them without cover), the tank has 3 air pipes and one is completely locked.

Two covers of infiltration well are needed

Necessary make excavation in the all area to check all the pipes from the septic tank to the infiltration wells.

Necessary replace two covers of infiltration wells.

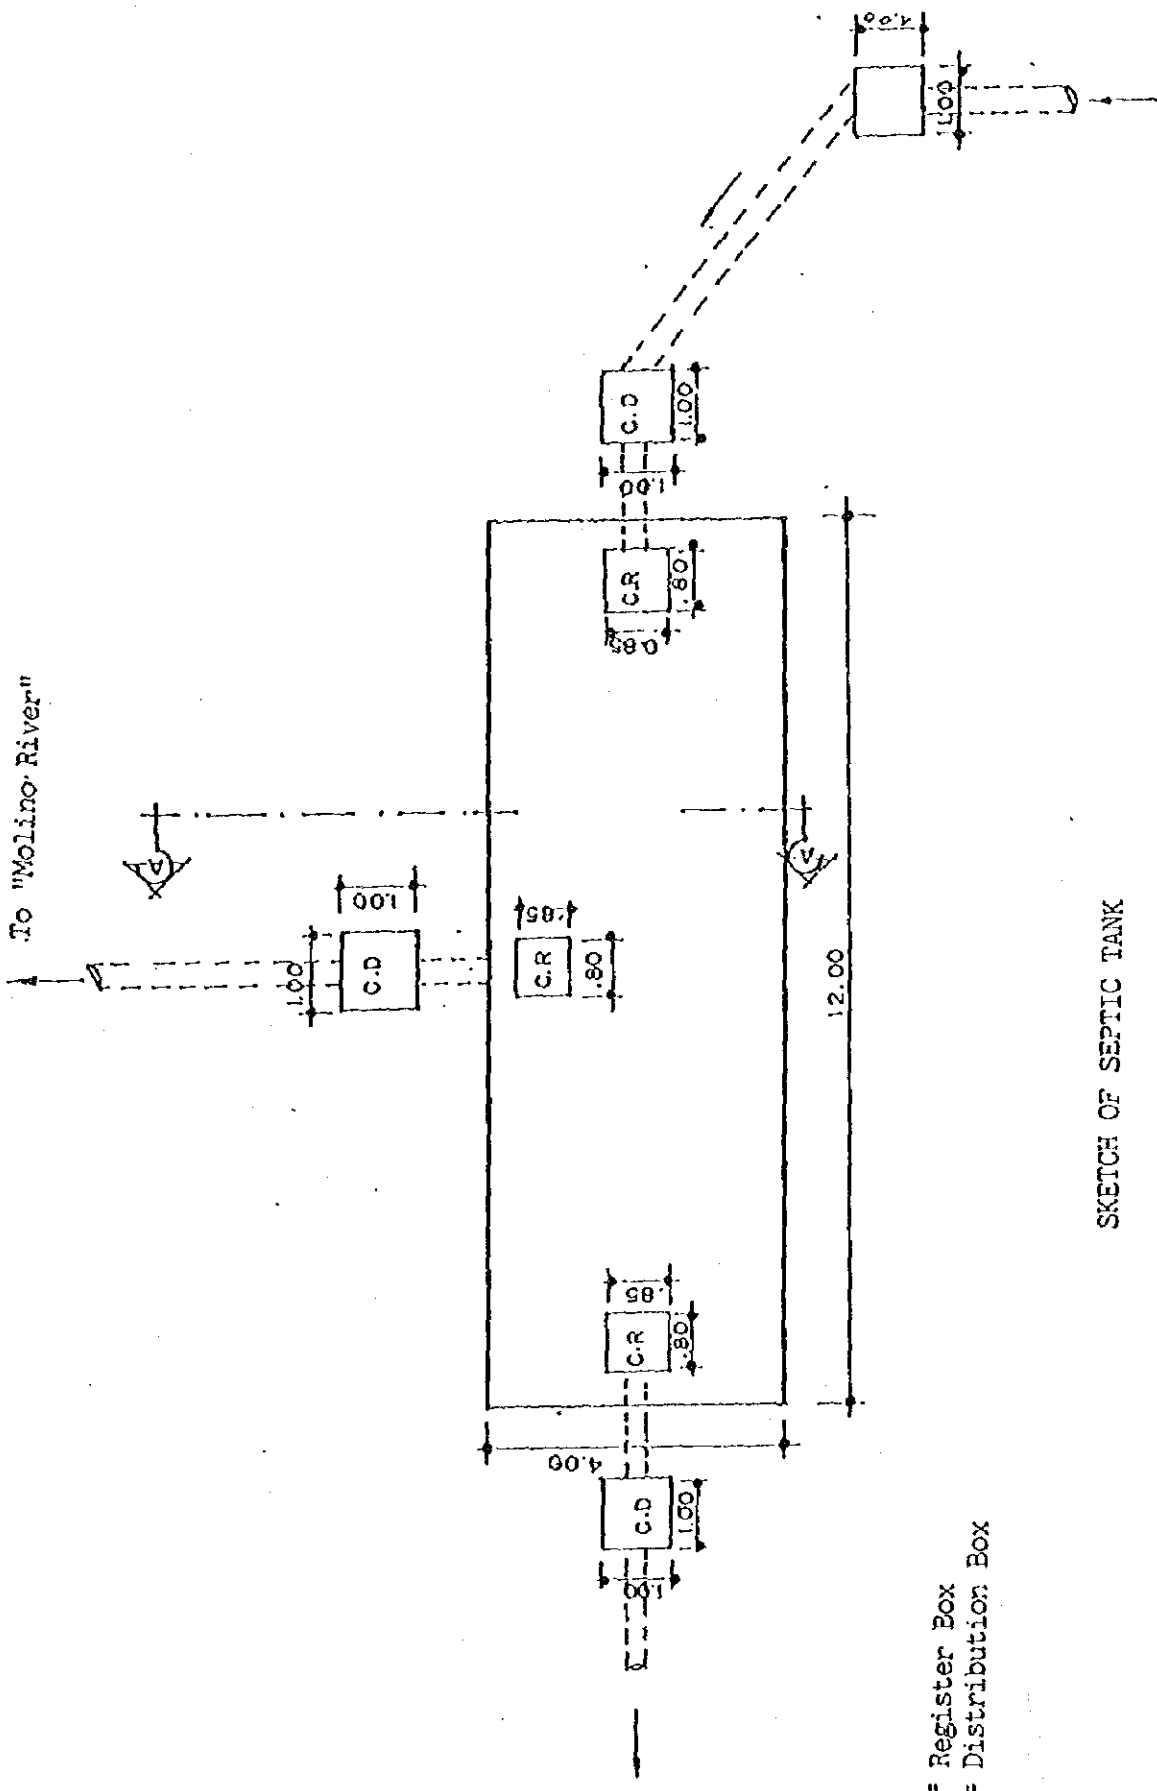
"LOMAS DE PORTUGAL"

5.2 STATE OF PIPES  
The outlet pipes are broken.

5.3 BOXES AND COVERS  
It has full damage.

6.2 PIPES  
Necessary to replace 20 meters of concrete pipes of 18"

8.1 The size of the septic tank, could not serve to the actual number of habitants in good way. It is recommended to build another treatment system.
