APPENDIX II-4

Results of Shoulder Inspection

APPENDIX III-2

Photographs of Bridges on Priority Projects

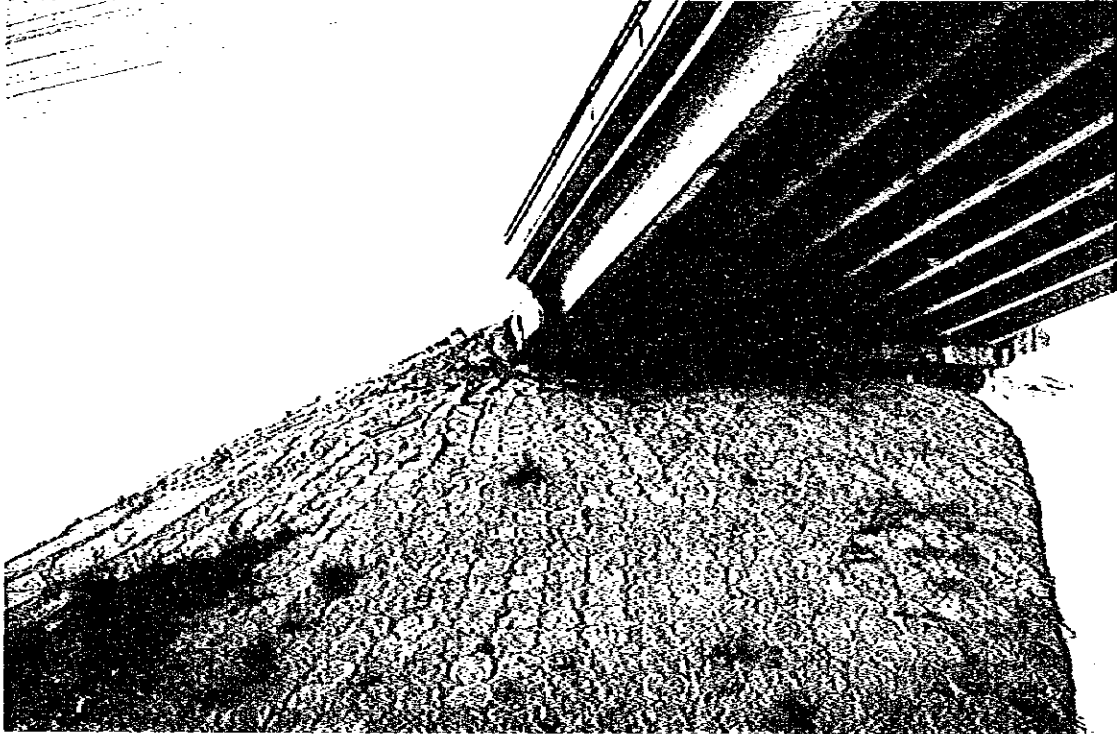
Photo III-1 : Bridge No.1 on the Atyrau ~ Mahambet Road Section
Condition of abutment

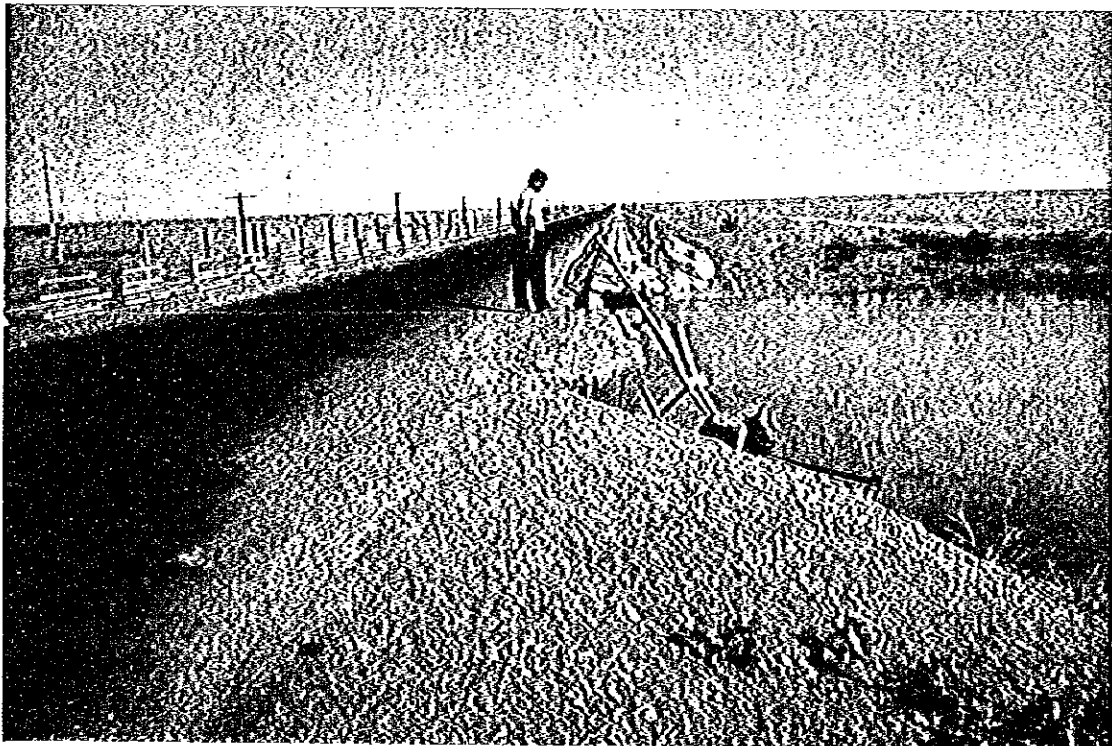
Photo III-2 : Bridge No.3 on the Atyrau ~ Mahambet Road Section
Condition of Handrail

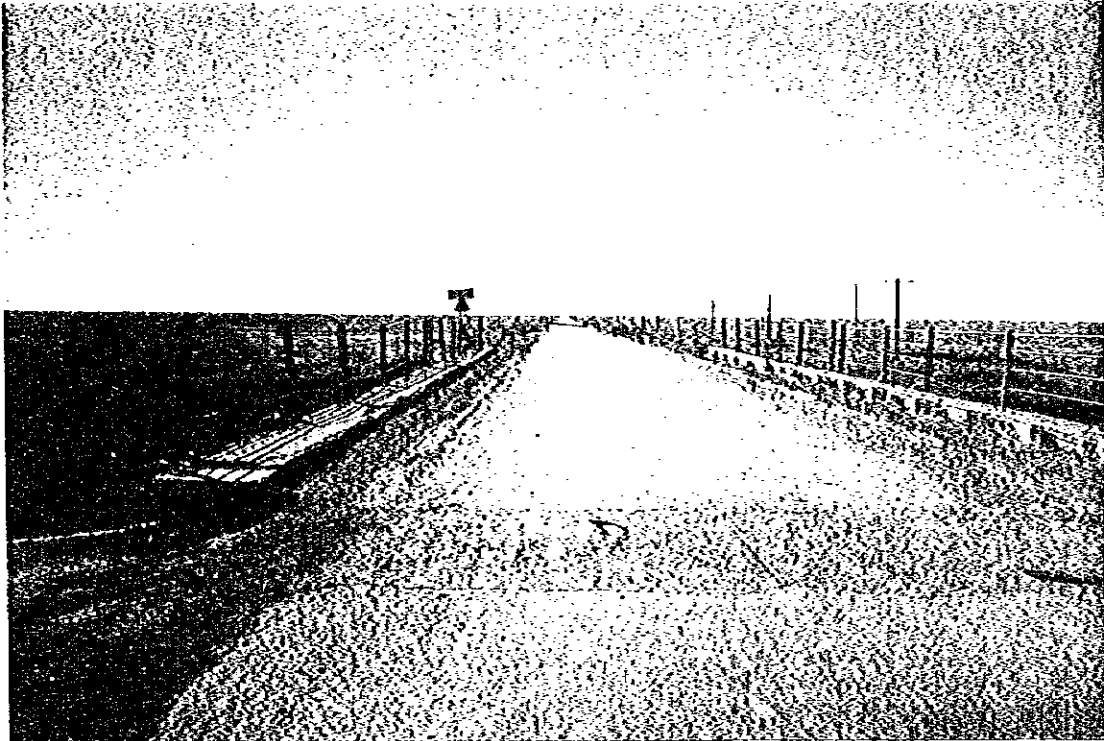
Photo III-3 : Bridge No.5 on the Atyrau ~ Mahambet Road Section
Condition of approach

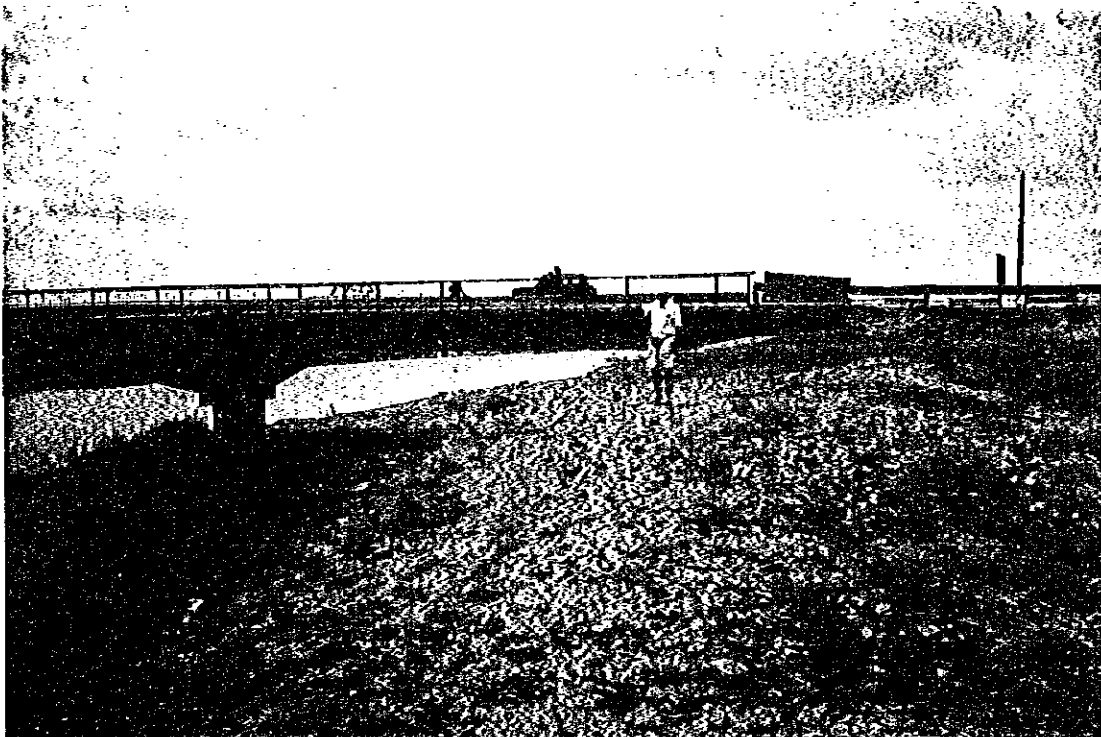
Photo III-6 : Bridge No.26 on the Karabutak ~ Kzyl Orda Border Road Section
Condition of approach

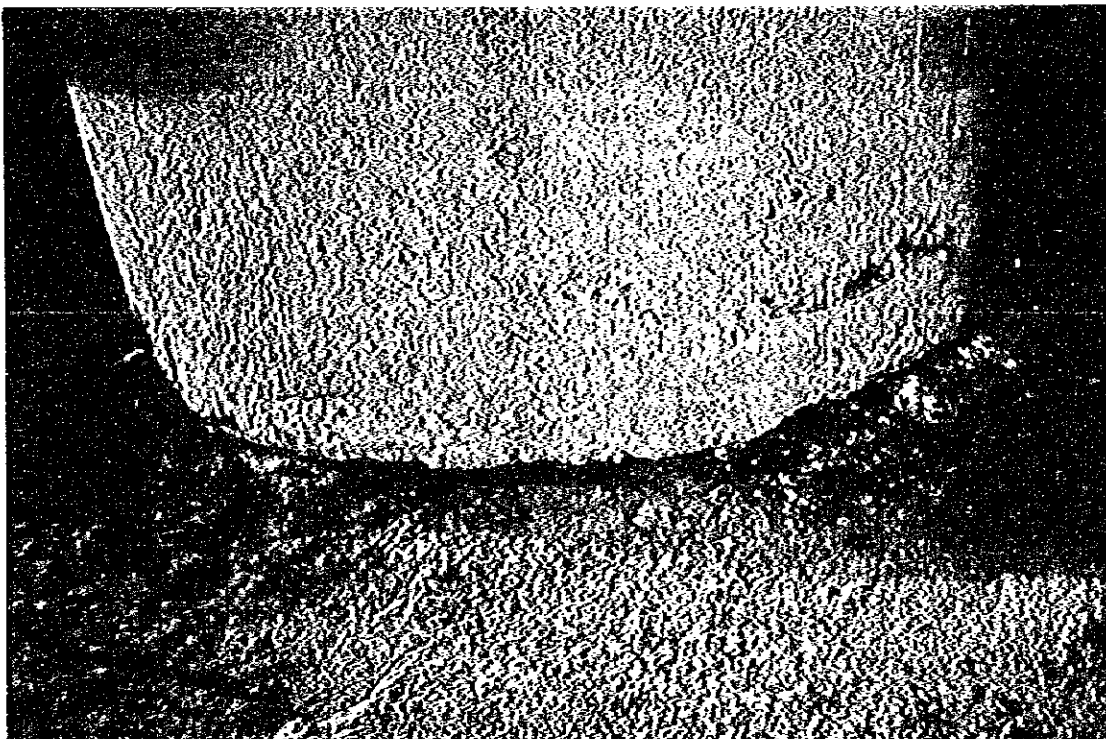
- Because the large-sized round shape pillars do not have enough insert length, the effluent which is flowing under the pillar scour off the base ground of the pier and easily to make space during the ground and the pier basis. To make matters worse, they have no footings nor piles. The facts cause the unequal sinking of the pillar or hanging of the pillar.

- Also the insufficiency with the insert depth of the abutments causes the movement of soil by their earth pressure.

**Photo III-8 : Bridge No.29 on the Karabutak ~ Kzyl Orda Boarder Road Section
Condition of washed out abutment**

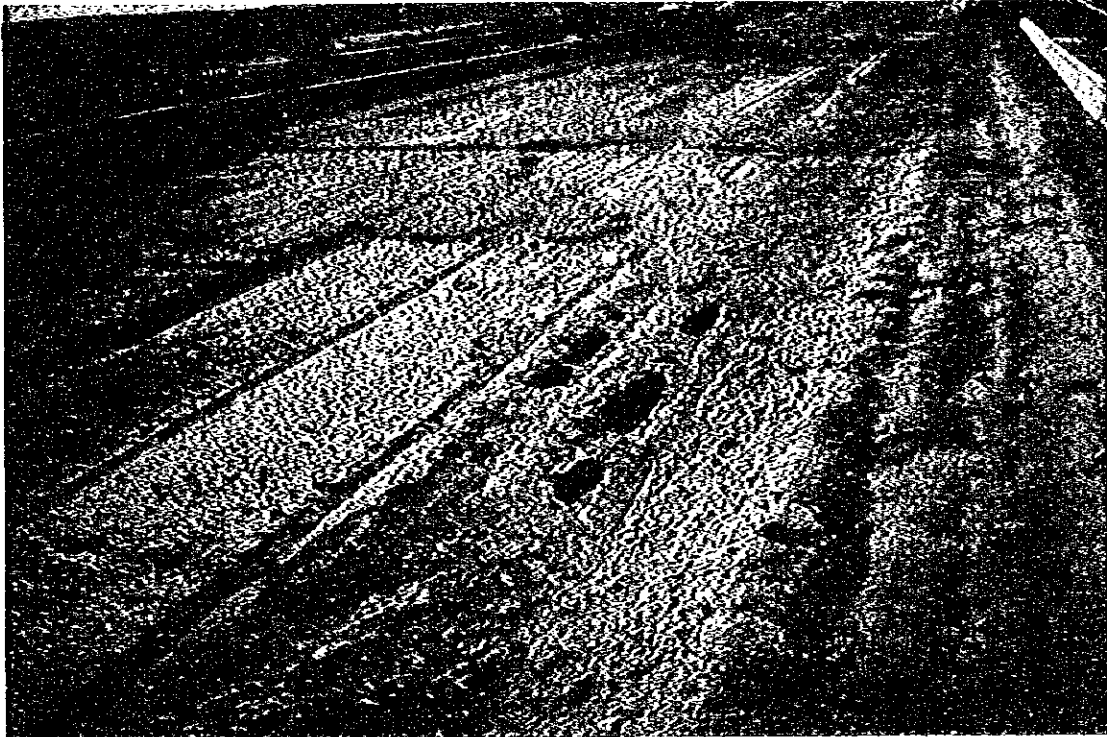
**Photo III-9 : Bridge No.29 on the Karabutak ~ Kzyl Orda Boarder Road Section
Condition of broken slab**

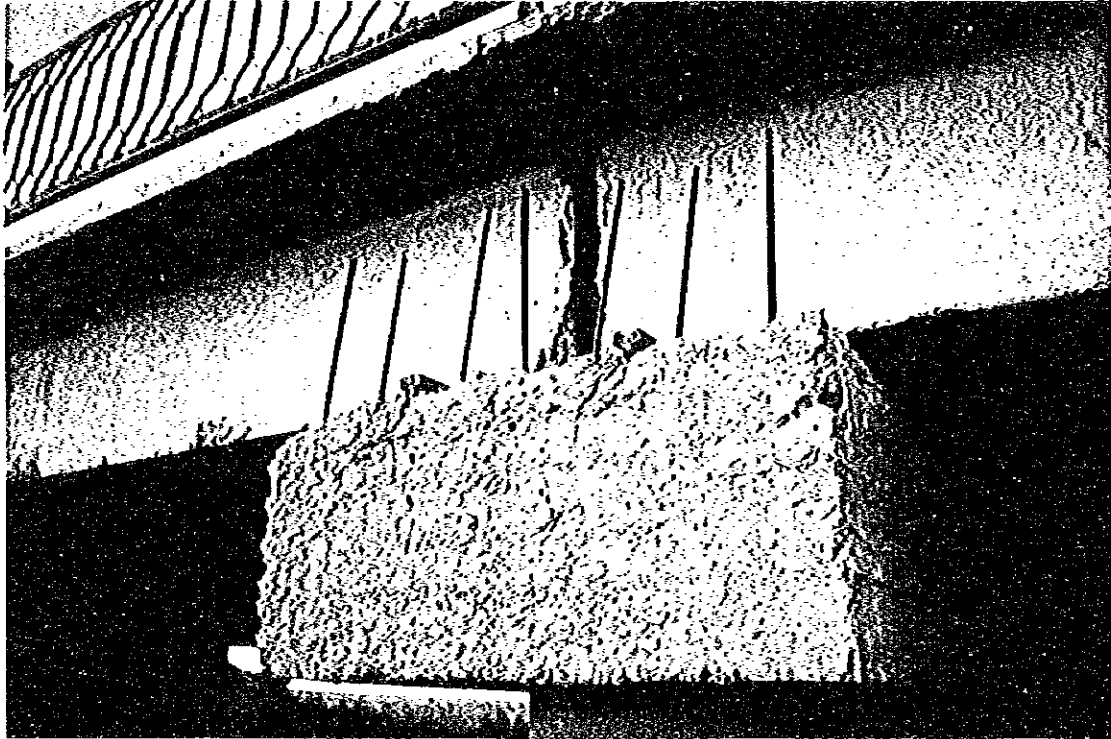
**Photo III-11 : Bridge No.31 on the Karabutak ~ Kzyl Orda Boarder Road
Section
Condition of in-completion of concrete work**

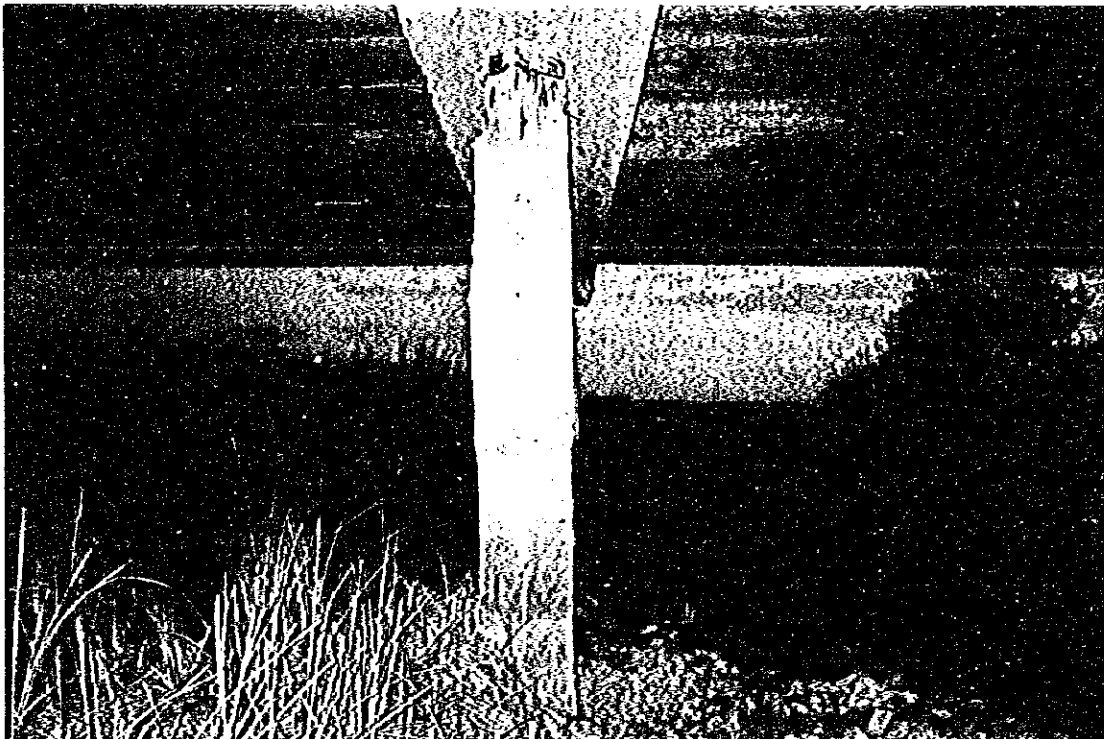
**Photo III-12 : Bridge No.32 on the Karabutak ~ Kzyl Orda Boarder Road
Section
Condition of broken pier**
