*Photographs*  
*-Phedigaon/Phatbazar-*

Photograph Location Map - Phedigaou/Phatbazar -

His Majesty's Government of Nepal  
 Ministry of Forest and Soil Conservation/Department of Soil Conservation  
 THE STUDY ON THE DISASTER PREVENTION PLAN  
 FOR SEVERELY AFFECTED AREAS BY 1973 DISASTER  
 IN THE CENTRAL DEVELOPMENT REGION OF NEPAL  
 JAPAN INTERNATIONAL COOPERATION AGENCY

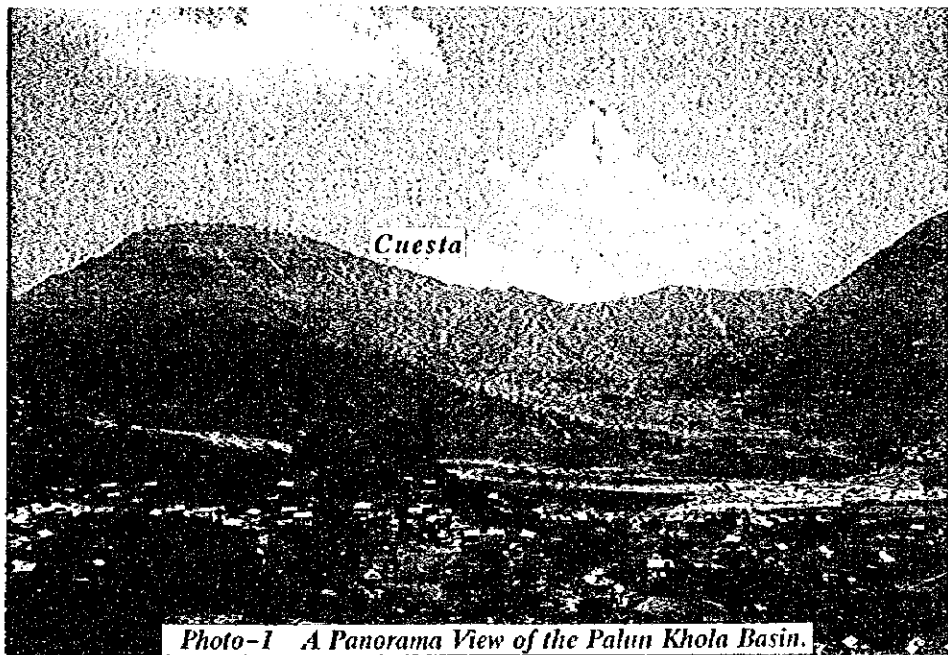
*Photo-1 A Panorama View of the Palun Khola Basin.*

The cuesta landform is observed on the left.

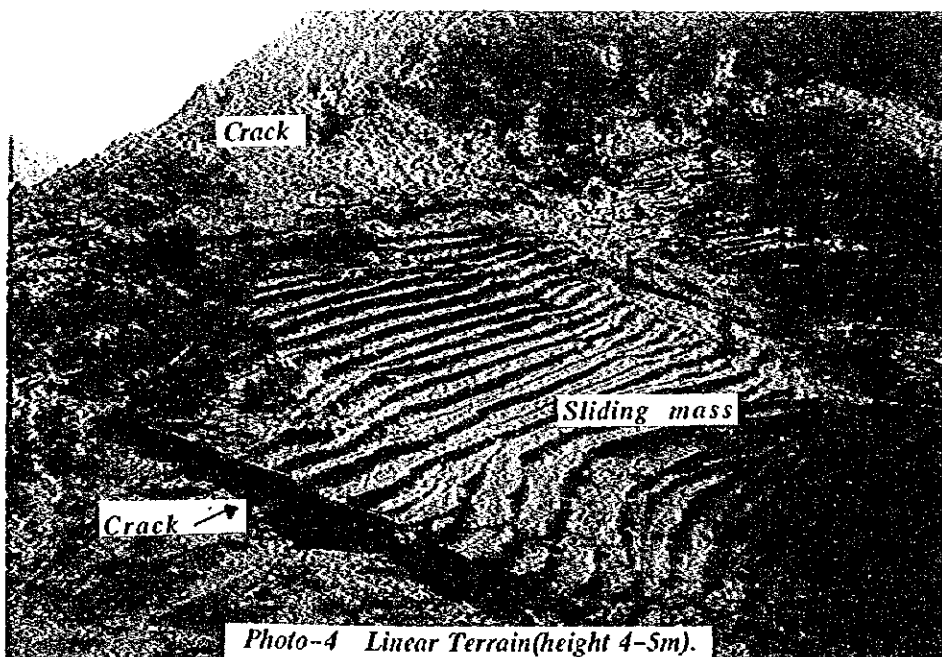
Cracks at side edge of sliding mass.

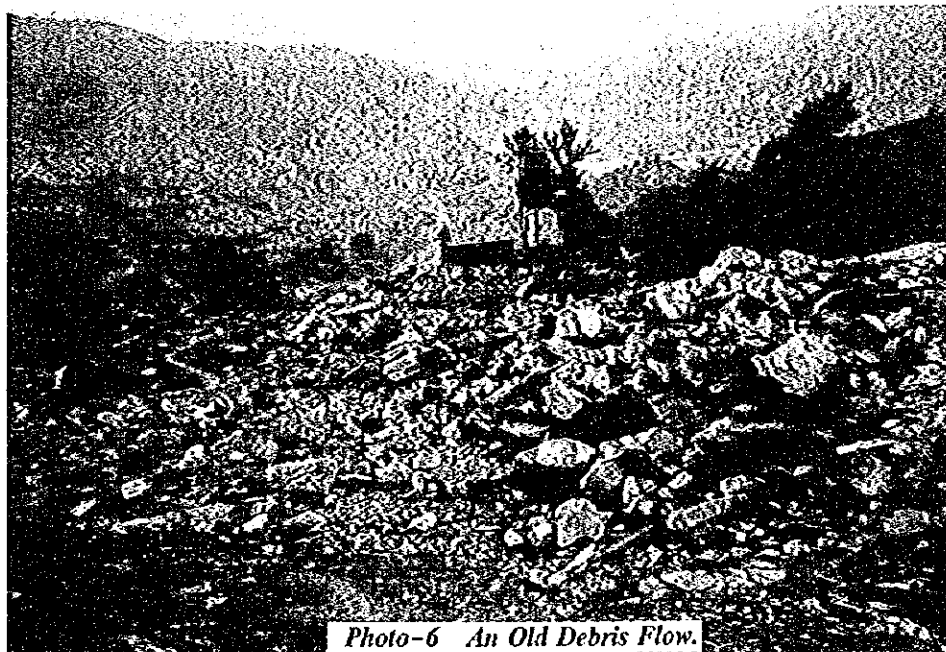
The landslide debris trapped on the slope of Dhungakate Khola.

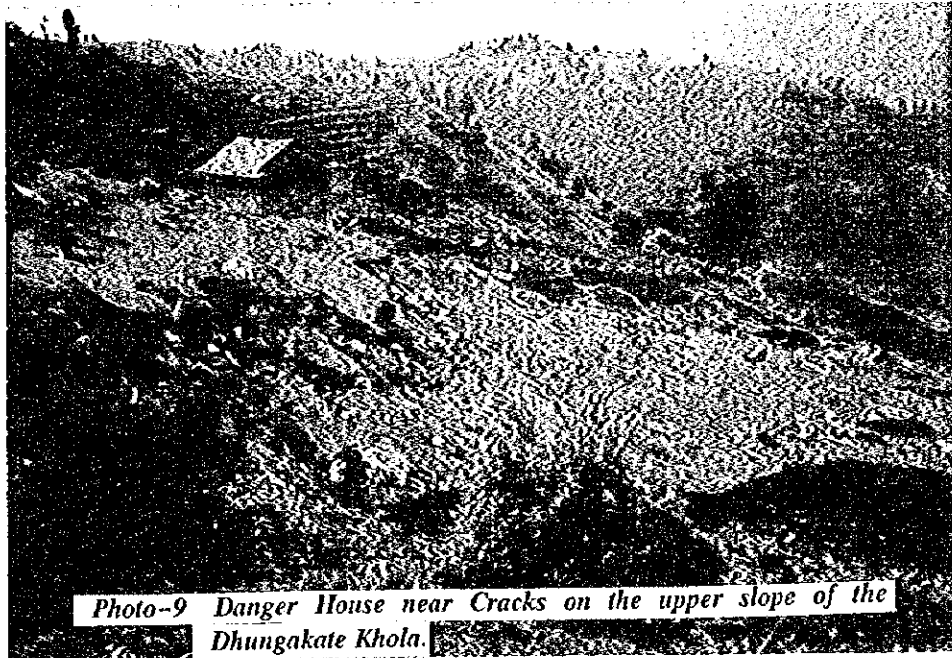
**Photo-9** *Danger House near Cracks on the upper slope of the Dhungakate Khola.*

The gentle head scarp is observed unclearly.

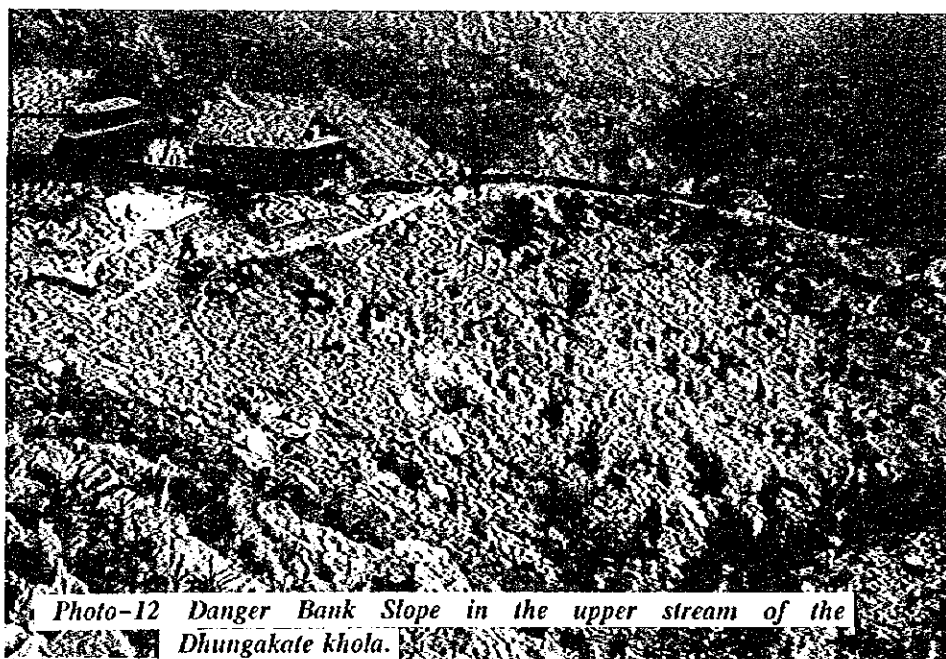
*Photo-12 Danger Bank Slope in the upper stream of the Dhungakate khola.*

At the bank of gentle slope, the natural vegetation is recovering.

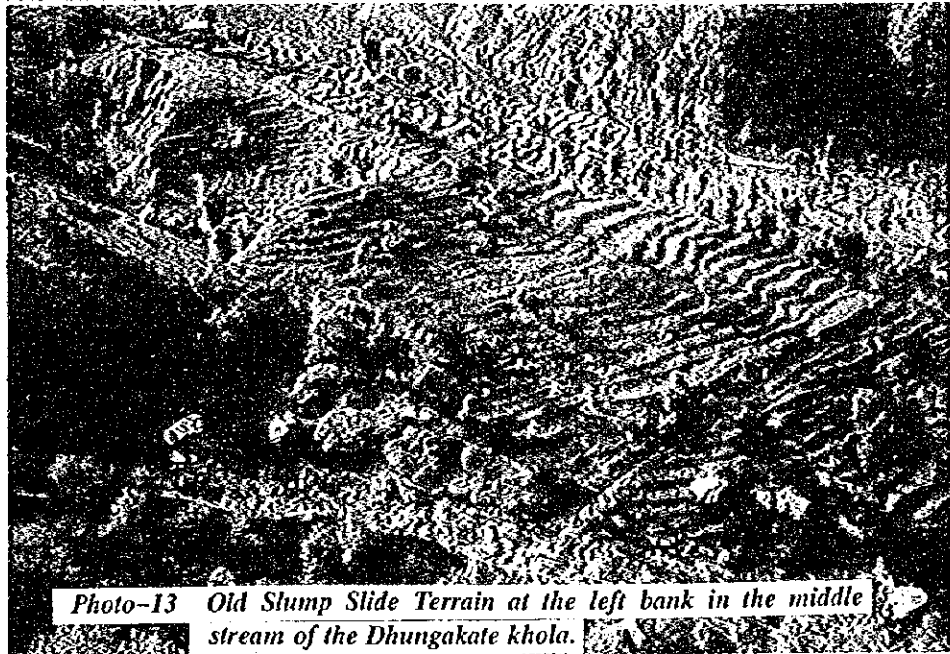
*Photo-13 Old Slump Slide Terrain at the left bank in the middle stream of the Dhungakate khola.*

The old slump terrain is made with unhardened landslide deposits.

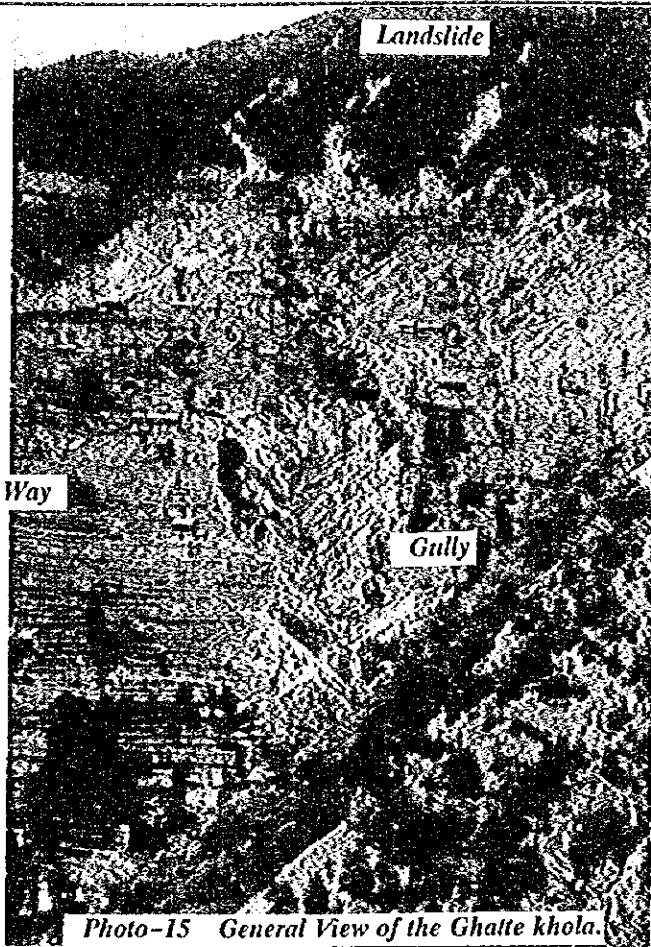
The gully, landslide, indistinct water way are showed in the Photo.

*Photo-15 General View of the Ghatte khola.*

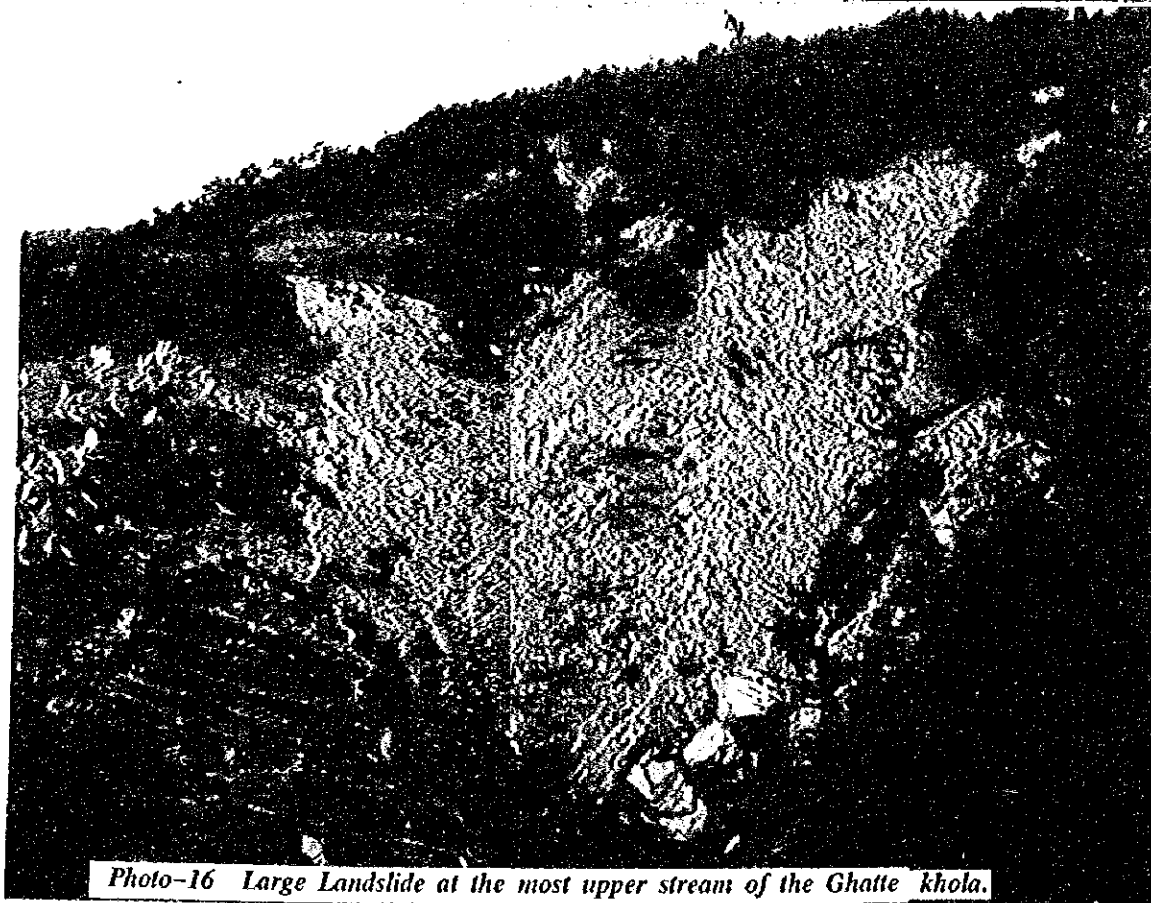
*Photo-16 Large Landslide at the most upper stream of the Ghatte khola.*

The rock layers are sliced off. The large boulders are accumulating in the right.

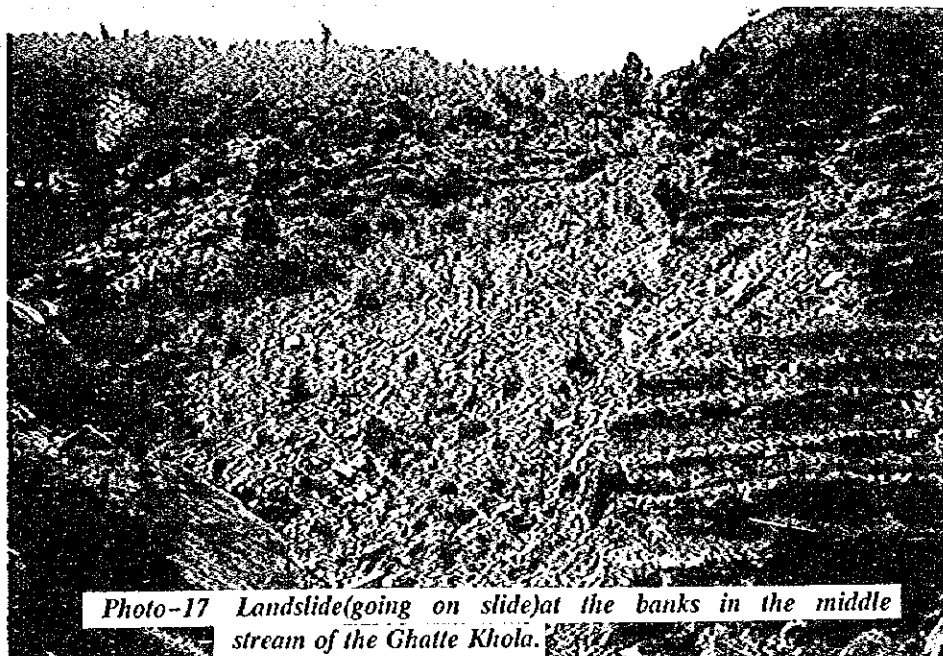
The land is expected to be unstable by the corrosion of the head though the vegetation is recovering.

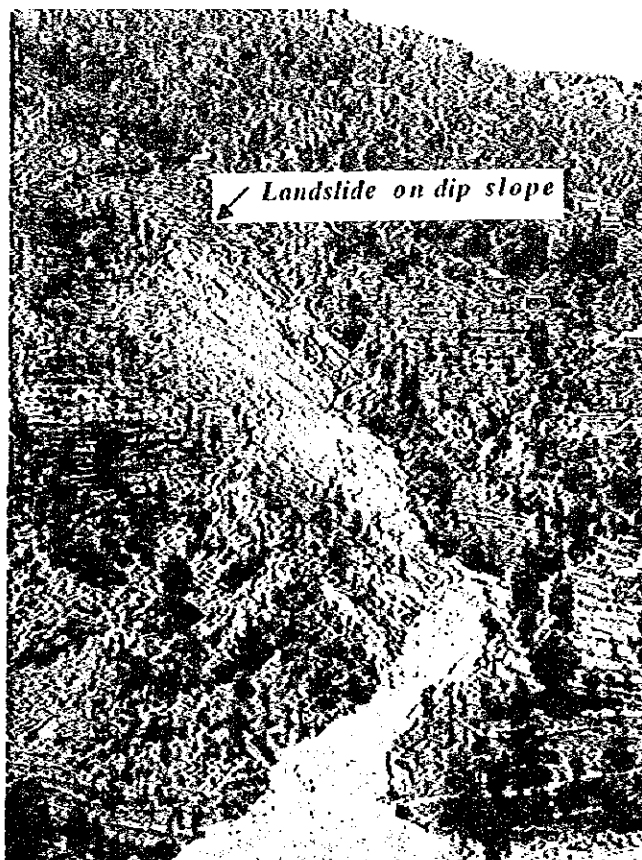
A typical landslide on dip slope is observed at the upper side.

Photo-18 Slump Slide Terrain accompanied with Crack, Large Landslide and Innudation area of Debris Flow in Bhottekhoria Khola Basin.

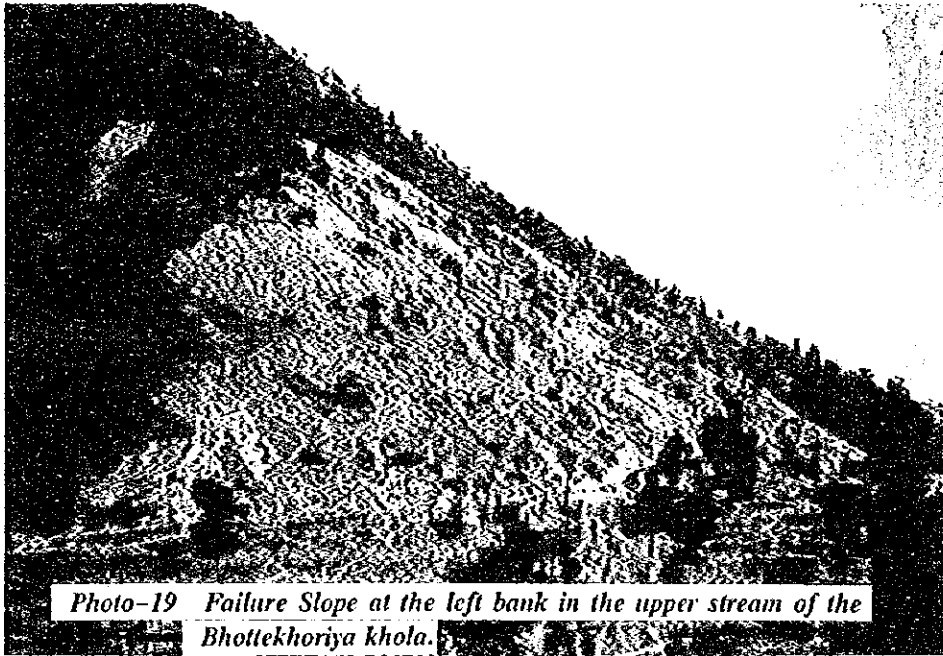
**Photo-19** Failure Slope at the left bank in the upper stream of the Bhottekhoriya khola.

The outer layer of the slopes slipped down.

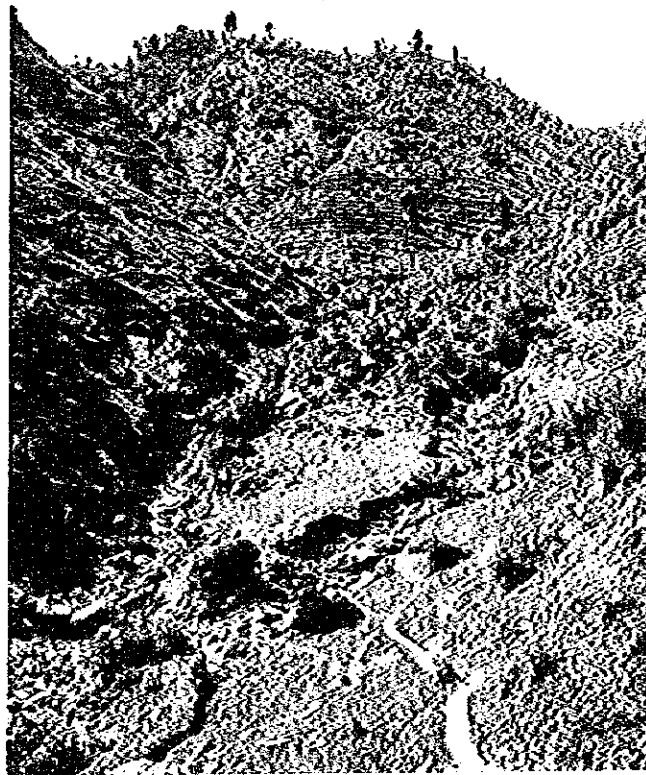
**Photo-20** Old Debris Flow Deposits in the upper stream of the Bhottekhoriya khola.

Secondary erosion occurred by the 1993's rainstorm on the old debris fan.

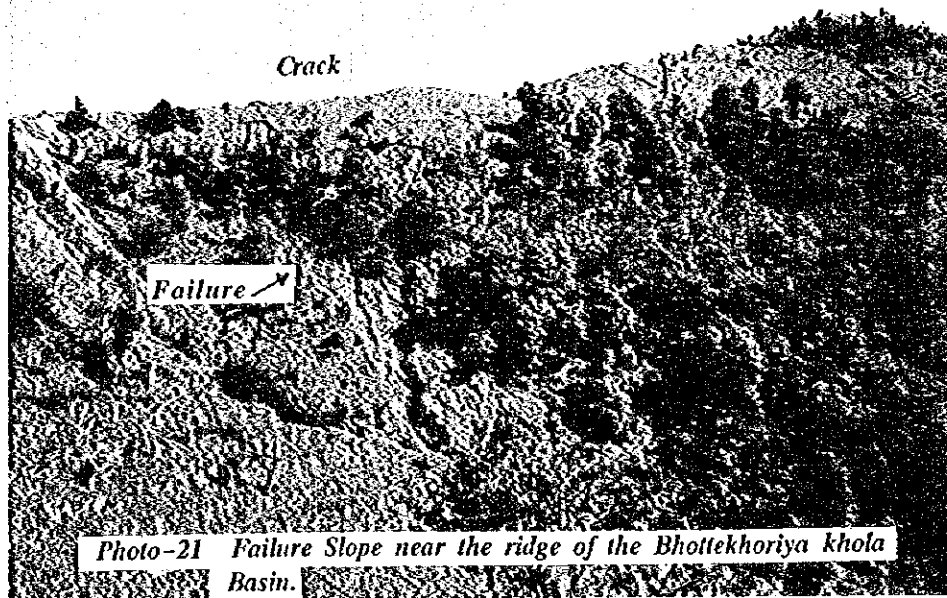
*Photo-21 Failure Slope near the ridge of the Bhottekhoriya khola Basin.*

**The failure occurred on bald slope.**

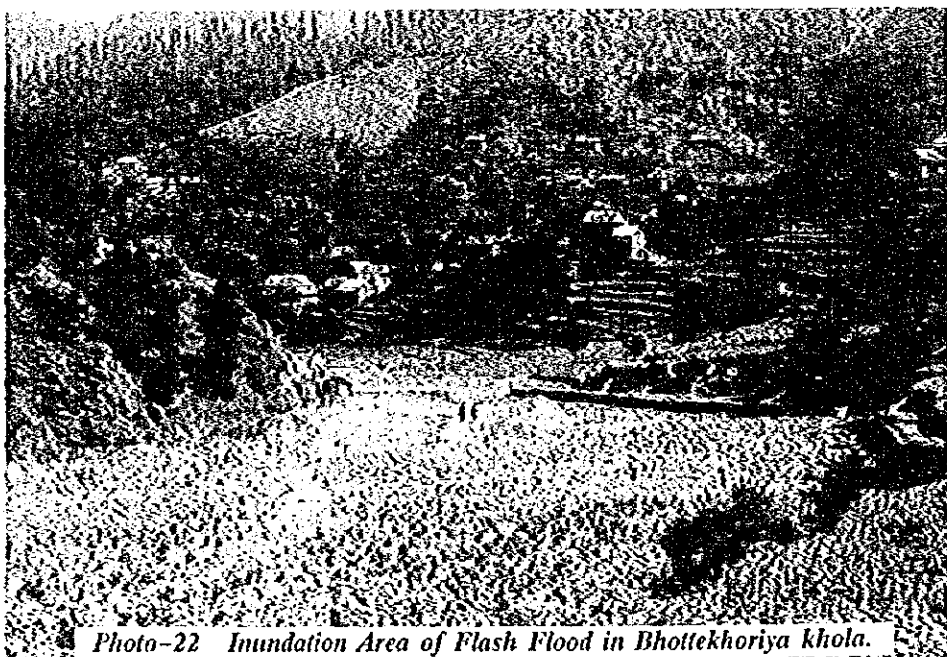
*Photo-22 Inundation Area of Flash Flood in Bhottekhoriya khola.*

**The riverbed was buried by the 1993's rainstorm and the river width was expanded.**

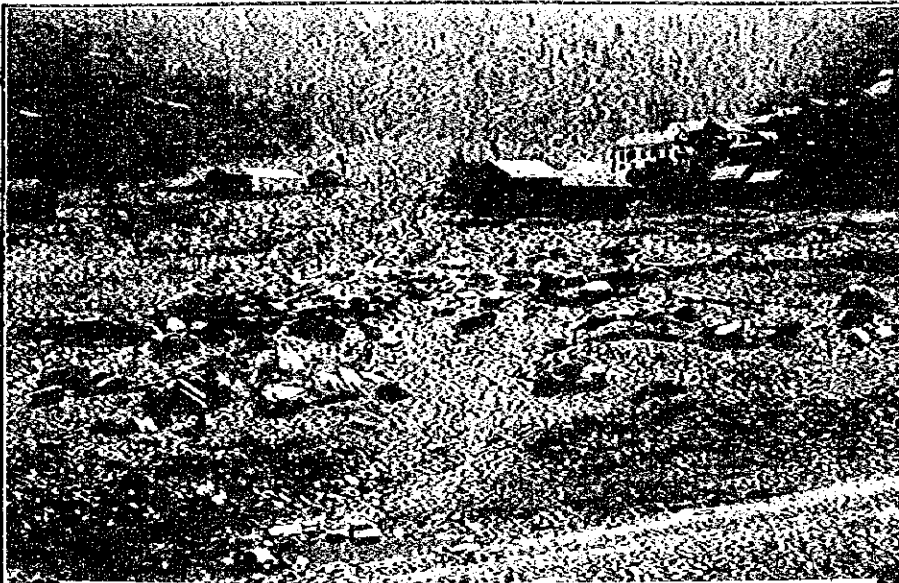
The large boulders were accumulated.

Photo-24 Terminal Edge of Inundation Area by Debris Flow.
