Photographs
-Namtar/Tilar-

Photograph Location Map -Namtar/Tilar-

**THE STUDY ON THE DISASTER PREVENTION PLAN
FOR SEVERELY AFFECTED AREAS BY 1993 DISASTER
IN THE CENTRAL DEVELOPMENT REGION OF NEPAL**

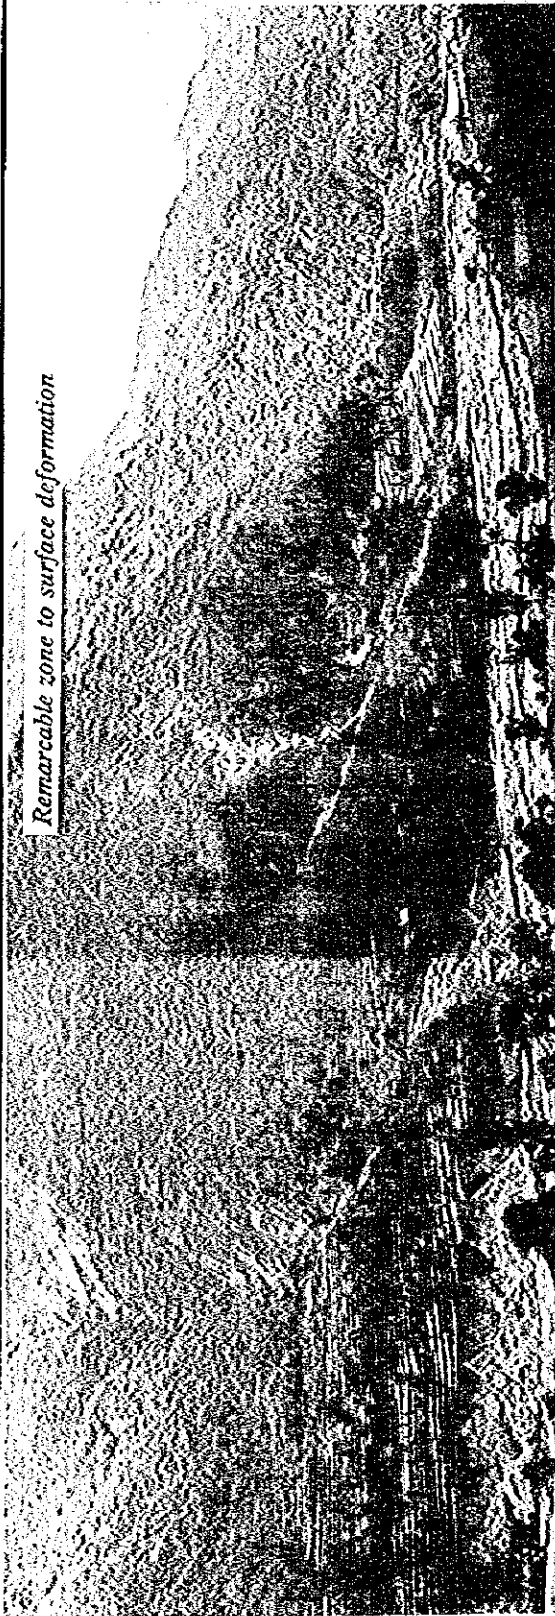
Photo-3 A Panorama View at the left bank towards the downstream from the confluence of the Manhari Khola and the Sarse Khola. The landslides and failures mainly occurred under the knick line, the upper edge of the Photo.

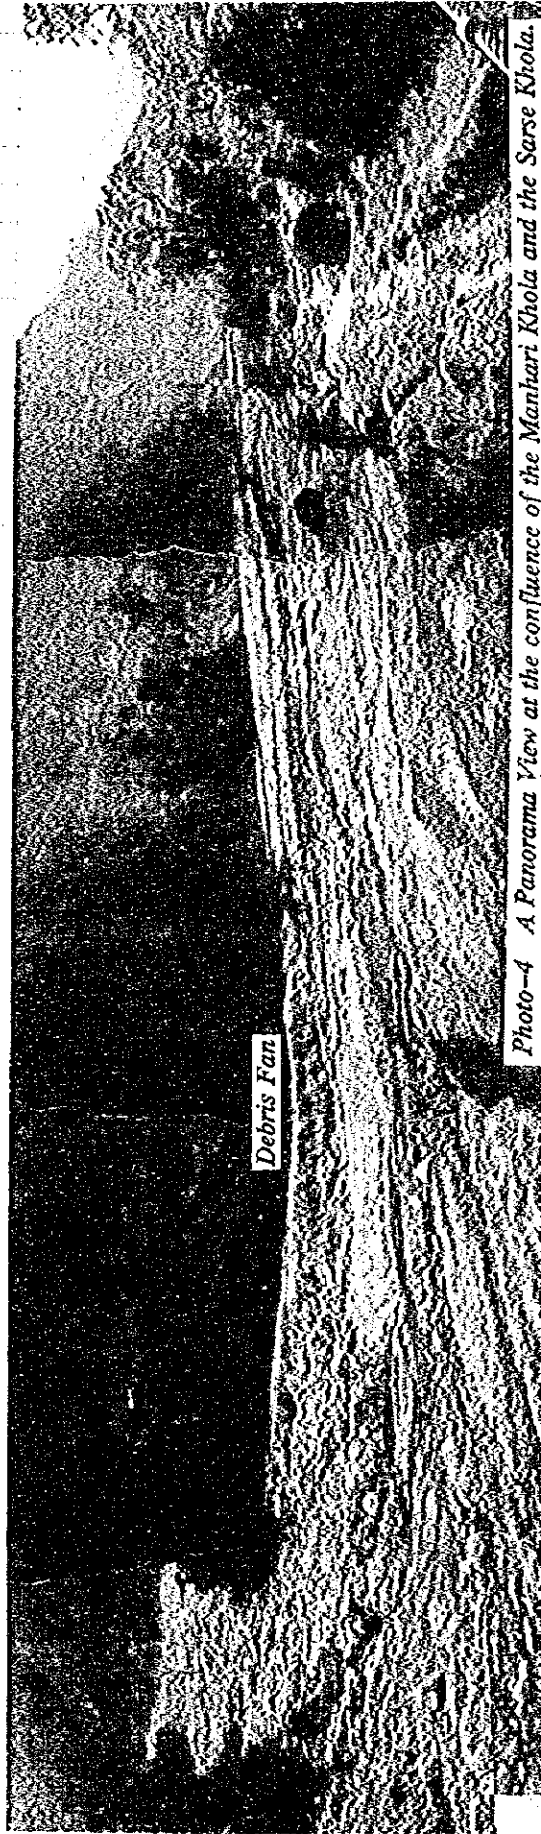
Photo-4 A Panorama View at the confluence of the Manhari Khola and the Sarse Khola.

A part of debris fan remains which was formed by the Sarse Khola.

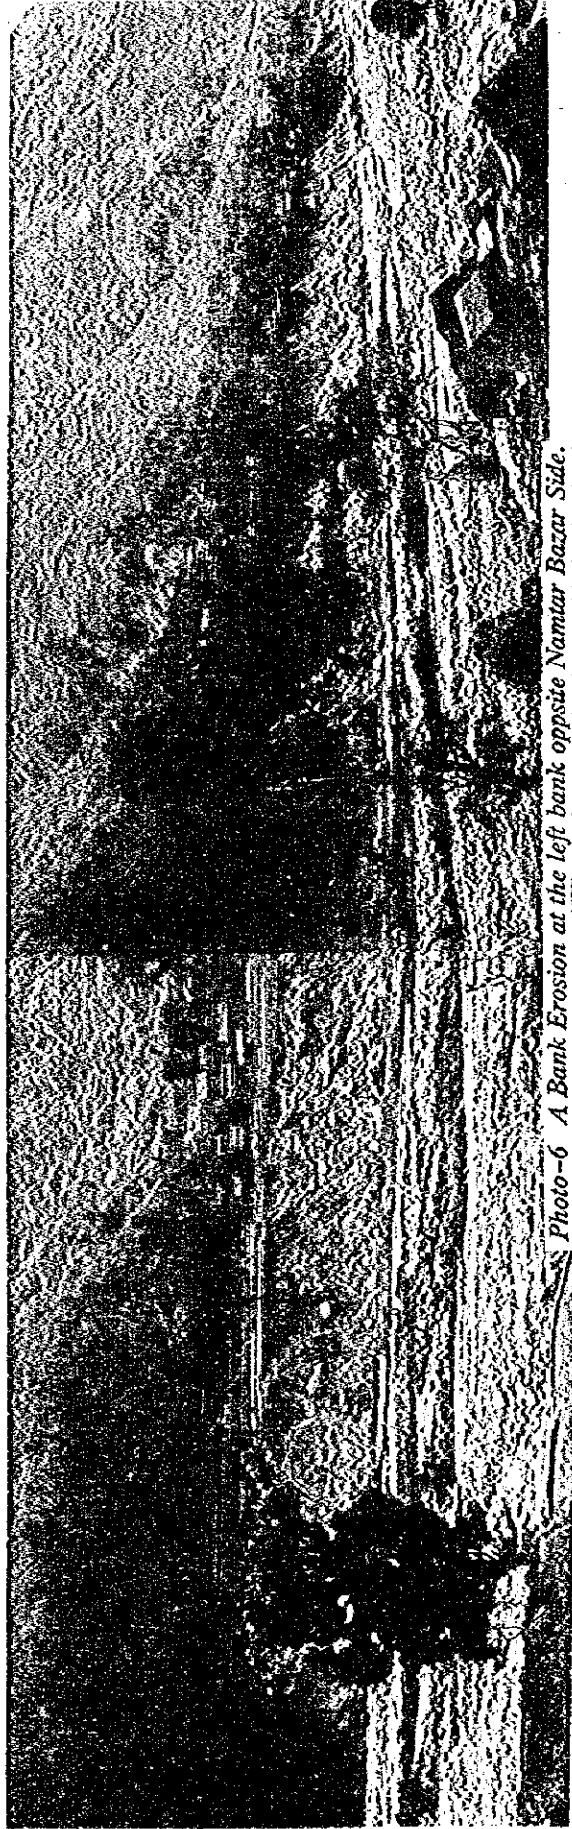
Photo-6 A Bank Erosion at the left bank opposite Namtar Bazar Side.

It is very dangerous to be re-erosion by the future flood.

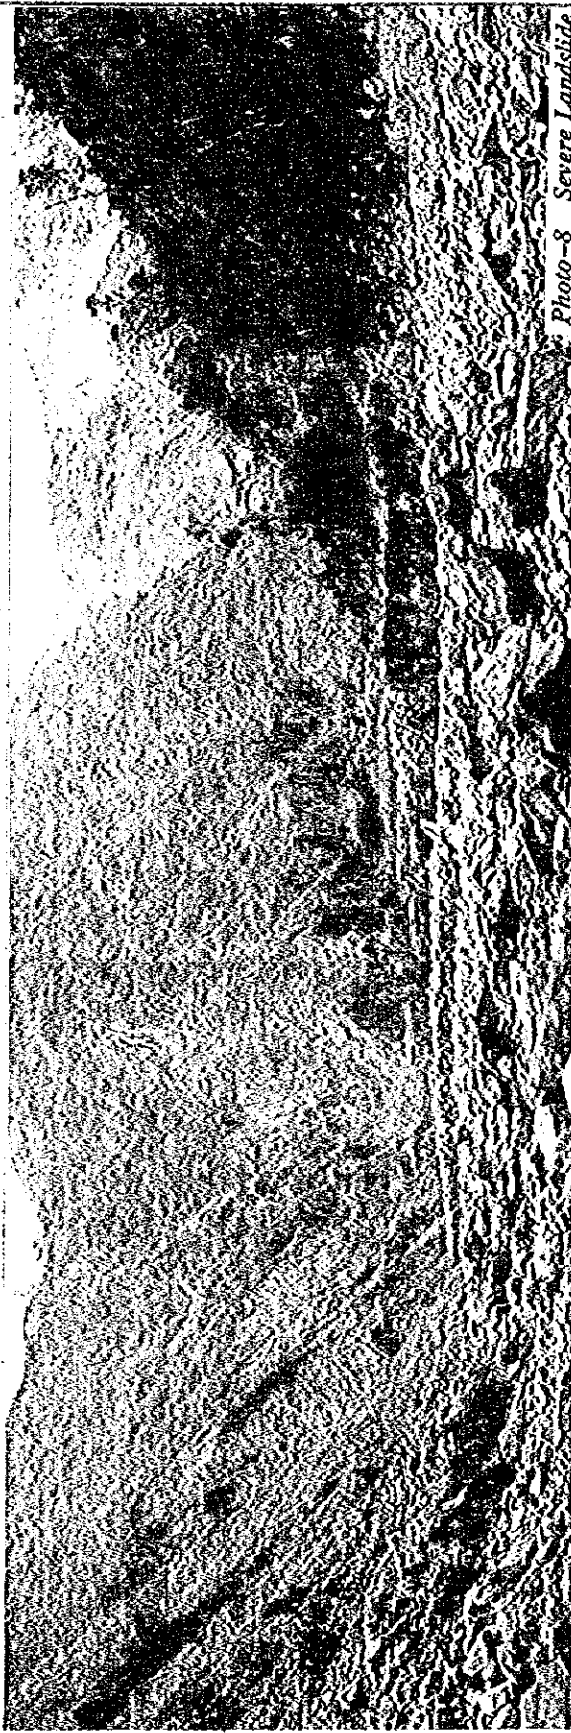
Photo-8 Severe Landslide

A series of big failure occurred on the river bend at the upper Manhari Khola, the deposit is accumulated at the toe portion.

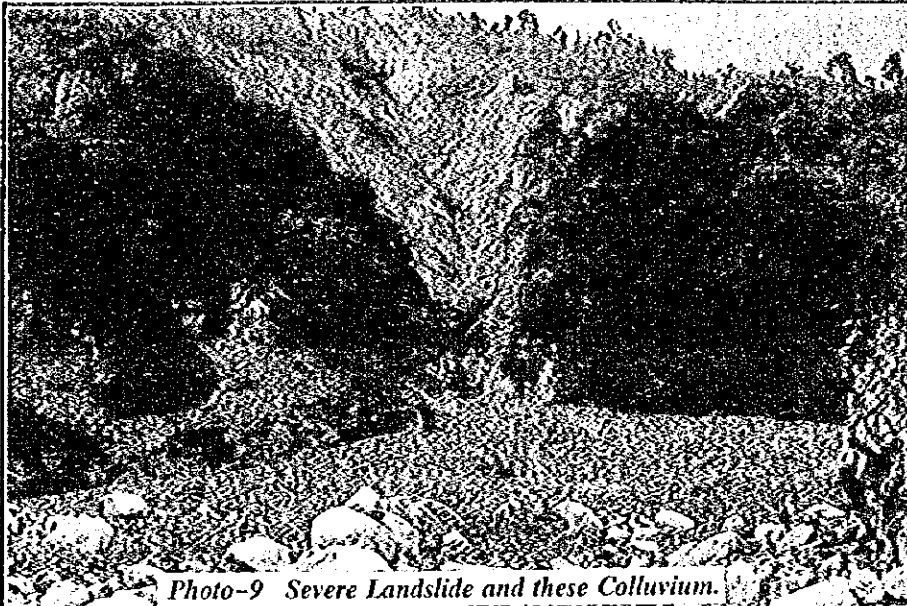
Photo-9 Severe Landslide and these Colluvium.

The terrace of debris formed by the 1993's flood is on the left.

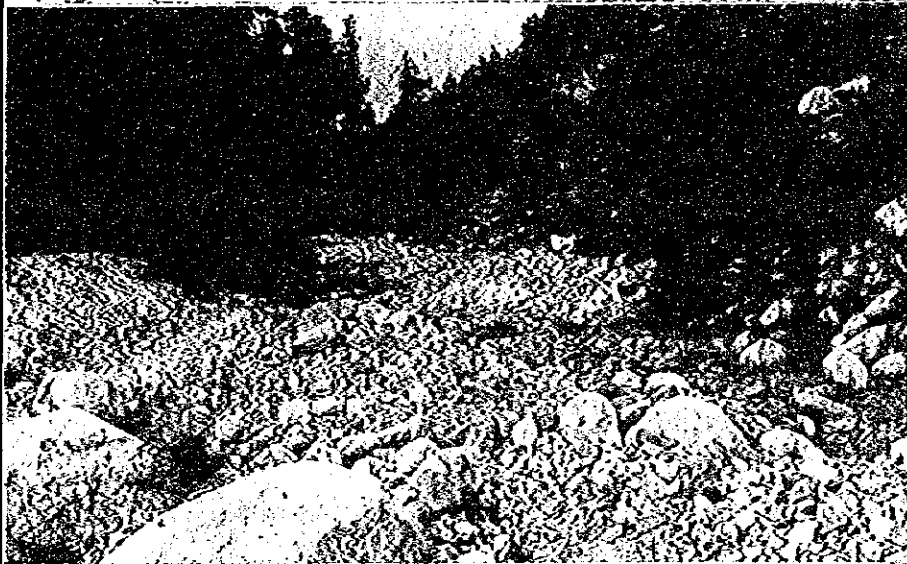
Photo-10 River Bed Condition in the lower stream of the Goruduwa Khola.

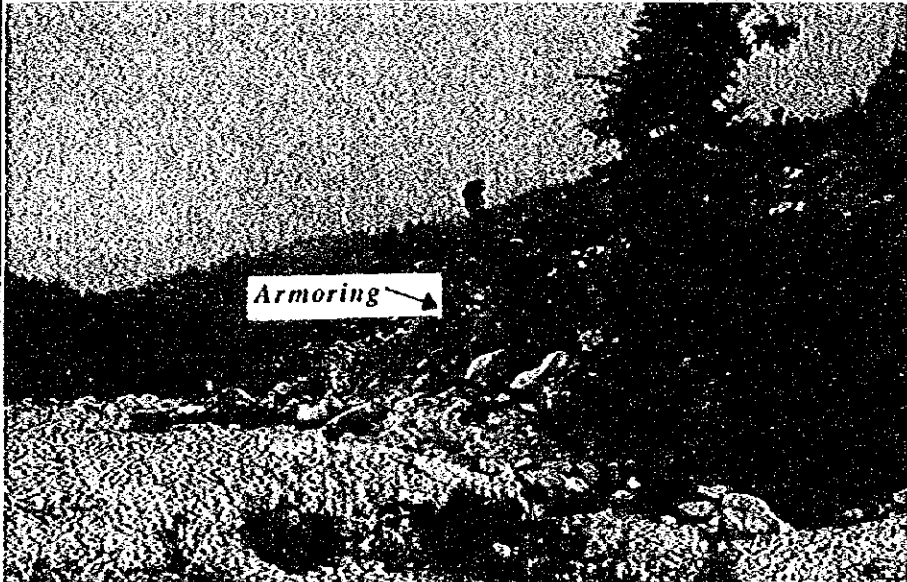
The slope is possible to collapse because of unstability.

Photo-11 Armoring on Terrace Scarp at the right bank towards the downstream from the confluence of the Manhari Khola and the Goruduwa Khola.

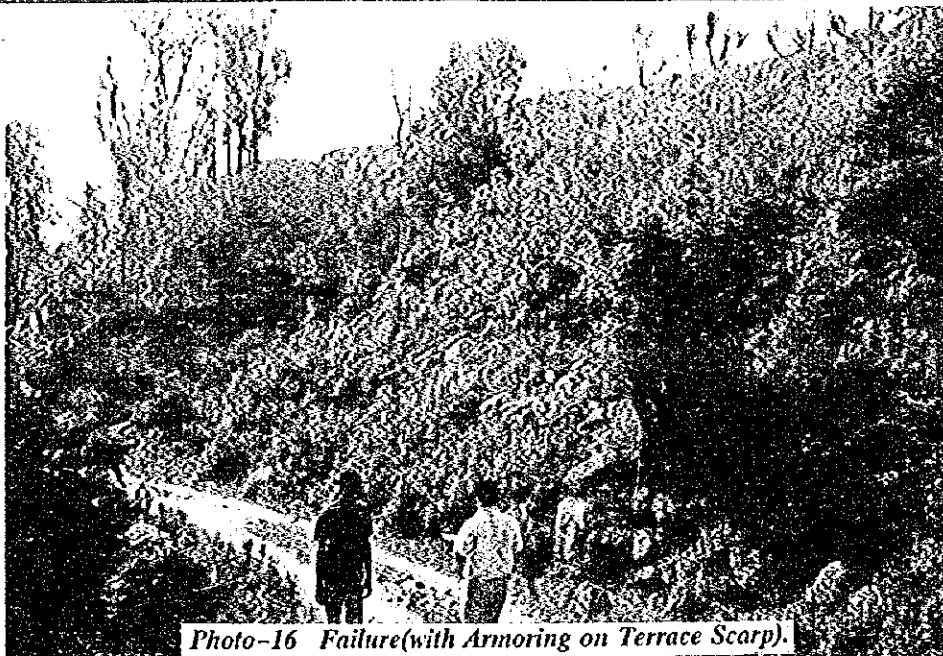
Photo-16 Failure (with Armoring on Terrace Scarp).

Scattered along the road, comparatively stable
